Assessment of
Ameren Illinois Company's
Annual Reliability Report and
Electric Service Reliability
For Calendar Year 2011

Pursuant to 83 Ill. Adm. Code 411.140

April 18, 2013

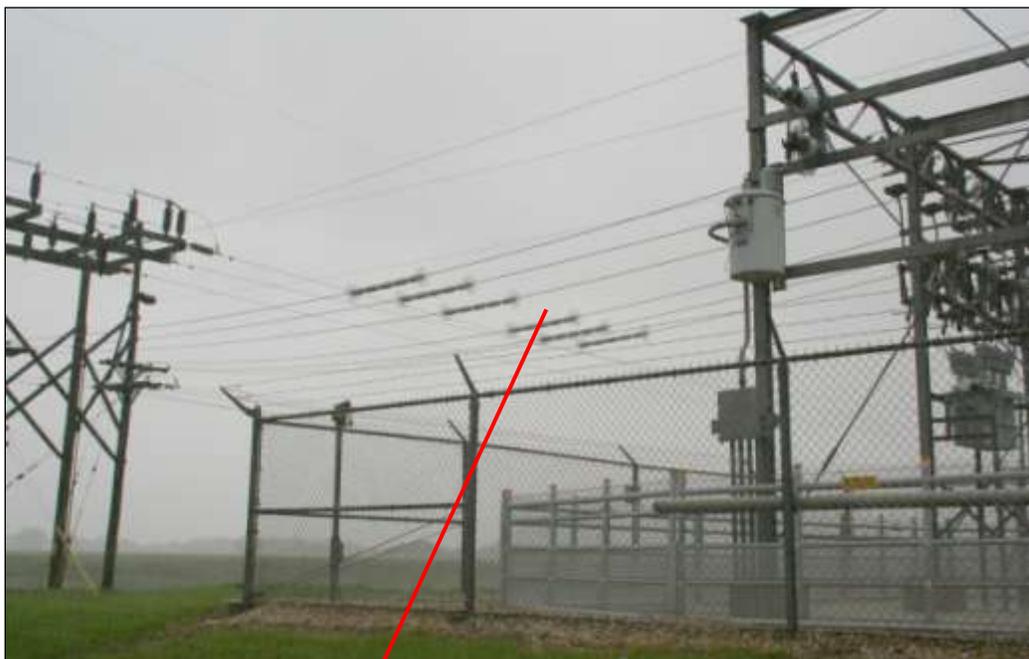
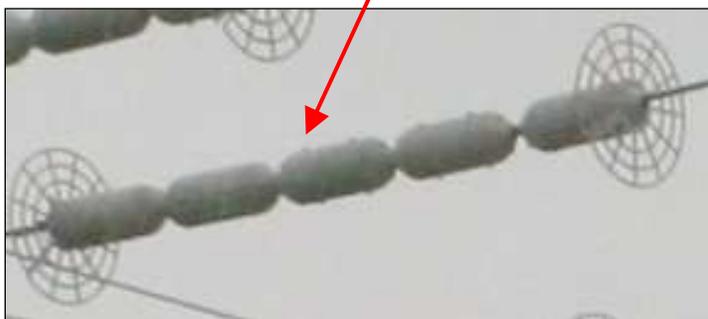
When inspecting Circuit V83-505 in early May, Staff was impressed with the animal protection that AIC had installed at South Winchester Substation, the circuit's source, which included a separate electrified animal fence inside the substation perimeter fence, animal guards on the bushings of the distribution equipment within the substation, and "spinner" animal guards on the distribution conductors exiting the substation to prevent squirrels or other animals from getting inside the fence via these conductors (Photo 1). The extensive animal protection that AIC has installed at South Winchester Substation is an effective method to keep raccoons, squirrels, and other animal pests from causing large-scale interruptions. The only problem that Staff noted at the substation was that the substation transformer was rusting and should be painted. Out on the distribution circuit, Staff observed few potential threats to reliable service: four locations where new tree growth was coming close to the primary conductors, and one location where a primary insulator was coming loose from its crossarm. Staff found that the steps AIC has taken or plans to take to improve the reliability of Circuit V83-505 are reasonable.

Photo 1: Interior electrified animal fence and animal guards at South Winchester Substation.

Individual segments of this animal guard spin when an animal attempts to crawl across.

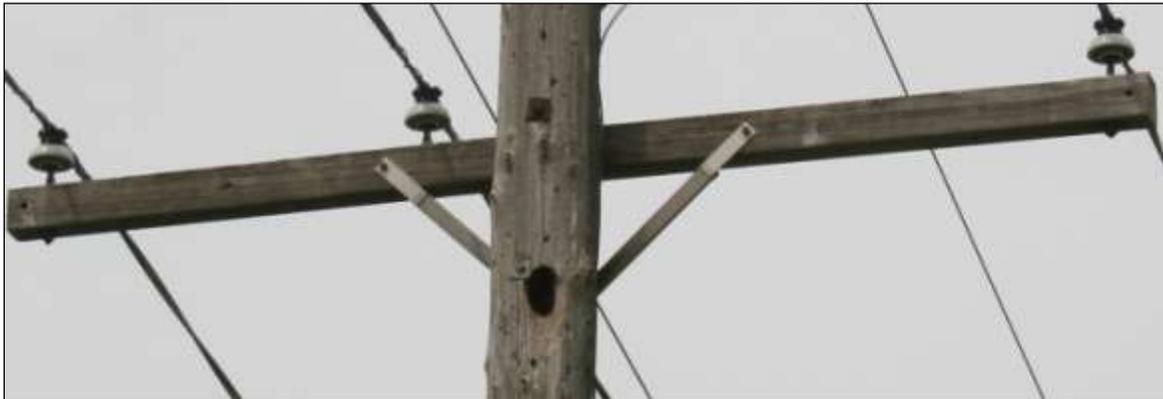
location where a maple tree was contacting the primary, several poles with varying degrees of woodpecker damage (Photo 2), adjacent poles with missing crossarm braces, a static wire support coming loose from the top of a subtransmission pole, a lightning damaged crossarm (Photo 3), and a secondary riser with inadequate stand-off bracket spacing.⁴ Staff noted that AIC had replaced a large number of poles, had installed overhead fault indicators at several locations, and had installed animal guards on most of its distribution transformers –all of which should increase the reliability of Circuit U41-517 in the future. Staff believes that the steps AIC has taken or plans to take to improve reliability for customers supplied by Circuit U41-517 are reasonable

Photo 2: Large Woodpecker hole at location of crossarm brace attachment (U41-517).

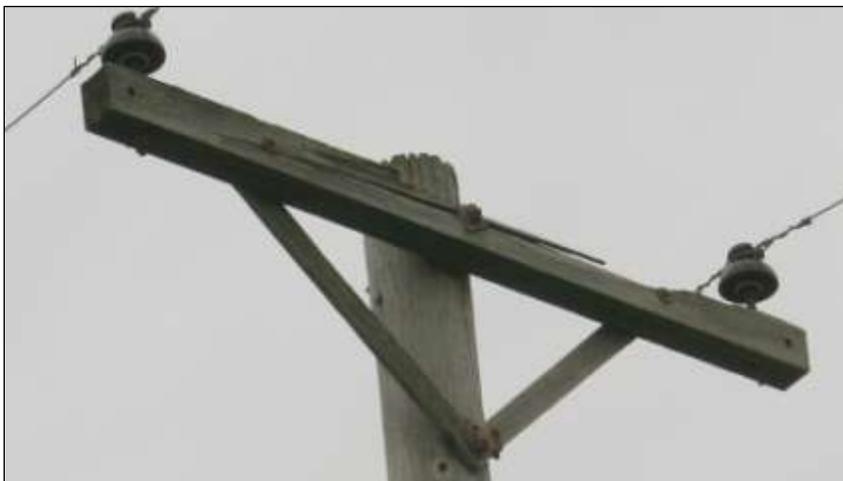
Photo 3: Lightning damaged crossarm (U41-517)

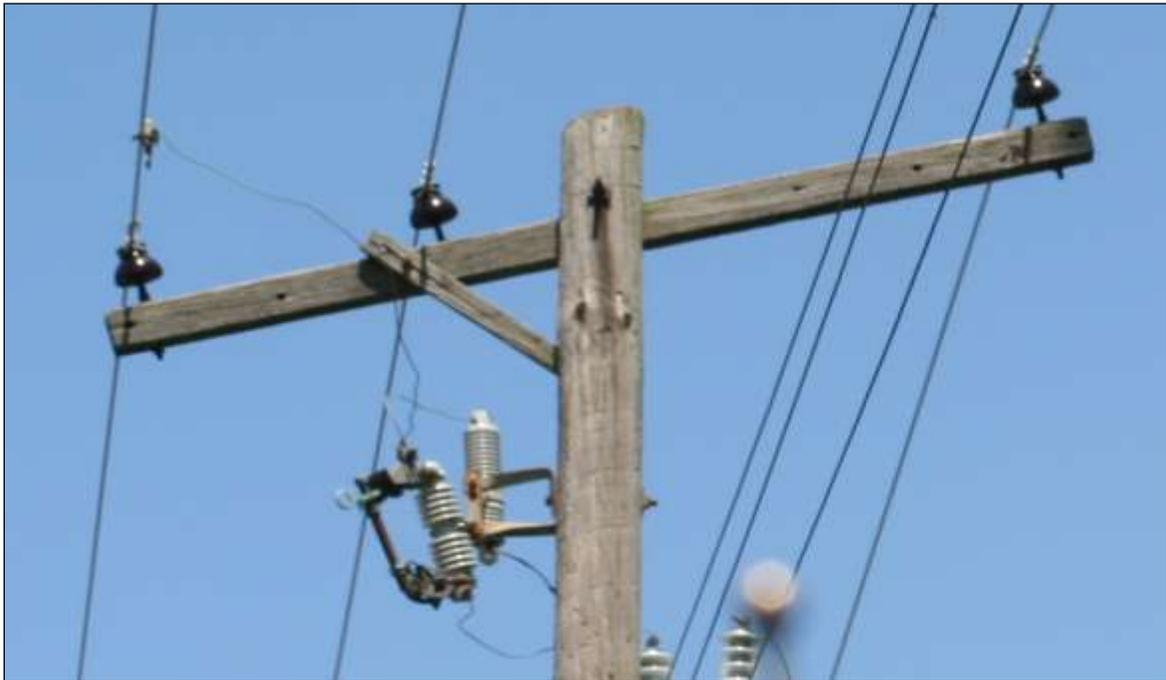
Photo 4: Crossarm leaning due to splitting single brace (Y68-581)

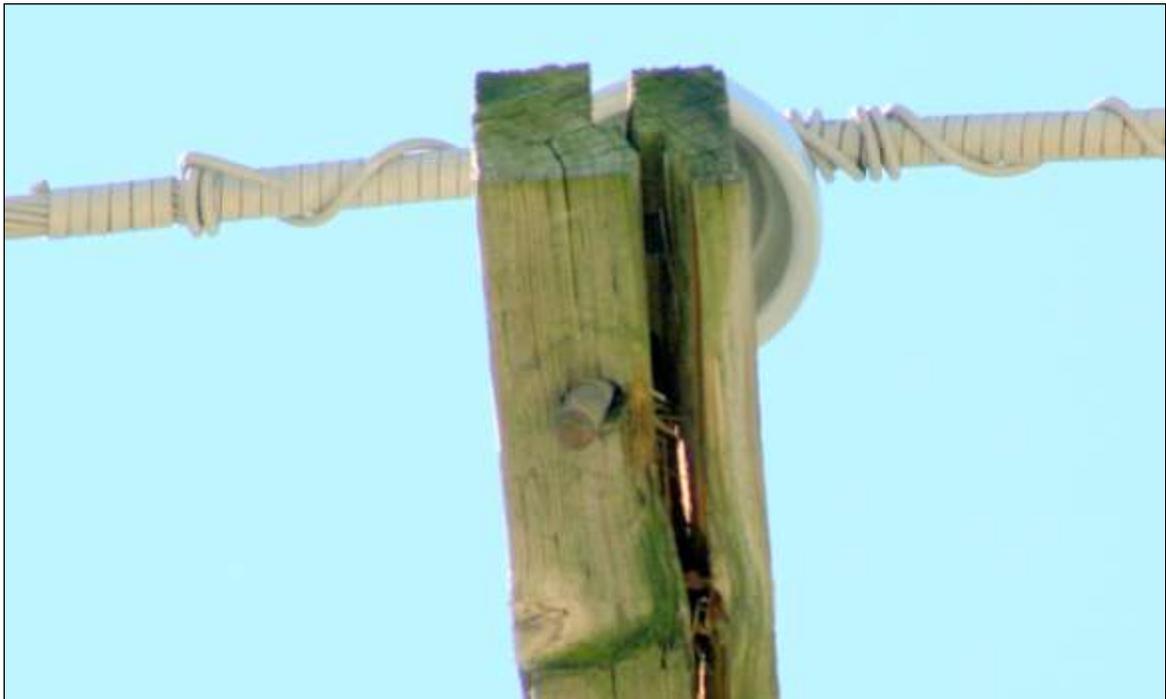
Photo 5: Crossarm is split near pin insulator that is missing mounting nut (Y68-581)

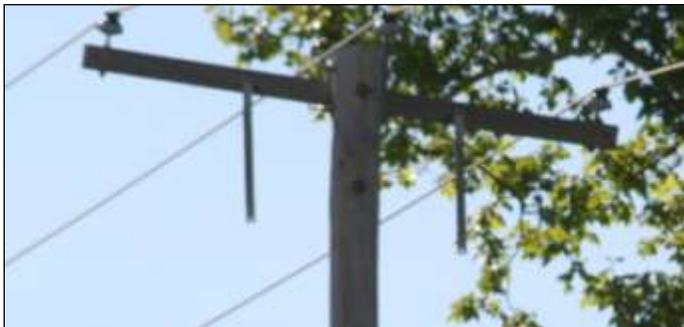
Photo 6: Both braces detached from pole (Y60-593)

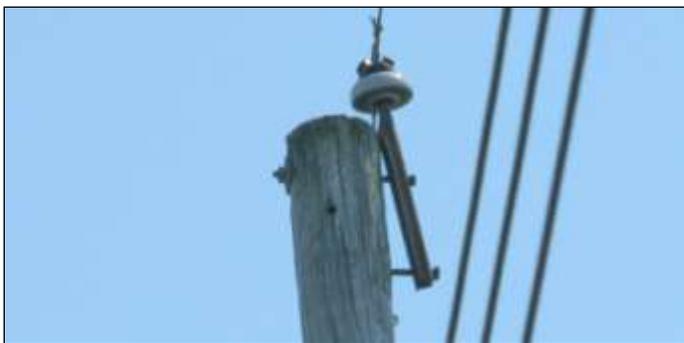
Photo 7: Pole top pin with top nut loose and lower nut missing (Y60-593)

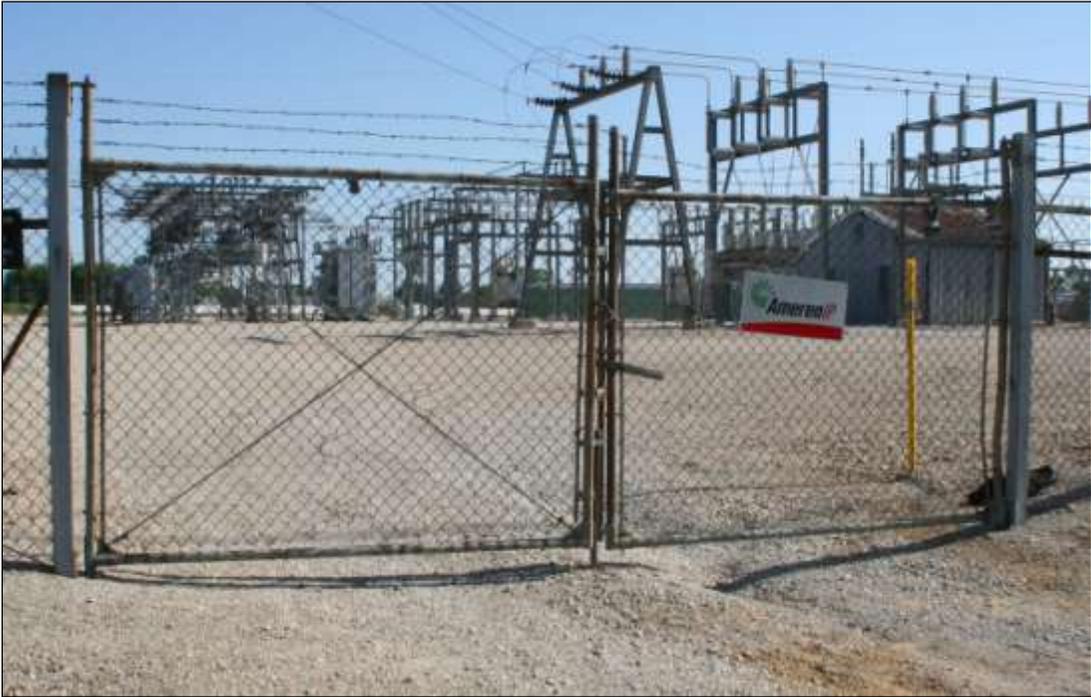
During Staff's inspection, Staff noted that Kewanee South Street Substation had no grounding straps on its entrance gates, and very large gaps under the gates and fence – some that were large enough for a person to crawl through (Photos 8). There was no electrified animal fence inside the perimeter fence, but AIC had installed animal guards on the distribution equipment bushings. One of the substation's regulators was very rusty (Photo 9). AIC has done a good job keeping vegetation away from its primary conductors out on the circuit. However, Staff noted a few other problems: a location where the primary conductor had come loose from the post insulator so that it was floating very close to the neutral (Photo 10); several locations with improper riser stand-off bracket spacing; two locations where the ground clearance of AIC's neutral conductor appeared to be inadequate; two locations where crossarm braces were broken or detached (Photo 11); and several locations where down guys appeared to be neither insulated nor effectively grounded. Given that Circuit N70-330 was a 2010 worst performing circuit, the Company should have identified and addressed the abovementioned issues.

Photo 8: Large gaps under gates at Kewanee South Street Substation (N70330)

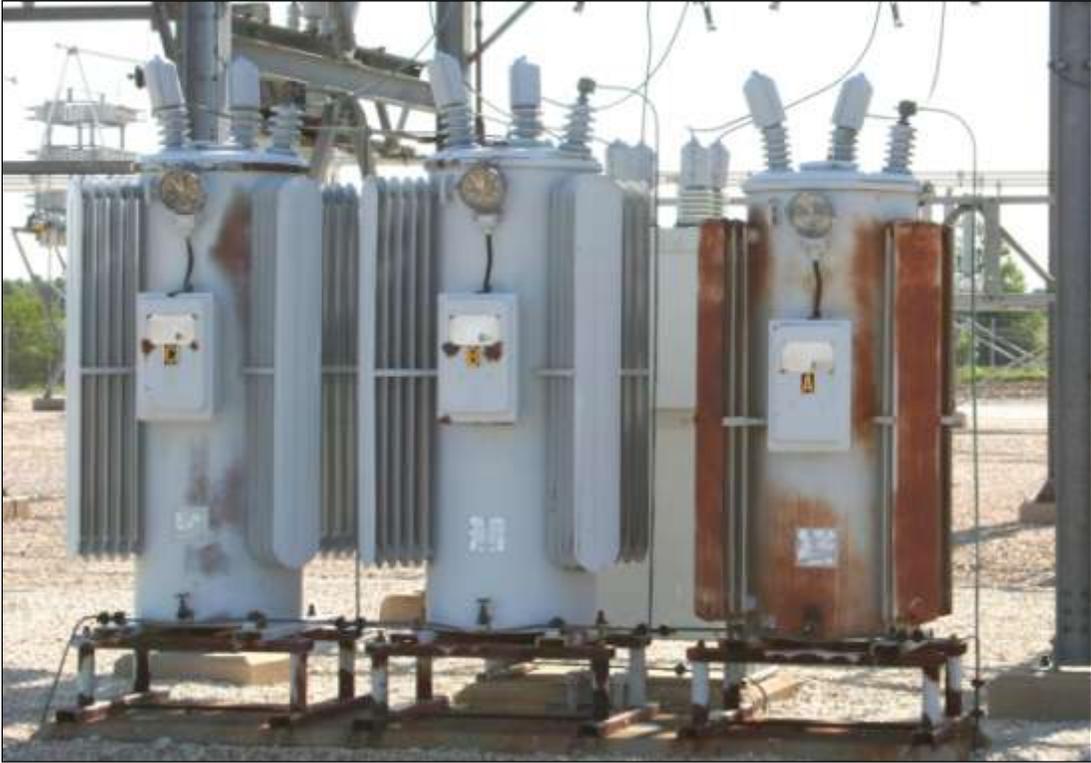
Photo 9: Rusty regulator at Kewanee South Street Substation (N70330)

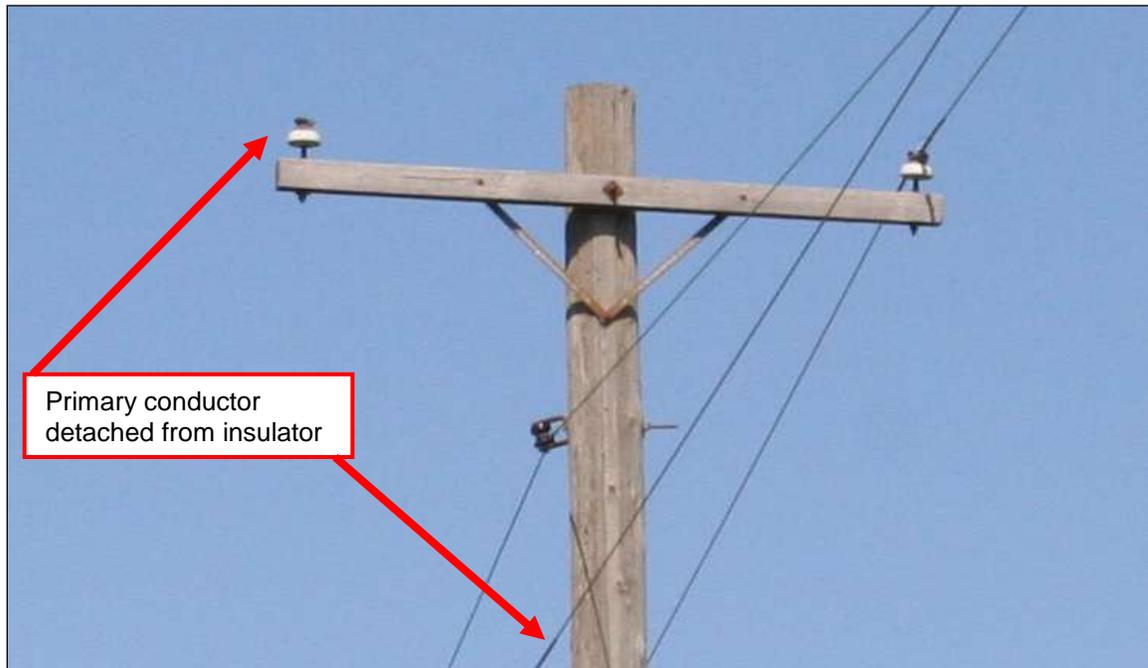
Photo 10: Primary conductor detached from insulator and floating near neutral (N70330)

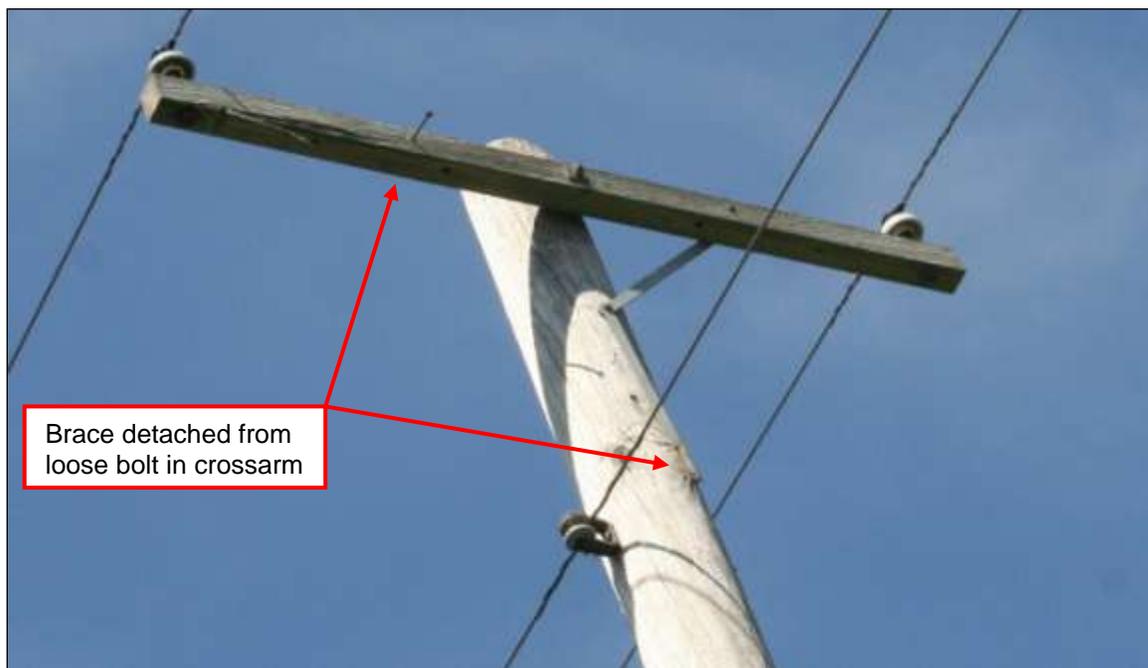
Photo 11: Bolt for brace coming out of crossarm – brace detached (N70330)

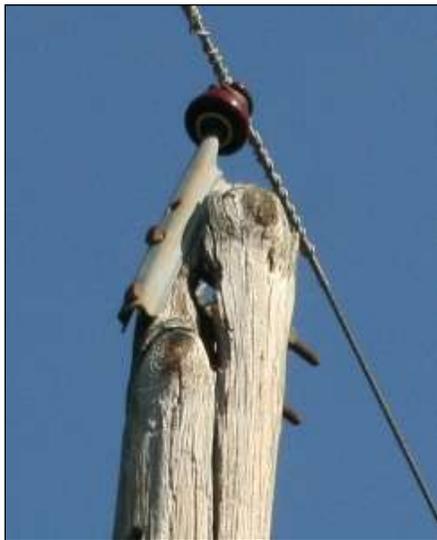
Photo 12: Split pole top (R73-841)

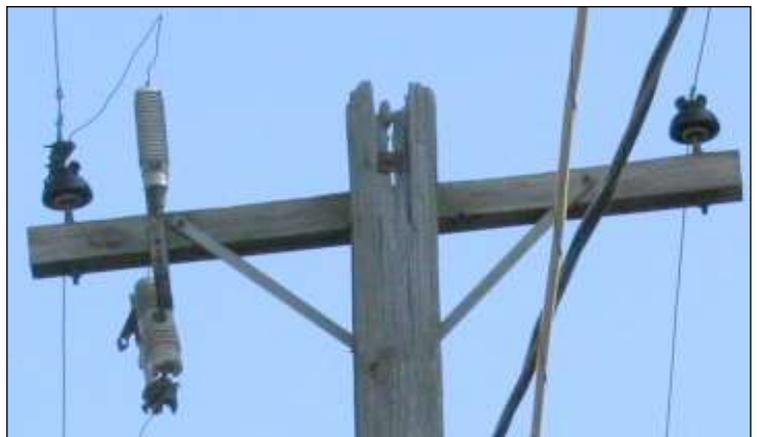
Photo 13: Deteriorated pole top (R73-841)

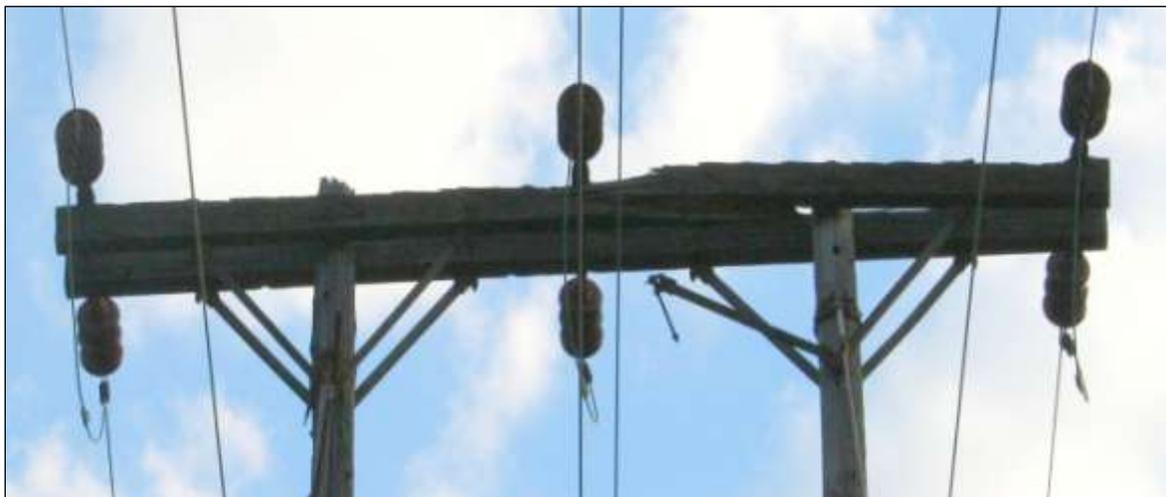
Photo 14: Damaged 34 kV crossarm on structure above 12 kV circuit (S47-576)

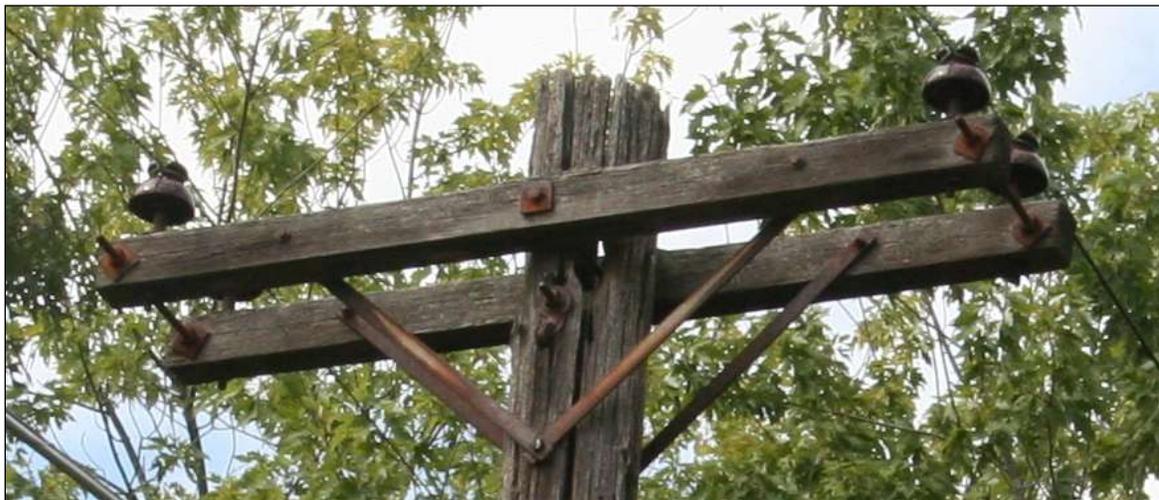
Photo 15: Top of pole is split and hollow below the crossarm mounting bolt (S47-576)

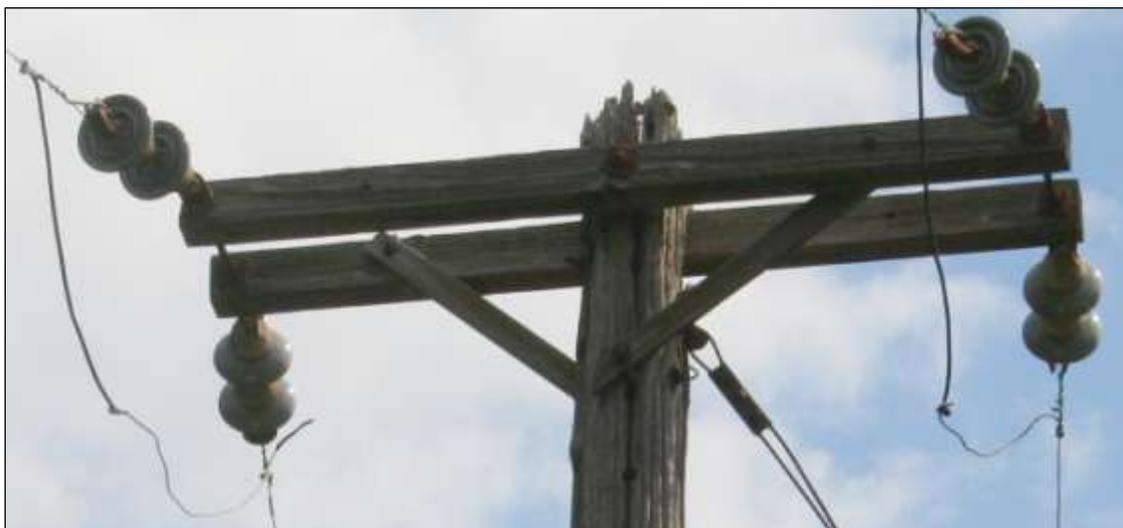
Photo 16: Pole @ RR crossing with split top & single brace on both crossarms (S47-576)

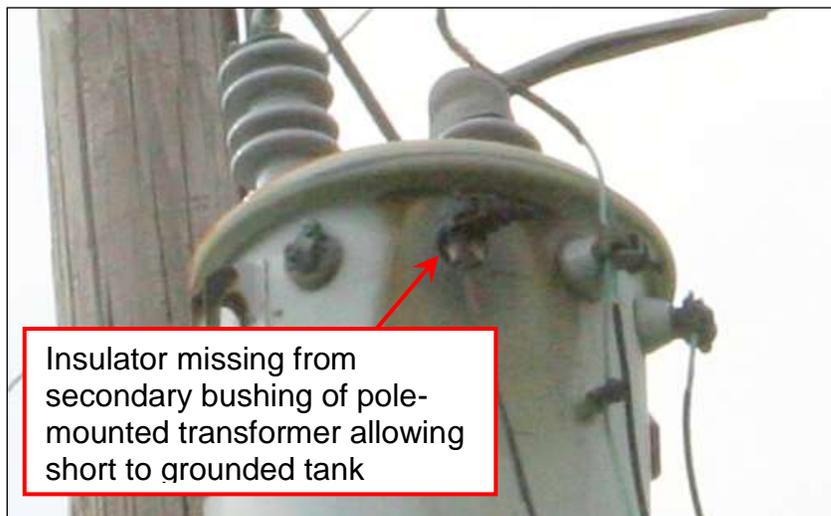
Photo 17: One of the secondary bushings missing on transformer (T08-502)

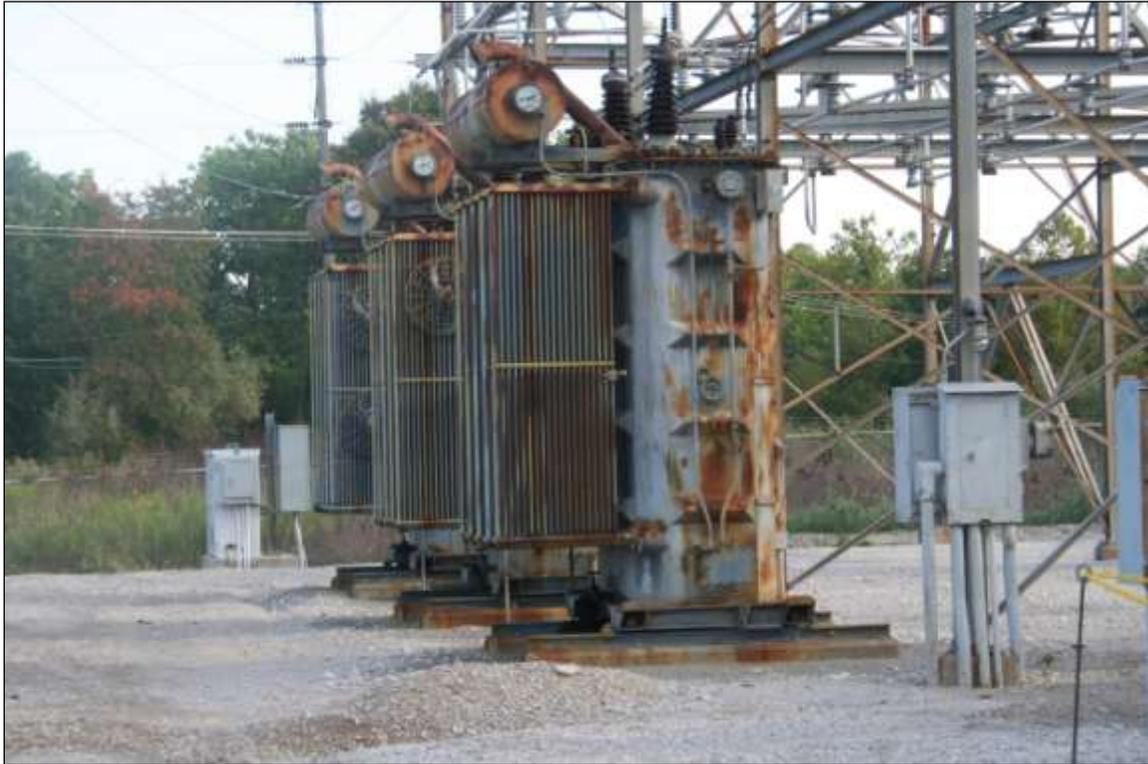
Photo 18: Rusting transformers at Texas Substation (R41-131)

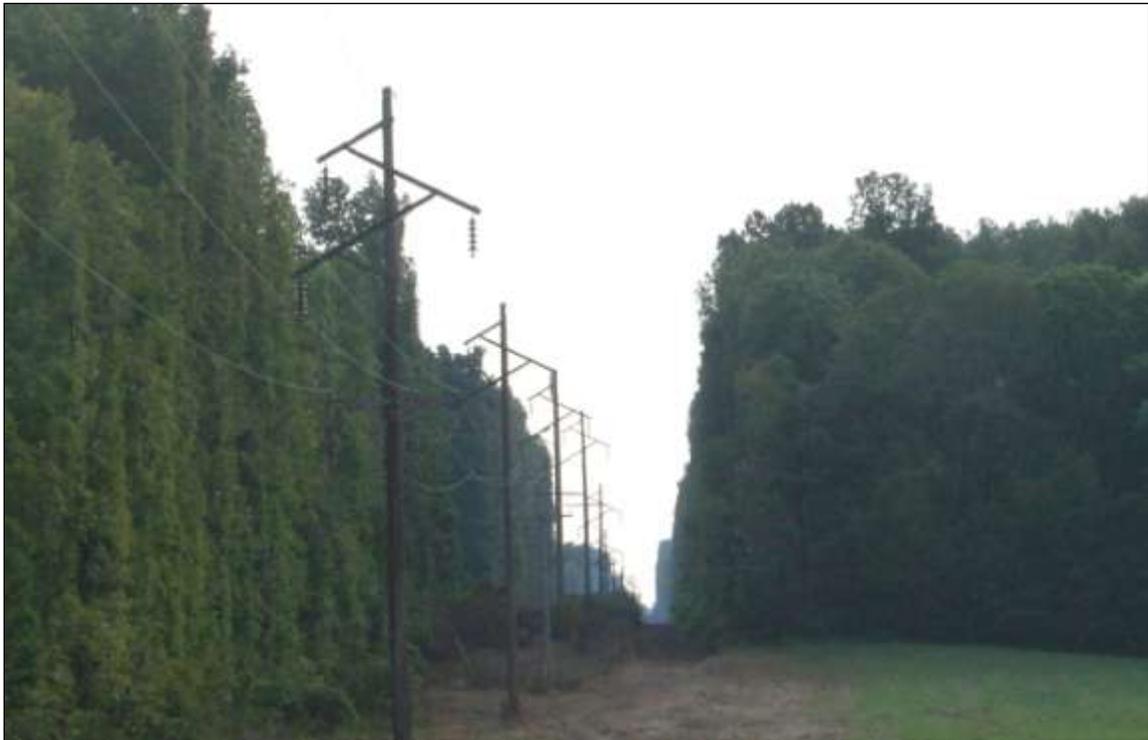
Photo 19: AIC's vegetation clearing (R41-131)

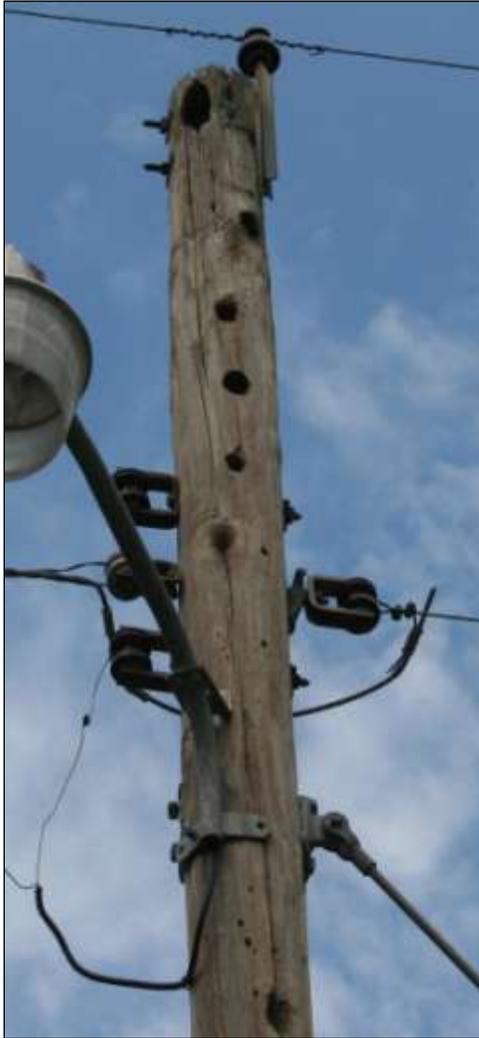
Photo 20: Woodpecker damaged pole (R41-131)

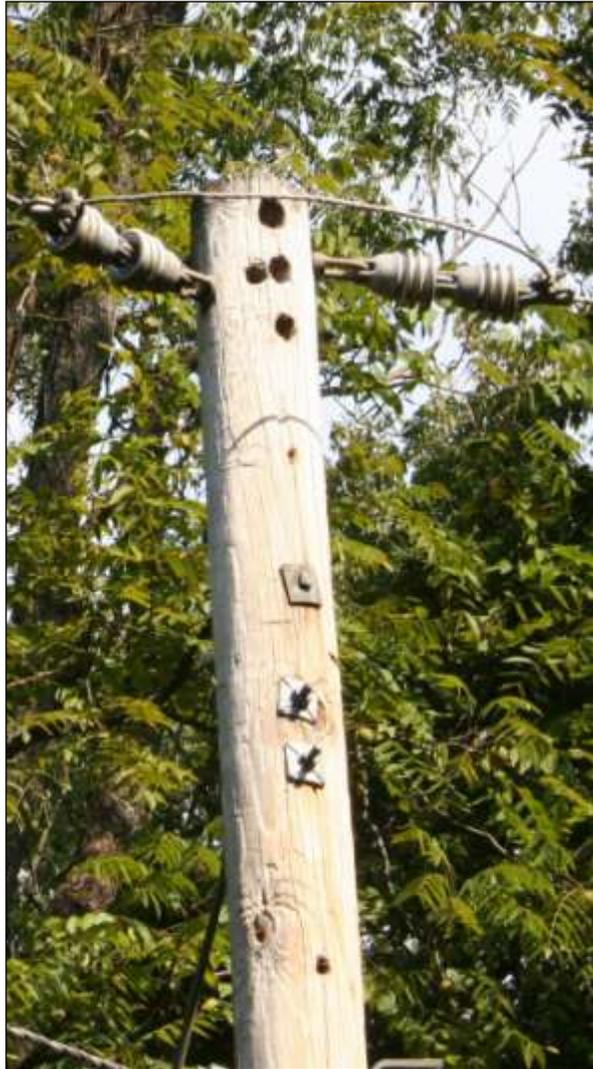
Photo 21: Woodpecker damaged pole (R41-131)

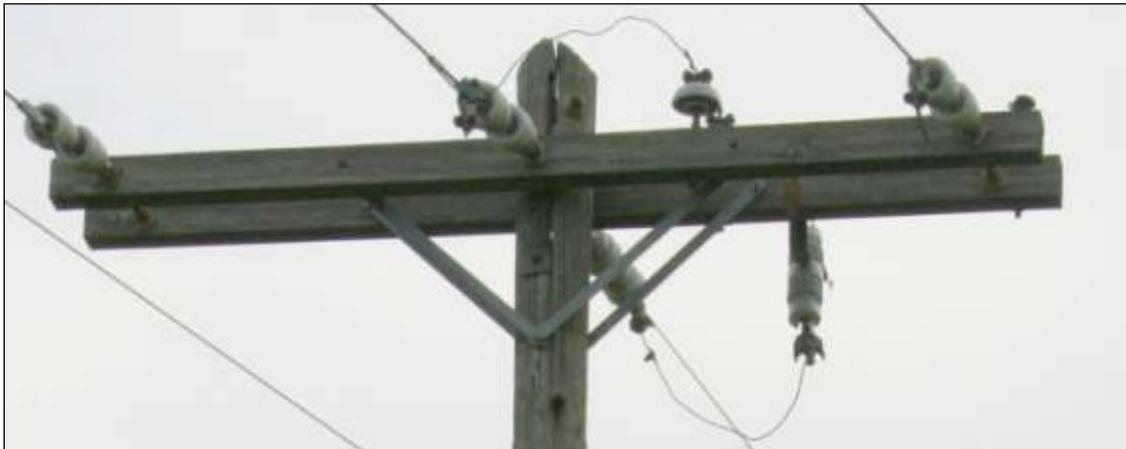
Photo 22: Pole top splitting to below crossarm mounting bolt (R41-131)

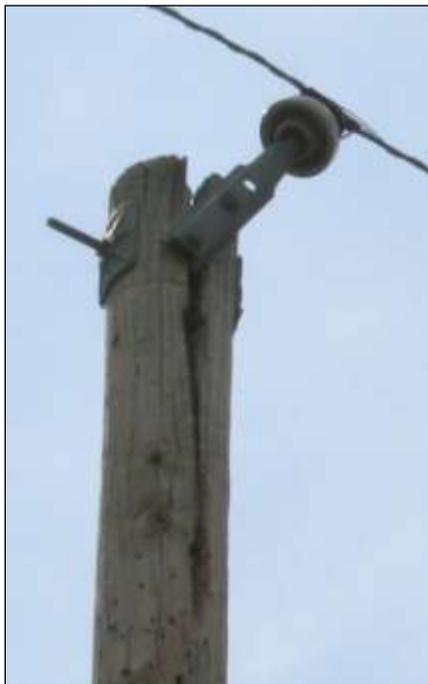
Photo 23: Split pole top (R41-131)

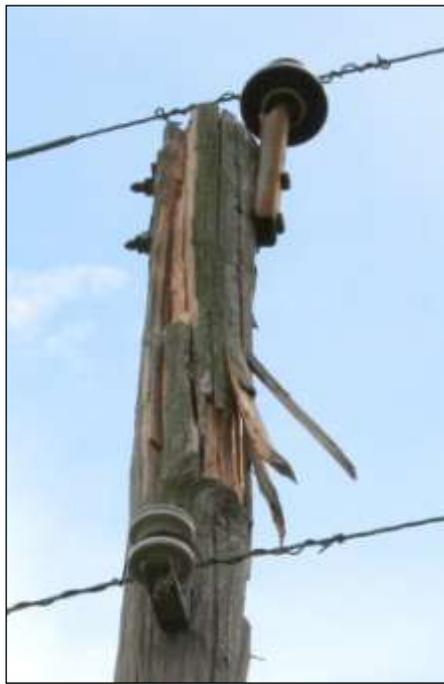
Photo 24: Lightning damaged pole top (R41-131)
