Appendix A: Chicago Region Circuit Z1408

Chicago Region Circuit Z1408 (Page J-12 of ComEd's 2002 Reliability Report):

Utility: ComEd Investigators: J. Stutsman & J. Spencer

Feeder Ckt/Sub: Z1408/TDC814 (Dundee) City: Chicago Voltage: 12kV Date: Wednesday, June 18, 2003

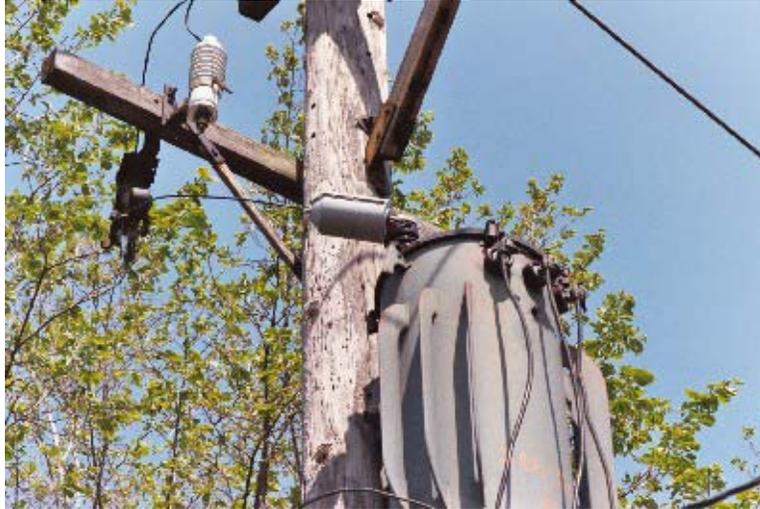
Picture A-1

Photo ID	Drawing No.	Location Description	Observations at this Location
A1	Z1408-2	Transformer 7532041 (Open Delta)	Animal Guards detached and ineffective on 2 transformer in a row (2 open delta transformers that were mounted on separate poles next to each other)
A2	Z1408-2	Transformer 7531641	Pole supporting transformer has cross-arms bolted to base
A3	Z1408-3	2nd pole South of Transformer 7271801 [behind houses (on west side of alley) between house number 6923 and 6949]	Split pole top
A4	Z1408-3	1 pole west from 5 Bell	Badly shell rotted pole
A5	Z1408-3	Same as A5	Cross-arm driven in ground at base of pole and broken off
	Z1408-1	Various Location	Noted animal guards on many transformers such as transformers 7802443 and 7802441 but no animal guard on transformer 7802202
	"	Primary just south of transformer 7802441	Trees were close to primary
	Z1408-2	Transformer 7530141	Animal Guard is hanging off of transformer
