Appendix H: Random Inspections – Wednesday, July 16, 2003

Utility: ComEd Investigators: J. Stutsman & J. Spencer

Feeder Ckt/Sub: Random Overhead Sys Insp City: Thornton, Homewood, Richton Park, Kankakee Voltage: 4/12kV

Date: Wednesday, July 16, 2003

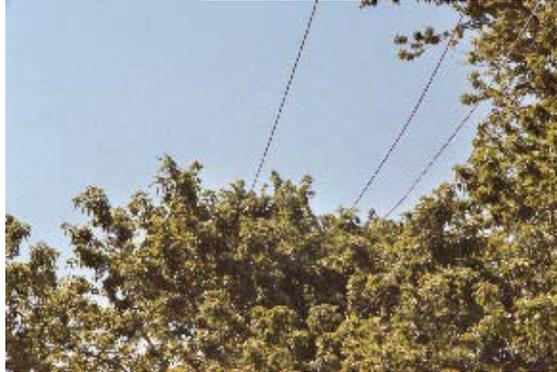
Picture H-1

<u>Photo ID</u>	<u>Drawing No.</u>	<u>Location Description</u>	<u>Observations at this Location</u>
K11	Thornton	Vincens Ave Just South of Armory St (167th) -- Across the street from Rockwell Automotive	Primary into soft maple tree
K12	Thornton	Vincens Ave Just South of Armory St (167th) -- Across the street from Rockwell Automotive [same location as K11]	Primary into soft maple tree
K13	Thornton	Margaret Street (about 100-150 yd stretch)	Primary into trees (Mulberry principally) with burning visible and All three phases into trees the eastern end of the ckt looks poorly terminated -- may be unused or dead but doesn't look clean
K14	Thornton	"	"
K15	Thornton	"	"
K16	Thornton	"	"
K17	Thornton	Margaret Street just south of intersection with Levenworth Street	Cottonwood tree looks close and overhanging
K18	Thornton	"	"
K19	Homewood	Heather Rd just East of Martin Ave.	Cottonwood close to primary
	Homewood	West on Martin Ave from Martin Ave & Heather Rd. Intersection	Noticed extensive trimming west of Martin Ave where there had been clearances problems in 2001

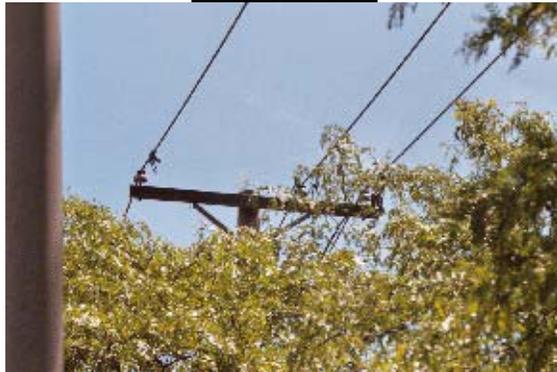
Picture H-10

K20	Richton Park	Salk Trail @ intersection with Hillside in front of Lakewood Bowl in Lakewood Plaza by device 497332U6	Primary very close and may be in contact with Locust tree
K21	Kankakee	Alley between Greenwood and Rosewood and north of Station St. by 75yds	Tree Contact with Primary
K22	Kankakee	On Oak St. between Myrtle and Evergreen	Silver Maple Tree Contact with Primary
