Substation Inspections for Monday & Tuesday, June 27-28, 2005:

Field Report – Monday, June 27, 2005

Appendix D: Substation Inspections

ICC Docket No. 05-0597
ICC Staff Exhibit 10.0
Attachment 10.1

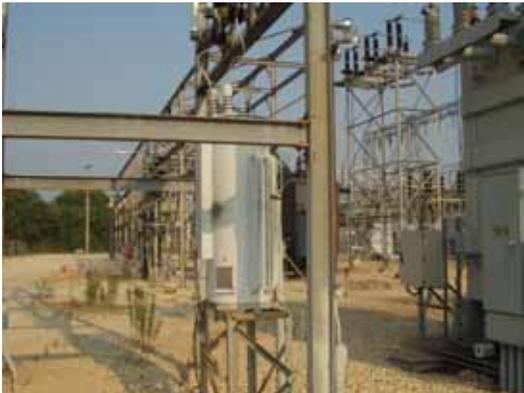
P6270003 – weeds in yard

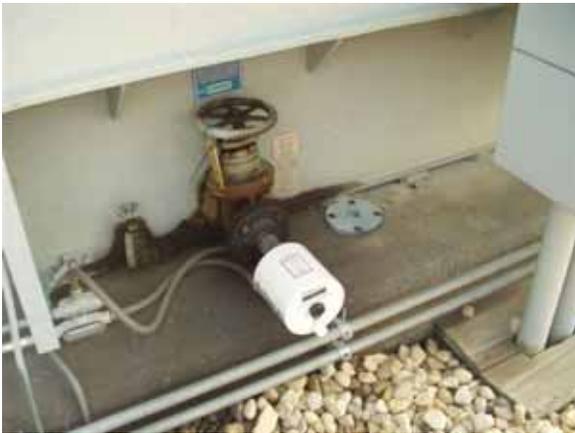
P6270005 -- Hydran at TR 76 with some oil leakage or spillage

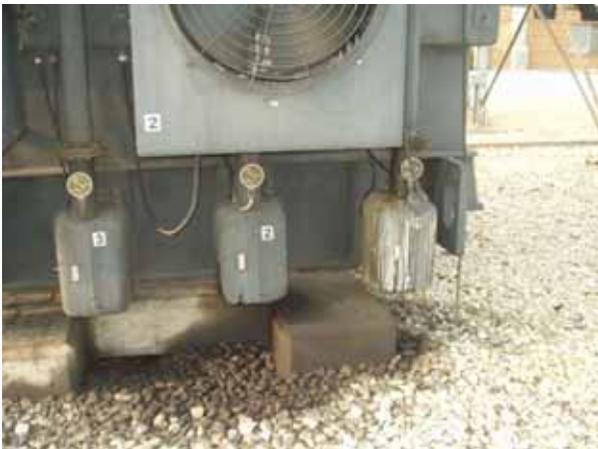
P6270008 – Fresh oil on ground at TR 77

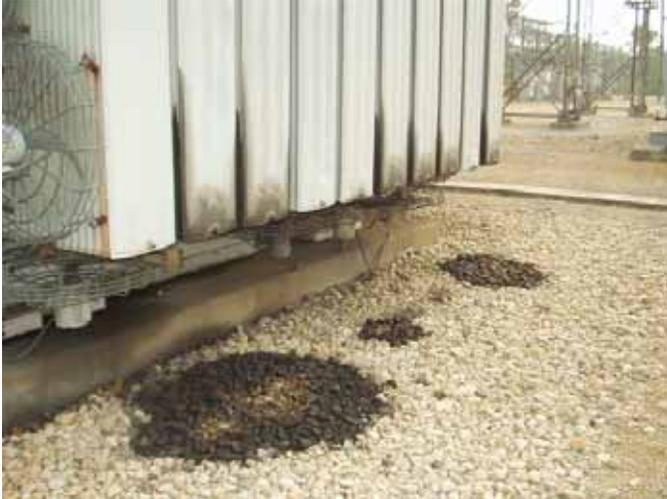
P6270012 – TR 74 old oil leaks below fins has not been cleaned up.

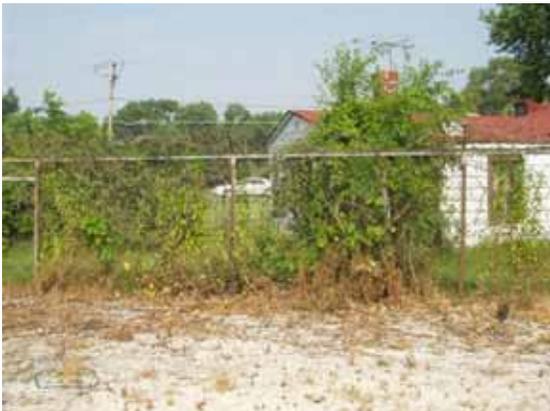
P6270025 – Vegetation within Substation. There was some trash in this area but ComEd personnel with Staff picked it up as they came into the Substation.

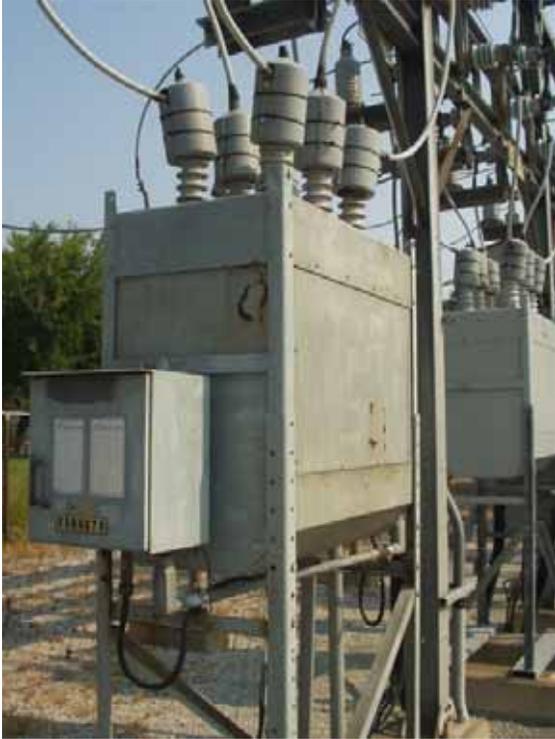
P6270026 – FDR4674 Bus Disc – with rust & bad paint job

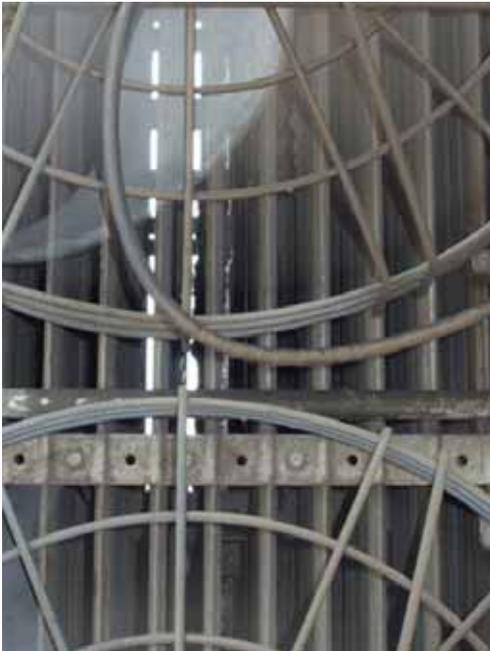
P6270031 – Dirt visible on cooling fins on transformer XFMR71

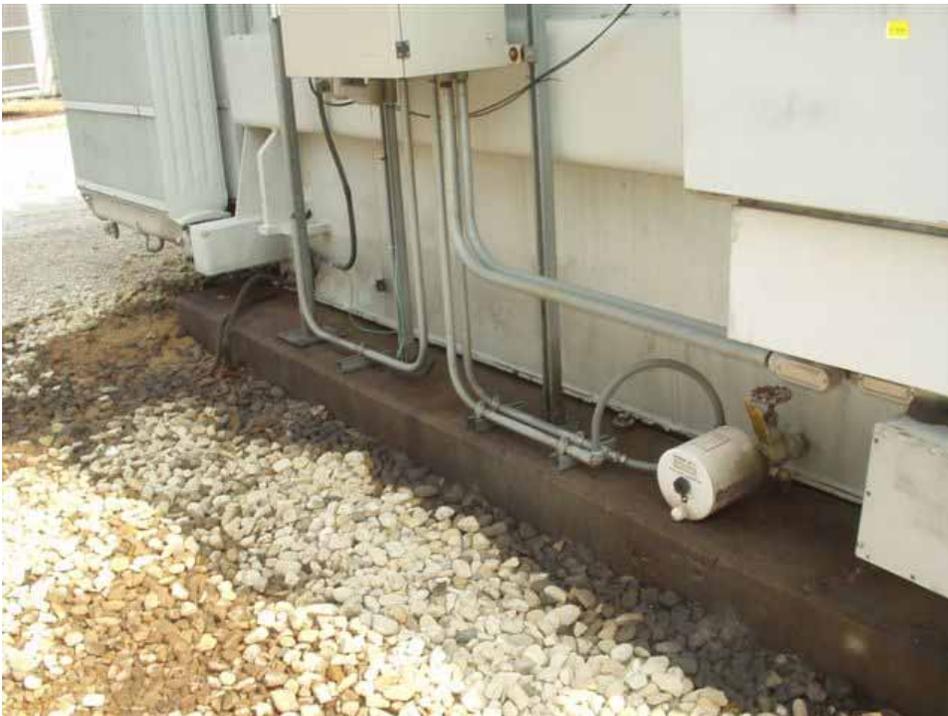
P6270036 – Leak on other side of XFMR 74. Noted ground cable partly out of ground

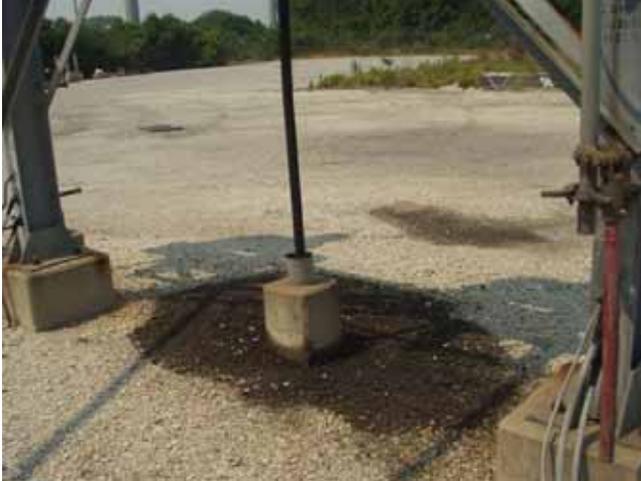
P6270040 – XFMR78 oil leak on ground from secondary cable

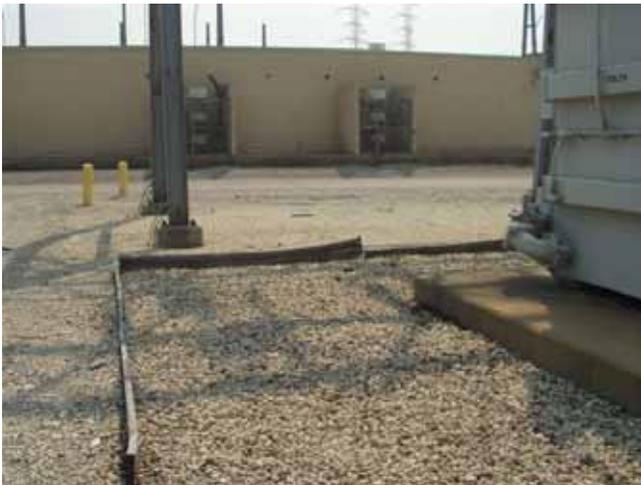
P6270041 – XFMR 78 tripping hazard.

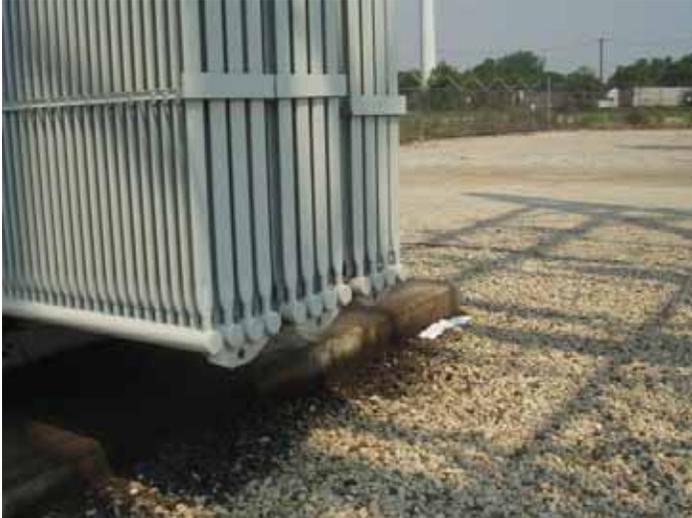
P6270043 – XFMR76 Trash around XFMR and oil stain.

XFMR76 rust observed on the outside

XFMR 76 oil leak at top of cooling fins and body of XFMR

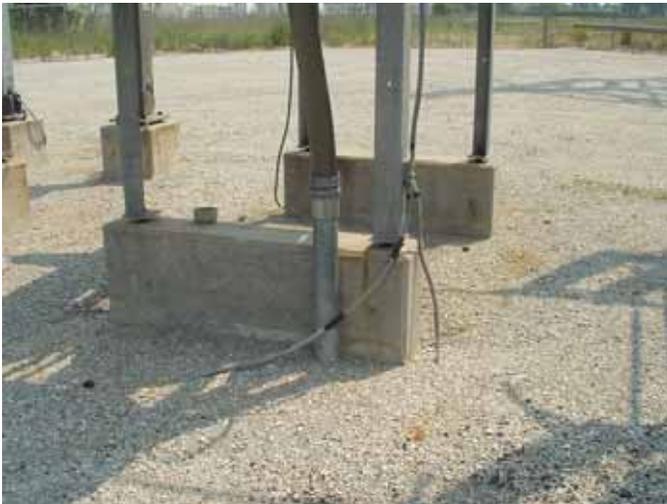
P6270046 – Ground wire laying on ground near L94402 Breaker

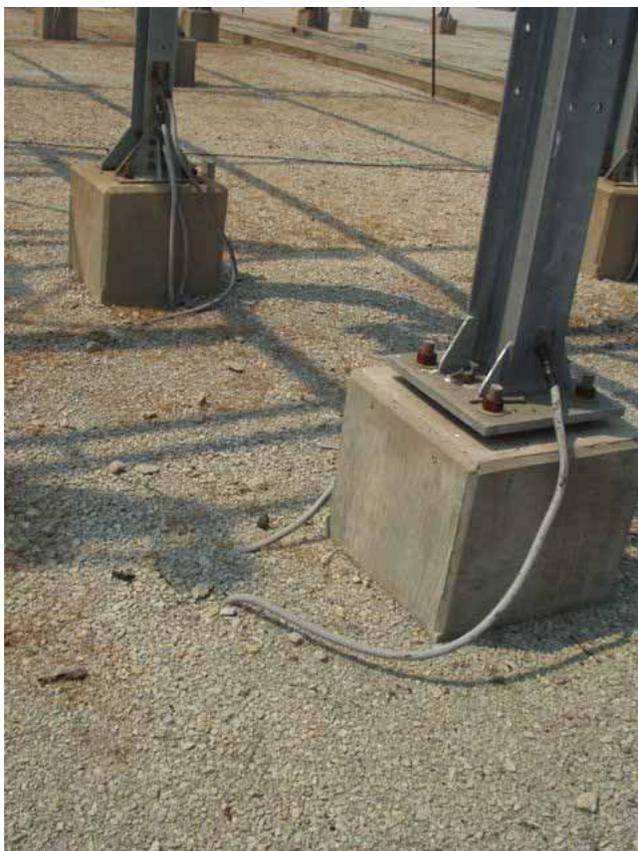
P6270048 – Ground wires laying on/across top of ground

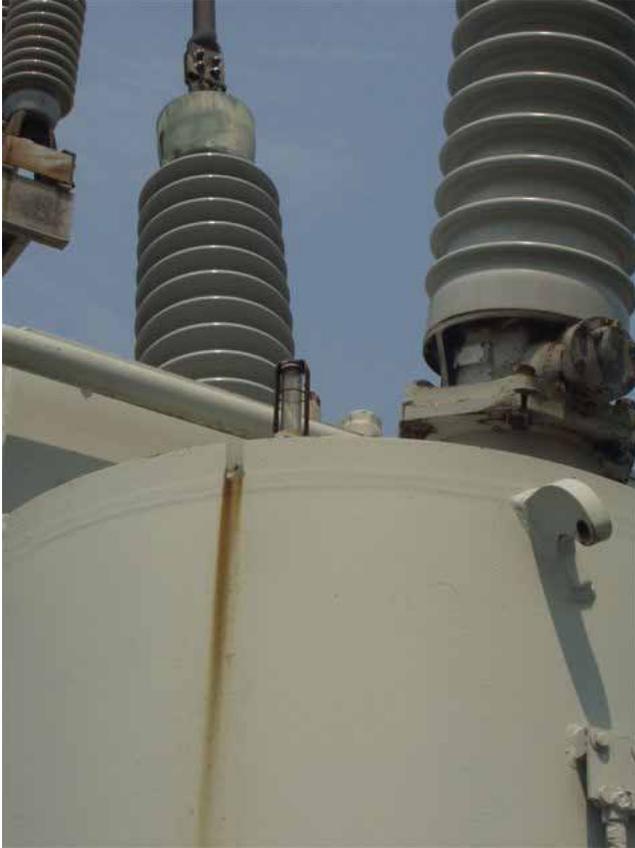
P6270050 – A phase oil level in tank OCB L0707 plug/float up against top of tank oil gauge

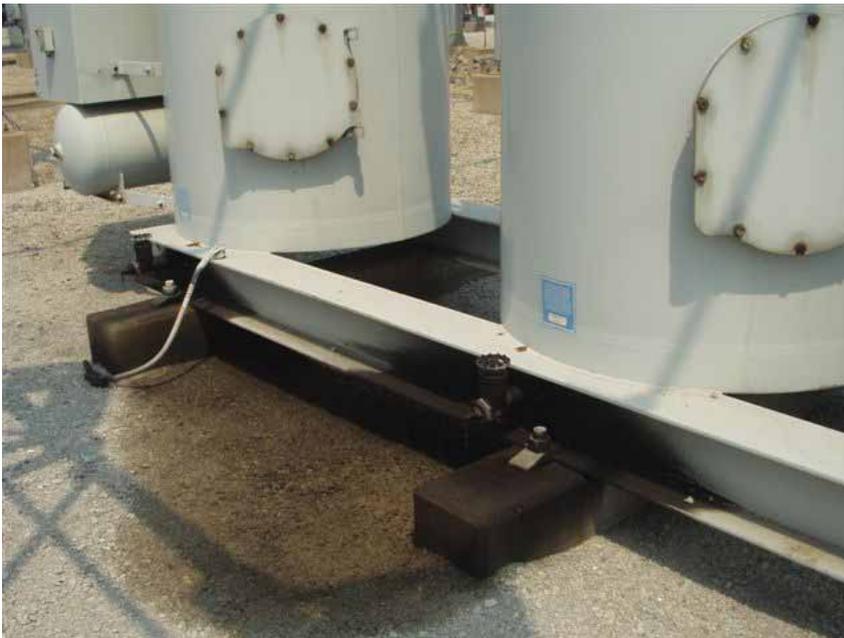
P6270051 – Oil leak at B&C phase tanks of BT2.3

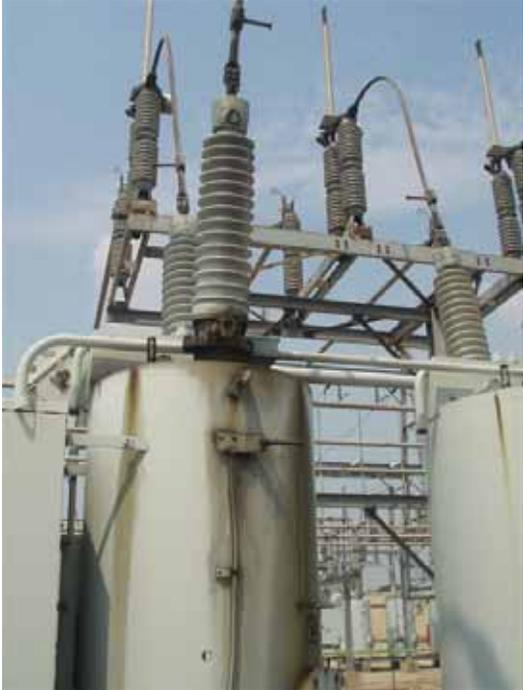
P6270053 – P.U. 33.34 C phase Tank bushing oil on “L” and oil leak visible == ComEd personnel noted that it is being decommissioned and is not currently in service

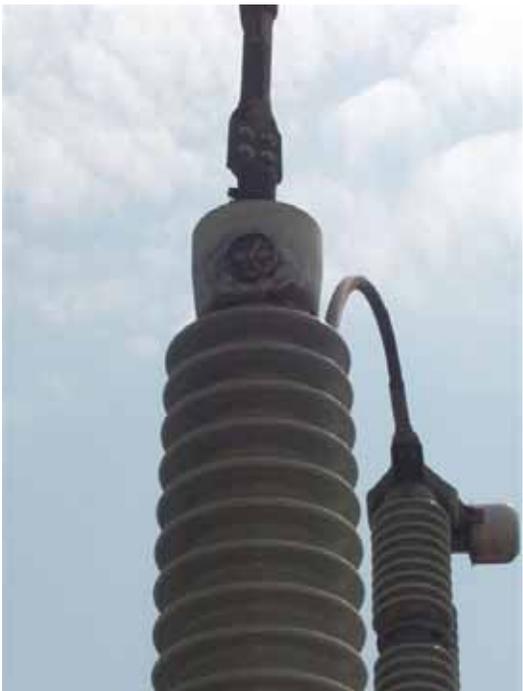
P6270055 – C phase bushing of L15001 OCB level on H

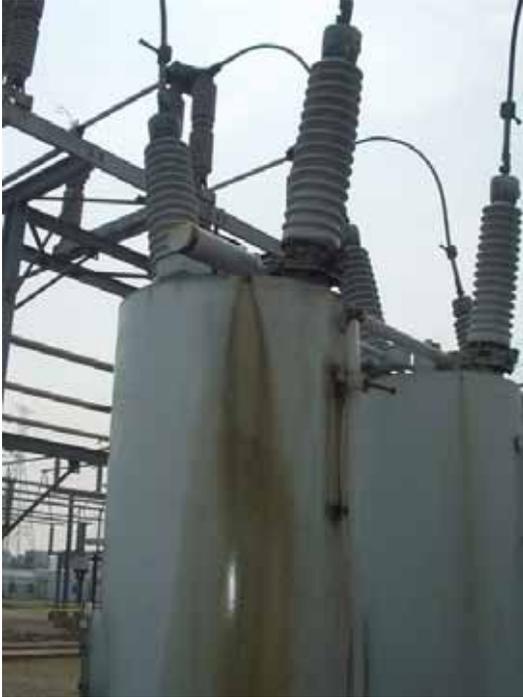
P6270057 – TR 72&76 OCB C phase tank active oil leak

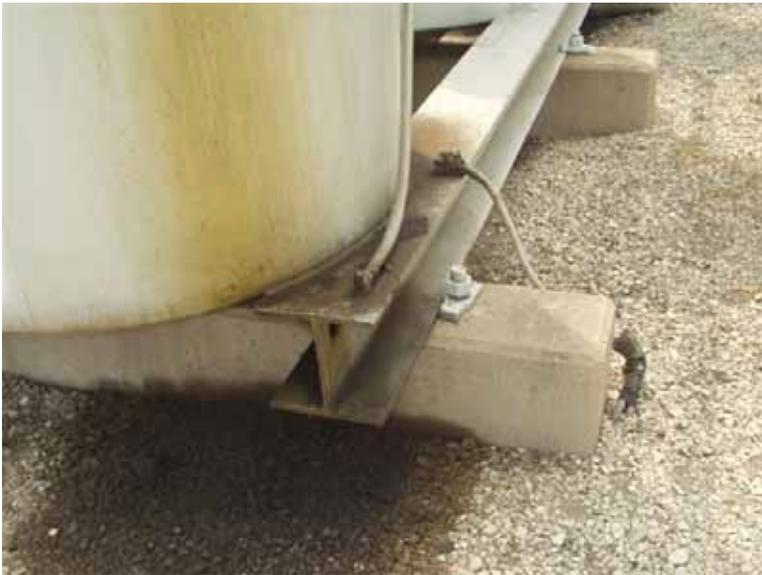
P6270059 – TR 72&76 OCB C phase anchor clamp off – all off on opposite side

XFMR 72&76 OCB C phase rust on tank

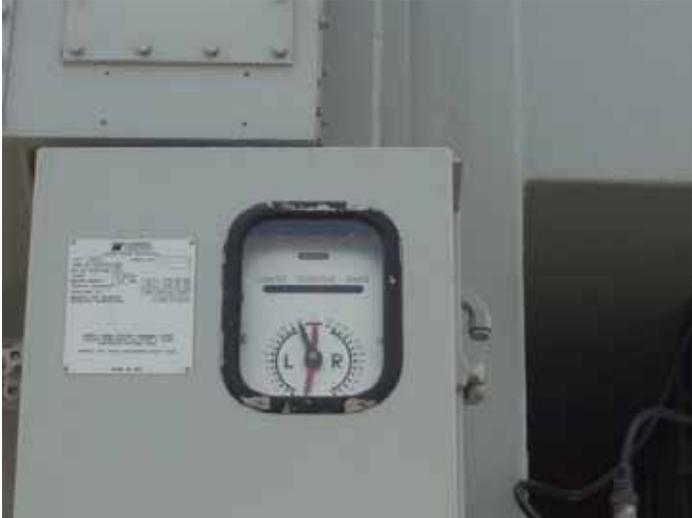
P6270061 – XFMR 71X LTC – noted operation at extreme limit.

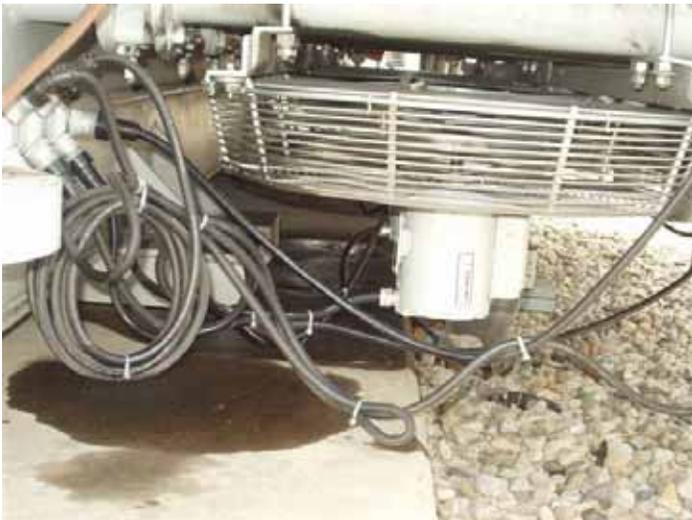
P6270062 – XFMR 71X oil leak under fins

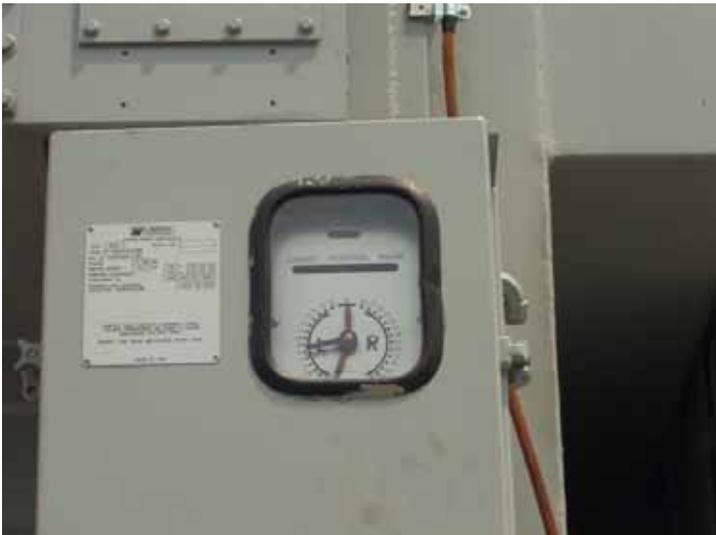
P6270063 – XFMR 71Y LTC – note operation at extreme limit

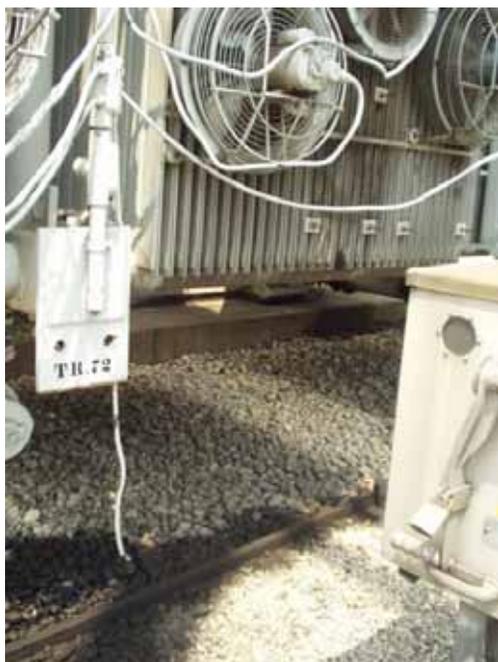
P6270065 – XFMR72 missing fan has been disconnected and is out for repairs

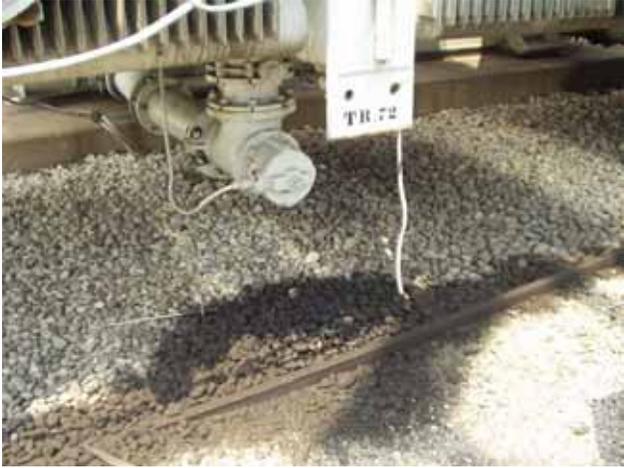
P6270066 – XFMR72 oil on ground

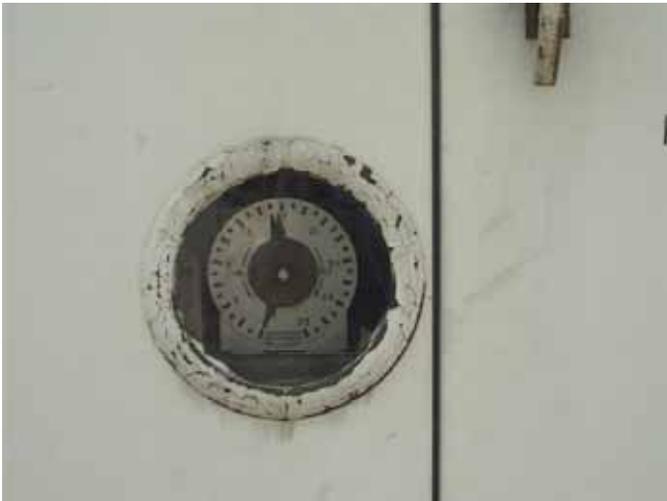
P6270068 – XFMR73X LTC shows that it has operated in one extreme position – XFMR also missing a fan that ComEd reports was removed for replacement

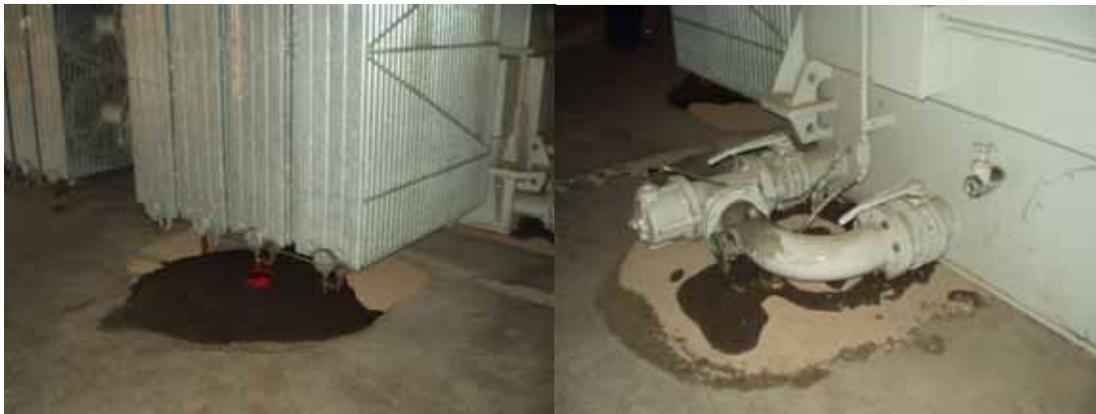
P6270076 & P6270077 XFMR73 oil leaks – note material placed down to absorb the oil for easier clean-up later

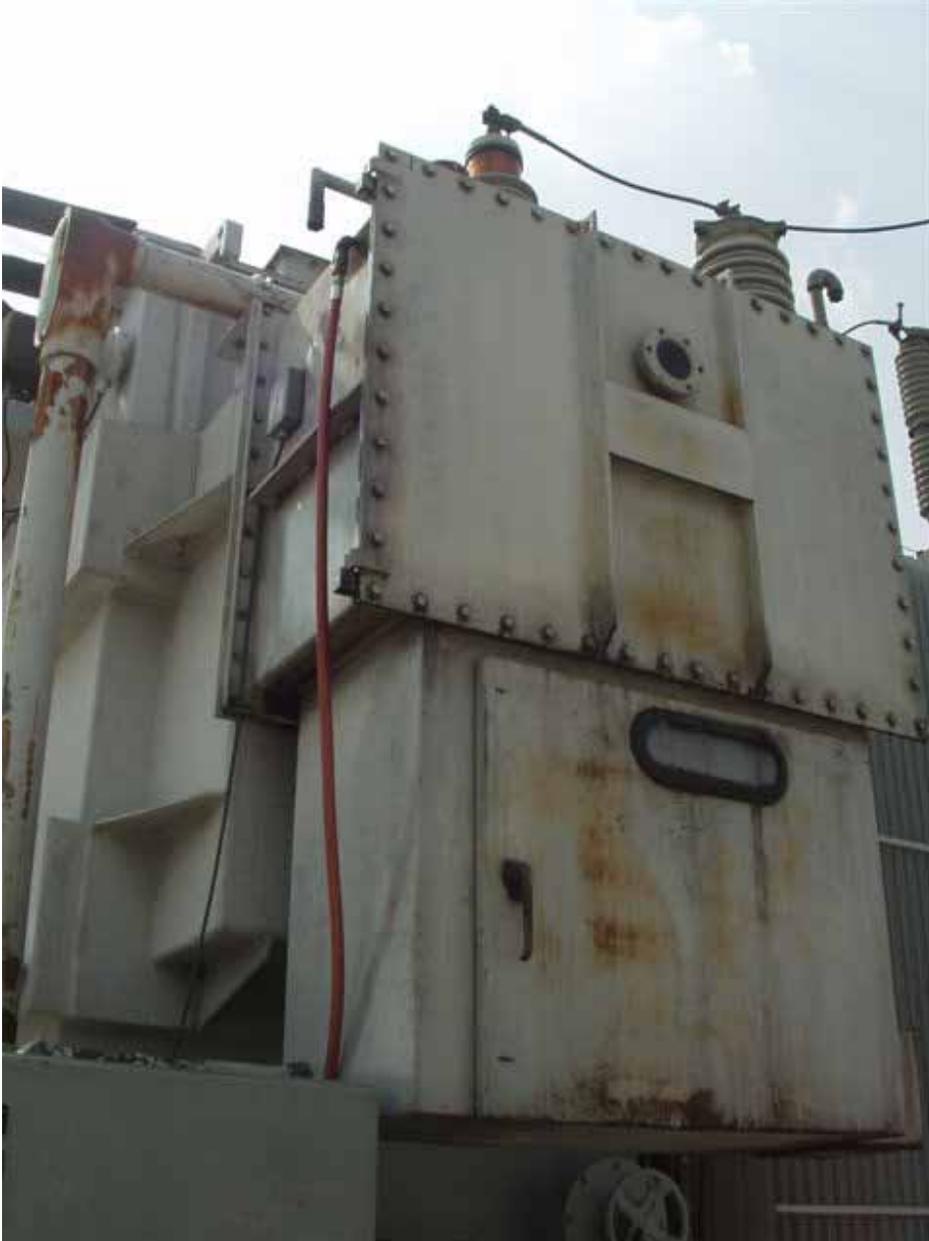
P6270084 – XFMR73: Oil coming out of vent – ComEd commented this was due to high oil levels and that the LTC had a leaking headboard.

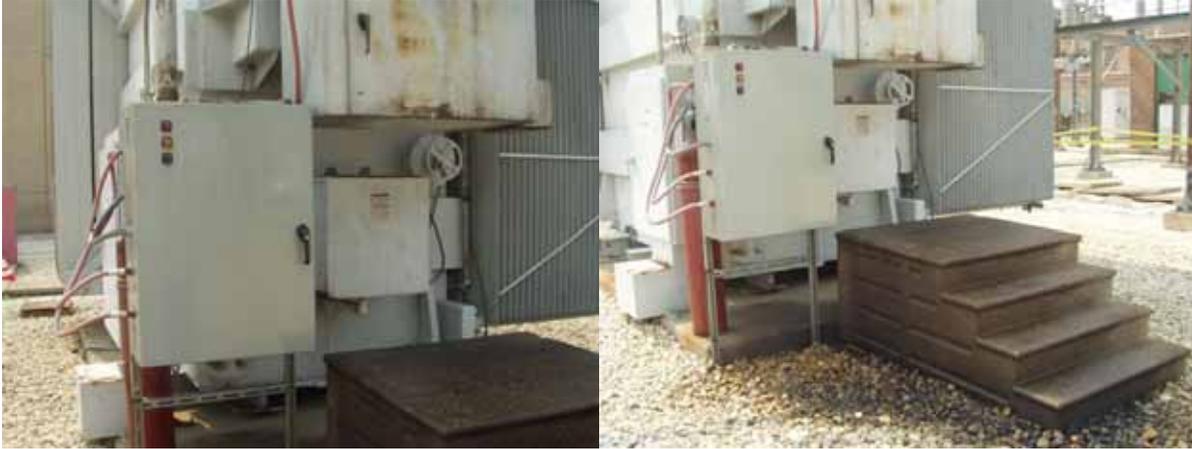
P6270085 & P6270086 -- XFMR73: oil from overflow onto cntl cabinet and onto ground and stairs – Staff was not able to check LTC position indicator without opening cabinet door because front was covered by oil obscuring view glass on door

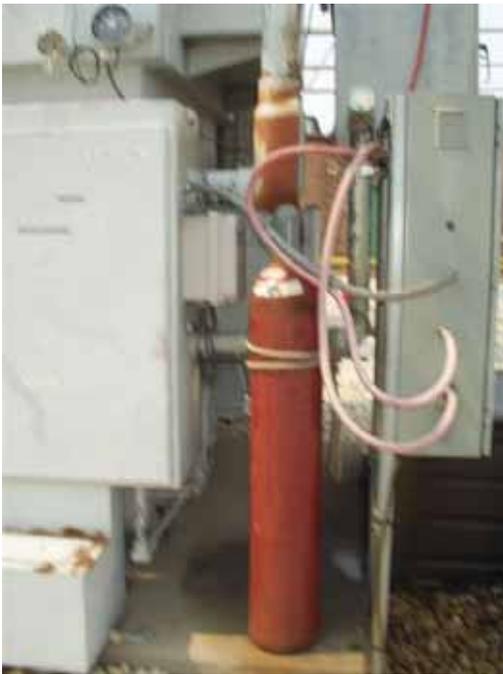
P6270087 XFMR73: cylinder held by rope and not chain

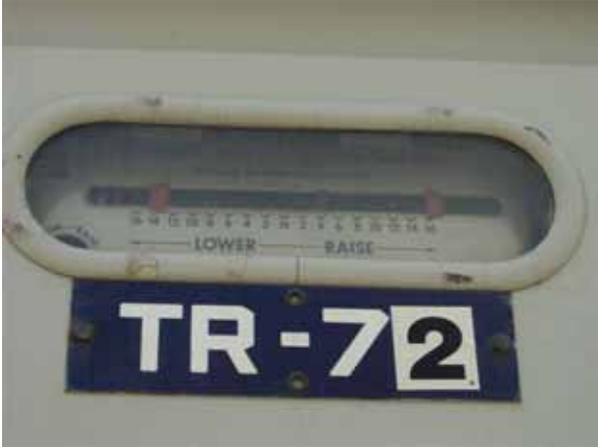
P6270090 – XFMR72 LTC range 13L to 16H

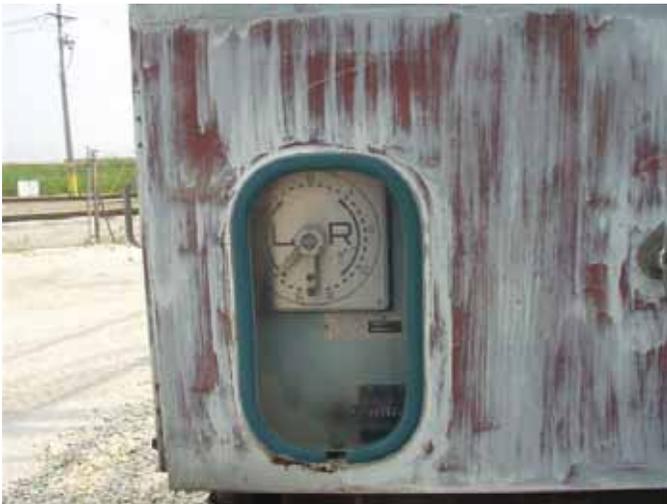
P6270093 – XFMR71 LTC – bad paint job on XFMR – old oil spill was also observed at XFMR71.

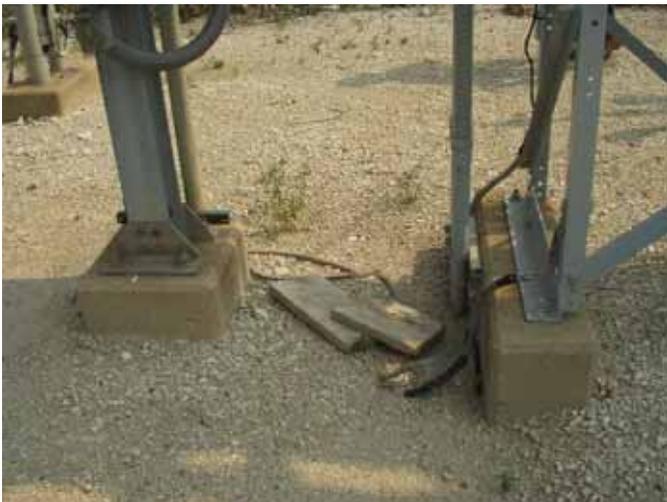
P6270096 – Ground cable laying on top of ground – trash and weeds in yard.

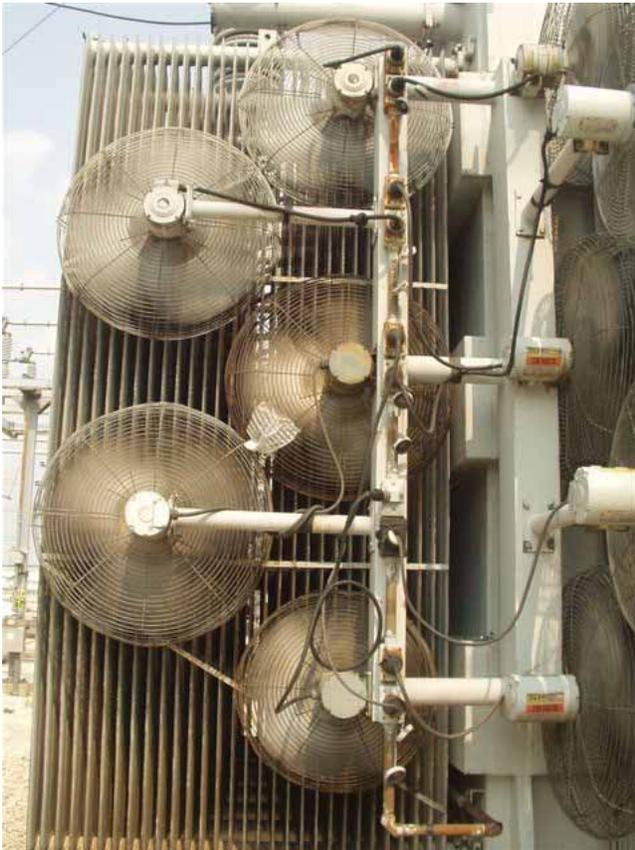
P6270099 – Trash on XFMR cooling fan.

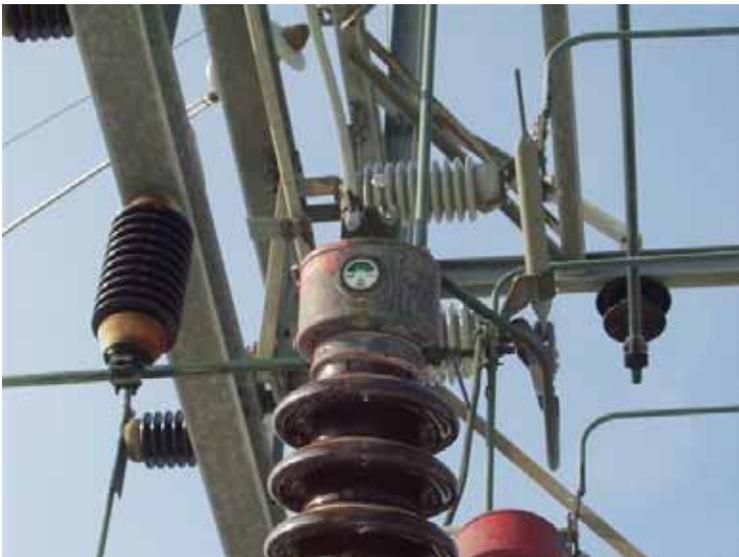
P6280104 – Arm on oil level gauge missing on POT & can't determine fluid level – ComEd personnel at substation said that POT is on W.O. order to replace on next PEG

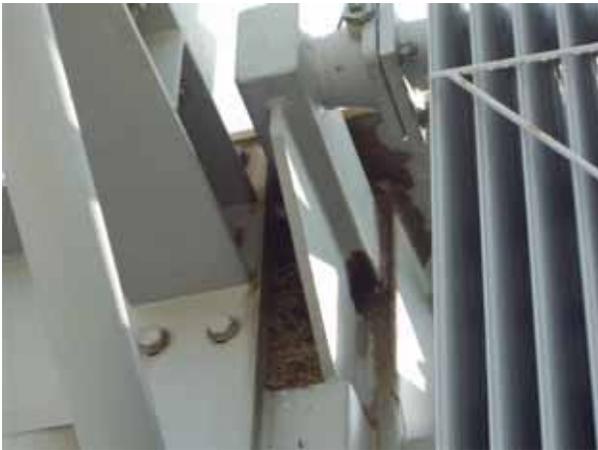
P6280107 – Bird nest in equipment [center of photo] and rust on equipment.

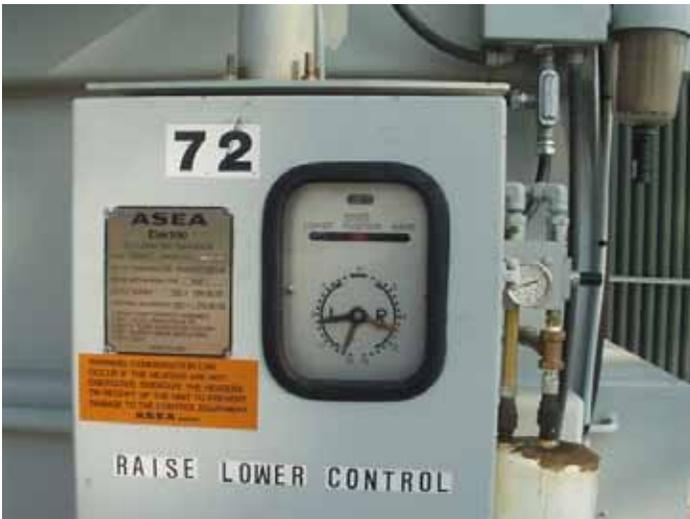
P6280108 – XFMR72 LTC shows operation at extreme lower limit. XFMR71 LTC was similar.

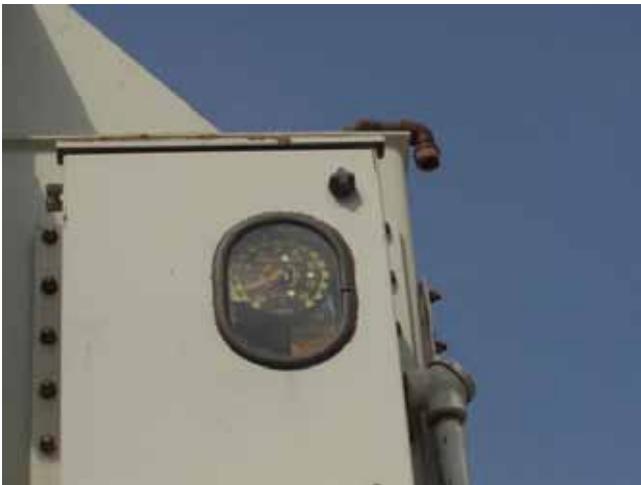
P6280122 – XFMR71 LTC – noted some oil on XFMR pad and in rock around XFMR

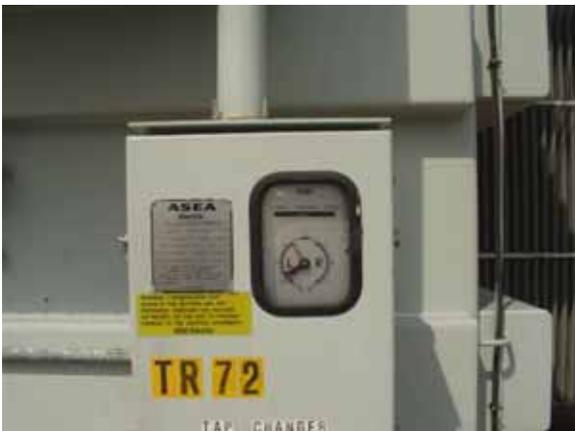
P6280123 – XFMR72 LTC – Bushing oil on XFMR looked high and noted some oil around base

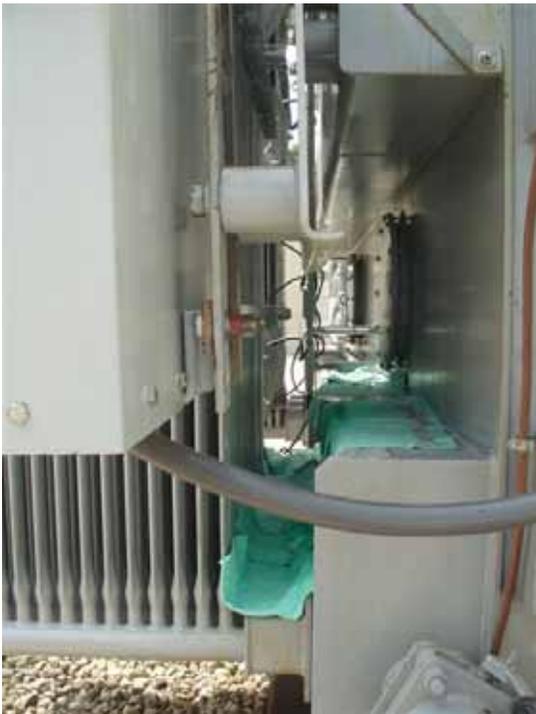
P6280133 – XFMR71 oil leak on fins – note absorbent material placed to capture leaking fluids making for easier cleanup later.

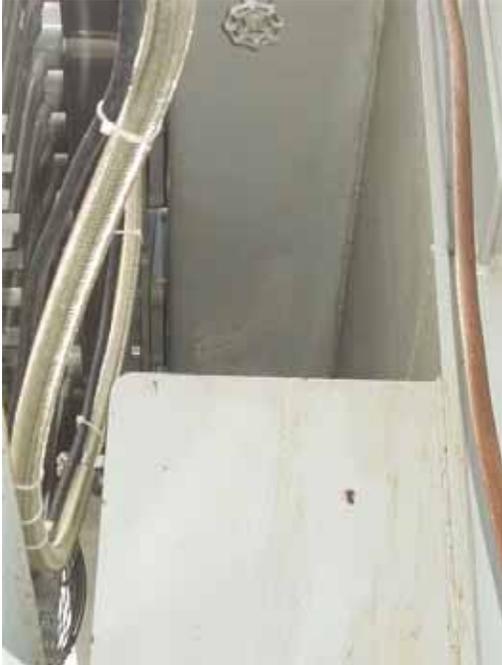
P6280134 – XFMR71 oil leak on fins

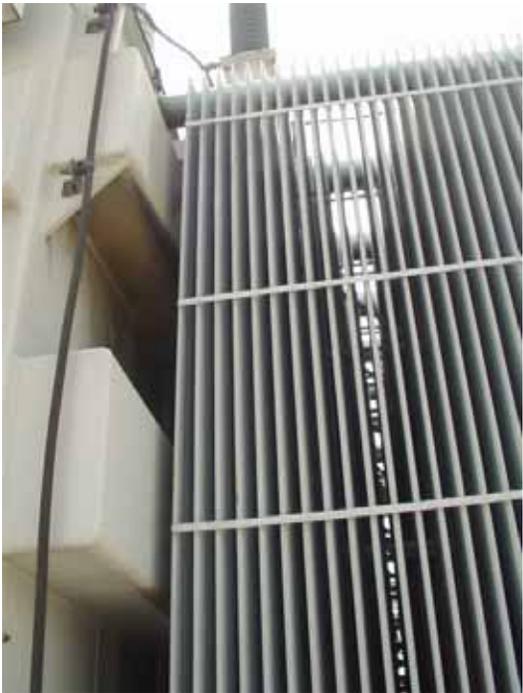
P6280138 – XFMR73 possible slow leak from top flange and down side

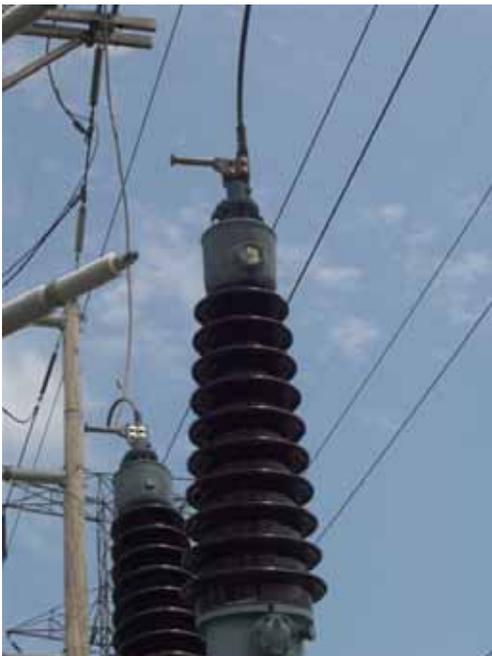
P6280141 – L14310 OCG 138KV BREAKER – C phase bushing oil level gauge glass broken – ComEd personnel know about it and are waiting for the next planned outage to correct

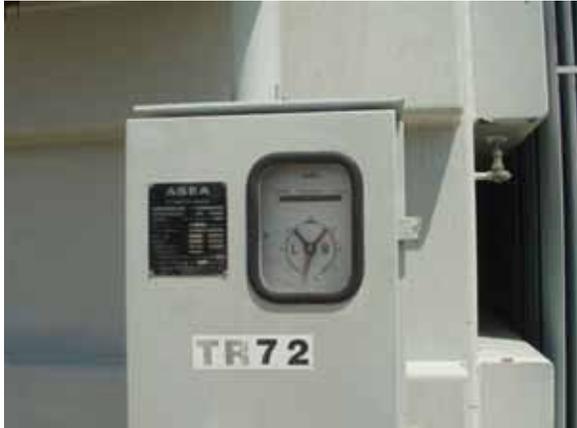
P6280156 – XFMR72 LTC – also noted that C phase bushing oil level was high

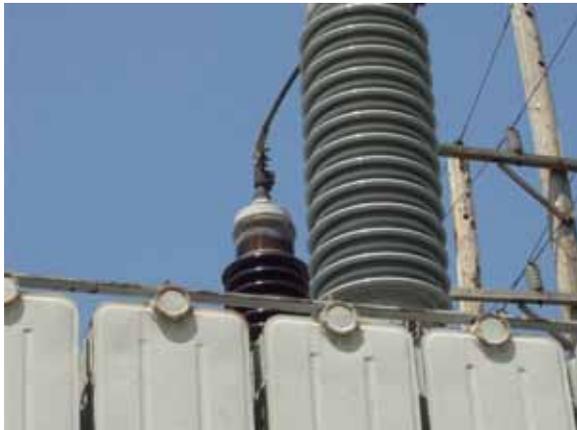
P6280158 – paint on top of XFMR B phase bushing covering glass indicator for oil level – ComEd noted that the oil level can still be seen and the glass was only partially covered by paint.

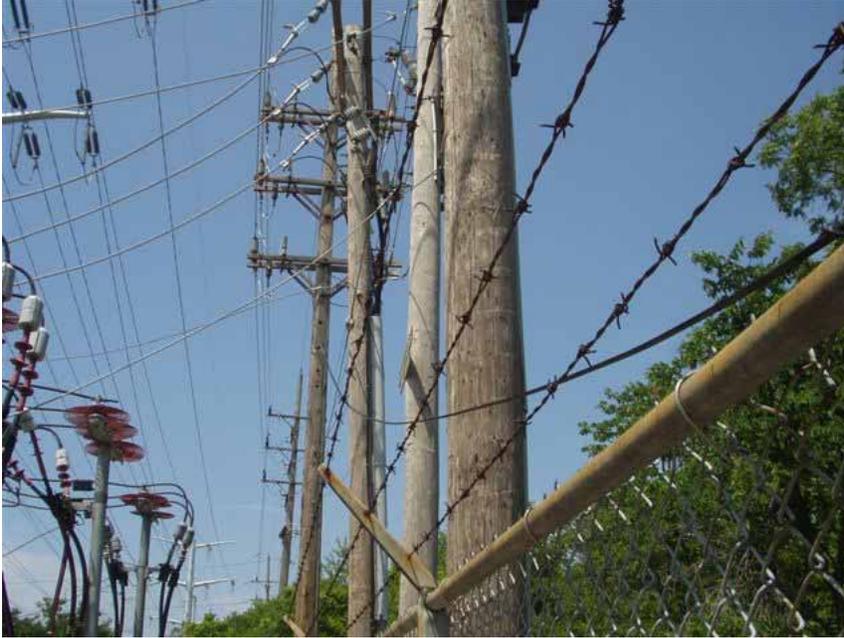
P6280160 – phone line loosely draped across poles and along substation fencing

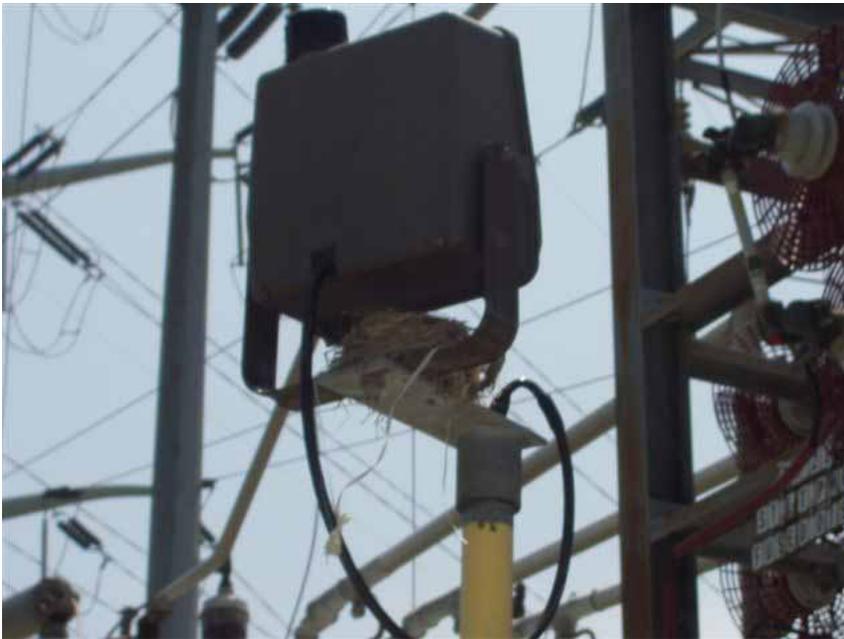
P6280162 – birds nest in framework for light in substation

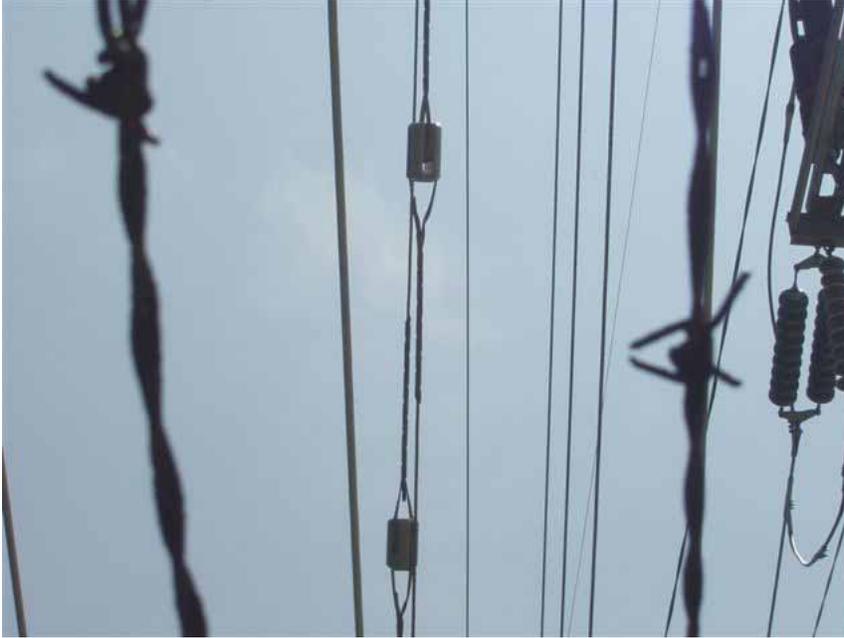
P6280163 – guy wire that looks close to primary

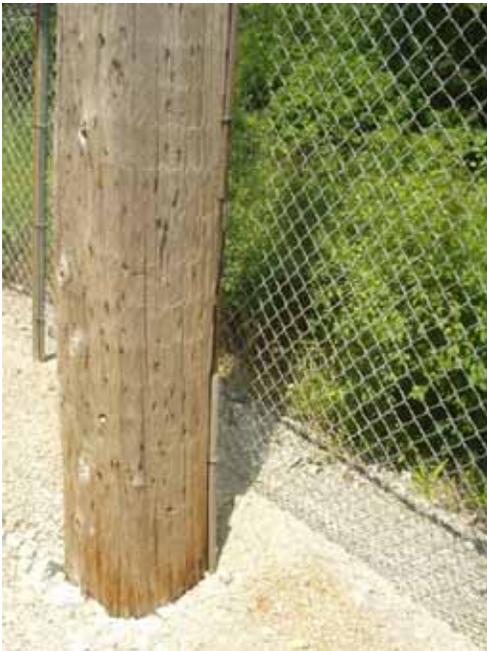
P6280165 – broken/missing cover/molding on ground wire on pole. Usually see this in rural areas where tractors may have hit the pole and knocked off the cover but inside a substation and next to the fence not sure how this would occur

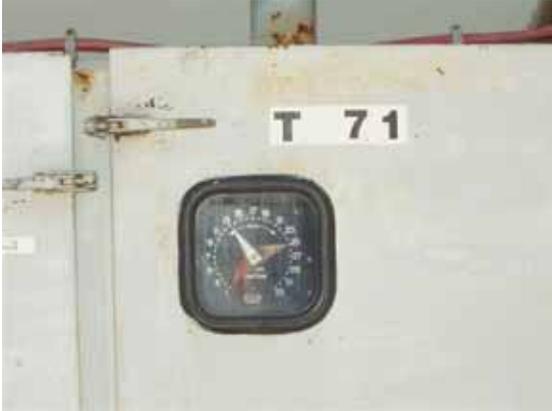
P6280170 – XFMR71 LTC – some rust on equipment – some oil leakage at this XFMR

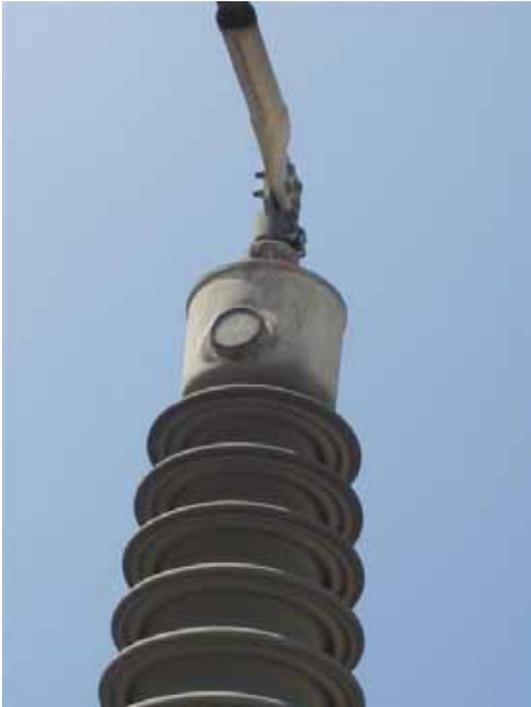
P6280171 – 138KV BT 1-2 OCB A phase bushing oil near/at H – glass cracked

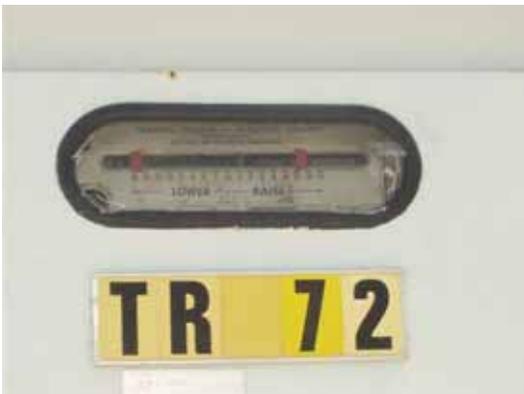
P6280172 – XFMR72 LTC – stop at 16 lower

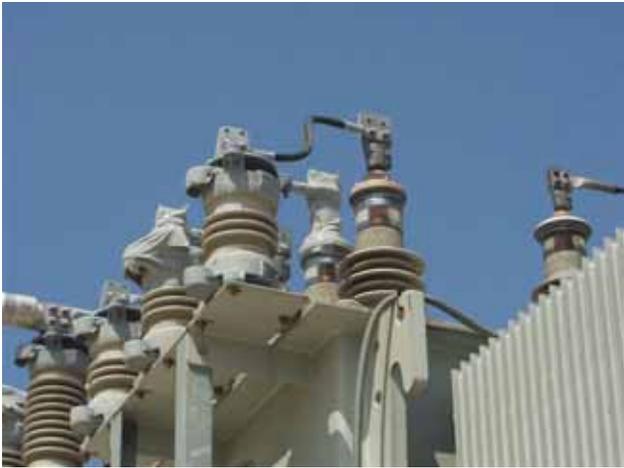
P6280174 – XFMR77 tape cover top part of window for oil level – ComEd noted that the oil level can still be seen.

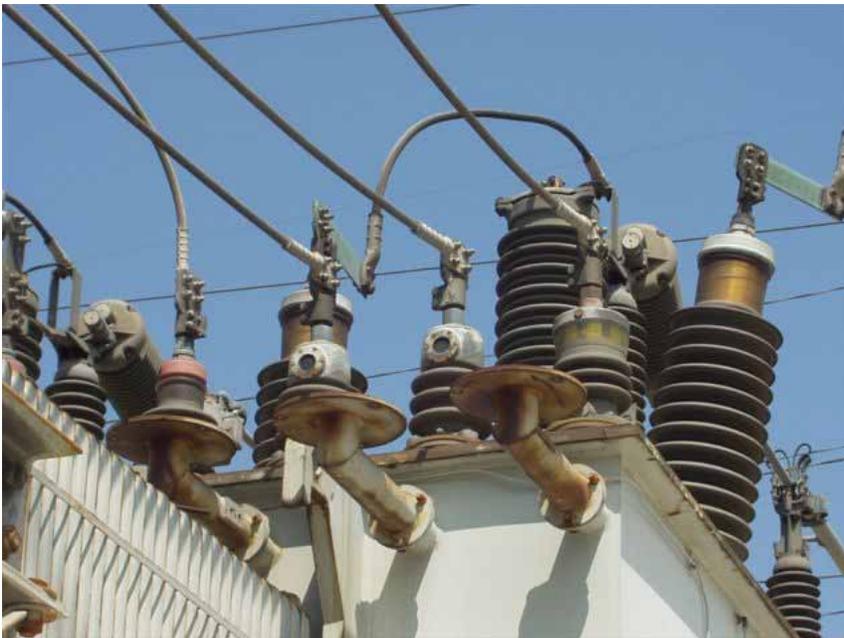
P6280178 – XFMR78 2 phases on low side can't read oil level from ground without binoculars

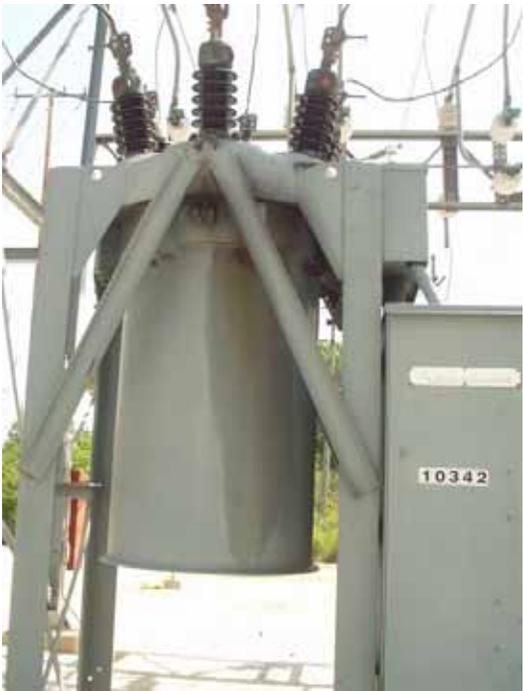
P6280180 – 34KV10342 – oil leak on tank

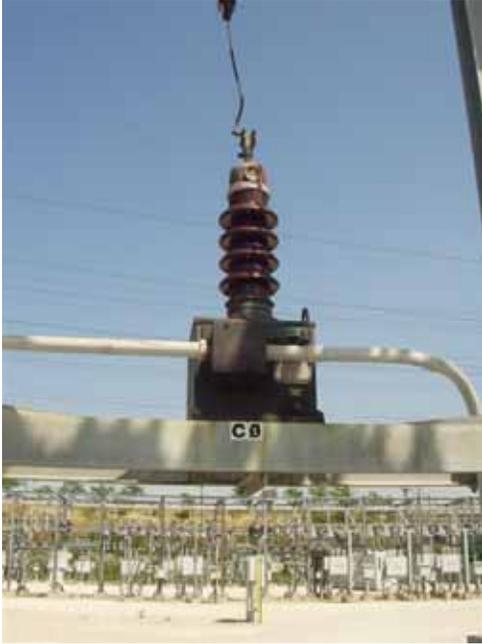
P6280181 – Bus 2 pots c phase cracked indicator window

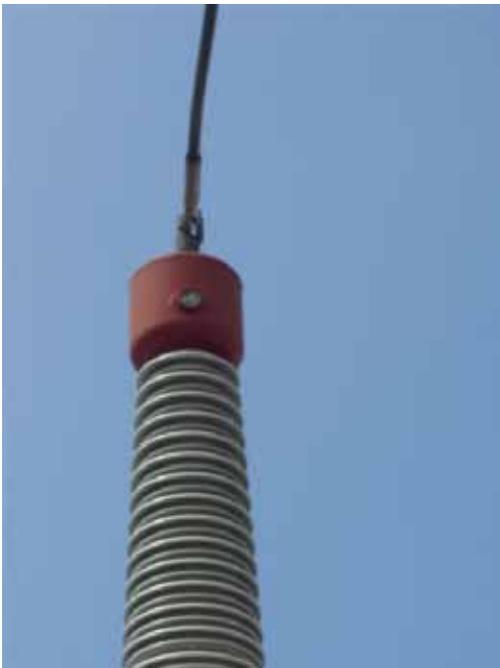
P6280185 – 345KV BT1-2 – A phase bushing looks high
B phase bushing looks high on other side
C phase bushing looks high on other side

ComEd personnel know about bushing leaks on 345 OCB Bushings A phase and C phase
