ILLINOIS COMMERCE COMMISSION
TRANSPORTATION DIVISION / RAIL SAFETY SECTION

Illinois Commerce Commission Inspection
CSX Crossings – Woodland Jct. To Danville

CSX Crossings - Iroquois & Vermilion Counties
June 2006

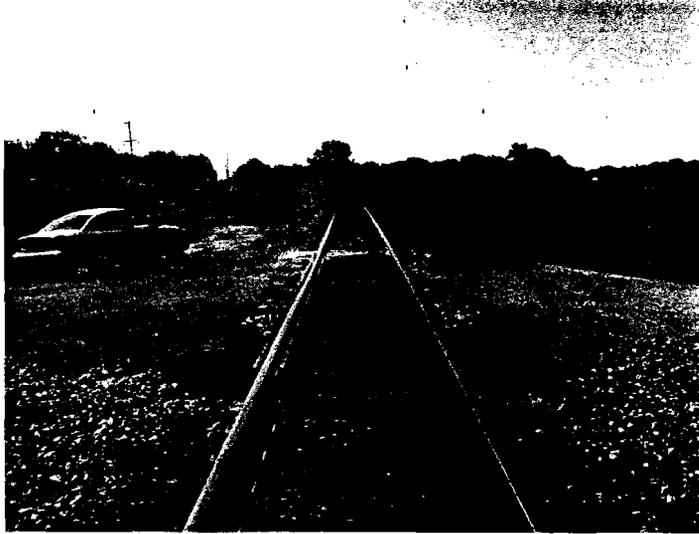
TR 245 (353 632H), near Woodland Junction – Looking South

DOT/Milepost	Street Name	Near/In	County	Comments
353 632H, 82.70	TR 245	Near Woodland	Iroquois	Crossbucks. The asphalt portion of the existing Epton Rubber/Asphalt surface needs to be patched with hot mix asphalt.
353 633P, 83.80	CH 47	Near Woodland	Iroquois	AFLS. Epton Rubber/Asphalt surface is low; scrape marks on pavement indicate rail equipment is scraping the crossing. Small holes in the asphalt portion of the surface need to be patched with hot mix asphalt.
353 634W, 84.85	TR 253	Near Woodland	Iroquois	Crossbucks; the crossbuck on the east approach is too far from the crossing and too low. The Epton/Asphalt surface is in fair condition.
353 636K, 86.18	TR 273	Near Milford	Iroquois	Crossbucks; the crossbuck on the east approach only has one bolt and is too far from the track. The Epton/Asphalt surface is in fair condition.
353 637S, 86.79	TR 275A	Near Milford	Iroquois	Crossbucks; the crossbuck on the east approach only has one bolt and is too far from the track. The Epton/Asphalt surface has one hole that needs patched with hot mix asphalt.

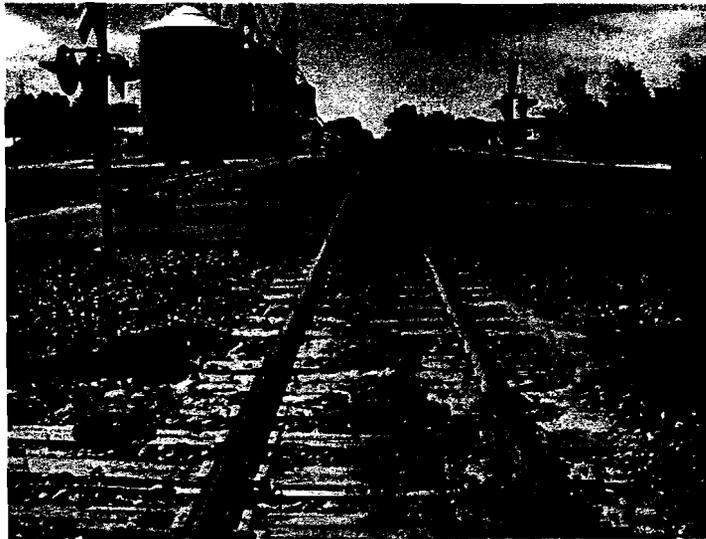
Frederick Street (353 640A) Ped. Xing – Milford, Looking South

353 640A, 87.96	E. Frederick St.	In Milford	Iroquois	AFLS. Epton Rubber/Asphalt surface on Main Track crossing; Timber/Asphalt surface on Elevator Track crossing. A pedestrian crossing on the north side of Frederick Street has been removed. There is significant mud in the track in the area of the crossings. The asphalt areas of the crossing surfaces have been patched, but need to be patched again with hot mix asphalt. The pedestrian crossing needs to be reinstalled. An existing "4 Tracks" sign needs to be replaced with a "2 Tracks" sign.
353 641G,	E. Jones St.	In Milford	Iroquois	AFLS. Epton Rubber/Asphalt

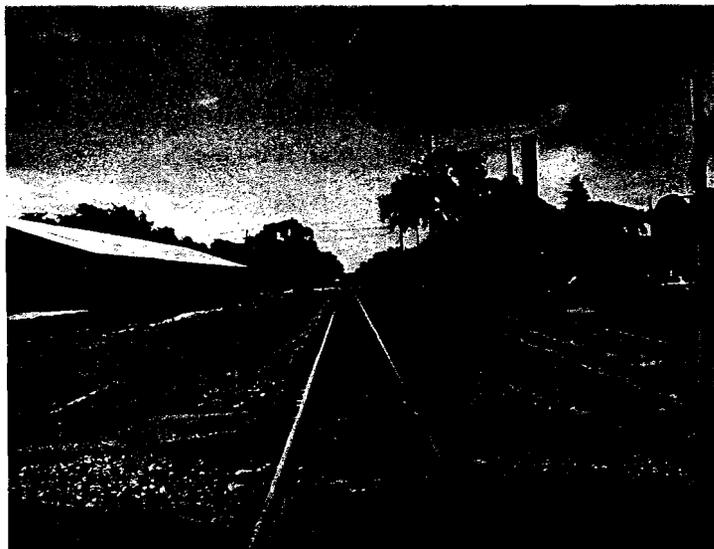
Jones Street (353 641G) Ped. Xing – Milford, Looking South

88.03				surface on the Main Track crossing; the asphalt area of the main track surface needs to be patched with hot mix asphalt. The pedestrian crossing surface needs to be reconstructed.
353 642N, 88.03	E. Jones St.	In Milford	Iroquois	Timber/Asphalt surface on the Elevator track crossing. The elevator track is lower than the main track, and needs to be raised to same elevation. A new Crossbuck sign needs to be installed at the Elevator Track crossing.
353 643V, 88.11	Lyle St.	In Milford	Iroquois	AFLS. Epton Rubber/Asphalt surface on the Main Track crossing; the asphalt area of the main track surface needs to be patched with hot mix asphalt. <i>The Advance Warning Sign for the East Highway Approach is missing.</i>
353 644C, 88.11	Lyle St.	In Milford	Iroquois	Elevator Track, Timber/Asphalt surface. A new Crossbuck sign needs to be installed at the Elevator Track crossing.
353 646R, 88.75	TR 301C	Near Milford	Iroquois	AFLS/Gates. Epton Rubber/Asphalt surface in fair condition. The west signal unit is bent and needs to be realigned.

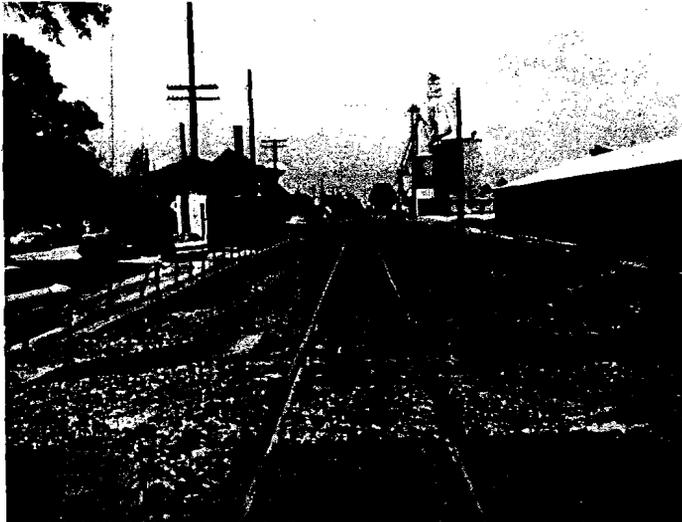
Lyle Street (353 643V) Ped. Xing – Milford, Looking North

353643V	Lyle Street Milford	Main track crossing OK, pedestrian crossing needs patched again ASAP; Elevator track crossing needs patching. CSX ownership????
353 646R	TR301C	Epton/Asphalt crossing that has been patched. Needs patched again.
353 649L	TR343	Epton/Asphalt crossing that has been patched. Needs patched again.
353651M	CH 10	Epton/Asphalt crossing that has been patched. Needs patched again till it can be redone this year.
353659S	TR 1 -County Line Road	Epton/Asphalt crossing that has been patched. Needs patched again.
353 661T	Thompson St. Hoopeston	Epton/Asphalt. Ok. Rebuilt last year.
363 663G	Main Street Hoopeston	Epton/Asphalt crossing that has been patched. Needs patched as needed till new crossing can be installed. The City is willing to pay difference in cost to get concrete crossing. Need meeting to discuss.
353 664N	Penn Street Hoopeston	Epton/Asphalt. Ok. Redone last year.
353 667J	Lincoln Street	Main crossing (Epton/Asphalt) has been

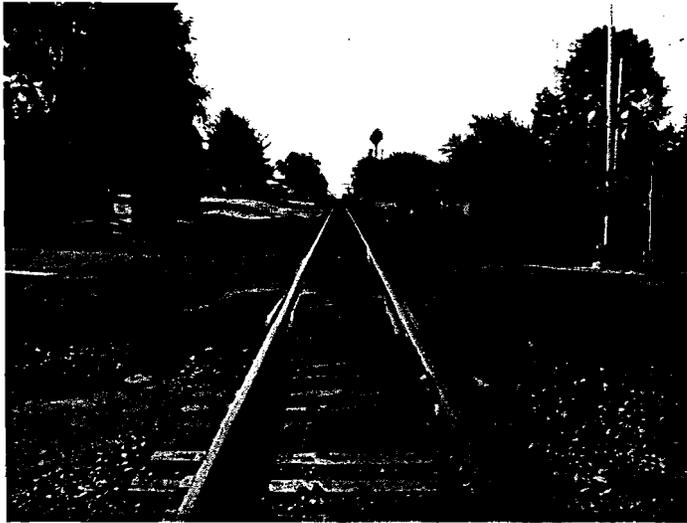
Henderson Street (353 676H) – Rossville, Looking South

recently rebuilt, but the final surface layer was not applied. The surface is 1 ½" lower than top of rail.
353 676H, 105.05	Henderson Street	In Rossville	Vermilion	AFLS/Gates. Epton Rubber/Asphalt. 1/3 of the surface was removed last year for track work and patched with cold mix asphalt over ballast. The entire asphalt portion of the surface needs to be replaced with new hot mix asphalt. <i>The Advance Warning Sign for the East Highway Approach is too close to crossing; needs to be moved away from crossing.</i>
353 678W, 105.23	Benton Street	In Rossville	Vermilion	AFLS. Epton Rubber/Asphalt surface. New asphalt was partially installed, but the final surface layer was not applied. The surface is 1 ½" lower than top of rail. Potholes in the asphalt need patched with hot mix asphalt. <i>The Advance Warning Sign for the West Highway Approach is missing.</i>
353 679D, 105.42	Attica Street	In Rossville	Vermilion	AFLS/Gates. 2 track crossing; Epton Rubber/Asphalt surface for main track, Timber Asphalt surface for elevator track. Asphalt portion of both crossing surfaces needs to be replaced with hot mix asphalt.

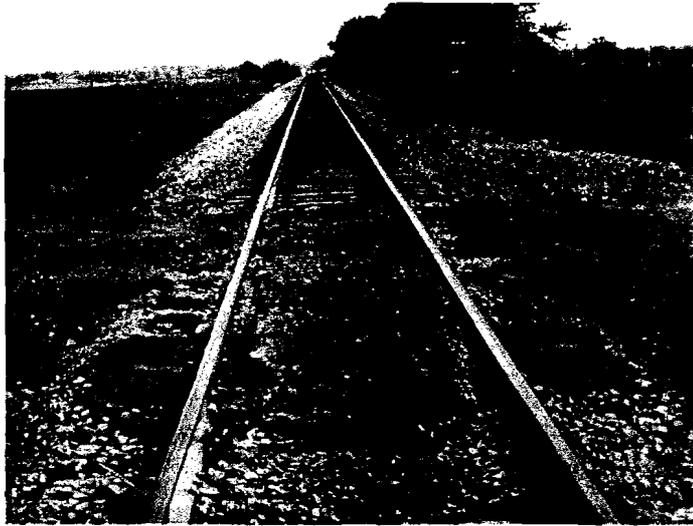
TR 113A (353 693Y) – near Rossville, Looking North

353 693Y, 112.23	TR 113A	Near Alvin	Vermilion	<p>Crossbucks; both sets of crossbuck signs need to be replaced. The existing crossing surface, consisting of ballast covered with cold mix, is very rough and needs to be repaired. Brush needs to be cut back to 500' in the SE quadrant of the crossing.</p>
353 694F, 112.99	TR 344	Near Alvin	Vermilion	<p>Crossbucks; the east crossbuck signs are too far from the track.</p>

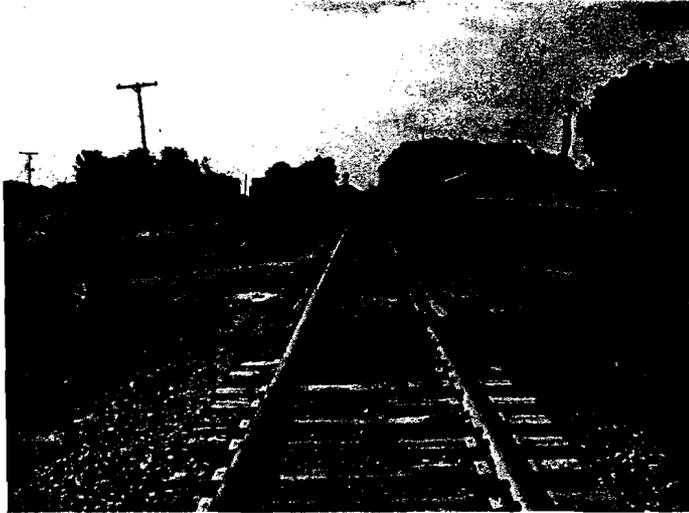
South Street (353 699P) – Bismarck, Looking South

353 699P, 114.32	TR 729	Near Bismarck	Vermilion	Crossbucks; the east crossbuck is too far from the track. Epton Rubber/Asphalt surface needs to be replaced. Roadway appears to dead end east of the track.
353 700G, 115.24	TR 147	Near Bismarck	Vermilion	AFLS. Epton Rubber/Asphalt surface. Crossing is lower than the adjacent highway approaches; evidence of dragging rail equipment. Brush needs to be cut back to 500' in all quadrants of the crossing.
353 702V, 116.27	TR 155A	Near Bismarck	Vermilion	AFLS. Epton Rubber/Asphalt surface. Asphalt portion of the surface needs to be replaced with hot mix asphalt. Crossing is lower
