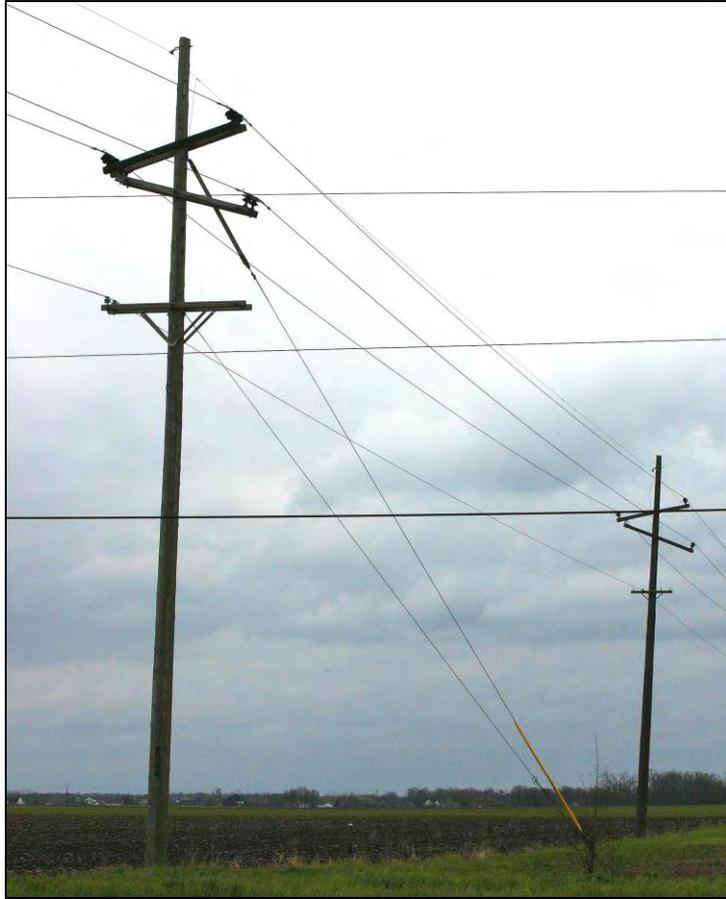
Figure 15 (Photo 07-IP1393)
Ungrounded 34 kV & 12 kV downguys without properly placed strain insulators
(NESC Guying Violation)

Circuit J34356, in the easement north of Constitution Court, Bethalto

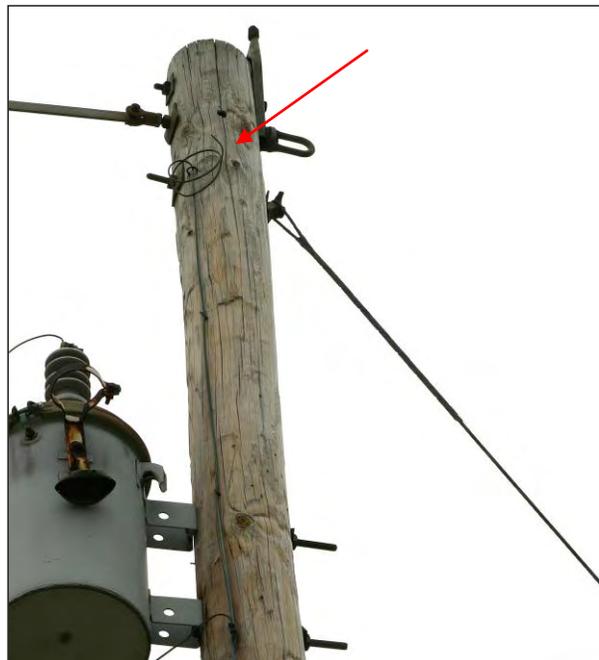
Figure 16 (Photo 07-IP1398)
Ungrounded 12 kV downguy without strain insulator – ground wire installed to top of pole, but not connected to downguy
(NESC Guying Violation)
Circuit J34356, Rt. 159, Midway

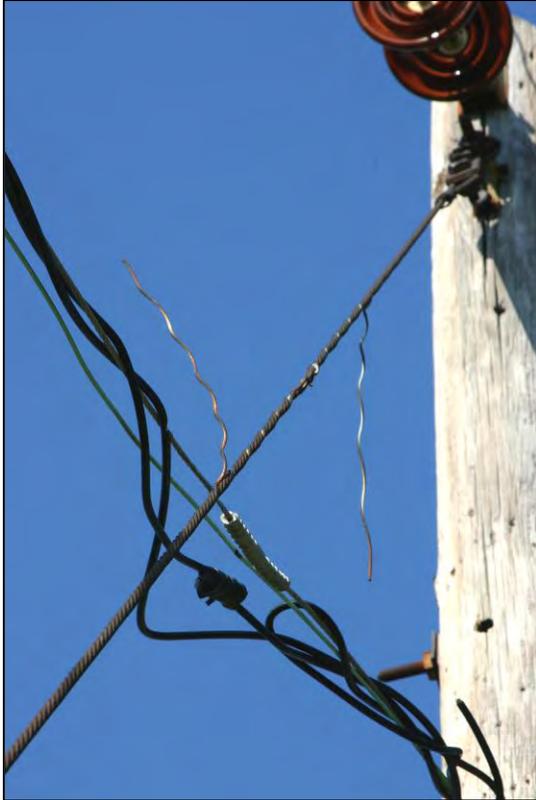
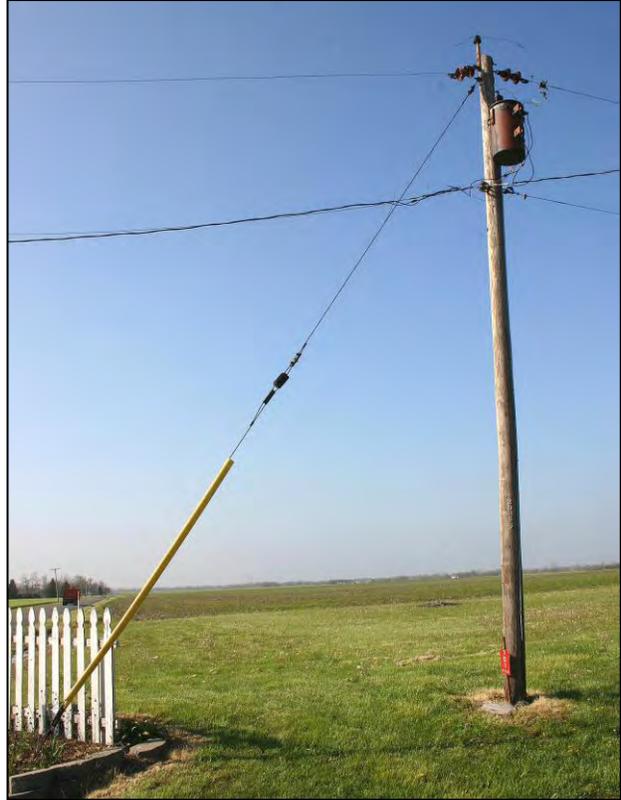
Figures 17 & 18 (Photos 07-IP1406 & 07-IP1404)

**Broken strand in guy wire and strain insulator too low in ungrounded 12 kV downguy
(NESC Guying Violation)**

Circuit J34356, west of Geaman St. (Old Prairietown Rd.), Prairietown

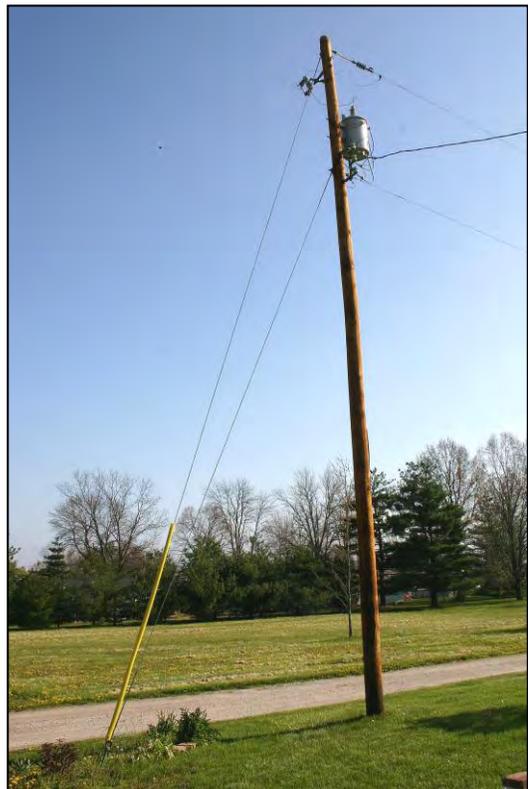
Figure 19 (Photo 07-IP1407)

**Two ungrounded 12 kV downguys without strain insulators (new pole-- branded 1995)
(NESC Guying Violations)**

**Circuit J34356, west of Geaman St.
(Old Prairietown Rd.), Prairietown**

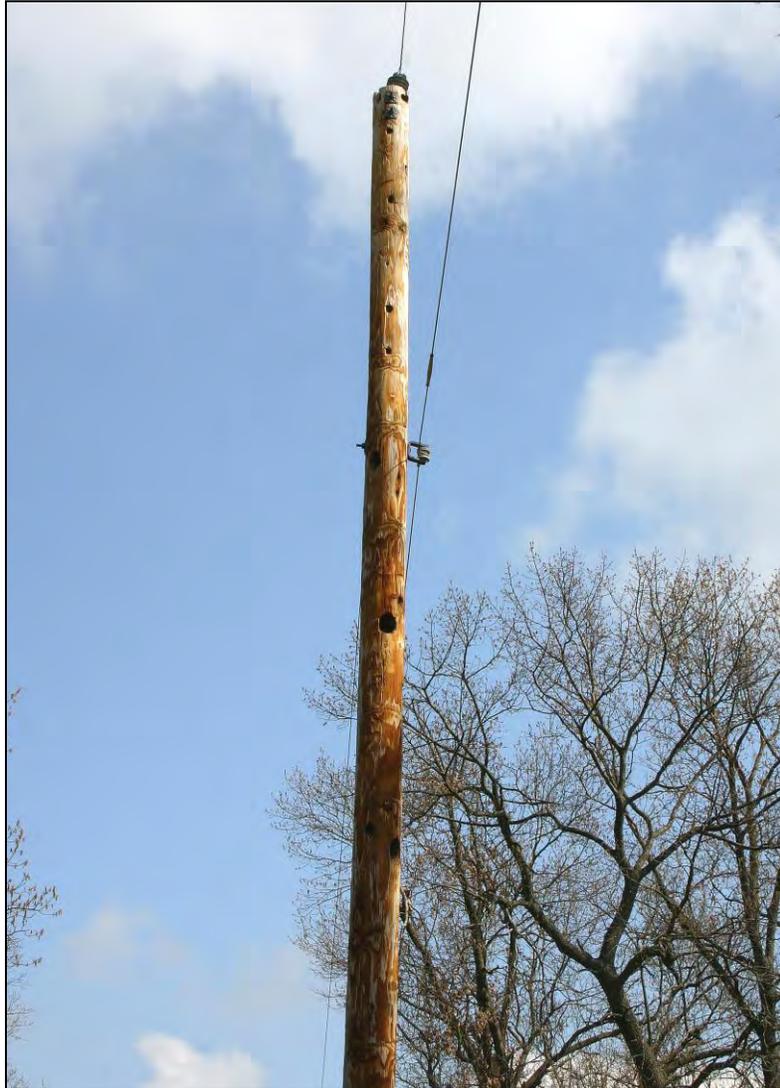
Figure 20 (Photo 07-IP1409)
Several (at least 14, with 3 very large) woodpecker holes in pole
Circuit J34356, Klondike Rd., north of Prairietown

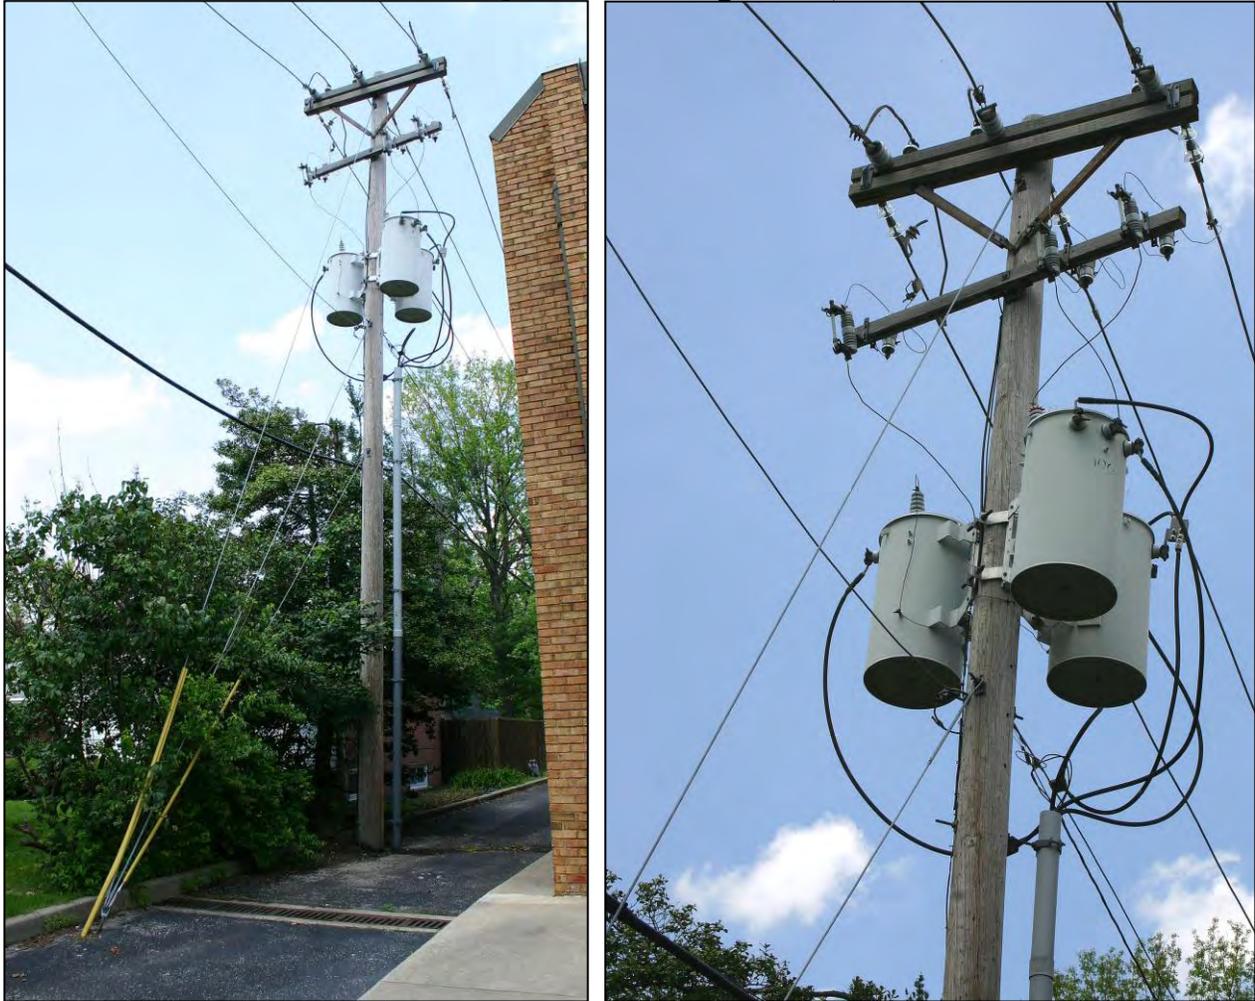
Figures 21 & 22 (Photos 07-IP1471 & 07-1472)
Two ungrounded 12 kV downguys without strain insulators
(NESC Guying Violations)
Circuit Q18245, just north of Virginia Dr., O'Fallon

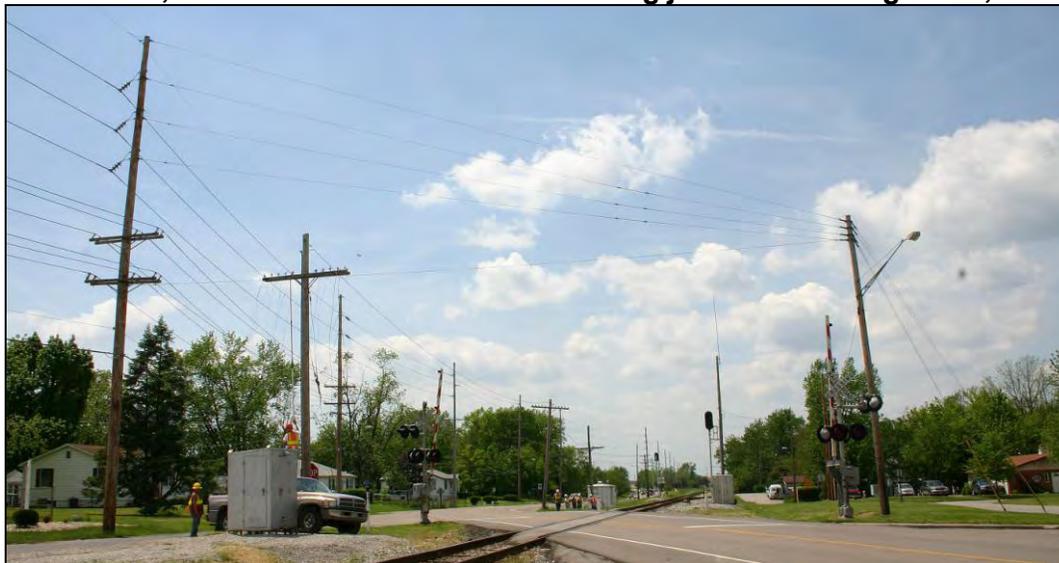
Figure 23 (Photo 07-IP1474)

Three ungrounded 34 kV overhead guys without properly placed strain insulators
(NESC Guying Violations)

Circuit Q18244, W. State St. at the railroad crossing just east of Douglas St., O'Fallon

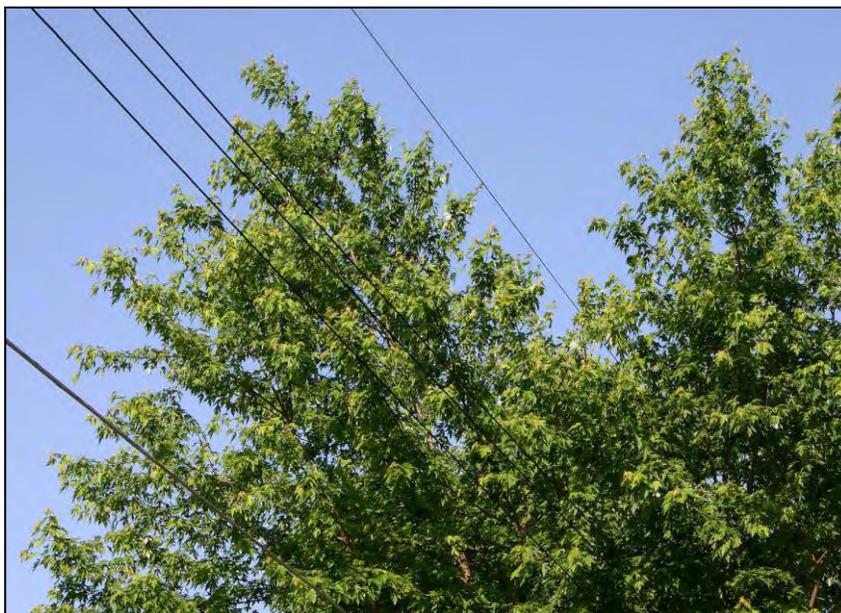
Figure 24 (Photo 07-IP1476)

Maple tree into primary
Circuit N86228, Schuetz St.
east of Chamberlain St.,
Lebanon

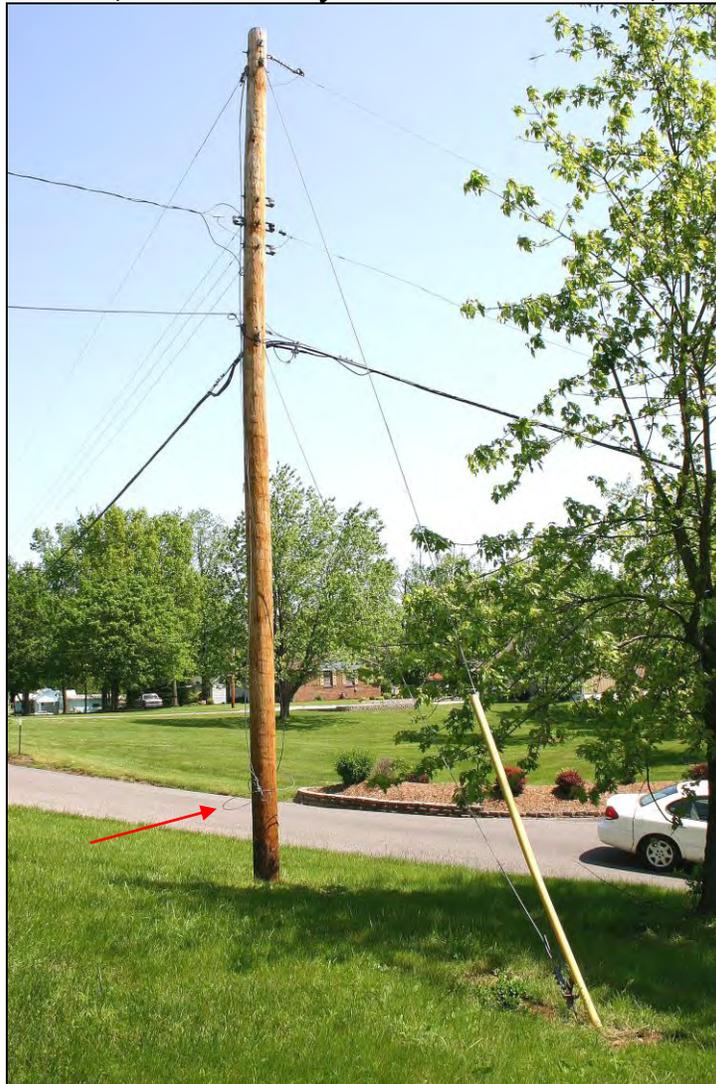
Figure 25 (Photo 07-IP1489)

**Broken primary downguy (wrapped around pole) and two ungrounded downguys without strain insulators (NESC Guying Violations)
Circuit K43386, Corner of Mary Ellen Ave. & Clifton St., Collinsville**

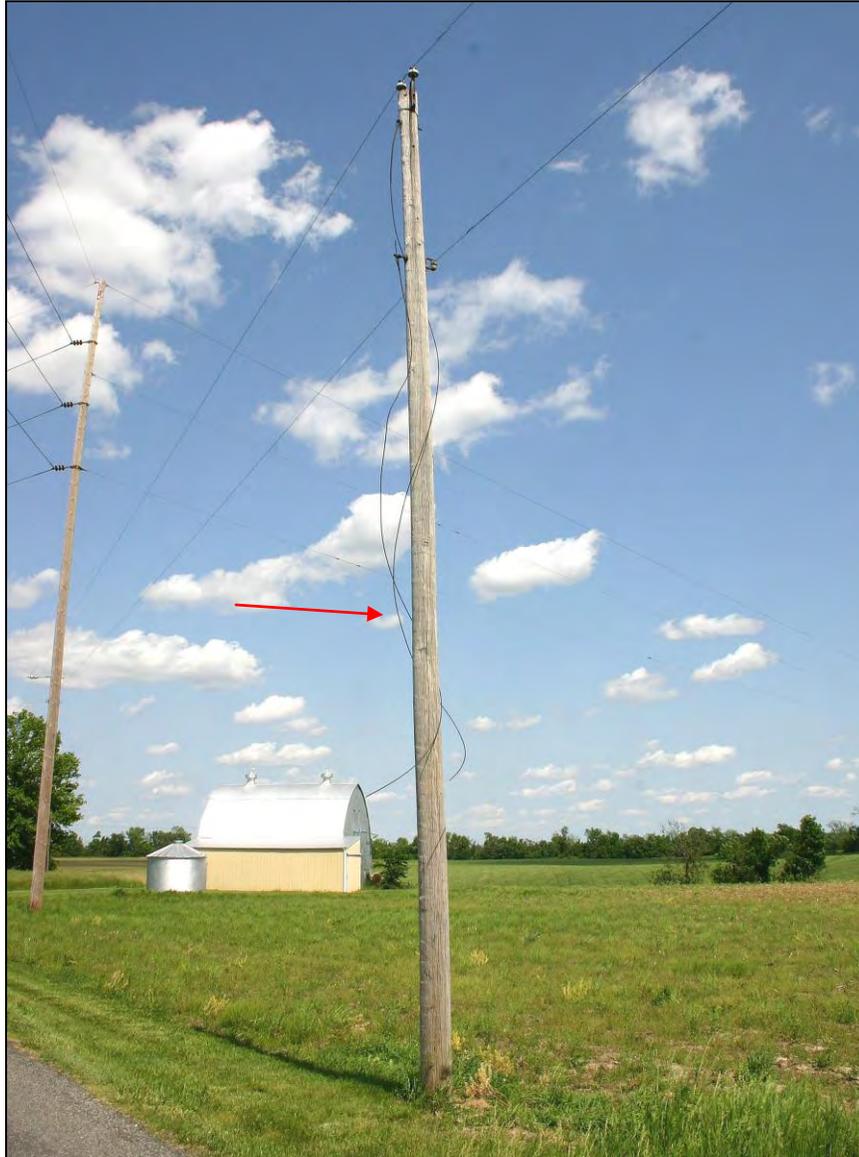
Figure 26 (Photo 07-IP1490)
Two broken guy wires hanging on pole
Circuit K43386, Clay School Rd., east of Collinsville

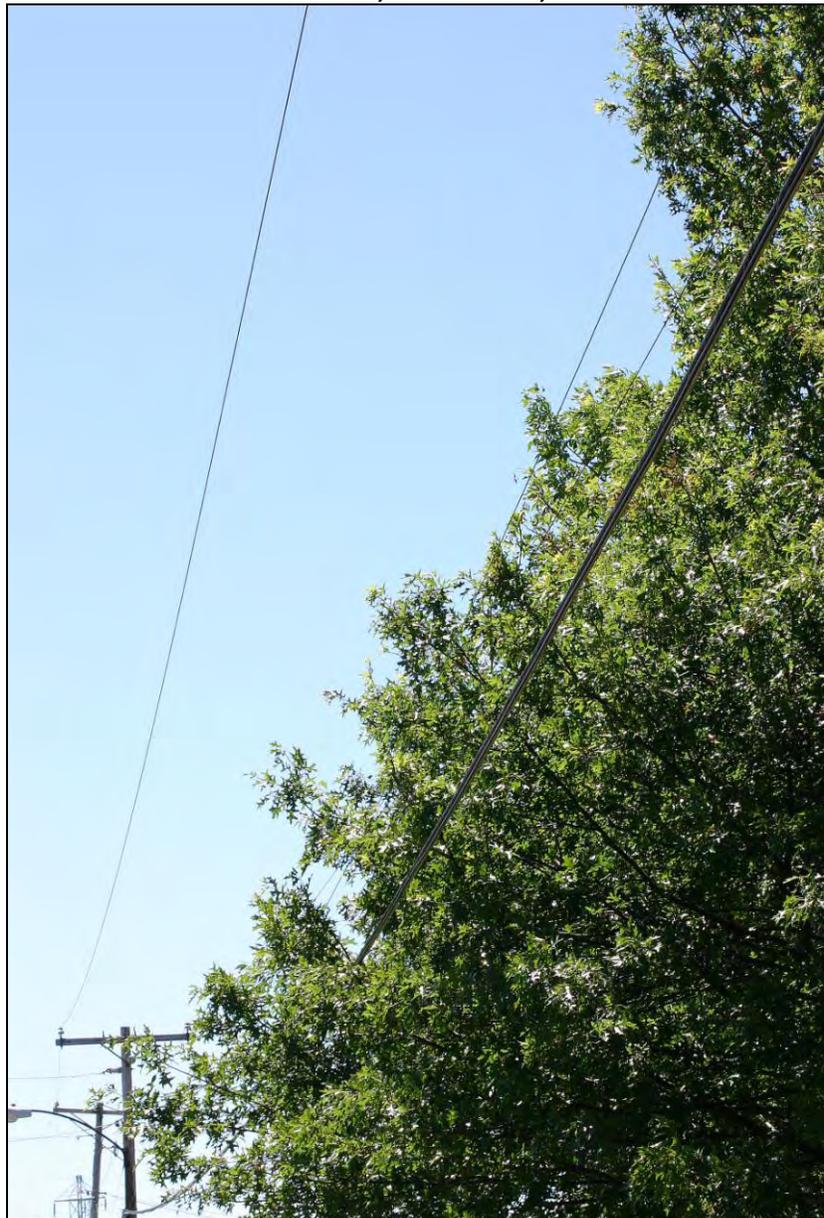
Figure 27 (Photo 07-IP1730)
Pin oak tree into & burned by primary
Circuit J12166, S. View St., Oreana

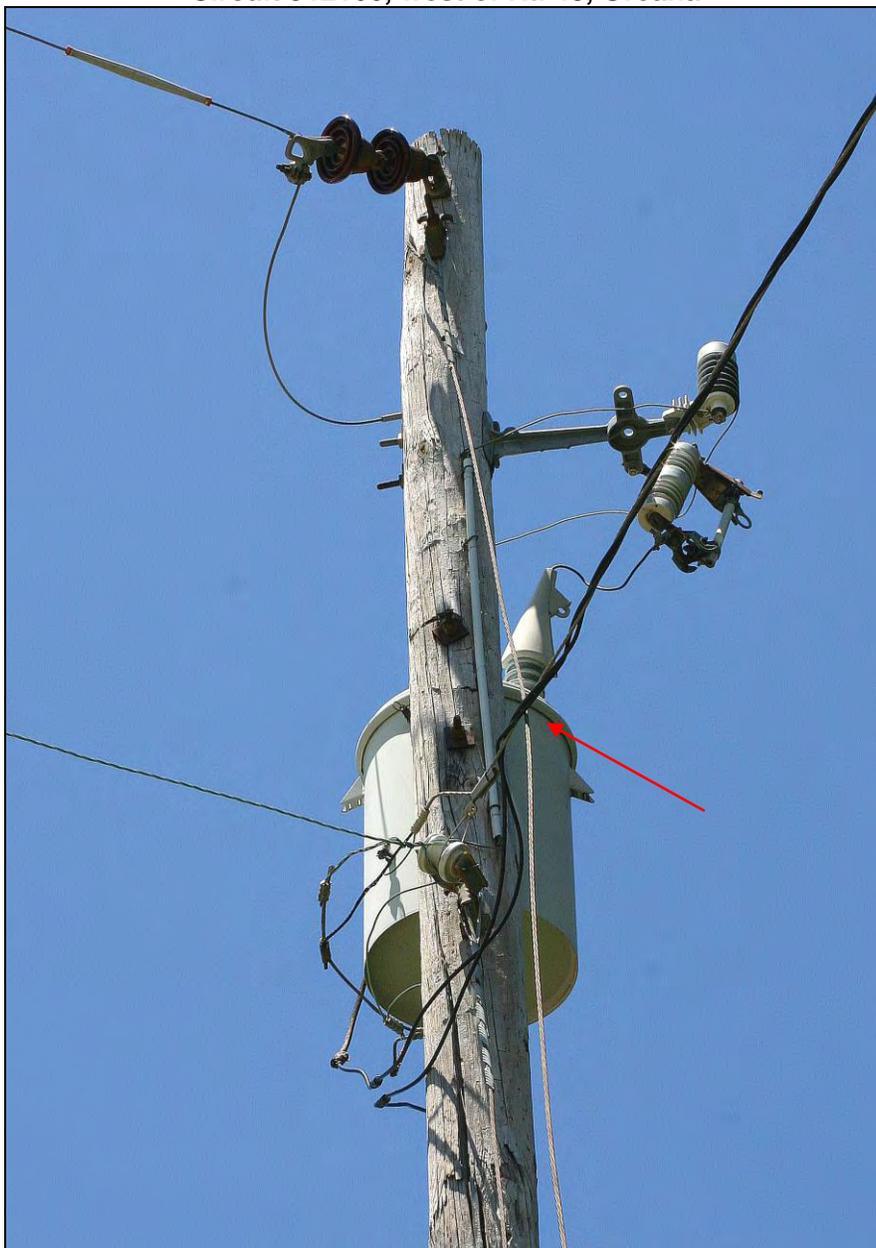
Figure 28 (Photo 07-IP1732)

Two ungrounded 12 kV downguys without strain insulators (top downguy in contact with secondary conductor) (NESC Guying Violations)
Circuit J12166, west of Rt. 48, Oreana

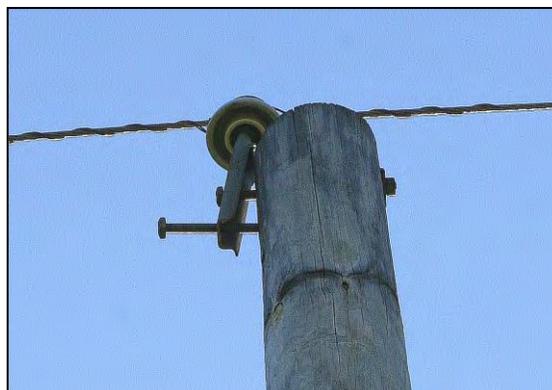
Figure 29 (Photo 07-IP1727)
Bottom pin bolt coming out of pole
Circuit J12166, Conners Rd.,
northeast of Oreana
