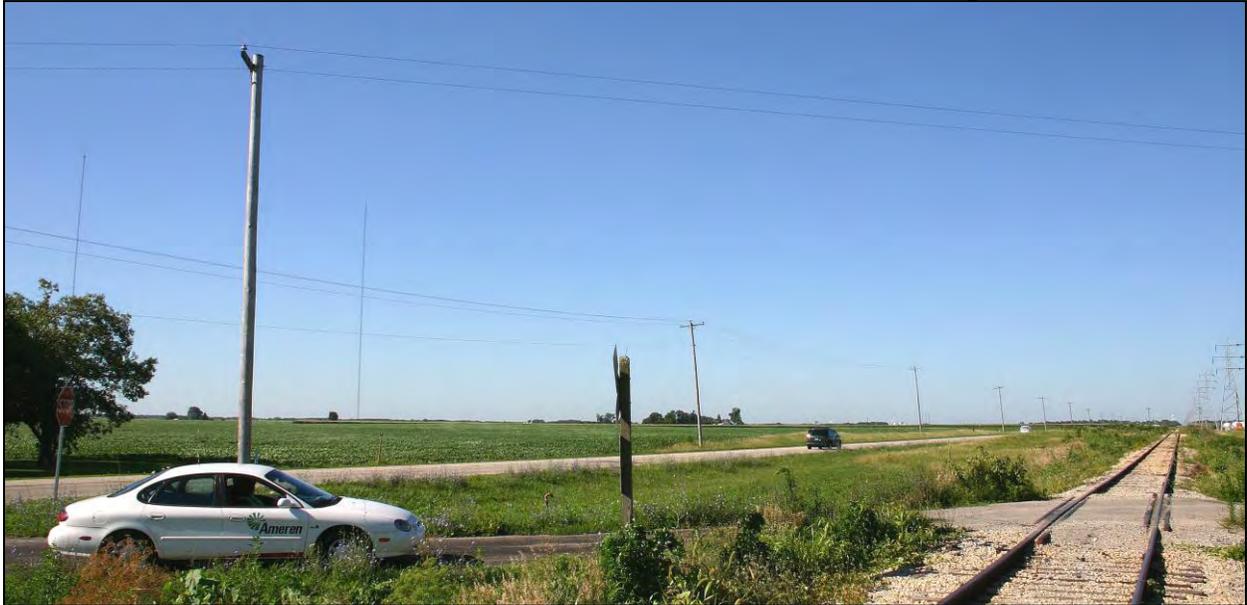
**Figure 30 (Photo 07-IP1726)**  
**Single wood crossarm supporting a single-phase crossing of a railroad**  
**(NESC Railroad Crossing Violation)**  
**Circuit J12166, Wise Rd. west of Rt. 48, southwest of Argenta**

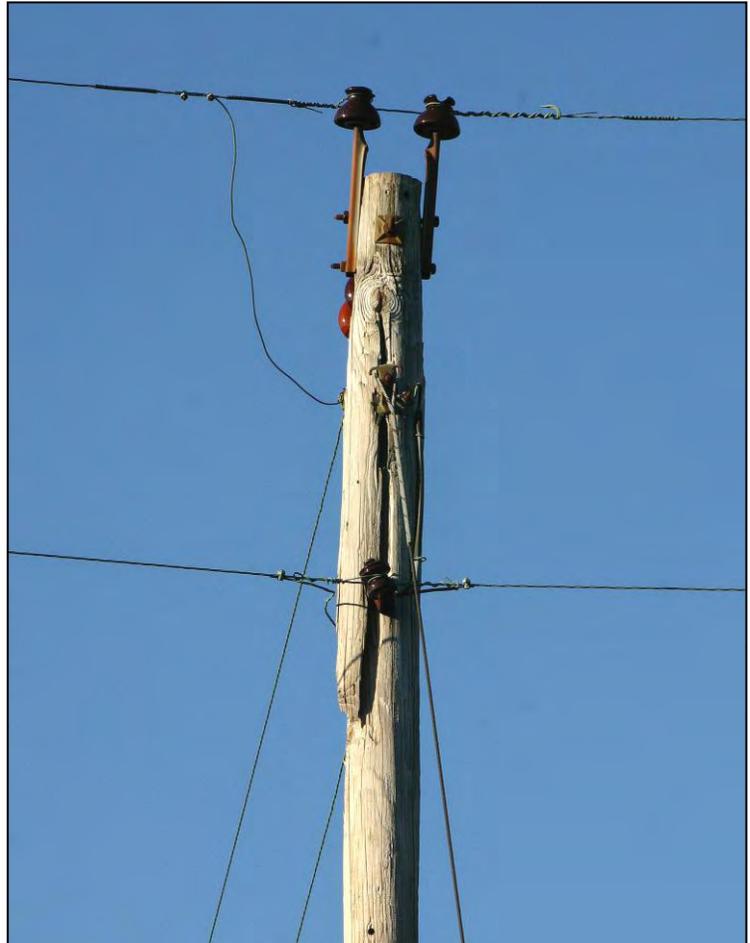
**Figure 31 (Photo 07-IP1723)**  
**Split (lightning damaged) pole top**  
**Circuit J12166, Hampshire Rd.,**  
**north of Argenta**

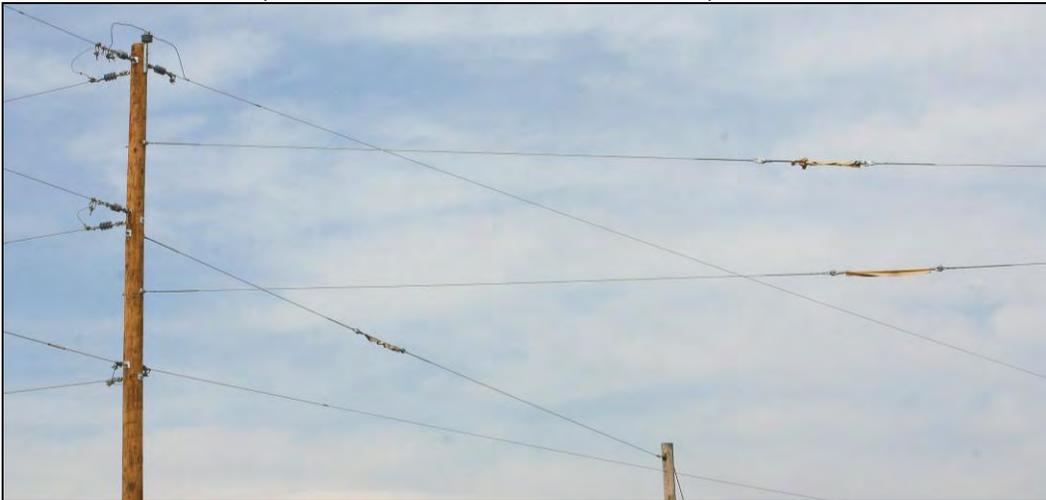
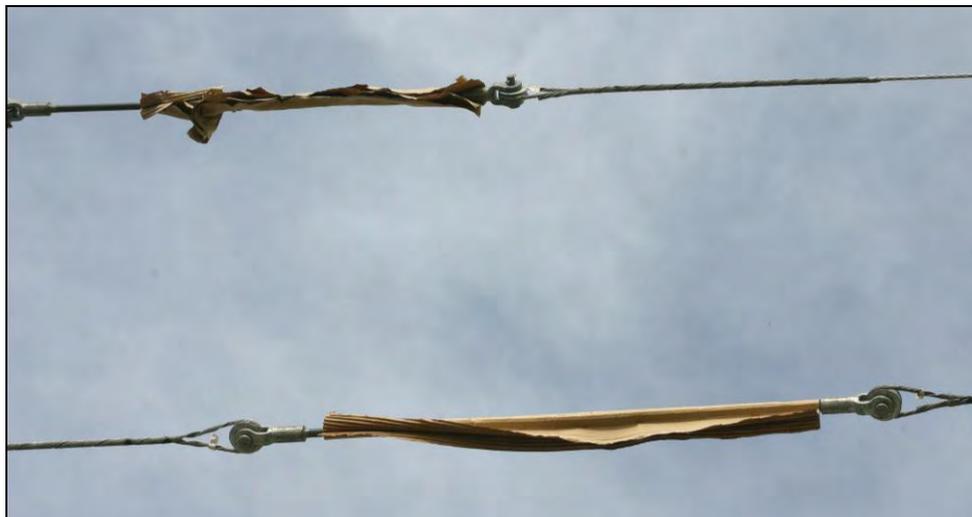
**Figures 32 & 33 (Photos 07-IP1744 & 07-IP1745)**  
**Corrugated paper left on fiberglass strain insulators**  
**Circuit P54828, corner of Rd. 2700N & Rd. 800E, northwest of Harvel**

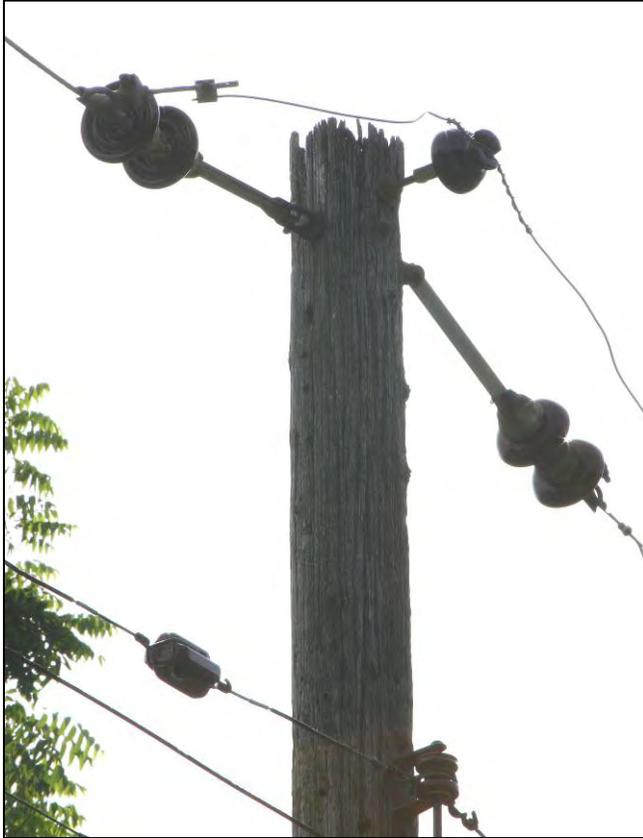
**Figure 34 (Photo 07-IP1746)**  
Badly deteriorated pole top  
Circuit P54828, Main St., Harvel

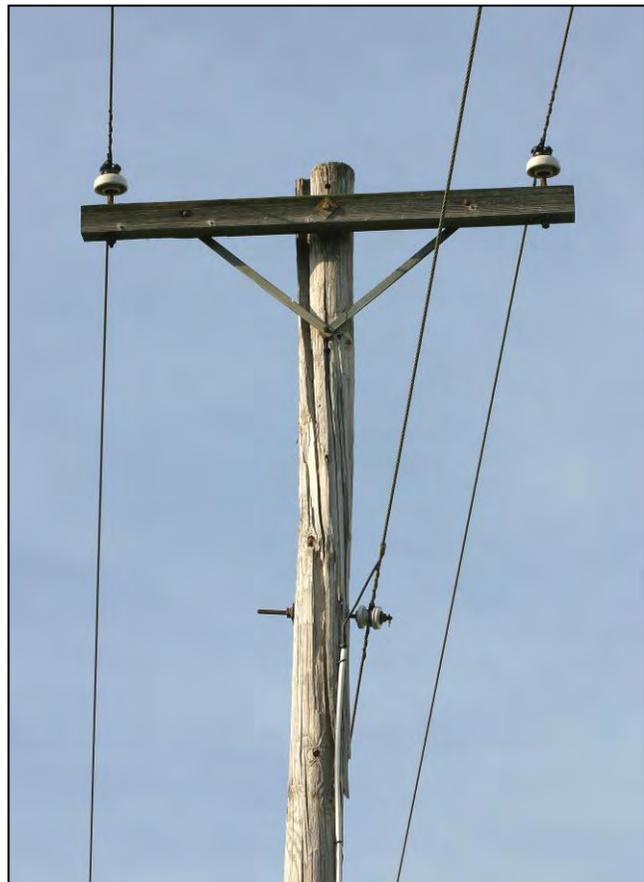
**Figure 35 (Photo 07-IP1738)**  
Badly lightning damaged, split pole top  
Circuit P54828, Smith (Berrie) St.,  
north of Harvel

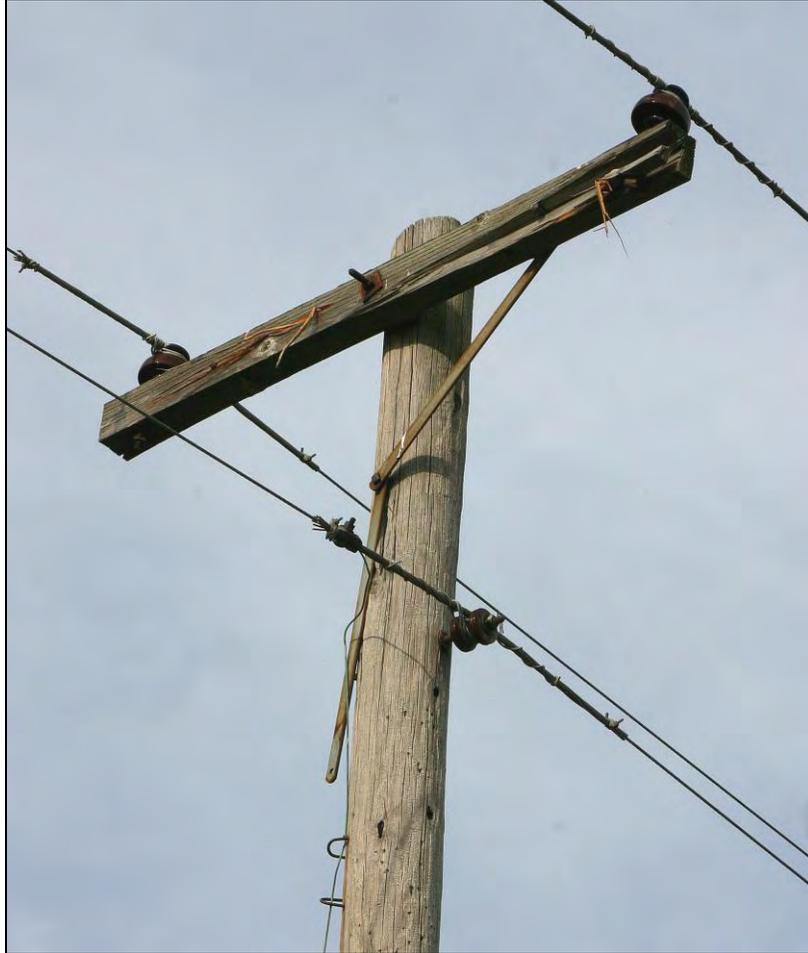
**Figure 36 (Photo 07-IP1741)**  
**Badly lightning damaged crossarm & hanging steel brace**  
**Circuit P54828, west of N. 100E Rd. on CH 10, northeast of Harvel**

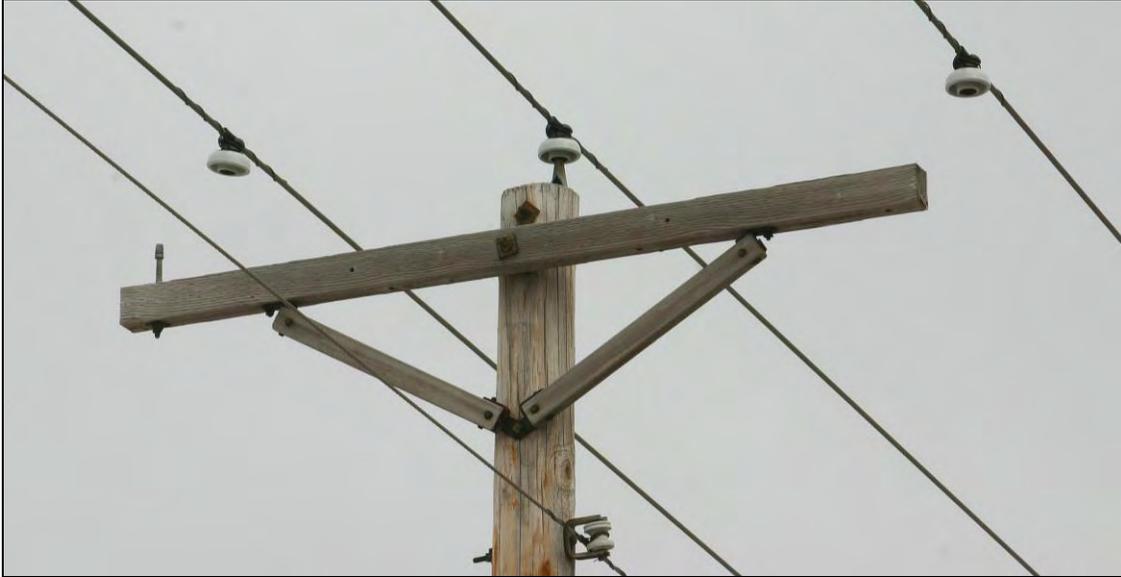
**Figure 37 (Photo 07-IP1267)**  
**Two primary floaters (road side & field side)**  
**Circuit M26164, CH 20 east of Glasgow Rd., east of Warrensburg**

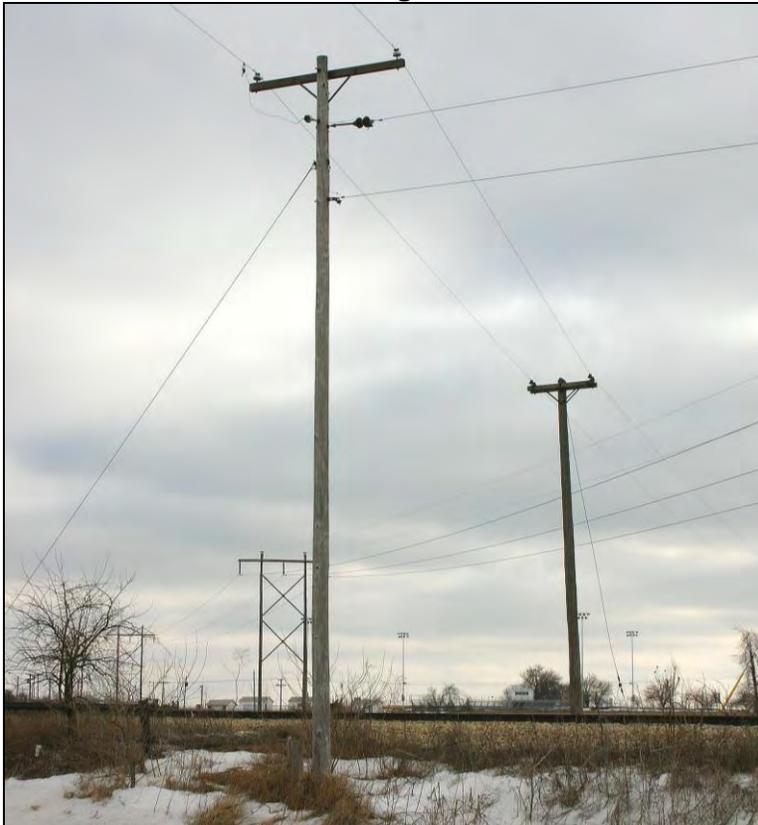
**Figure 38 (Photo 07-IP1273)**  
**Single wood crossarm supporting a single-phase crossing of a railroad**  
**(NESC Railroad Crossing Violation)**  
**Circuit M26164, Rt. 121 at Flanagan Rd., west of Warrensburg**

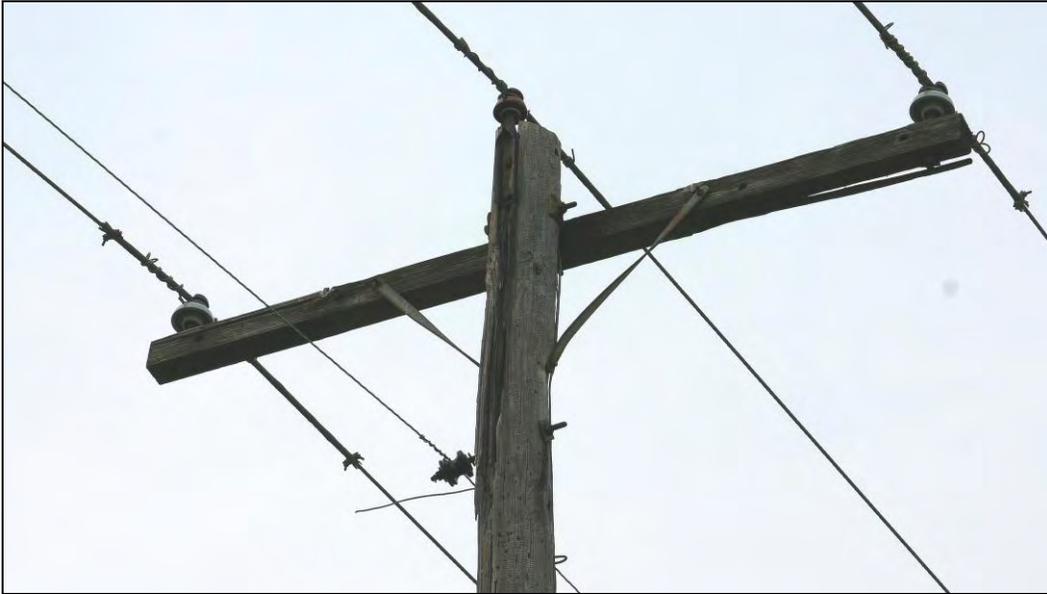
**Figure 39 (Photo 07-IP1754)**

**Lightning damaged pole top, lightning damaged & split crossarm, & broken ground wire  
Circuit P54827, north of Rd. 200E on Rt. 48, south of Morrisonville**

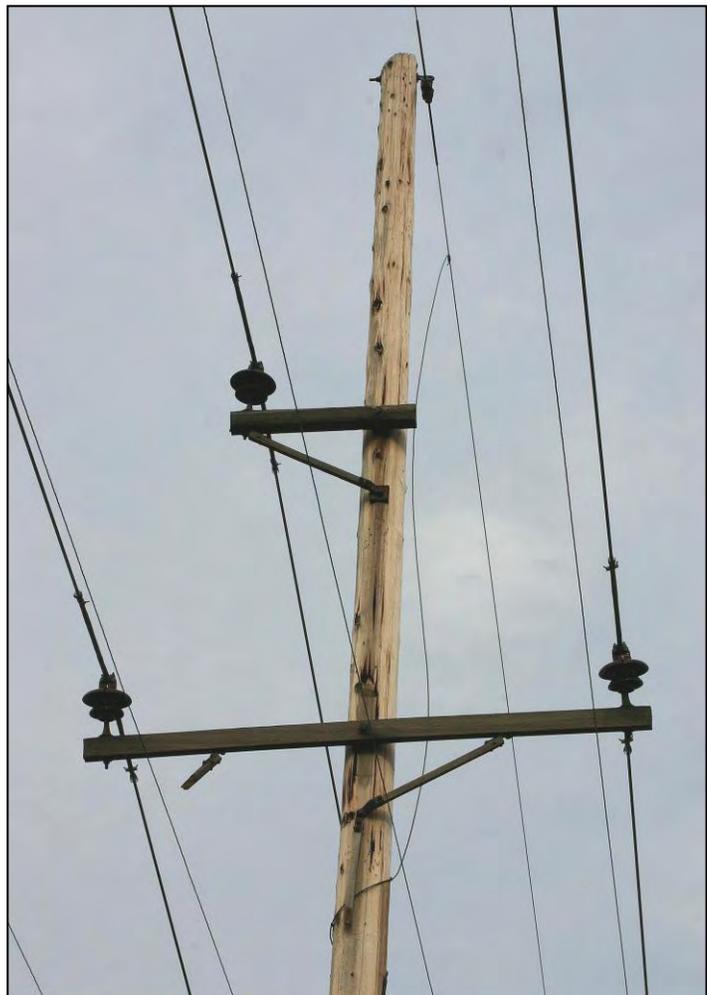
**Figure 40 (Photo 07-IP1756)**

**Broken wood brace on 34.5 kV line  
Line 3454 (Str. #192), Rt. 108,  
east of Carlinville**

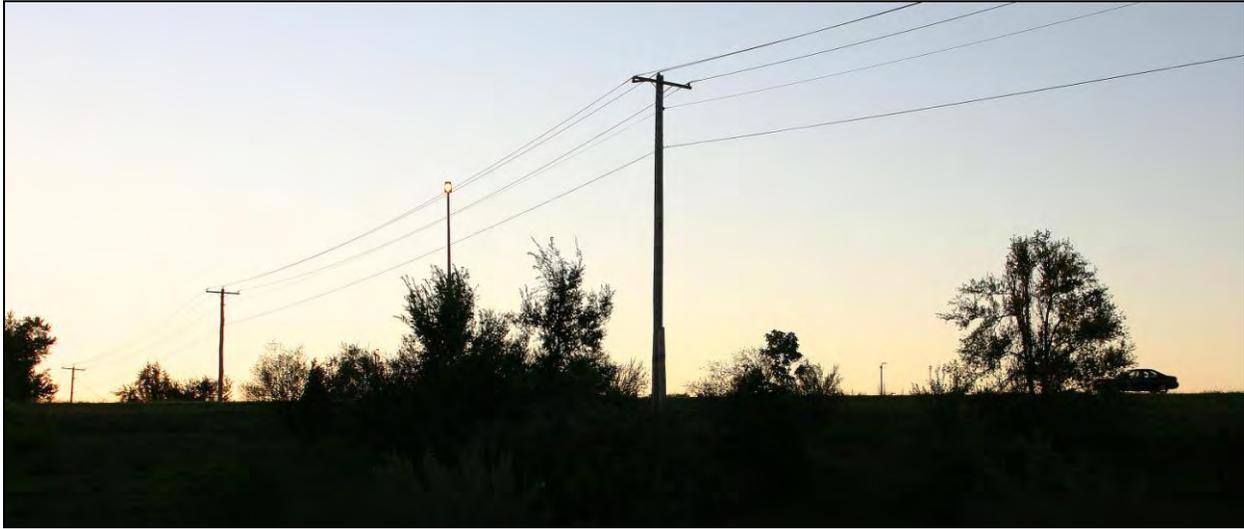
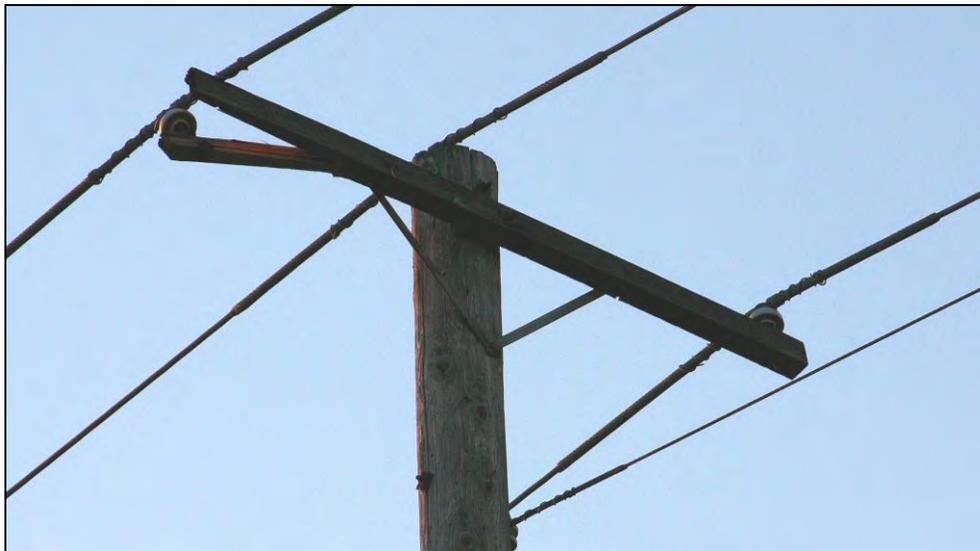
**Figures 41 & 42 (Photos 07-IP1802 & 07-IP1800)**

**Broken crossarm in a single crossarm support of a 3-phase interstate highway crossing  
Circuit M18131, I-72 at exit 133, Harristown**

**Note: AmerenIP refused to install double crossarms at this and some other limited access highway crossings in 2005, claiming grandfathering rights for installations prior to 1984, when the NESC requirement for double crossarms became effective in Illinois. In its reliability assessment report covering AmerenIP's 2004 reliability, Staff stated "*Staff does not believe that AmerenIP's limited action plan is in the best interest of public safety, though it may meet the minimal statutory requirements in Illinois due to the "grandfathering" approach allowed by the safety code.*" Because of AmerenIP's policy, situations at some interstate highway crossings, such as pictured in Figures 41 & 42, have resulted in a danger to public safety. AmerenIP replaced this broken crossarm with new double crossarms promptly when notified of the danger by Staff, but still has not added the second crossarm in many other single arm interstate highway crossing locations (including another one in the median at this same interchange) due to its grandfathering policy. Staff continues to believe this policy is not in the best interest of public safety.**

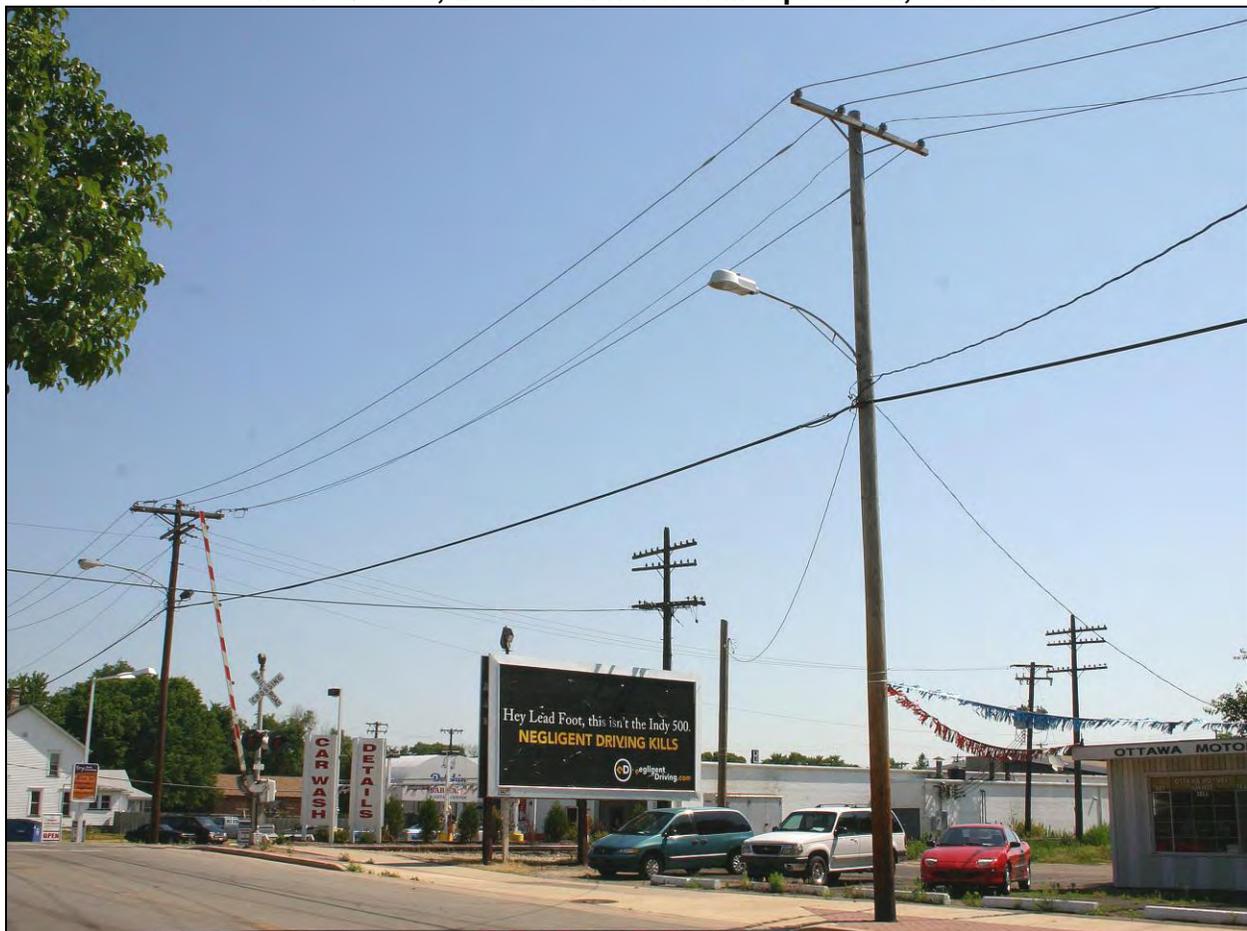
**Figure 43 (Photo 07-IP1634)**  
**Single wood crossarm supporting a 3-phase crossing of a railroad**  
**(NESC Railroad Crossing Violation)**  
**Circuit Q34366, LaSalle St. north of Marquette St., Ottawa**

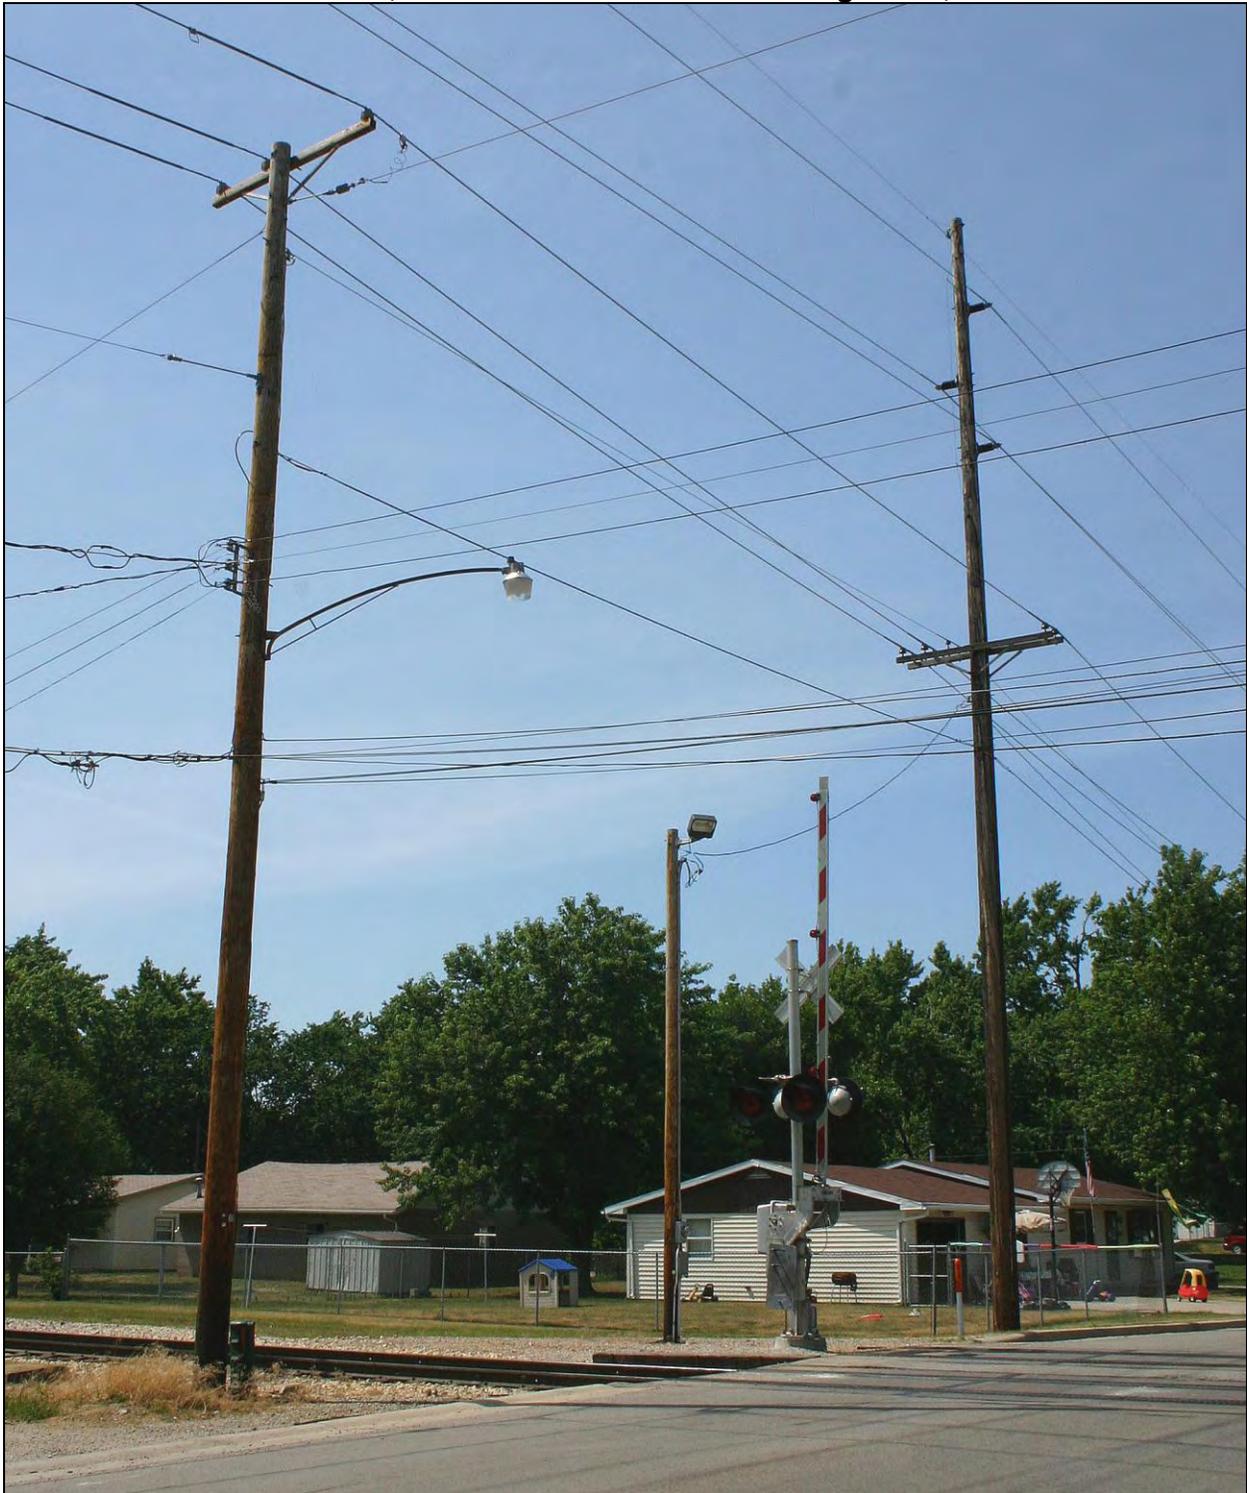
**Figure 44 (Photo 07-IP1640)**  
**Single wood crossarm (ON NEW POLE) supporting a 3-phase crossing of a railroad**  
**(NESC Railroad Crossing Violation)**  
**Circuit K36251, Alexander Ave. north of Washington St., Clinton**

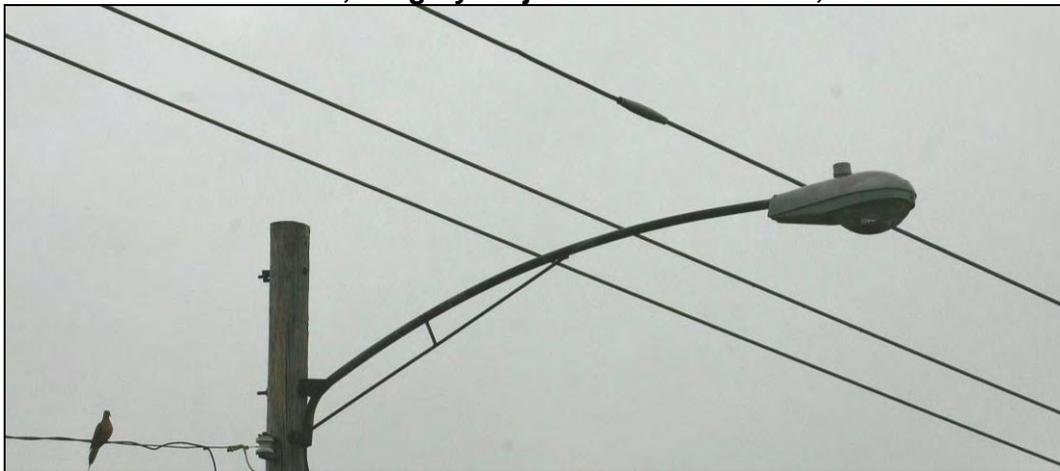
**Figure 45 (Photo 07-IP1673)**

Inadequate clearance of 12 kV primary over a street light on a skip-span pole  
**(NESC Clearance Violation)**

Circuit P98193, Gregory St. just west of Grove St., Normal

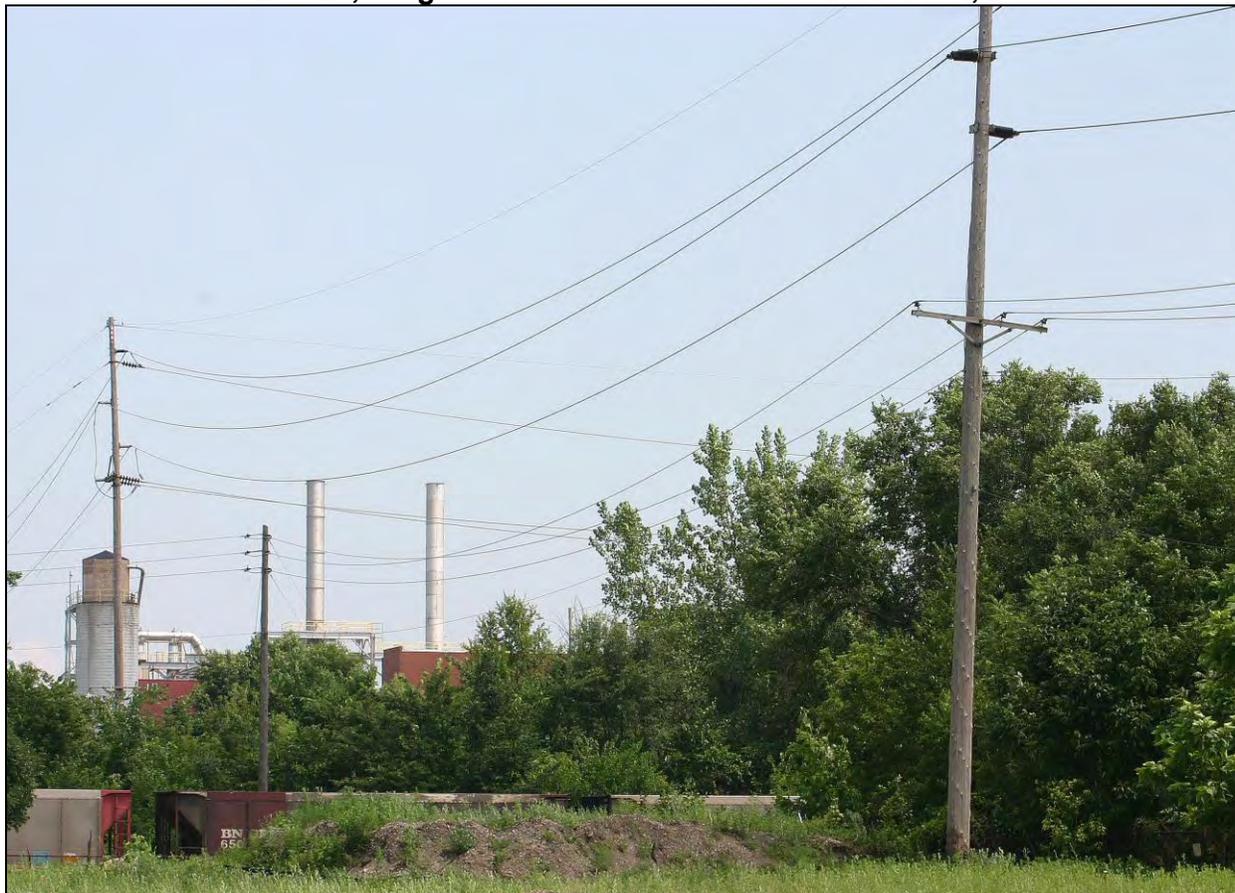
**Figure 46 (Photo 07-IP1705)**

Single wood crossarm supporting a 3-phase crossing of a railroad  
**(NESC Railroad Crossing Violation)**

Circuit L70125, Oregon Ave. between Fairchild & Daniel Sts., Danville

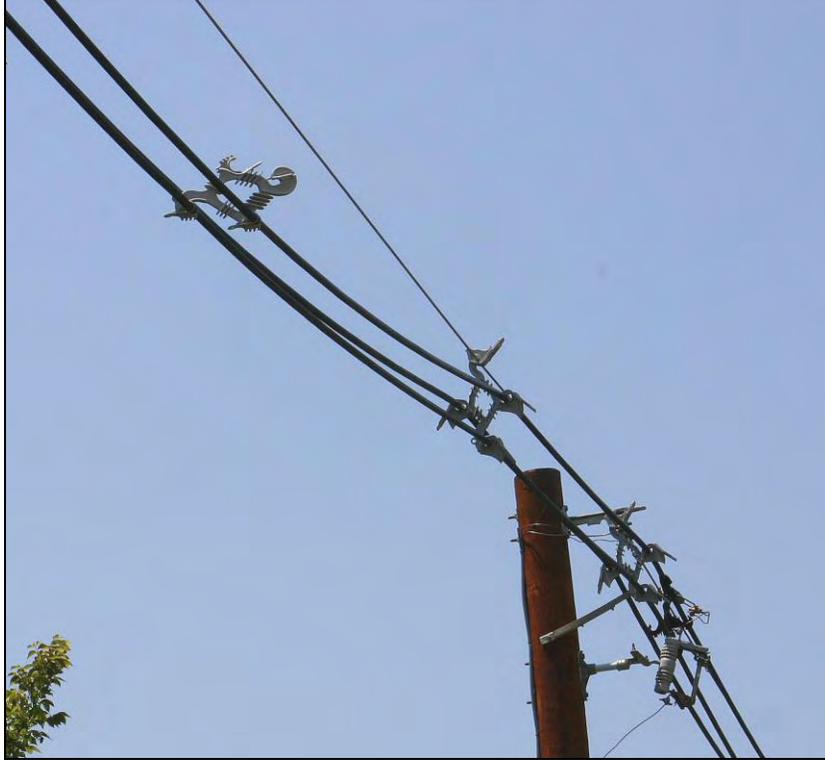
**Figure 47 (Photo 07-IP1788)**  
**Spacer cable spacer off of messenger**  
**South Shores Dr. at Lake Pointe Subdivision entrance, Decatur**

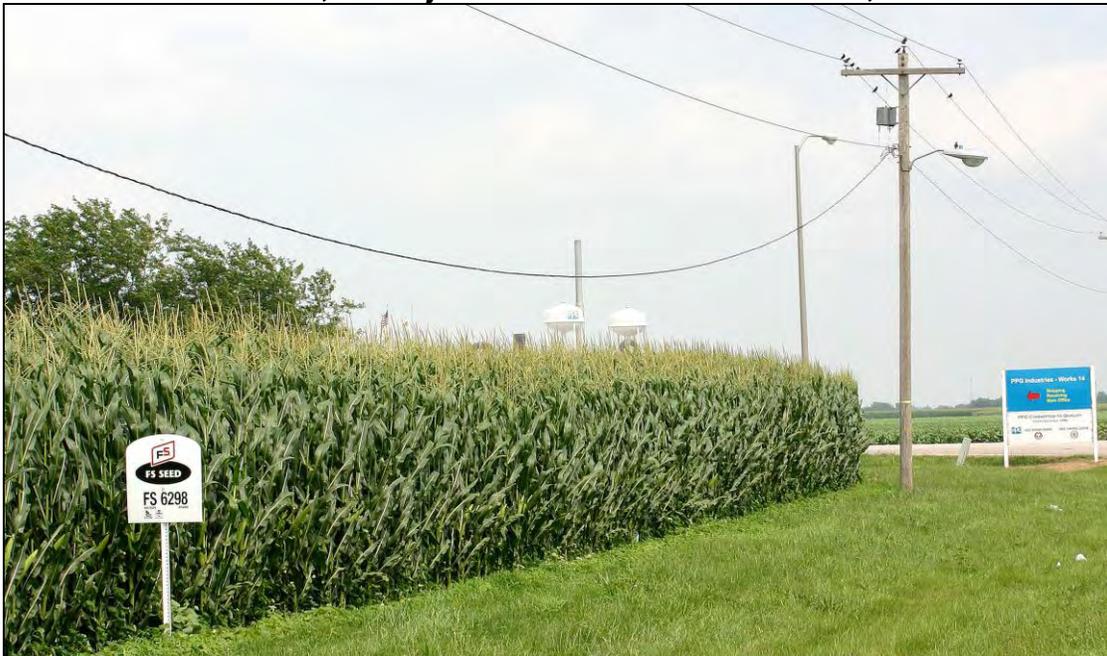
**Figure 48 (Photo 07-IP1771)**  
**Inadequate secondary clearance above ground**  
**(NESC Clearance Violation)**  
**Circuit L24122, CH 30 just west of the entrance to PPG, Mt. Zion**
