Illinois Commerce Commission  
Assessment of Commonwealth Edison Company  
Reliability Report and Reliability Performance  
for Calendar Year 2007

Pursuant to 83 Ill. Adm. Code 411.140

April 8, 2009

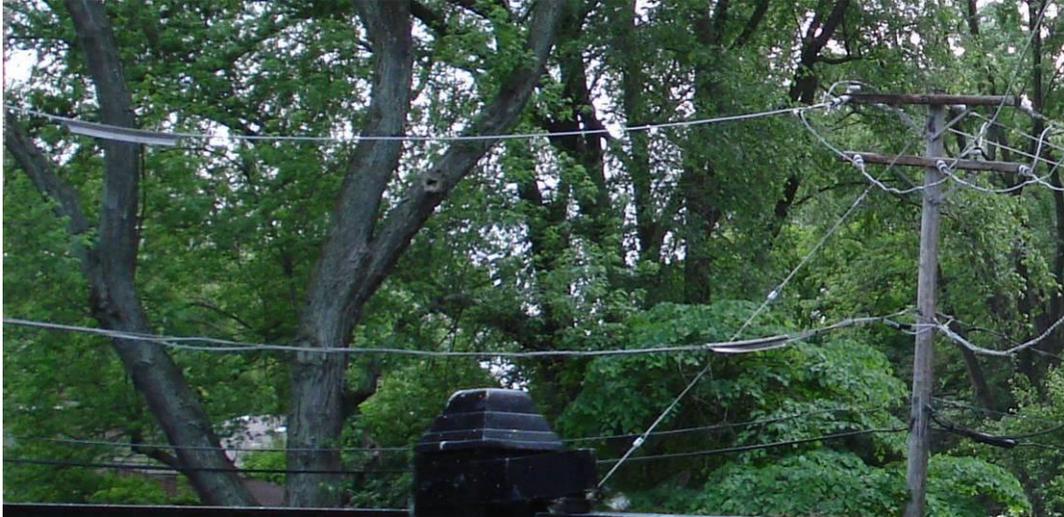
In some cases, Staff noted the conditions of portions of circuits randomly observed while travelling within ComEd's service territory, going to and from locations of circuits chosen for inspection, while evaluating conditions in randomly picked areas, or going to random locations and locations where problems had generally existed in the past. Staff observed a number of deficiencies (materials deficiencies such as broken or hanging cross arm braces, bad pole tops, and blown lighting arrestors, and vegetation management deficiencies such as trees and vines growing into equipment). In some locations Staff found only minor materials issues. See Appendices A & D or pictures 1 and 2 for examples.

**Picture 1 – Line Hose<sup>21</sup> where Line is next to Tree in Residential Back Yard**

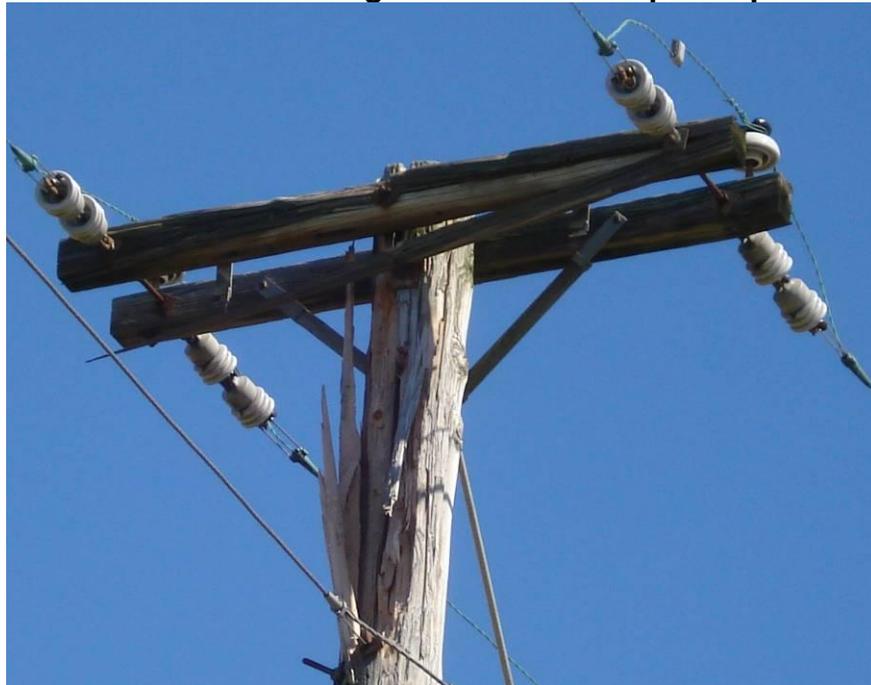
**Picture 2 – Damaged cross arm and pole top**

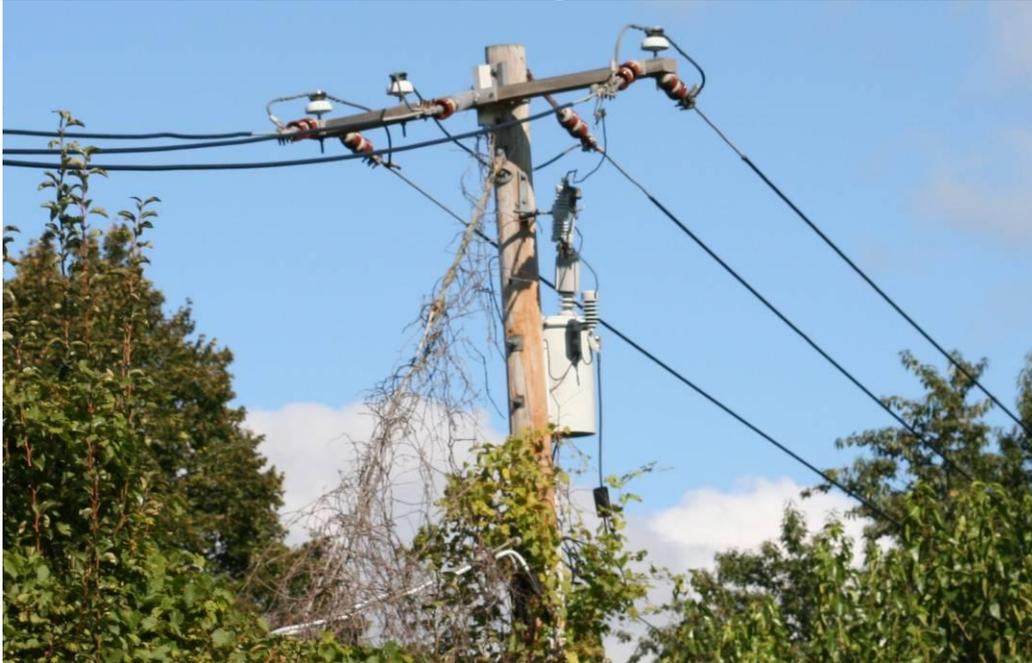
Staff reviewed random locations with problems last year and noted, in most cases, that the identified problems had been fixed while in the case of W7217 (a worst performing circuit repeat that had been reviewed by Staff in previous years including the most recent 2006 Assessment Report) Staff found that problems continued to exist with vegetation regrowth. (See picture 3 and 4.)

**Picture 3 – Vine Regrowth in 2006**

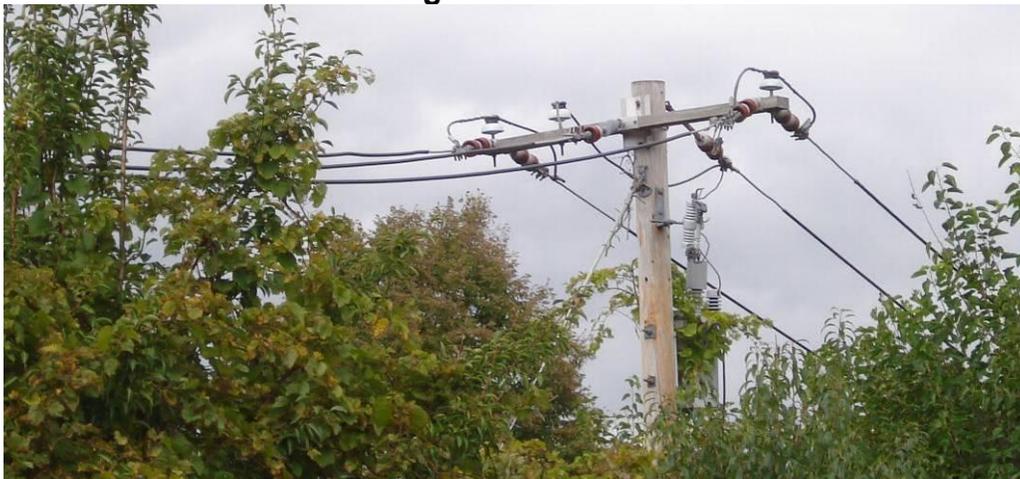
**Picture 4 – Vine Regrowth in 2008 on Same Circuit**

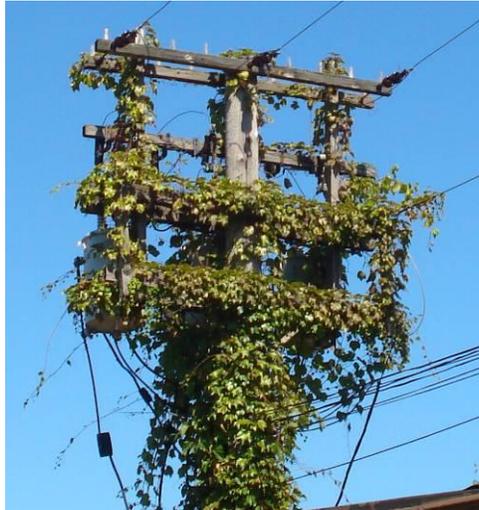
Staff noted varying degrees of vegetation issues including many fast growing trees & vines (see Picture 5) as well as areas with significant canopy overhangs that will be perpetual problems without careful attention. One WPC (B703 – see appendix B) had a number of materials issues (such as a floating insulator – see Picture 6) that could result in future interruptions.

**Picture 5 – Vine Growth on Pole Mounted Transformer Bank**

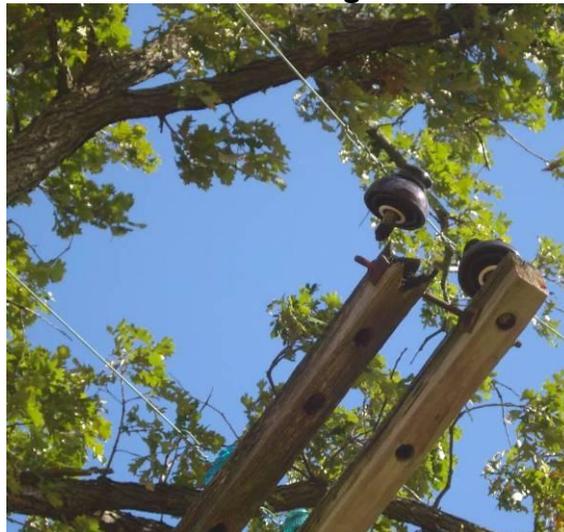
**Picture 6 – Floating Insulator**
