Illinois Commerce Commission  
Assessment of AmerenIP's  
Reliability Report and Reliability Performance  
For Calendar Year 2009

Pursuant to 83 Illinois Administrative Code 411.140

July 12, 2011

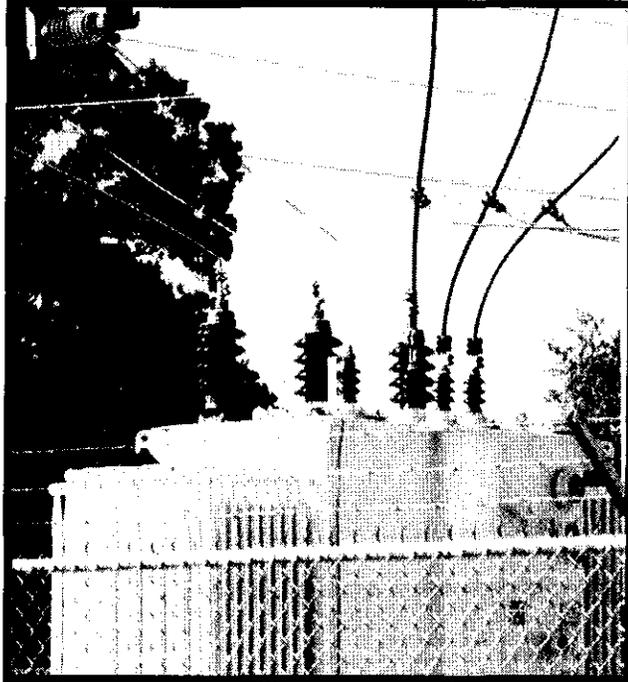
**Circuit R71286 Located at Valmeyer  
Rt 156 Substation, North of IL RT  
156**

with red ribbons as a sign of rejection during a circuit inspection. Staff also noted some transformers without animal guards. AmerenIP corrected some of Staff's findings and provided a schedule to correct others.

**Photo No. 1: Substation Transformer without Animal Guards**

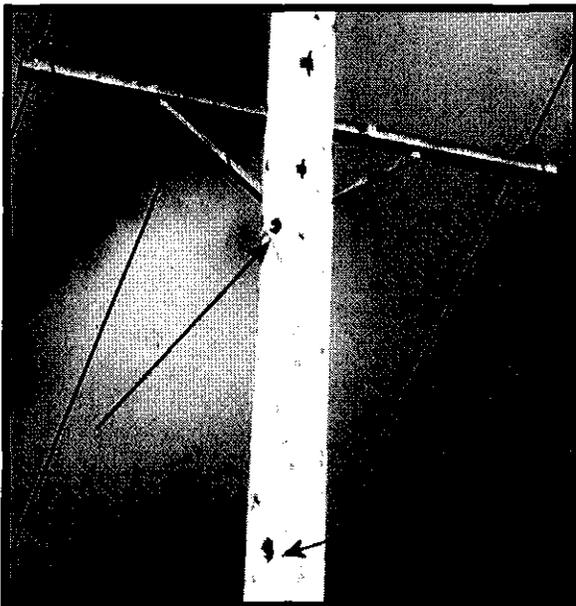
**Circuit R71286 – Pole No. 2315406**

**Photo No. 2: Woodpecker Holes in a Pole**

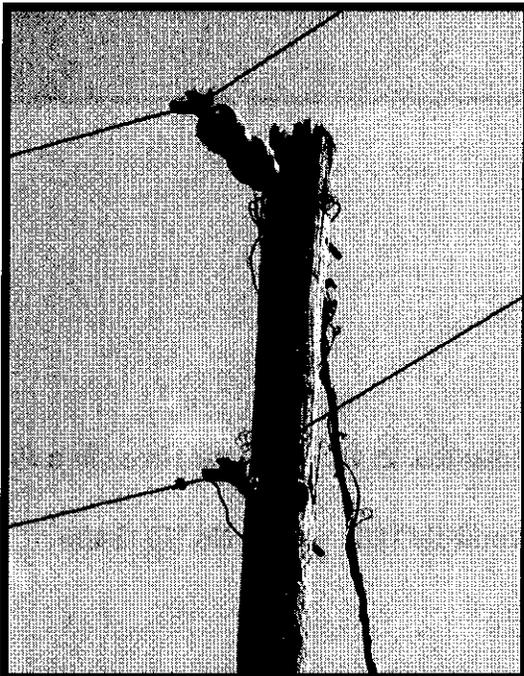
**Circuit R71286 – Located at Deer Hill Rd - Pole No. 2875074**

**Photo No. 4: Deteriorated Pole Top**

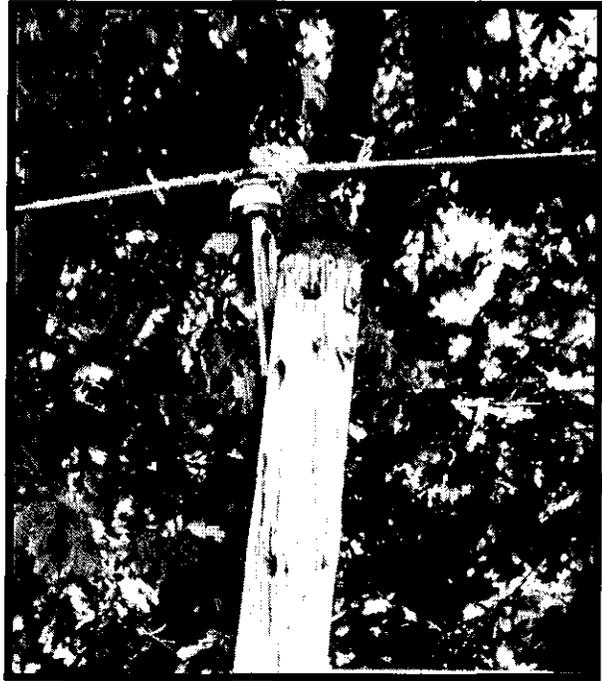
**Circuit R71286 – Located in front of the intersection of Deer Hill Rd and Trout Camp Rd-Pole No. 2906220**

**Photo No. 5: Woodpecker Holes in a Pole and Loose Pole-Top Pin**

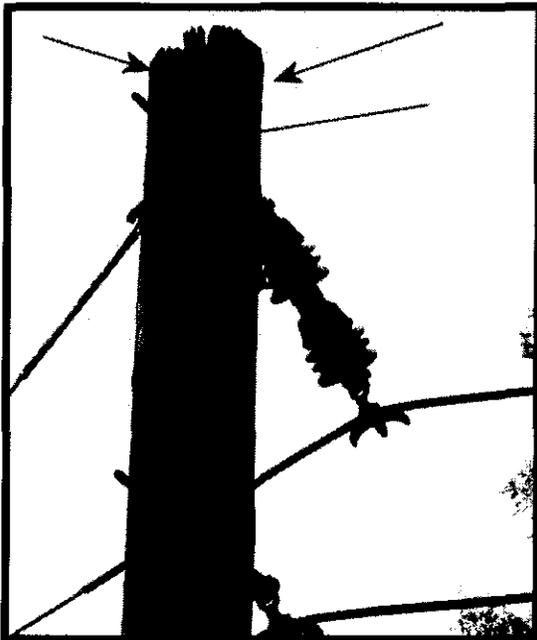
**Circuit R71286 – Pole No. 2891985**

**Photo No. 6: Woodpecker Holes in a Pole**

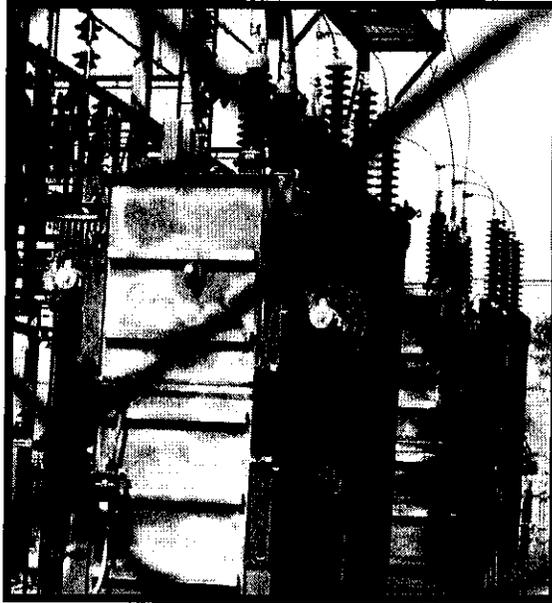
**Circuit M41-112: Located at 2347 N Seminary St**

**Photo No. 8: Rusted substation transformers**

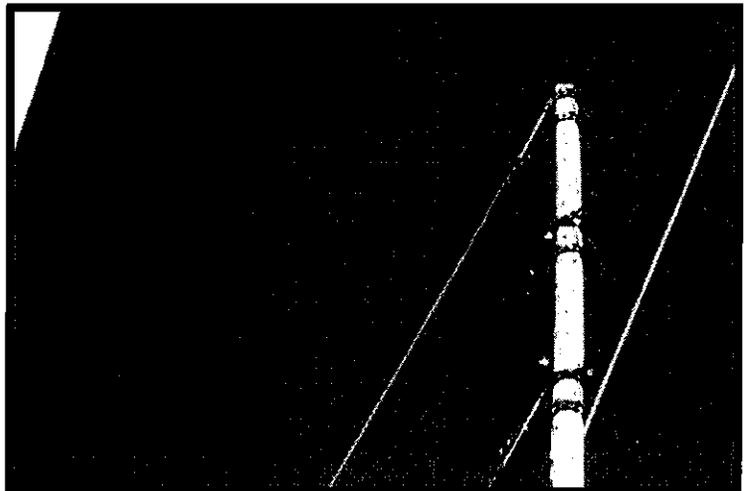
**Circuit M41-112:** Located at Carl Sandburg Dr. outside the Substation Fence

**Photo No. 11:** Bad insulator placement on a down guy (the insulator should be below the level of the lowest energized conductor when the guy is loose)

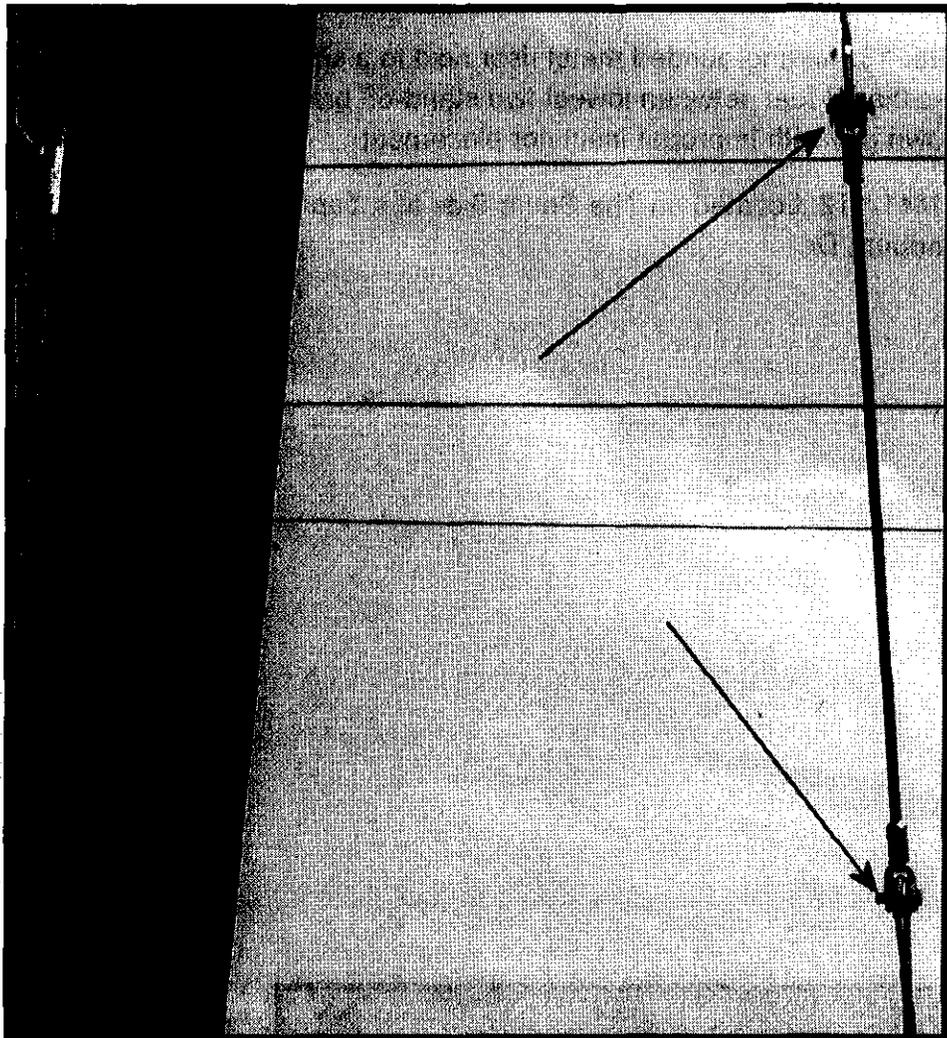
**Photo No. 12: Missing Cotter pin in the lower connection of guy insulator**  
**Circuit M41-112: Located on a The South Side in a Tap off Carl Sandburg Dr**

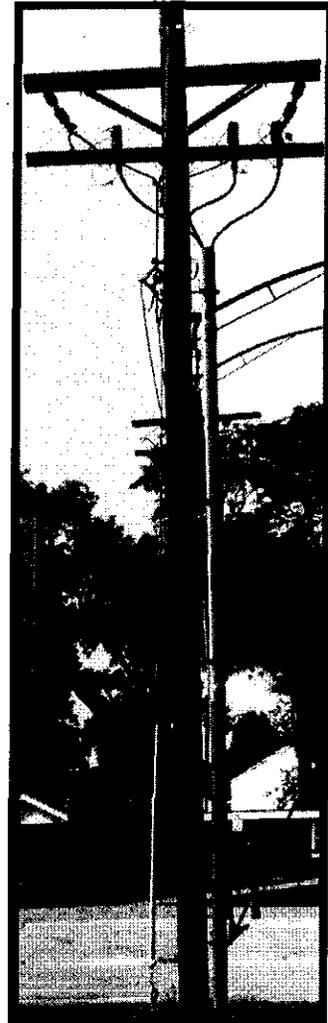
**Circuit M41-112:** Located on The South Side in a Tap off Carl Sandburg Dr

**Photo No. 13:** An ungrounded metal riser next to a school with Less than 8 feet between lowest two stand-off brackets and a down guy with improper insulator placement

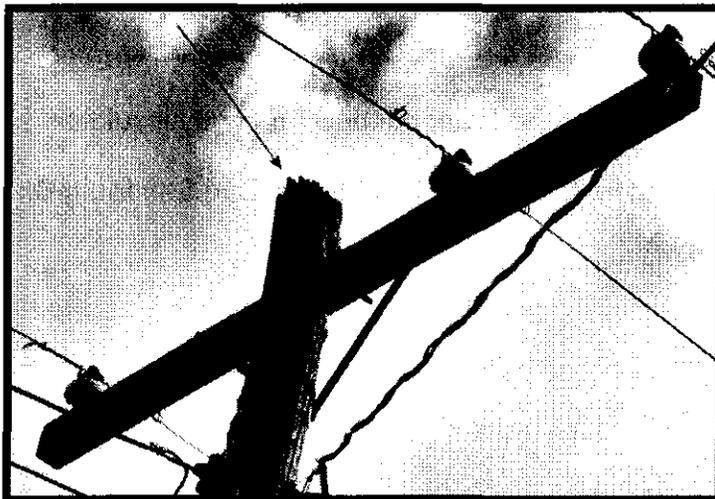
**Circuit M41-112:** Located in Front of 907 Lane Ave

**Photo No. 14:** A Deteriorated Pole Top

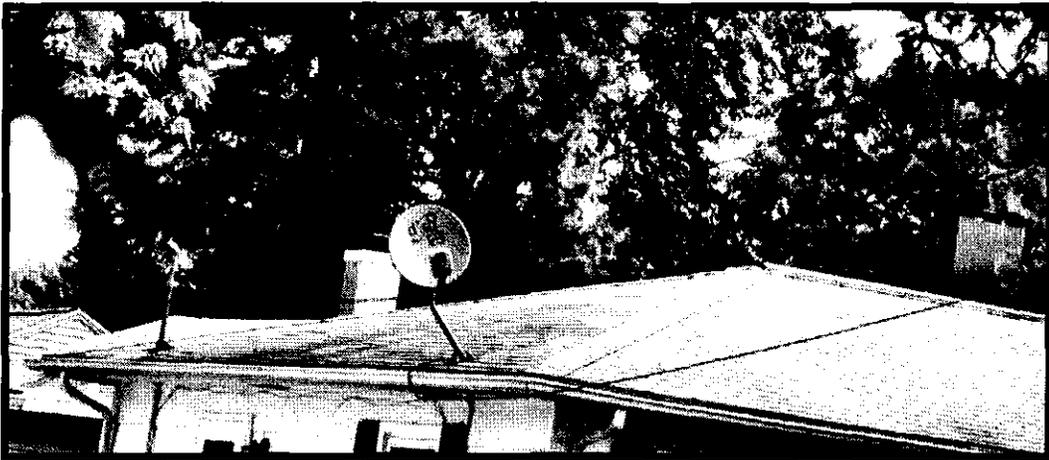
**Circuit M41-112: Located on 907 Lane Ave**

**Photo No. 15: Service drop over a roof with inadequate clearance**

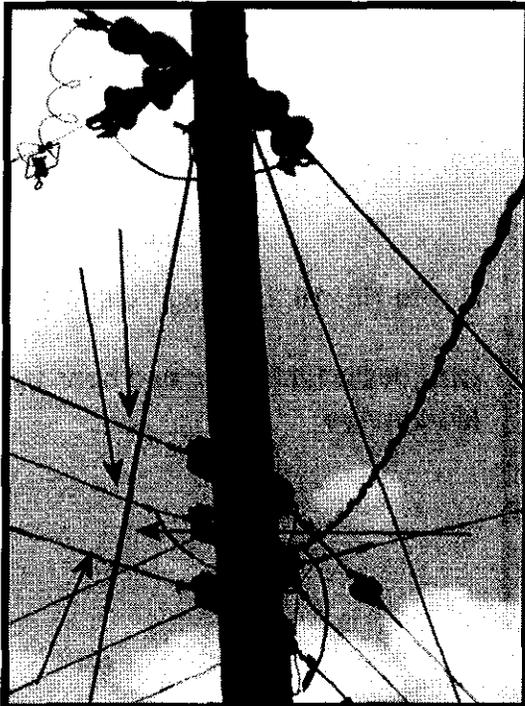
**Circuit M41-112: Located in the Intersection of Dayton St and Willard St**

**Photo No. 16: A down guy W/O grounding or insulator, contacting the secondary line (three wires). There is a hose on the guy wire to keep the guy wire from being energized (inappropriate insulation)**

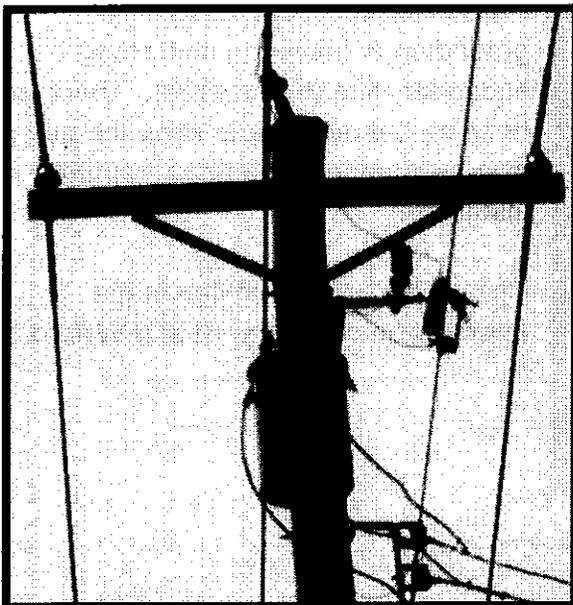
**Circuit M41-112:** Located near 1608 Morton Ave

**Photo No. 18: Leaning Pole-Top Pin**

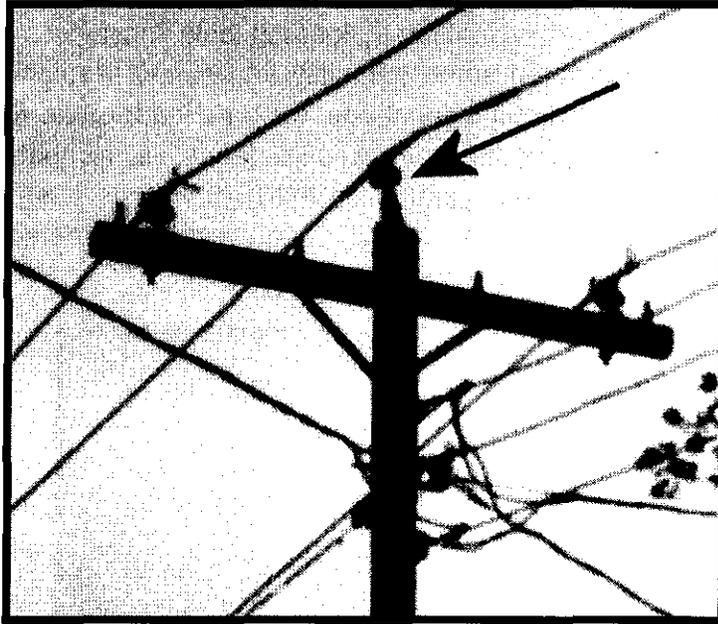
**Circuit M41-112: Located near 1116 Harrison St**

**Photo No. 19: Leaning Pole-Top Pin**

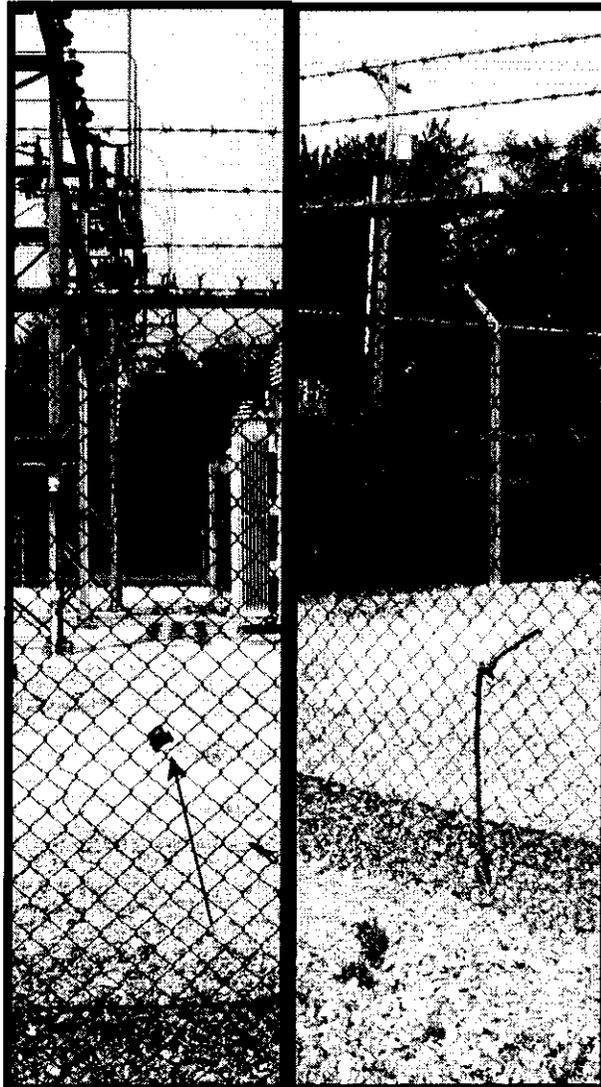
**Circuit R05-115:** Located at 1245 S Farnham St.

**Photo No. 20:** Missing ground wire from the substation fence in the left photo compared to the right photo

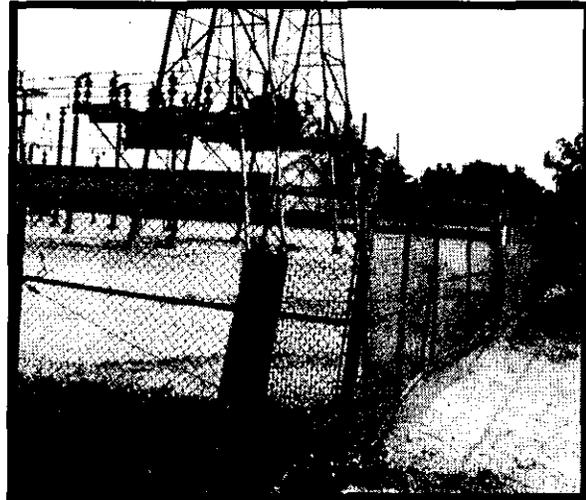
**Circuit R05-115: Located at 1245 S Farnham St., S Farnham St Substation**

**Photo No. 21: Broken substation gate**

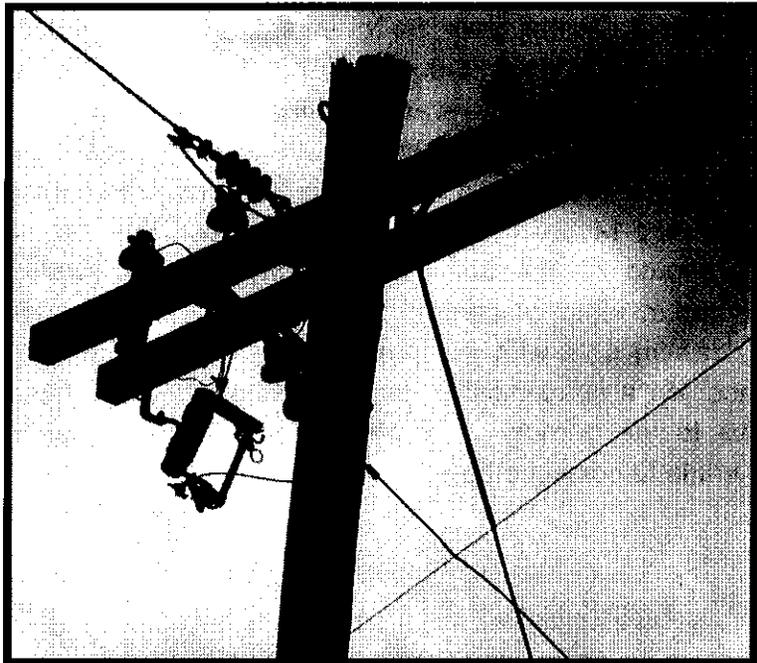
**Circuit K74-166:** Pole No. 2208301 – near Mattis Substation

**Photo 23:** Split Pole Top

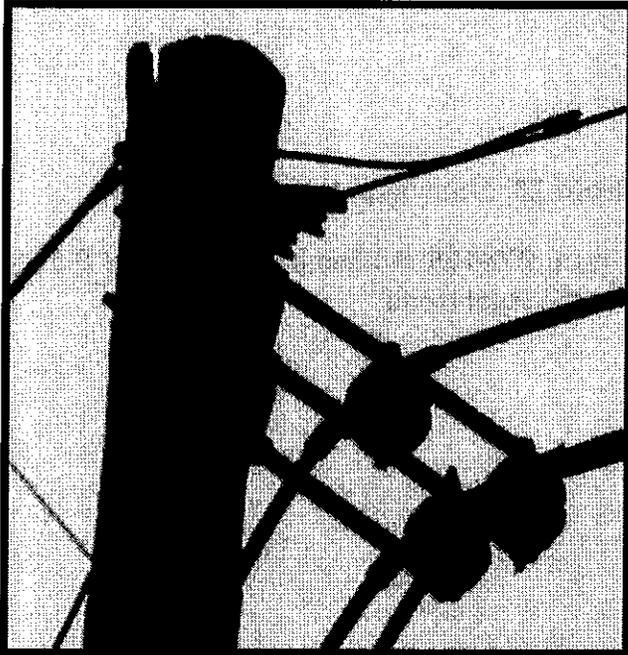
**Circuit K74-166: Pole No.  
2208305 – near Mattis Substation**

**Photo 24: Split/damaged pole top**

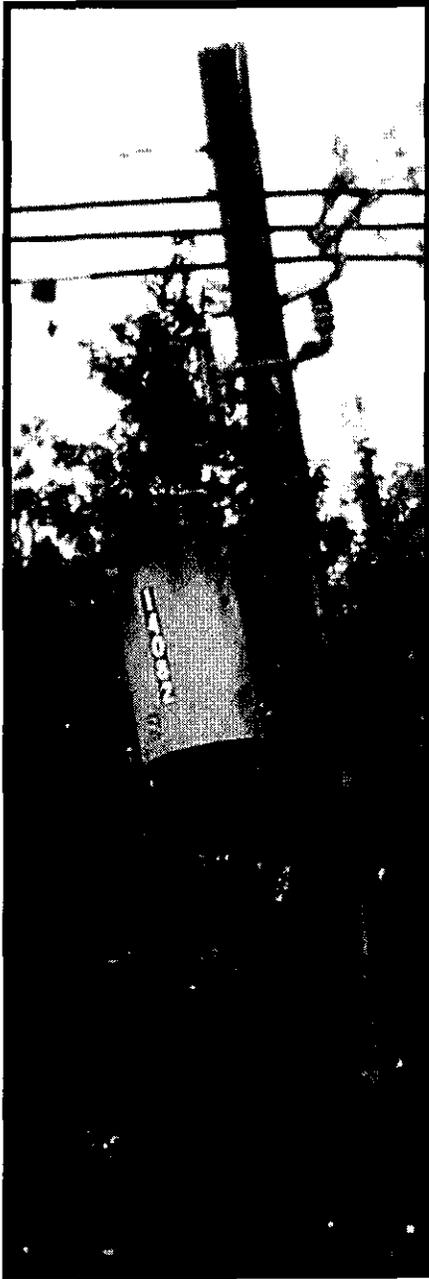
**Circuit K74166:** Across from the Mattis Substation  
and the Real Road

**Photo 26:** Leaning pole with equipment
