Enbridge Incorporated  
Hazardous Liquid Pipeline Rupture and Release  
Marshall, Michigan  
July 25, 2010

NTSB/PAR-12/01  
PB2012-916501

# Pipeline Accident Report

**National Transportation Safety Board. 2012. *Enbridge Incorporated Hazardous Liquid Pipeline Rupture and Release, Marshall, Michigan, July 25, 2010. Pipeline Accident Report NTSB/PAR-12/01. Washington, D.C.***

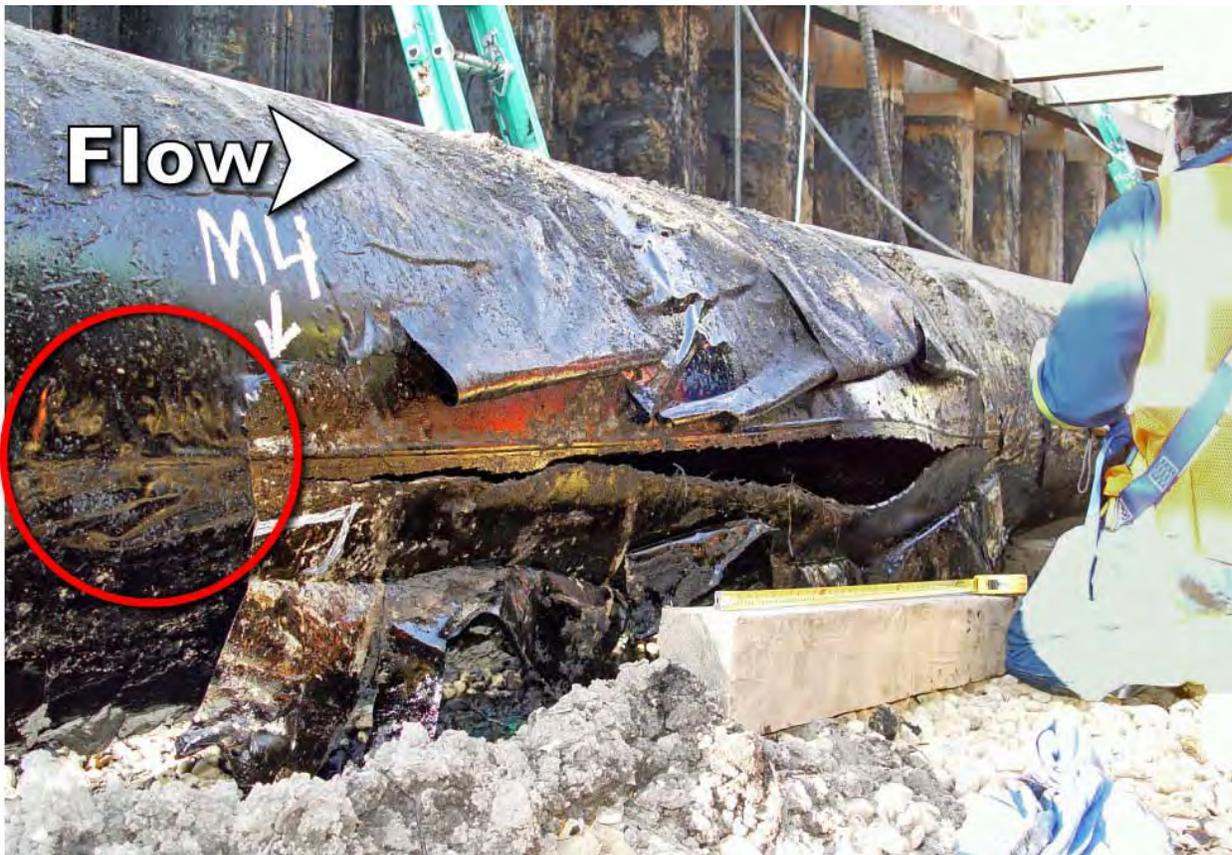
The fracture in the ruptured segment measured 6 feet 8.25 inches long and up to 5.32 inches wide. (See figure 2.) External corrosion was present along the longitudinal weld seam and in areas where the adhesive bond between the pipe and its protective polyethylene tape coating had deteriorated (disbonded). The coating was wrinkled and had separated from the pipe surface as shown in the red circle in figure 2.

**Figure 2.** The ruptured segment of Line 6B in the trench following the July 25, 2010, rupture. The fracture face measured about 6 feet 8.25 inches long and was 5.32 inches wide at the widest opening. The fracture ran just below the seam weld that was oriented just below the 3 o'clock position. A red circle shows a location where the coating was wrinkled and had separated from the pipe surface.

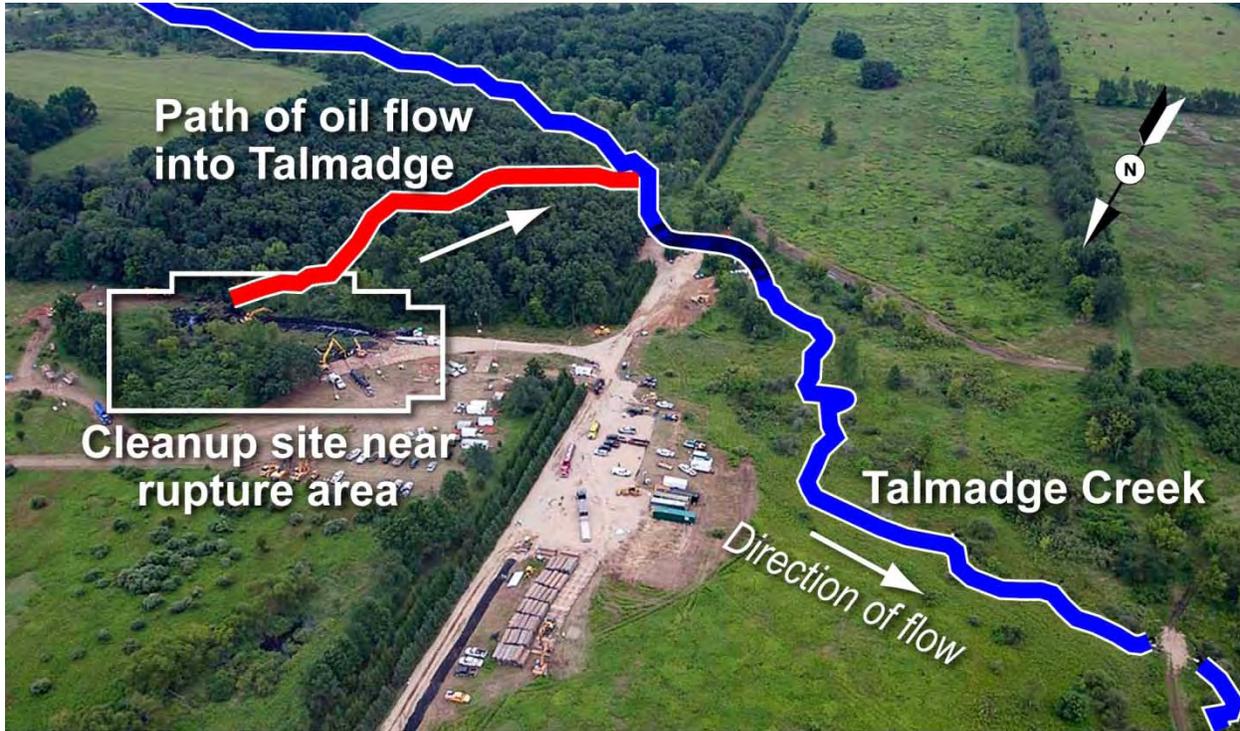
The crude oil release soaked the rupture site and the surrounding wetlands, eventually spreading to the Talmadge Creek and the Kalamazoo River. Enbridge's early response efforts were focused downstream of the rupture. Recent heavy rainfall had increased the flow of the Talmadge Creek and the Kalamazoo River, which spread the oil faster, hindering the response efforts. (See figure 3.)

**Figure 3.** Aerial view of the accident location showing the rupture site to the left and the Talmadge Creek flowing west toward the Kalamazoo River.

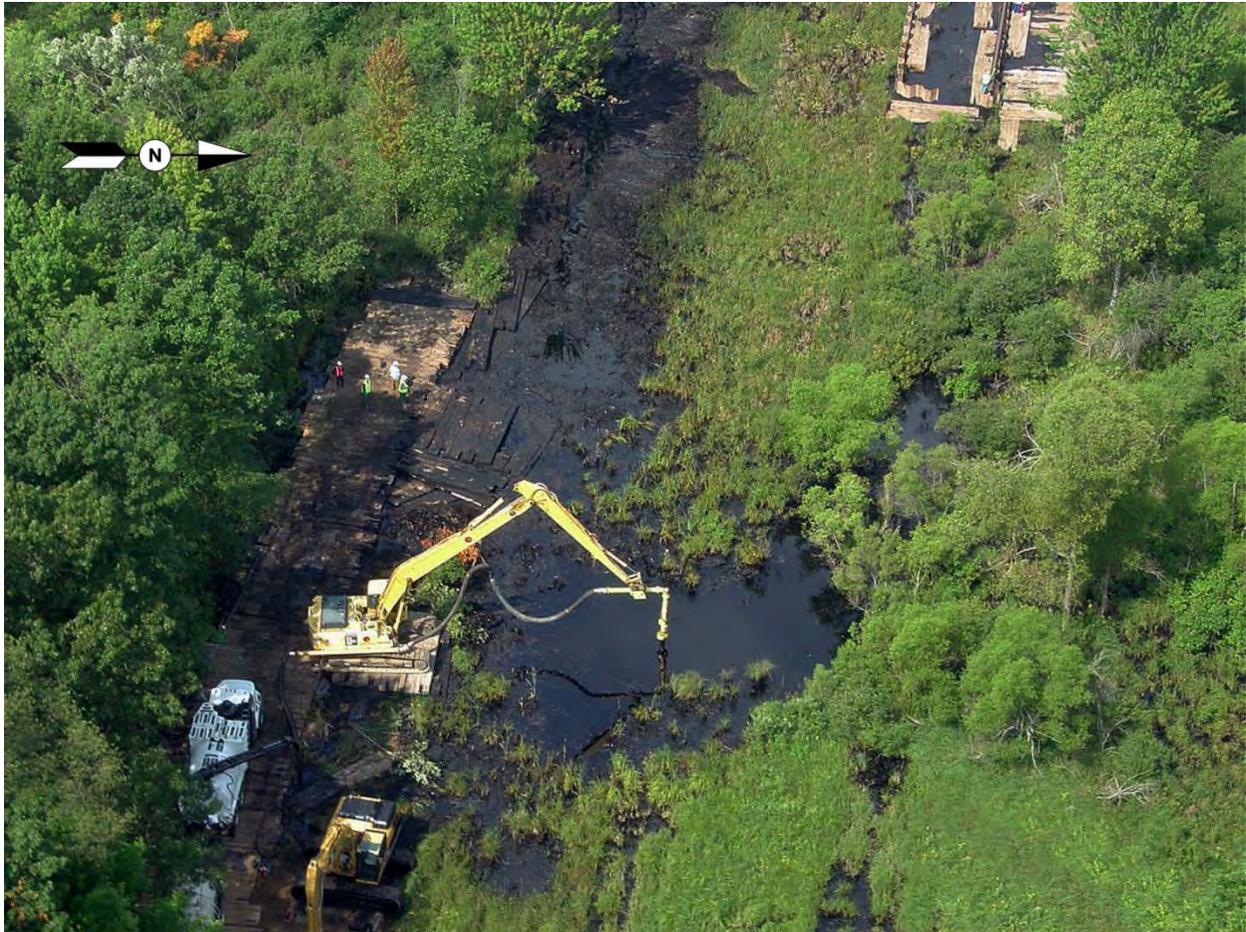
The wetland conditions in addition to the crude oil release made it difficult for vacuum trucks and excavators to get near the rupture location. Large wooden matting had to be placed around the rupture location to bring heavy equipment close to the release. (See figure 4.) The conditions at the accident site also delayed efforts to extract the pipe and to contain the oil near the rupture source.

**Figure 4.** Cleanup efforts in an oil-soaked wetland near the rupture site. Saturated soil complicated the cleanup and excavation efforts. An excavator with a vacuum attachment is shown situated on wooden matting near the rupture site.

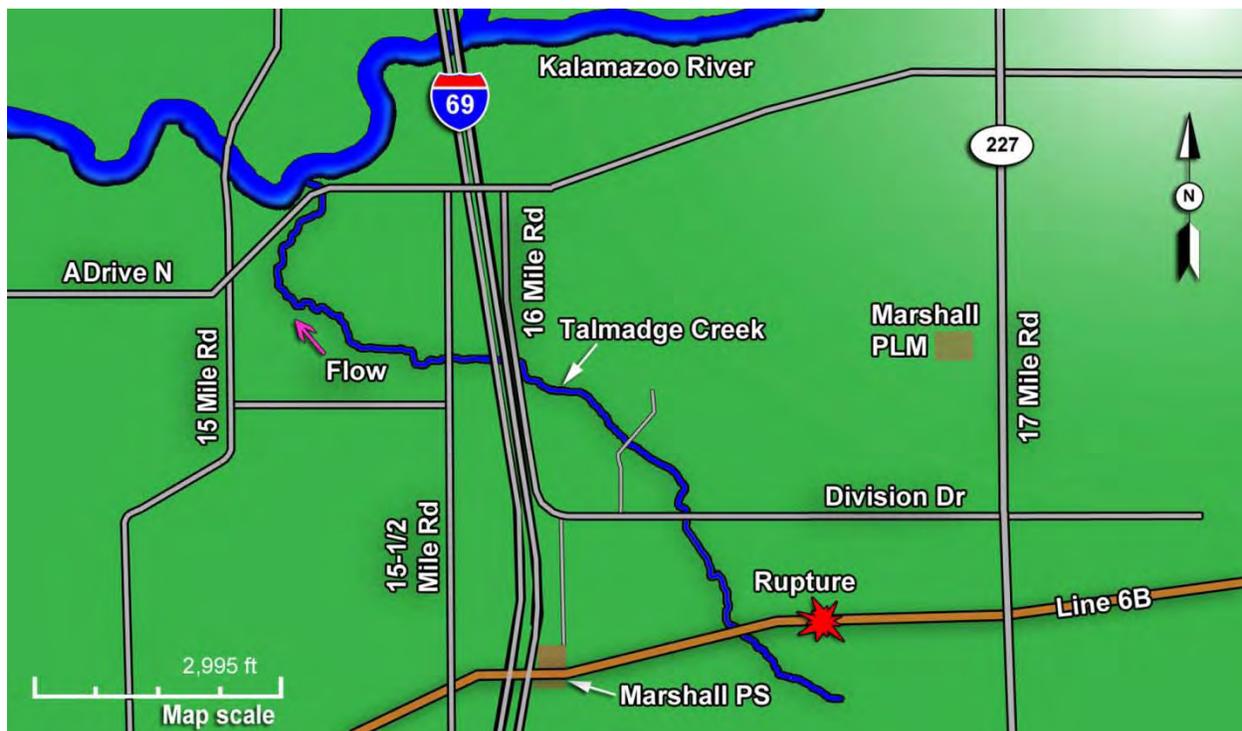
The four-person crew returned to the Marshall PLM shop and retrieved a vacuum truck, a work truck, a semi-truck, and an oil boom trailer. About 12:10 p.m., they returned to A Drive North and installed a double 20-foot length of sorbent boom across Talmadge Creek, where they observed only a little oil flowing. They also installed 20-foot lengths of sorbent boom across Talmadge Creek upstream of A Drive North and at a culvert on the south side of A Drive North. The Enbridge crossing coordinator told NTSB investigators that the Marshall PLM crew was not aware of the severity of the oil spill when it used these initial oil containment measures. The Enbridge first responders did not have an estimate of released volumes when they began their efforts to contain the oil. (See figure 9 for a map of the area around the rupture site where response efforts began.)

**Figure 9.** Area between rupture site and the Kalamazoo River where first responders concentrated efforts to contain the released oil.

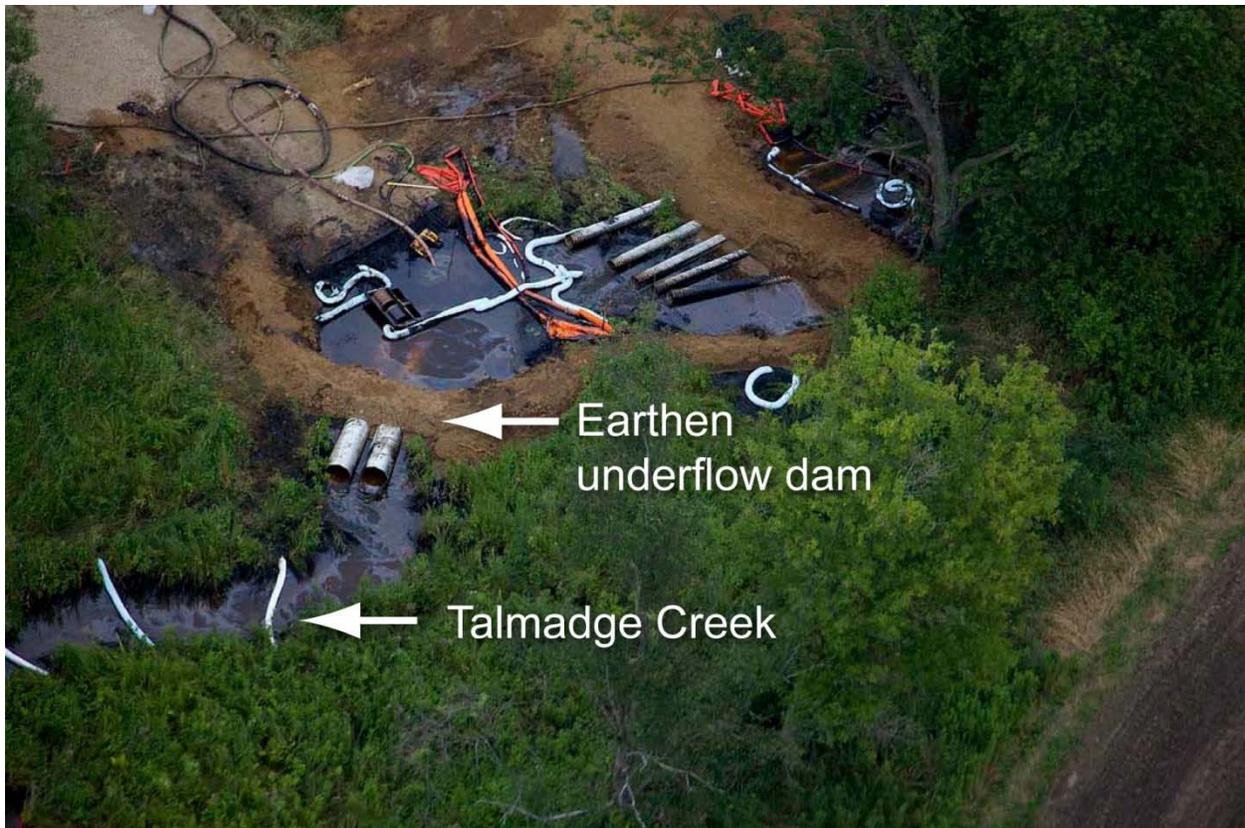
Working with a six-person crew, the Marshall PLM supervisor constructed an earthen underflow dam, which consists of a mound of soil holding back oil-contaminated water with pipes submerged on the dam side and rising toward the discharge end. The angle of the pipe allows the deeper water in the dam to flow downstream, preventing the contaminated surface waters from flowing into Talmadge Creek. (See figure 10.)

**Figure 10.** Underflow dam on Talmadge Creek on July 30, 2010.
