1.7 Examination of the Accident Pipe

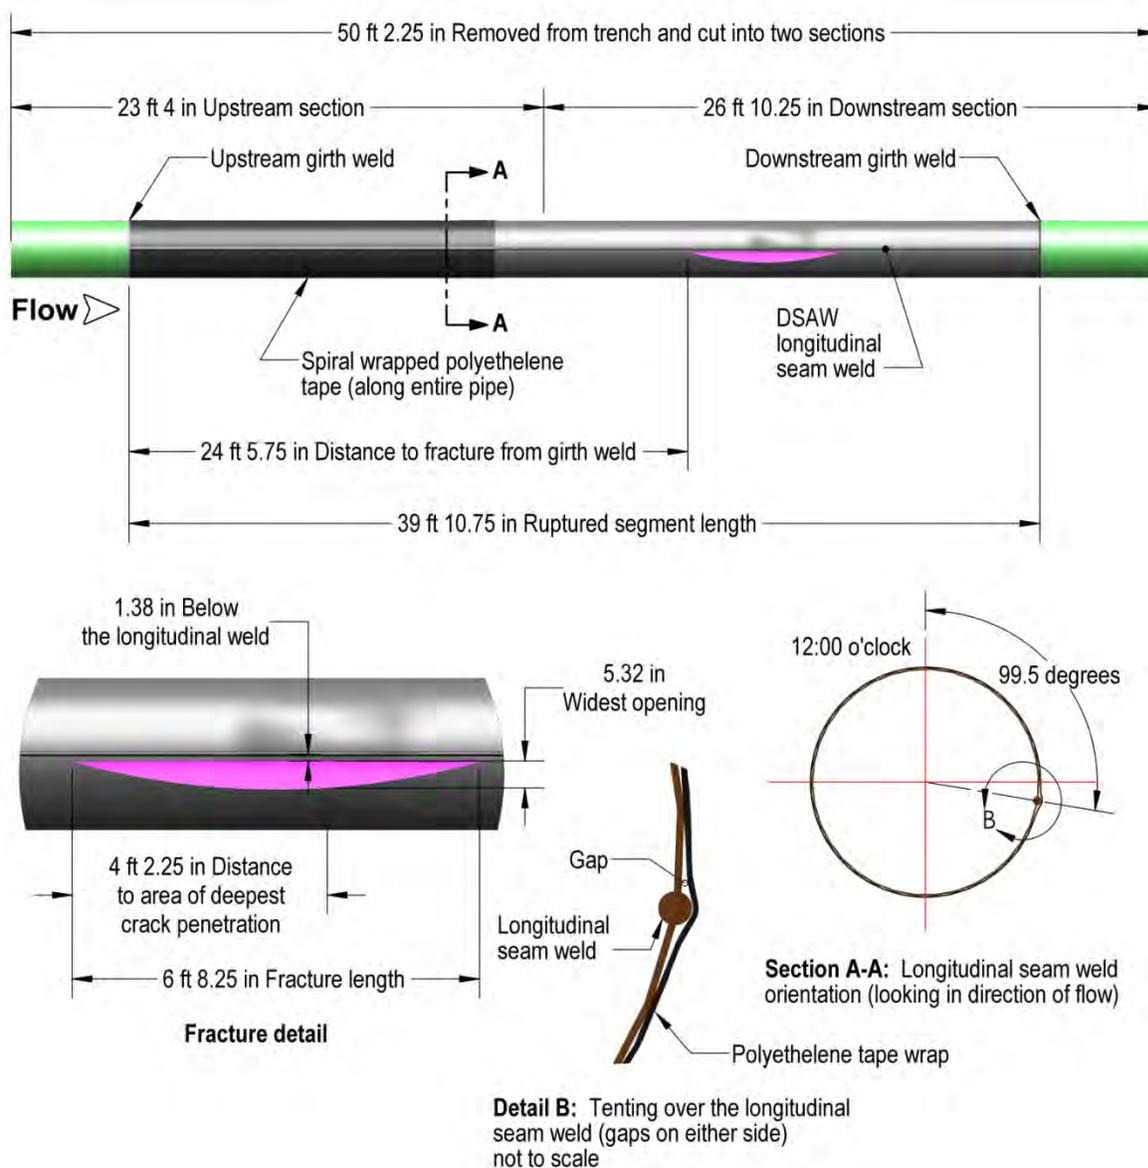
The ruptured pipe segment was 39 feet 10.75 inches long. The longitudinal seam was oriented at 99.5° clockwise.⁴³ A 50-foot length of pipe that included the rupture was removed and cut into two sections for shipping to the NTSB's Materials Laboratory for examination. The upstream section measured 23 feet 4 inches. The downstream section measured 26 feet 10.25 inches. (See figure 11.)

Figure 11. Line 6B ruptured segment showing upstream and downstream sections used for Materials Laboratory examination. Detail B shows tented coating over the longitudinal seam weld.

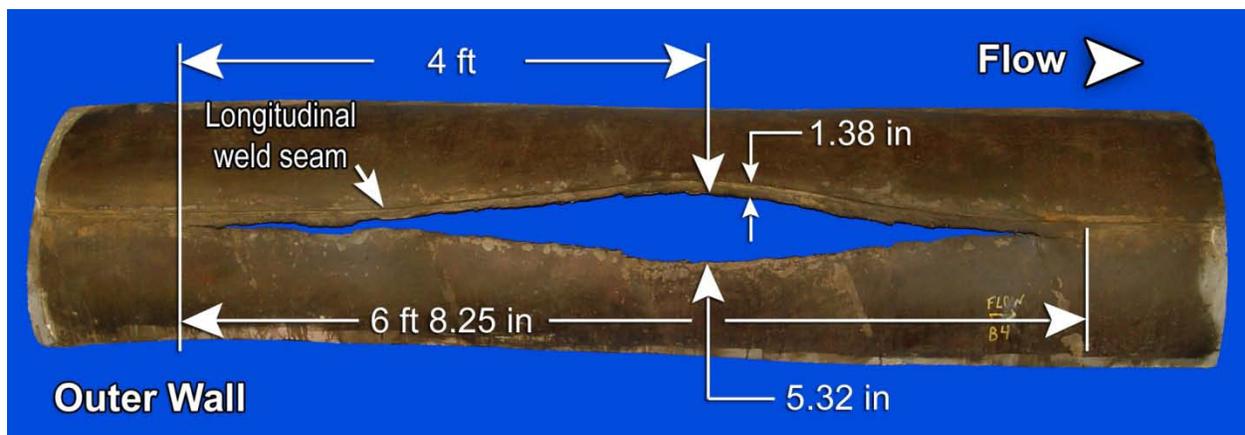
The fracture measured 6 feet 8.25 inches in length with the upstream end of the fracture located 24 feet 5.75 inches away from the upstream girth weld. The widest point along the fracture measured 5.32 inches and was about 4 feet from the upstream end of the rupture. The upper fracture face at the widest opening was measured at 1.38 inches below the longitudinal seam weld away from the heat-affected zone, with this offset ranging from 0.5 to 1.5 inches below the longitudinal weld seam for the length of the fracture face. (See figure 12.)

Figure 12. The outside surface of the pipe looking at the fracture area cut for lab examination.

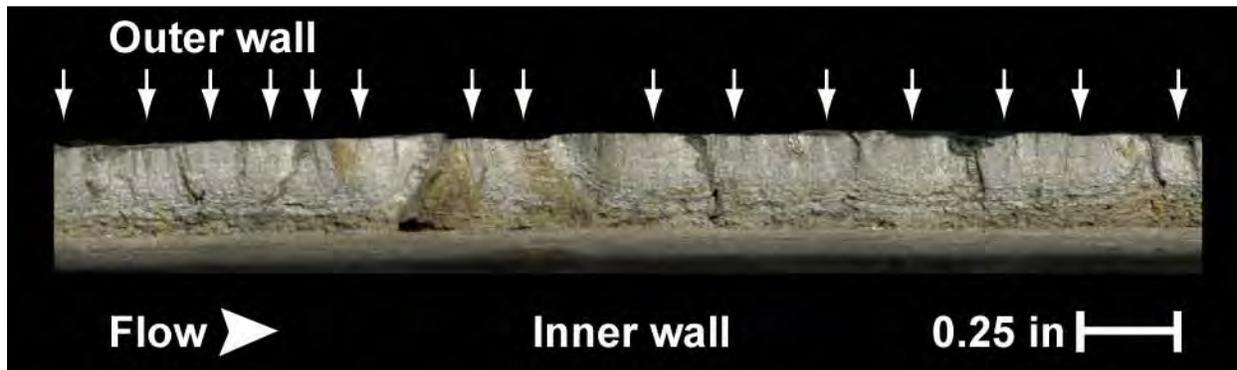
A continuous series of preexisting cracks was found extending from the outer edge of the fracture surface, linked together on the fracture surface, up to 10.8 inches upstream and 7.9 inches downstream from the area of deepest penetration. (See figure 13.) Black oxide was

observed on the preexisting crack portion of the fracture consistent with oxidation in an oxygen-poor environment.

Figure 13. Curving arrest lines of preexisting cracks along the upper fracture face shown after cleaning to remove oxides. White arrows indicate multiple origin areas of preexisting cracks.

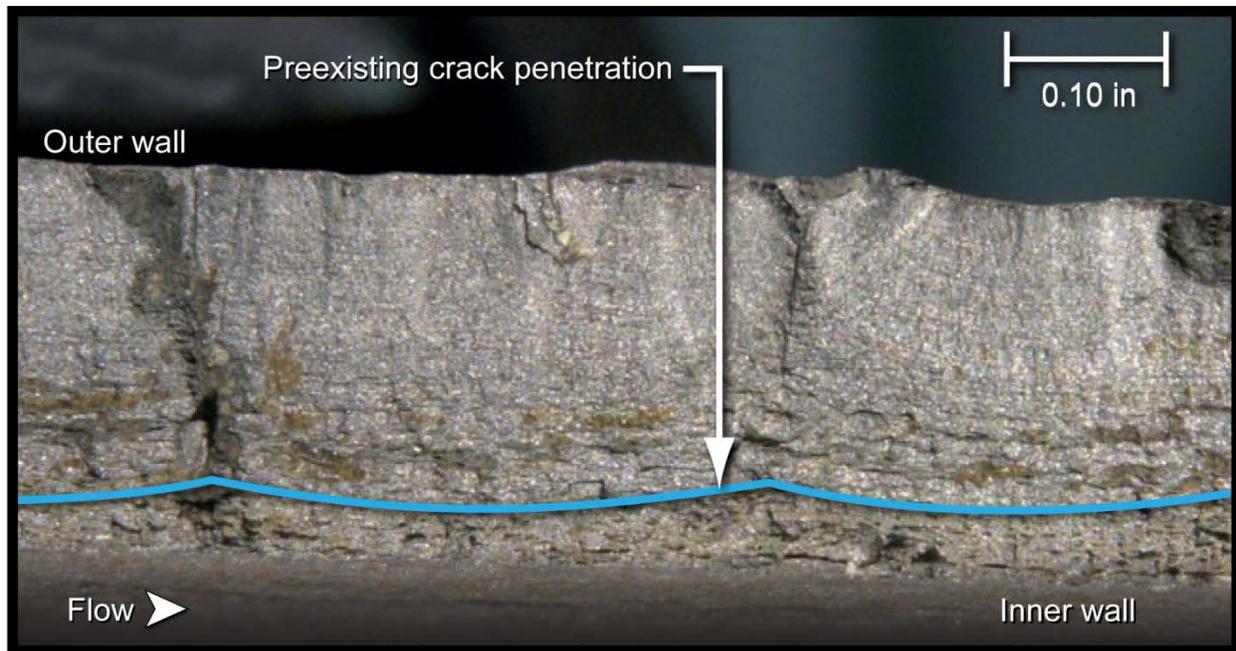
At the deepest crack penetration (see figure 14), the preexisting cracks extended 0.213 inch deep into the wall of the pipe relative to the original exterior surface, or 83.9 percent of the original wall thickness of 0.254 inch. The curving line in figure 14 indicates the extent of preexisting crack growth near the deepest penetration. The remainder of the fracture face had rough, matte gray features consistent with an overstress fracture. The preexisting cracks had fracture features perpendicular to the outside surface, consistent with corrosion fatigue^{46,47} or near-neutral pH stress corrosion cracking (SCC).⁴⁸ Fine crack arrest features were present within about 0.015 inch of the crack origins with broader crack arrest features appearing farther away from the origins. These crack arrest features were indications of progressive crack growth and can be associated with corrosion fatigue or near-neutral pH SCC.

Figure 14. Close view of fracture surface area in the area of deepest crack penetration. The solid blue line indicates the extent of the preexisting crack penetration.

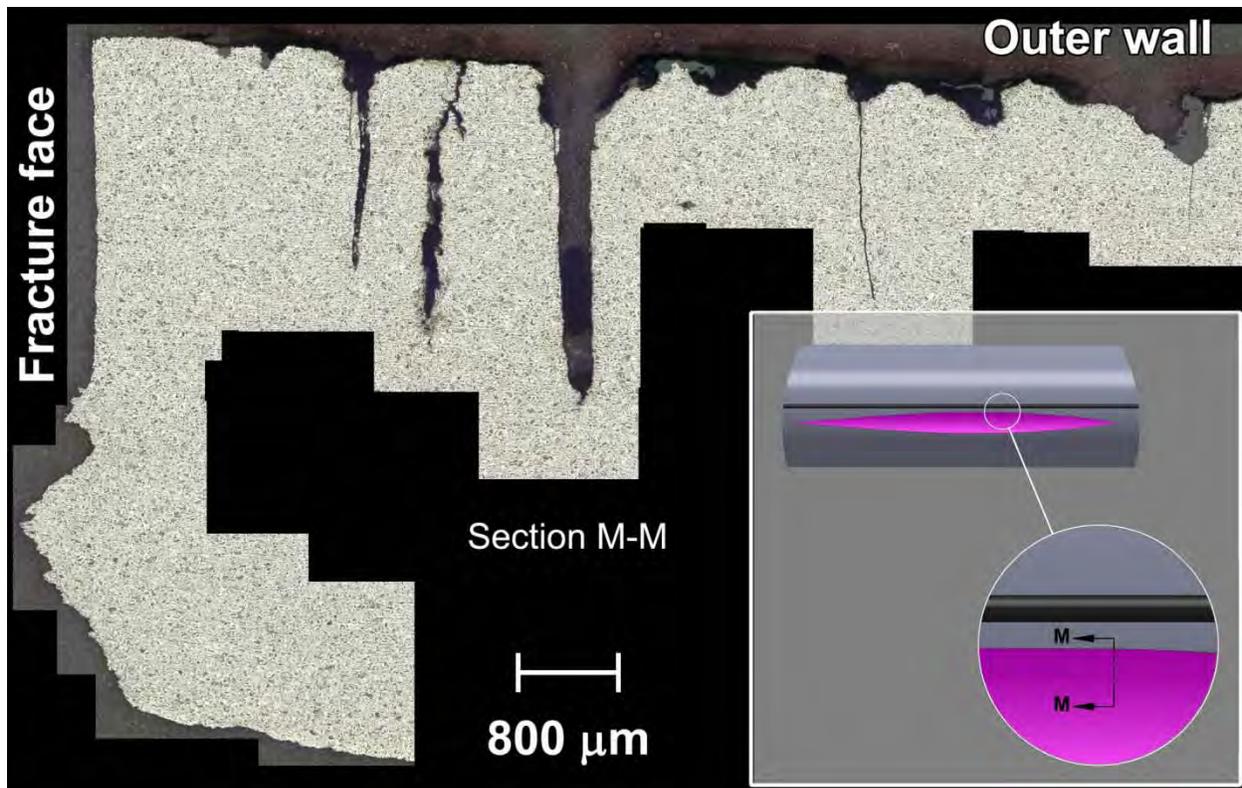
A cross-section through the fracture was prepared as shown in figure 15. The preexisting crack portion of the fracture showed a transgranular⁴⁹ fracture path with limited crack branching, consistent with near-neutral pH SCC or corrosion fatigue. Multiple closely spaced and parallel secondary cracks (with transgranular propagation paths and limited crack branching) emanated from corrosion pits on the outside wall near the fracture face, also consistent with corrosion fatigue or near-neutral pH SCC. The deepest secondary crack extended through about 43 percent of the wall thickness.

Figure 15. Transverse section through the top of the fracture showing multiple parallel cracks emanating from corrosion pits on the outside surface.

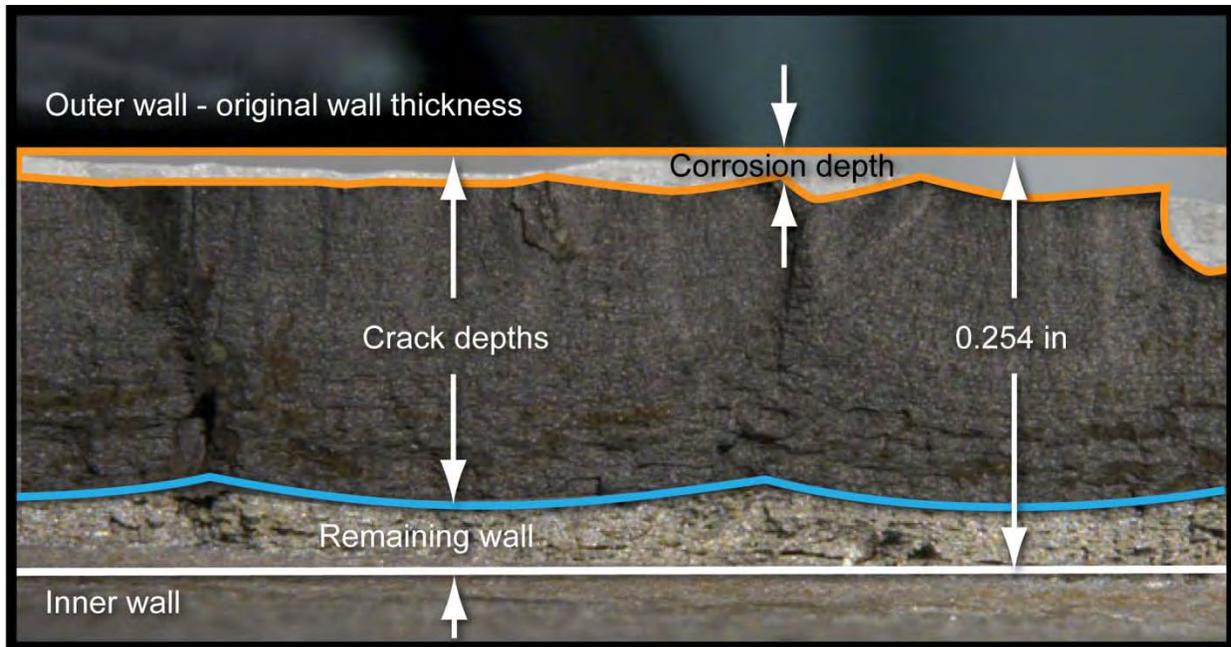
The preexisting crack depth and corrosion depth along the length of the rupture was measured relative to the original local wall thickness (as shown in figure 16).⁵⁰ The corrosion depths, which were measured on the fracture face under a microscope, did not necessarily reflect the deepest corrosion within the field of view but reflected the corrosion depth at the location where the crack depth was measured for each point. The corrosion depth at the location of deepest penetration measured in the plane of fracture was about 0.030 inch relative to the original wall thickness. The maximum depth of penetration of the preexisting cracks relative to the approximate original exterior wall surface was 0.213 inch at a location corresponding to approximately 28 feet 8 inches (344 inches) downstream of the upstream girth weld.

Figure 16. Lab measurements of crack and corrosion depths along the fracture face measured from images similar to figure 14 near area of deepest penetration (about 344 inches from upstream girth weld).

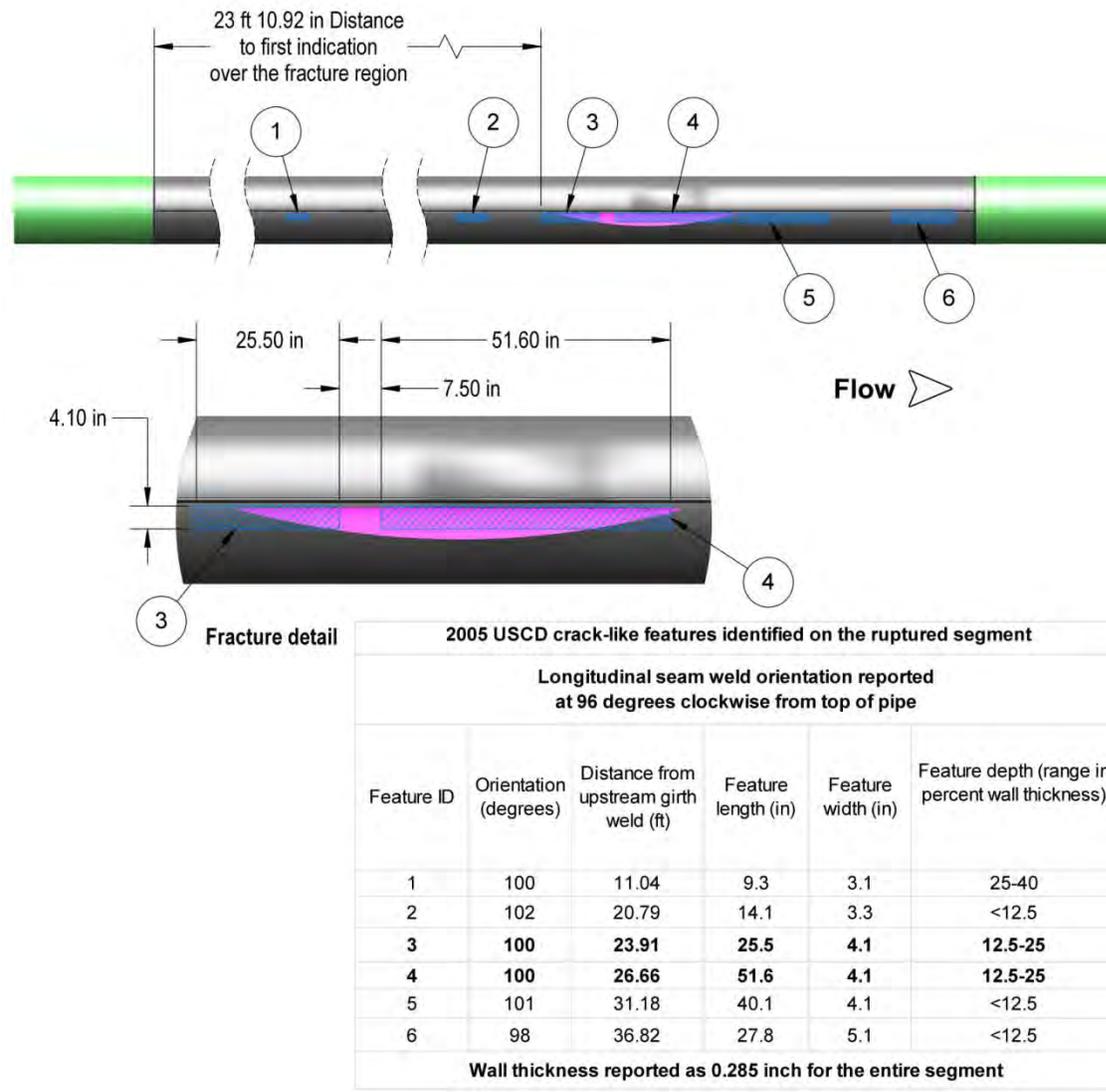
PII identified six crack-like indications in the 2005 Line 6B in-line inspection report for the ruptured pipe segment. (See figure 18.) Two of the crack defects had depths of 12 to 25 percent of the tool-reported wall thickness. These features were 25.5 inches and 51.6 inches long and were located directly over the area of rupture. The deepest (with a depth of 25 to 40 percent of the tool-reported wall thickness) of the six crack-like features was 9.3 inches long and was located 11.04 feet from the upstream girth weld of the ruptured segment.

Figure 18. 2005 in-line inspection regions where crack-like characterizations were reported by PII on the ruptured segment of Line 6B.

According to PII, all six features identified on the ruptured segment, including the 51.6-inch-long crack, were originally characterized as crack-field indications by a junior analyst; however, a supervisor changed the analyst’s characterizations to crack-like defects during a final quality check.

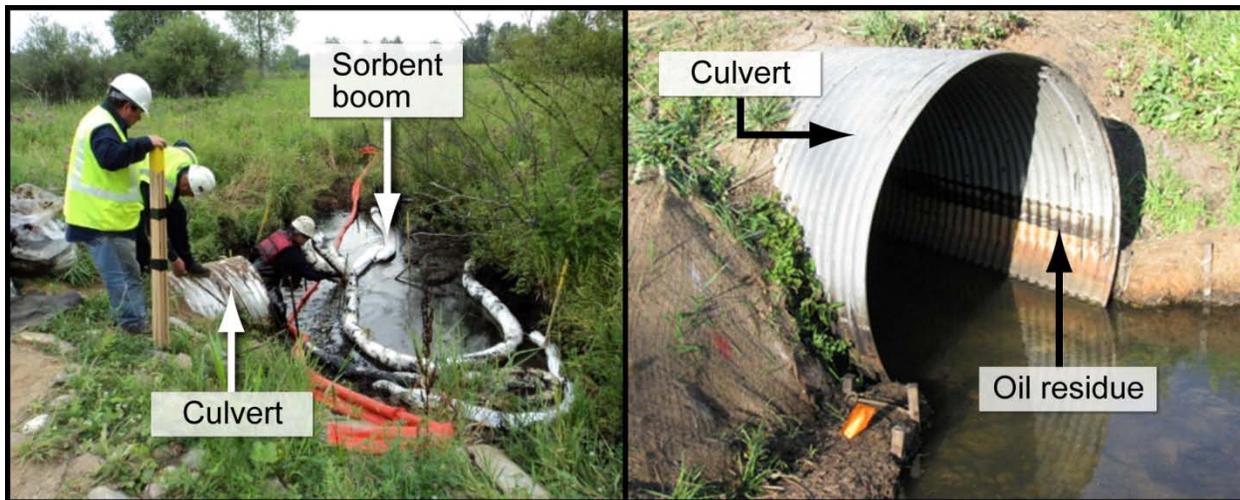
Figure 21. (Left) Enbridge employees install sorbent boom in front of a culvert at Division Drive. (Right) Oil residue marks the level of the oil carried through this culvert following the Enbridge release from Line 6B.

learned from the response, the Bay City PLM supervisor told NTSB investigators that, in the future, he would ensure that sheets of plywood are included in Enbridge's boom trailers so that adjustable underflow dams can be constructed over culvert pipes.
