To evaluate the overall trend of conditions in ComEd's service territory, Commission Staff conducted a series of field inspections in 2011. The purpose of the inspections was for Staff to see if there were any obviously visible reasons for poor reliability performance. For example, on distribution circuits Staff looked for problems such as poor tree trimming practices, broken or damaged equipment, rotten poles, and overly slack spans (low sagging lines), while at substations Staff looked for problems such as low or leaking oil, load tap changers regularly operated at extreme positions, and poor maintenance practices. It is important to note that it is not the purpose of Staff's field inspections to find problems for ComEd to fix² but rather to develop a picture of the overall condition of the power delivery infrastructure in ComEd's service territory.

Appendix A: Log of Summer Field Observations

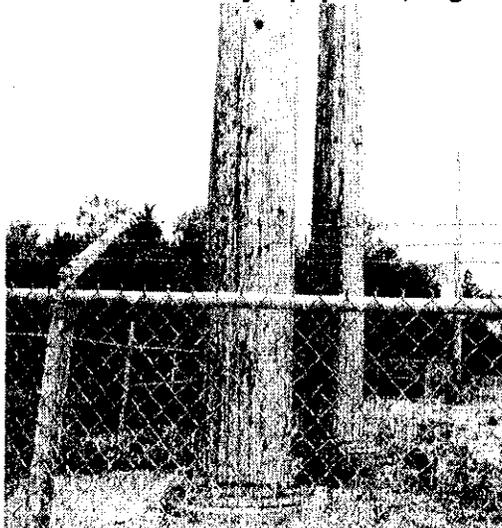
Picture 20: 058 Burr Ridge Substation: Rusty equipment, vegetation in yard & in/on fence

needing attention in Appendix A. Staff recommends ComEd explain how they have allocated sufficient resources to work down the substation CM backlog.

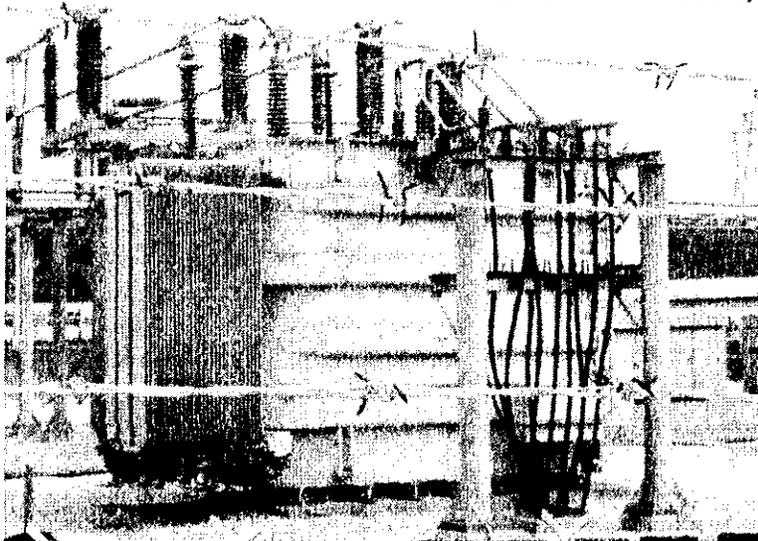
Picture 21: 110 Oakbrook Substation: rust on transformer and radiators, active oil leak

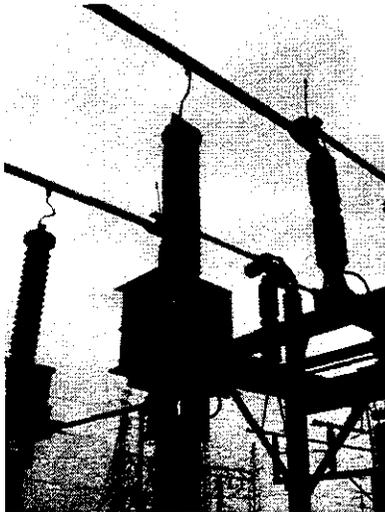
Equipment Rust
857 Calumet Substation

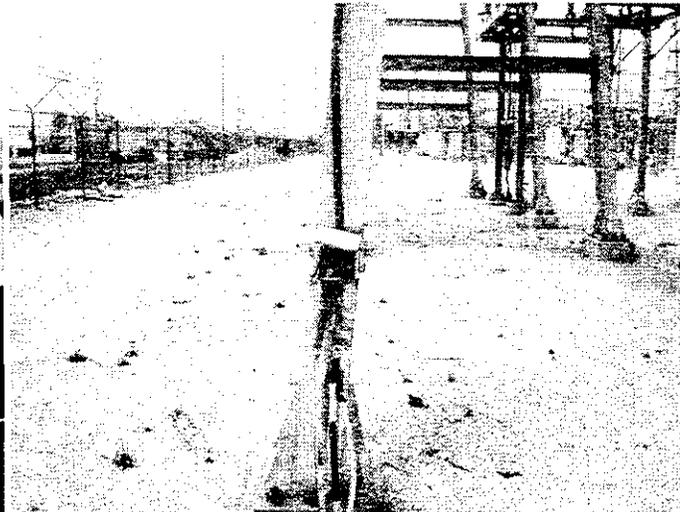
Yard trash, Broken box, Equipment Rust
860 Calumet Substation

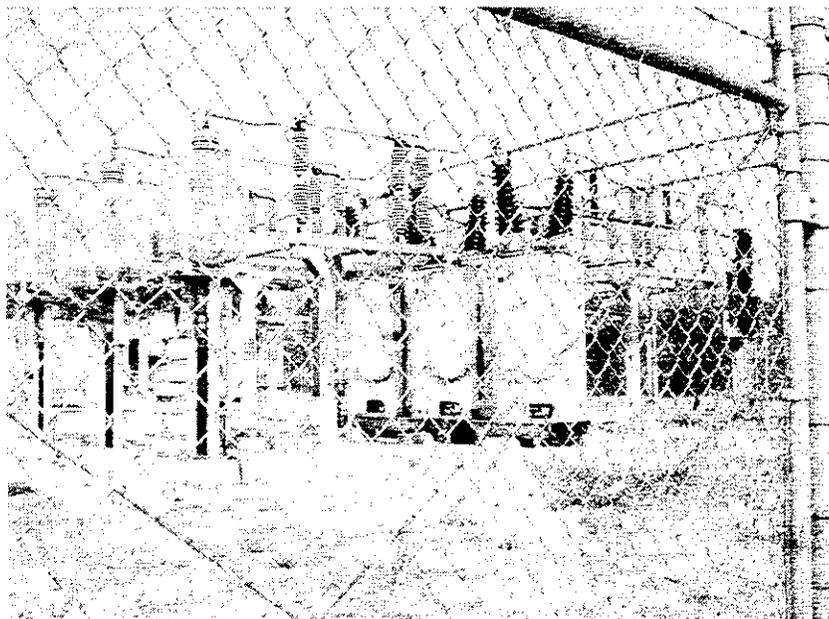
Grass & Weeds in Yard, OCB Rust and poor paint work
917 Wallace Substation

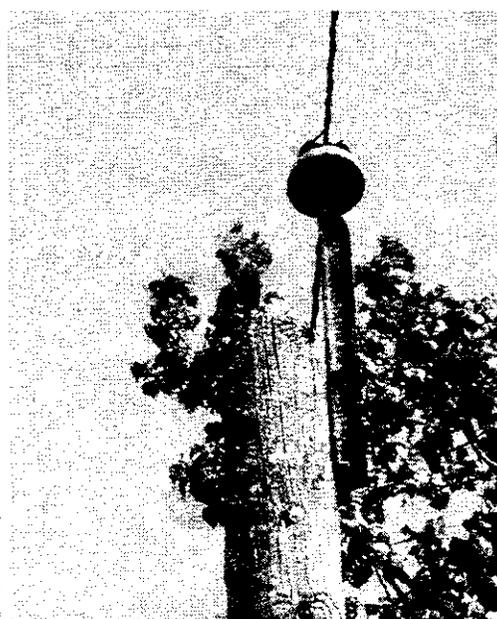
Loose Hardware
927 Feeder Z11863

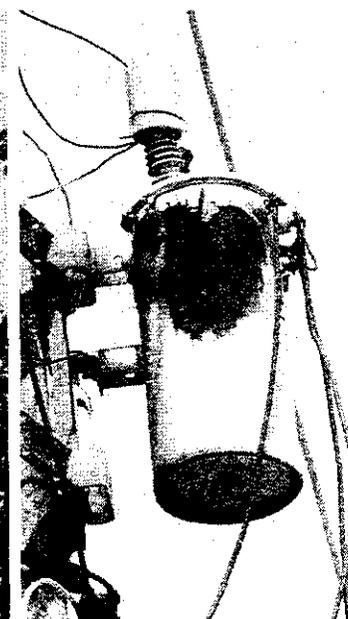
Transformer had overheated
931 Feeder Z11863

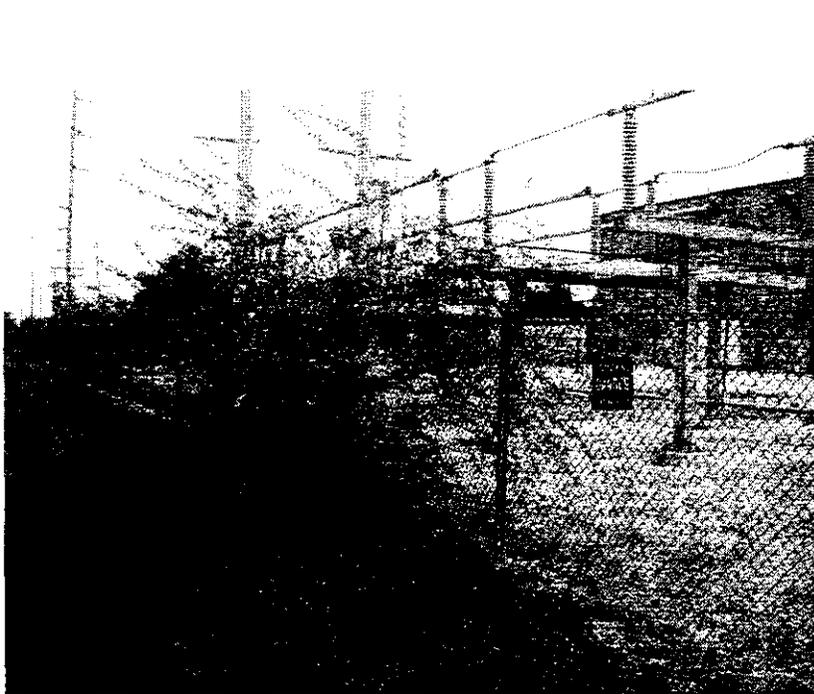
Bushes growing into/over fence
009 Harvey Substation

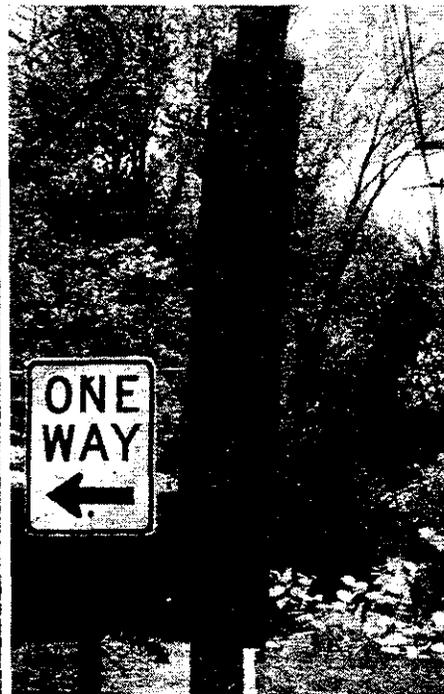
Broken pole braced with cross-arms
017 Feeder G4373

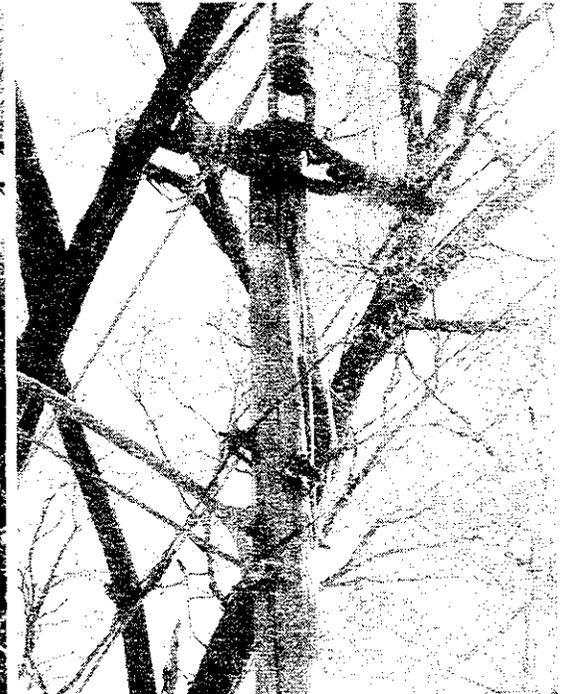
Cracked/broken pole top
222 Feeder G4373

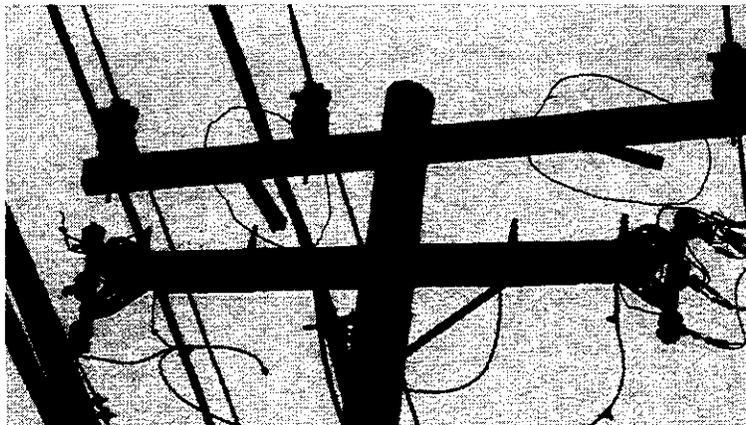
Broken/disconnected braces
028 Feeder G652

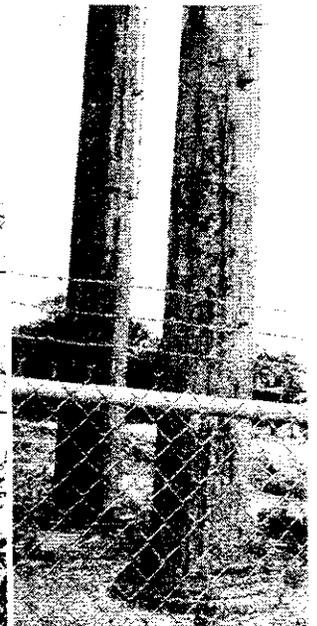
Badly rusted poles
060 Burr Ridge Substation

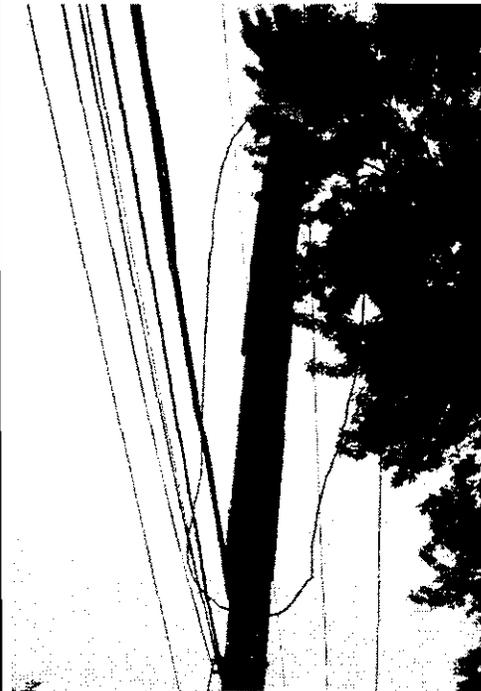
Blanket on pole next to Primary
135 Feeder W668X

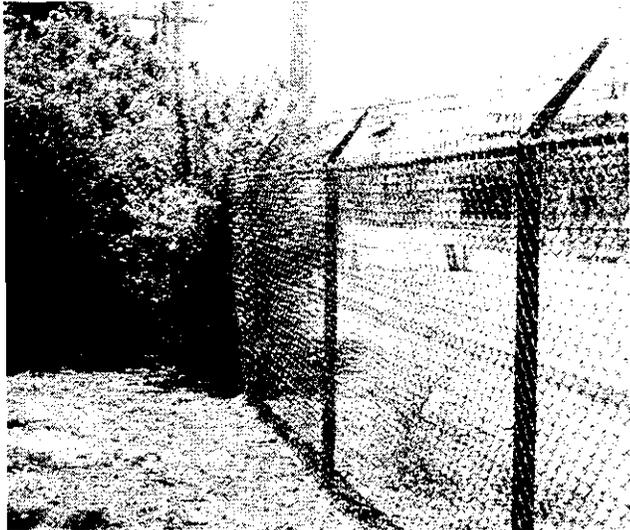
Vegetation growing in/thru fence & in station yard
160 Skokie Substation

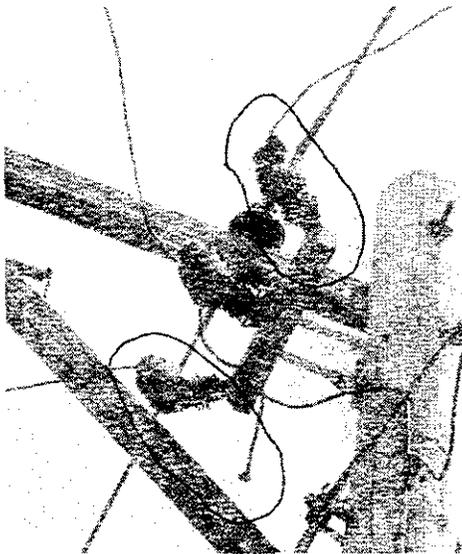
Blown/damaged Arrester
168 Feeder C82

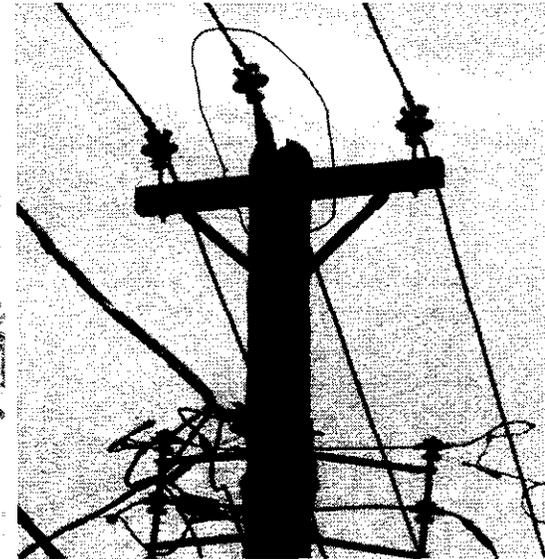
Old/Ragged pole top – center Primary bracket loose
193 Feeder D4901

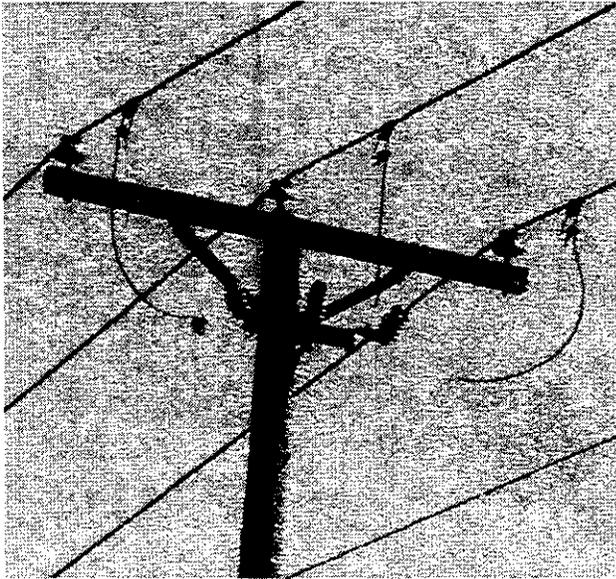
3 blown arrestors
327 Feeder RANDOM

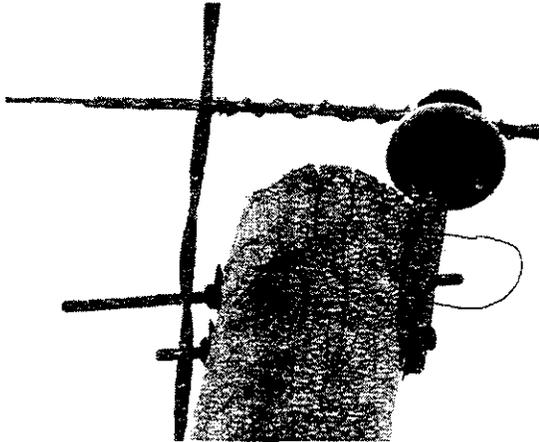
Missing Bolt Cap/Nut
336 Feeder E4004

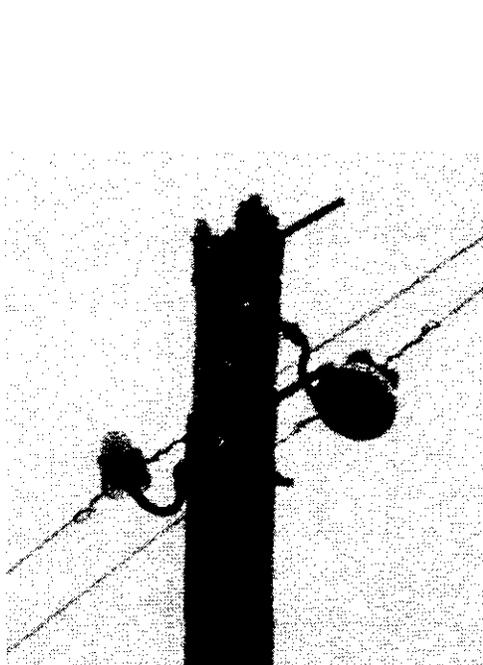
Bad pole, Loose HW, Split pole top
400 Feeder B116

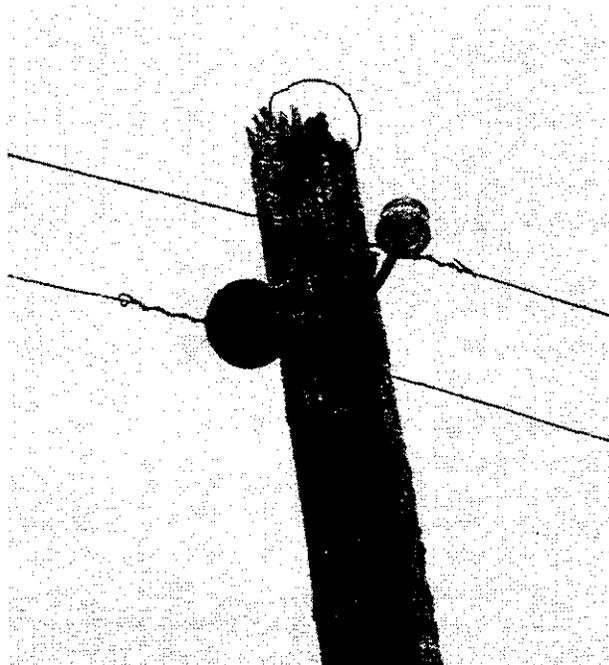
Bad pole, HW supporting Primary near failure
405 Feeder B116

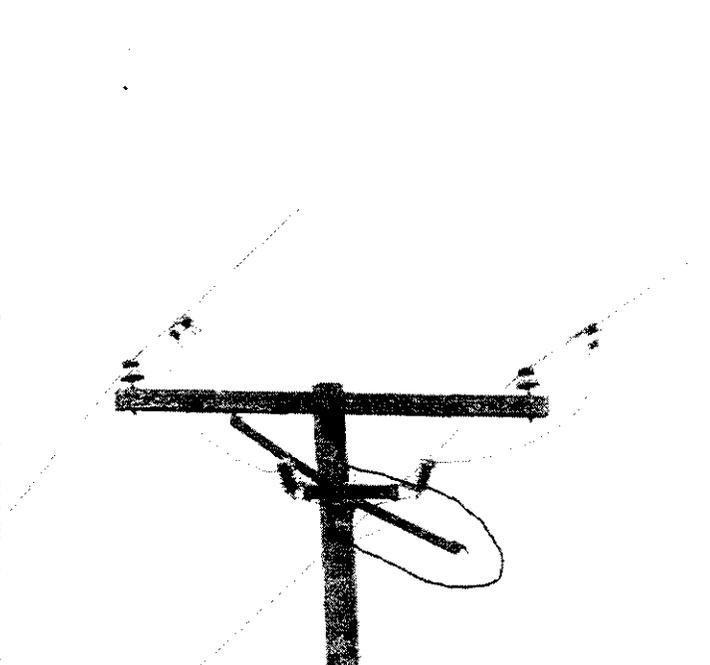
Disconnected Cross-Arm Support
420 Feeder RANDOM

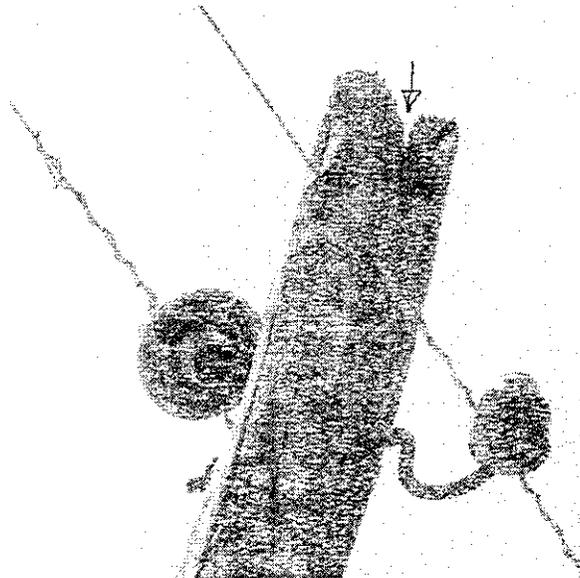
492 Feeder RANDOM

Bad pole, Loose HW supporting Primary near failure

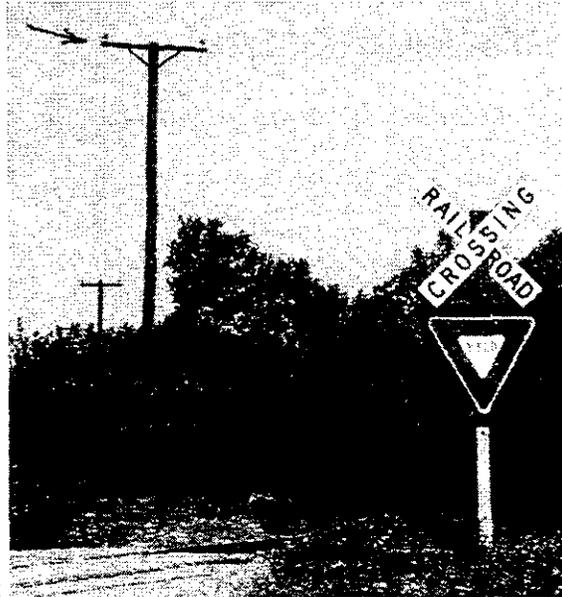
504 Feeder RANDOM

NESC Violation

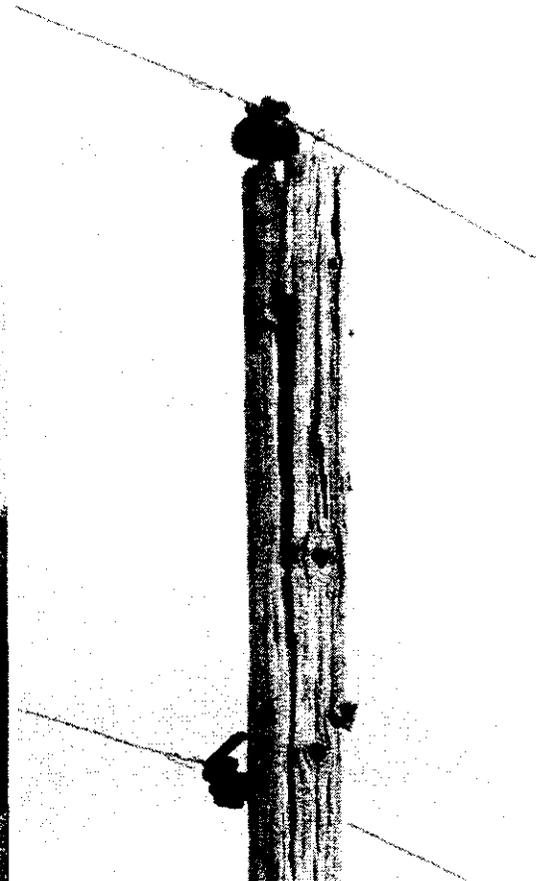
535 Feeder RANDOM

Bad pole, Primary HW sliding down split to Insulator Bell
Neutral HW loose

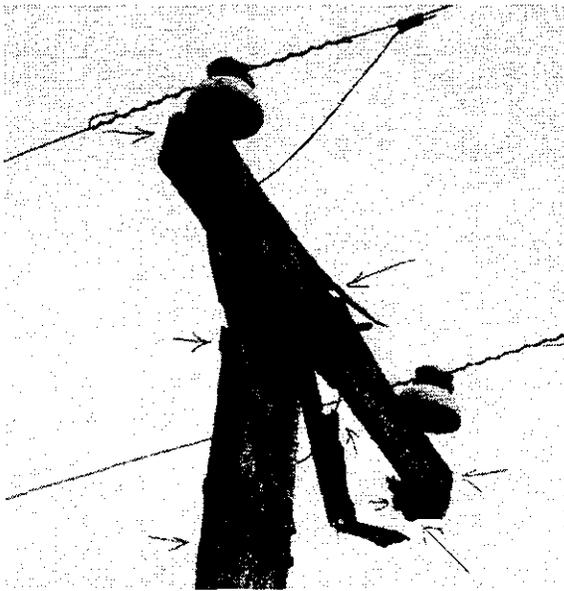
Bad pole, Split Cross-Arm, Loose & exposed HW,
Gnd wire hanging loose
549 Feeder RANDOM

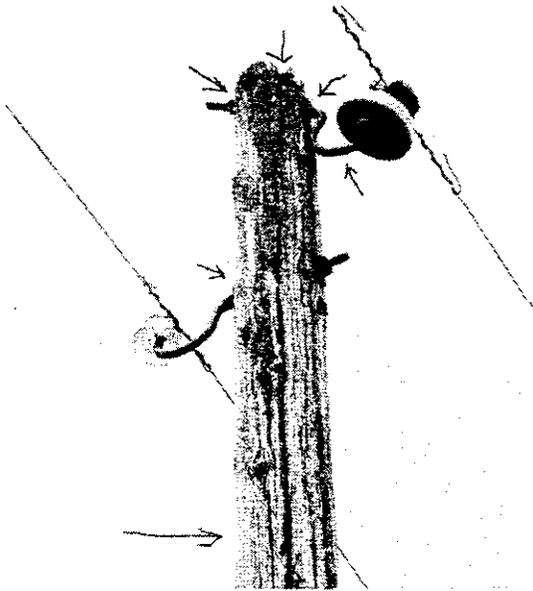
Subsidence of pole on top, Bad Pole, Loose Hardware
553 Feeder RANDOM

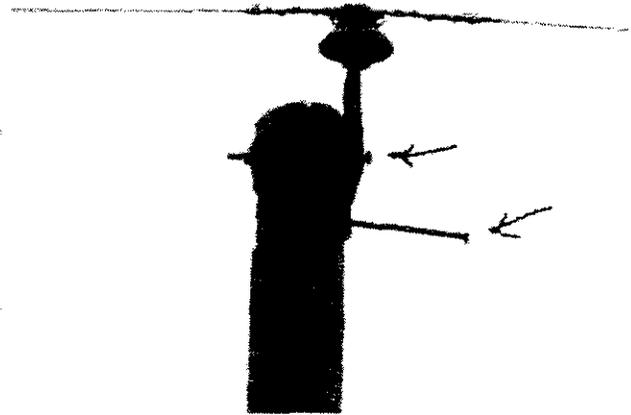
Loose Hardware
560 Feeder RANDOM

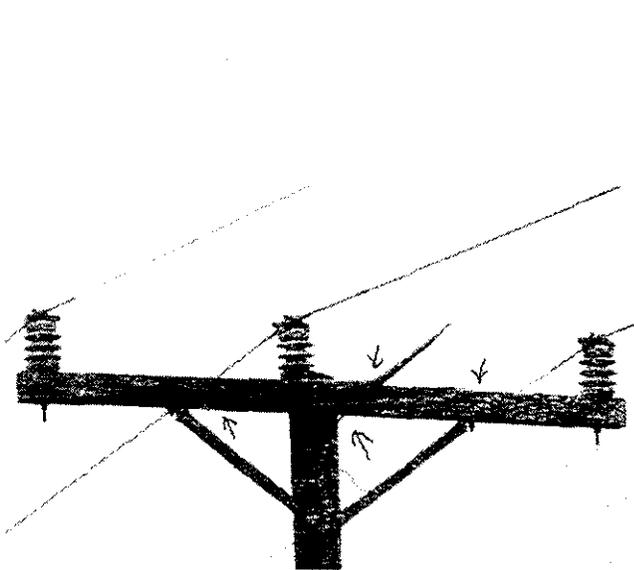
Splintered/Broken Cross-Arm

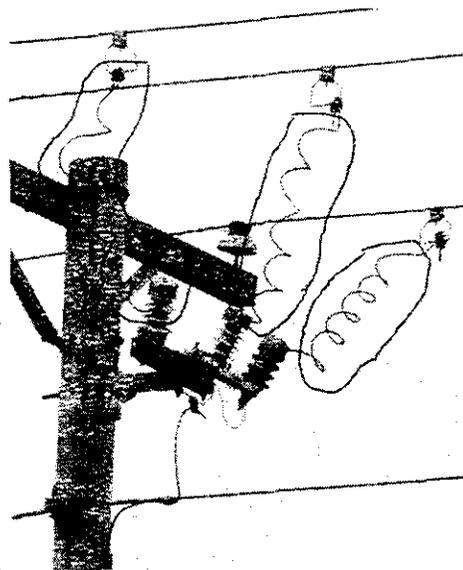
"Curley" or High Impedance connections

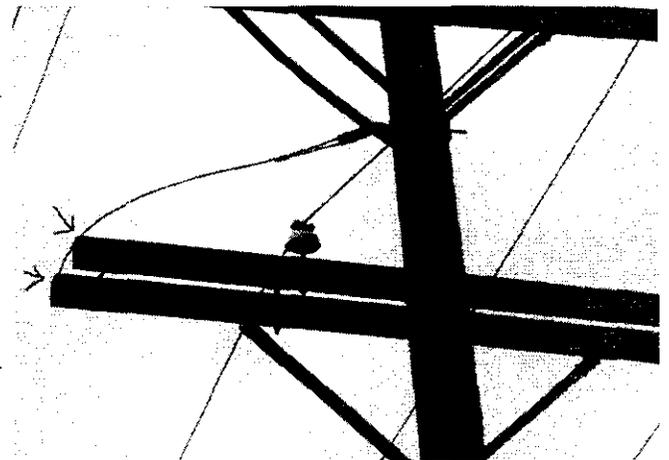
Down guy broken and resting on end of Cross-Arm

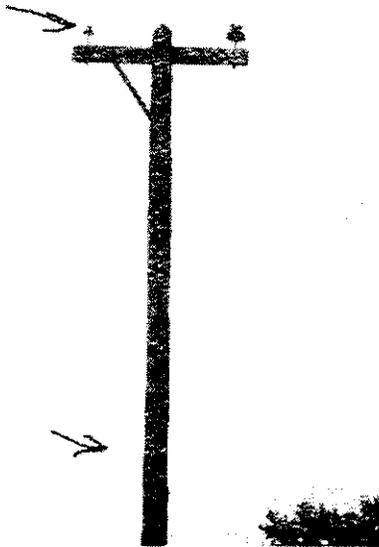
Neutral disconnected and hanging low

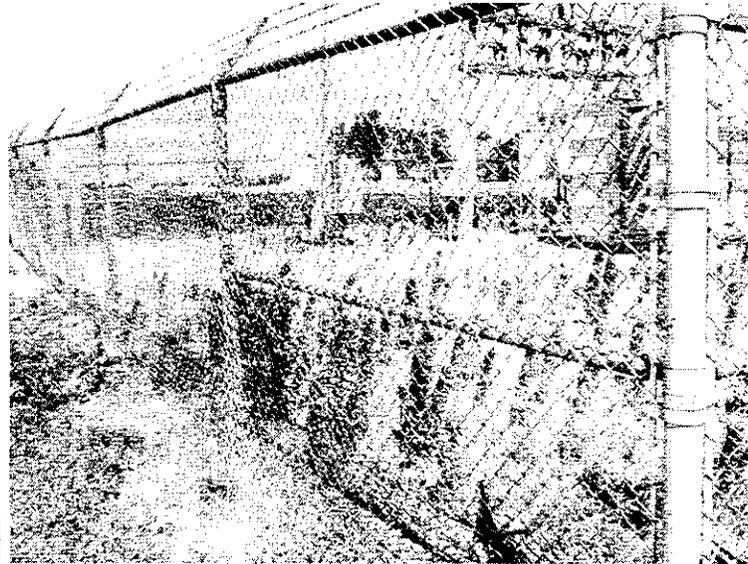
Weeds in yard could provide animal cover

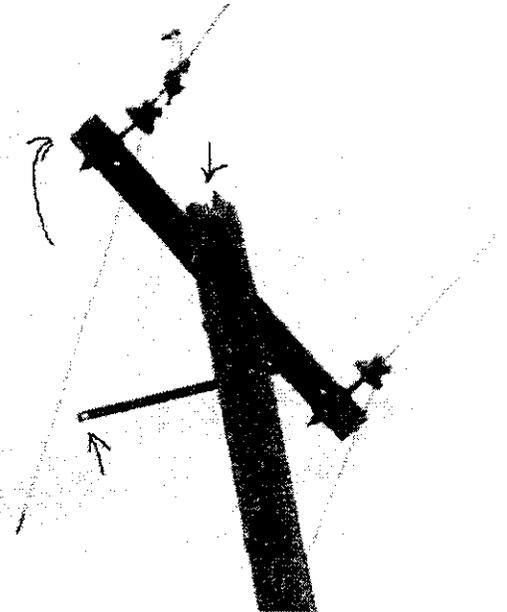
Bad pole top, disconnected Cross-Arm Brace, Twisted Cross-Arm
