Appendix A: Log of Summer Field Observations

Field Inspection Log

Utility: ComEd Investigators: J. Stutsman (Staff)

Feeder Ckt: F5283 City: Homewood Voltage: 12kV Date: Tuesday, June 24, 2014

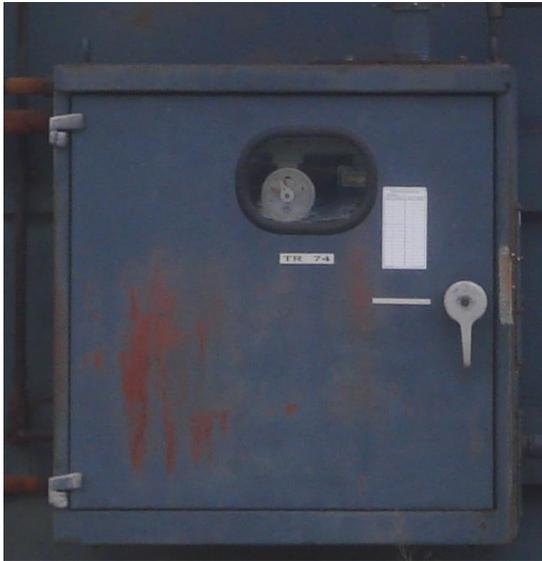
Settings on Transformer 74 LTC
629 Glenwood Substation

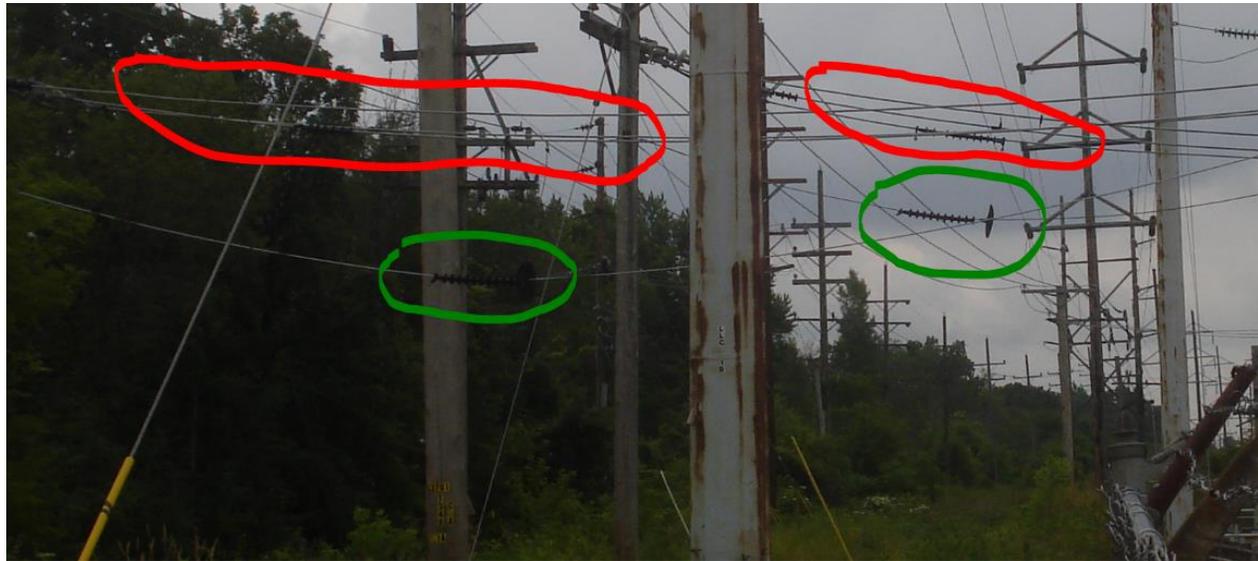
Squirrel Guards Broken/Missing
634 Glenwood Substation

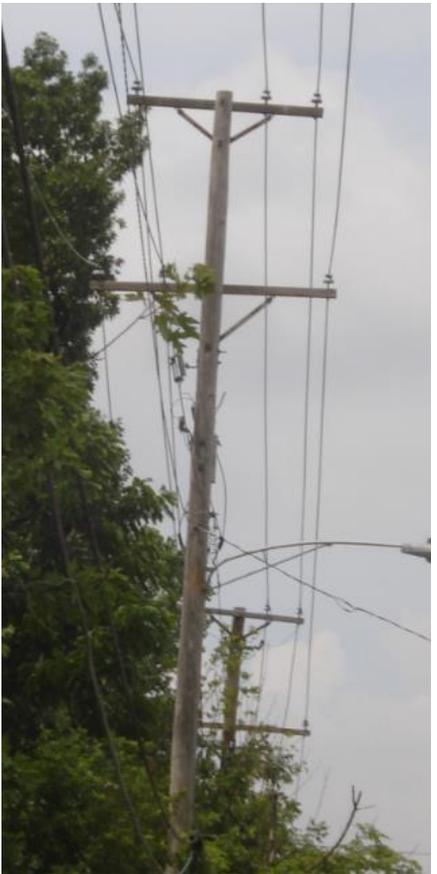
Tree in contact with Primaries
660

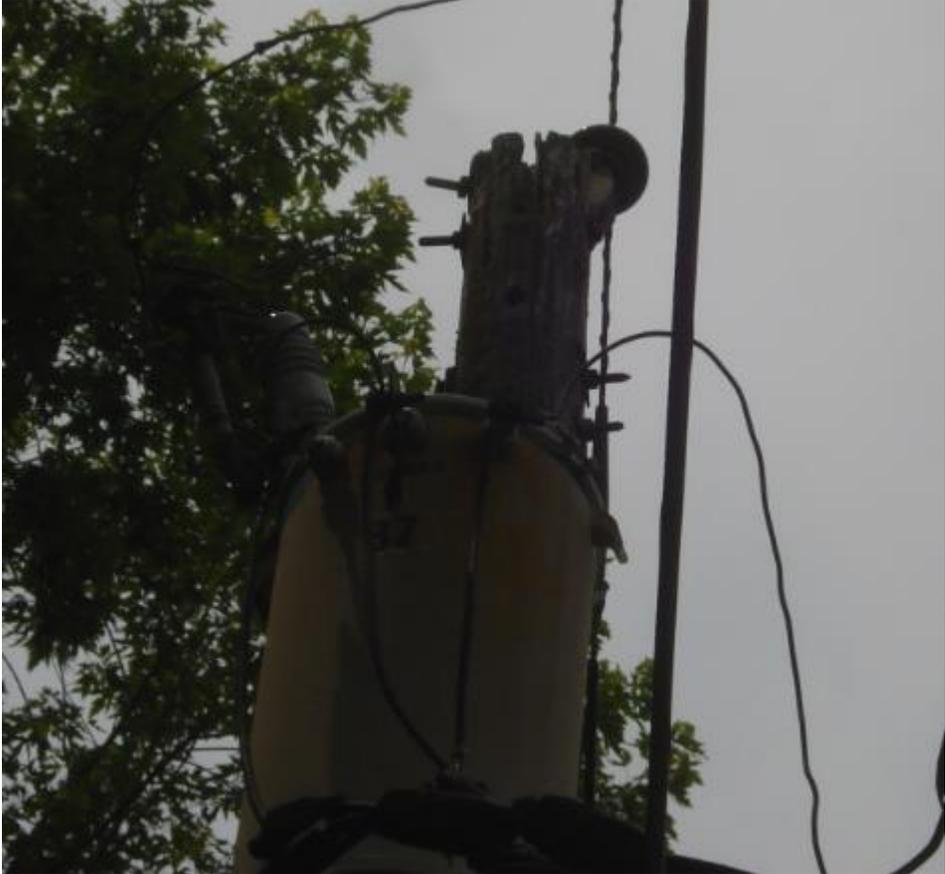
682-7	3	1911 Hanover LN	Pole Top Bad – Mount for Primary is lose/lose bolts Pole Top Subsidence
689-90	3	1934 Hanover LN	Only 1 bolt holding Primary Mount & Primary Mount is twisting
691	3	1933 Hanover LN	Missing Guy Guard
	3	Near 1716 Cambridge Ave	Trees into Primary
692-4	4	187 th St	Overhang above Primary
696	5	1854 Heather Rd	Missing Down Guy Guard

Bad Pole Top & Lose Mount
684

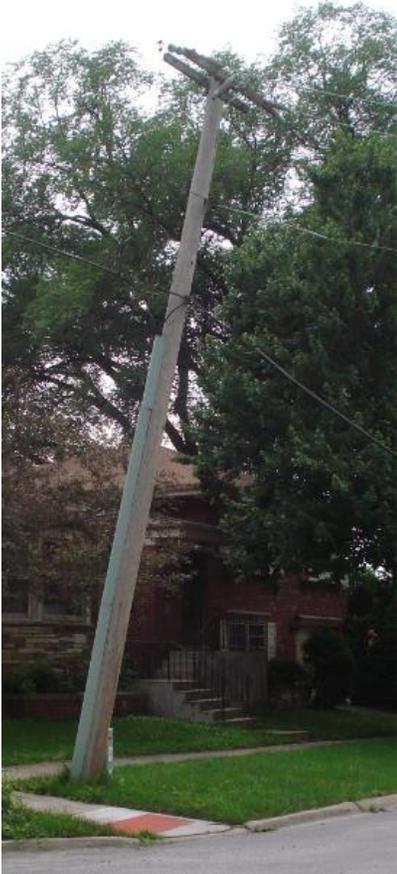
697-9	5	Near Intersection of Klimm Ave & Willow Rd	Badly leaning Pole
		Feeder Ckt: <u>Unknown Circuit(s)</u> City: <u>Homewood and Homewood Area</u> Voltage: <u>12kV</u>	
	NA	Vollmer Road between I-57 and HWY-1	Several locations of Vegetation into Primary and 1 location of broken lightning arrestors
700-4	NA	On Chicago Heights/Glenwood Rd in front of Coales Rd	Vines on Poles & down Guys
709	NA	771 Coales Rd	Service on old Pole and Replacement Pole – Service only partly moved to replacement pole
706-8, 710	NA	779 & 774 Coales Rd	2 dead Trees overhang Primary – 1 from each side of the road

Leaning Pole
699

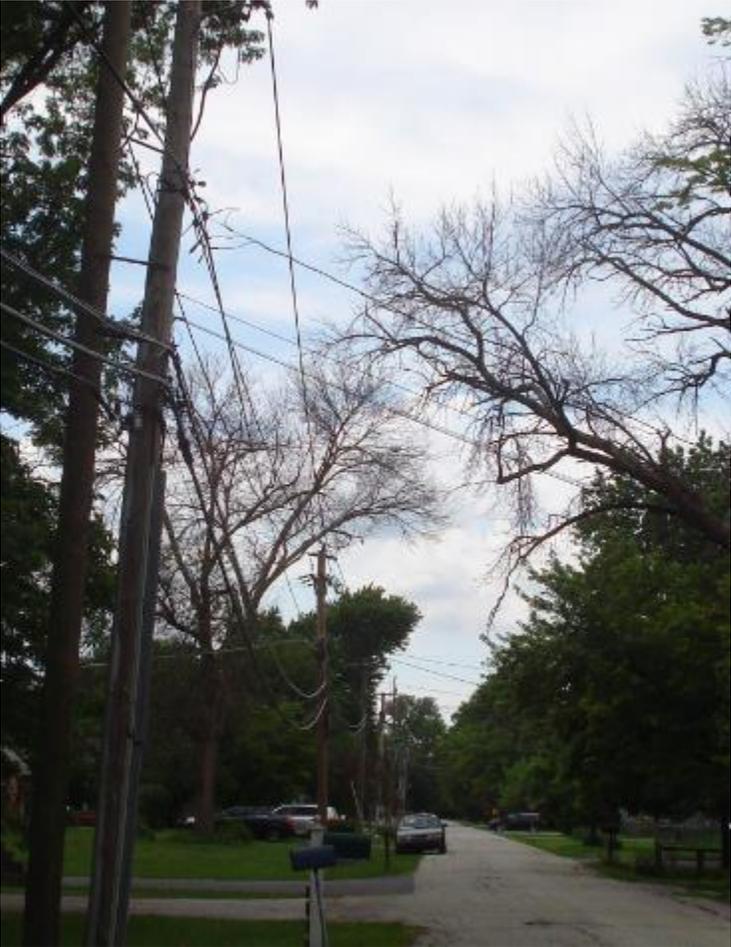
708: 2 dead trees overhanging/threatening Primary

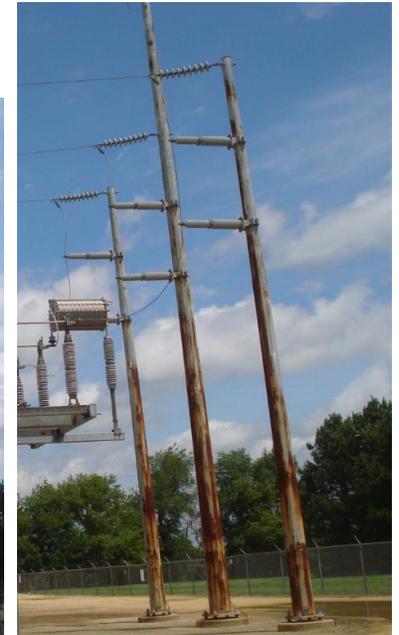
Rust & Peeling Paint
717 Eleroy Substation

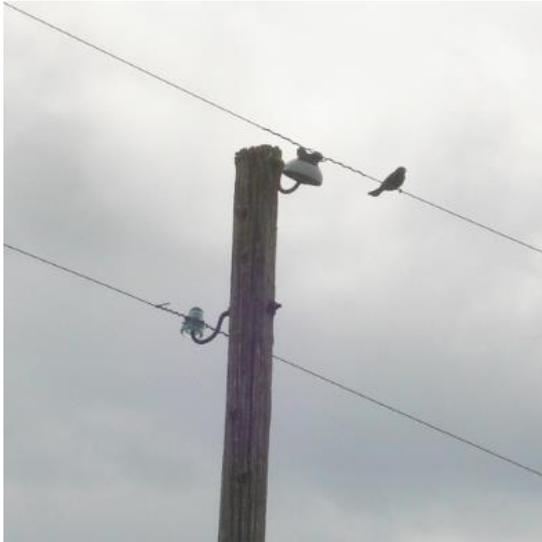
Lose J-Mount/Bad Pole Top
744

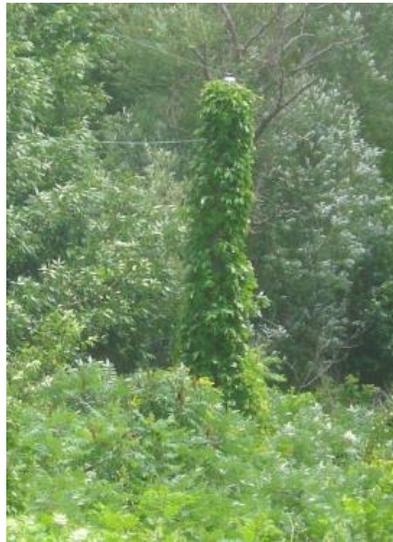
Pole Completely Vine covered
753

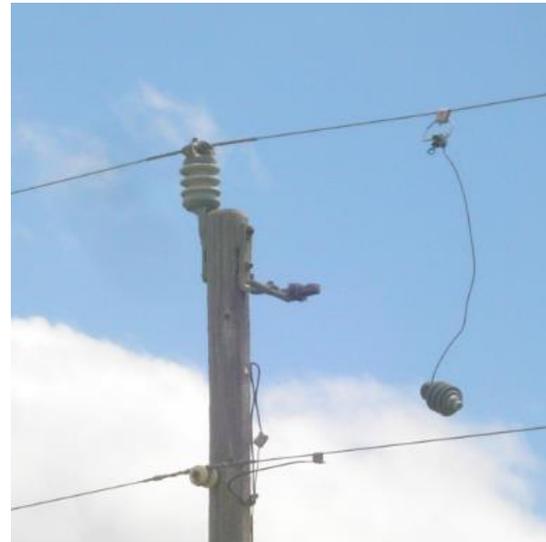
757-9	NA	8178 US Highway 20E	Catastrophic failure of Lightning Arrestor
761-3	NA	16101 W. State Rd, Pecatonica	Near Failure -- Loose bolt on Primary insulator Mount Noted 3 more locations East of here with similar issue (between here & Winnebago Rd)
765-6	NA	15788 W. State Rd, Pecatonica	Damaged/Splintered Pole Top
768-71	NA	15682 W. State Rd, Pecatonica	Damaged Pole Top – Large portion of pole missing and exposing bolts holding primary mount
	NA	~1/2-1 mile East of: 15682 W. State Rd, Pecatonica	Very loose down guy covered with vines
773-5	NA	10662 N Kennedy Hill Rd	Damaged Cross Arm Brace

Catastrophic failure of Lightning Arrester
758
