Appendix A: Log of Summer Field Observations

Field Inspection Log

Utility: ComEd Investigators: J. Stutsman (Staff)

Feeder Ckt: H321 City: Garden Plain Township Voltage: 12kV Date: Tuesday, August 12, 2014

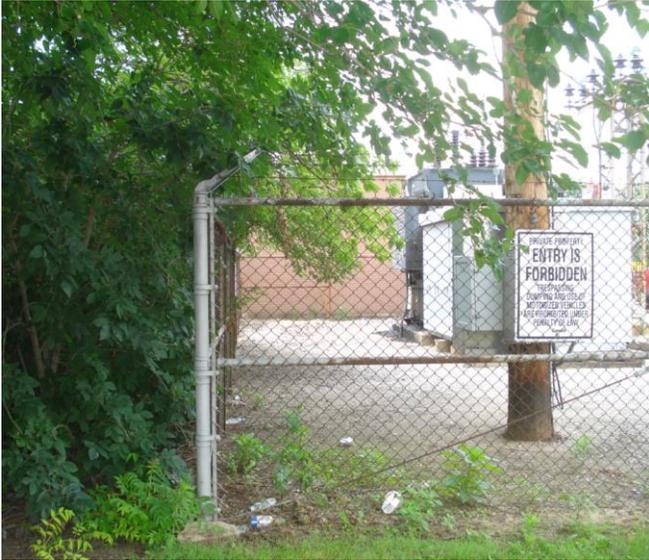
Trees into/over Fence
820 Calumet City Substation

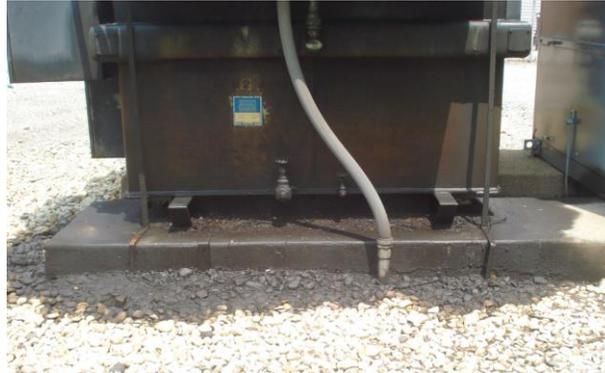
Transformer Oil
823 Calumet City Substation

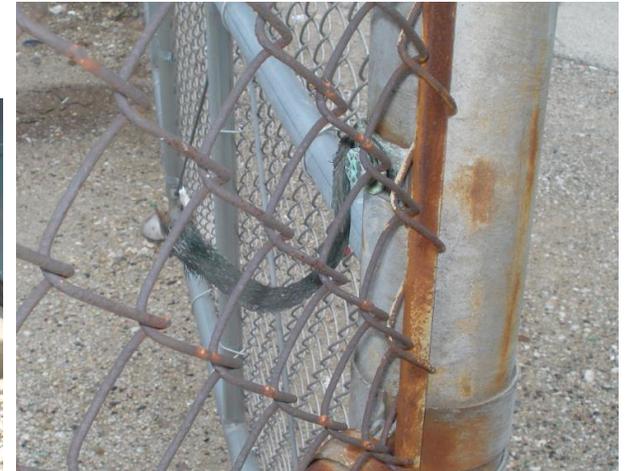
Gate Ground Bonding Strap not attached
814 Calumet City Substation

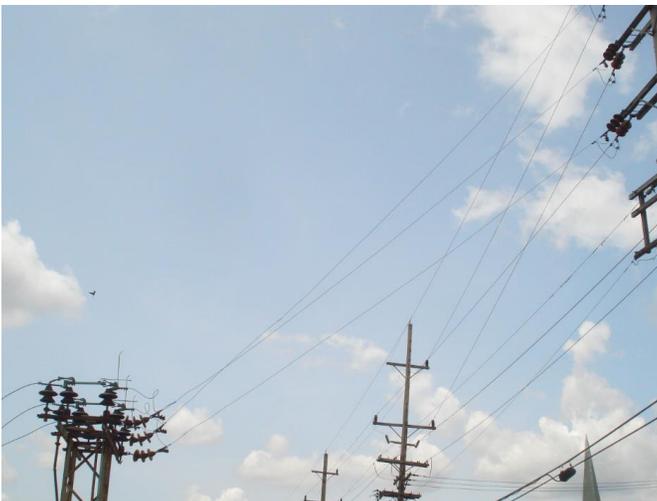
No Animal Guards
817 Calumet City Substation

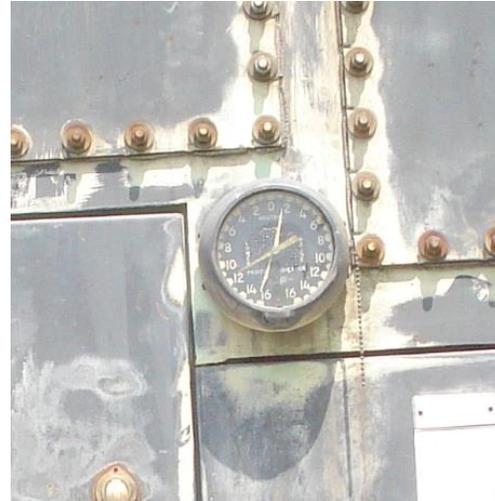
Load Tap Changer Range of Travel
826 Calumet City Substation

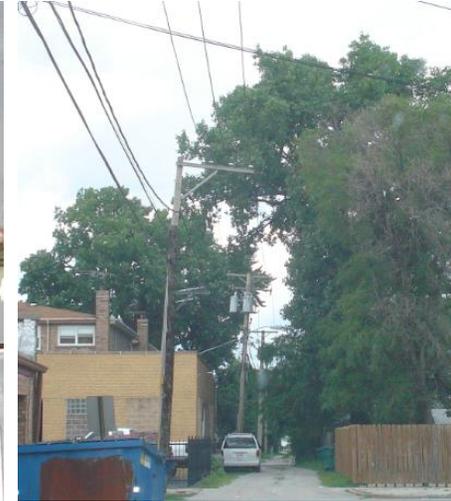
Trees Canopy Overhang Primary
843

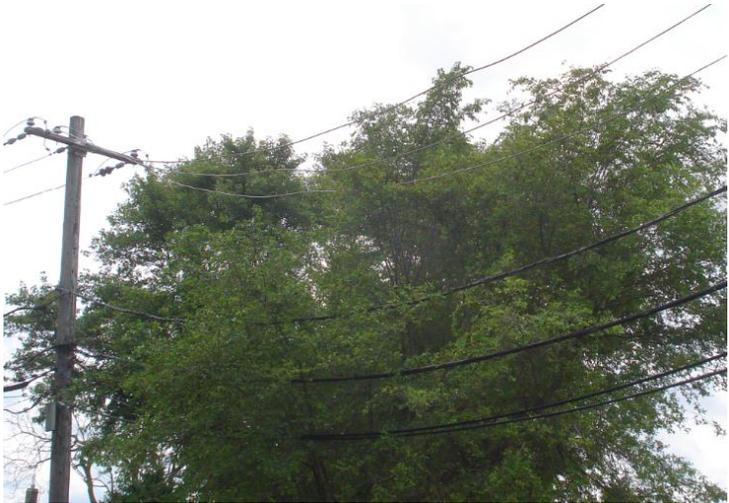
Tree into Primary
846

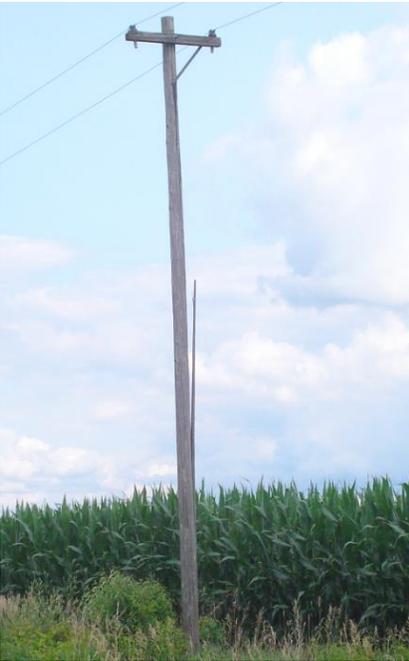
-	Random	Approx. 4 poles East of 30095 South Kedzie Ave, Beecher, IL	Blown Lightning Arrestor
-	Random	29979 S. Kedzie Ave Beecher, IL 41.34469 -87.68909	Badly leaning Pole
858	Random	41.35478 -87.69700	Split Pole

Split Pole
858

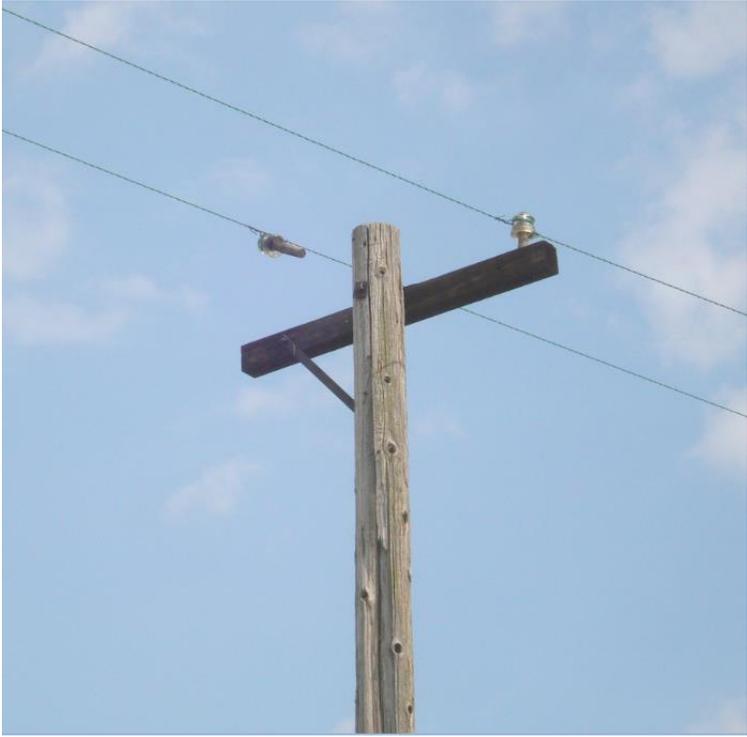
-	Random	41.35470 -87.70429	Primary into Tree
860	Random	41.34357 -87.70837	Primary Insulator Lifted Out Of Cross-Arm Heavy Pole Subsidence

Hanging Primary Insulator
860

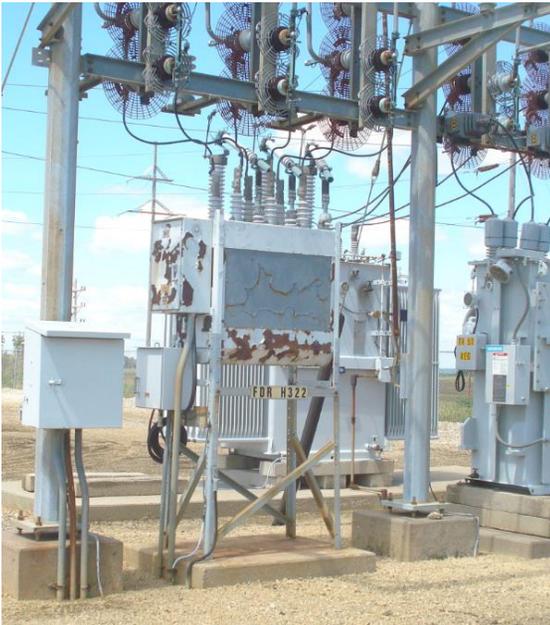
<p>Animal guards on insulators on Distribution Buss-work for H321 & H322 – H322 bkr is badly rusted</p> <p>No squirrels guard on Circuit H322 overhead out of substation – Circuit H321 goes to riser and then underground to riser in front of Substation</p> <p>No direct stroke lighting protection seen in substation yard – 138kV and 34kV lines outside of yard do have static wire over primaries</p> <p>Vine observed growing up guy on pole for H322 outside of substation yard</p> <p>Another Guy seen with Vine growth just outside south side of Substation</p> <p>Signs that Trees/brush had been cut back outside North-East corner of Substation yard (near where Distribution equipment is located)</p>
		<p>Feeder Ckt: <u>H321</u> City: <u>Fulton</u> Voltage: <u>12kV</u></p>	
907	1	41.79301 -90.11115	Riser 3S143 outside of Substation from H321 breaker by transformer 51
909-910	1	41.79356 -90.11125 Device #13318277	Lose ground cover on ground to transmission tower static line

Rust/Peeling Paint on Circuit H322 Breaker
885 Garden Plain Substation

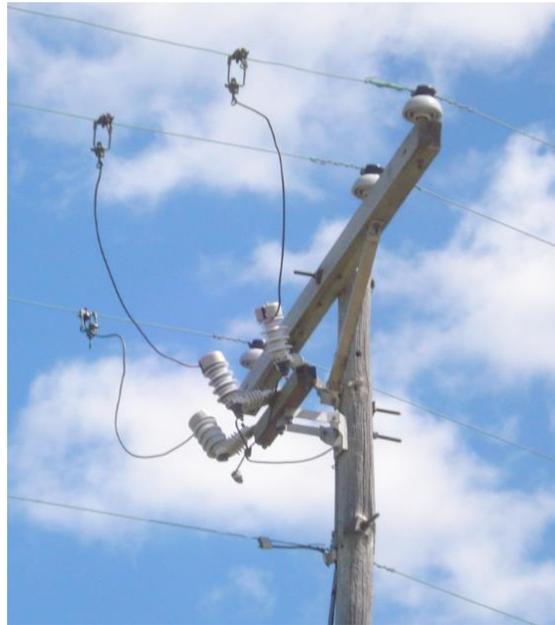
Field Side Lightning Arrester Blown
924

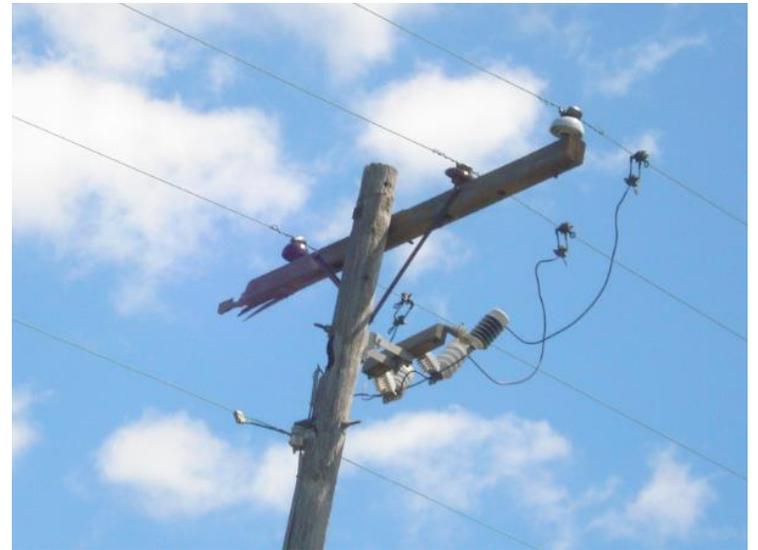
912-915	Random	41.86069 -90.14112	<p>Vines on Down Guy</p> <p>Very old pole with substantial subsidence – may have been marked already for replacement</p> <p>Old cross-arm</p>
916-917	1	41.800556 -90.13046	Pole – cross-arm – cutout – all being replaced
918	1	41.79956 -90.13056	Missing down guy guard
920	1	41.79823 -90.13058	Hanging ground cover
921-922	1	41.79410 -90.13053	Center Lightning Arrestor has curly leads (which cause High Impedance)
924	1	41.78973 -90.13049	Field Side Lightning Arrestor is Blown
925	1	41.78696 -90.13052	Line Hose on Field Side Primary
926	1	41.78696 -90.13052	Damaged Pole Top and Damaged Cross-Arm

Damaged Pole & Damaged Cross-Arm
926

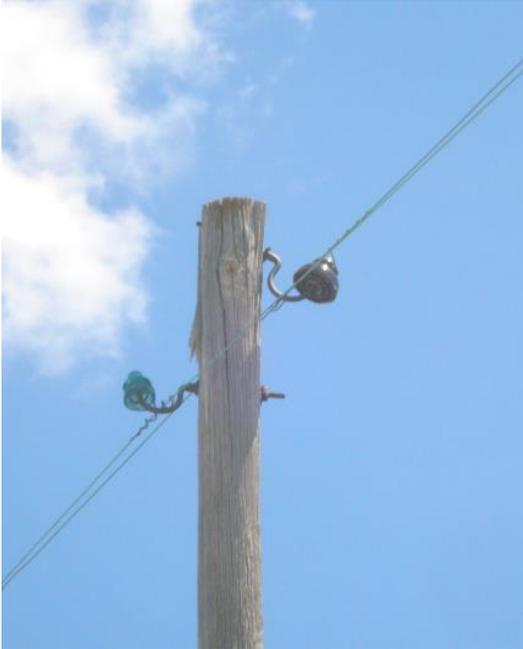
927-928	2	41.78138 -90.13054	Blown Lightning Arrestor on Field Side
929	2	41.77822 -90.13055	All three Lightning Arrestor have curly lead connections and thus High Impedance
930-931	2	41.77204 -90.12243	Primary J-Mount is lose and near failure Pole Top is Damaged
932-933	2	41.77202 -90.11204	Pole looks bad Pole top bad Primary J-Mount is Lose
935-936	2	41.77208 -90.11990	Split Pole / Damaged Pole
937	2	41.77623 -90.16814	Cross-Arm holding Cut-Outs appears to be in bad shape
--	2	41.75977 -90.15942	Curly Leads (High Impedance) to Field & Road Side Lightning Arrestors
--	2	41.75694 -90.15137	Curly Leads (High Impedance) to Field & Road Side Lightning Arrestors
938	5	41.73690 -90.15194	Curly Leads (High Impedance) to Field & Road Side Lightning Arrestors
--	5	41.73692 -90.1584	Curly Least (High Impedance) to Field & Road Side Lightning Arrestors
--	5	2 Poles East of 41.73692 -90.1584	Very Lose/Hanging Ground Guard

Primary J-Mount is Loose & Pole Damage
930

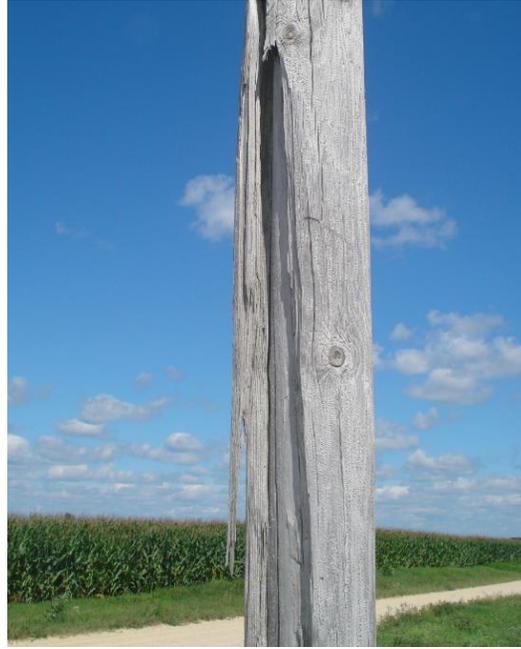
Split/Damaged Pole
936

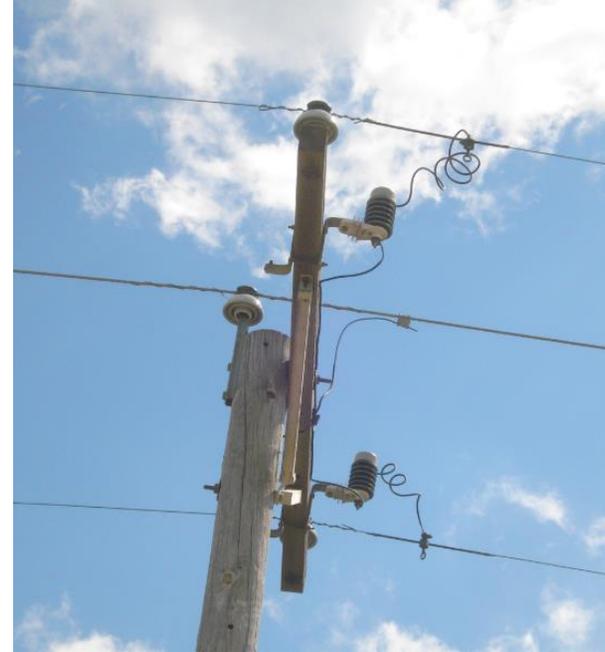
Curly Leads (High Impedance) to Lightning Arrestors
938

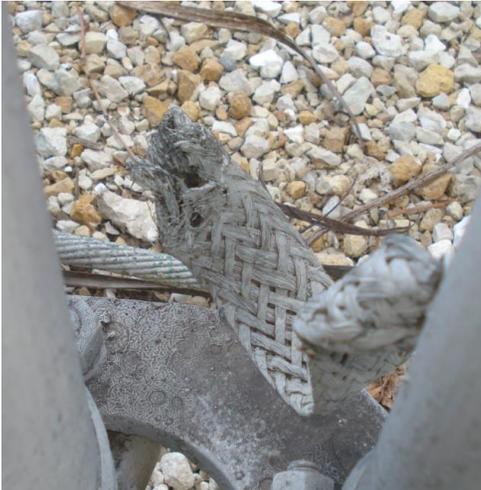
939-991		DCH62 Sterling Substation	<p>Fence line Inspection:</p> <p>Ground Bonding Straps from Gates to Gate Posts is Broken Transformer 51 appears older and while it needs painting it is not visibly Rusty Transformer 52 does appear newer than Transformer 51 Rock in Substation yard is up to fence bottom to help prevent animal entry Bushing oil levels on Transformer 52 look OK Overall: Yard Looks Good – Some Old equipment but it appears in Maintained shape No vegetation intrusion into substation yard – obvious had some in the past but it is OK now Signs of trees/bushes being cut back from substation fence line Gate may have been painted Some Rust and/or old paint on equipment in yard but overall looks good from fence line</p>
---------	--	----------------------------------	---

Broken Ground Bonding Strap
946 Sterling Substation

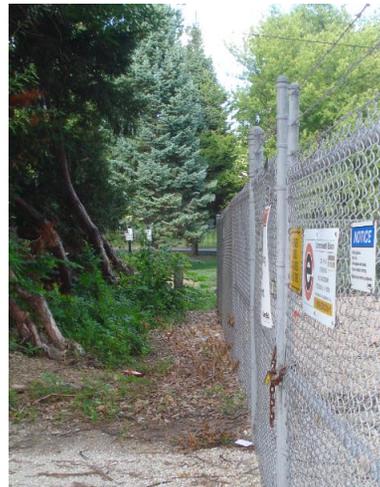
Trees/Brush cut back from fence line
944 Sterling Substation

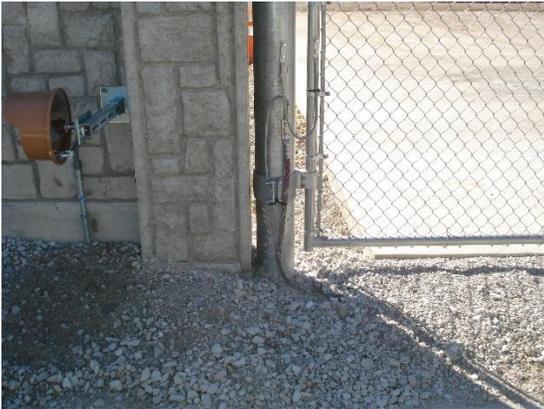
Gate bonded to grounded Post
 Part of perimeter detection system also visible
 996

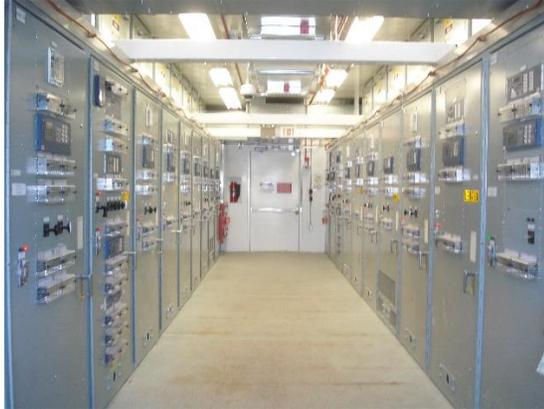
34KV Switchgear building
 992

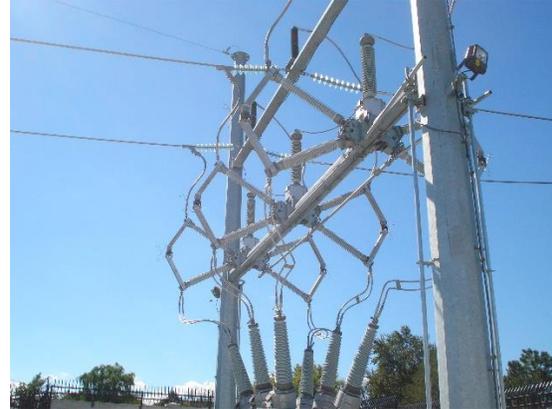
Creative design used to install switches above Breaker
 028

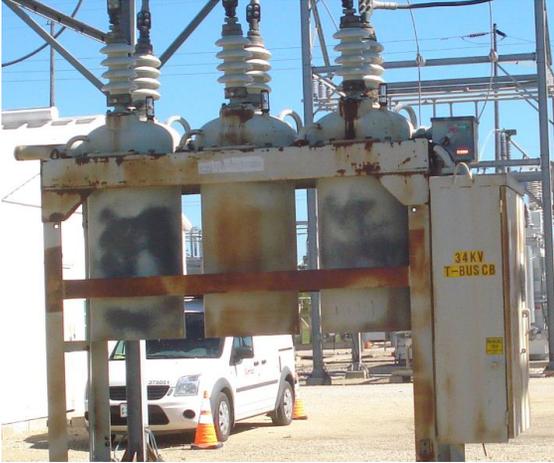
Rust 34kV Transfer Bus Circuit Breaker
062

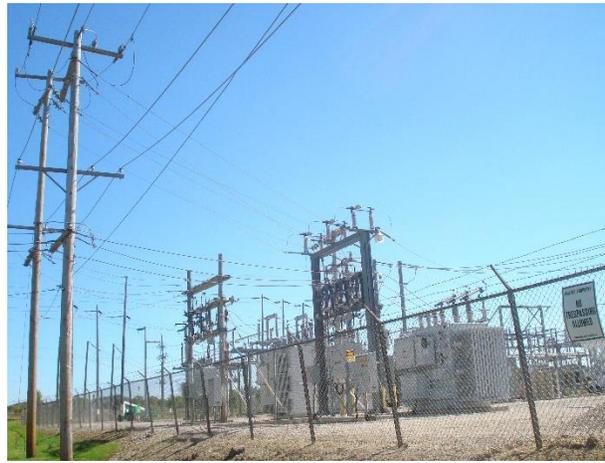
Animal guards on 12kV bushings in yard
No squirrel guards on 12kV lines in/out of yard
Fence line clean of vegetation/weeds
067

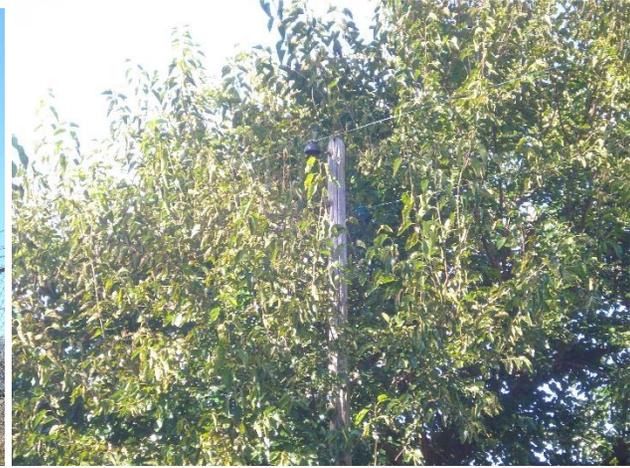
Pole surrounded by tree/bush
078

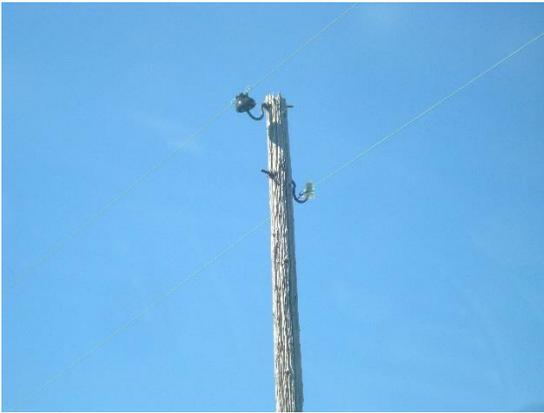
-	3	3 poles North of Above	Loose/hanging Gnd Cover near top of pole
-	4	South of Lakewood Drive on Meyer Rd	Loose/hanging Gnd Cover near top of pole
077-080	10	42.20192 -88.64607	Pole buried in tree/bush
081	10	42.20277 -88.64825	Old pole & J-hook primary mount barely in pole

Old pole & Primary J-Mount Loose
081

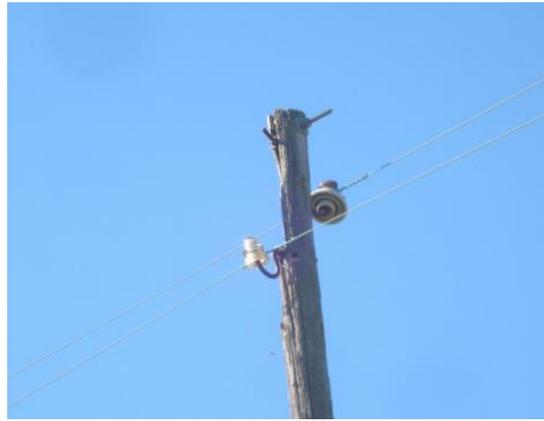
-	10	Promary running along Blissdale North of Grange Rd	A large number of old poles
082-084	10	42.21169 -88.70924	Pole buried in tree/bush
085-086	Random	42.24434 -88.76117	Bad pole top / bad pole / primary near failure

Old & Split/Damaged Pole & Loose Primary J-Mount
085
