Illinois Environmental Protection Agency

Bureau of Water - Division of Public Water Supplies
Inspection Report - Elgin Regional Office

FACILITY NAME		Northern Illinois Utilities, Inc.		FACILITY NUMBER		111-5850	
PLANT PHONE		1-815-653-2961		COUNTY		McHenry	
INSPECTION DATE		May 30, 2000		INSPECTED BY:		Chris Johnston and Manny Abad	
SEND CORRESPONDENCE TO				EXEMPTION / LABORATORY FEE STATUS			
NAME OR ENTITY		Mr. Thomas P. Mathews		CHLORINE (Date)		Not exempt.	
ADDRESS		7314 Hancock Drive		CERTIFIED OPERATOR (Date)		Not exempt.	
CITY, STATE, ZIP		Wonder Lake, Illinois 60097		LAB FEE PARTICIPANT (Y/N)		No.	
CONTACT INFORMATION							
CERTIFIED OPERATOR		Mr. Thomas P. Mathews		CLASS		"C"	
PHONE		1-815-653-2961		FAX		1-815-653-2081	
PORTABLE PHONE		1-815-482-1401		OTHER		Home: 1-815-653-7171	
OWNER - RESPONSIBLE PERSONNEL		Mr. Thomas P. Mathews		TITLE OR POSITION		President	
PHONE		1-815-653-2961		FAX		1-815-653-2081	
OTHER CONTACTS		NAME		TITLE OR POSITION		PHONE	
		Mr. Jeff Claus		Vice President		1-815-653-2961	
		Mrs. Evelyn Raske		Office Manager		1-815-653-2961

ATTACHMENT "A"
VIOLATIONS, DEFICIENCIES AND RECOMMENDATIONS

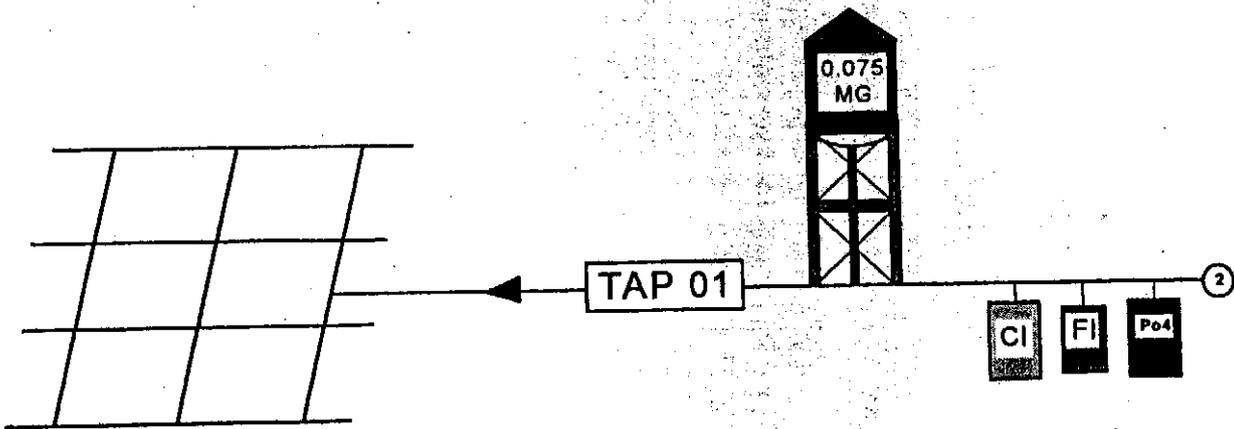
Northern Illinois Utilities, Inc.
McHenry County - 111-5850

Well #2
ID 20148
Status: Active
Capacity: 110 gpm
Aquifer: Sand & Gravel
