Primary Clarifiers

6.5.3 Primarily Effluent Pumping

6.5.4 Secondary Treatment

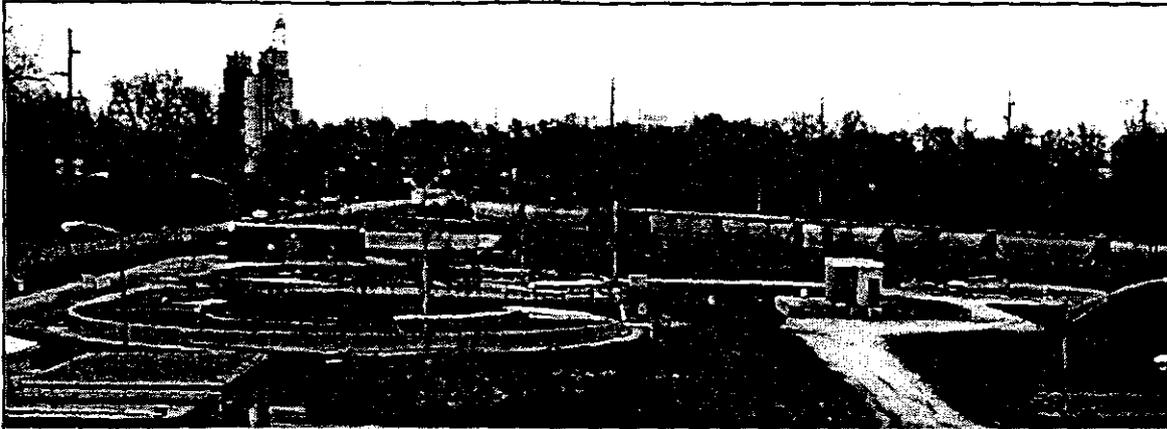
Figure 6.8 - Secondary Treatment

The existing secondary treatment facilities, shown in Figure 6.8, are comprised of three secondary treatment units. Two of the units, constructed in 1970, shown as the South Secondary Treatment Unit and the North Secondary Treatment Unit in Figure 6.4, are circular, multi-compartment tanks, 120 feet in diameter. The South Secondary Treatment Unit is divided into contact aeration, re-aeration, 70-foot diameter clarifier, chlorine contact, and a waste-activated sludge holding tank used for all three secondary treatment systems. The North Secondary Treatment Unit is divided into contact aeration, re-aeration, 70-foot diameter clarifier, chlorine contact and contact aeration and re-aeration for the third secondary treatment system. The third secondary treatment system, shown as Clarifier No. 3 in Figure 6.4, constructed in 1995 includes a 70-foot diameter clarifier, chlorine contact, and a return and waste activated sludge pumping building. Located north of the North Secondary Treatment Unit is the Blower Building that houses two engine-driven positive displacement blowers, one electrically-driven positive displacement blower, and the chlorination systems for all three secondary treatment units. Additional secondary treatment system equipment details are included in Appendix B.

The secondary treatment system is comprised of components constructed at various times. As a result, the condition of certain parts of the system are good with others being in fair to poor condition. A summary of the components condition is listed in Table 6.5.3 and a more thorough description is included below.

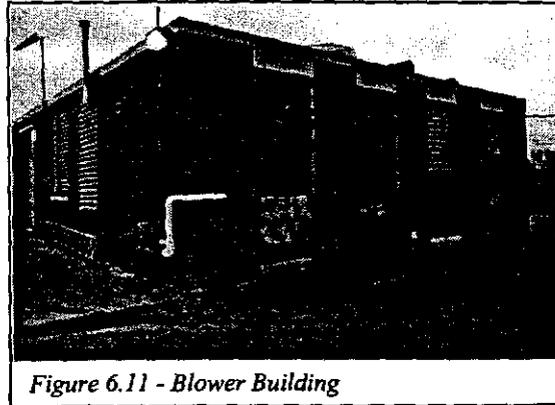
Figure 6.11 - Blower Building

The three existing blowers, installed in 1970, are rated at 3,500 CFM each. Caterpillar G342-NA-6 cylinder natural gas engines drive two of the blowers. Caterpillar has rebuilt the engines, but no longer manufacture the G342. The third blower is driven by a 200 HP, 480VAC electric motor which was replaced in 1990. The blowers are in fair to poor condition and exhibit significant bearing noise. The blowers have been in service for 30 years. They should be replaced in the next 1-2 years or sooner.

The Blower Building shown in Figure 6.11, was also constructed in 1970 and is in fair condition. United Water and the City of Pekin have developed a list of required building improvements, included in Appendix C for reference.

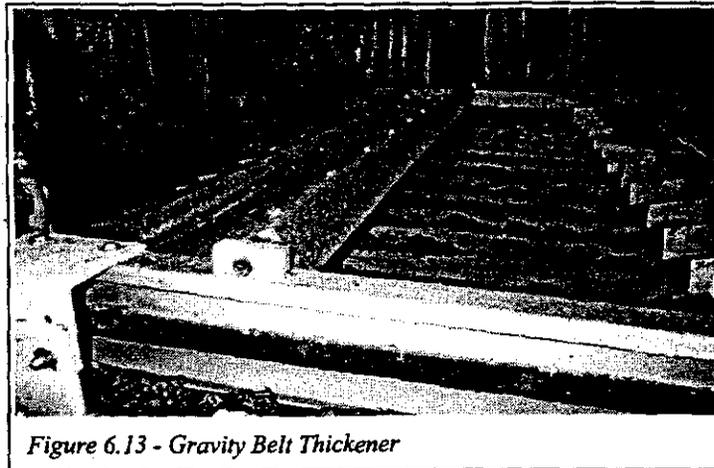
Figure 6.13 - Gravity Belt Thickener

Currently, United Water operates the gravity belt thickener, shown in Figure 6.13, for thickening both primary and waste activated sludge prior to digesting the sludge in the anaerobic digesters. The vacuum sludge drying beds and the sludge storage pad are currently not in use. The liquid sludge is stored in the sludge storage lagoons and then land applied.

The gravity belt thickener (GBT) was installed in 1989 and is used on a daily basis. The belt has been replaced several times and other system components have been repaired or replaced. The hydraulic drive unit and all moving parts are susceptible to wear and require periodic maintenance and replacement.

Based on the site investigation, it appears that the unit will require complete replacement within approximately 10 years. The vinyl curtain system is in fair condition and will need to be replaced in approximately five years. The concrete floor and curbing are in good condition.

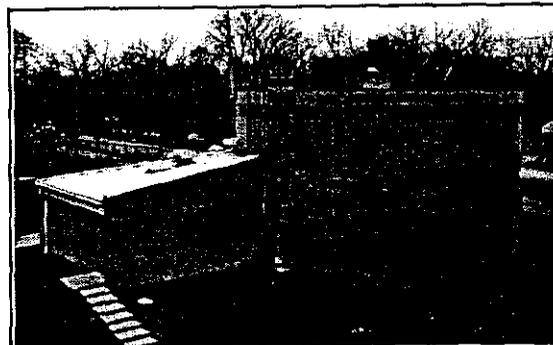
Figure 6.15 - Digester No. 1

Digester No. 1, shown in Figure 6.15 was constructed in 1989 and is generally in good condition. The various components that comprise the complete mix digester system are in poor to good condition.

The dual fuel sludge heater boiler tubes have been replaced several times since installation. The digester gas is corrosive and has decreased the life of the tubes. United Water contracts out the maintenance and repairs to the sludge heater and heat exchanger and it is maintained in good condition. The anticipated remaining useful life of the heat exchanger is approximately 15 years, but system components will require replacement prior to that time.

A 5 HP, 300 GPM centrifugal pump re-circulates the sludge in the digester tank and through the sludge heater. The electric motor had failed and was being replaced during the site visit. On a prior visit, it was

noted that significant seal water and/or sludge was leaking from the pump seal. Due to the importance of the pump, a stand-by unit should be considered.

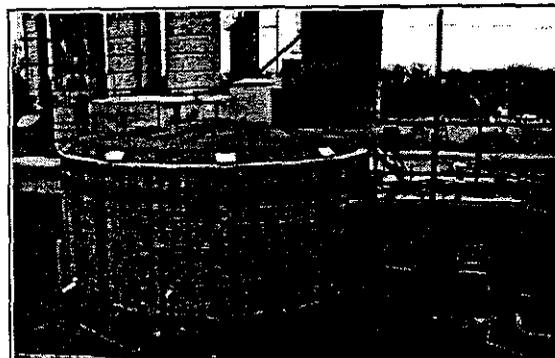
Figure 6.16 - Digester No. 2

Digester No. 2, shown in Figure 6.16, was upgraded in 1996 and is in good general condition. All of the major system components were replaced in 1996, including the sludge heat exchanger, re-circulation pump, complete mix system, gas collection system, building heating and ventilation, and a majority of the sludge piping. These components are in good condition. The sludge piping that was not replaced is in fair condition, and needs to be repainted.

The Digester No. 2 tank was rehabilitated on the exterior in 1996. The original bricks, installed in 1963, were removed, the tank height was increased by placing concrete walls on the top of the old tank, and split face CMU's were installed around the exterior of the tank. The CMUs need to be resealed with a waterproof coating. The digester building, constructed in 1963, has the original brick exterior and appears to be in good condition.

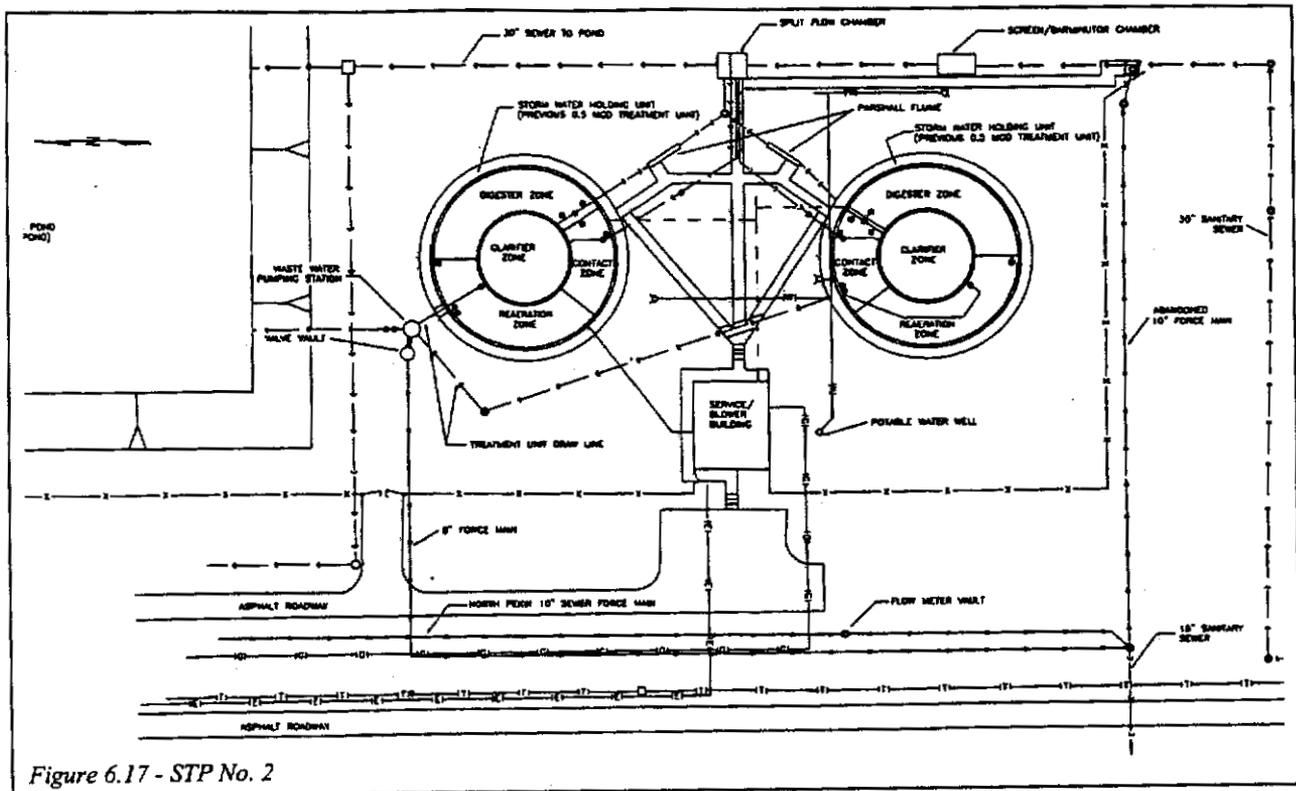
Figure 6.17 - STP No. 2

STP#2, shown in Figure 6.17, is presently being used for wastewater storage during wet weather conditions when the CSOs are overflowing. The existing plant, built in 1971 and expanded in 1975, includes two activated sludge treatment units (north unit is shown in Figure 6.18), polishing pond, blower and office building, and sludge drying beds. The plant was removed from service in 1989, following completion of the north side interceptor sewer. The decision to discontinue the use of the 1MGD plant was based on the estimated cost to rehabilitate and operate the plant compare to the construction of a new interceptor sewer. It was determined that the annualized costs of improving, operating and maintaining

The condition of STP#2 is fair to poor. The components were all inspected and while some could be salvaged, many will require replacement if the treatment plant was returned to service. When in operation, the treatment systems were difficult to operate and compliance with the discharge permit was inconsistent. The design of the original system was less than ideal and restoring the existing plant is discouraged.
