Illinois Commerce Commission
Assessment of
Central Illinois Light Company's
Annual Reliability Report and
Electric Service Reliability
For Calendar Year 2005

Pursuant to 83 Ill. Adm. Code 411.140

December 2006

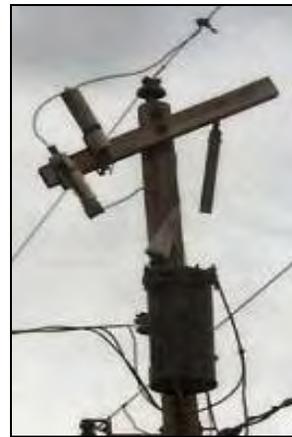
Photo 2: Disconnected Brace Allowing Cross Arm to Tilt (C50-001)

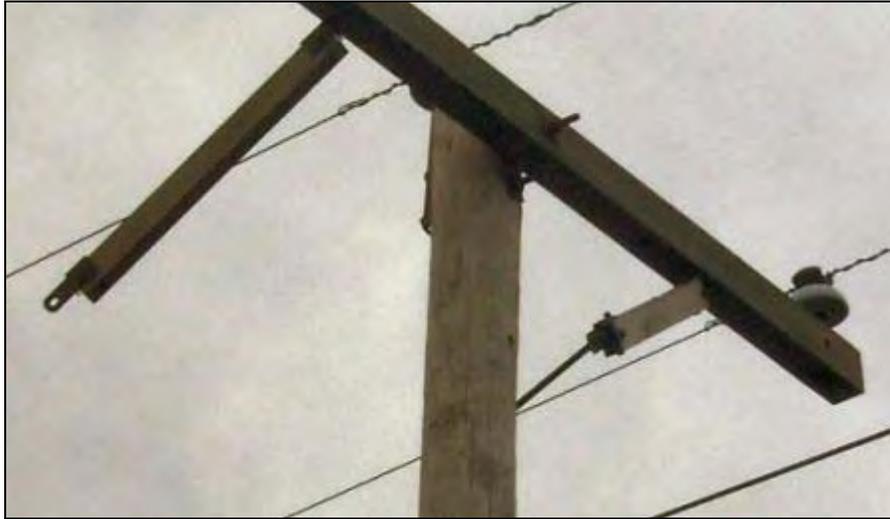
Photo 3: Detached Bolt No Longer Holding either Brace to Pole (C50-001)

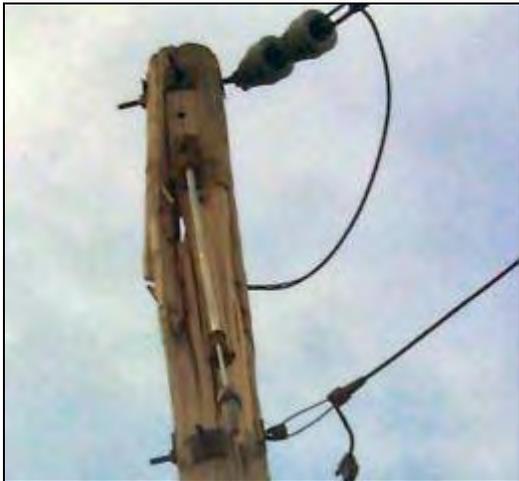
When inspecting Circuit C50-003, Staff observed no vegetation issues. Staff was pleased to note that AmerenCILCO had utilized overhead fault indicators at a few locations, and appeared to have made good use of tap fuses. Potential reliability threats Staff did observe included a deteriorated cross arm, a missing cross arm brace, 3 poles that were leaning severely, and a pole top that had been damaged by lightning (Photo 4). Staff noted 3 locations with blown or detached lightning arresters (Photo 5). Staff was disappointed that many down guys on this circuit were not covered with guy guards. Though Circuit C50-003 was reported as a worst performing circuit during 2005, generally Staff observed fewer and less severe threats to reliable service on Circuit C50-003 than on Circuit C50-001 (discussed previously) which supplies more customers and originates from the same substation.

Photo 4: Lightning Damage (C50003)

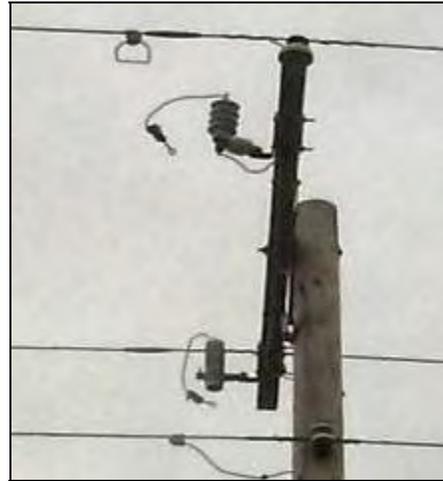
Photo 5: Detached Lightning Arresters (C50003)

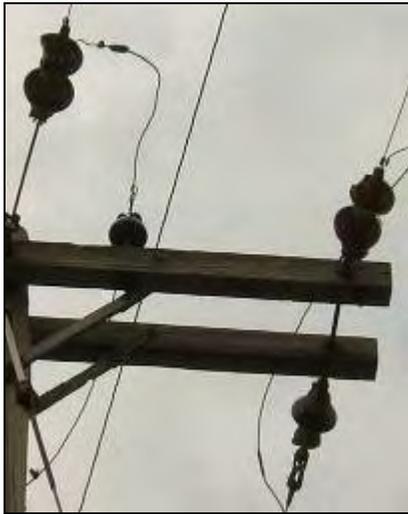
Staff observed no vegetation conflicts when inspecting Circuit C36-001. Staff identified two locations where the primary and neutral conductors did not have adequate ground clearance per the NESC. Other facility problems Staff noted included broken insulators, deteriorated cross arm braces, and a splitting cross arm. Staff noted that many down guys on this circuit were missing guy guards. Though there were relatively few locations on this circuit that caused Staff concern, Staff was disappointed to find both NESC violations and reliability threats on a circuit that AmerenCILCO claimed to have recently inspected, in January of 2006, with no problems found. Staff's May 25, 2006, inspection revealed NESC violations and reliability threats that appeared to have existed for some time, and certainly existed at the time of AmerenCILCO's recent inspection.

Photo 6: Broken Insulators (C36001)

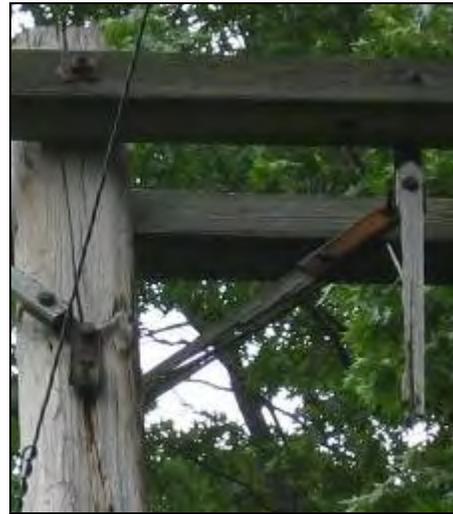
Photo 7: Deteriorated Braces (C36001)

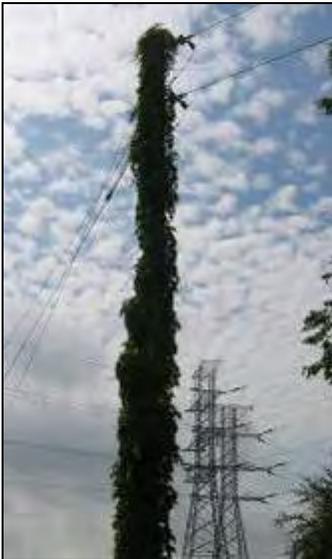
Staff noted only one vegetation issue when inspecting Circuit A91-001: a vine grown up a pole to the primary level (Photo 8). Staff identified one location where excessive sag in a neutral conductor caused it to have inadequate ground clearance, per NESC. Staff was disappointed AmerenCILCO had not identified and corrected this clearance violation as part of its own recent inspection. In addition,

**Photo 8: Vines Grown to Primary
(A91001)**

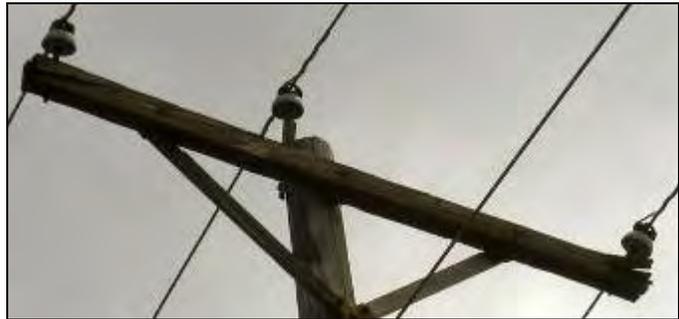
Staff noted two broken/disconnected cross arm braces, three deteriorated cross arms (Photo 9), one pole with several woodpecker holes, and one pole leaning severely while supporting a transformer. Staff was very impressed that AmerenCILCO appeared to have installed guy guards on every down guy on the circuit. It appeared to Staff that with some fairly minor maintenance this circuit could perform much more reliably in future years.

**Photo 9: End of Cross Arm Splitting at Insulator Pin
(A91001)**

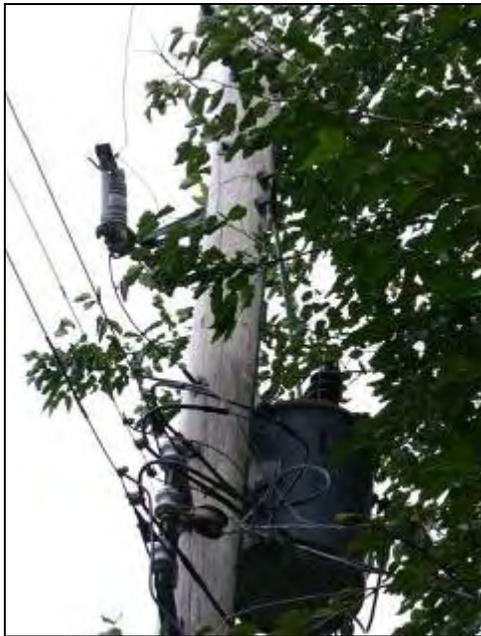
During Staff's inspection, Staff noted 7 locations where vegetation was contacting the primary (Photo 10), plus one location where limbs were growing between the wires, and one location where vines had reached the primary. In addition to these vegetation concerns, Staff noted 2 splitting cross arms (Photo 11), and 2 splitting or deteriorated pole tops. Staff also noted one location where down guys on a pole that is jointly occupied by AmerenCILCO and CWLP had no strain insulators installed beneath the primary level, which is a violation of NESC Rule 297A. AmerenCILCO informed Staff that it reported the infraction to CWLP, and CWLP corrected that infraction in October of 2006. Staff believes AmerenCILCO needs to perform some maintenance at specific locations, and perform a mid-cycle trim on trees throughout this circuit in order to avoid an additional year of poor performance.

Photo 10: Trees Enveloping Transformer Pole (C66002)

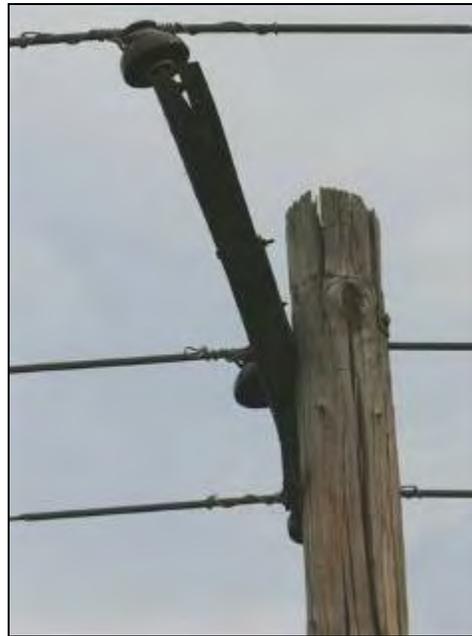
Photo 11: Splitting Cross arm (C66002)

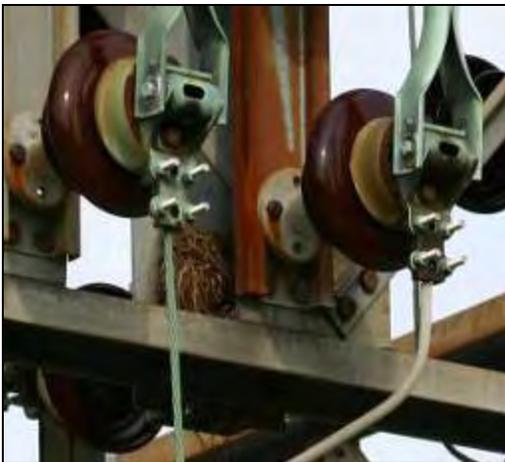
During the summer of 2006, Staff revisited about 20 locations Staff had noted during its 2005 inspection, and found that AmerenCILCO had addressed some of Staff's concerns, and not addressed others. Following its inspection in 2006, Staff asked AmerenCILCO to confirm that it had completed the work request it created for Circuit E10-001, and AmerenCILCO confirmed that it had. Staff understands that when many facilities on a circuit require repair, such as on Circuit E10-001, AmerenCILCO might need to prioritize its work, however, Staff was disturbed by the condition of some of the distribution facilities on Circuit E10-001 that AmerenCILCO failed to address. For example, Staff found bird nests all over the structure and high-voltage disconnects at the substation (Photos 12 & 13). As Staff indicated in its previous assessment, Staff believes these nests are a reliability threat not only because of the birds themselves, but because other animals, for example raccoons or opossums, sometimes go after birds and their eggs, and might be attracted to the nests. These larger animals might cause significant facility damage if they contact the grounded bus structure and the energized components when climbing on the structure to get to the nests.

Photo 12: Bird Nest on Substation Bus behind Disconnect (E10001)

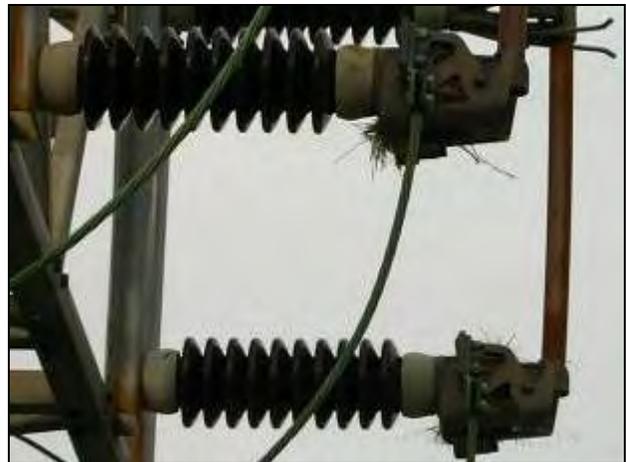
Photo 13: Bird Nests at Hinge Points at High-Side Fuses (E10001)

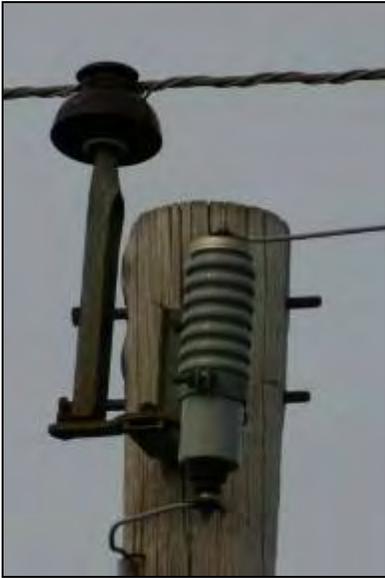
Staff also found locations where loose and missing hardware had not been secured and/or repaired (Photo 14), locations where deteriorated cross arms and insulator pins had not been replaced (Photo 15 & 16), and locations that still require tree trimming (Photo 16 & 17).

Photo 14: Nuts Missing from Both Bolts (E10001)

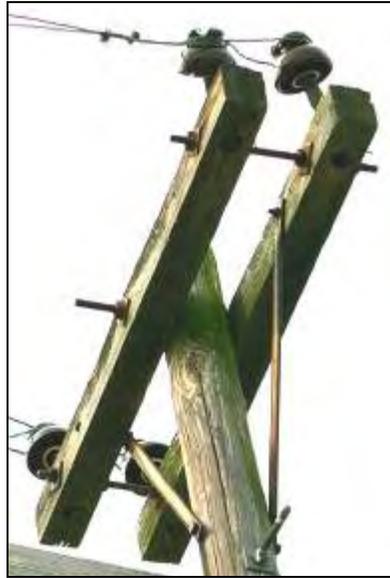
Photo 15: Wood Pins Loose in Arm & Insulators Laying Over (E10001)

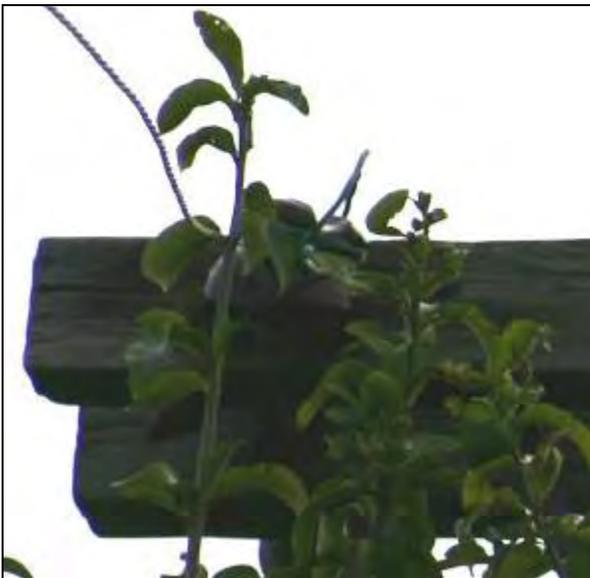
Photo 16: Wood Pin Broken & Pin Insulator Hanging from Conductor Next to Arm while Tree Envelopes Pole, Screening the Problem (E10001)

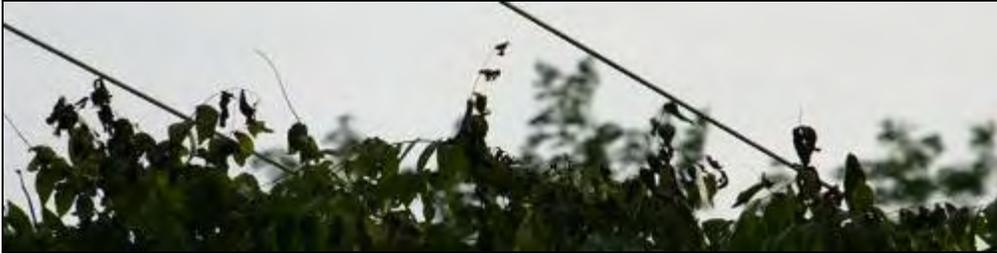
Photo 17: Trees Contacting and Growing through Primary (E10001)

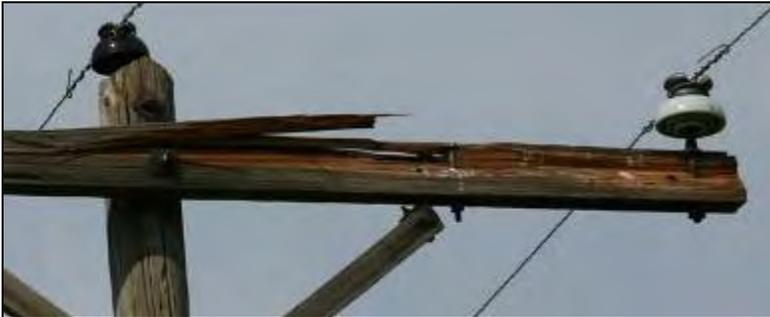
Staff also noted a few new locations where reliability issues existed that were not noted during its 2005 inspection. Staff believes AmerenCILCO should address some of these new locations promptly, especially a location where a cross arm had been severely damaged by lightning (Photo 18). Staff's new findings discovered when re-checking just a few of the locations from its 2005 inspection illustrate why frequent facility inspections are a critical part of providing reliable service to customers.

Photo 18: Lightning Damaged Cross arm (E10001)

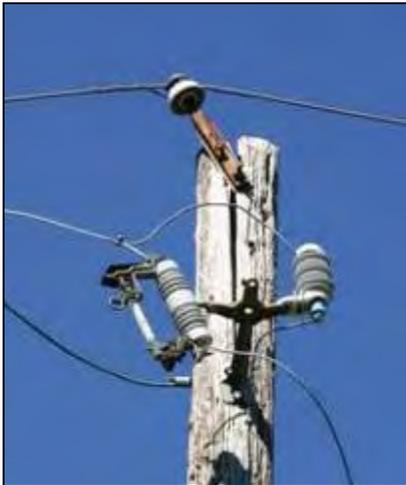
Photo 19: Split & Deteriorated Pole Top (In Washington)

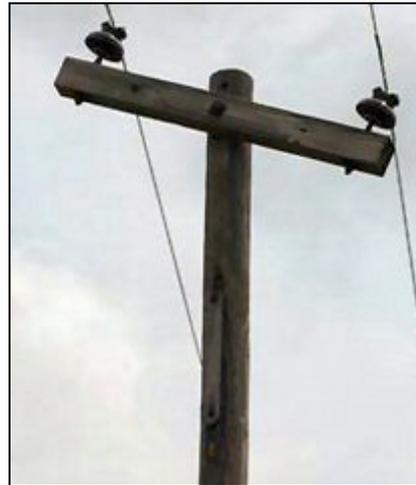
Photo 20: Detached Brace with Arm Beginning to Lean (Near Homer)

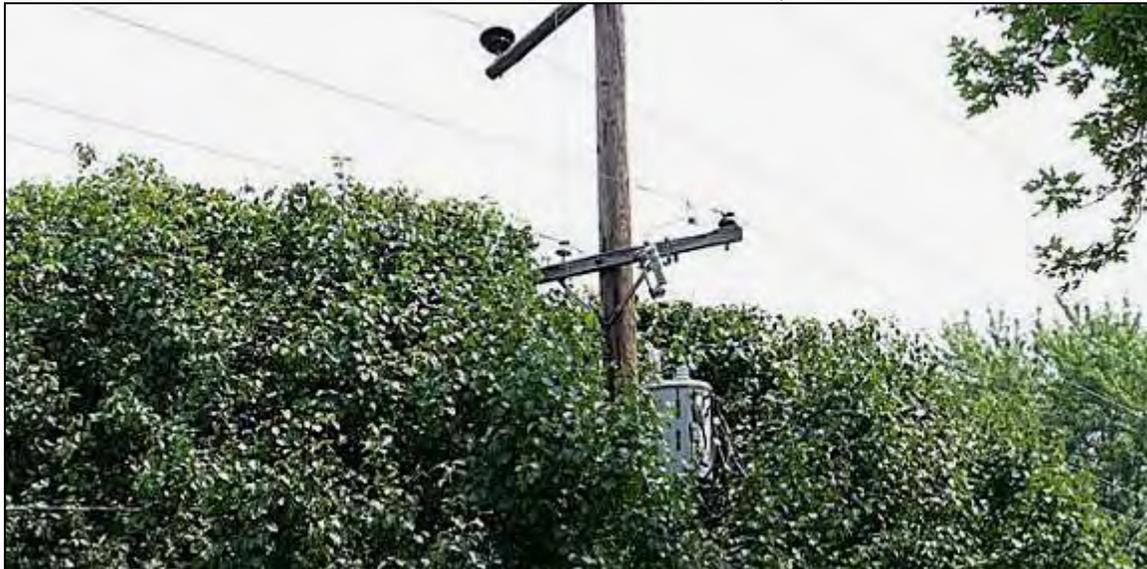
**2 Bradford pear trees into primary, with burning,
DeKalb St. between Mason & Park Sts., Mt. Pulaski**

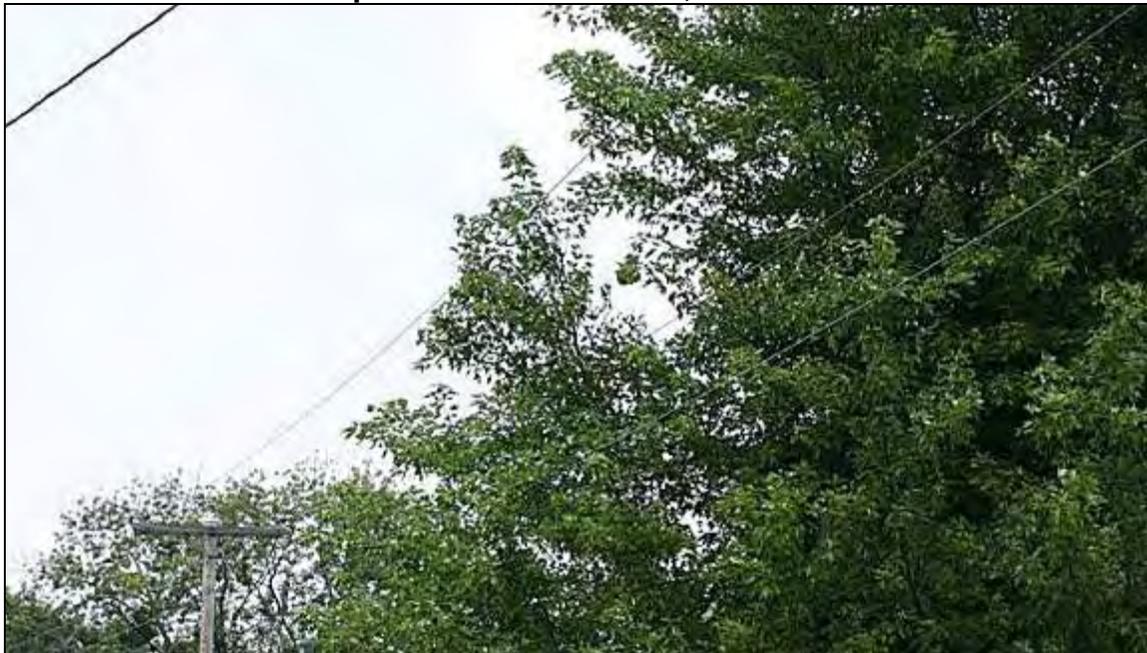
Figure 2 (Photo 06-CIL1101)

**2-phase primary through a soft maple tree ,
Jasper St. at Belmont St., Mt Pulaski**

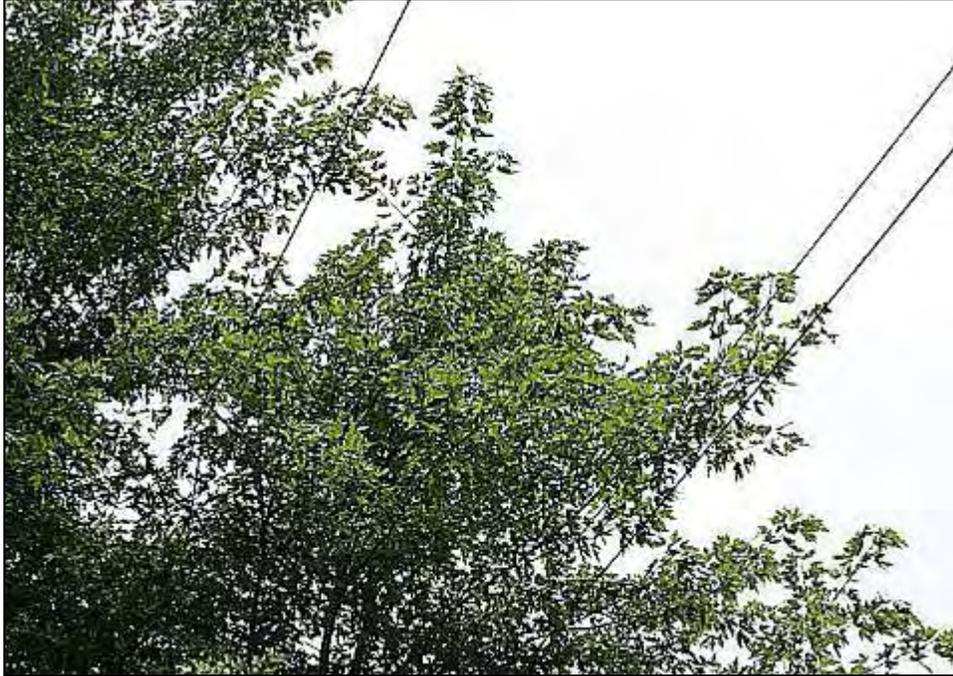
**2-phase primary through a soft maple tree, with burning ,
Jasper St. at Belmont St., Mt Pulaski (same location as in Figure 2)**

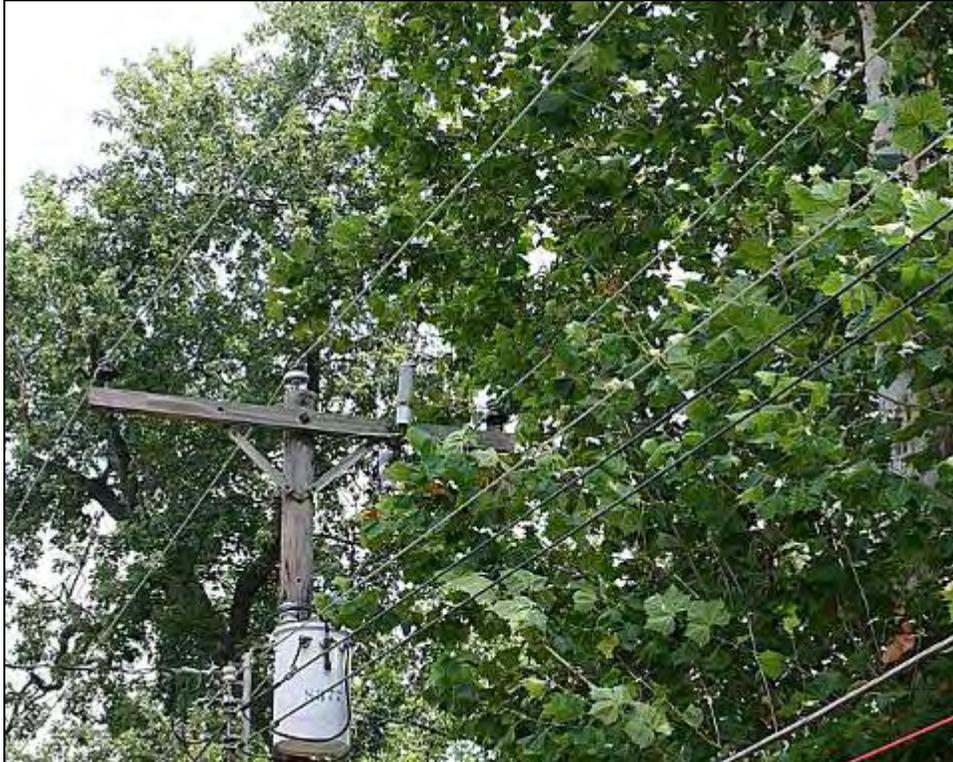
Figure 4 (Photo 06-CIL1102)

**Sycamore tree into primary, with burning
Just south of Morgan St. in the alley east of Vine St., Mt. Pulaski**

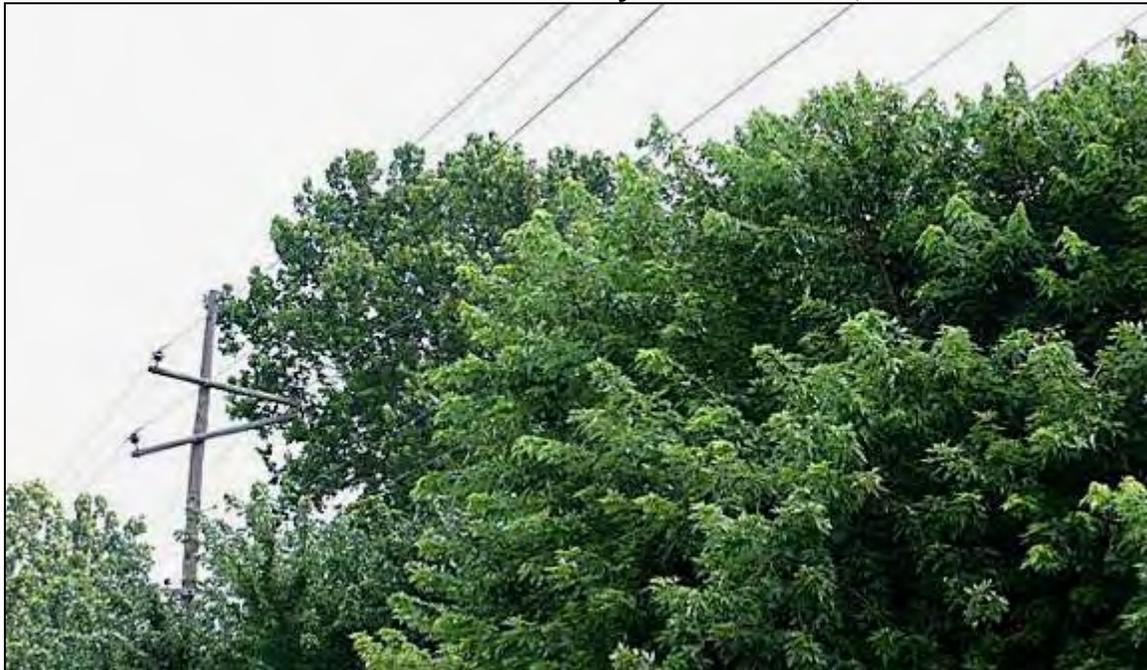
**Soft maple trees into 12 kV underbuild on 34 kV line,
Beason St. between Broadway & Pulaski Sts., Lincoln**

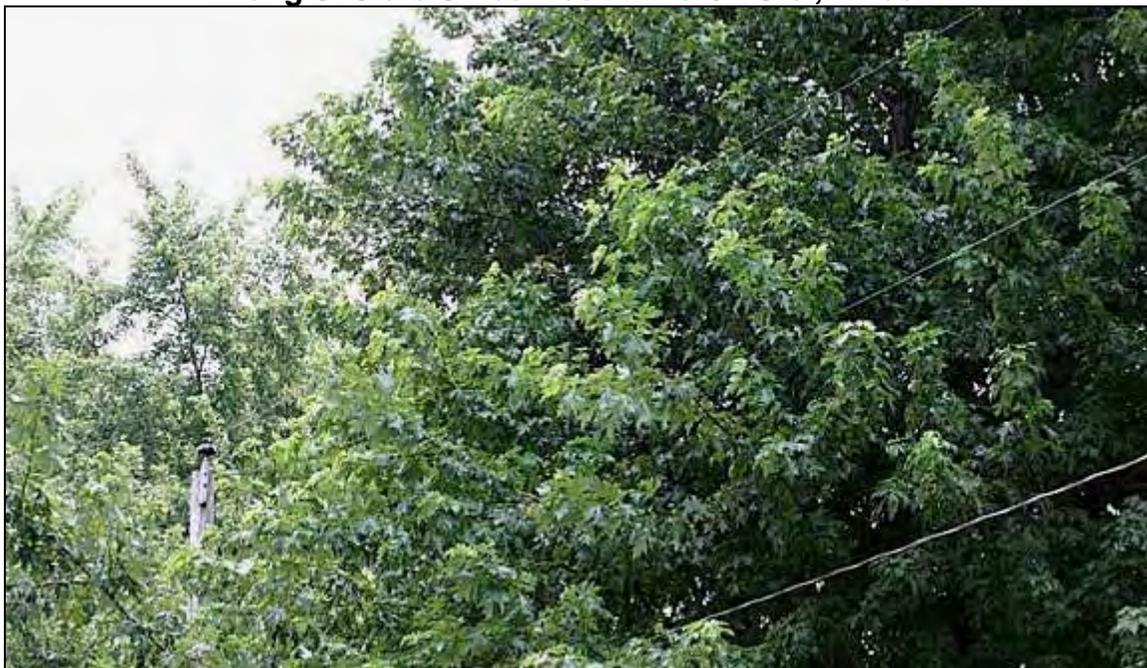
Figure 6 (Photo 06-CIL1110)

**Several soft maple trees into primary, with burning,
Along S. State St. between 2nd & 3rd Sts., Lincoln**

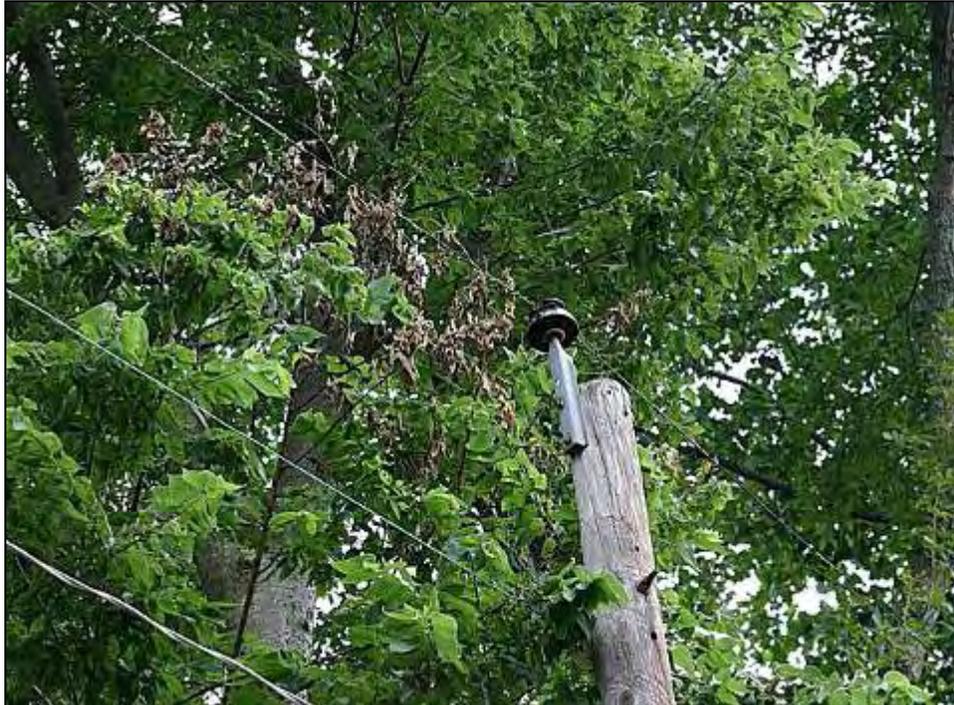
AmerenCILCO 2006 Tree Trimming Exhibit "A"
Figure 7 (Photo 06-CIL1105)
Trees into primary, with burning,
Along S. State St. between 1st & 2nd Sts., Lincoln

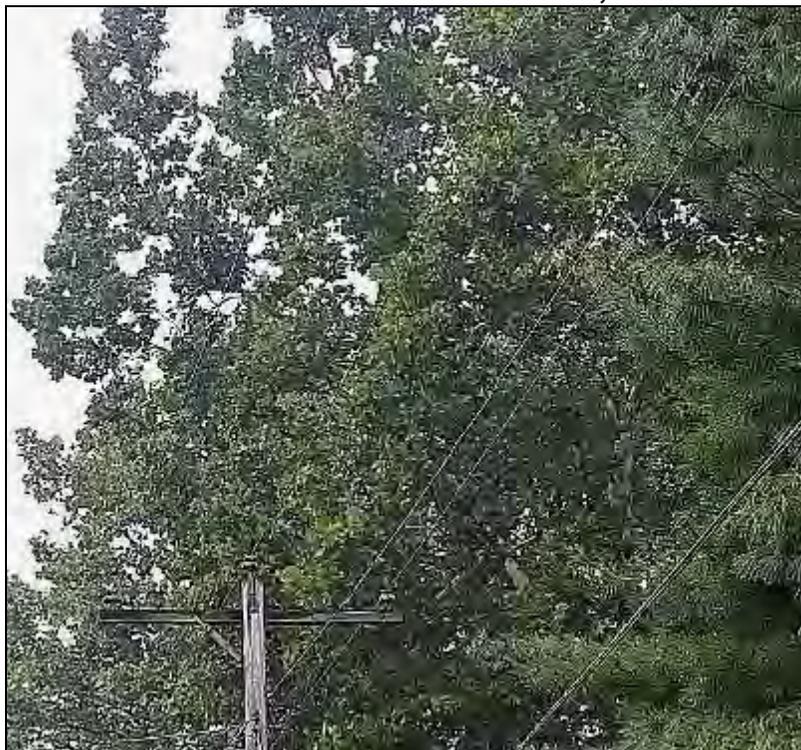
Figure 8 (Photo 06-CIL1155)
Primary burning white pine tree,
Jefferson St. west of Adams St., Philo

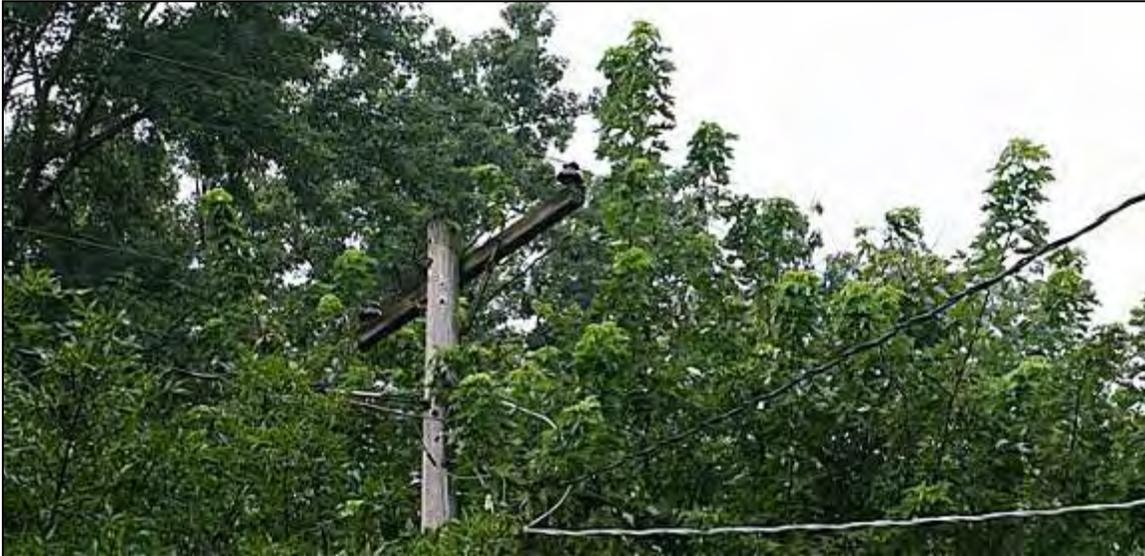
**Primary burning silver maple trees,
Van Buren St. west of Garfield St., Philo**

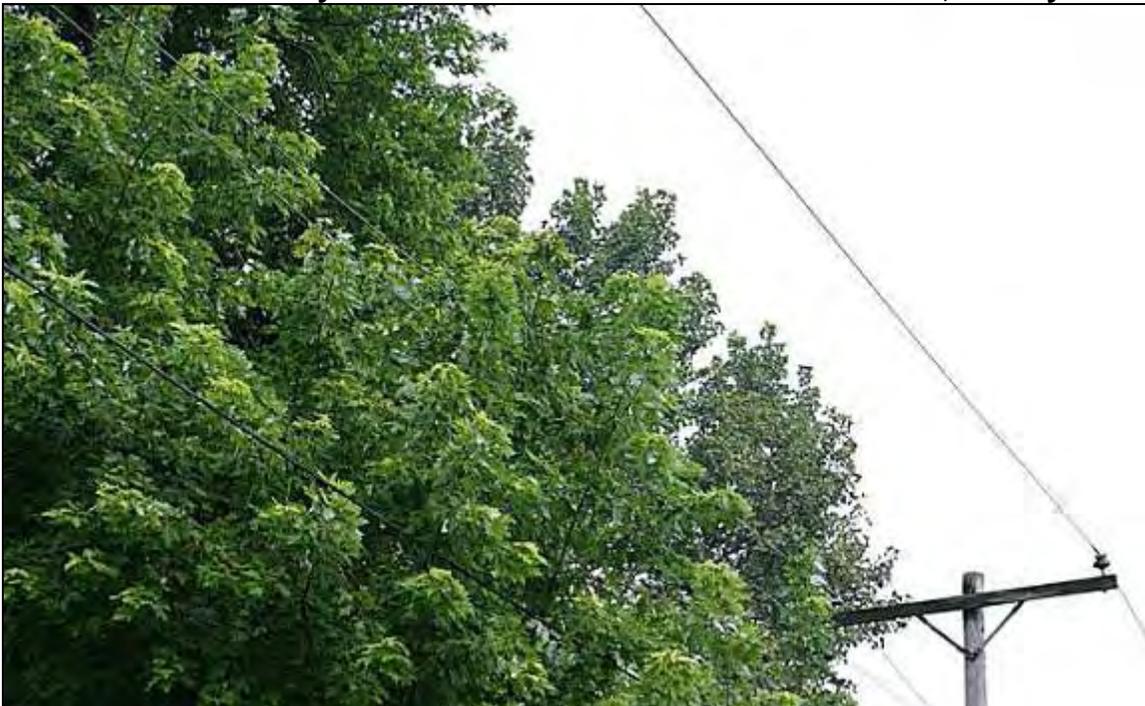
Figure 10 (Photo 06-CIL1168)

**Silver maple tree into primary, with burning,
Just north of Byron St. in the easement east of David St., Sidney**

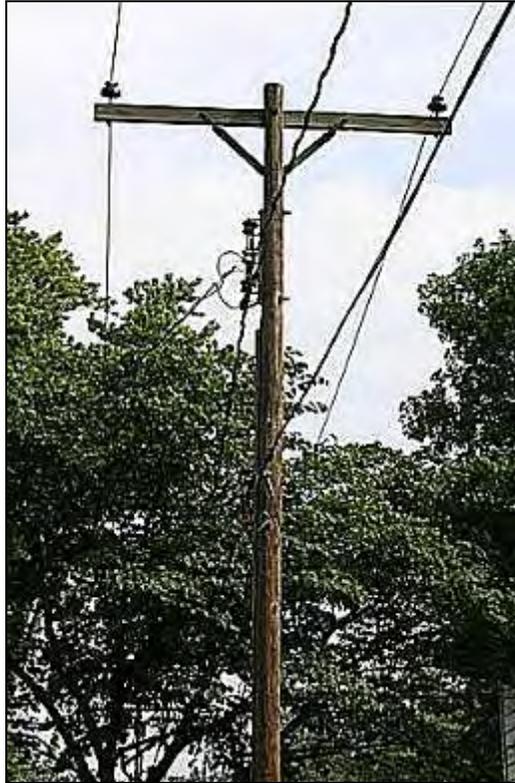
**Redbud tree into primary,
South of Prairie St. in the easement west of David St., Sidney**

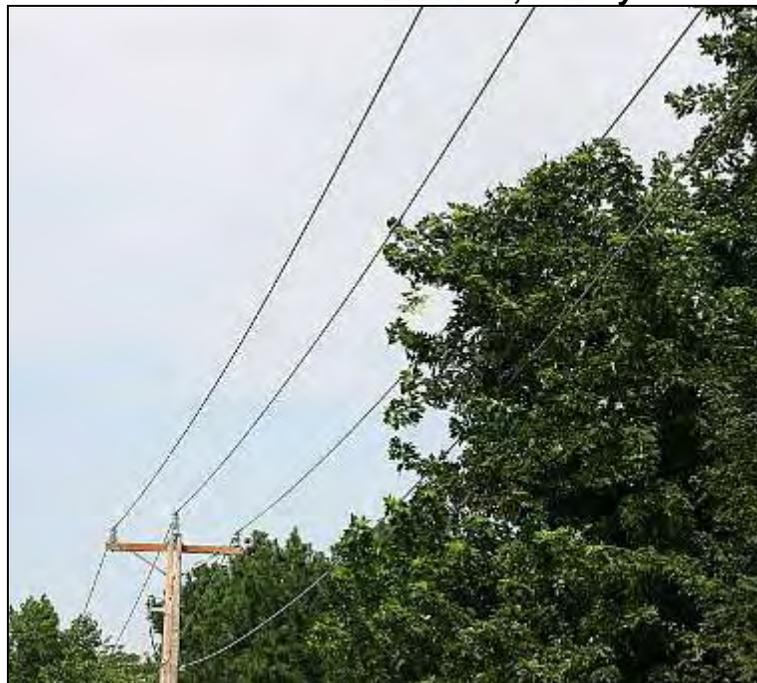
Figure 12 (Photo 06-CIL1178)

**Silver maple tree into 3-phase feeder, with burning,
Main St. east of Brian St., Sidney**

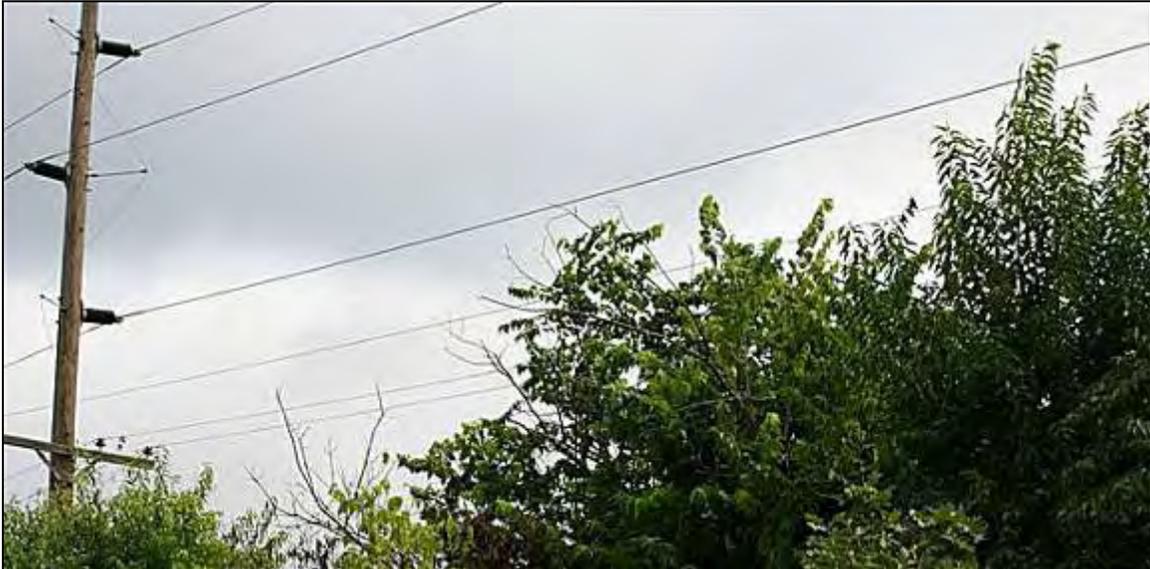
**Hackberry tree into primary, (just north of the substation),
On the south side of 3rd St. at the west end of the street, Homer**

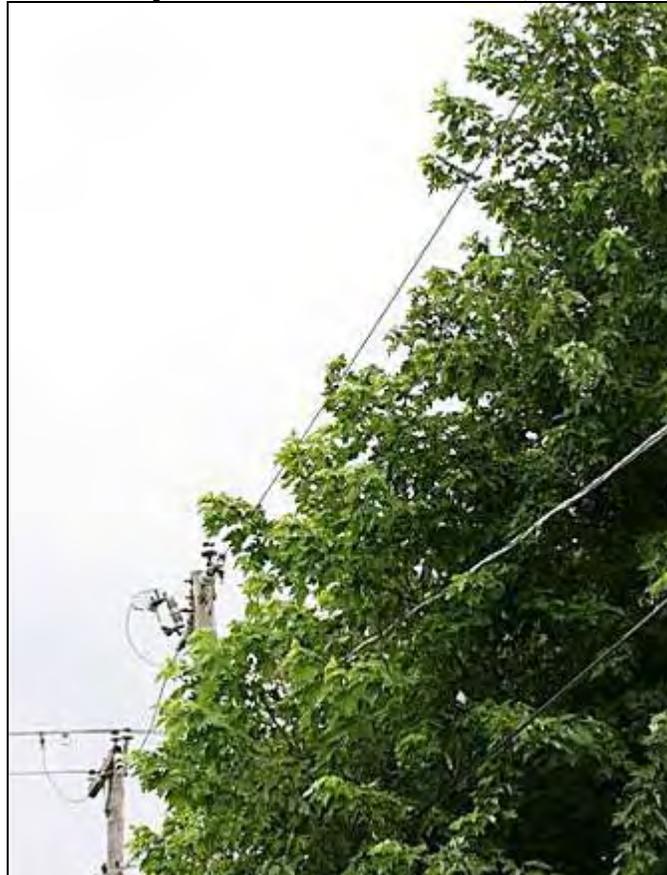
Figure 14 (Photo 06-CIL1190)

**Silver maple tree into primary, with burning,
Green St. just east of Oakwood St., Oakwood**

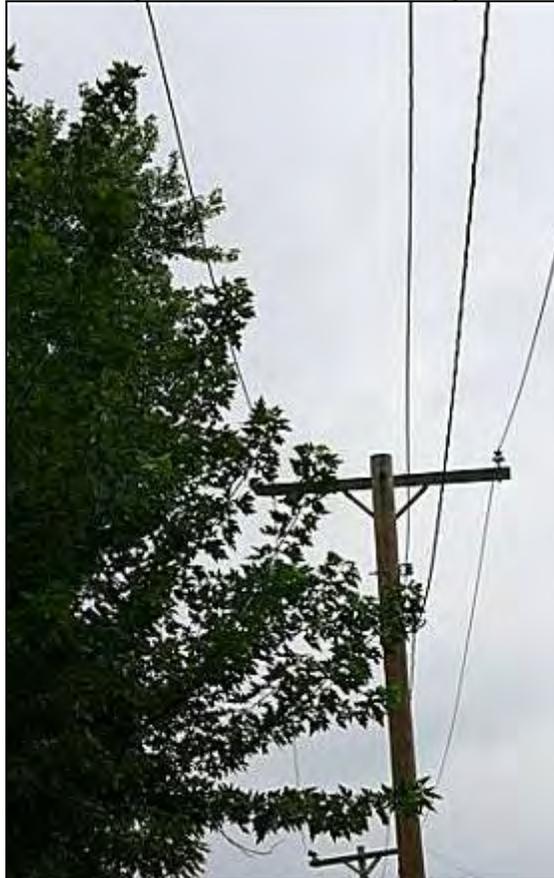
**Silver maple tree into primary, with burning,
Harrison St. just west of Sandusky St., Catlin**

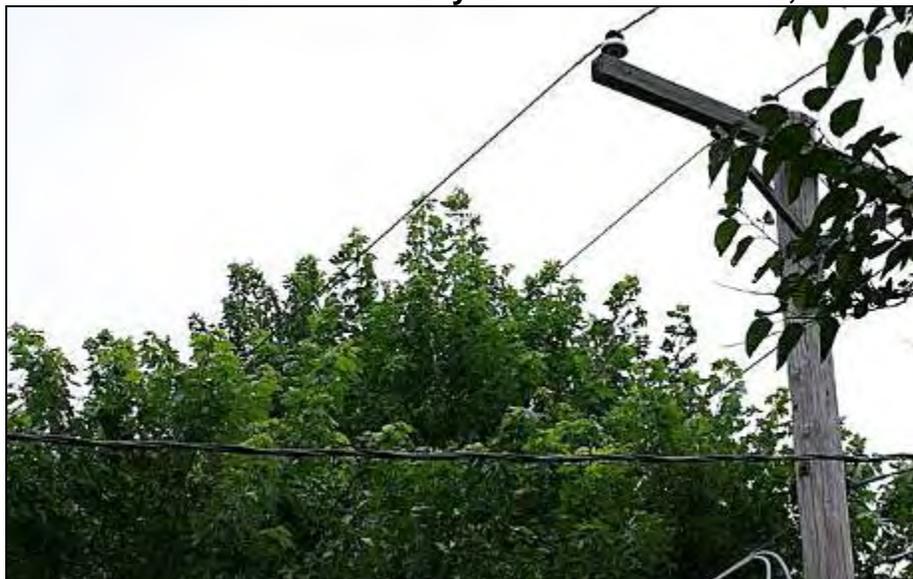
Figure 16 (Photo 06-CIL1201)

**Silver maple tree into primary, with burning,
East of Merrill St. in the alley north of Harrison St., Catlin**

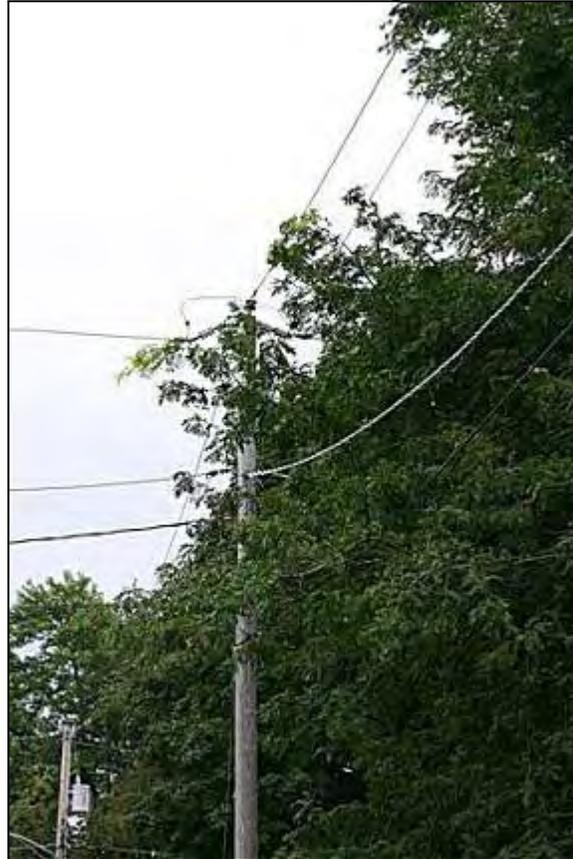
**Honey locust tree into single-phase primary, with burning,
Orchard St. south of Buckingham St., Catlin**

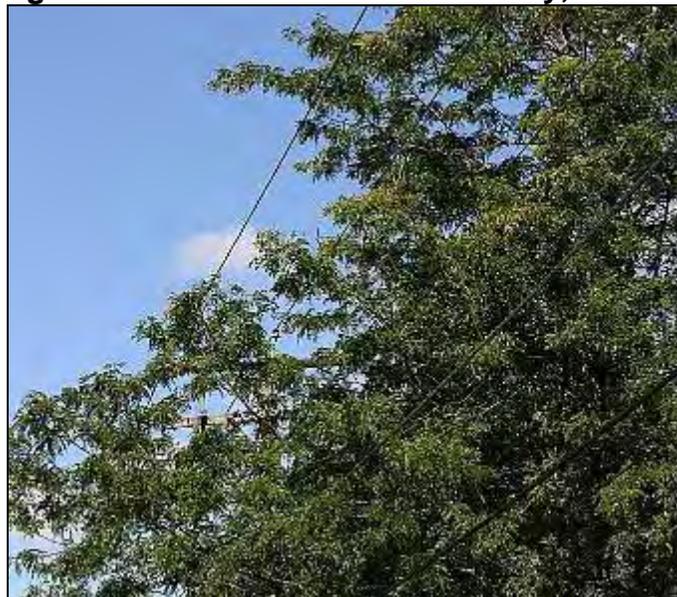
Figure 18 (Photo 06-CIL1227)

**Black locust tree into primary,
Springfield Rd. north of Lincoln Parkway, East Peoria**

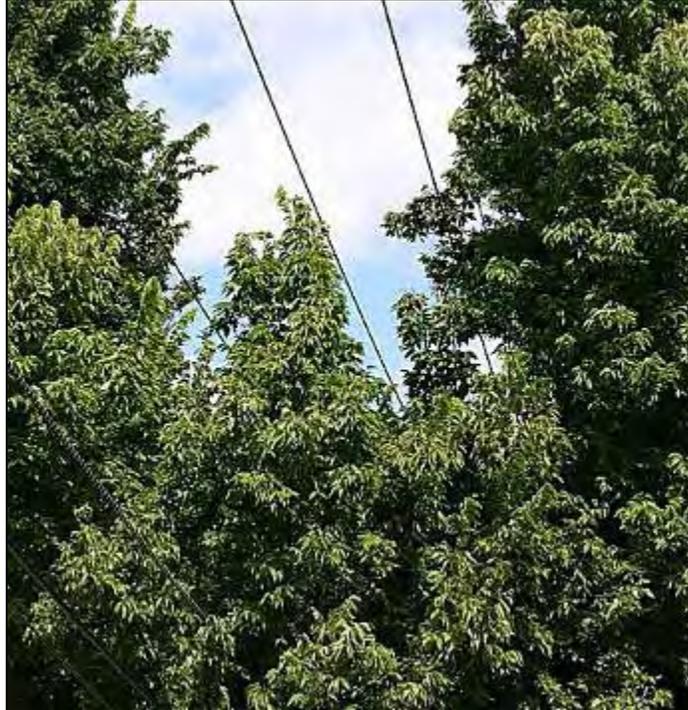
AmerenCILCO 2006 Tree Trimming Exhibit "A"
Figure 19 (Photo 06-CIL1225)
**Tree into primary,
Springfield Rd. just north of Season Dr., East Peoria**

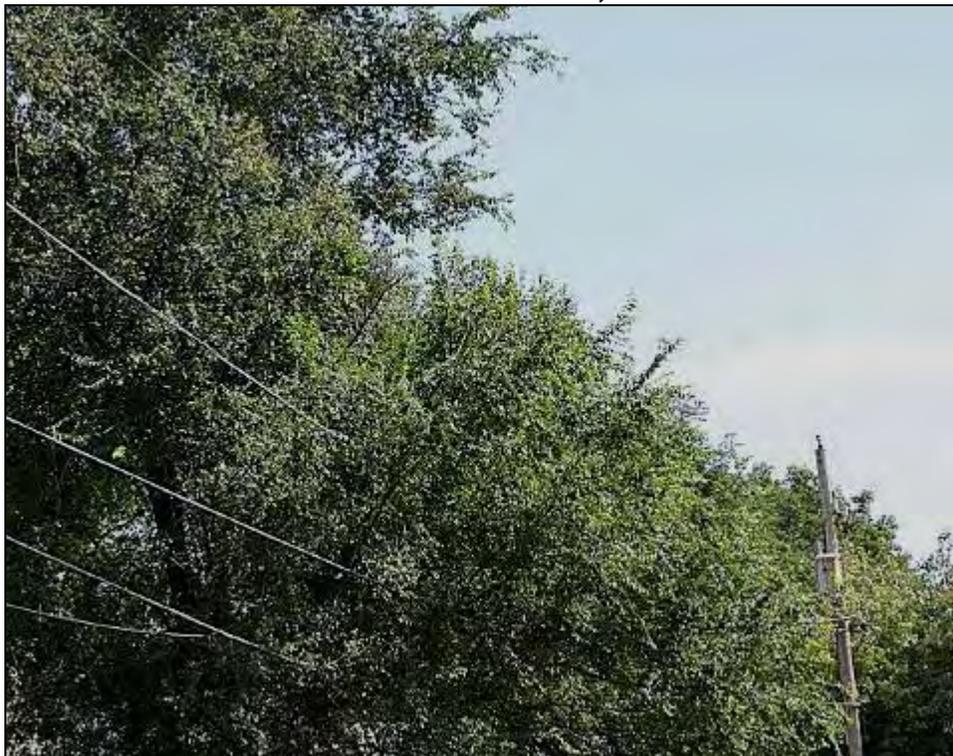
Figure 20 (Photo 06-CIL1221)
**Elm tree into primary,
Cass St. east of Monson St., East Peoria**

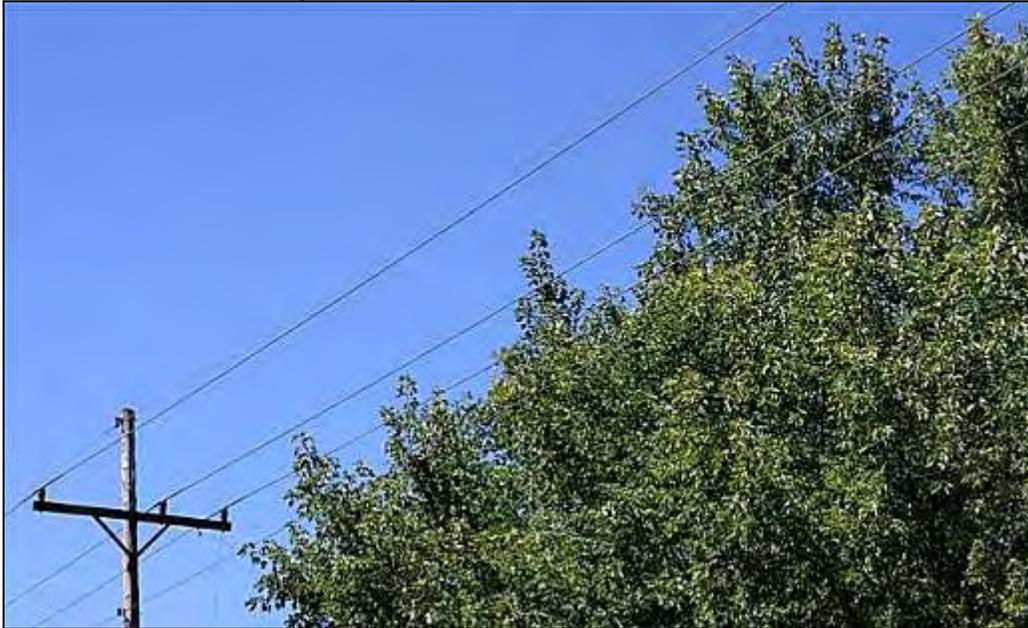
**Soft maple tree into 12 kV primary, with burning,
Meadow Ave. (Rt. 150) west of Gardener Ave., East Peoria**

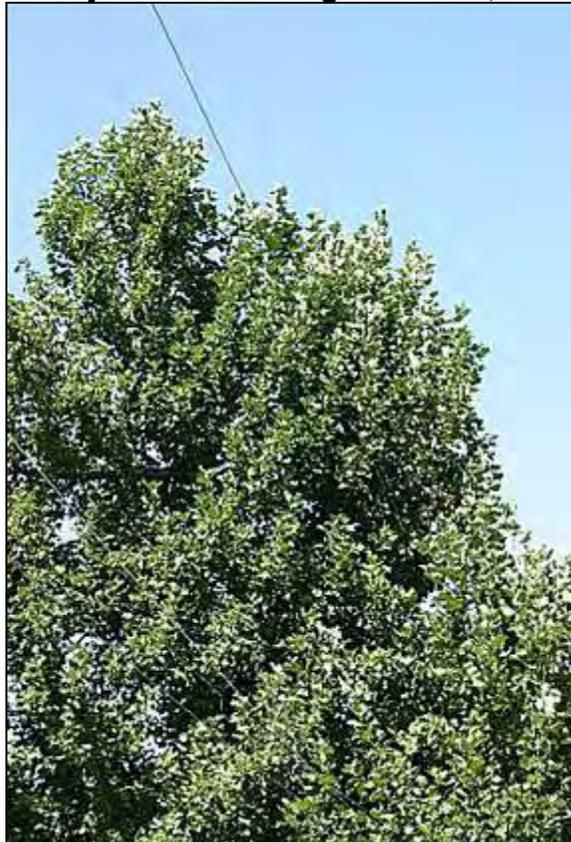
Figure 22 (Photo 06-CIL1230)

**Single-phase primary through a tulip tree,
Mt. Aire Dr. just south of Highview Rd., East Peoria**

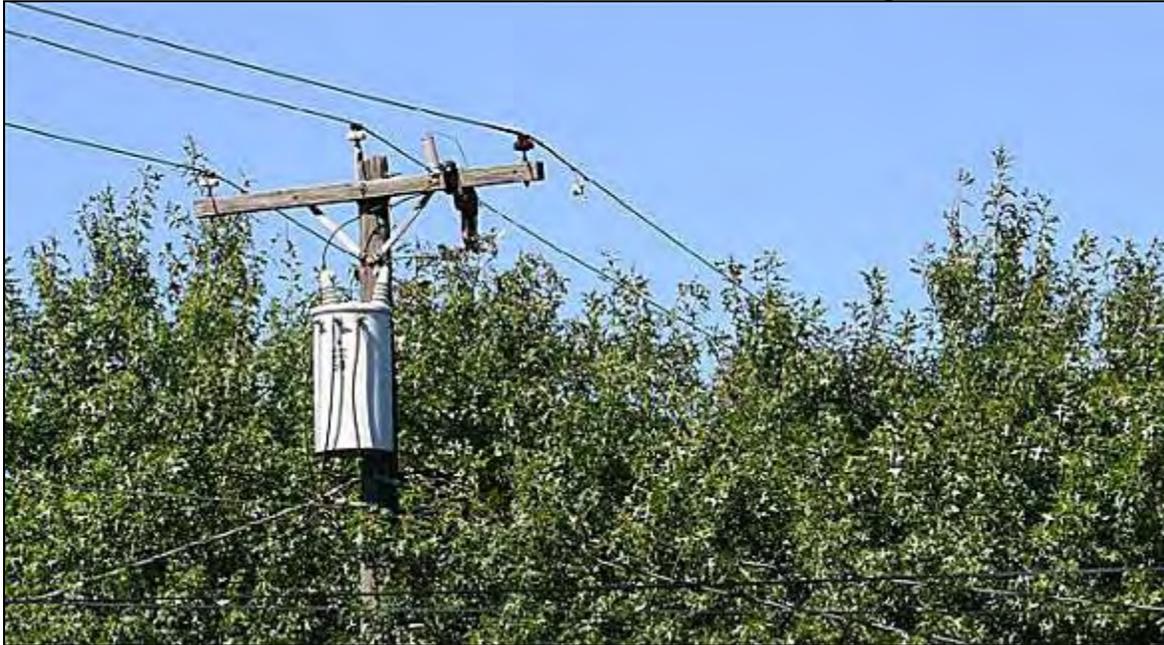
AmerenCILCO 2006 Tree Trimming Exhibit "A"
Figure 23 (Photo 06-CIL1233)
Oak tree into 3-phase primary,
Hillcrest Dr. north of Kern Rd., Washington
