Illinois Commerce Commission  
Assessment of AmerenCIPS'  
Reliability Report and Reliability Performance  
for Calendar Year 2005

Pursuant to 83 Illinois Administrative Code 411.140

**December 18, 2006**

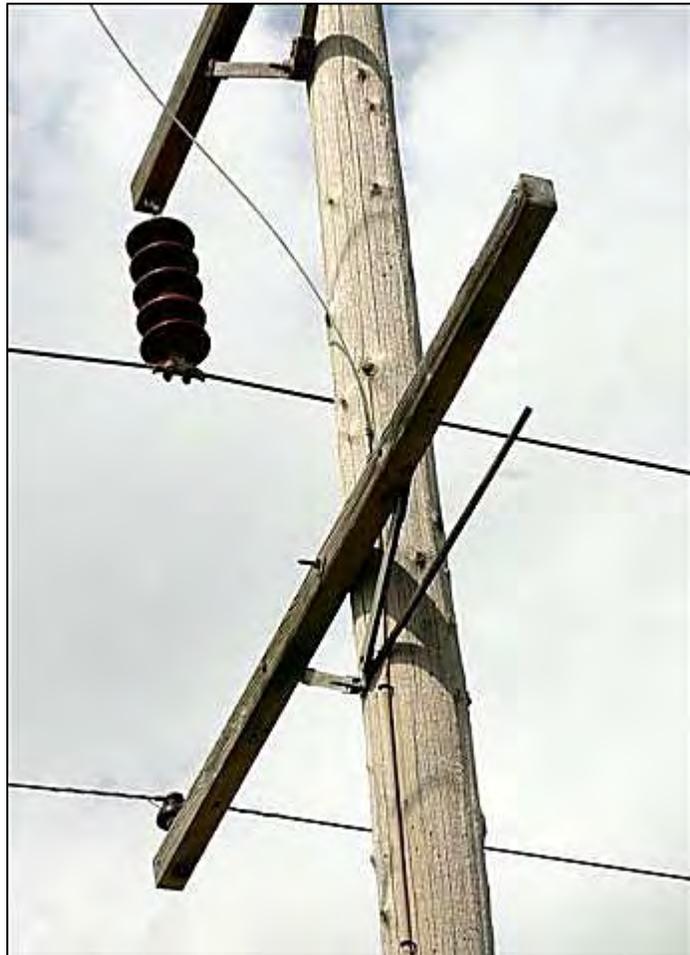
**Figure 2 (Photo 06-CIP842)**  
**Split wood crossarm brace,**  
**Circuit T11508, on SR 37 north of**  
**Cypress**

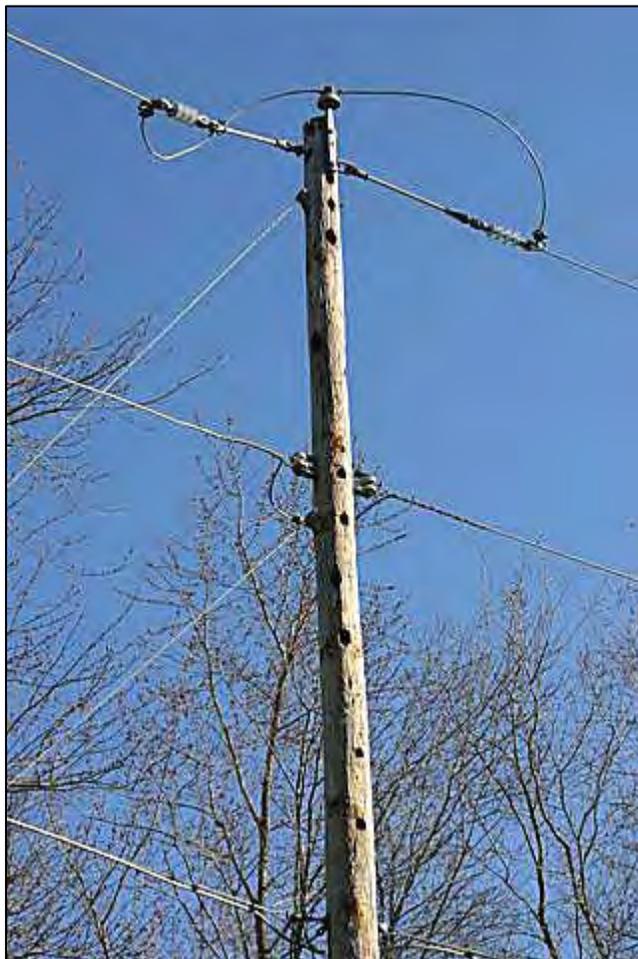
**Figure 3 (Photo 06-CIP843)**  
**15(+) woodpecker holes in pole,**  
**Circuit Z57516, Enterprise Ave., Iuka**

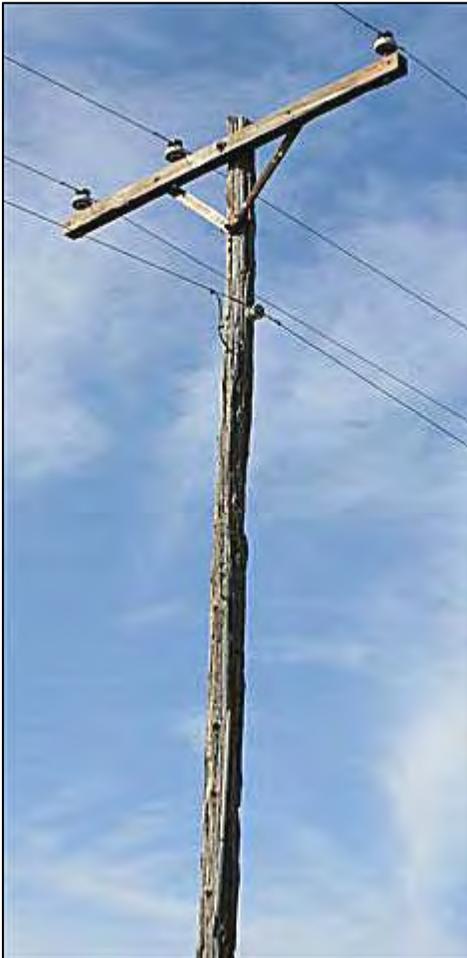
**Figure 4 (Photo 06-CIP846)**  
Badly shell rotted pole,  
Circuit V83505, Alsey-Glasgow Rd.

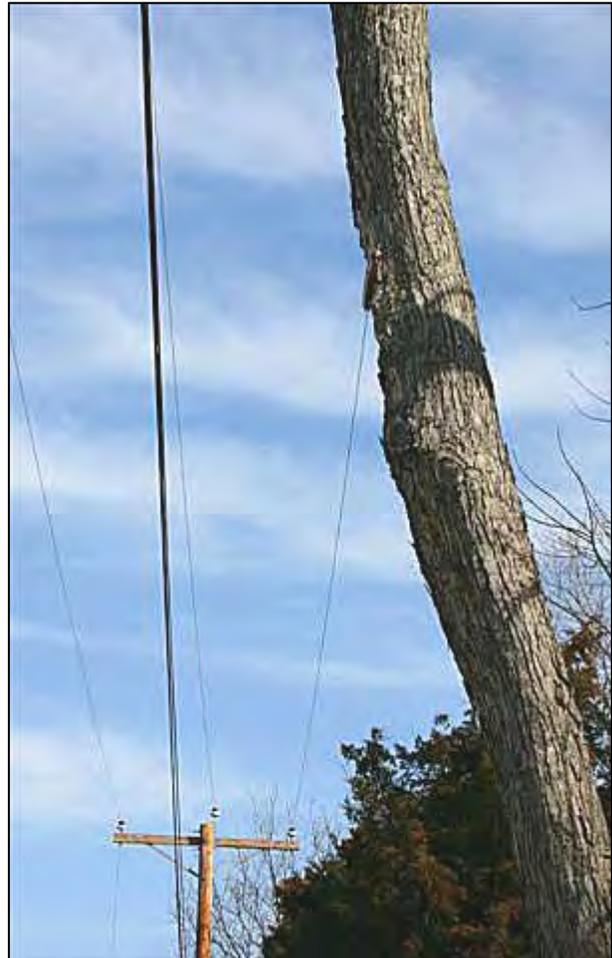
**Figure 5 (Photo 06-CIP848)**  
7.2 kV primary rubbing against tree,  
Circuit V83505, Jackson St., Glasgow

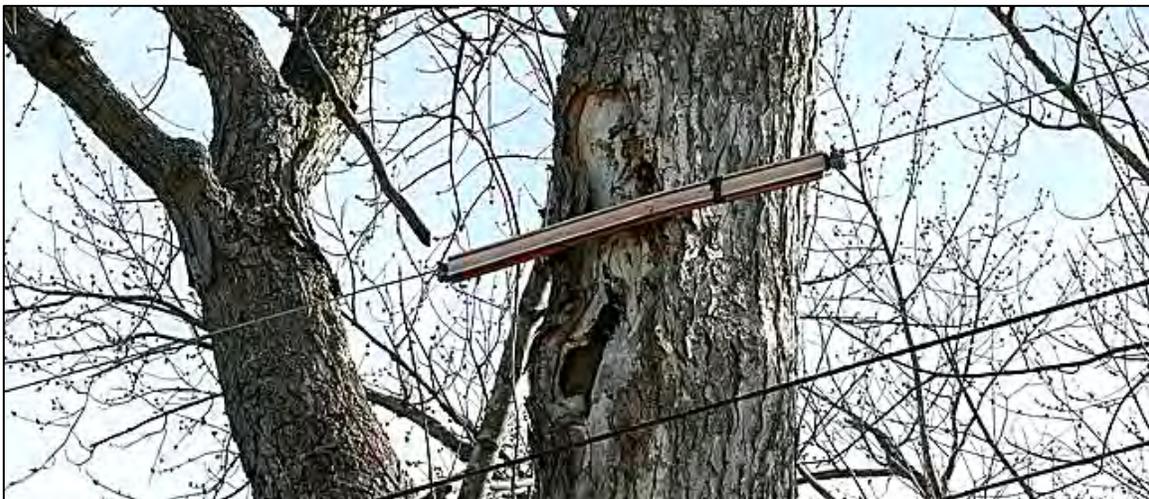
**Figure 6 (Photo 06-CIP849)**  
7.2 kV primary rubbing against tree,  
Circuit V83505, Jackson St., Glasgow (same location as Figure 5)

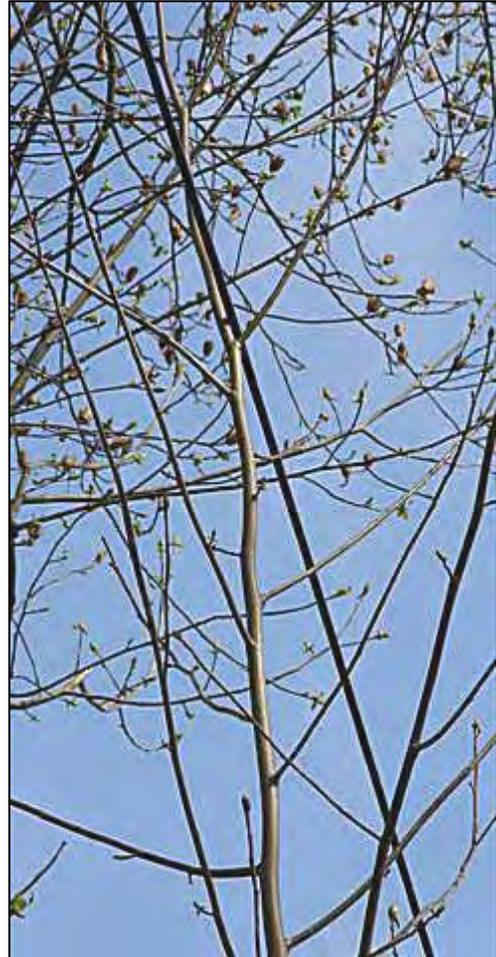
**Figure 7 (Photo 06-CIP894)**  
Tree into primary,  
Circuit 340-001, Forest Dr., Alton

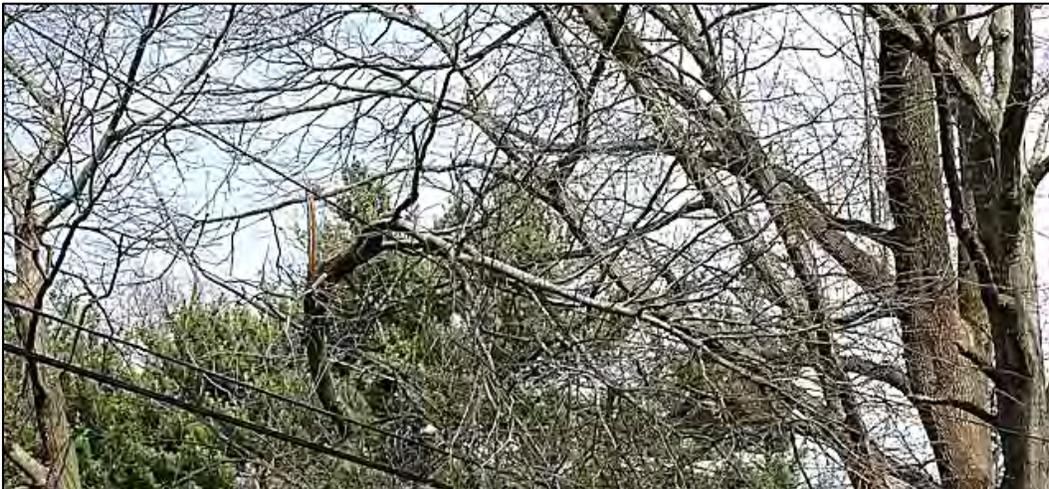
**Figure 8 (Photo 06-CIP892)**  
Large broken limb on primary,  
Circuit 340-001, Forest Dr., Alton

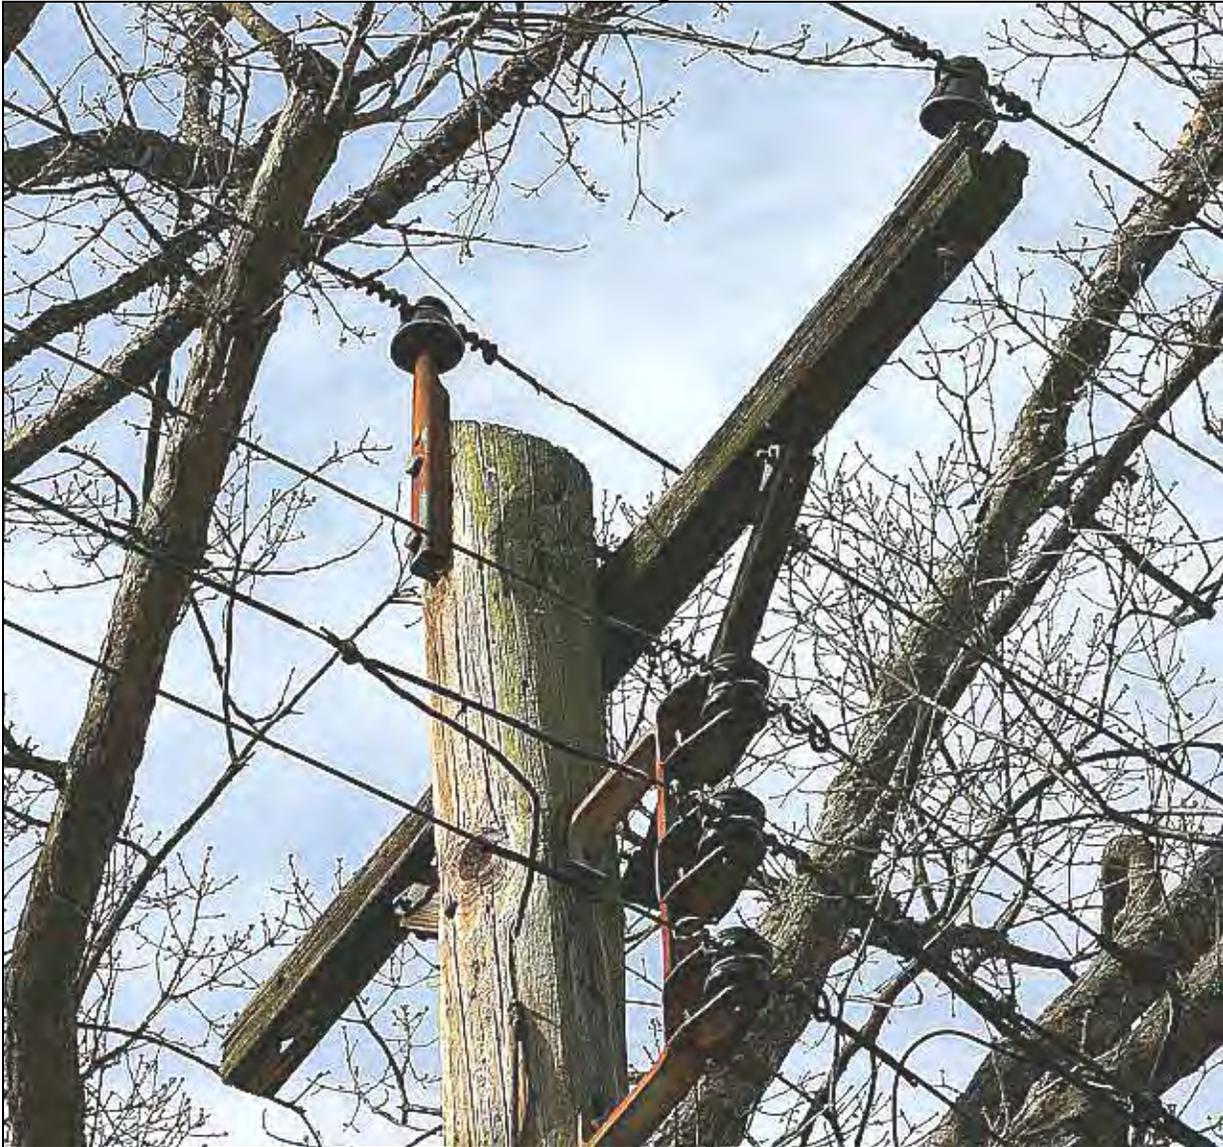
**Figure 9 (Photo 06-CIP888)**  
**Badly split & deteriorated crossarm,**  
**Circuit 340-001, Douglas St., Alton**

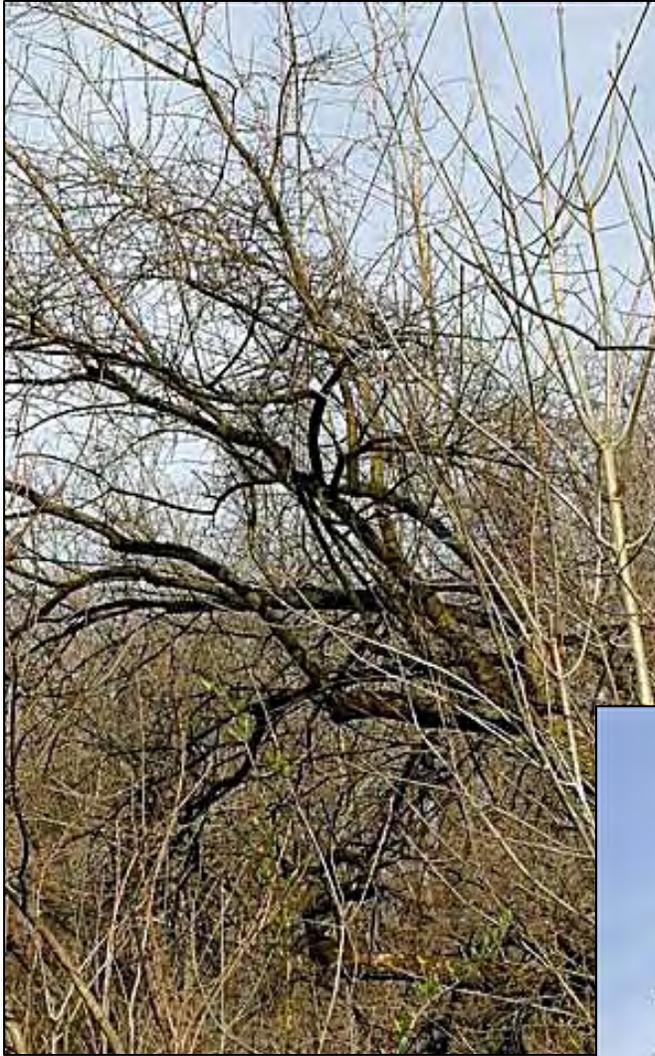
**Figure 10 (Photo 06-CIP882)**  
Primary through trees,  
Circuit 340-001, Shaw Ave., Alton

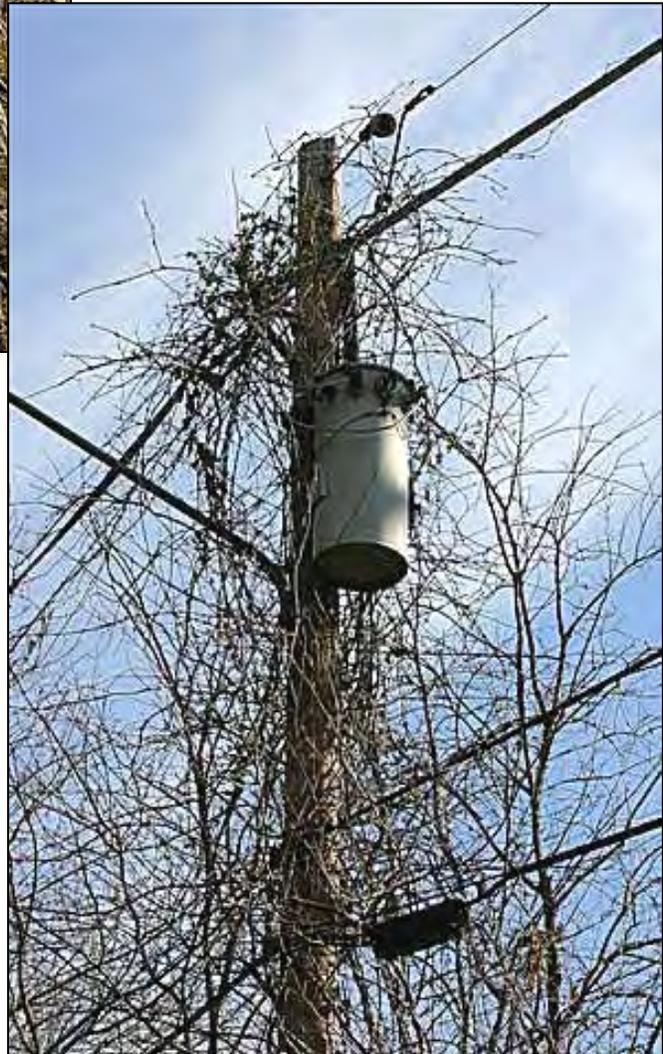
**Figure 11 (Photo 06-CIP881)**  
Trees into primary & vines up transformer  
pole,  
Circuit 340-001, Gesche St., Alton

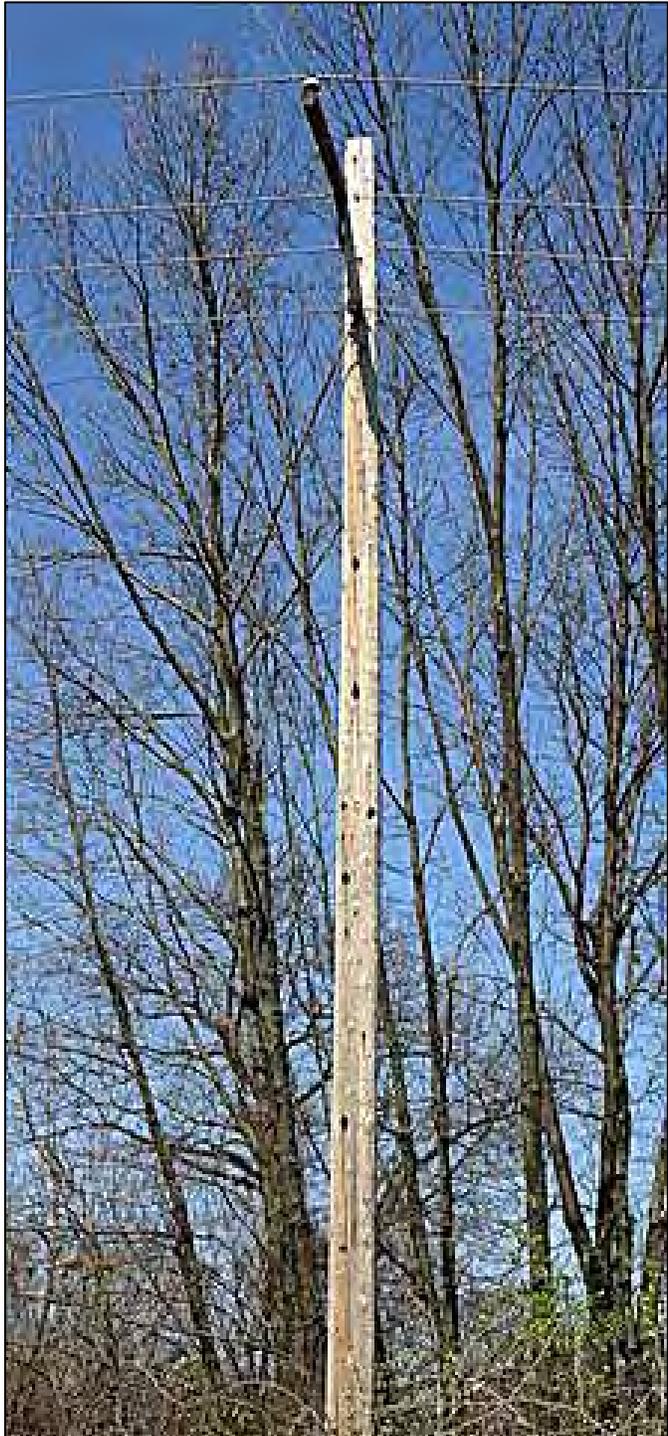
**Figure 12 (Photo 06-CIP897)**  
**10(+) woodpecker holes in pole,**  
**Circuit V25504, Elsay Hills Rd., west of**  
**Mill Creek**

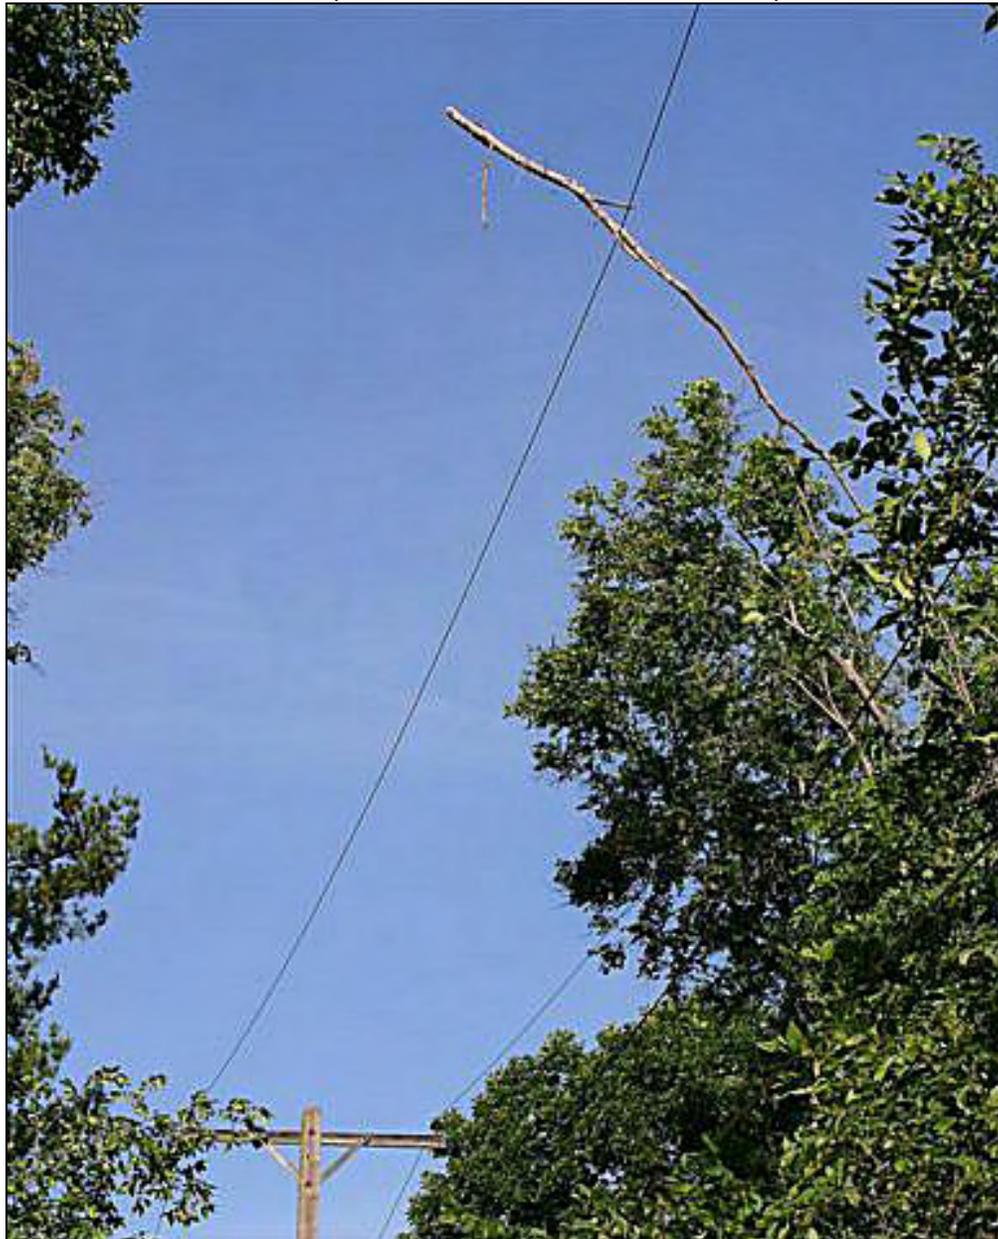
**Figure 13 (Photo 06-CIP1051)**  
**Broken tree limb on primary,**  
**Circuit X68506, in easement north of US Rt. 136, Fisher**

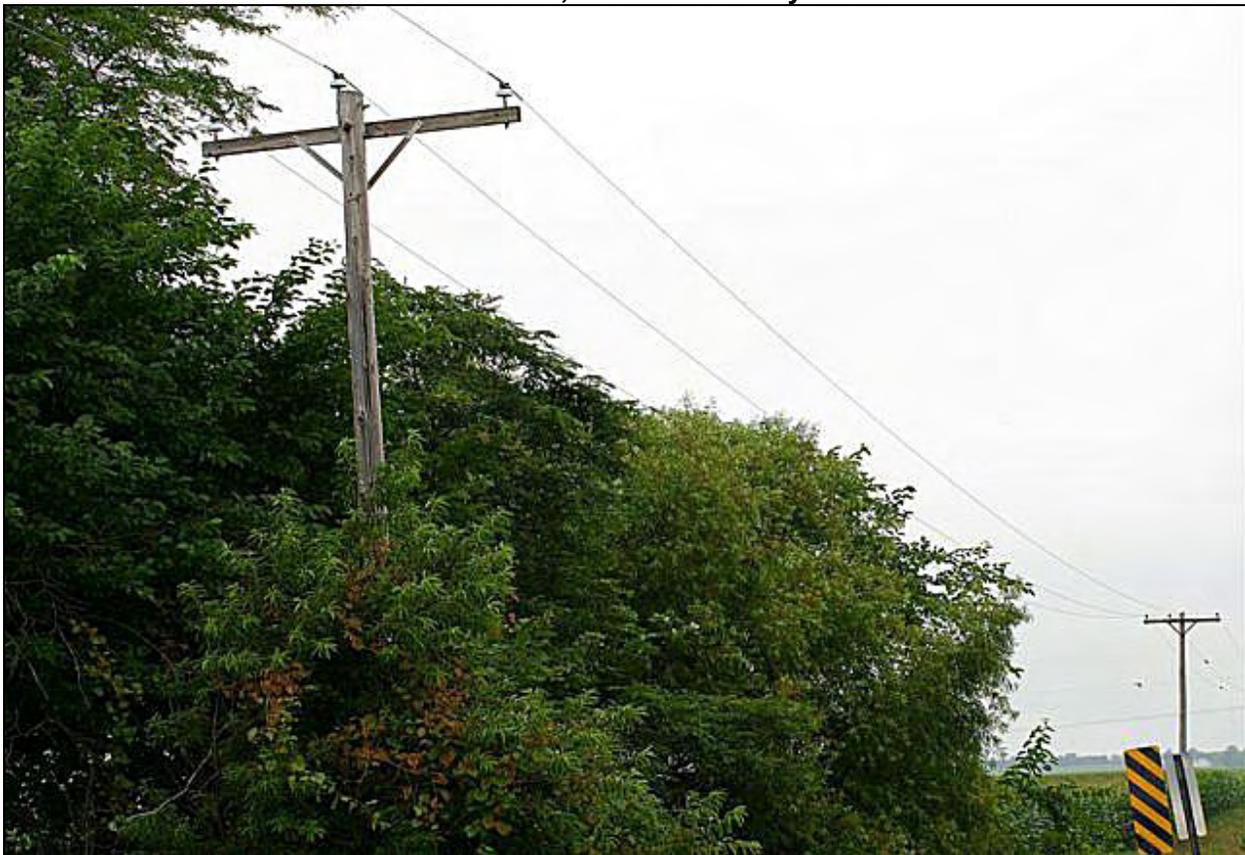
**Figure 14 (Photo 06-CIP1080)**  
**Trees growing into primary,**  
**Circuit X75571, northwest of Saybrook**

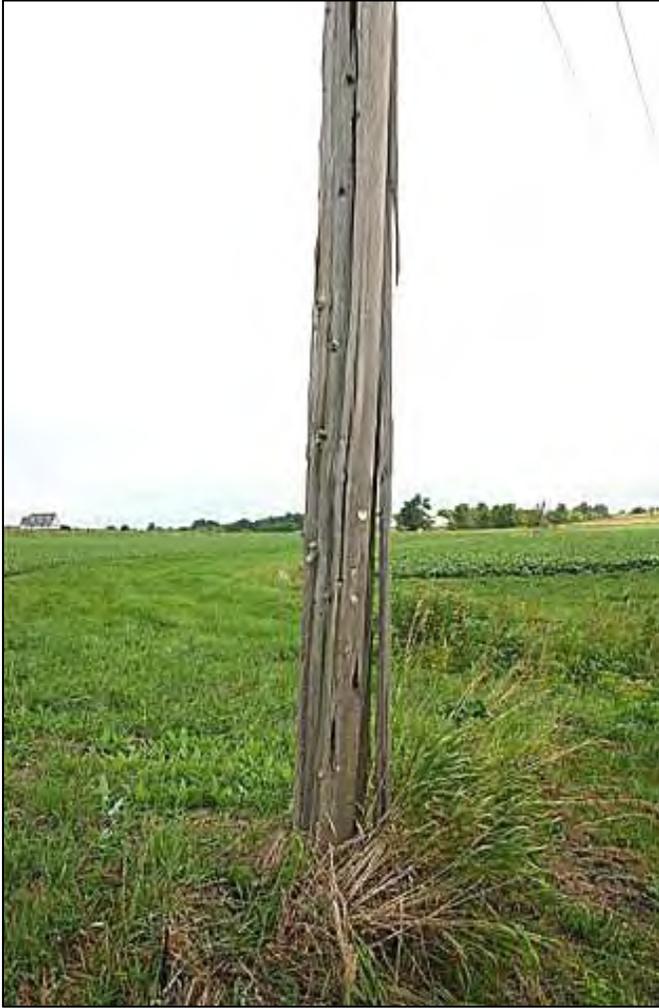
**Figure 15 (Photo 06-CIP1082)**  
Lightning damaged pole,  
Circuit X75571, northwest of Saybrook

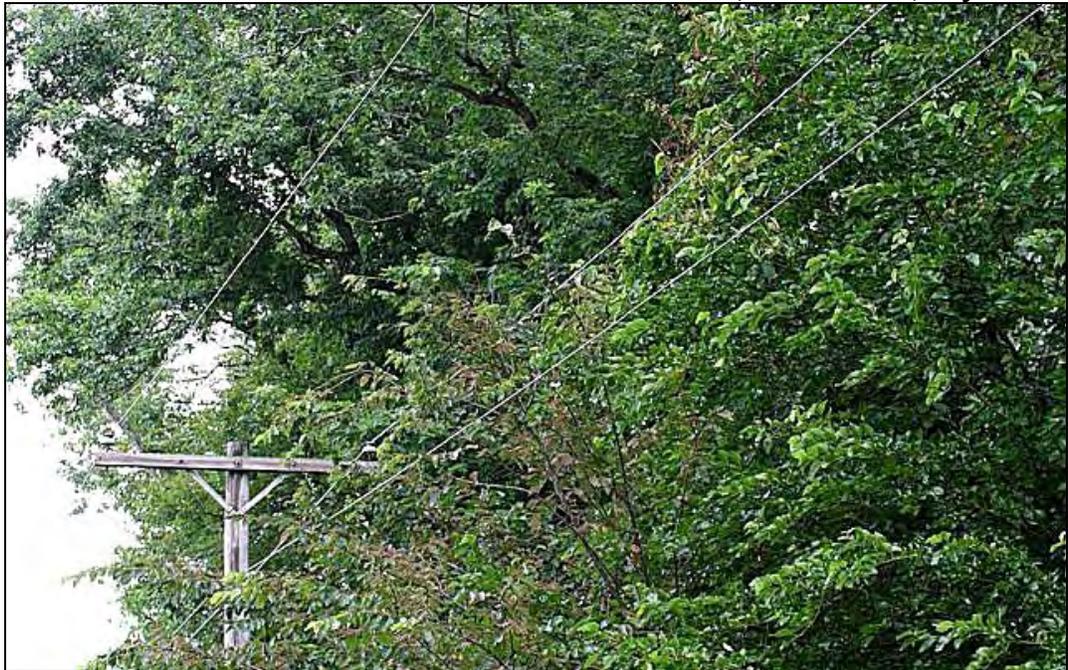
**Figure 16 (Photo 06-CIP1085)**  
Trees into primary, with burning,  
Circuit X75571, Harrison St., Saybrook

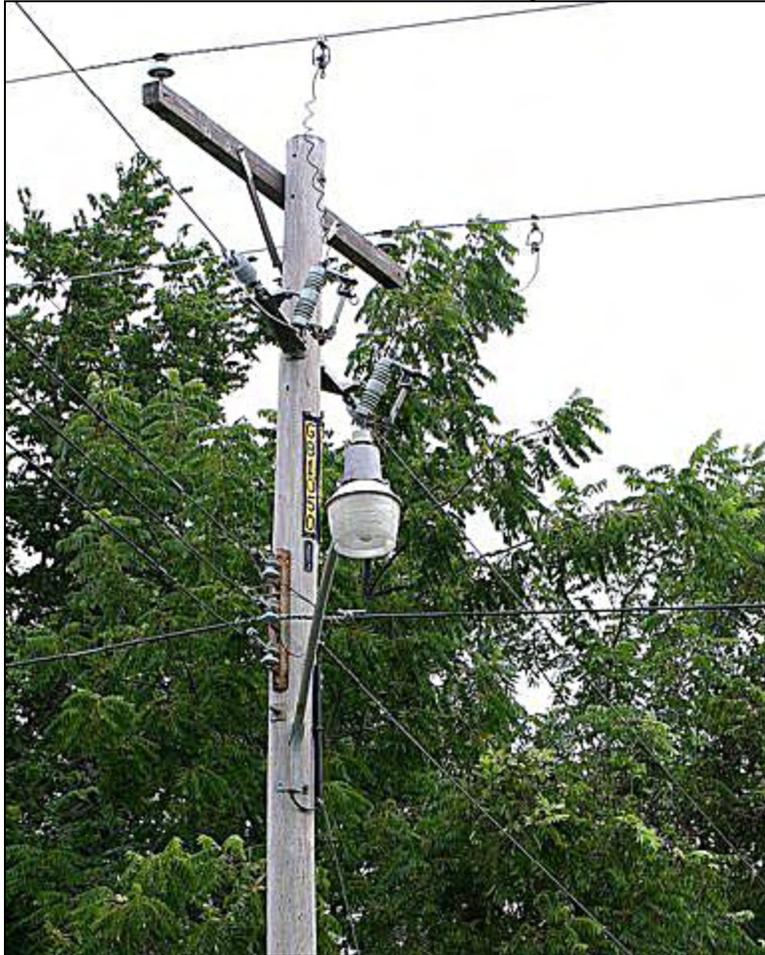
**Figure 17 (Photo 06-CIP1084)**  
**Walnut trees into primary,**  
**Circuit X75571, State St., Saybrook**

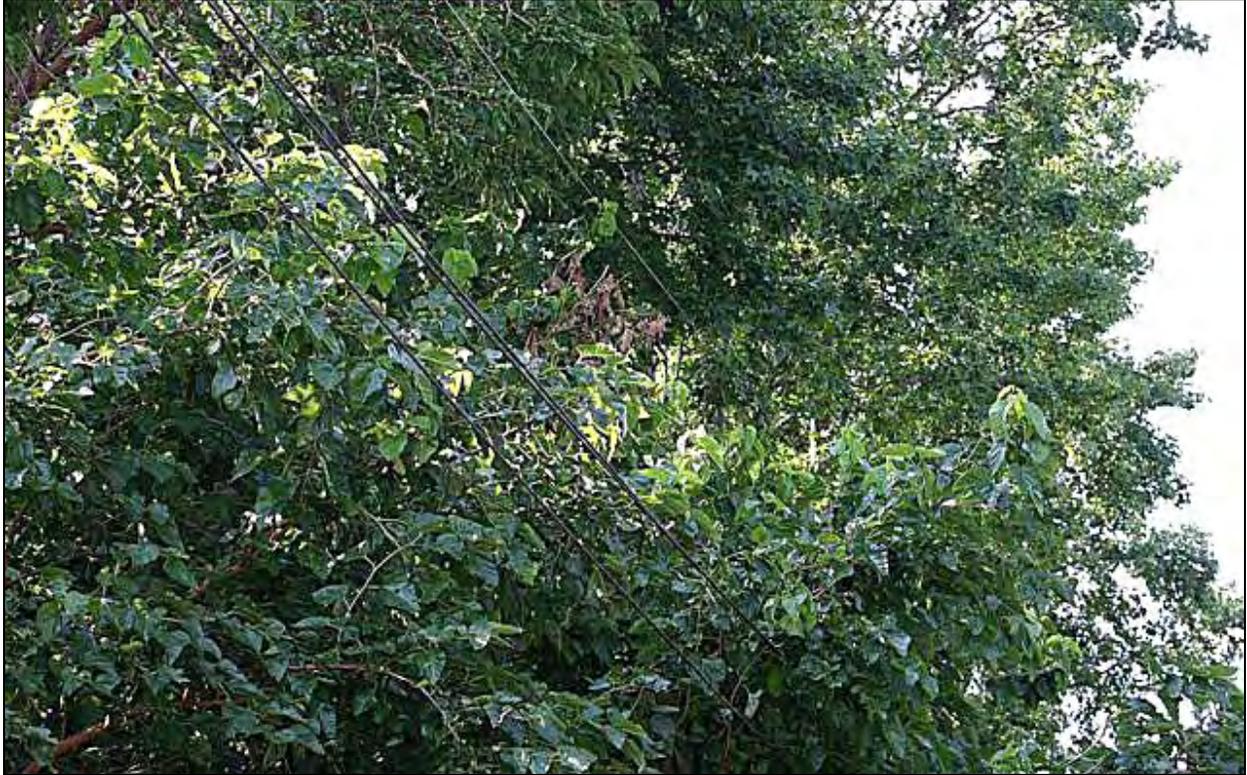
**Figure 18 (Photo 06-CIP1123)**  
Tree into primary, with burning,  
Circuit V18553, Main St., Glenarm

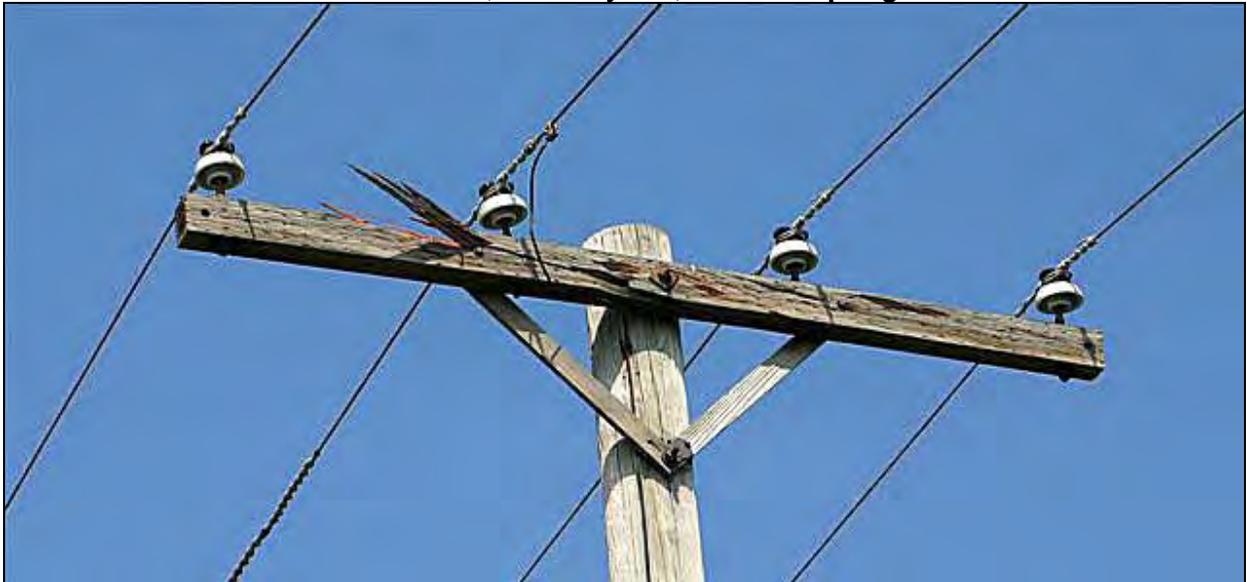
**Figure 19 (Photo 06-CIP1126)**  
Lightning damaged crossarm,  
Circuit V18553, New City Rd., south of Springfield

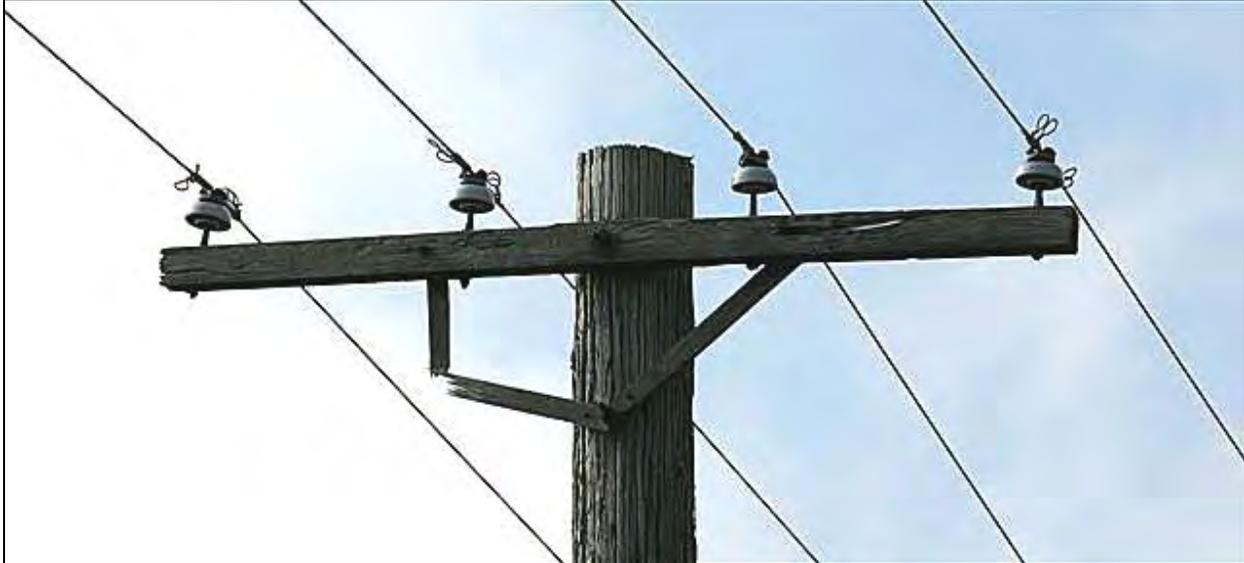
**Figure 20 (Photo 06-CIP1115)**  
**Broken wood brace & badly deteriorated crossarm,**  
**Circuit V18553, Jolene Rd., east of Glenarm**

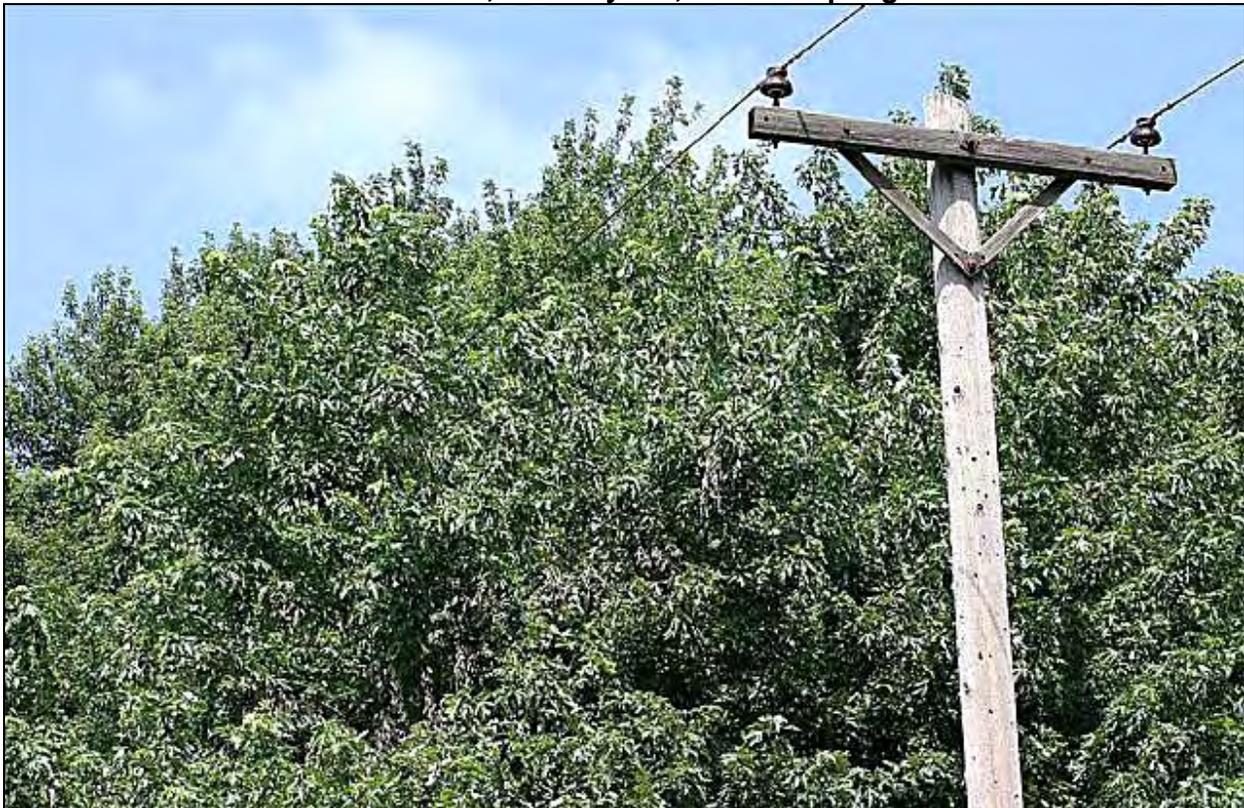
**Figure 21 (Photo 06-CIP1131)**  
**Silver maple tree into primary, with burning,**  
**Circuit V18553, New City Rd., south of Springfield**

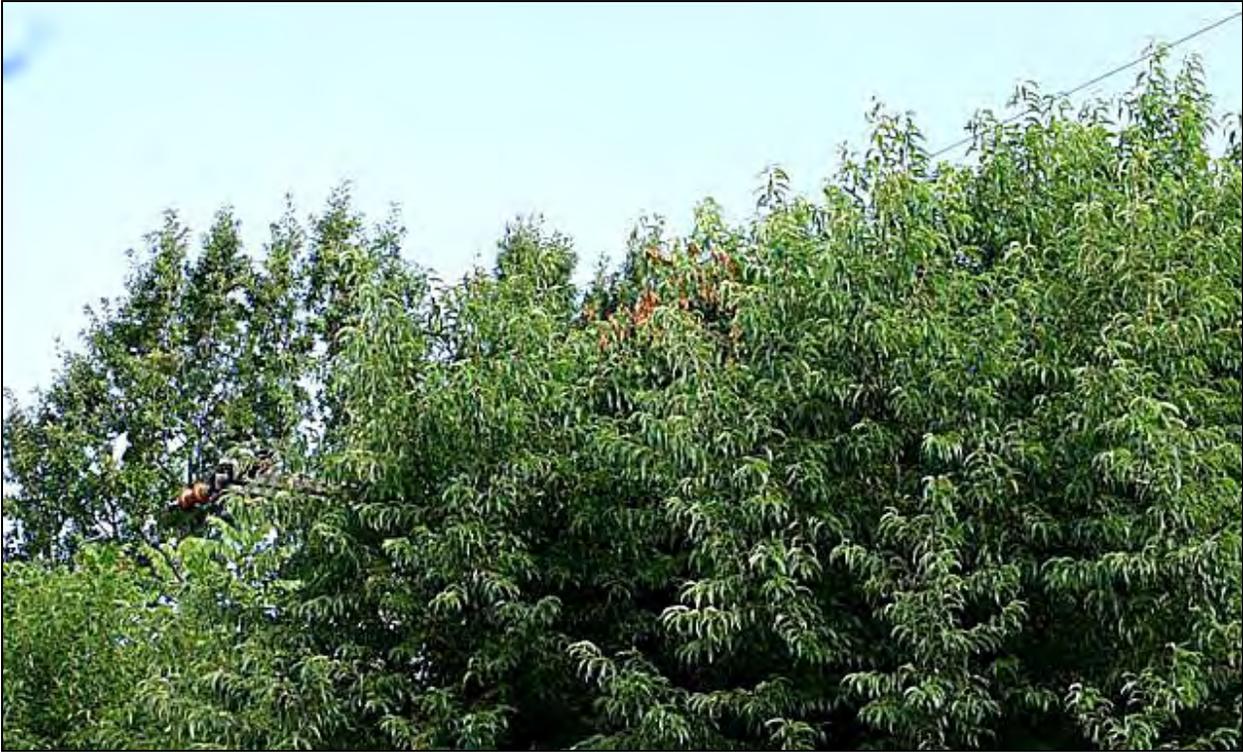
**Figure 22 (Photo 06-CIP1116)**  
2 trees into primary, with burning,  
Circuit V18553, E. Glenarm Rd., east of Glenarm

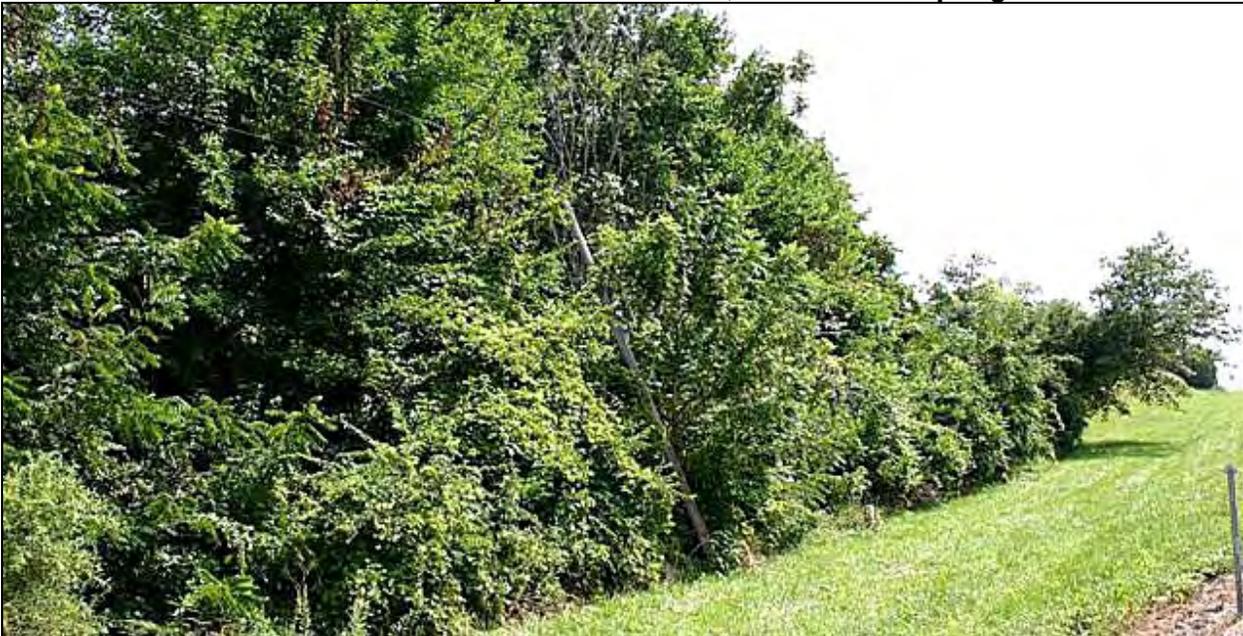
**Figure 23 (Photo 06-CIP1134)**  
Pole broken at groundline & leaning into trees,  
Circuit V18553, New City Rd. at Pond Rd., southeast of Springfield

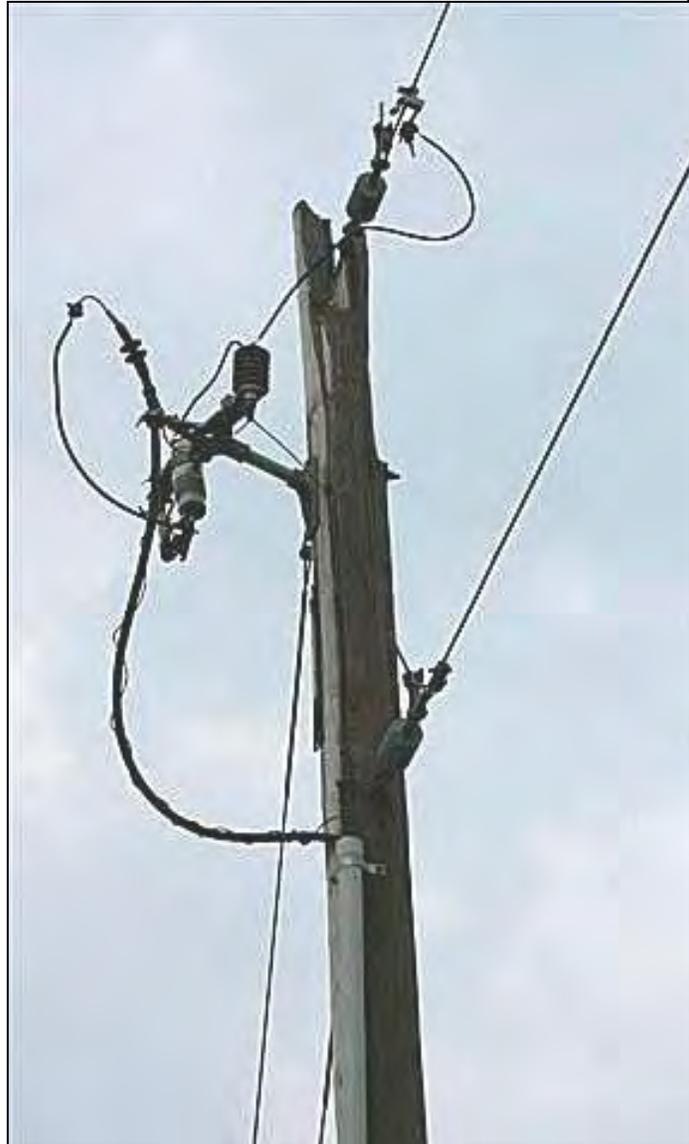
**Figure 24 (Photo 06-CIP1149)**  
**Single-phase deadend pole with badly split top,**  
**Circuit Y97514, CH 18 west of Rt. 45, south of Savoy**

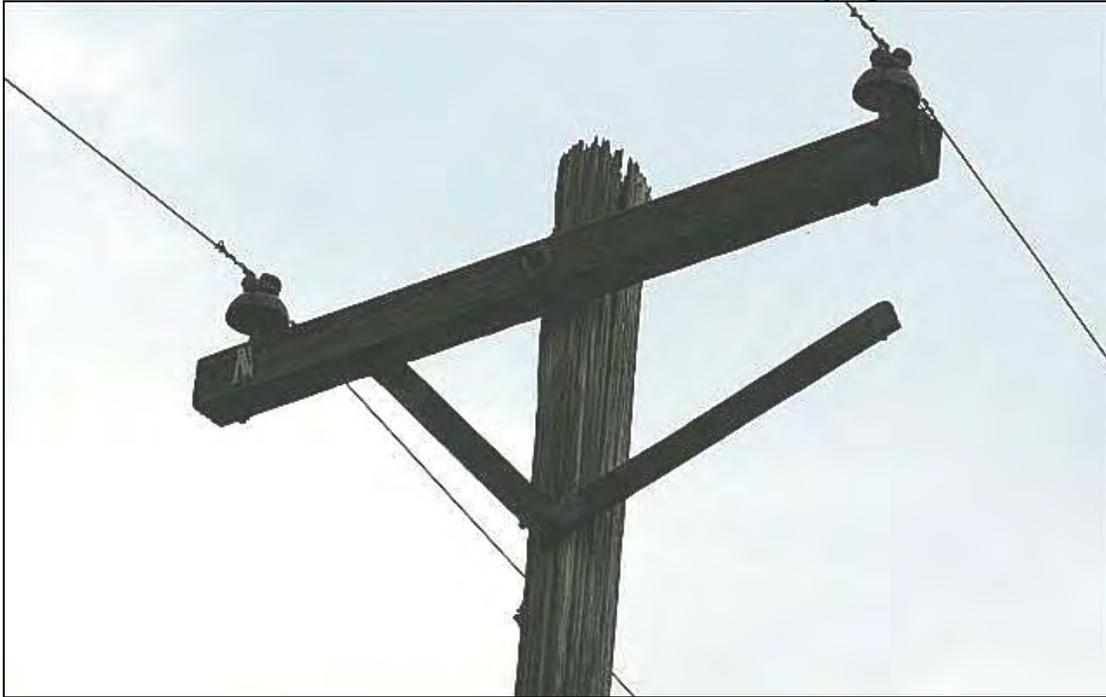
**Figure 25 (Photo 06-CIP1151)**  
**Disconnected wood crossarm brace & deteriorated pole top,**  
**Circuit Y97514, Rd. 700E, southwest of Champaign**

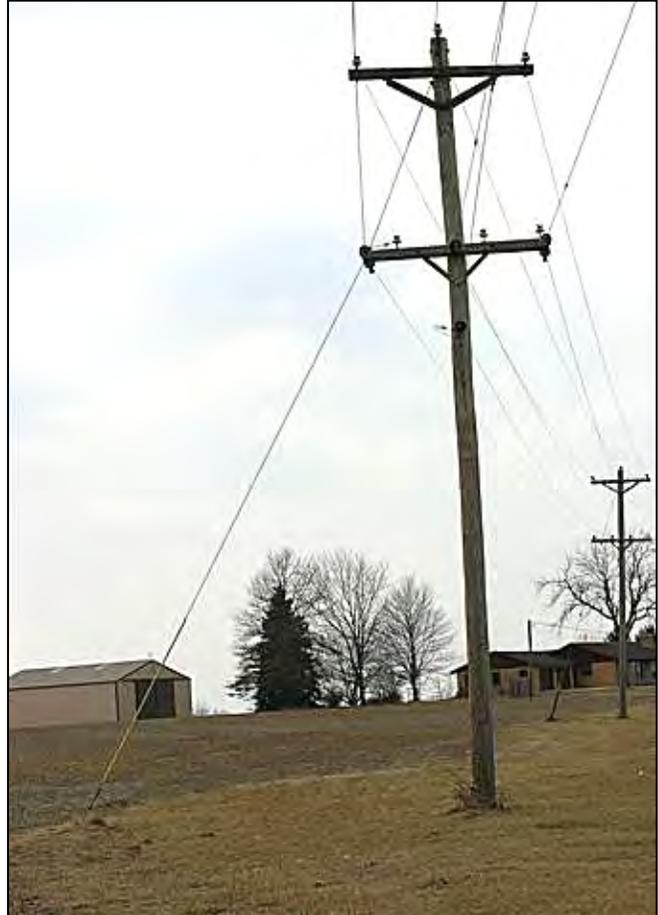
**Figure 26 (Photo 06-CIP791A)**  
**No strain insulator in ungrounded**  
**downguy (NESC violation),**  
**Circuit U05595, US Hwy. 24 east of Astoria**

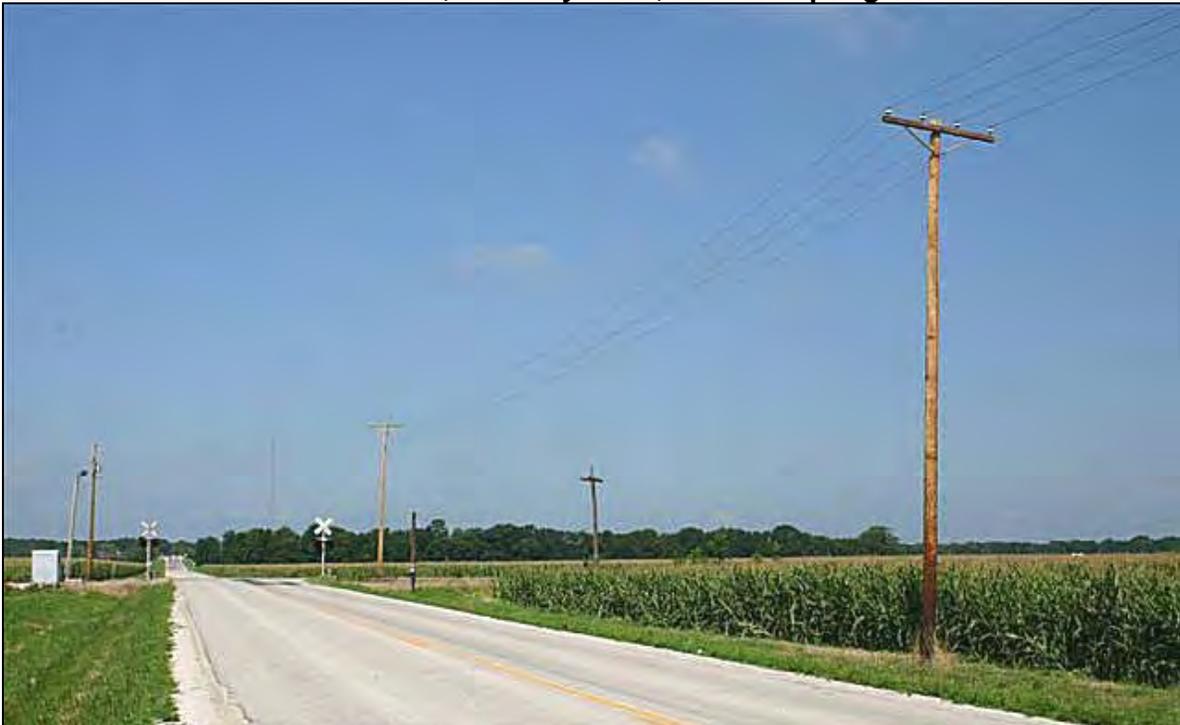
**Figure 28 (Photo 06-CIP1128)**  
Single wood crossarm supporting 3-phase crossing of a railroad (NESC violation),  
Circuit V18553, New City Road, south of Springfield

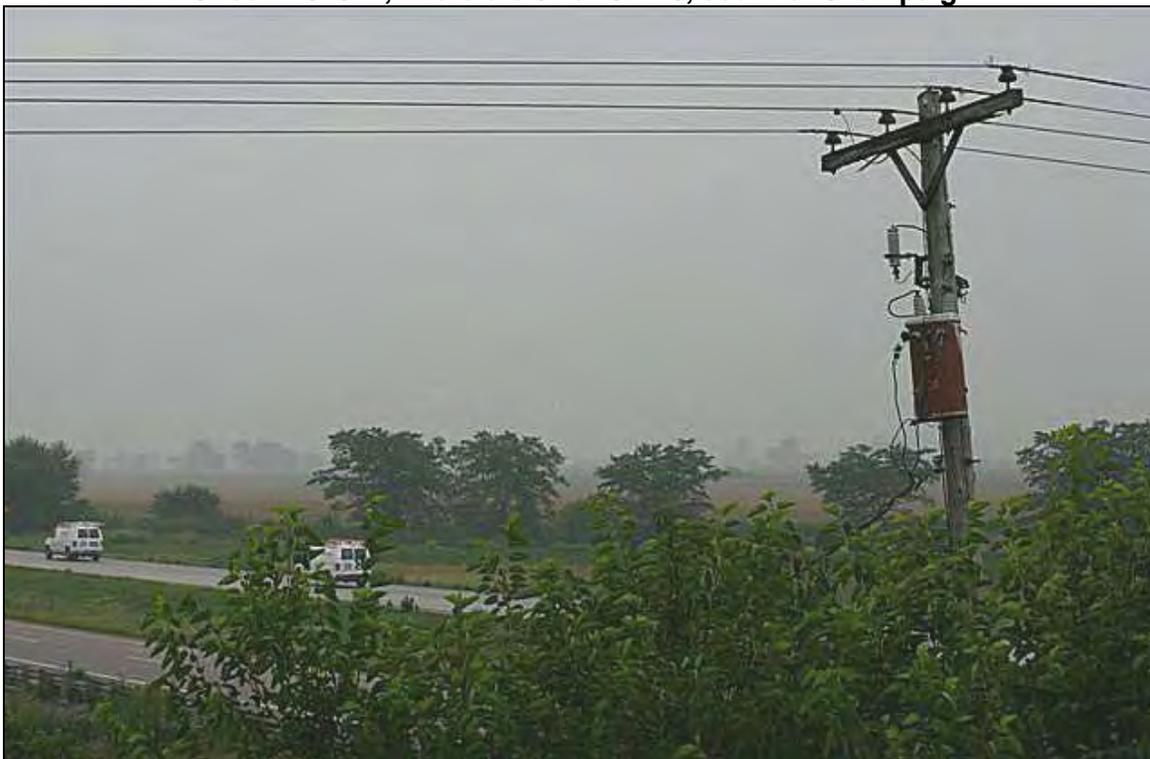
**Figure 29 (Photo 06-CIP1152)**

**Single wood crossarm supporting a crossing of a limited access highway (NESC violation),  
Circuit Y97514, Interstate 57 at CH 18, south of Champaign**
