Illinois Commerce Commission
Assessment of AmerenIP's
Reliability Report and Reliability Performance
for Calendar Year 2005

Pursuant to 83 Illinois Administrative Code 411.140

December 18, 2006

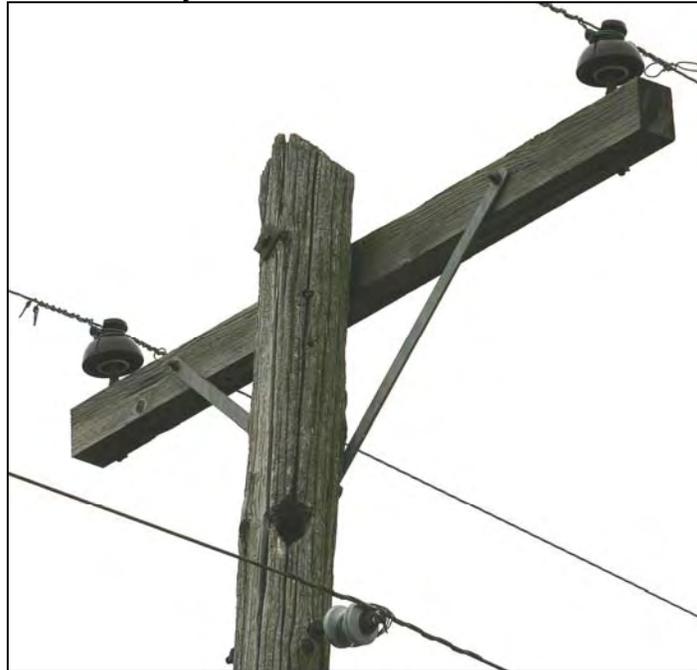
Figure 1 (Photo 06-IP797)
Badly shell rotted pole with large woodpecker hole,
Circuit H10843, McKay Avenue east of Held Road, south of Raymond

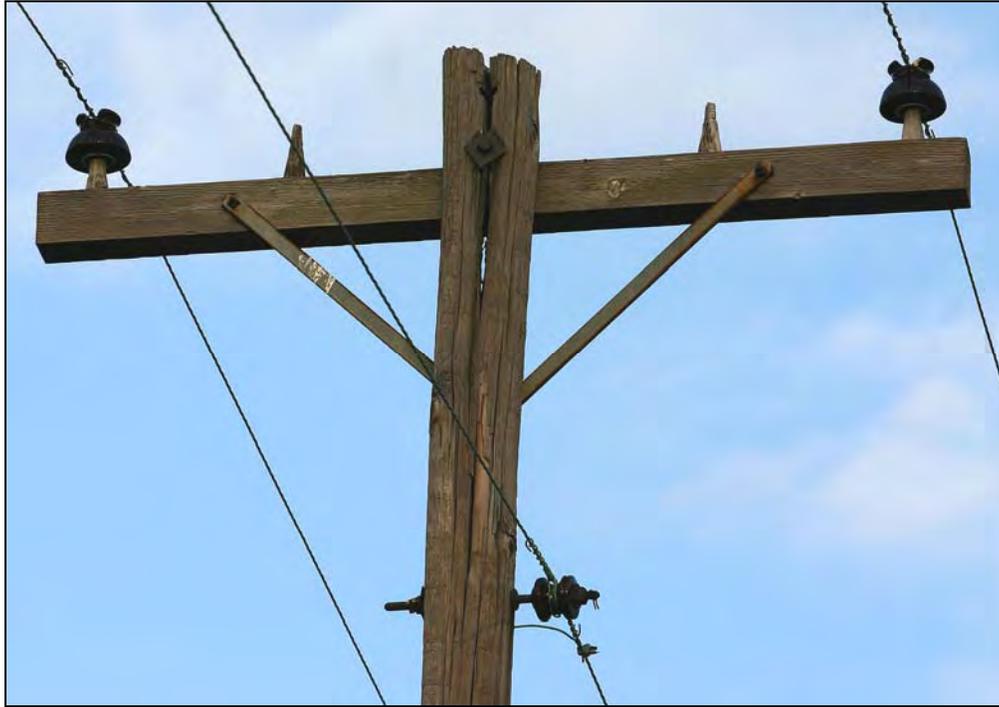
Figure 2 (Photo 06-IP812)
Split pole top,
Circuit H10843, N. 19th Street, southeast of Witt

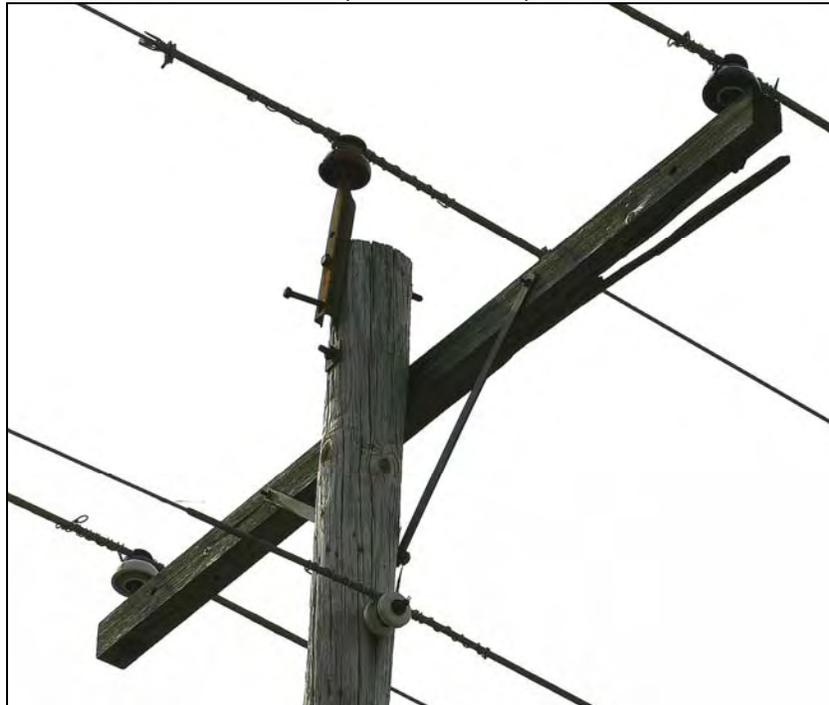
Figure 3 (Photo 06-IP823)
Split (lightning damaged) crossarm & bolt coming out of poletop pin,
Circuit H10843, Witt Avenue, west of Witt

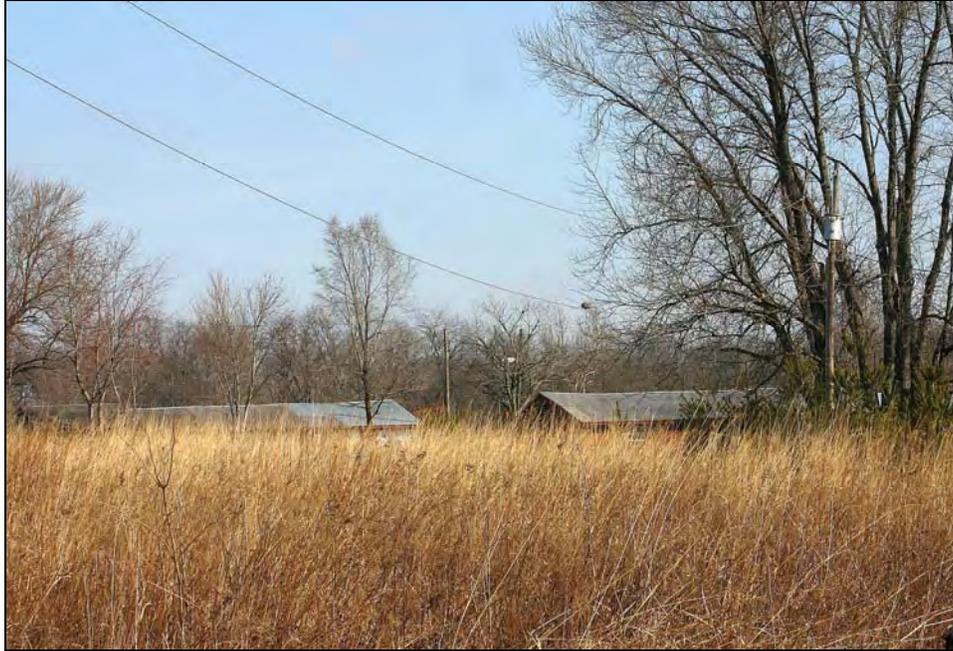
Figure 4 (Photo 06-IP813)
Inadequate neutral clearance above ground,
(NESC Clearance Violation)
Circuit H10843, north of Hillside Avenue, northeast of Witt

Note: AmerenIP reported that it corrected this code violation on 5/19/06.

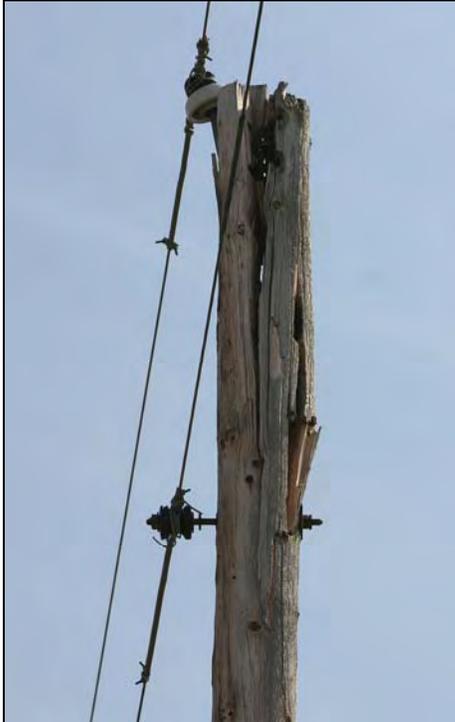
Figure 5 (Photo 06-IP821)
Badly split (lightning damaged) pole top,
Circuit H10843, N. 17th Ave., east of Witt

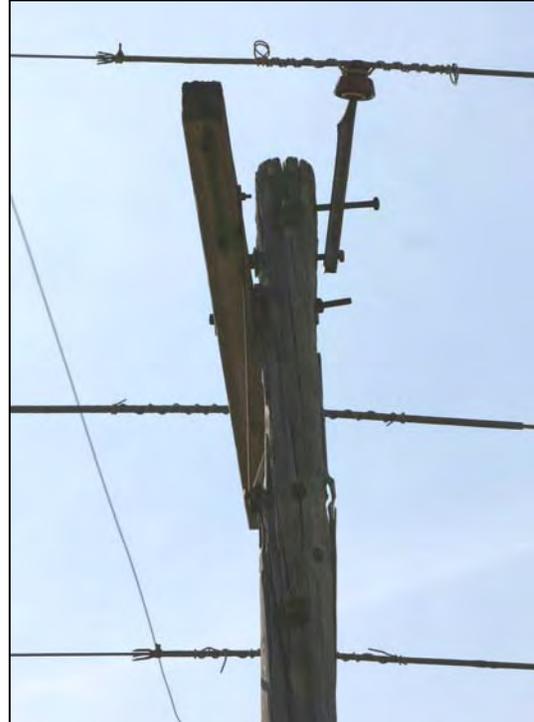
Figure 6 (Photo 06-IP819)
Pole top pin coming off pole & bad top,
Circuit H10843, N. 16th Ave., SE of Witt

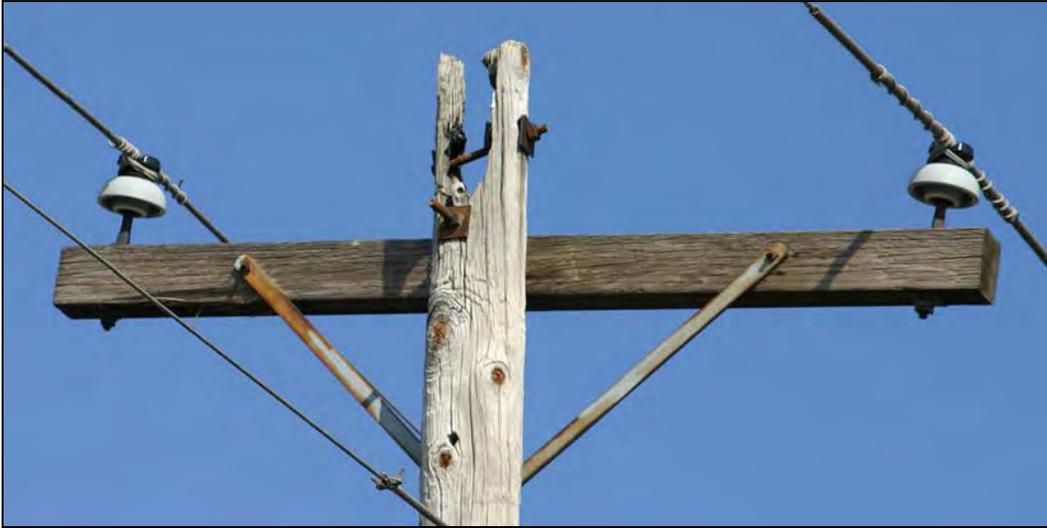
Figure 7 (Photo 06-IP815)
Bad pole top,
Circuit H10843, Witt Tr., southeast of Witt

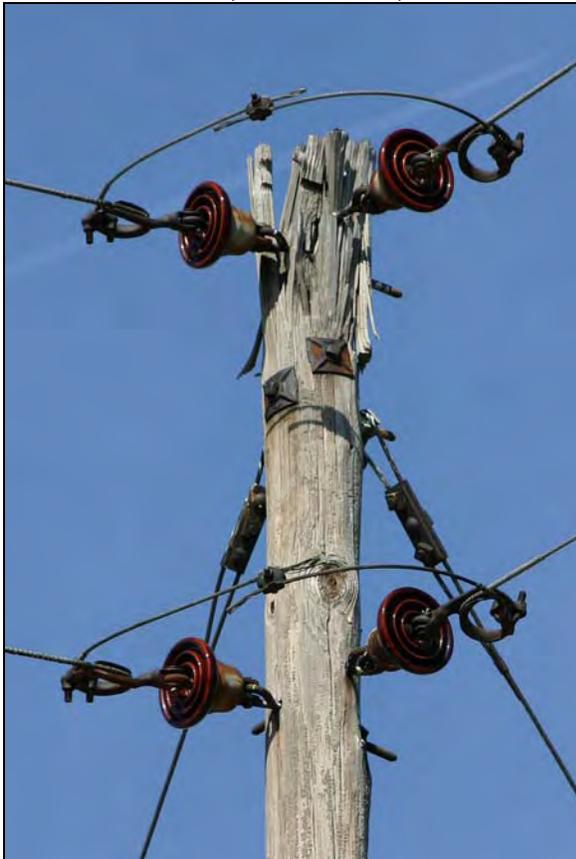
Figure 8 (Photo 06-IP818)
Badly split pole top,
Circuit H10843, Carriker Tr., SE of Witt

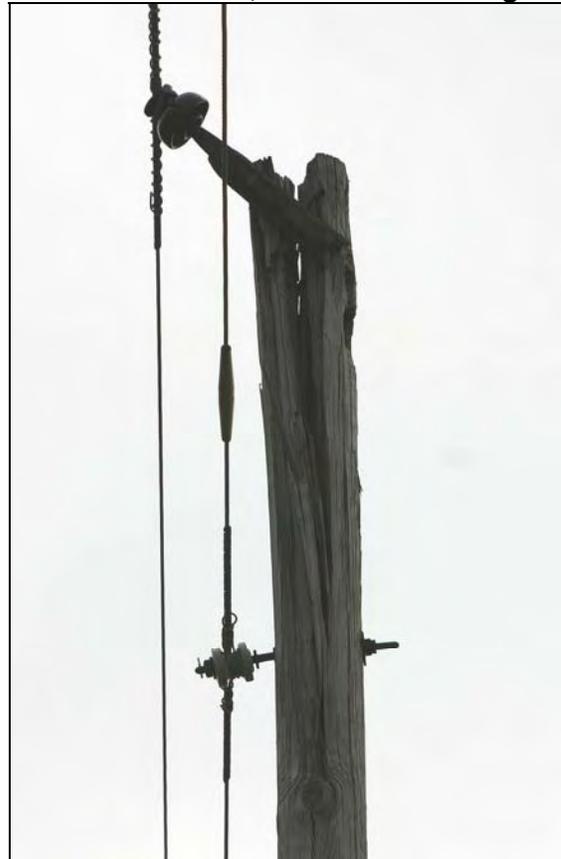
Figure 9 (Photo 06-IP802)
Split pole top,
Circuit H10843, northwest of Irving

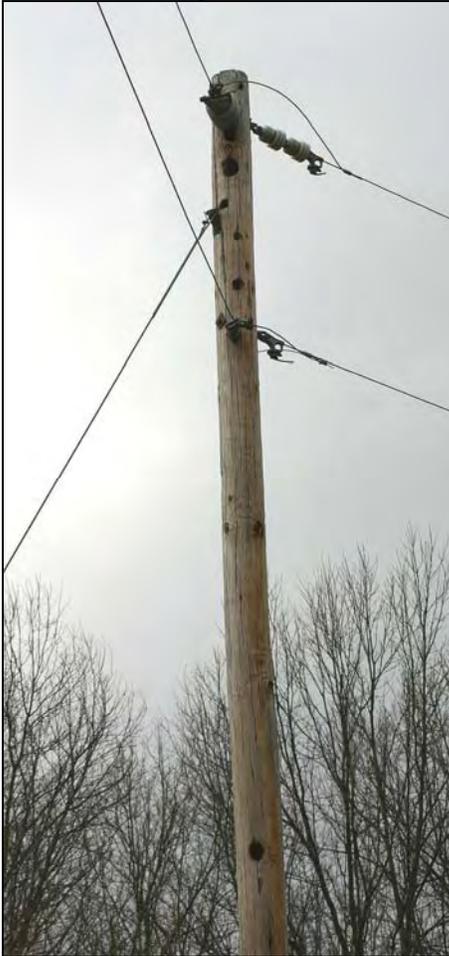
Figure 10 (Photo 06-IP803)
12(+) large woodpecker holes in pole,
Circuit H10843, Spike Rd., NW of Irving

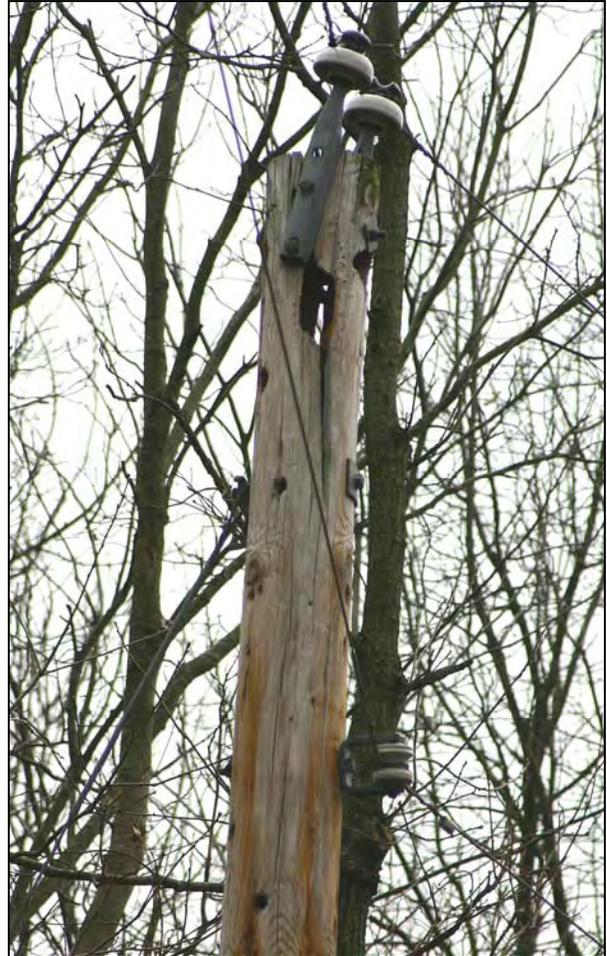
Figure 11 (Photo 06-IP805)
Hollow pole top (woodpecker holes),
Circuit H10843, Doe Run Ct., NW of Irving

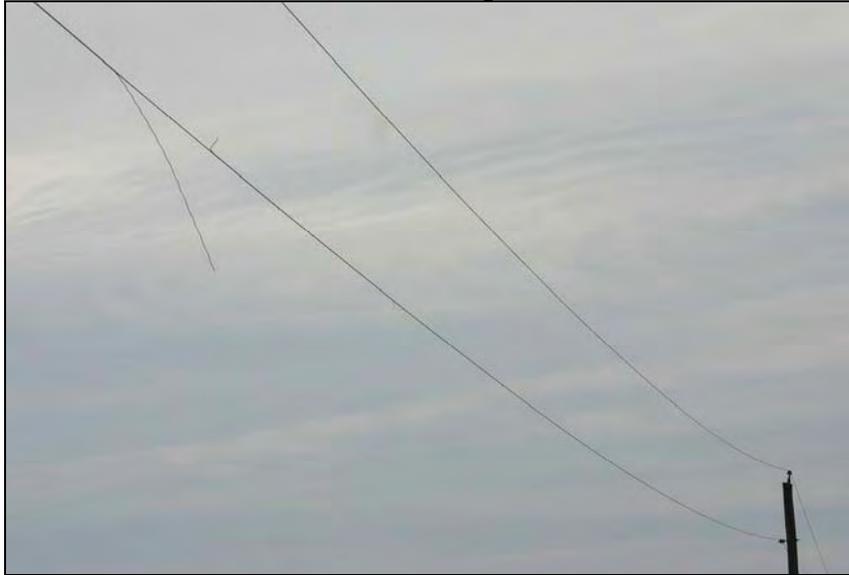
Figure 12 (Photo 06-IP827)
Broken strand in neutral conductor,
Circuit J80806, north of Fahrenkrog Lane, west of Dorchester

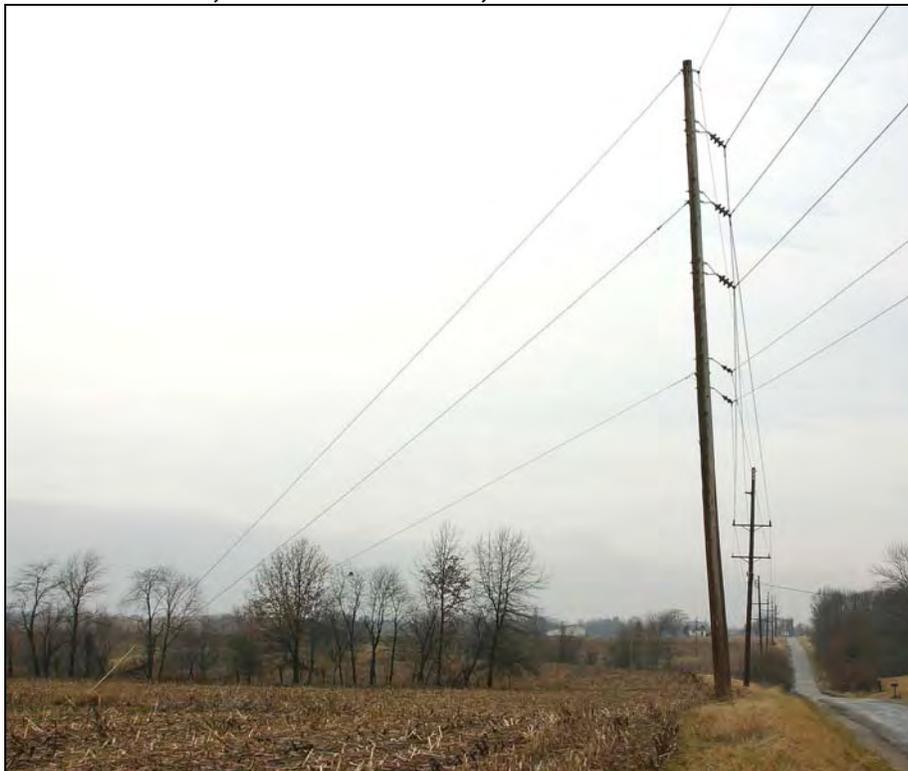
Figure 13 (Photo 06-IP829)
Ungrounded 34 kV & 12 kV downguys without required strain insulators,
(NESC Violation)
Circuit J80806, Miles Station Road, west of Bunker Hill Substation

Code violations (NESC 279.A.2): Ungrounded 34 kV & 12 kV downguys without strain insulators below energized conductors. <i>AmerenIP installed guy strain insulators in the downguys 5/10/06.</i>	829, 830	34 kV Str. 299 (Str. 133 on map) on Miles Station Rd. (1st pole east of Sta. 12755). (Map 6--Wilsonville, Dorchester, & rural).	3/8/06 8/10/06	5/10/06
	Code violations (NESC 279.A.2): Ungrounded 34 kV & 12 kV downguys without strain insulators below energized conductors. <i>AmerenIP installed guy strain insulators in the downguys 5/10/06.</i>	836	34 kV Str. 345 (Str. 179 on map) 1 span west of Schoeneman Rd. on Miles Station Rd. (Map 13--Wilsonville, Dorchester, & rural).	3/8/06 8/10/06	5/10/06
	Code violations (NESC 279.A.2): Ungrounded 34 kV downguys without strain insulators below energized conductors. <i>AmerenIP installed guy strain insulators in the downguys 5/10/06.</i>	835	35 kV Str. 344 (Str. 178 on map) at corner of Schoeneman Rd. & Miles Station Rd. (Map 13--Wilsonville, Dorchester, & rural).	3/8/06 8/10/06	5/10/06

Note: AmerenIP installed guy strain insulators in the downguys on 5/10/06.

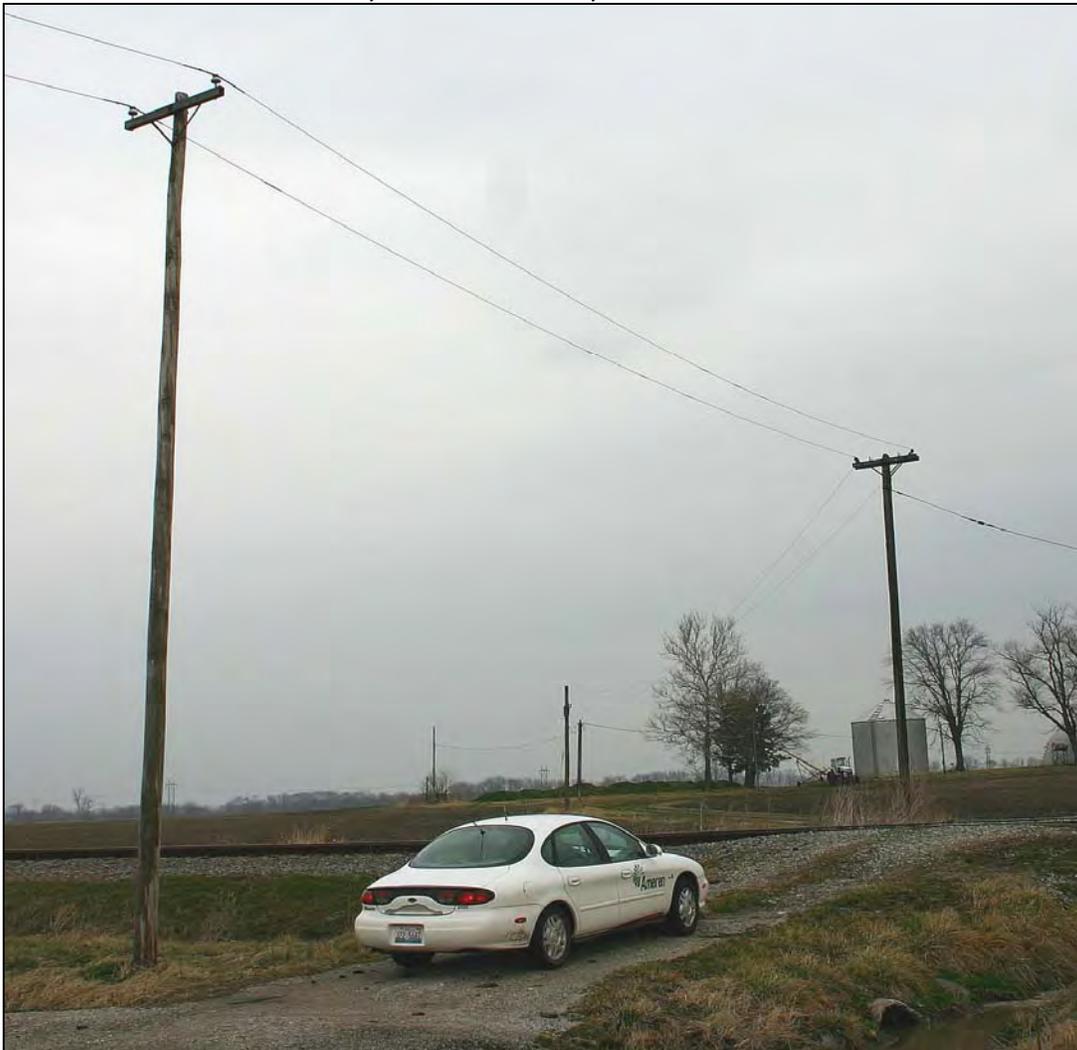
Figure 14 (Photo 06-IP837)

**Single wood crossarm supporting a single phase crossing of a railroad,
(NESC Structural Strength Violation)
Circuit Q27186, north of Rt. 160, northwest of Addieville**

Q27186-- 3/8/06	Code structural strength violation (NESC 261.D.4.c): Single wood crossarm supporting a single phase crossing of a railroad, on the south side of the railroad crossing. (Double crossarms required). <i>AmerenIP installed double crossarms on the south side of the crossing 8/16/06.</i>	108-0837	1st pole north of Rt. 160 in the tap to Sta. 11725. (Map 8--Addieville & rural).	3/8/06 9/7/06	8/16/06
	Code violations (NESC 279.A.2): Ungrounded 12 kV downguys without strain insulators below energized conductors (2 downguys going south and 1 downguy going east). <i>AmerenIP installed guy strain insulators 8/16/06.</i>	838	Corner pole on the south side of CH 6 where the circuit goes cross-country to the north. (Map 9--Addieville & rural).	3/8/06 9/7/06	8/16/06
	Broken primary (top) downguy, and: Code violations (NESC 279.A.2): Ungrounded downguys without strain insulators below energized conductors (3 downguys going west). <i>AmerenIP installed guy strain insulators 8/16/06.</i>	839, 840	3-way corner pole on the north side of CH 6 where the circuit goes cross-country to the north. (Map 9--Addieville & rural).	3/8/06 9/7/06	8/16/06

Note: AmerenIP installed double crossarms to resolve this code violation on 8/16/06.

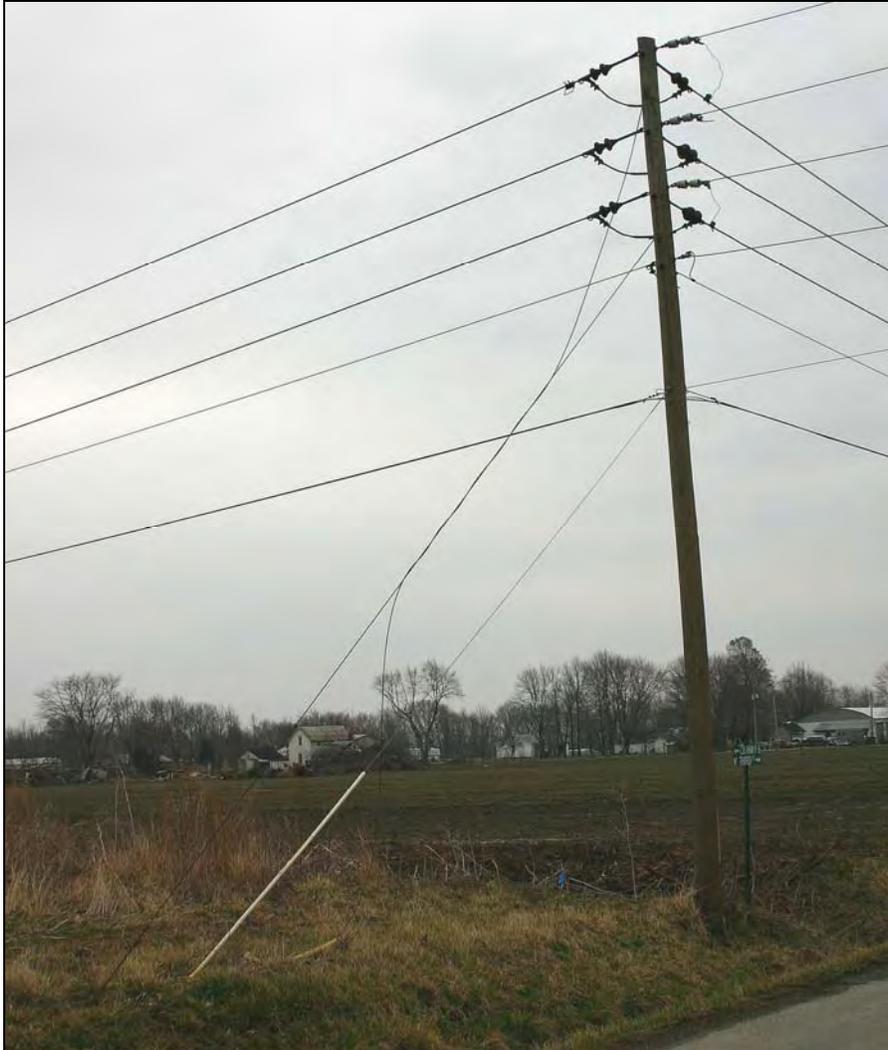
Figure 15 (Photo 06-IP839)
Broken top primary downguy, and:
Ungrounded downguys without strain insulators below energized conductors,
(NESC Violation)
Circuit Q27186, County Highway 6, west of Addieville

Code violations (NESC 279.A.2): Ungrounded downguys without strain insulators below energized conductors (downguys going west and going southeast). <i>AmerenIP installed guy strain insulators 8/16/06.</i>		Corner pole on the south side of CH 6 where the circuit goes northwest to Sta. 11726. (Map 9--Addieville & rural).	3/8/06 9/7/06	8/16/06
	Code violations (NESC 279.A.2): Ungrounded downguys without strain insulators below energized conductors (downguys going north). <i>AmerenIP installed guy strain insulators 8/16/06.</i>		Northwest corner of N. Gaebe & Center Sts., Addieville. (Map 10--Addieville & rural).	3/8/06 9/7/06	8/16/06
	Code violations (NESC 279.A.2): Ungrounded downguys without strain insulators below energized conductors (downguys going south). <i>AmerenIP installed guy strain insulators 8/16/06.</i>		Southeast corner of N. Gaebe & Center Sts., Addieville. (Map 10--Addieville & rural).	3/8/06 9/7/06	8/16/06

Note: AmerenIP reported that it installed guy strain insulators here 8/16/06.

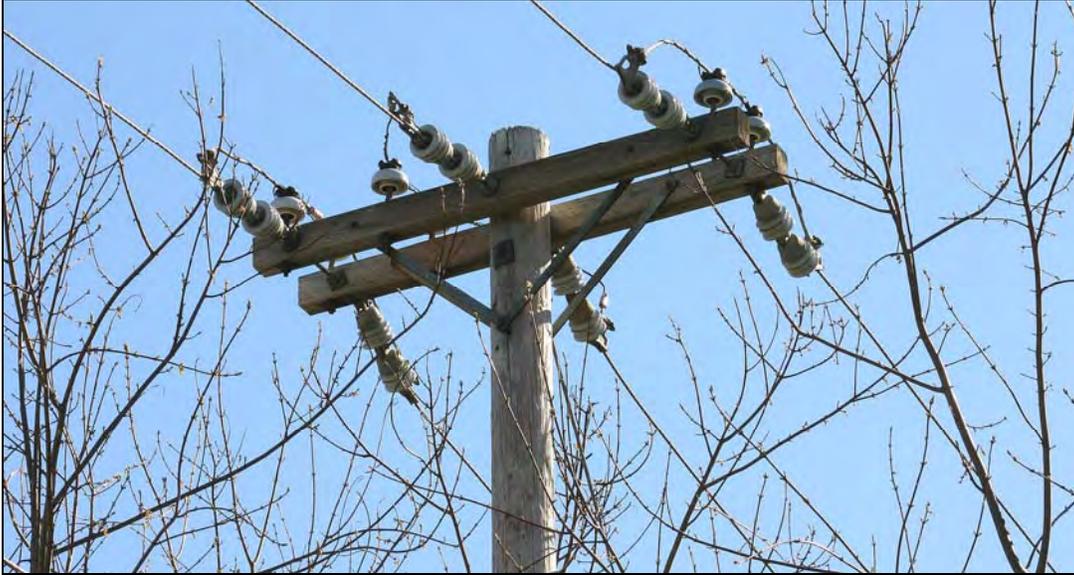
Figure 16 (Photo 06-IP870)
Soft maple tree into primary,
Circuit P58155, Cherry Street at 24th Street, Mt. Vernon

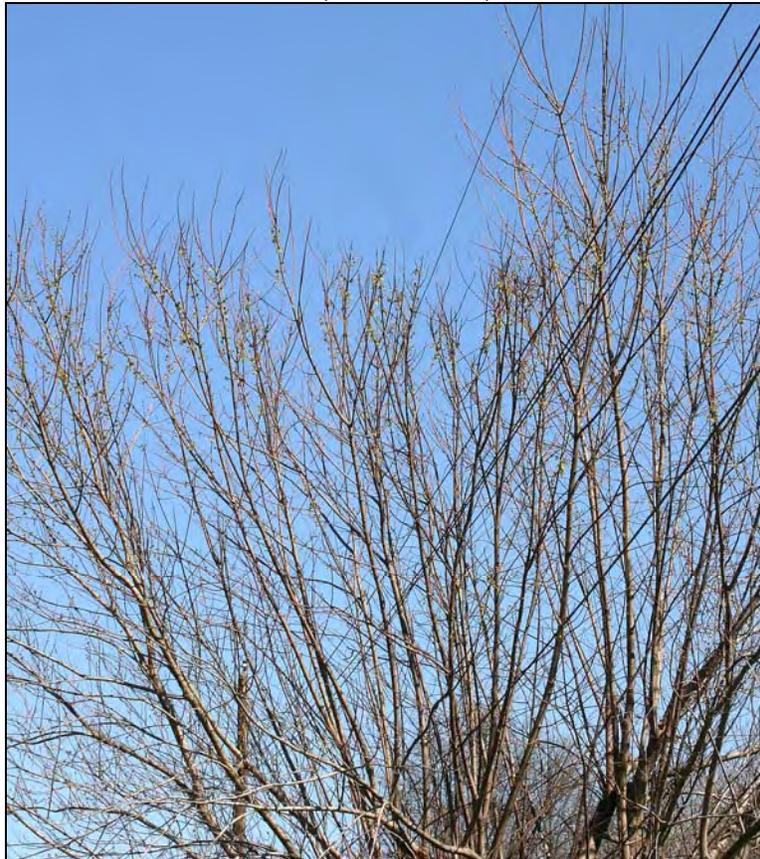
Figure 17 (Photo 06-IP874)
Trees into primary,
Circuit P58155, 28th Street, Mt. Vernon

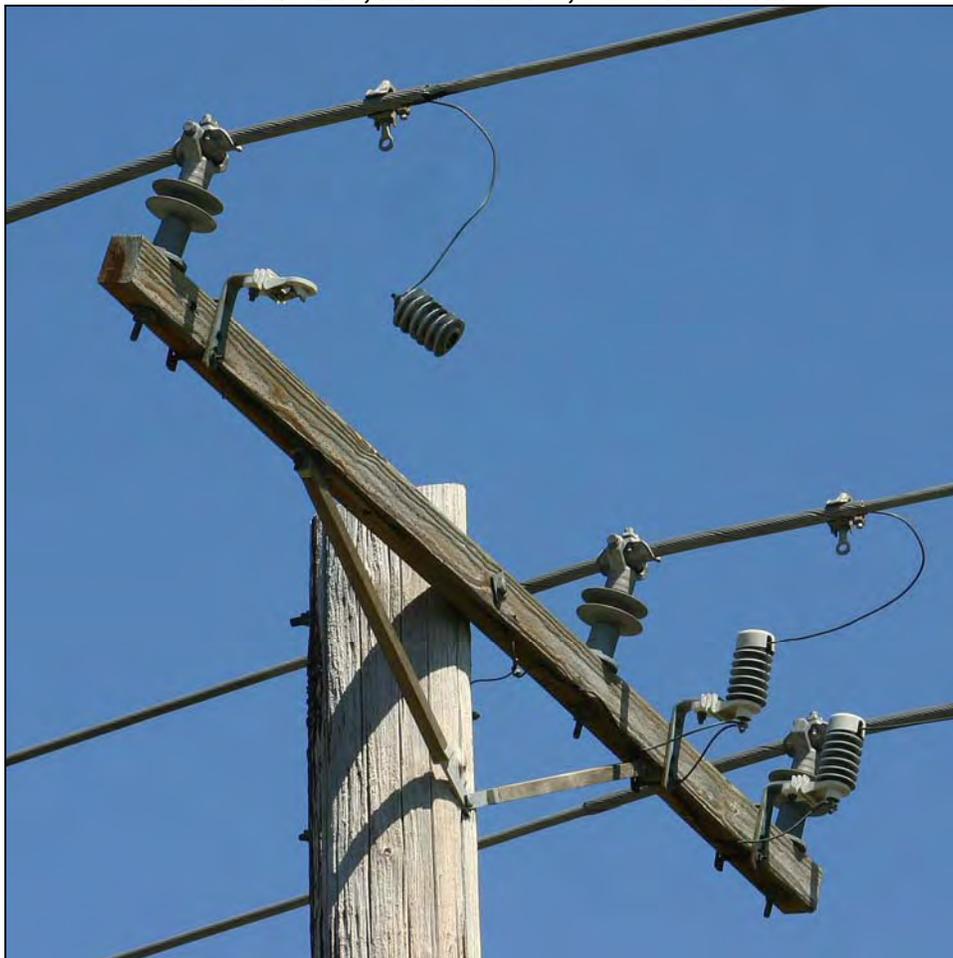
Figure 18 (Photo 06-IP875)
Lightning arrester blown apart,
Circuit Q95248, Illinois Rt. 158, east of Belleville

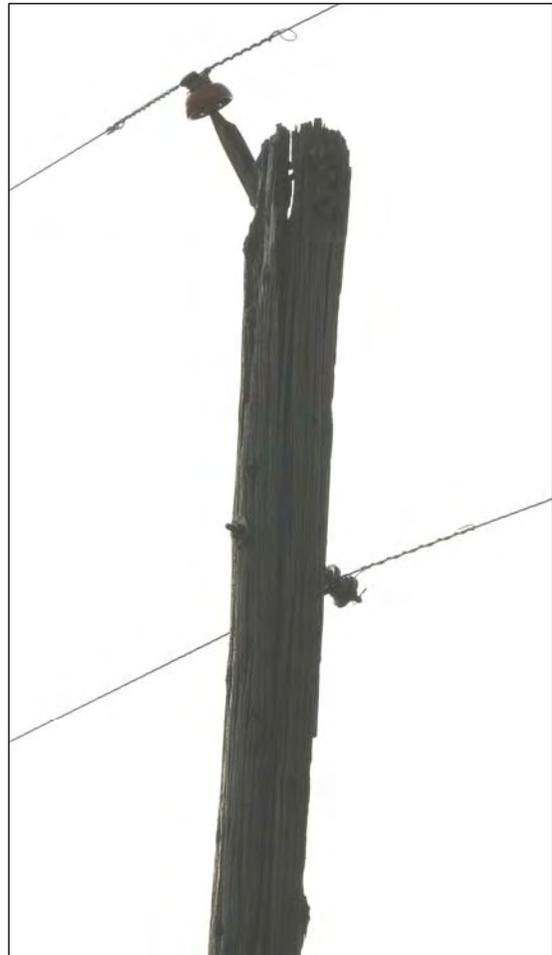
Figure 19 (Photo 06-IP900)
Shell rotted pole with badly split top,
Circuit K65221, Rd. 1700N, SW of Cooksville

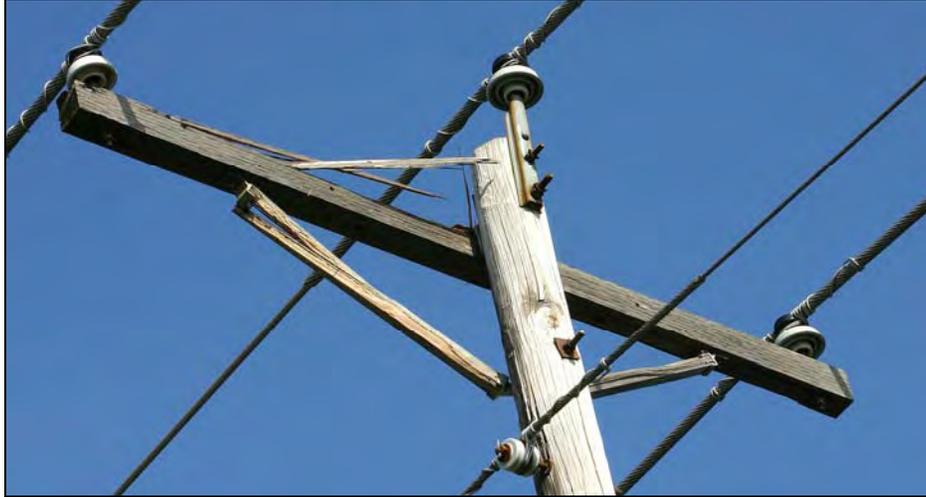
Figure 20 (Photo 06-IP902)
Badly split (lightning damaged) crossarm & wood brace,
Circuit K65221, Illinois Rt. 165, west of Cooksville

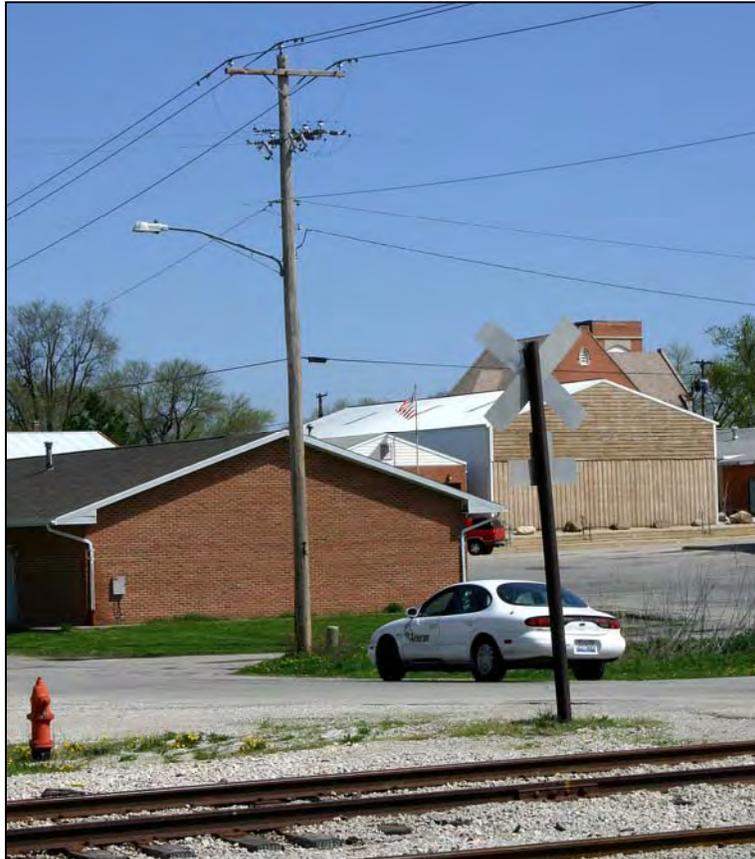
Figure 21 (Photo 06-IP907)
Single wood crossarm supporting a 3-phase crossing of a railroad,
(NESC Structural Strength Violation)
Circuit K65221, Grove Street, Colfax

Note: AmerenIP corrected this code violation on 5/17/06.

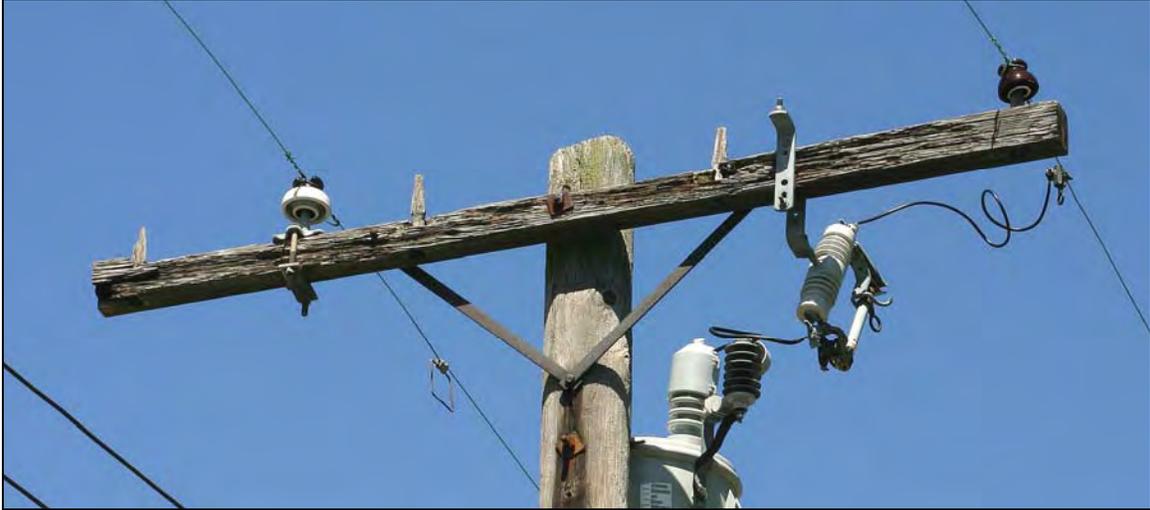
Figure 22 (Photo 06-IP909)
Badly deteriorated crossarm,
Circuit K65221, alley east of Center Street, Colfax

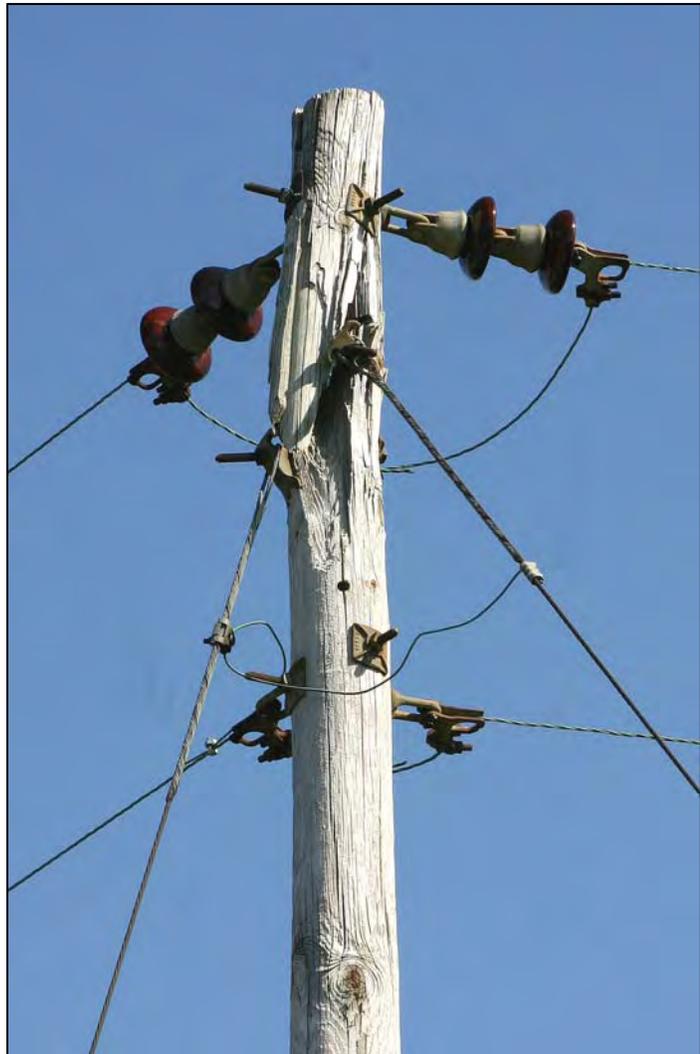
Figure 23 (Photo 06-IP924)
Split (lightning damaged) pole top,
Circuit K65221,
Rd. 1500N, south of Cooksville

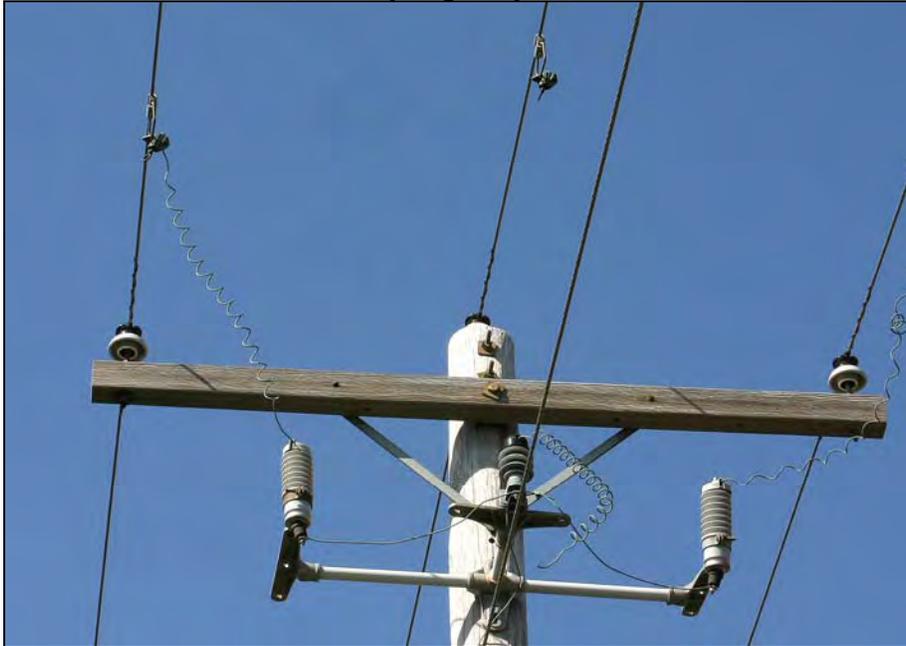
Figure 24 (Photo 06-IP923)
Center phase lightning arrester disconnected from primary,
Circuit K65221, County Highway 17, north of Ellsworth

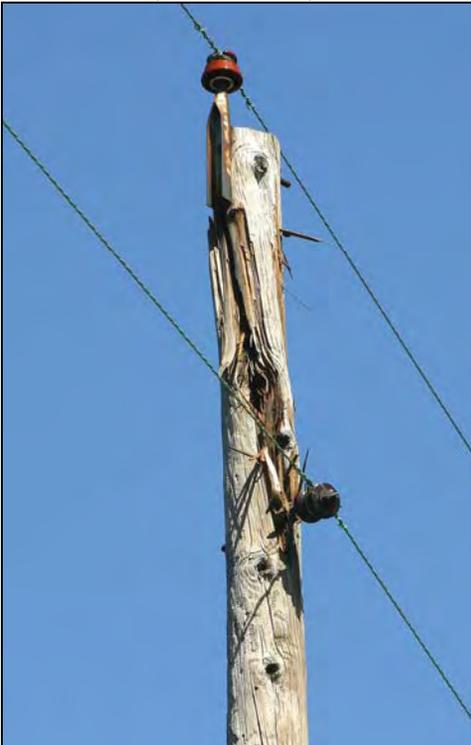
Figure 25 (Photo 06-IP917)
Lightning damaged pole top,
Circuit K65221, Rd. 1300N, E of Ellsworth

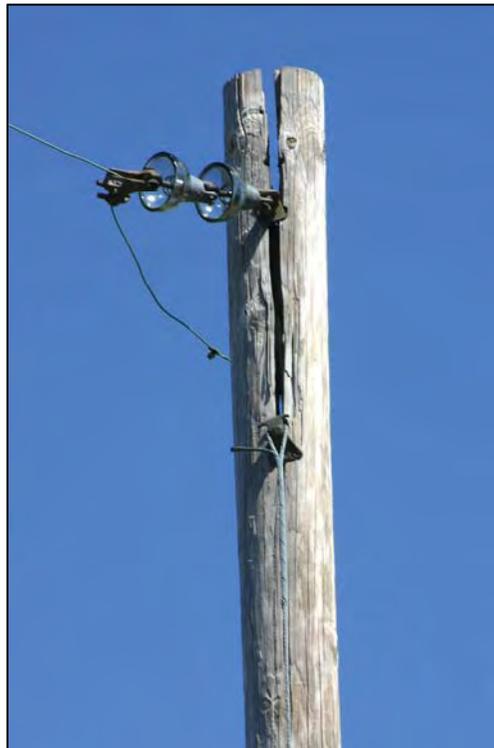
Figure 26 (Photo 06-IP918)
Split pole top,
Circuit K65221, Rd. 1300N, E of Ellsworth

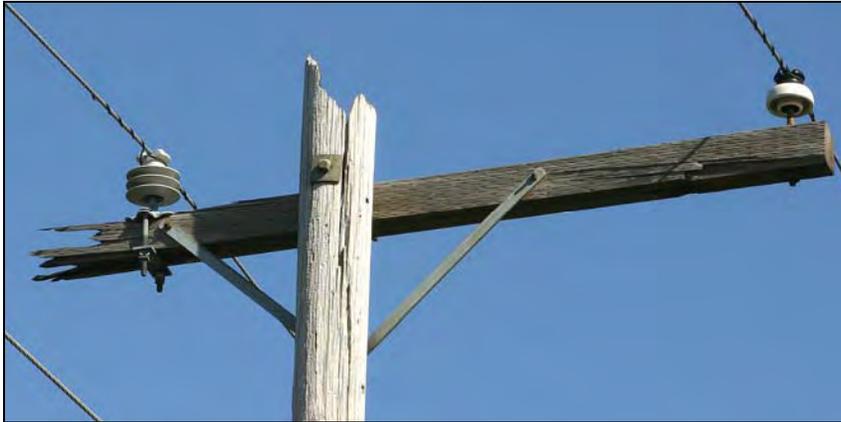
Figure 27 (Photo 06-IP935)
Badly damaged crossarm & pole top,
Circuit R99180, Road 950E, east of Weedman

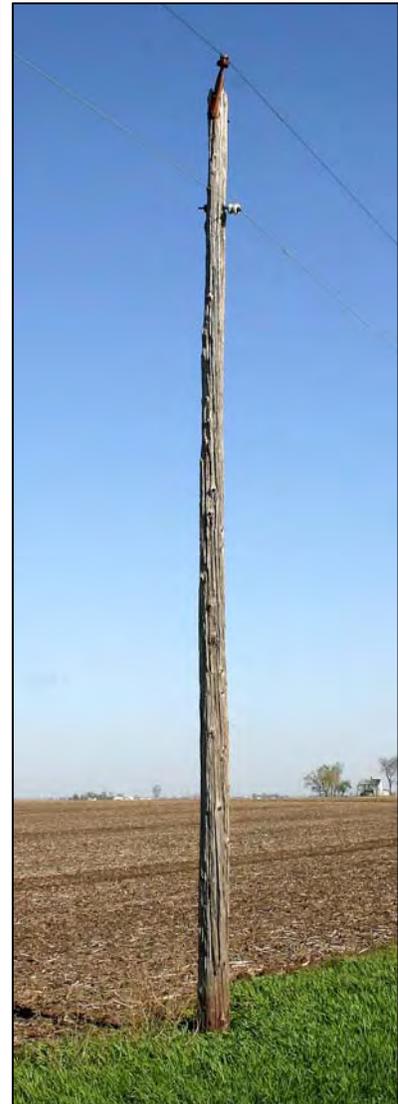
Figure 28 (Photo 06-IP933)
Badly shell rotted pole,
Circuit R99180, Road 900E, SE of Weedman

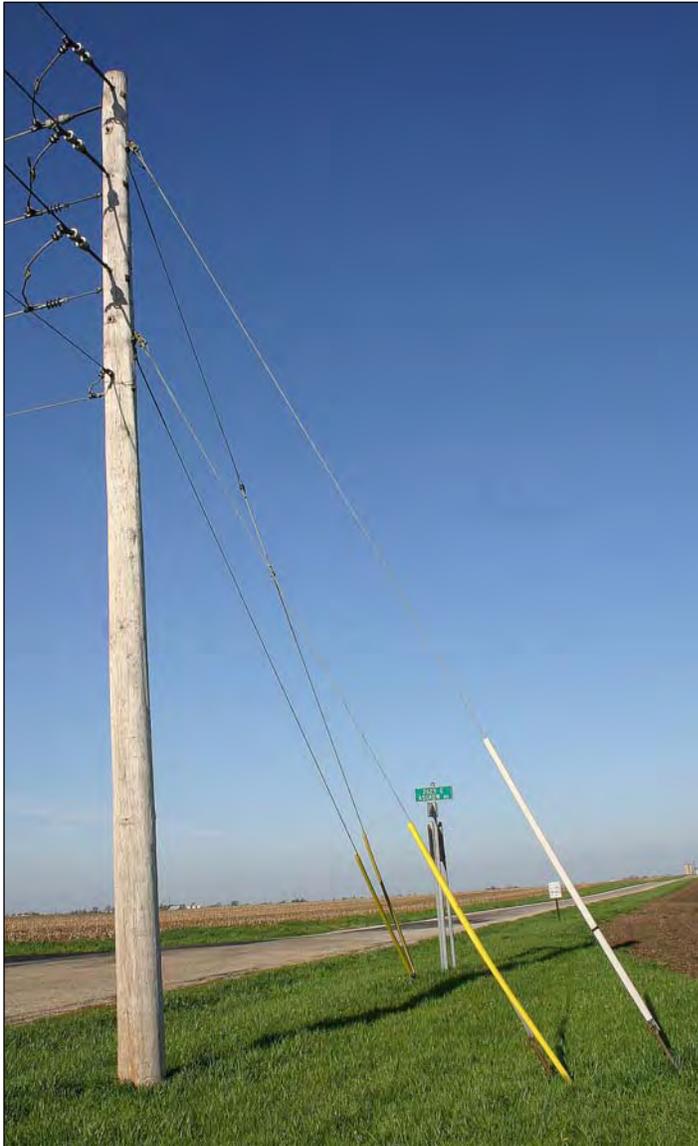
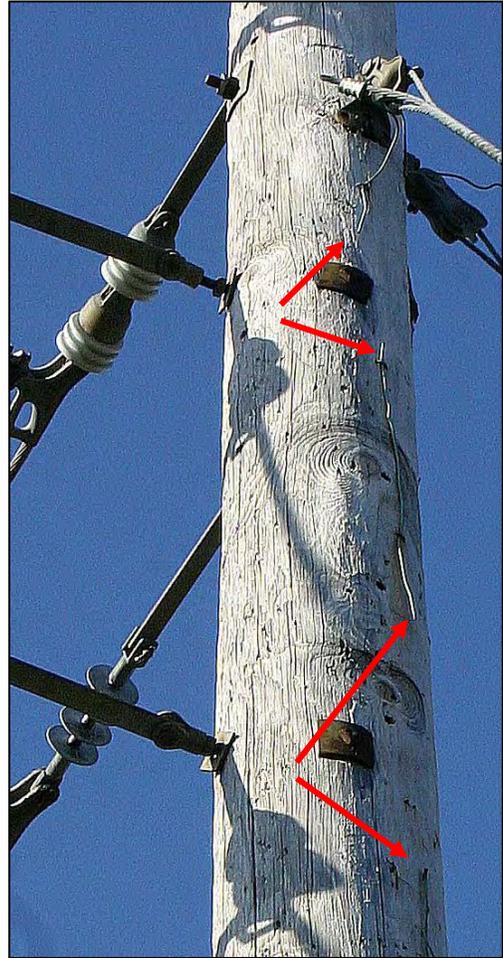
Figures 29 & 30 (Photos 06-IP931 & 06-IP932)
No strain insulator in top downguy & ground wire on pole broken in 2 places,
(NESC Violation)
Circuit R99180, Road 1600N, west of Weedman

Broken ground wire details:

Note: AmerenIP reported that it corrected this violation on 4/26/06.

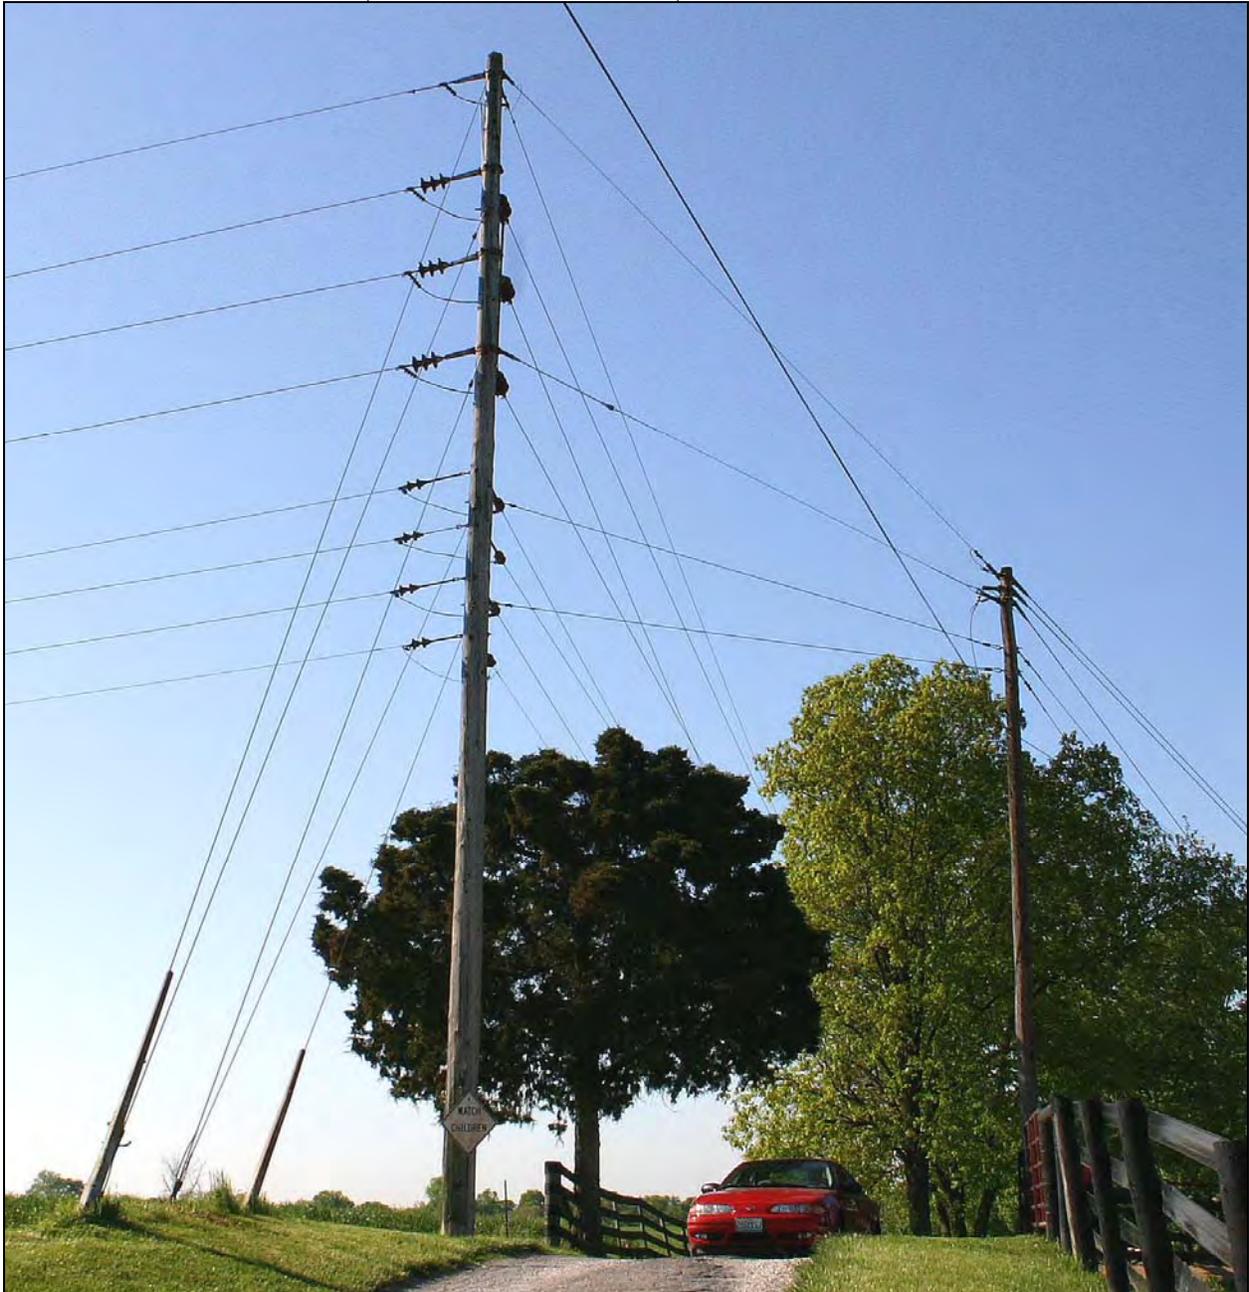
Figure 31 (Photo 06-IP936)
Ungrounded downguys & overhead guys without required strain insulators,
(NESC Violation)
Circuit R94271, at 34 kV Structure 161, north of Waterloo Substation

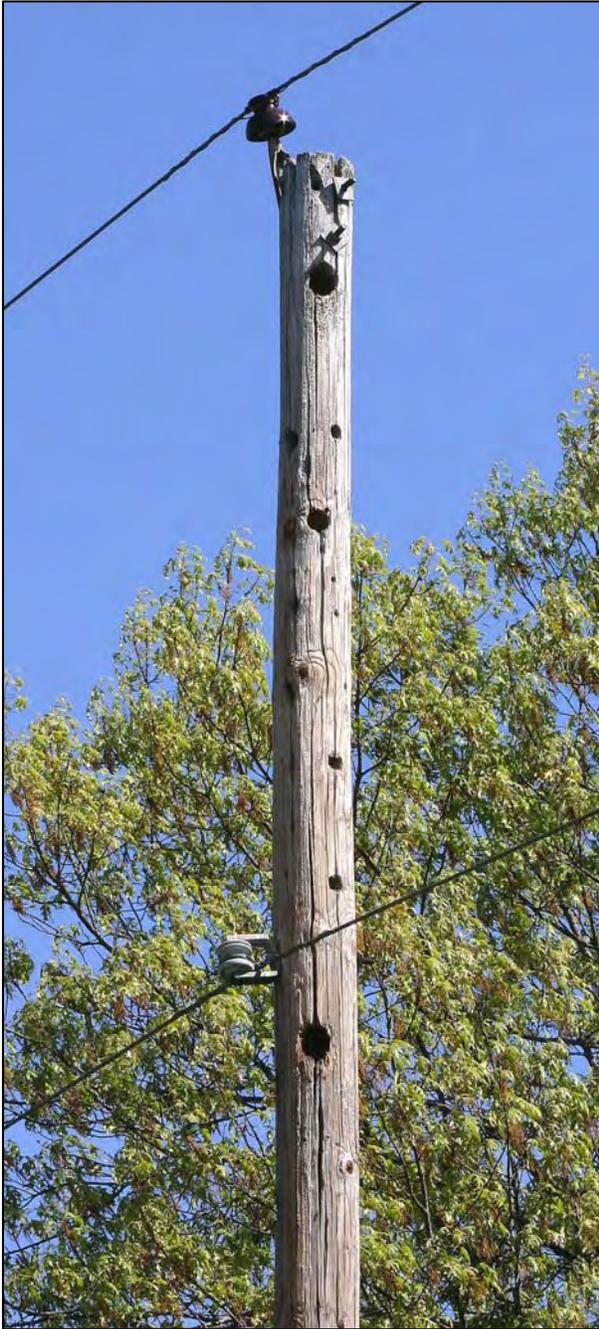
Figure 32 (Photo 06-IP939)
5(+) woodpecker holes in pole & bad top,
Circuit R94271, Andy Rd., W of Waterloo

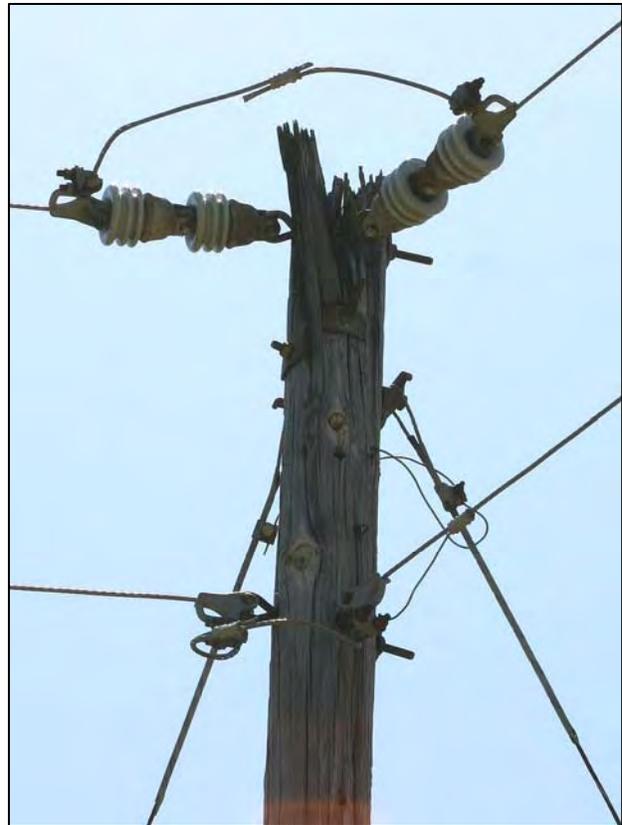
Figure 33 (Photo 06-IP941)
Split (lightning damaged) pole top,
Circuit R94271, west of Waterloo

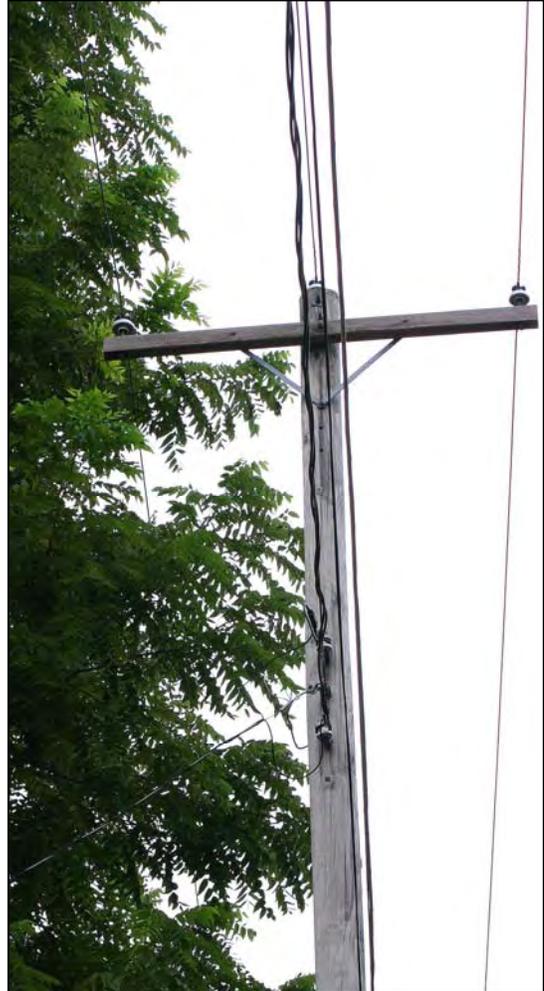
Figure 34 (Photo 06-IP1066)
Walnut tree into primary,
Circuit P26281, Bluff St., Marseilles
