Illinois Commerce Commission
Assessment of AmerenIP's
Reliability Report and Reliability Performance
for Calendar Year 2005

Pursuant to 83 Illinois Administrative Code 411.140

December 18, 2006

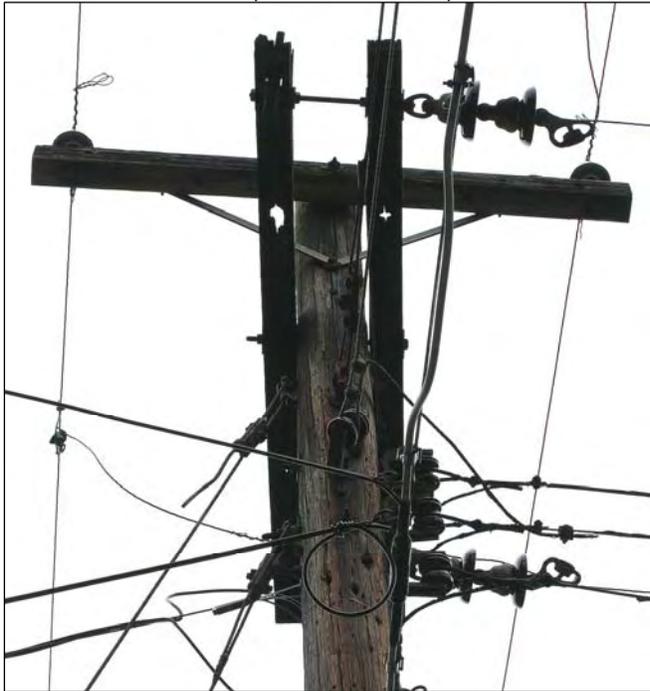
Figure 35 (Photo 06-IP1062)
Badly deteriorated crossarms,
Circuit P26281, Oakdale Ave., Marseilles

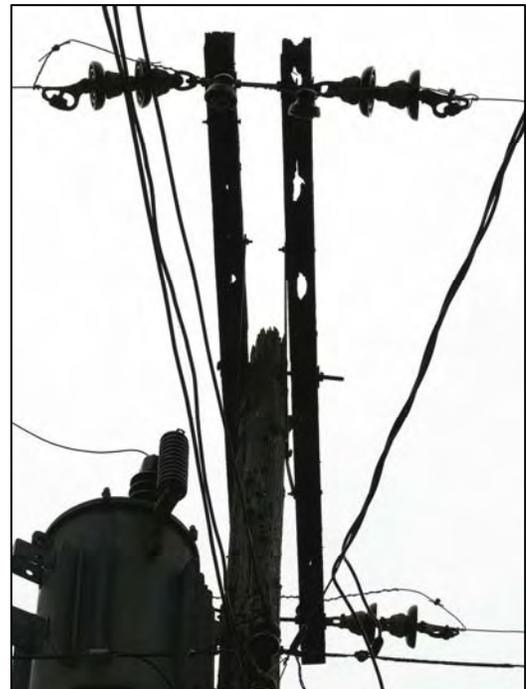
Figure 36 (Photo 06-IP1058)
Badly deteriorated crossarms & pole top,
Circuit P26281,
easement south of Bluff St., Marseilles

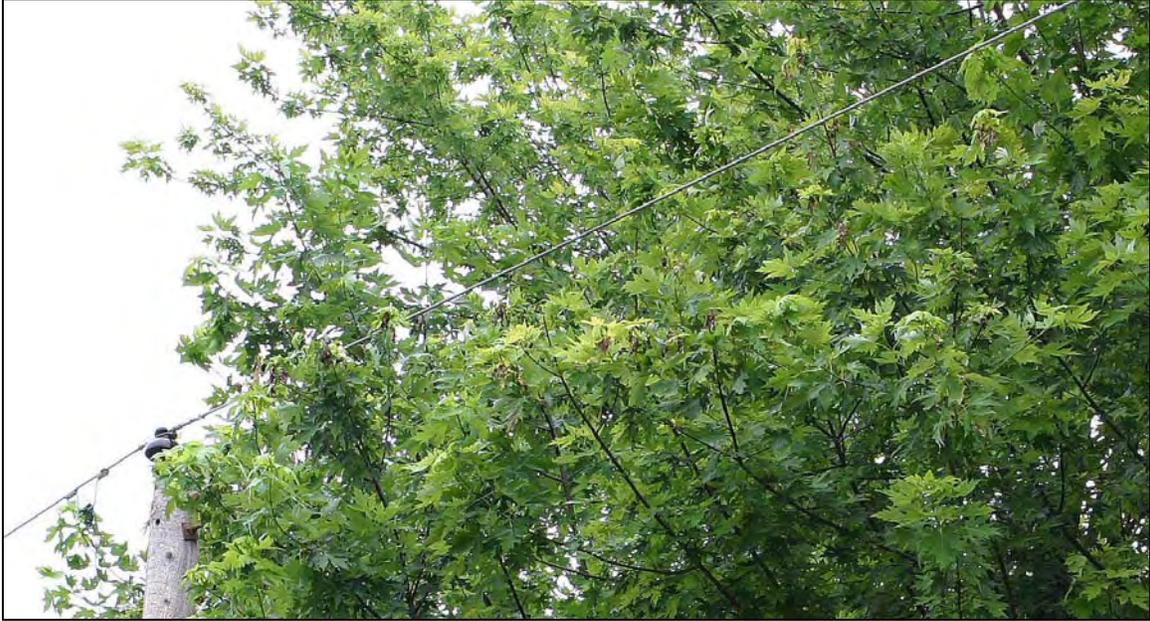
Figure 37 (Photo 06-IP1063)
Soft maple tree into primary (with burning),
Circuit P26281, Clark Street, Marseilles

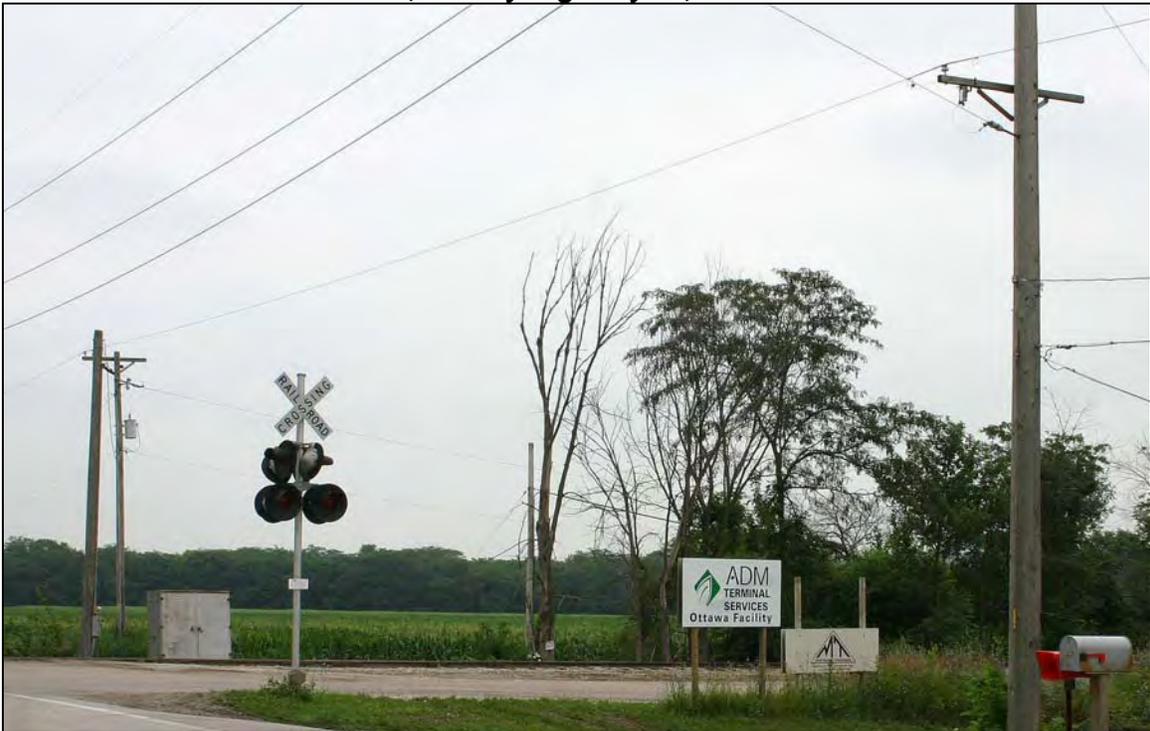
Figure 38 (Photo 06-IP1073)
Single wood crossarms supporting a 3-phase crossing of a railroad,
(NESC Structural Strength Violation)
Circuit P26281, County Highway 51, west of Marseilles

Note: AmerenIP installed double crossarms on both sides of the crossing 10/12/06.

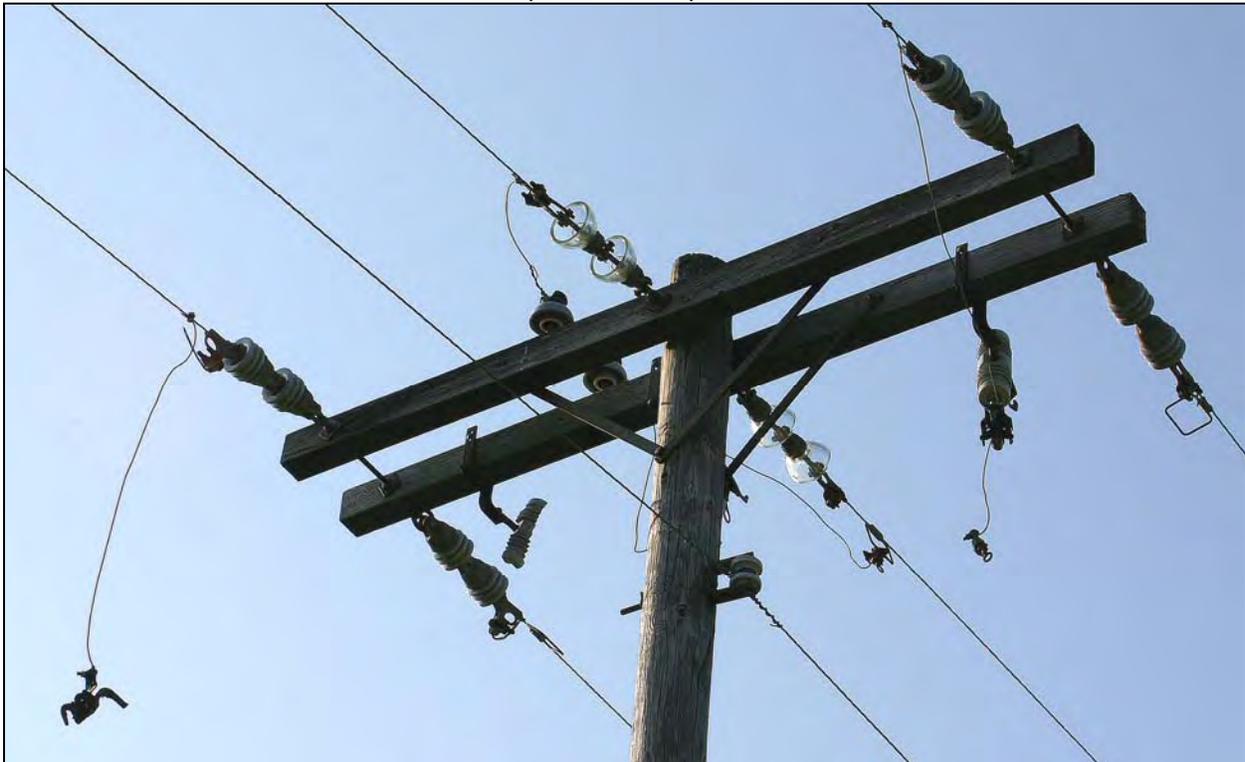
Cutout blown apart (field side) & road-side fused cutout disconnected from primary, Circuit L42158, Road 425E, west of DeLand

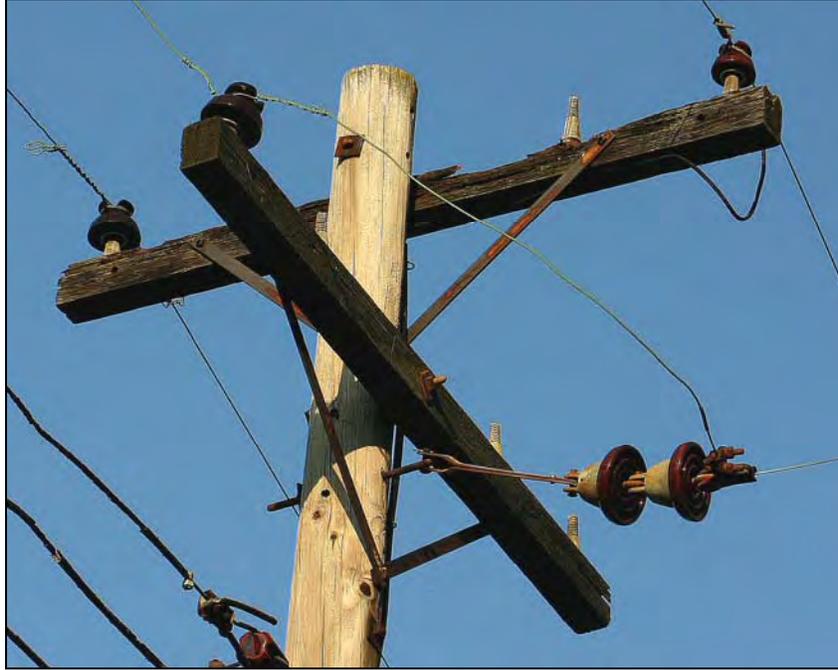
Figure 40 (Photo 06-IP1140)
Badly deteriorated crossarms,
Circuit L42158, corner of 6th & Short Streets, DeLand

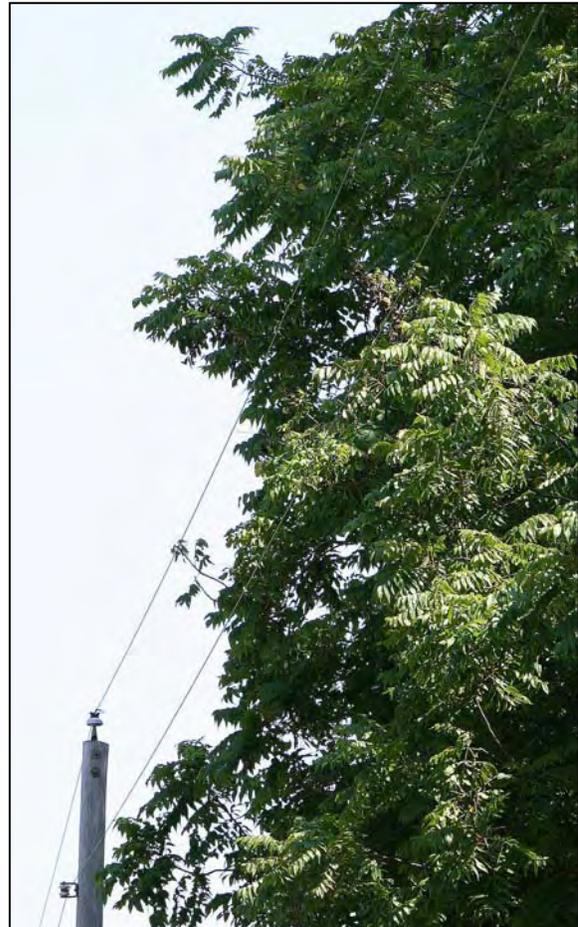
Figure 41 (Photo 06-IP1148)
Tree into primary, with burning,
Circuit L42158, Road 2000E, NE of DeWitt

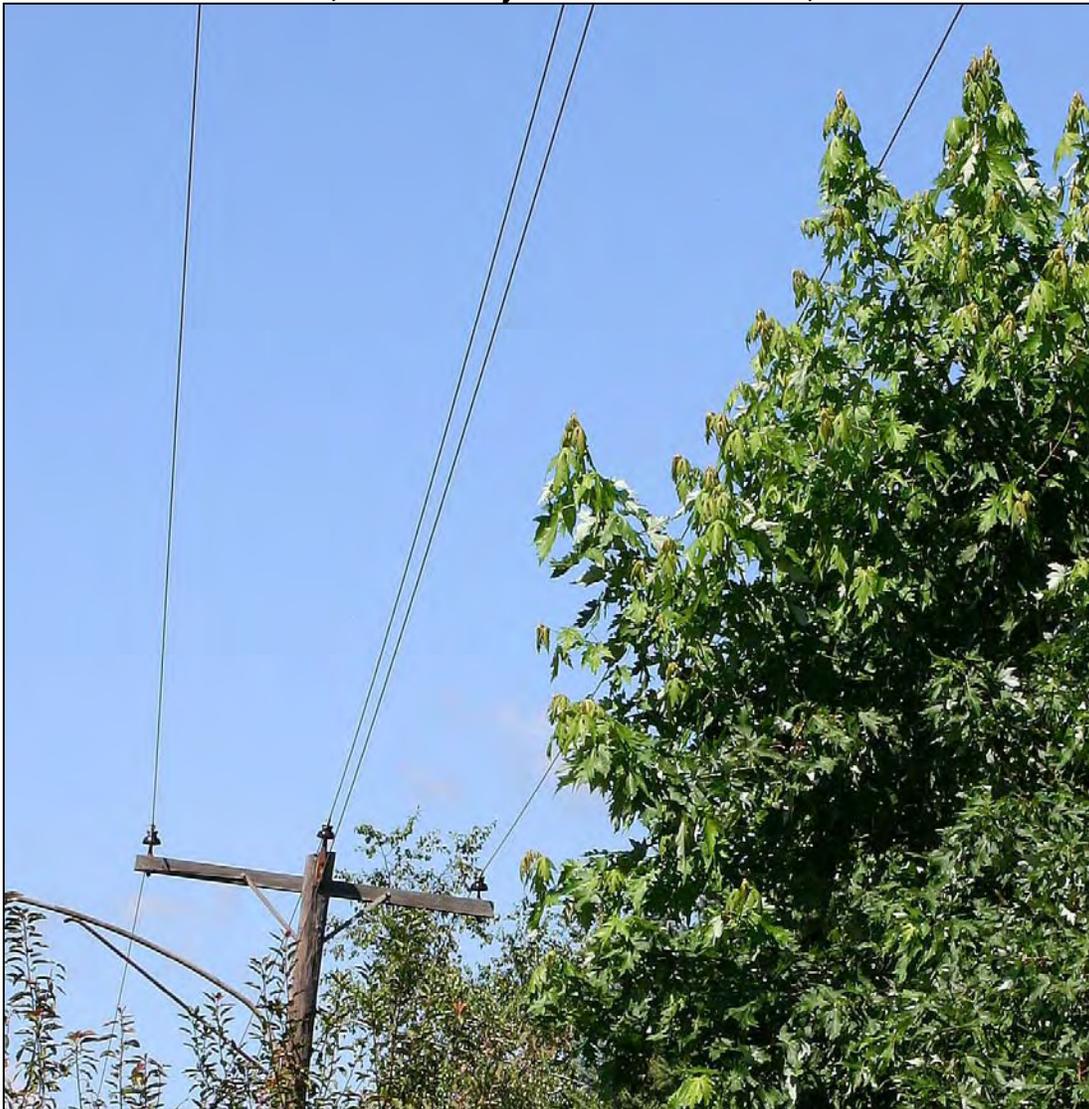
Figure 42 (Photo 06-IP1214)
Silver maple tree growing into primary,
Circuit P52306, Kratz Road just west of Van Buren, Monticello

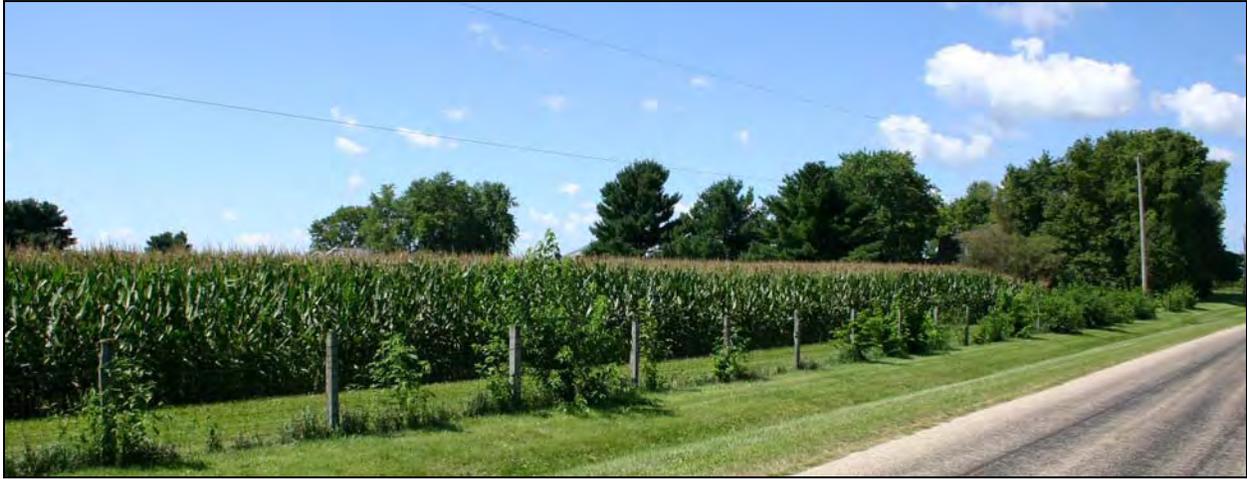
Figure 43 (Photo 06-IP1215)
Inadequate neutral clearance above ground,
(NESC Clearance Violation)
Circuit P52306, Road 1500N, southeast of Monticello

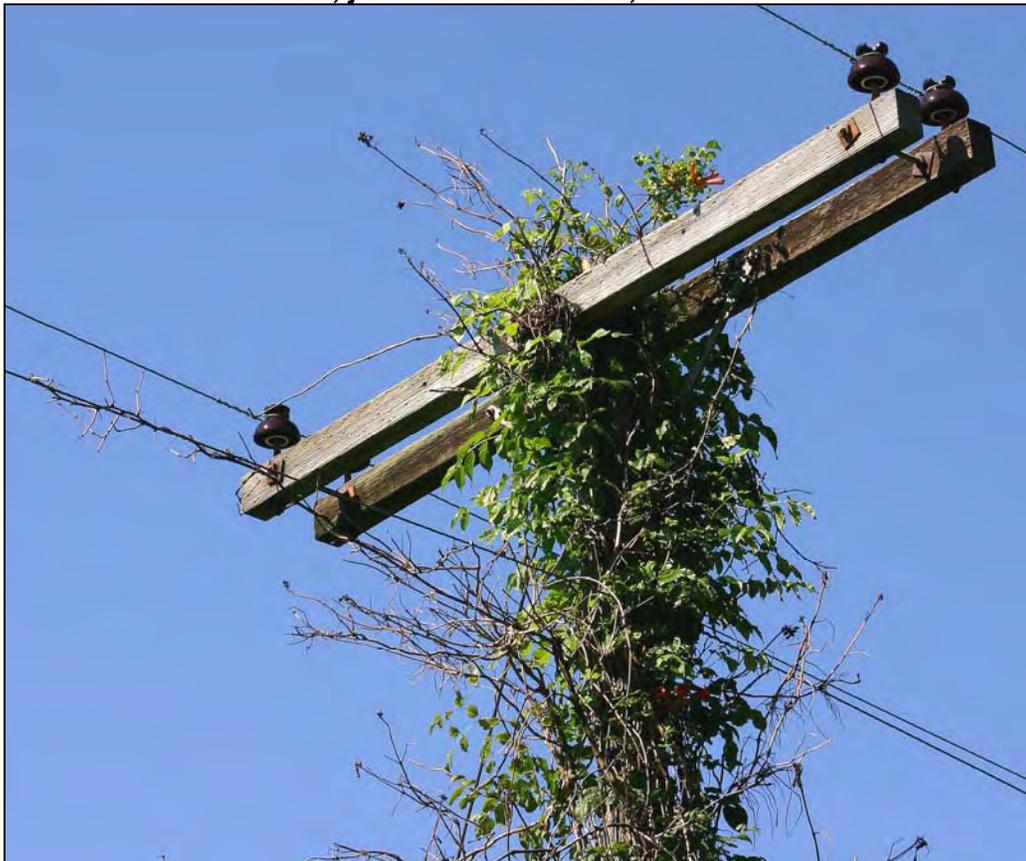
Figure 44 (Photo 06-IP1211)
Trumpet vine up pole,
Circuit P52306, just east of IL Rt. 105, south of Monticello

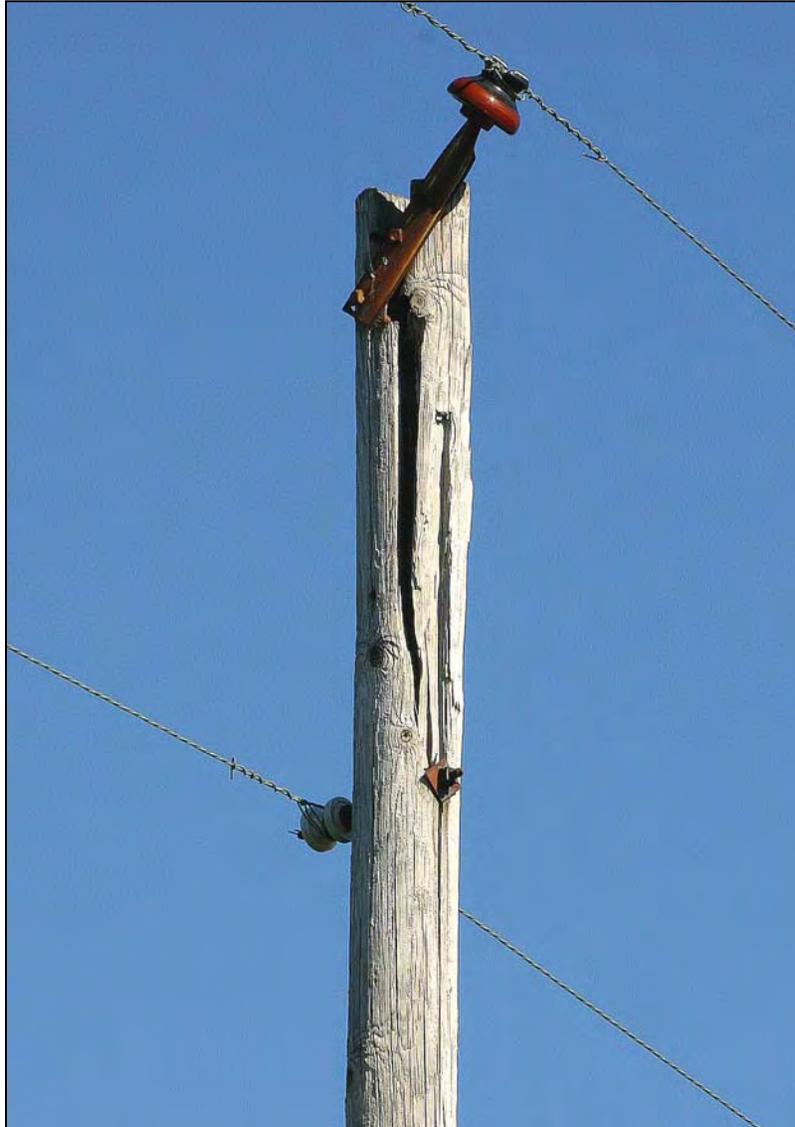
Figure 45 (Photo 06-IP1206)
Split (lightning damaged) pole top,
Circuit P52306, Road 800E, northwest of Bement

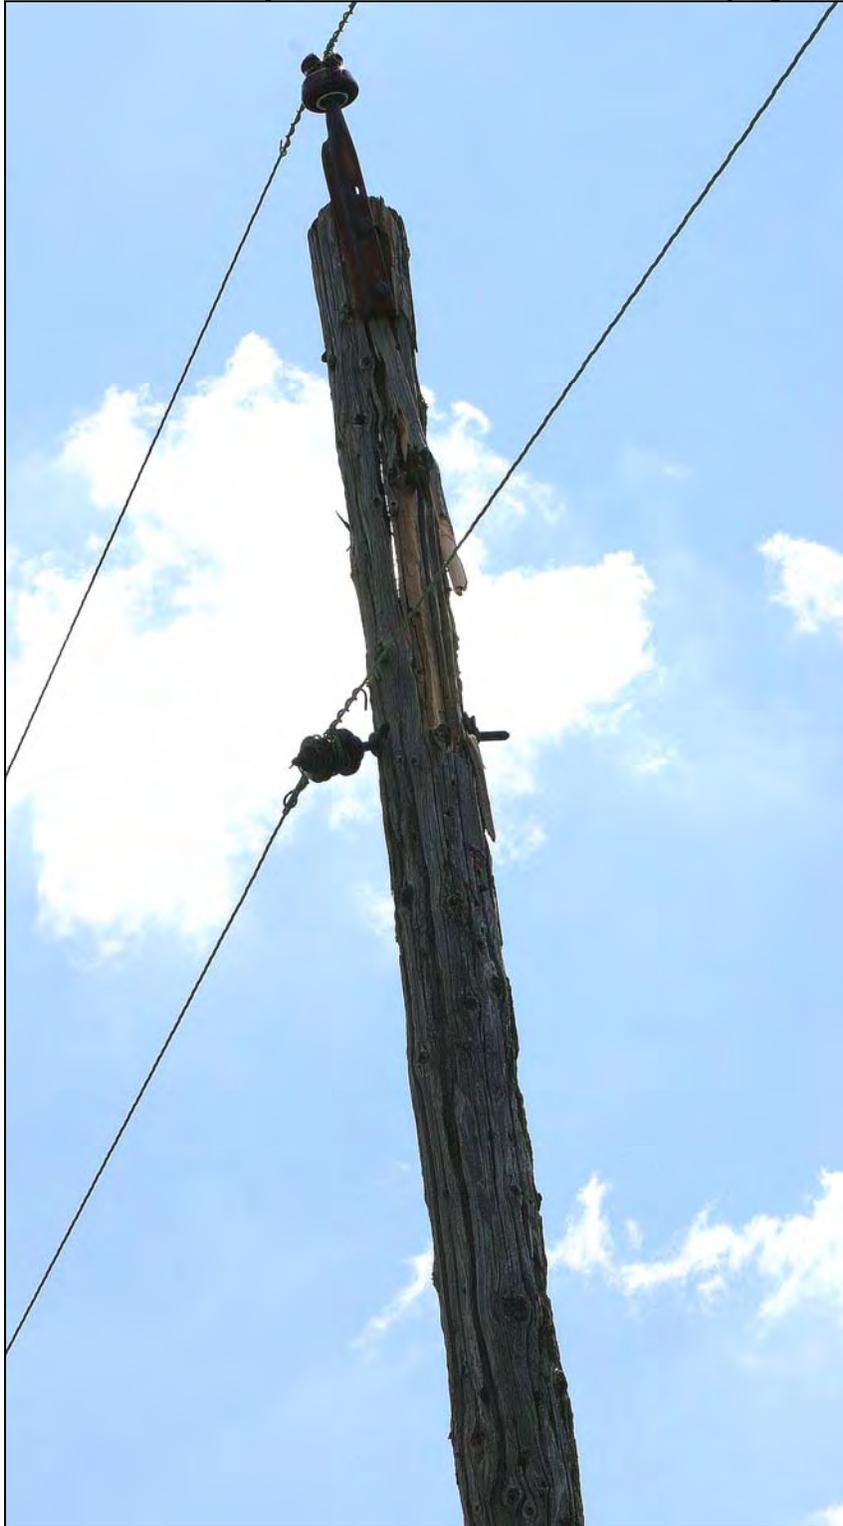
Figure 46 (Photo 06-IP1217)
Shell rotted pole & split (lightning damaged) pole top,
Circuit K74162, just north of CH 33, north of Champaign

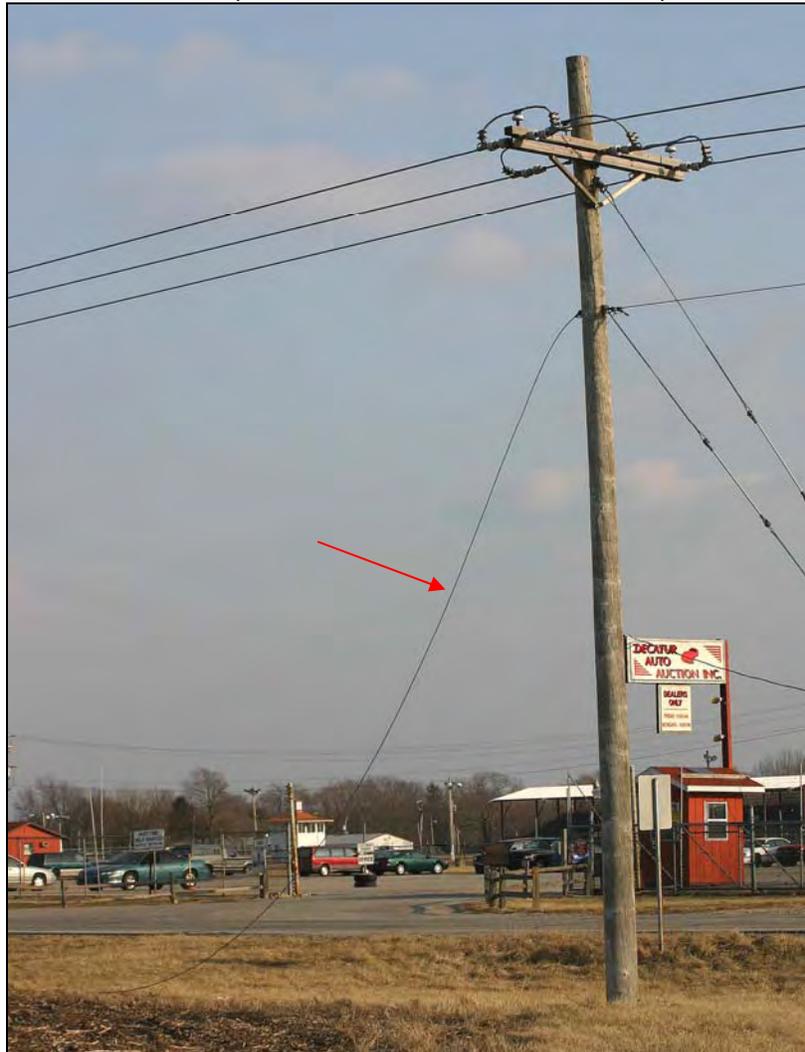
Figure 47 (Photo 06-IP793)
Primary neutral down (on the ground for two spans),
Circuit L17101, Mound Road east of Westlawn, Decatur

Note: This downed neutral has since been repaired (twice) by AmerenIP.

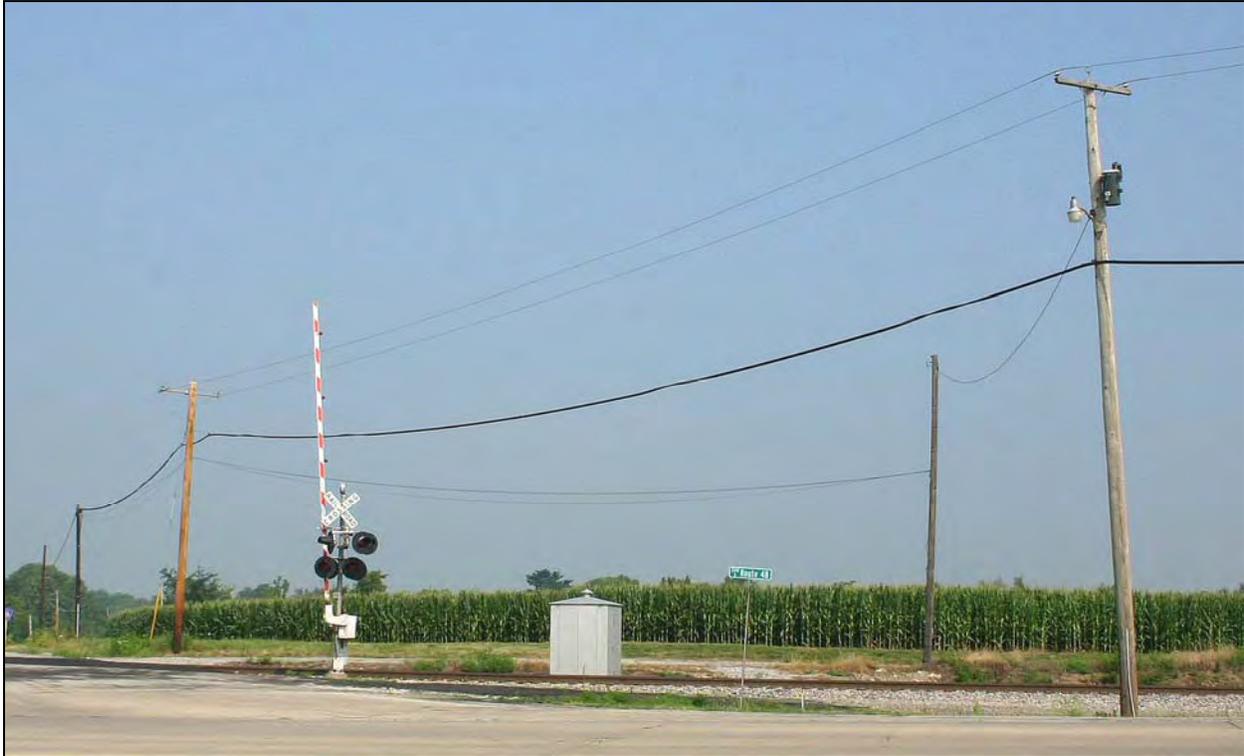
Figure 48 (Photo 06-IP1086)
Single wood crossarm supporting a 3-phase crossing of a railroad,
(NESC Structural Strength Violation)
Circuit L23145, Mt. Auburn Road at Rt. 48 south, Decatur
