Illinois Commerce Commission
Assessment of Commonwealth Edison Company
Reliability Report and Reliability Performance
for Calendar Year 2005

Pursuant to 83 Ill. Adm. Code 411.140

March 20, 2007

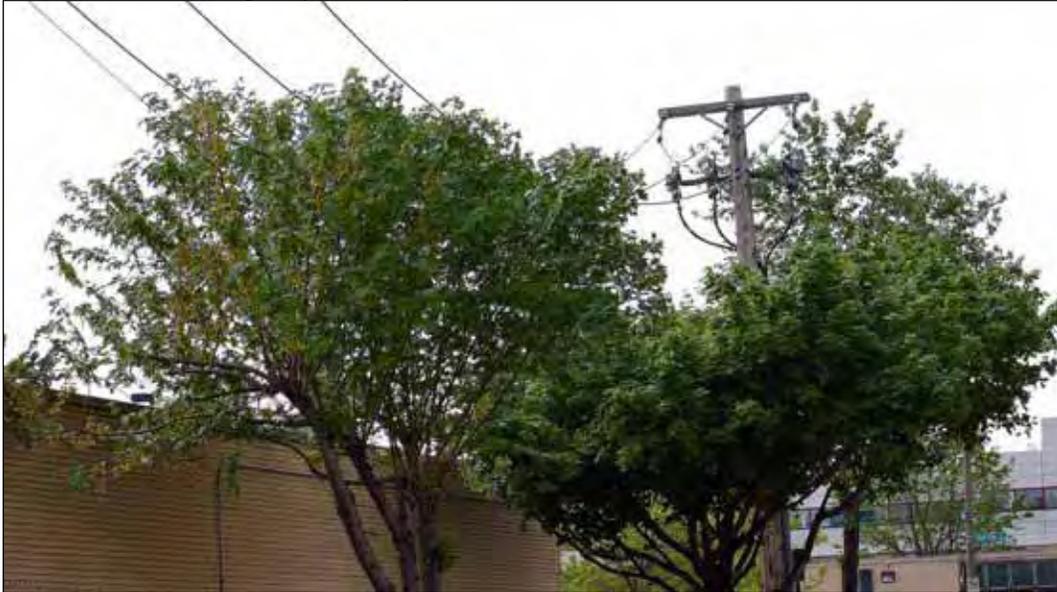
Figure 1 (Photo 06-CE955)
**Silver maple tree into 3-phase primary,
Ridgway Ave. just north of Oakton St., Skokie**

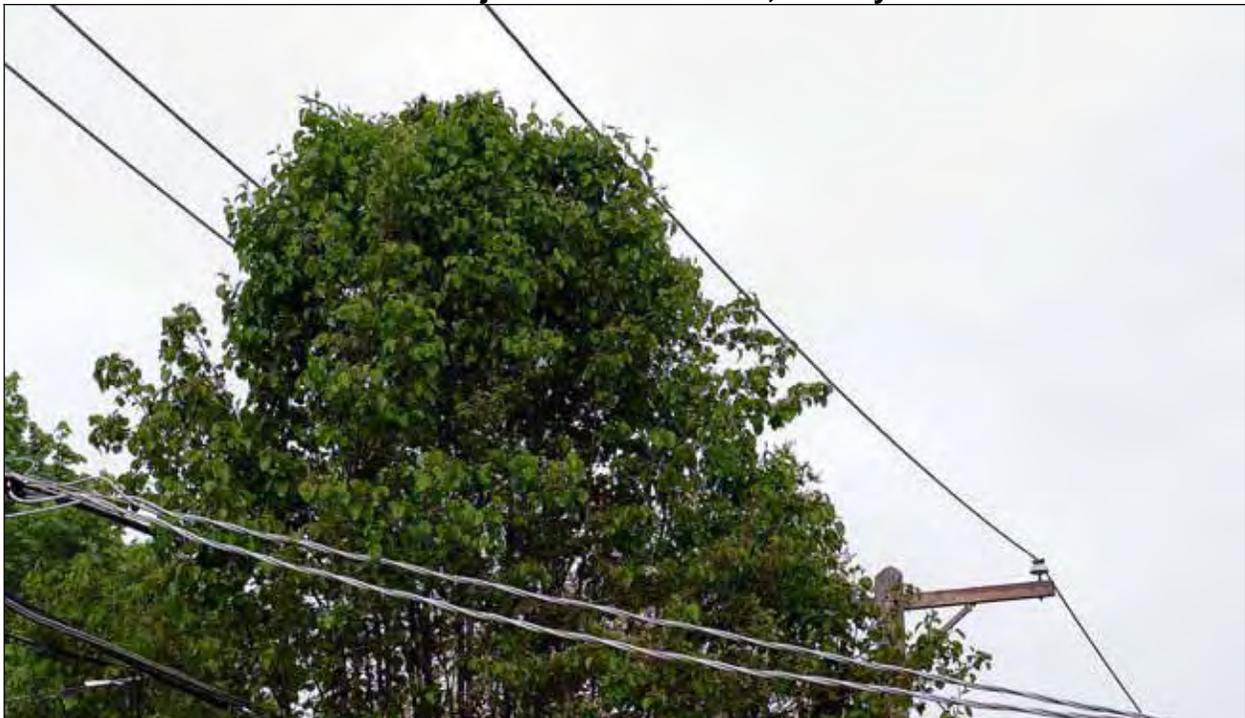
Figure 4 (Photo 06-CE972)
Bradford pear tree into primary,
Austin Ave. just east of Oak St., Libertyville

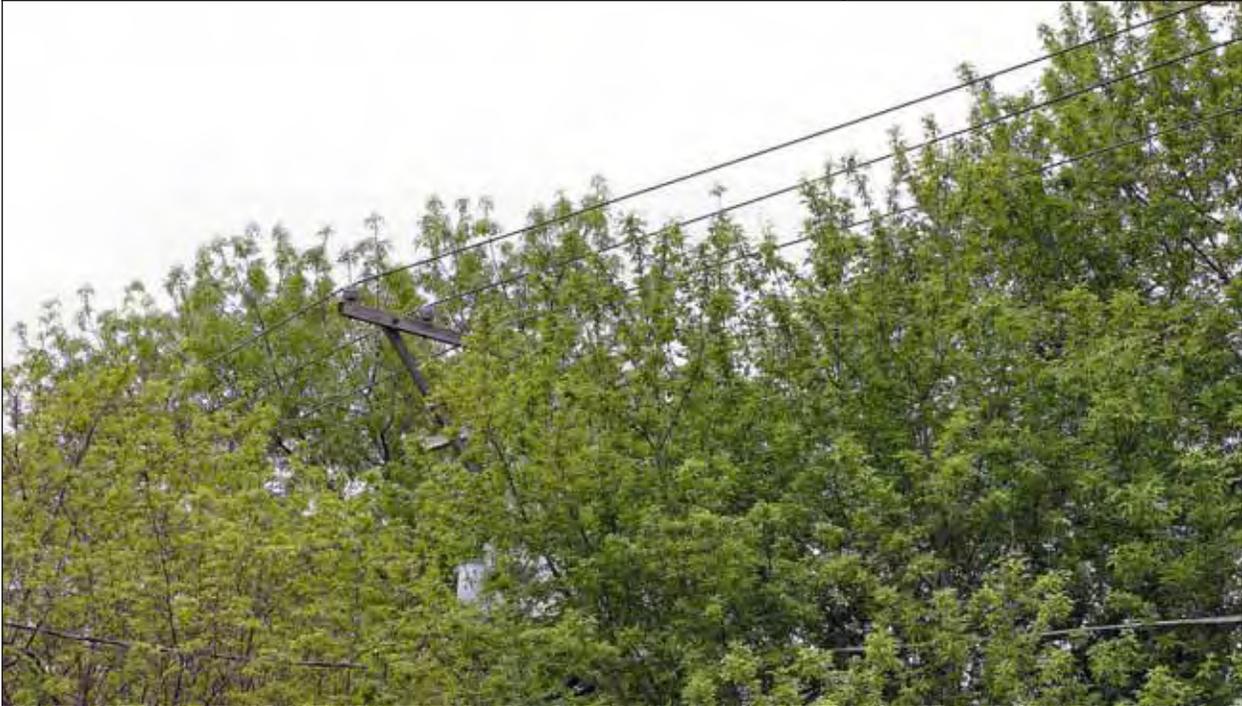
Figure 7 (Photo 06-CE984)
Box elder tree into primary,
Barlina Rd. west of St. Andrews Ln., Crystal Lake

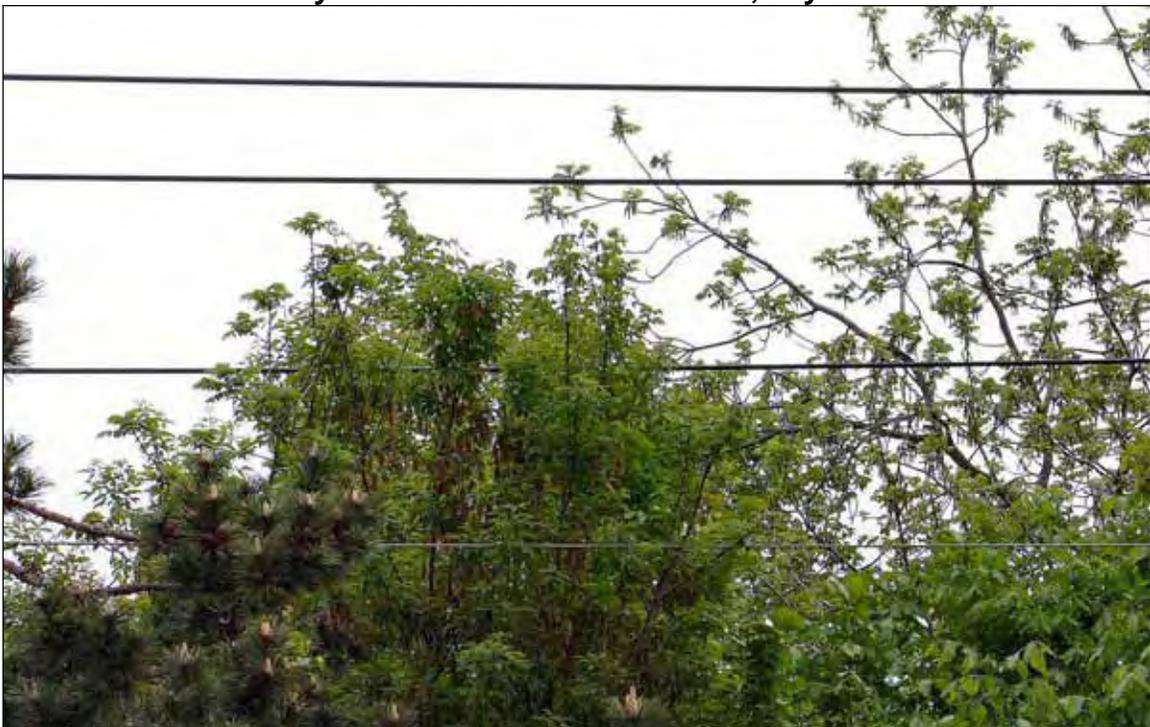
Figure 8 (Photo 06-CE980)
Box elder tree into 3-phase primary,
McHenry Ave. south of Berkshire Dr., Crystal Lake

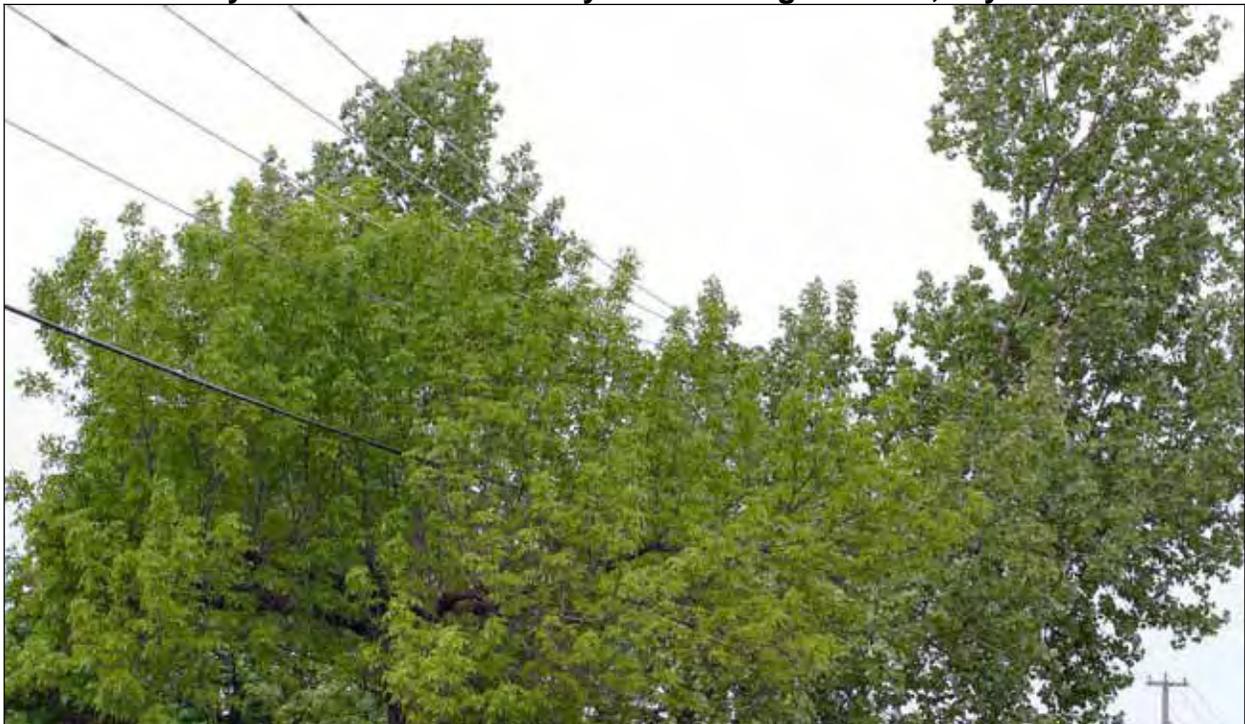
Figure 10 (Photo 06-CE983)
**Ash tree into 3-phase primary,
McHenry Ave. at entrance to Crystal Lake High School, Crystal Lake**

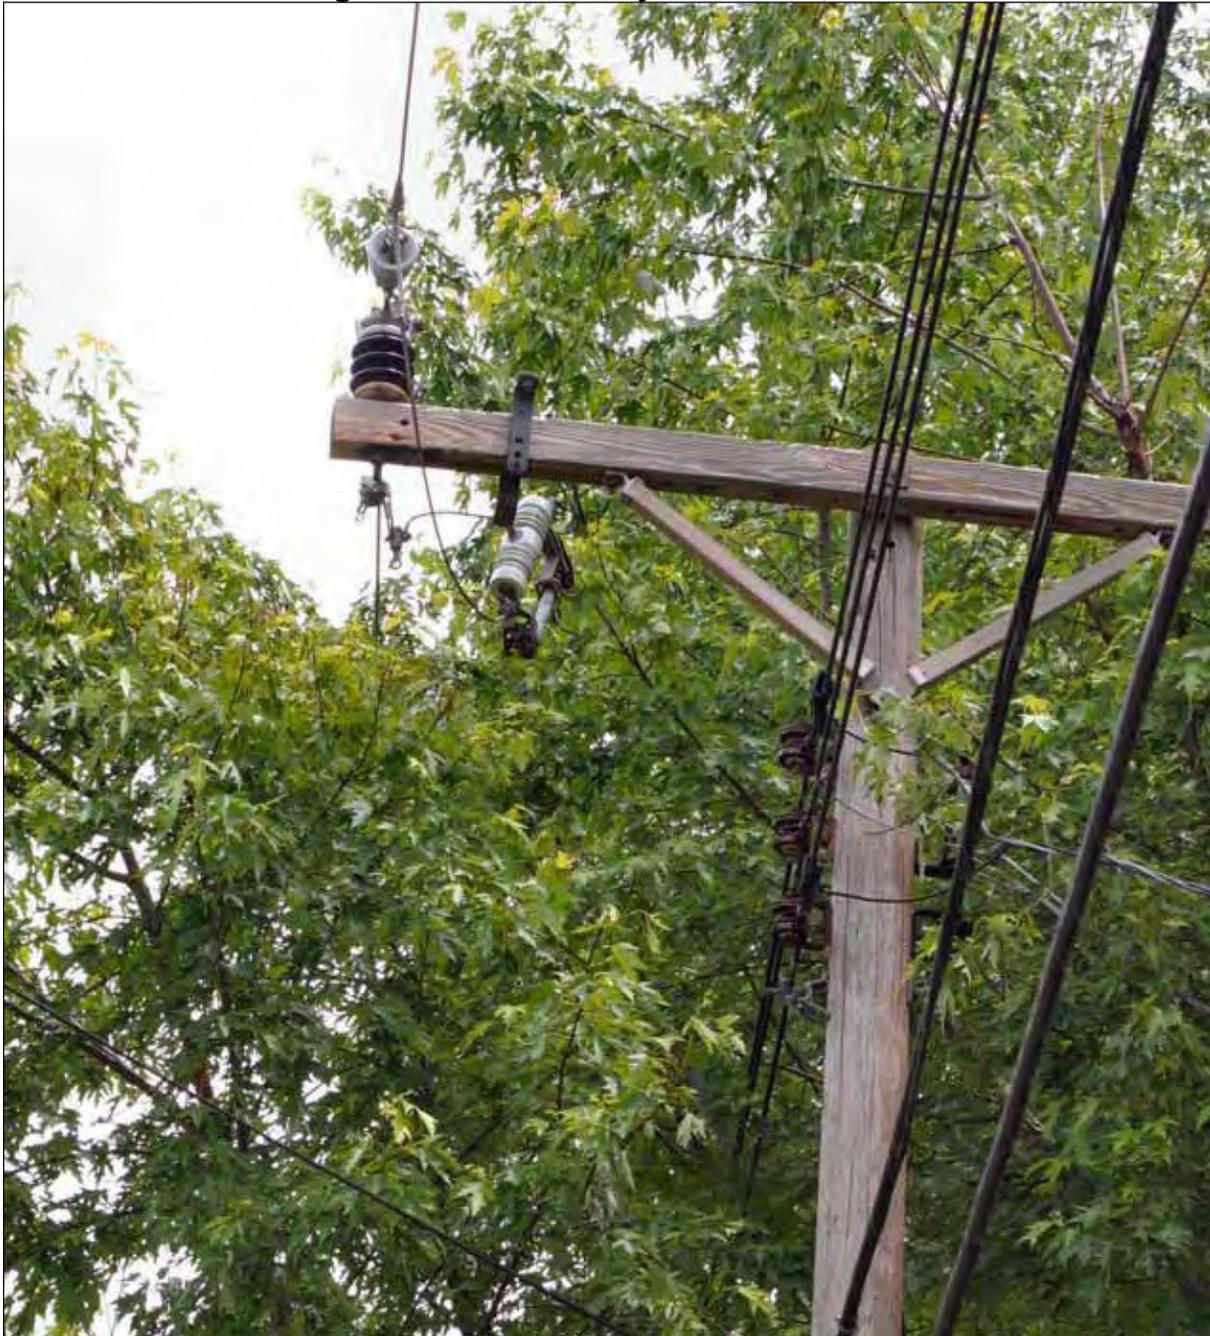
Figure 15 (Photo 06-CE1015)
Single phase primary through soft maple tree,
Chicago St. east of Pennsylvania Ave., Mendota

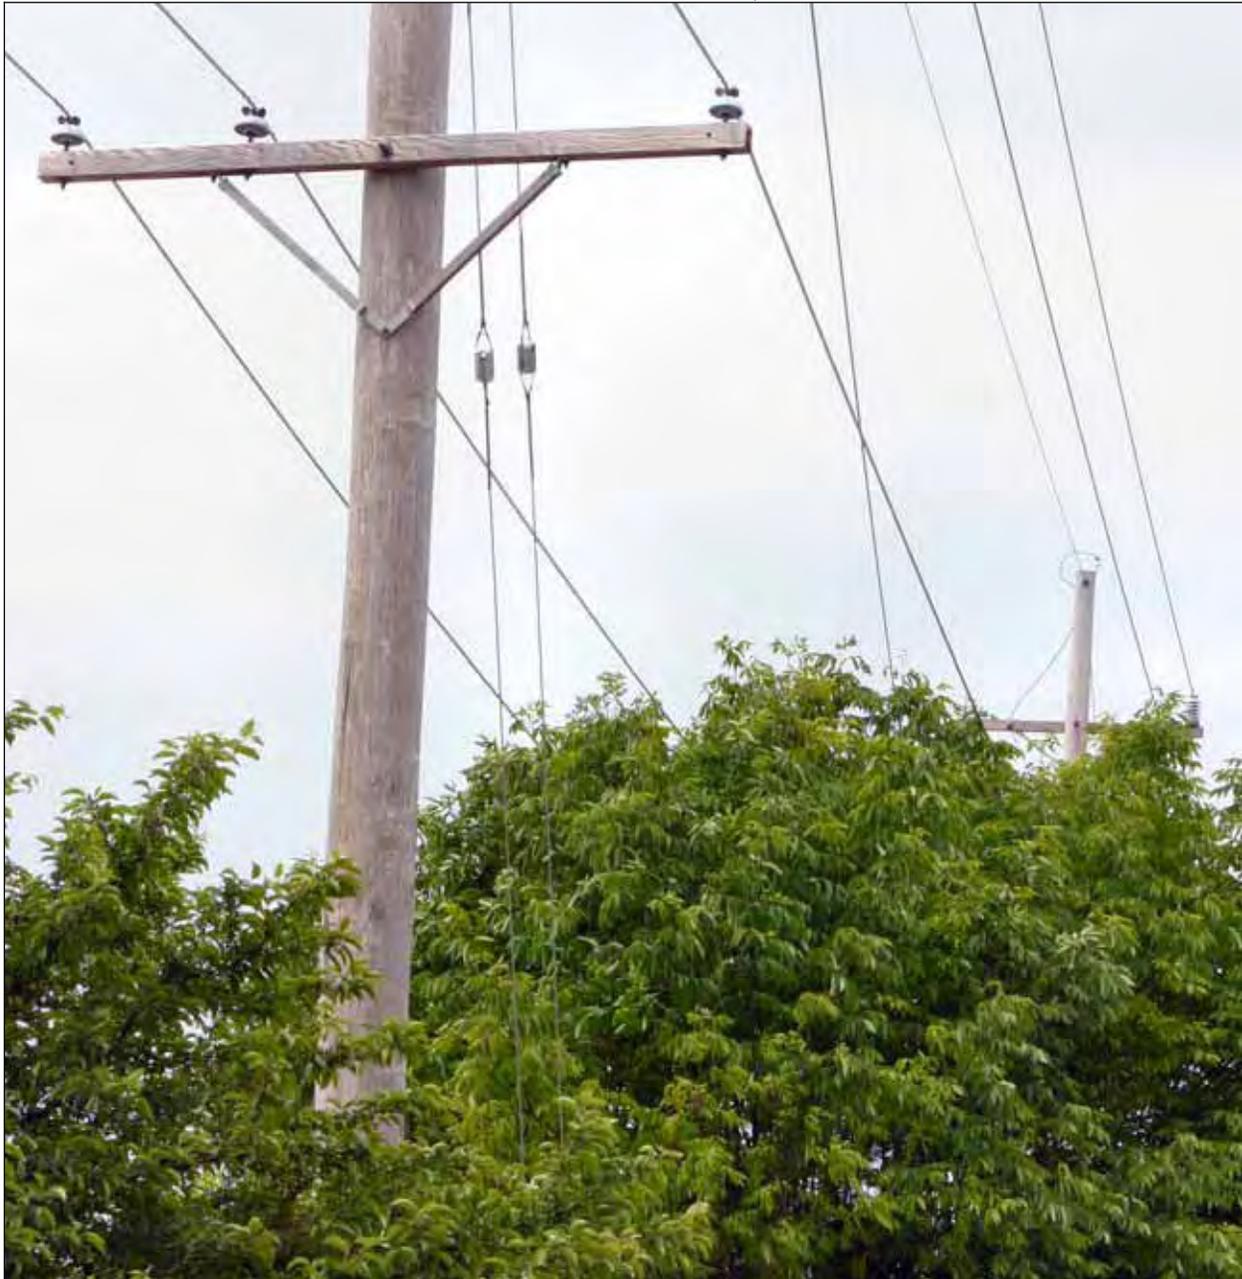
Figure 16 (Photo 06-CE1014)
Ash tree growing into 3-phase primary,
E. Main St. north of 12th St., Mendota

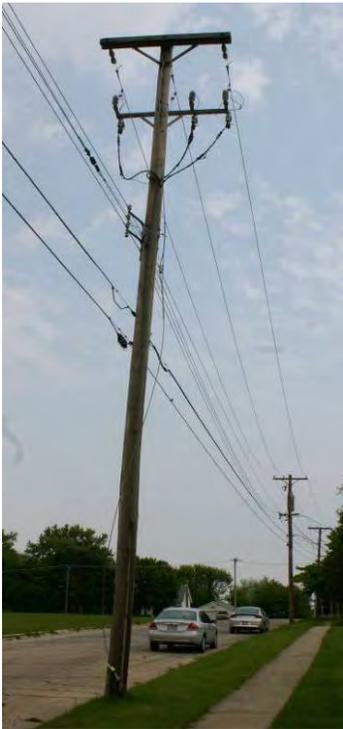
Img-1003 & 1004 – Transformer falling off pole (lower bracket off bolt through pole, upper bracket bent) – Pole #319-28-1A1

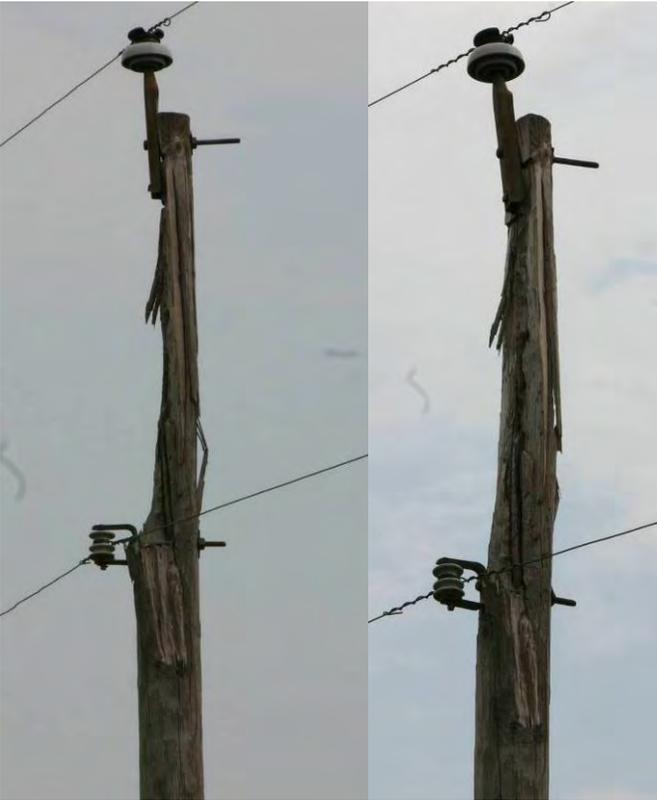
IMG-1008 – Old lightning damage to pole and broken spool in secondary clevis

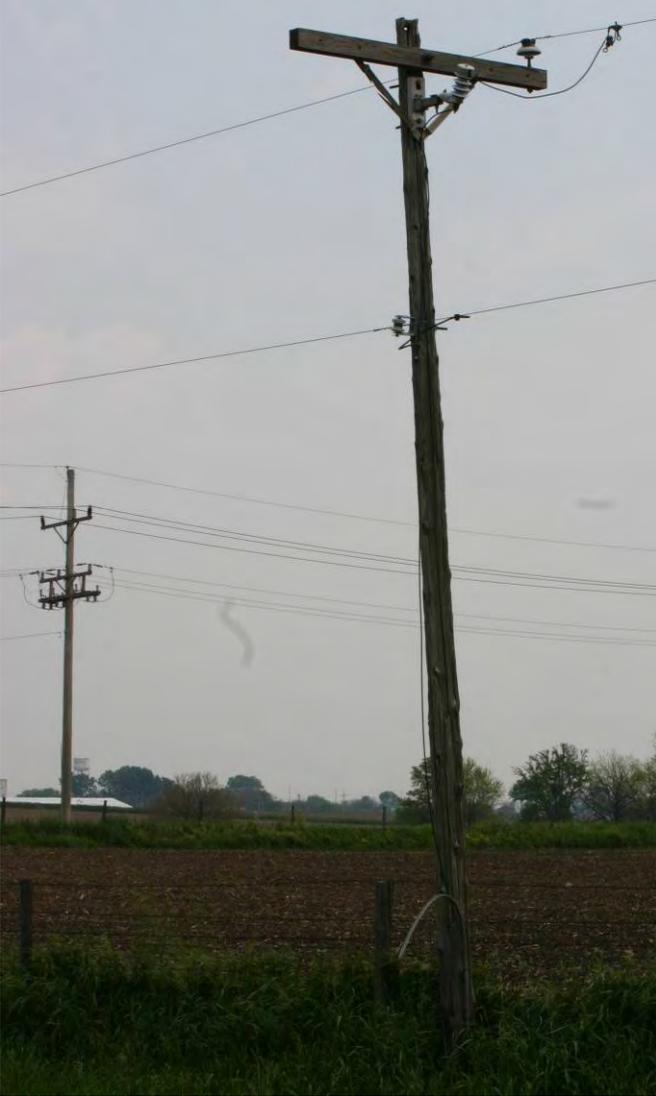
IMG-1009 & 1010 – Badly lightning damaged pole top

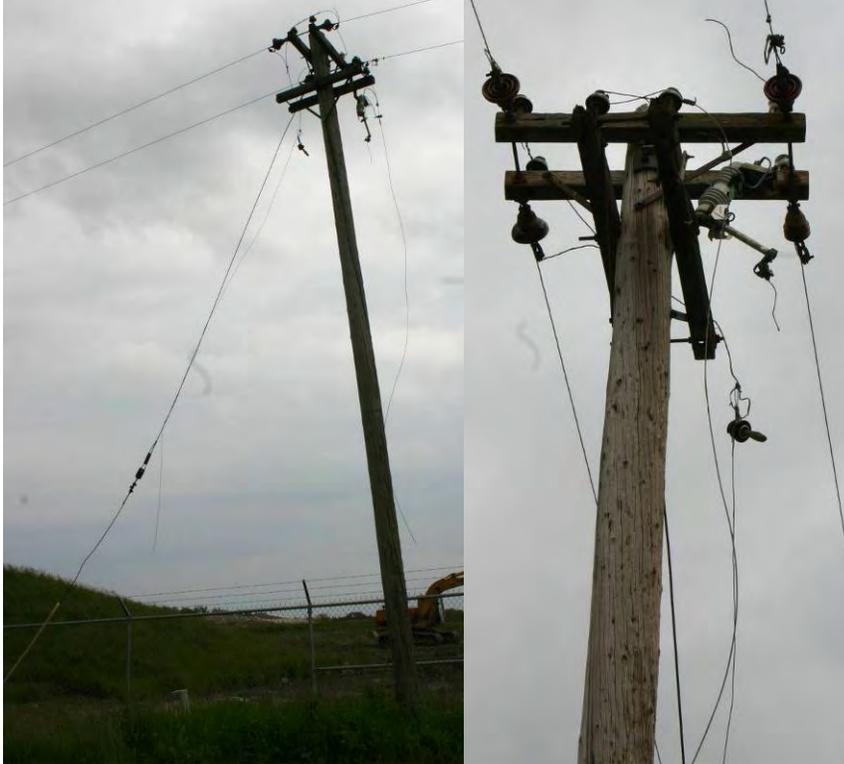
IMG-1028 & 1030 – Unsanitary conditions on pole (unused facilities left hanging on pole)

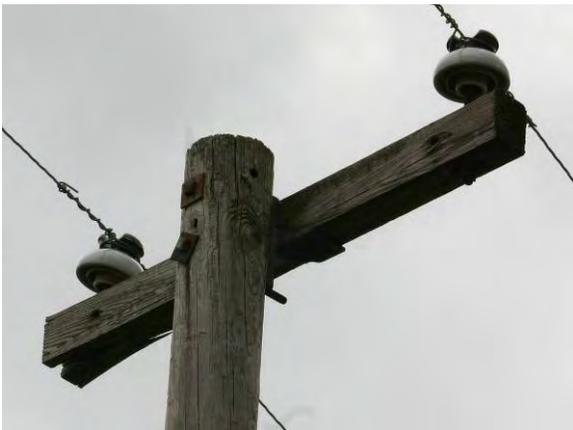
IMG-1032 -- Split crossarm (flagged for replacement)

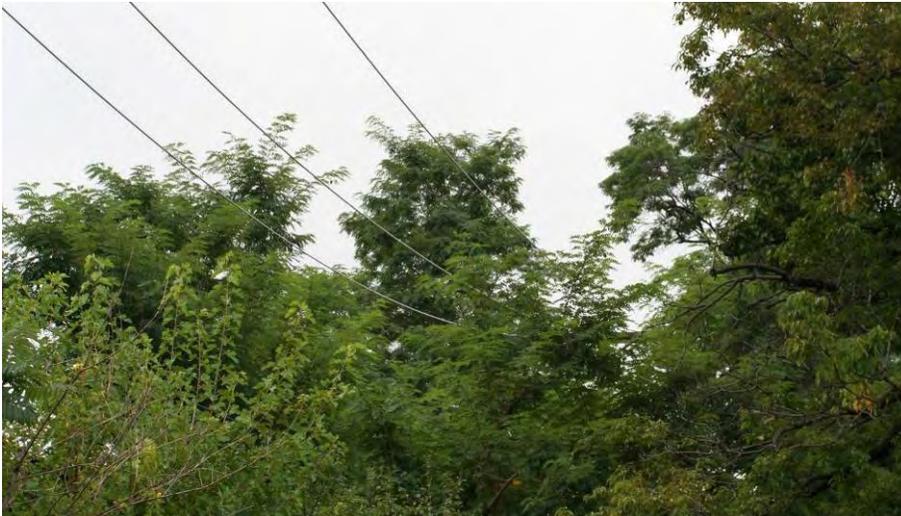
Pic_0062 – Tree contact with primary near corner of Cheese Rd and Oldfield Rd.

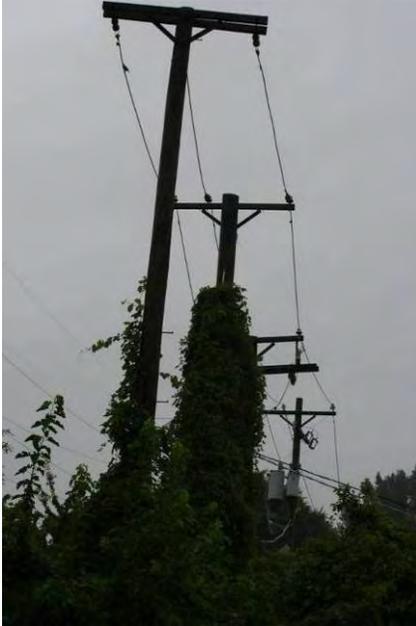
Pic_0071 – Vegetation on poles in ROW near TSS 55. [Hegewich/South Chicago Area]

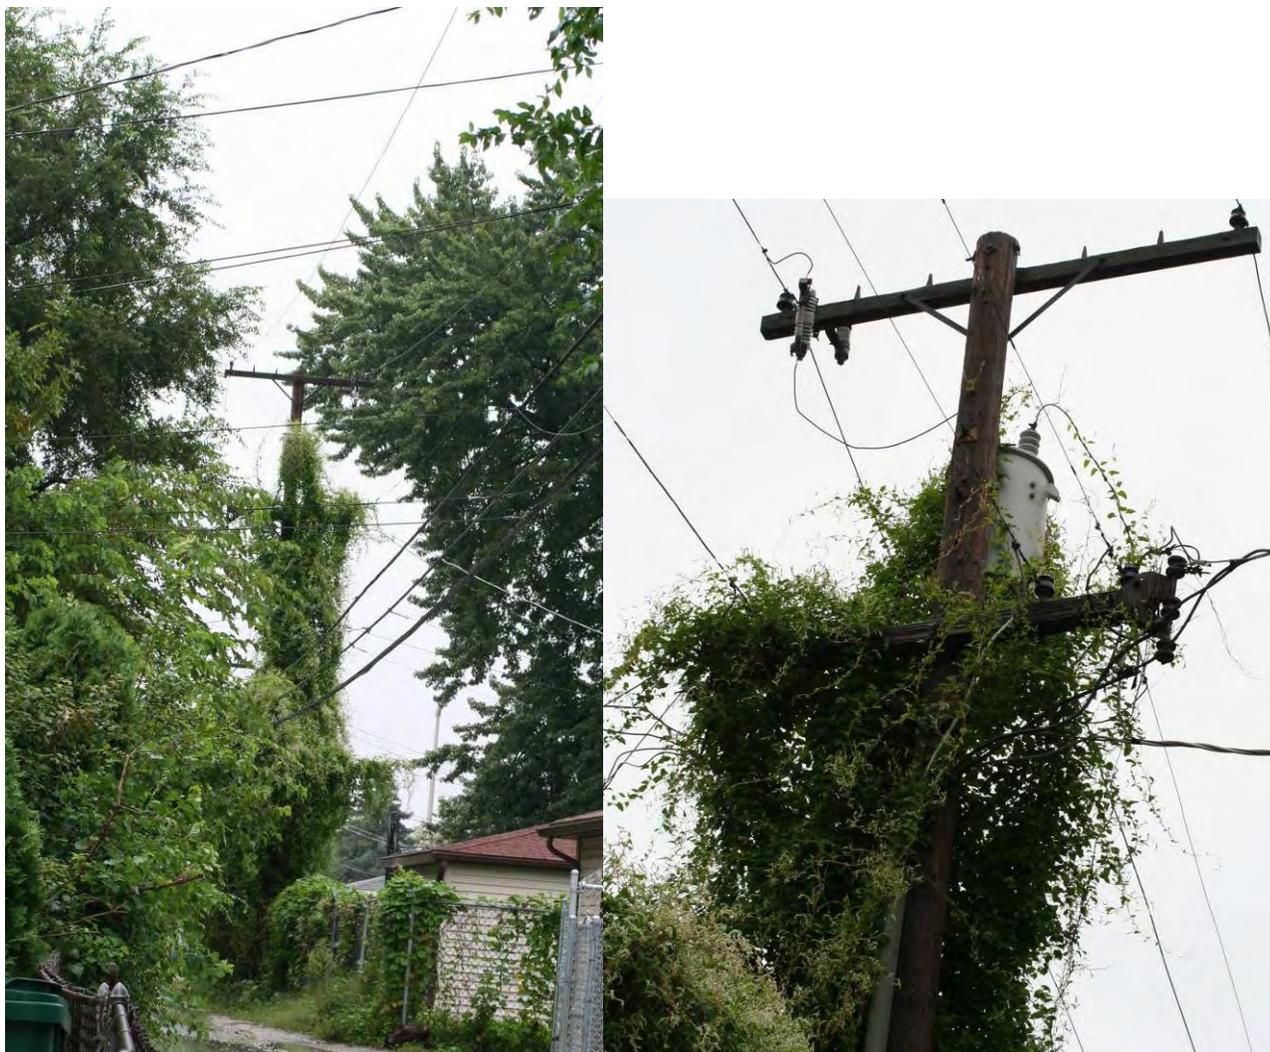
Pic_0080 & 0081 – Vines covering pole and transformer in Calumet City Alley. No animal guard.

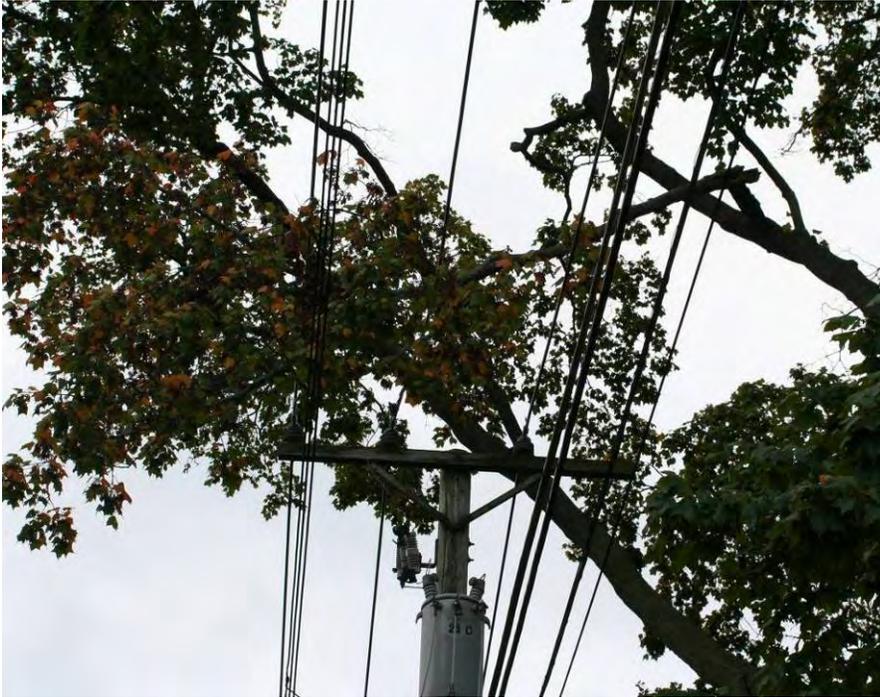
Pic_0088 – Broken overhead branch making contact (laying on) with primary. [Freeport Area]

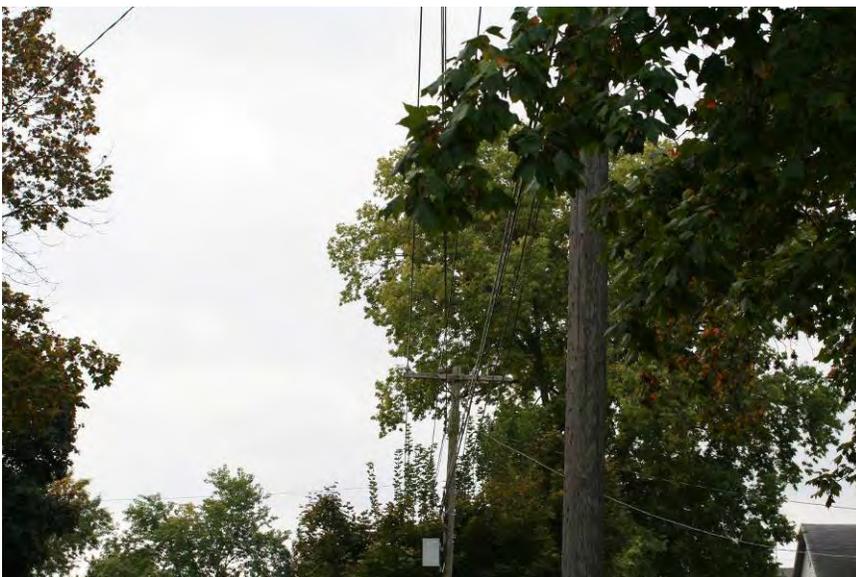
Pic_0089 – Trees close to primary [Freeport Area]

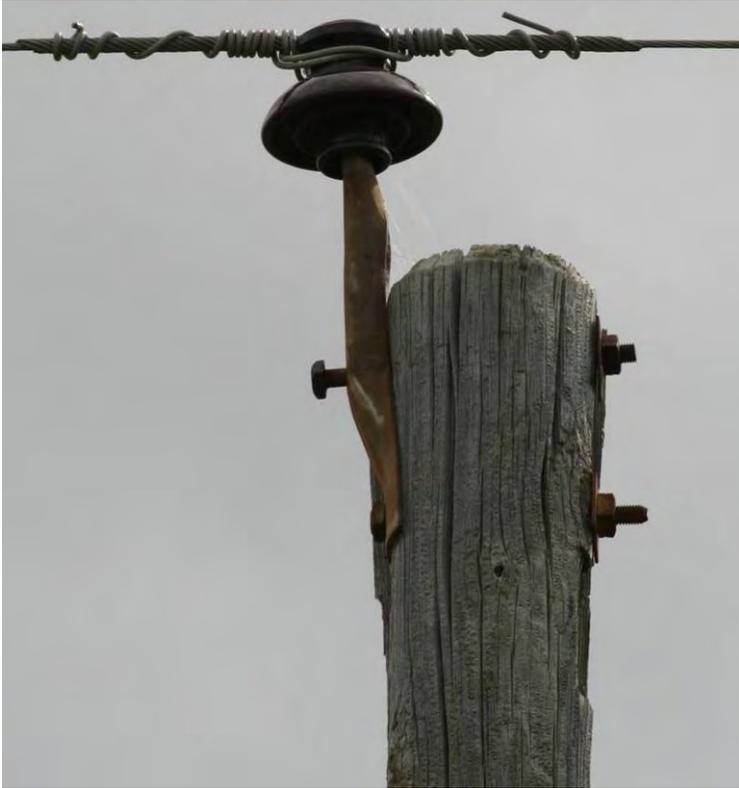
Pic_0121 – Top bolt is loose and poking out but nut is still on back.

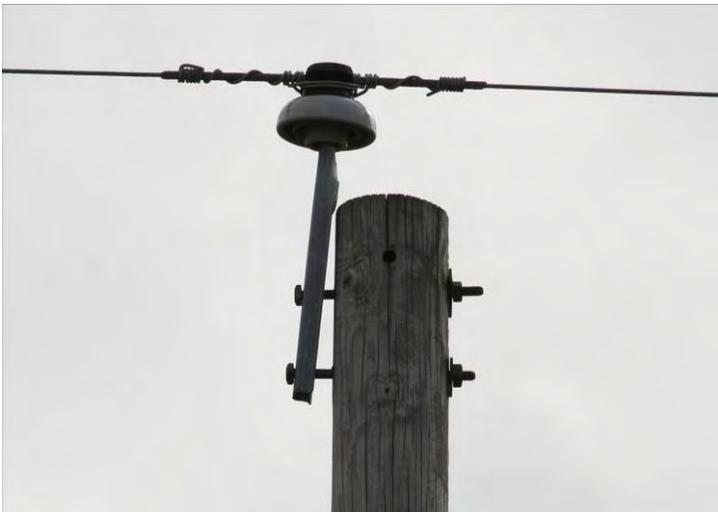
Pic_0123 – Both bolts appear loose.

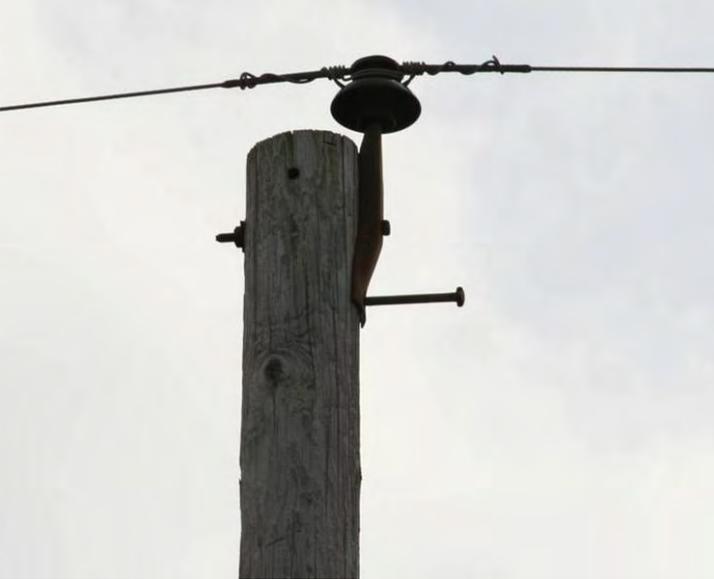
Pic_0124 – Nut is gone and bottom bolt is almost completely out of the pole.

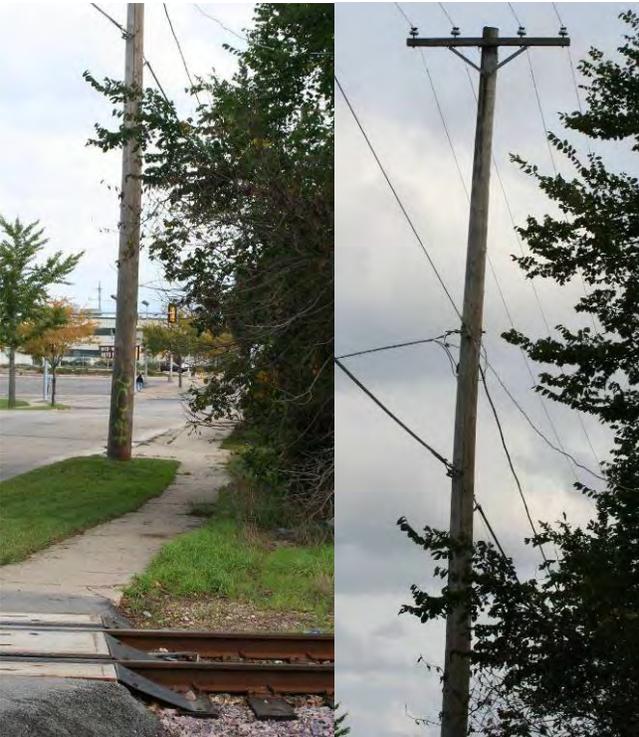
Pic_0125 & 126 – NESC violation seen in a single wood cross-arm supporting a 3 phase primary and neutral on the west side of a rail road crossing in Rockford.

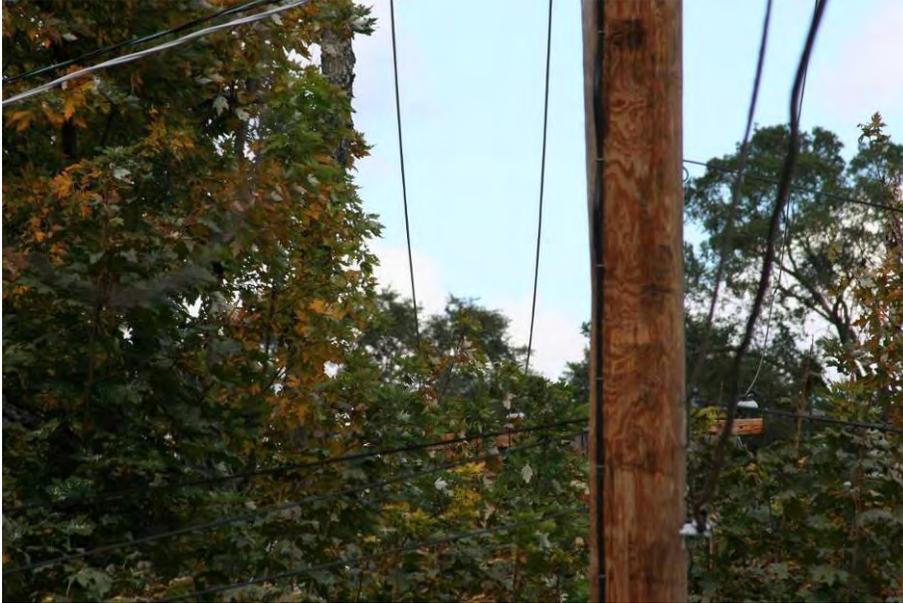
Pic_0158 – Elgin – example of various locations along Sheridan St of trees/vegetation into primary. Note to the left of the primary and partially hidden crossarm is the trunk of a tall dead tree that may be a hazard in the future.

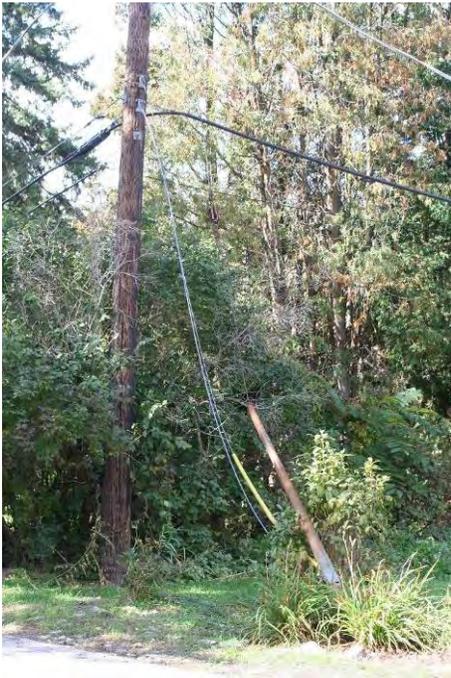
Pic_0162 – Elgin – slack guys in Union St & Sheridan St areas

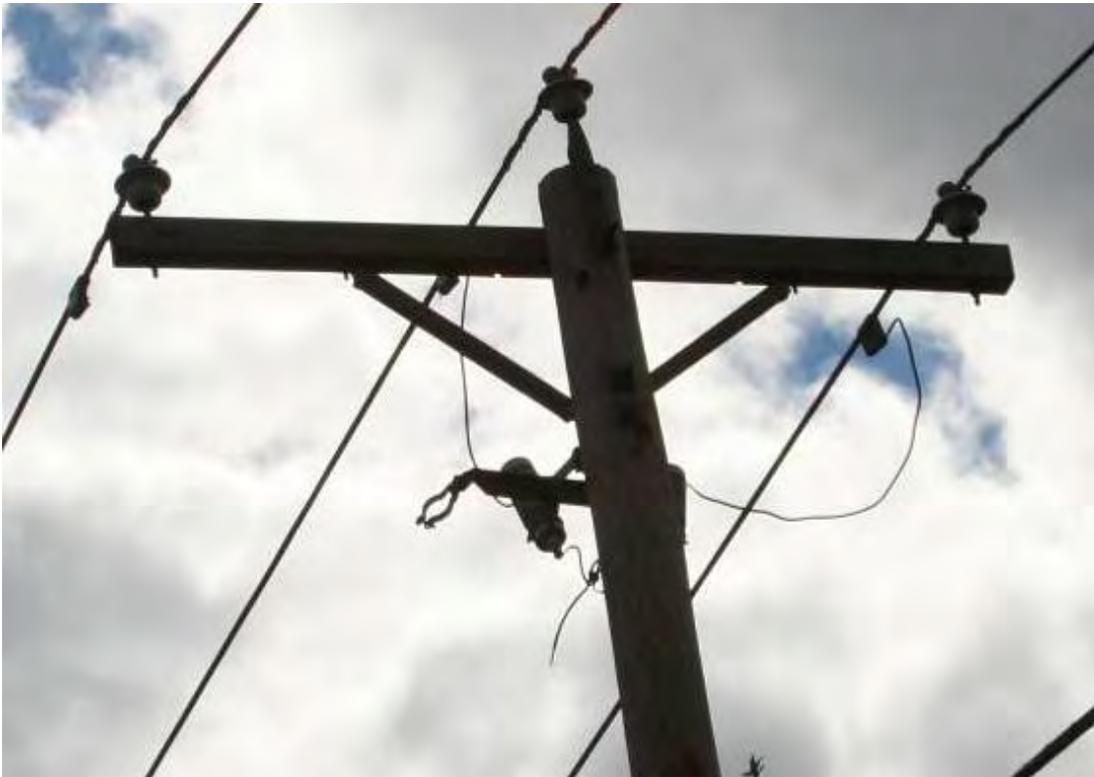
Pic_0165 – Elgin – Center St. Area -- lightning arrester for primary phase on left side is completely blown out of its bracket.

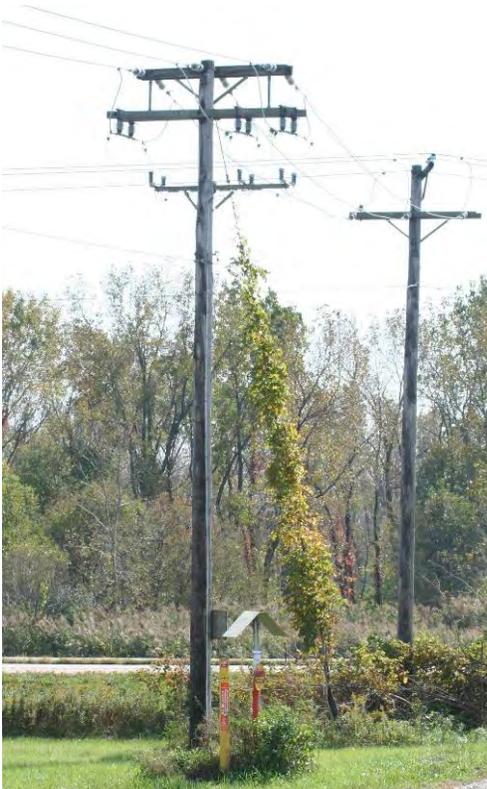
Pic_0192 – vegetation problem noted on the same circuit.

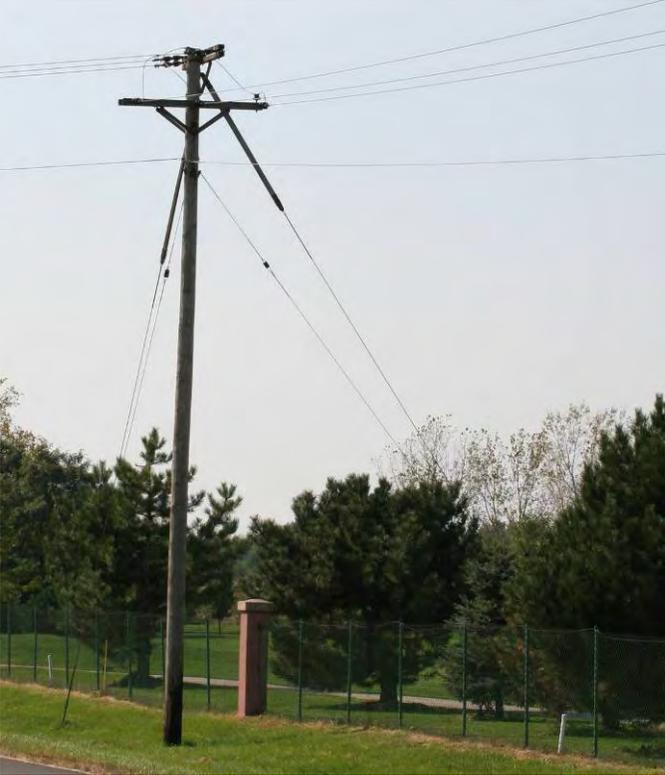
Pic_0195 – location on same circuit at one point where it crosses over Interstate 55 on West side – missing down guy markers.

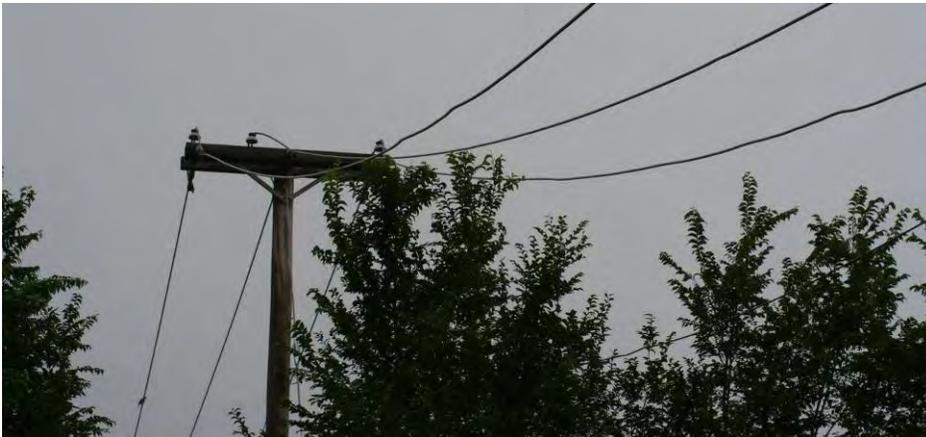
Pic_0037 – near originating substation vegetation was noted close to primary [ComEd Dwg W555—1 of 3]

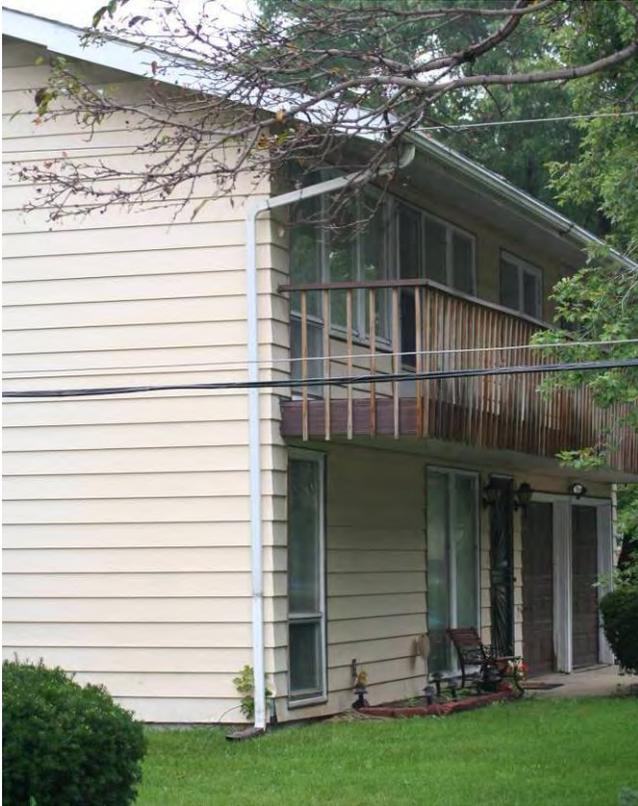
Pic_0039 – Primary looked low but may be OK [ComEd Dwg W550 – 3 of 3]

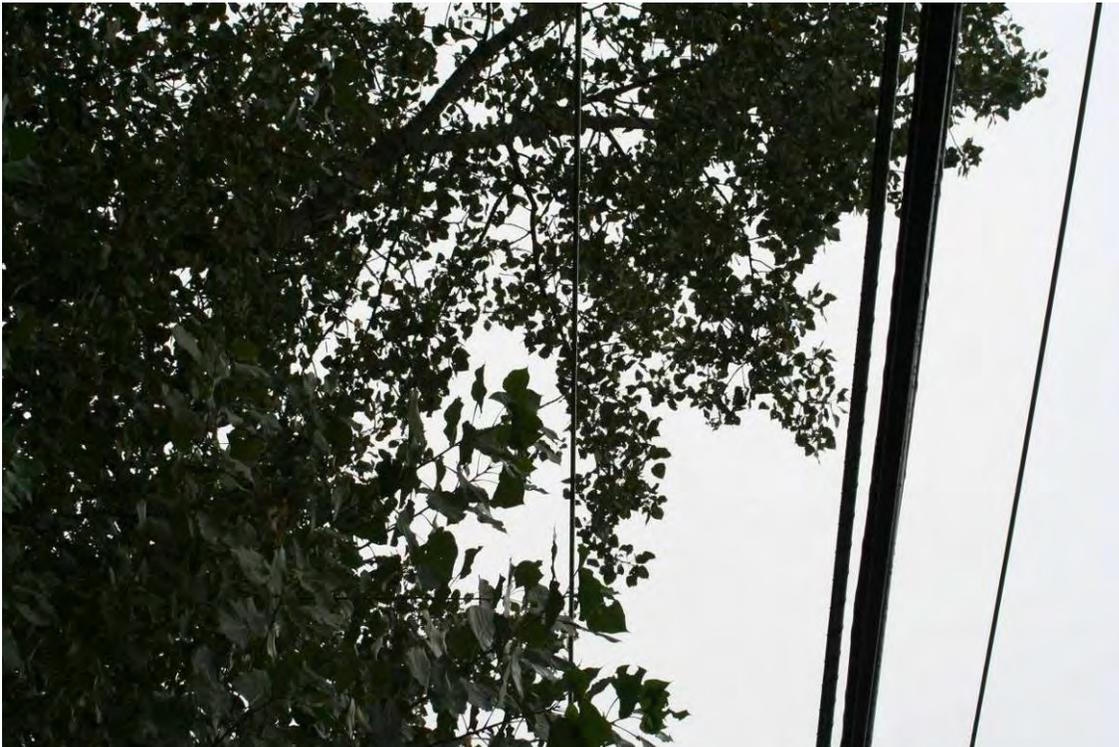
Pic_0040 – Popular tree close to Primary [Dwg W555 1 of 3]

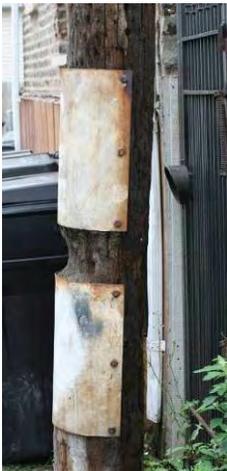
Pic_0049 – pole was worn between protective plates [Dwg Y2568 -- 3 of 3]

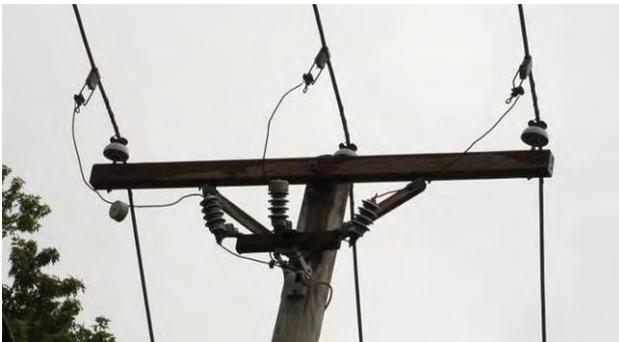
Pic_0056 – Lightning arrester blown on one phase [Dwg D7812 – 3 of 4]

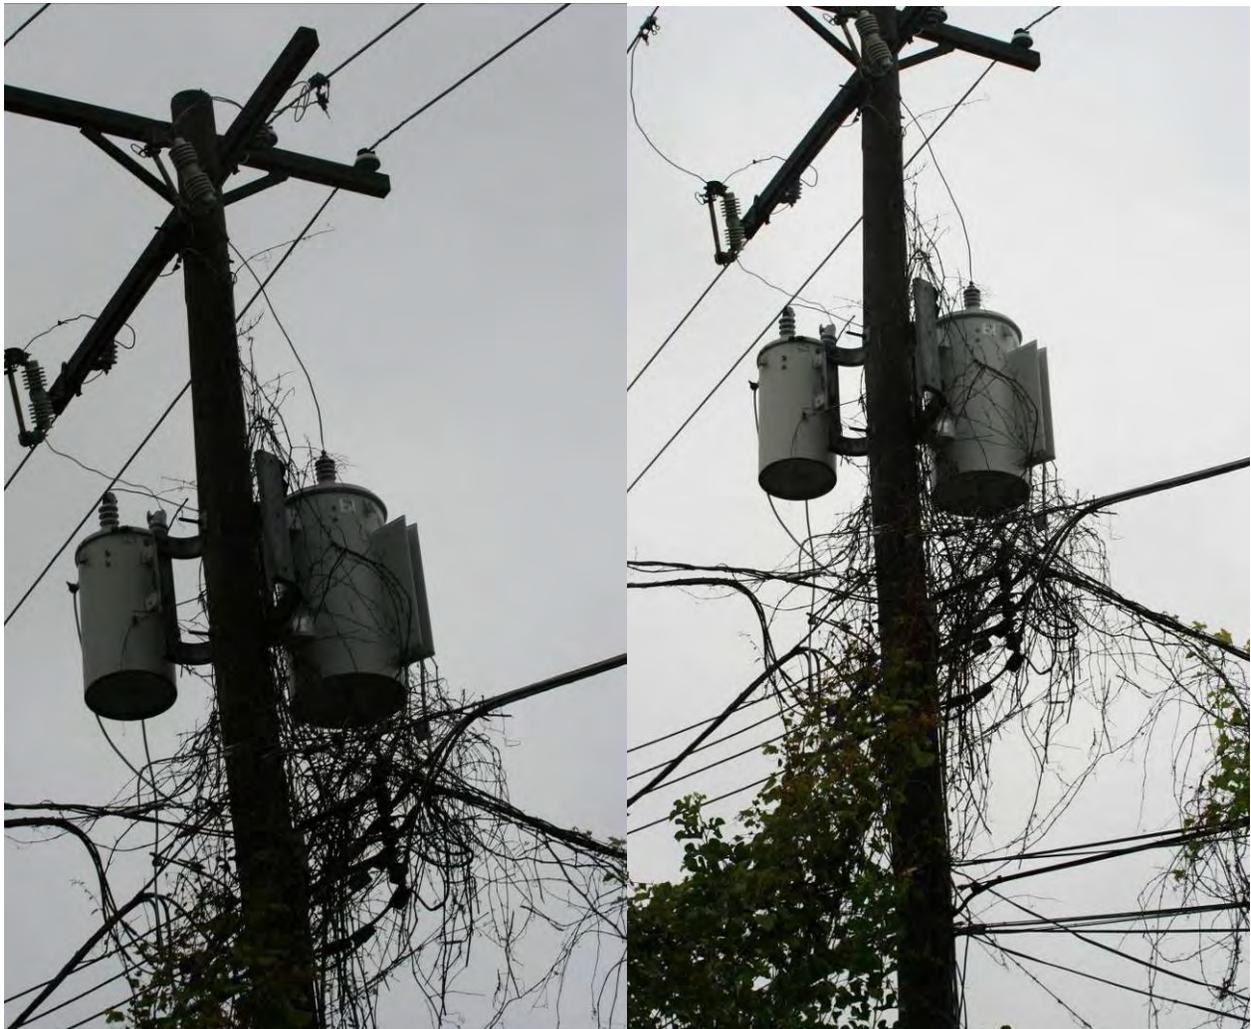
Pic_0065 & 0066 – Newer vines are seen growing up older vines existing on pole and equipment [Dwg G6083 – 2 of 4]

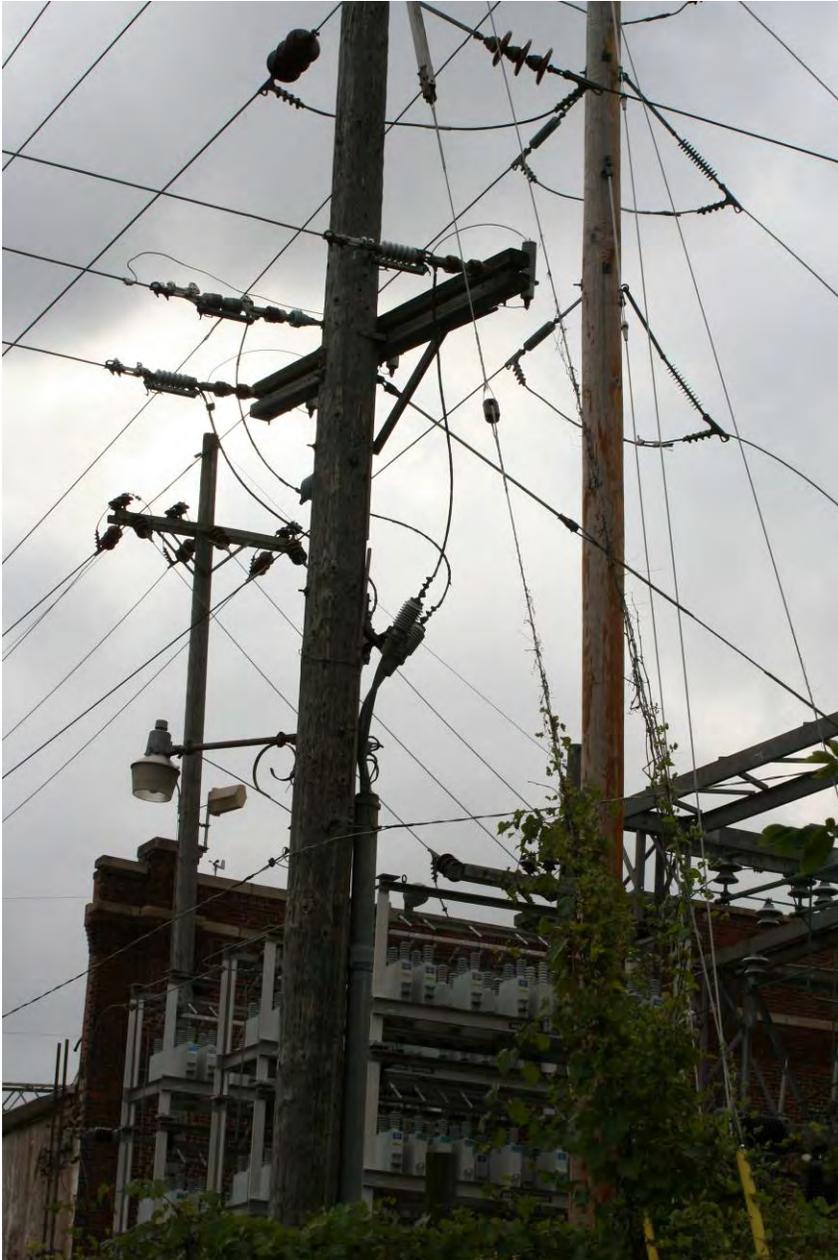
Pic_0097 – Vegetation on guy wires and vegetation on fence surrounding TSS121. DWG B210Y – 1 of 17

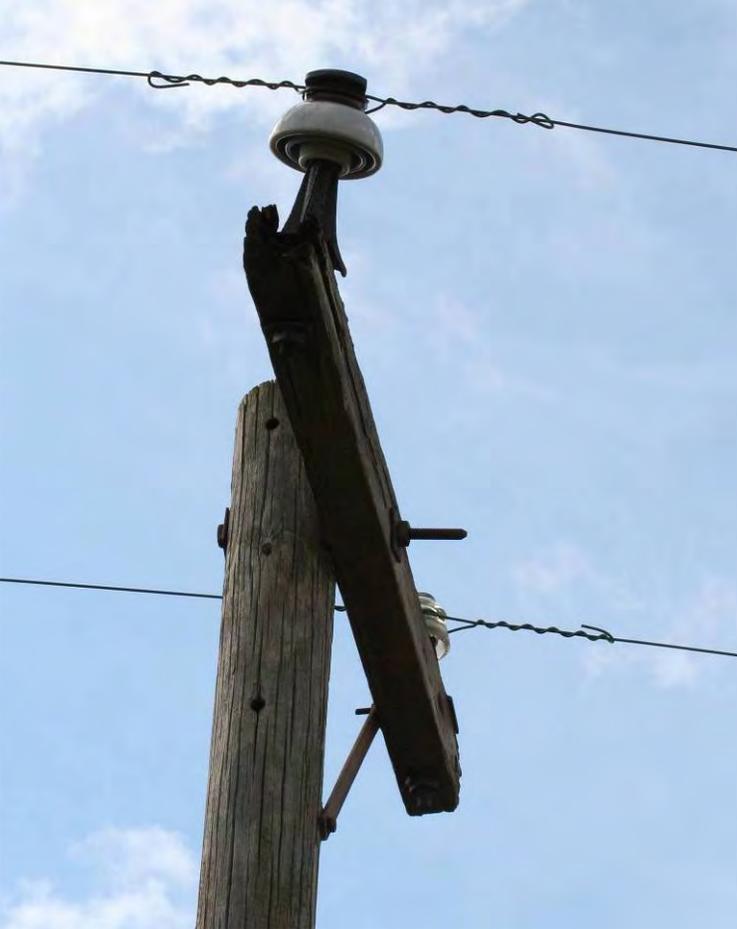
Pic_0099 – Deteriorated crossarm. DWG B210Y – 16 of 17
