Illinois Commerce Commission
Assessment of Commonwealth Edison Company
Reliability Report and Reliability Performance
for Calendar Year 2005

Pursuant to 83 Ill. Adm. Code 411.140

March 20, 2007

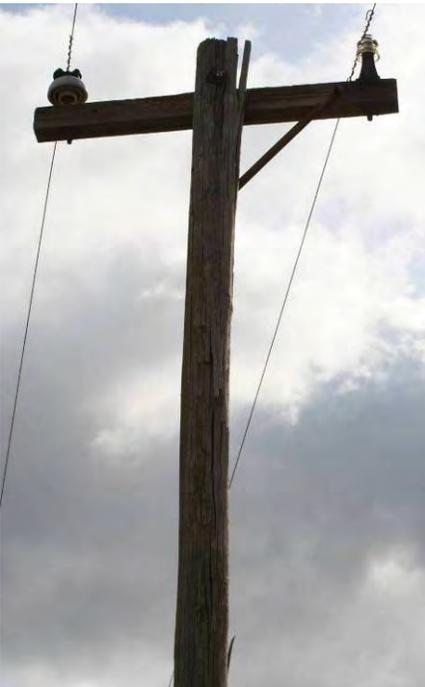
Pic_0100 – Splitting at pole top and possible shell rotting. Dwg B210Y – 16 of 17

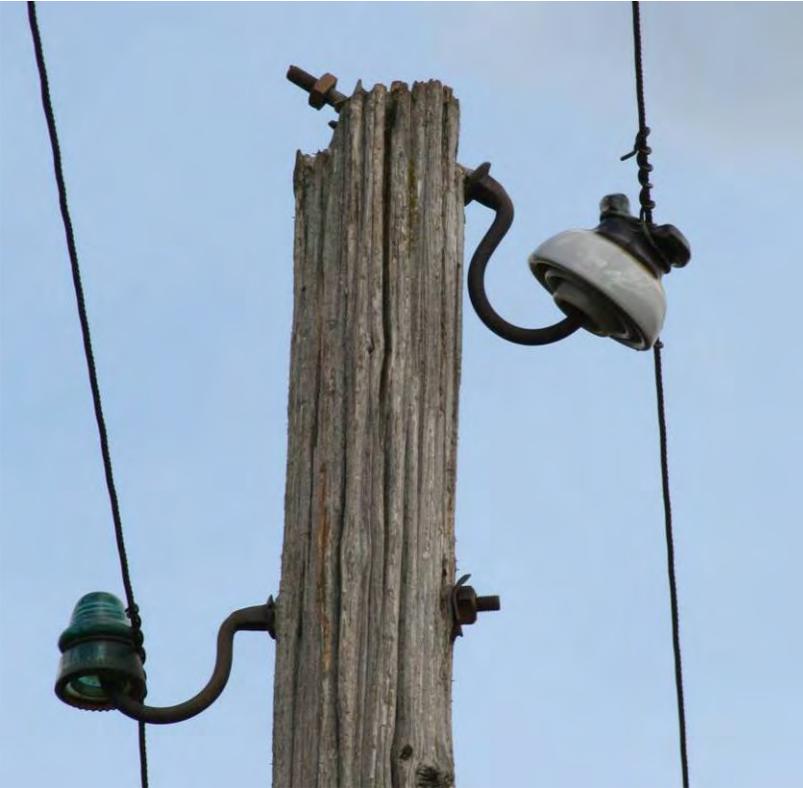
Pic_0102 – Primary phase conductor is in apparent imminent danger of falling -- Loose support bracket for Primary insulator and deteriorated pole top. Dwg B210Y – 16 of 17

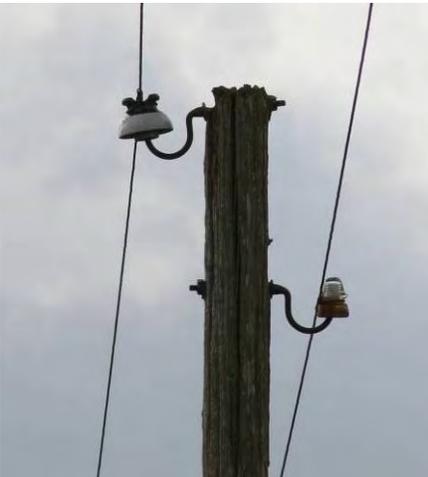
Pic_0103 – Primary phase conductor is in apparent imminent danger of falling -- deteriorated pole top. Dwg B210Y – 16 of 17.

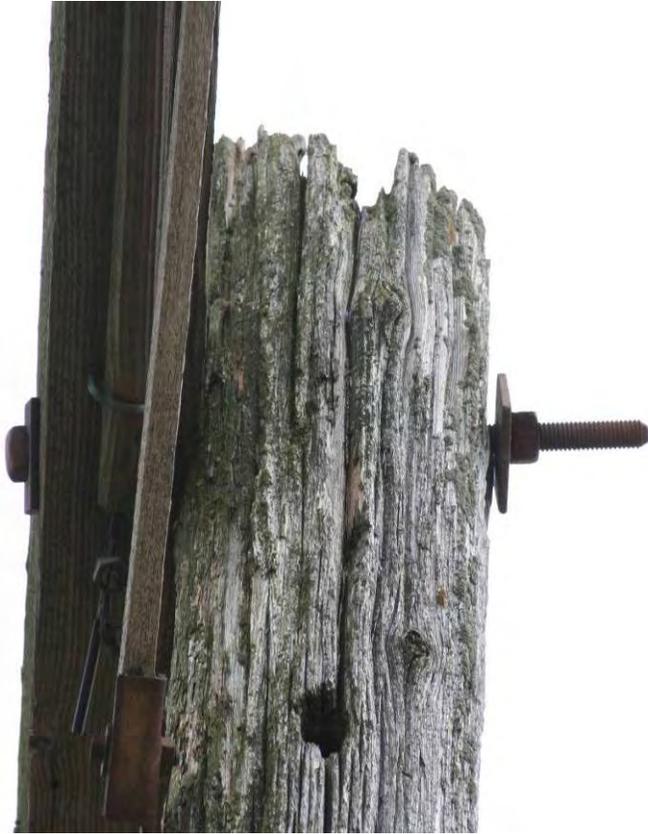
Pic_0106 – Loose bolt/washer supporting crossarm. Badly deteriorated pole top. Dwg B210Y – 12 of 17

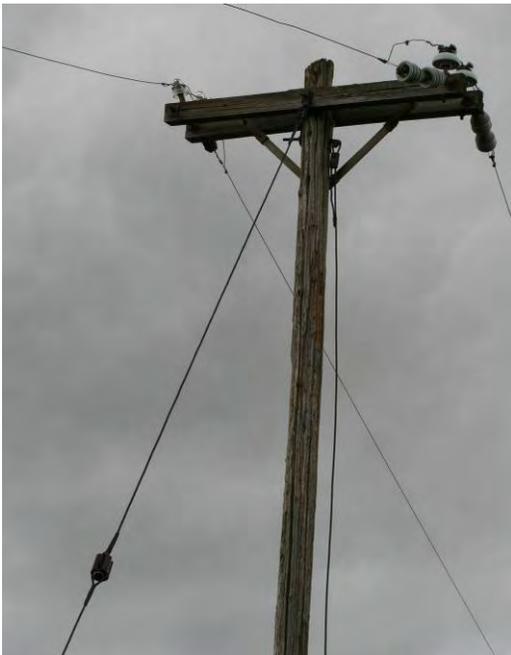
Pic_0109 – Broken guy wire hanging loose. Shell rotted pole. Dwg B210Y – 12 of 17

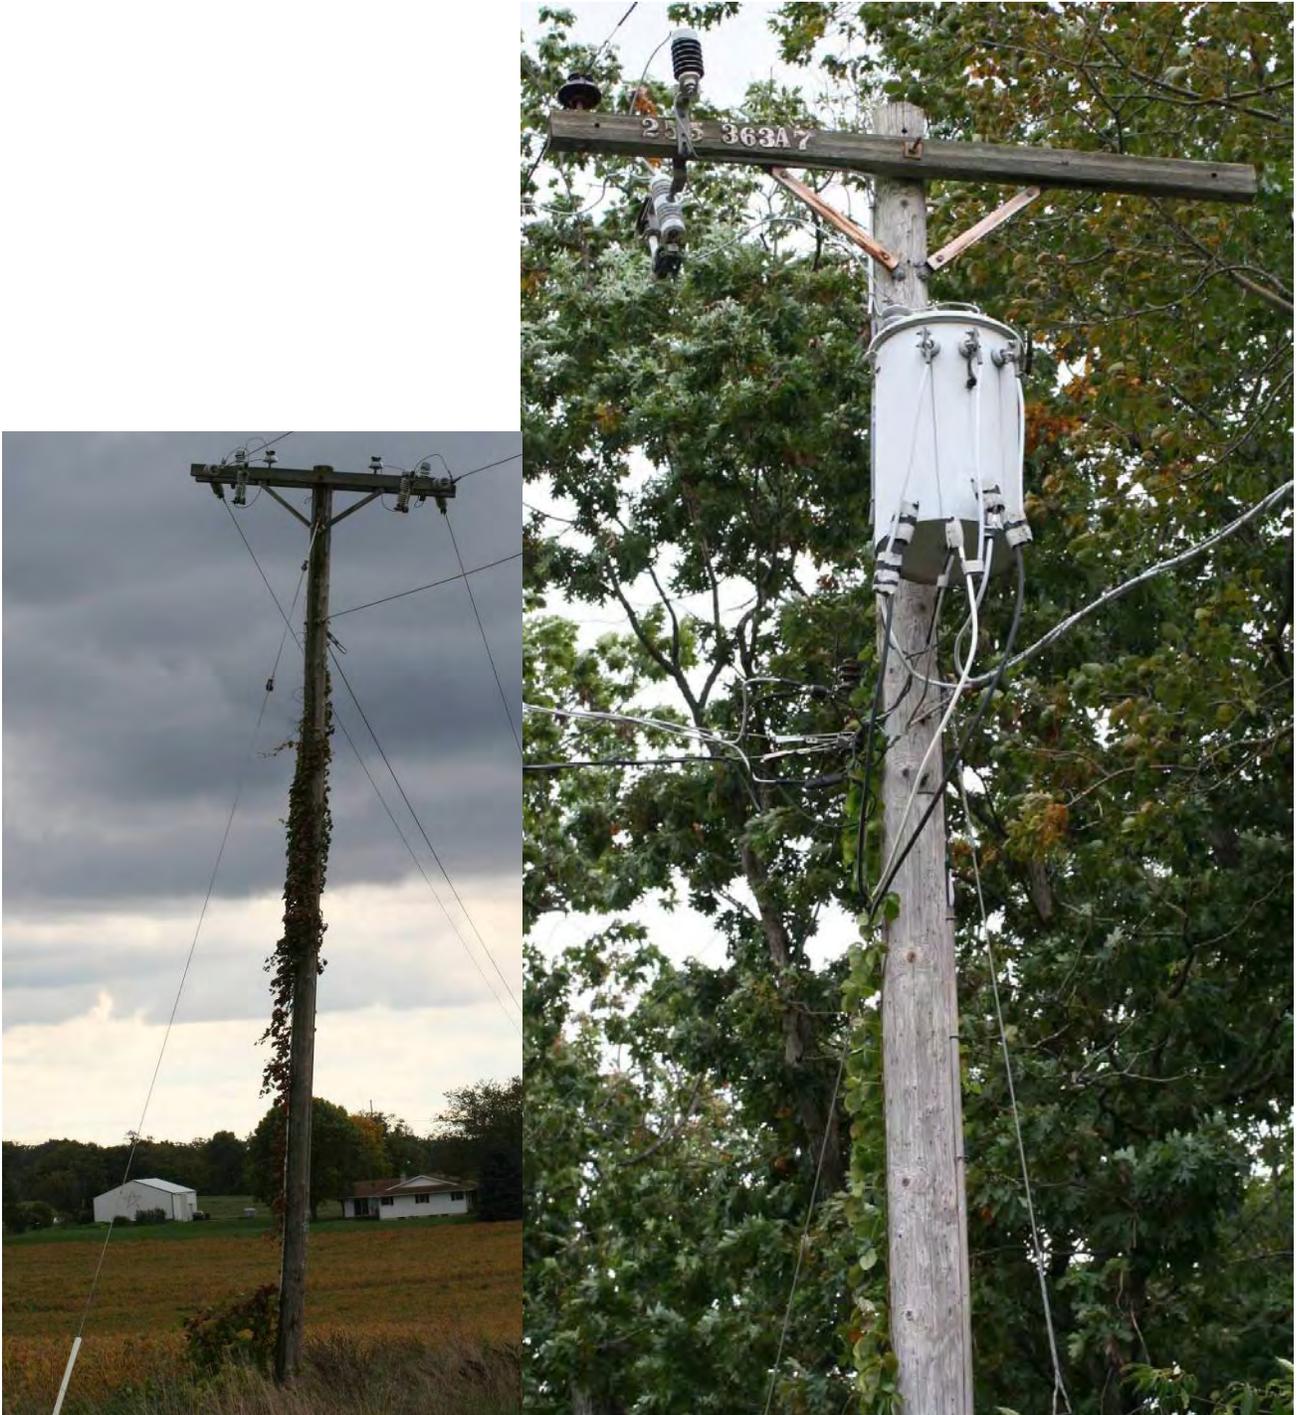
Pic_0110 & Pic_0111 – Vegetation growing up pole. Dwg B210Y – 10 of 17 and Dwg B210Y – 6 of 17

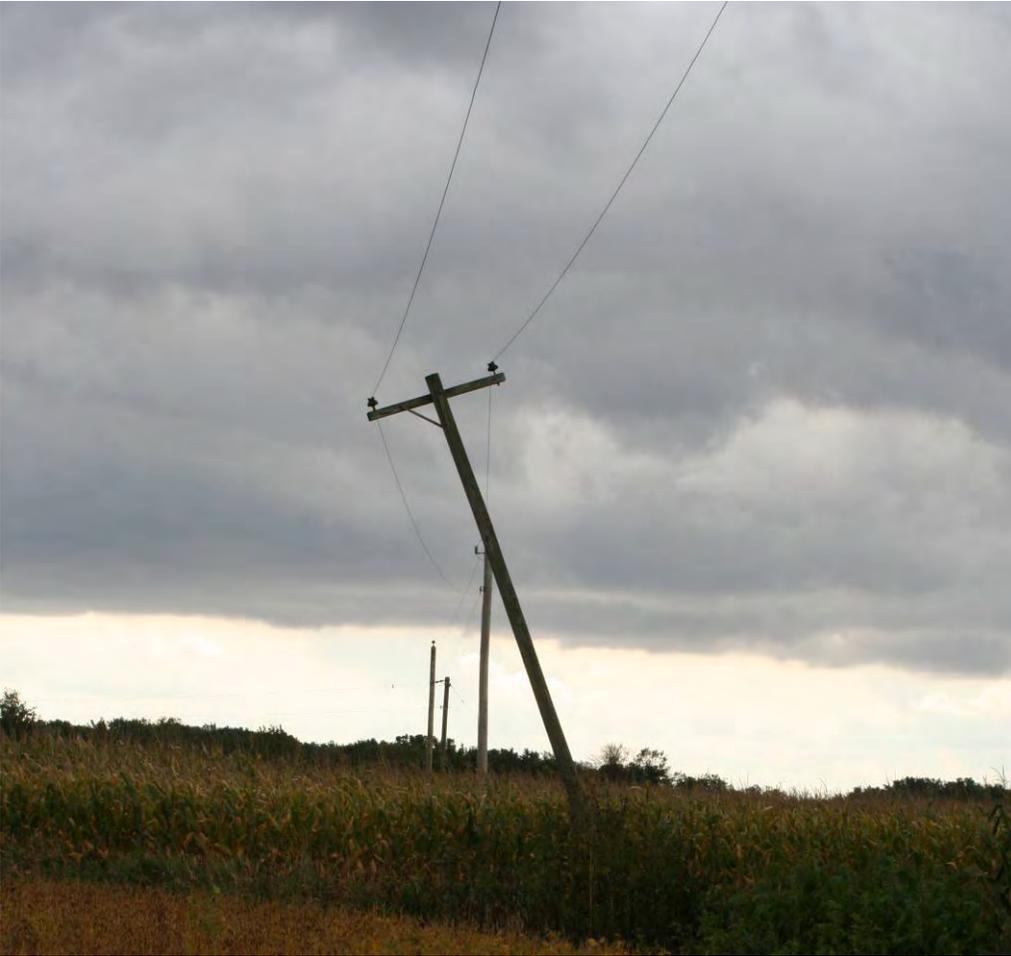
Pic_0116 – picture taken from between leaning poles and towards roadway. Dwg B210Y – 6 of 17.

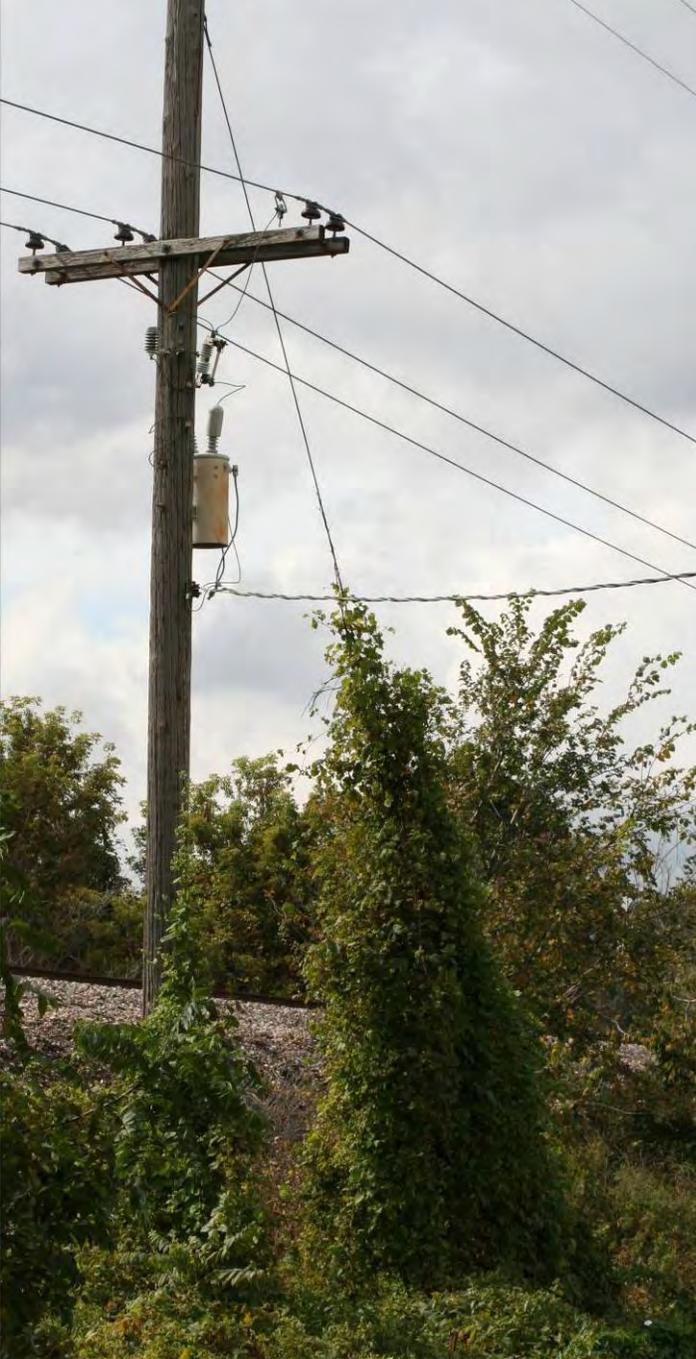
Pic_0117 – Vegetation growing up guy wire and pole. Note animal guard on transformer.
Dwg B210Y 5 of 17

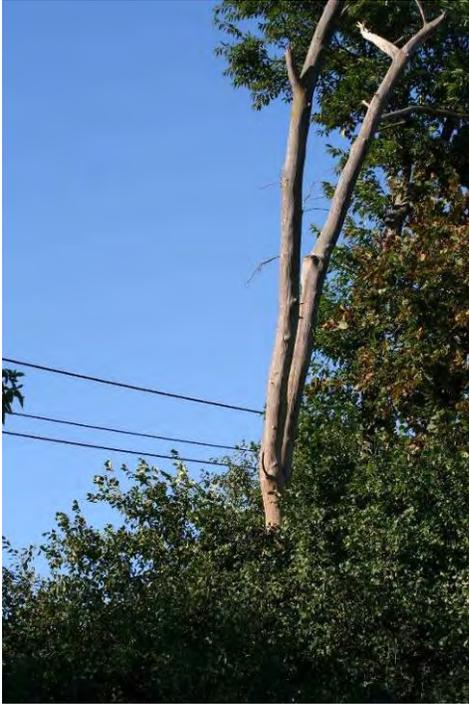
Pic_0140 – hazard/dead tree near primary. Dwg W7217 1 of 7

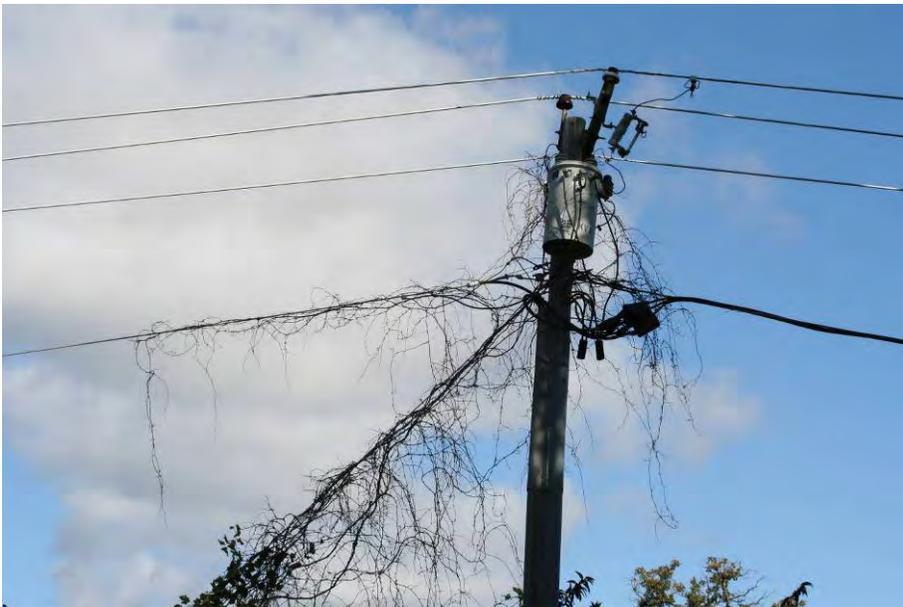
Pic_0155 – Another location where new growth is beginning to replace dead vines on a pole and transformer. Dwg W7217 4 of 7

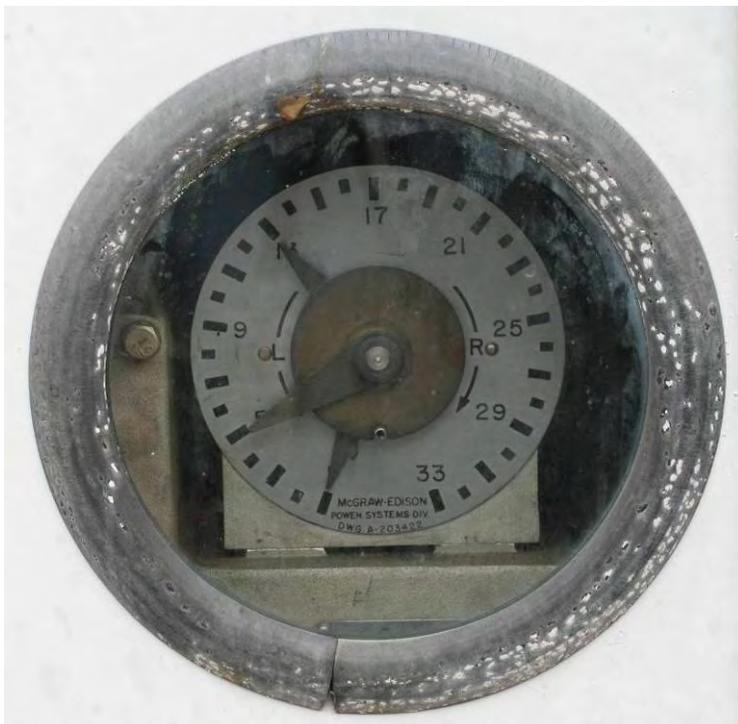
Appendix D has photos and comments from Staff inspections of two substations. Staff has found few notable deficiencies. On a few occasions Staff observed that load tap changers (“LTC”) had been operated at extreme positions which could over time tend to wear of the equipment sooner and require more attention from personnel in order to maintain reliable operation. ComEd personnel at the substation were aware this and appeared to be taking appropriate actions. Where LTC’s have been operating at the extremes, either high or low, may be an indication of excessively high or low voltages experienced by customers. Staff will continue to closely follow developments in this area.

Pic_0242 – This indicates the range that the load tap changer has operated on transformer 71 recently [and is currently operating]. Ideally one would expect or prefer the limits to be more centered on the scale in order to optimize the value of the tap changer to control distribution voltage and minimize maintenance requirements for the tap changer itself.

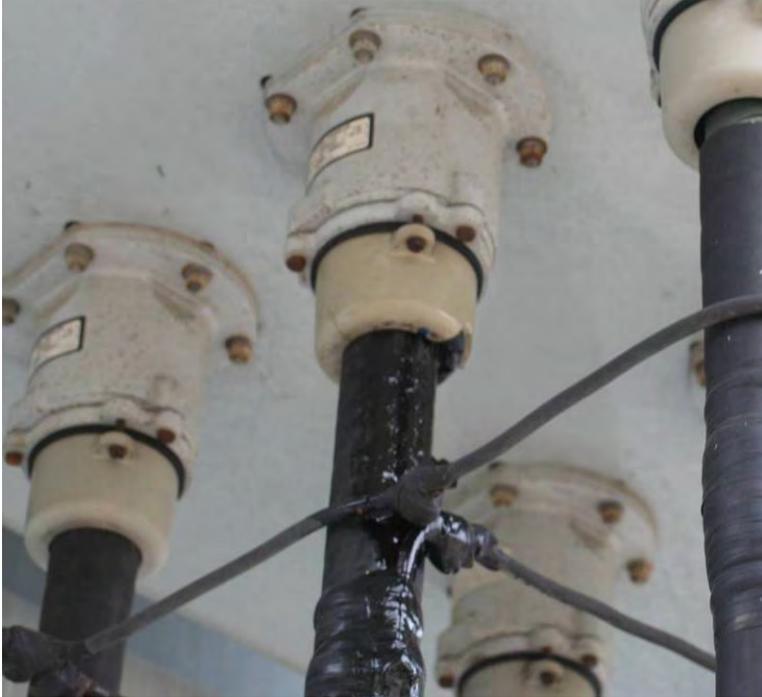
Pic_0291 – Oil leak on secondary of Transformer 74.

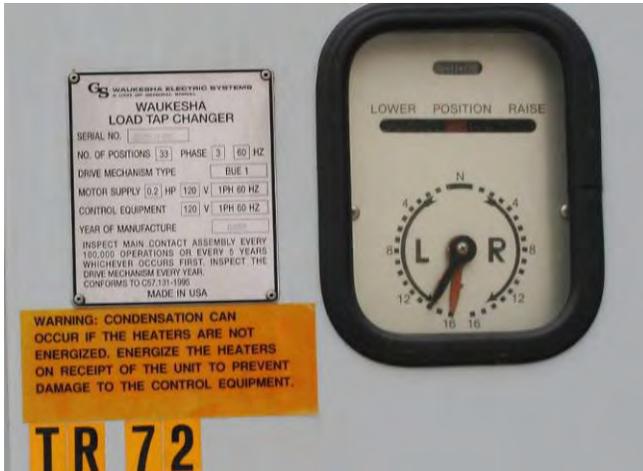
Pic_0301 – On transformer 72 the range of operation is at the very lower end of the load tap changer.

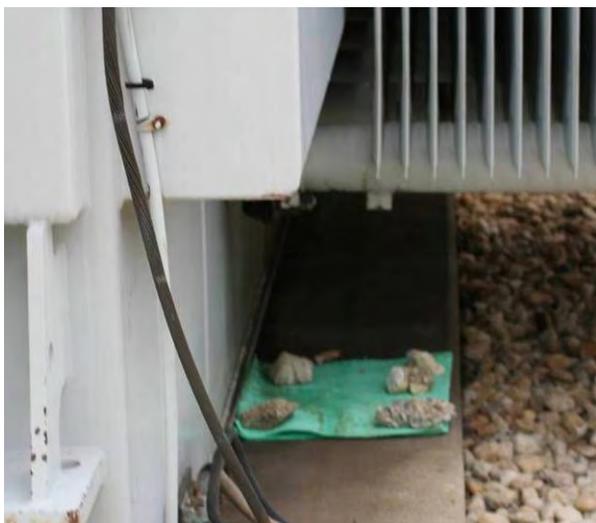
Pic_0303 – Absorbent paper set out to catch a slow oil leak.
