Illinois Commerce Commission
Assessment of Mt. Carmel Public Utility Company's
Reliability Report and Reliability Performance
for Calendar Year 2005

Pursuant to 83 Ill. Adm. Code 411.140

December, 2006

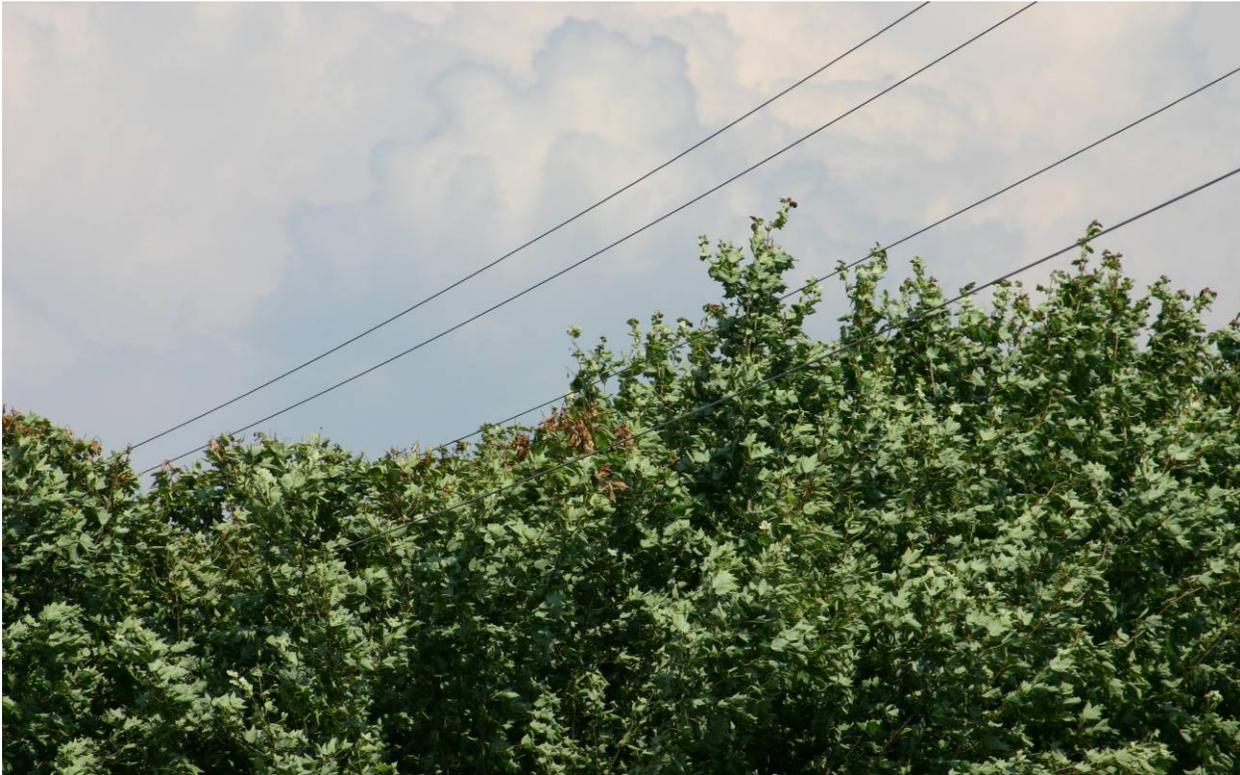
fifteen locations. Six of these locations Staff found trees or vines growing near or into the primary conductor(s). Considering this circuit was reported to be on its three year cycle tree trimming schedule Staff did not expect to find this many tree related problems during the inspection of the circuit. Staff recommends Mt. Carmel continue its three year tree trimming cycle and improve its coverage to reduce the number of missed trees.

Photo #1
On Highway 11 east of E700 Road
Tree into conductors

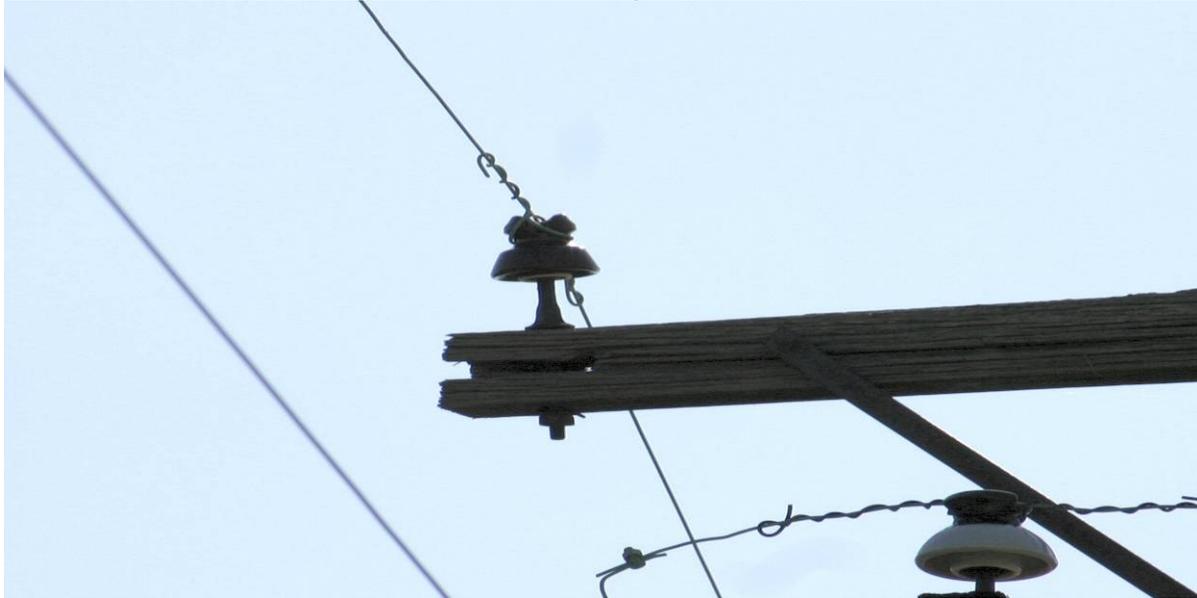
Photo #2

Of the remaining nine locations found during the field inspection of this circuit, six were poles and/or hardware were found to be in bad or deteriorated condition, two were areas that Mt. Carmel should consider adding lightning arresters, and the last location was an area that additional animal protection should be considered.

At N2100 Lane & E1000 Road north of Mt. Carmel
Weathered and split crossarm

Mt. Carmel needs to address all of the problems noted during Staff's circuit inspections.

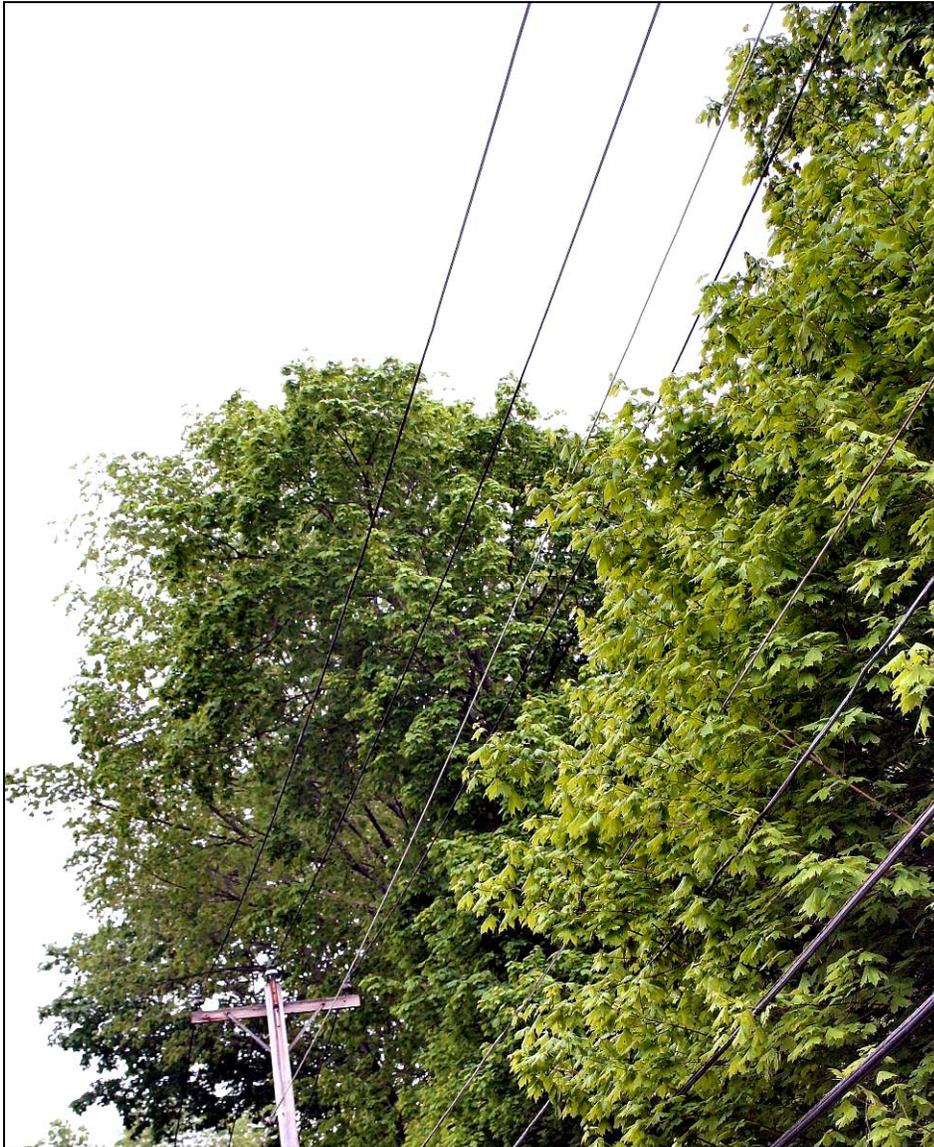
Figure 1 (Photo 06-MtC944)

Soft maple tree very close to 3-phase primary, Cherry St. between 12th & 13th Sts.

- Mt. Carmel should address all of the remaining tree conflicts in the City of Mt. Carmel, which were either missed or inadequately trimmed when scheduled.

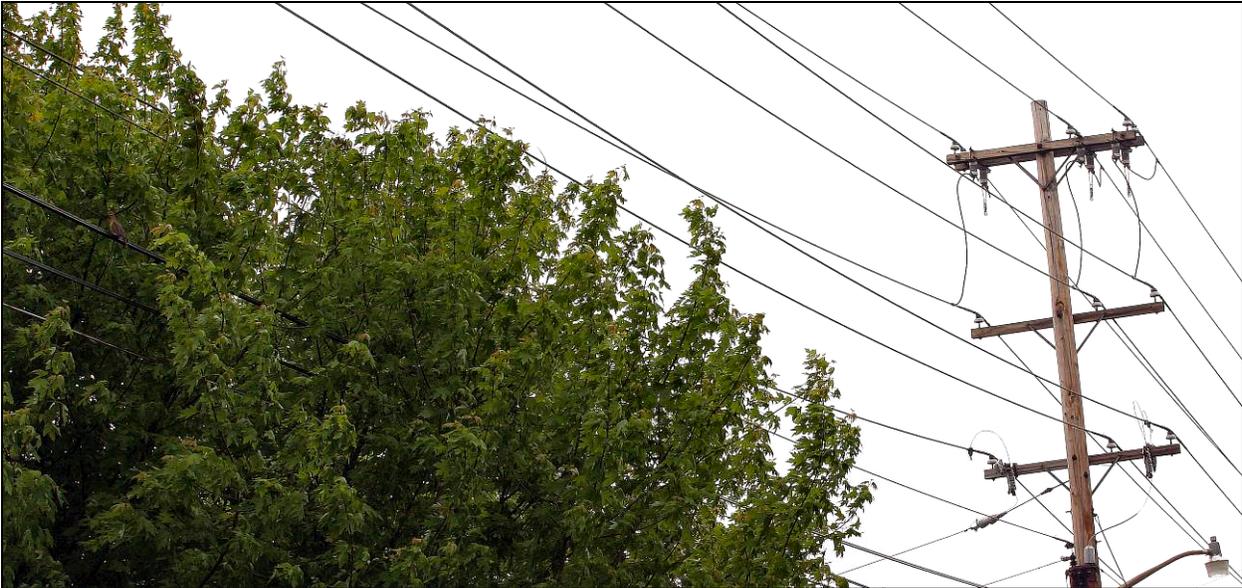
Figure 2 (Photo 06-MtC945)

Soft maple tree into 3-phase primary (main feeder 1 block from 11th St. Substation), 11th St. west of Hillcrest Dr.

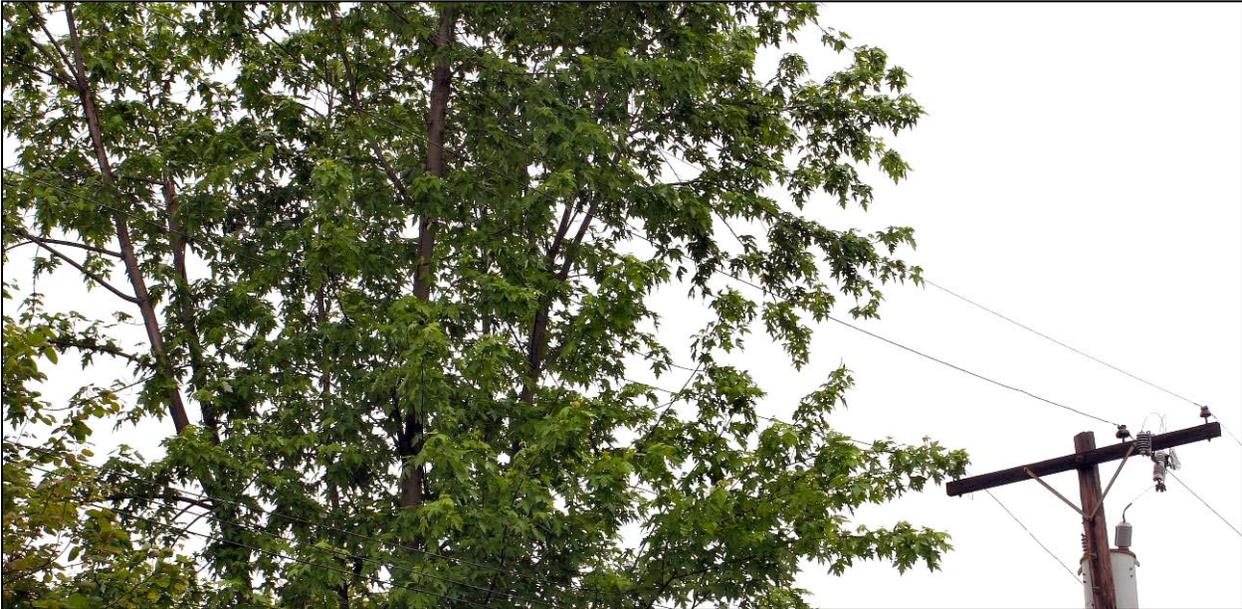
Figure 3 (Photo 06-MtC946)

Soft maple tree into 3-phase primary, Pear St. north of 9th St.

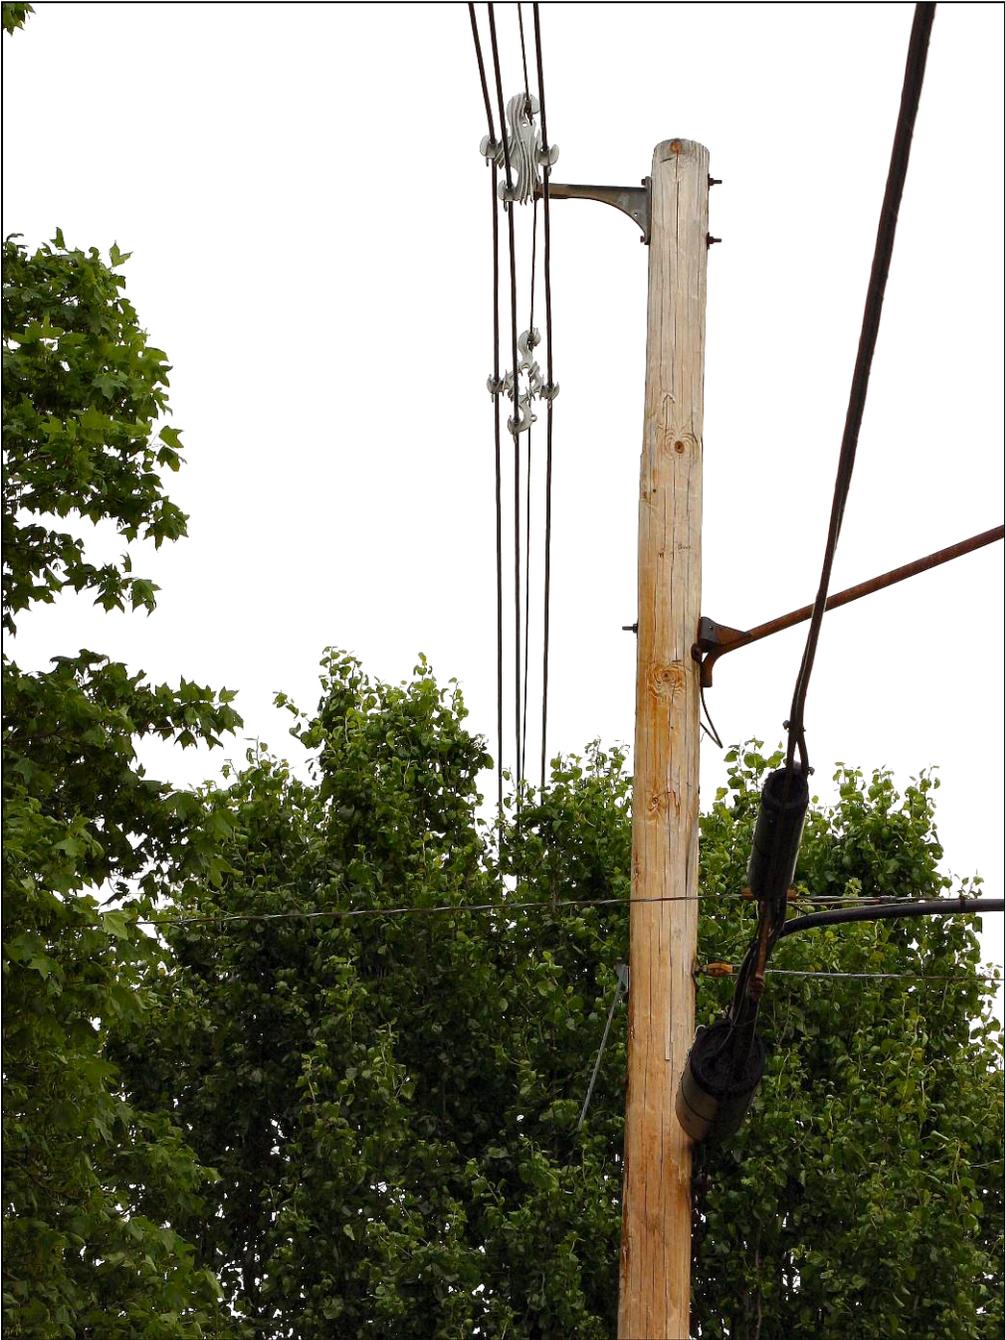
Figure 4 (Photo 06-MtC948)
Tree (Bradford Pear?) into spacer cable, Alley north of 4th St., just east of Chestnut St.

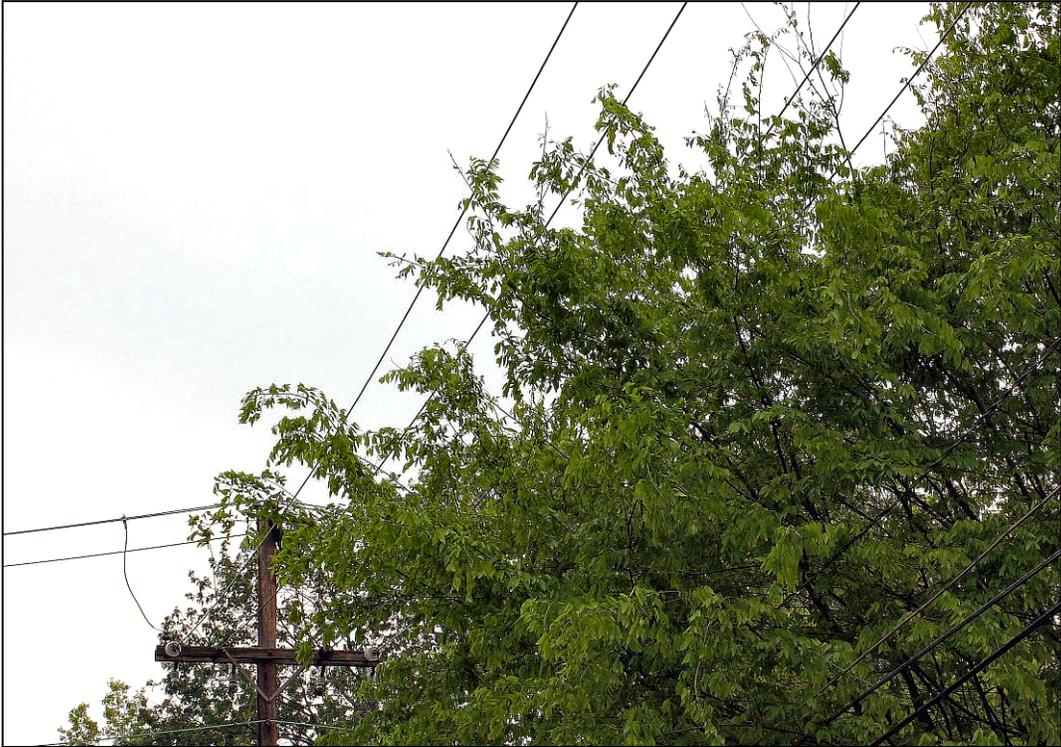
Figure 5 (Photo 06-MtC949)

Tree into 3-phase primary, Belmont St. south of 2nd St.

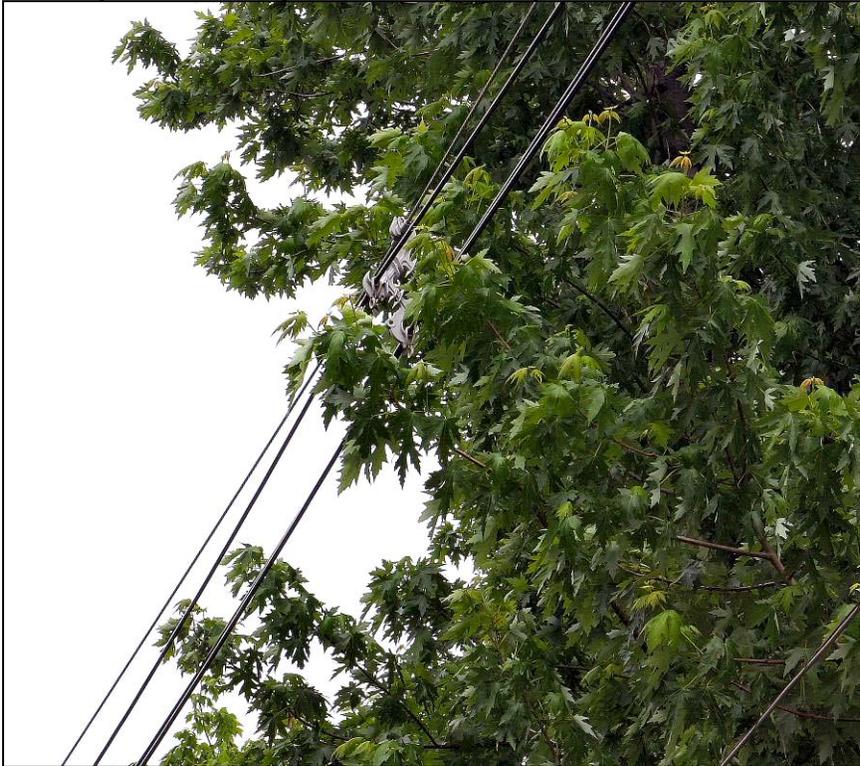
Figure 6 (Photo 06-MtC951)

Soft maple tree into spacer cable primary, Ash St. south of 5th St..
