Illinois Commerce Commission  
Assessment of  
Central Illinois Light Company's  
Annual Reliability Report and  
Electric Service Reliability  
For Calendar Year 2004

Pursuant to 83 Ill. Adm. Code 411.140

2005

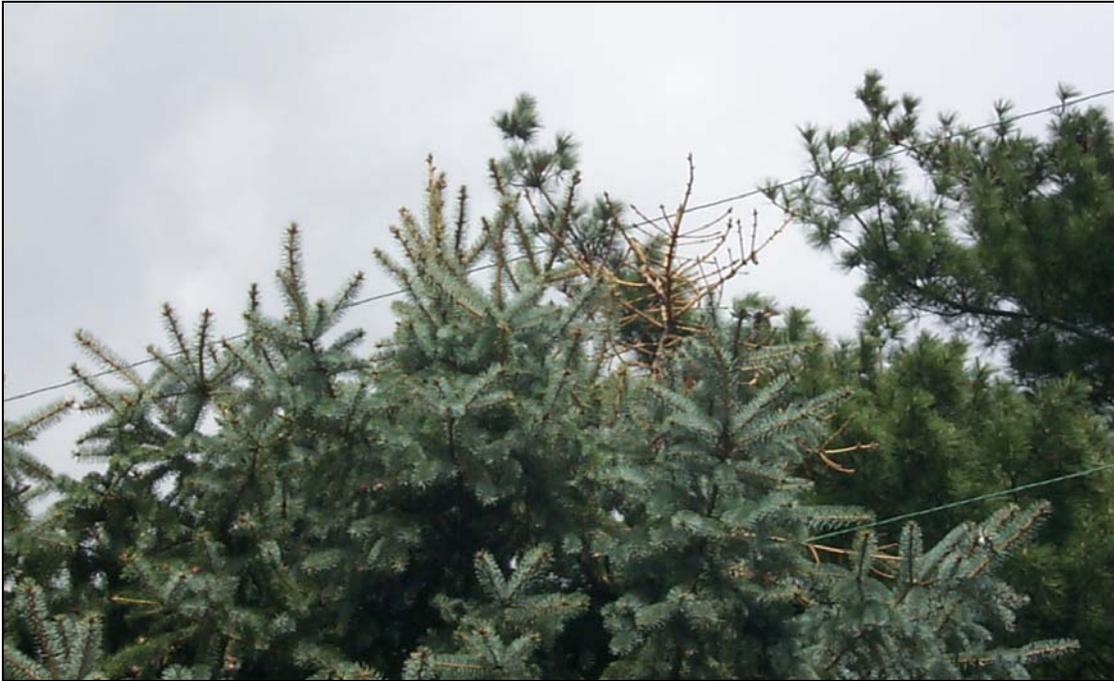
Staff observed very few problems when inspecting Circuit D69-008. Staff noted two shell-rotted poles, a National Electrical Safety Code clearance violation, and one tree contact (Photo 1). AmerenCILCO had done a good job on its own identifying and correcting reliability threats associated with overhead equipment. Staff expects the

**Photo 1: Conifer into primary wires (D69-008)**

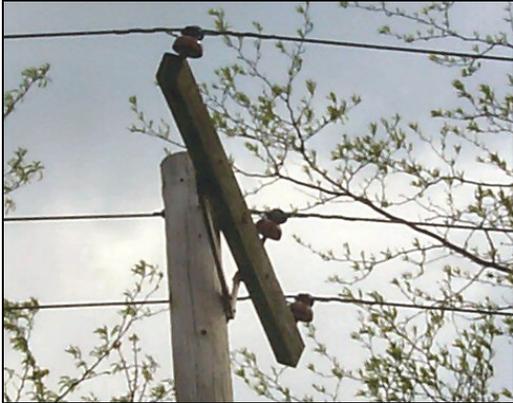
When inspecting Circuit B83-001, the only vegetation issues Staff observed were one tree contact along a rear lot-line and one location where vines had grown up a pole to the primary level. Other potential reliability threats Staff observed included 2 failing cross arms, one of which is shown in Photo 2, two poles that were leaning severely, and several poles with multiple woodpecker holes (Photo 3). While inspecting Circuit B83-001, Staff was pleased to note that AmerenCILCO had recently replaced several poles, and appeared to have made good use of animal guards and lightning arresters. Staff found few visible threats to reliable service following AmerenCILCO's remedial work resulting from its own inspection, and Staff expects that Circuit B83-001 will exhibit improved performance as a result of AmerenCILCO's efforts.

**Photo 2: Cross arm strained (B83-001)**

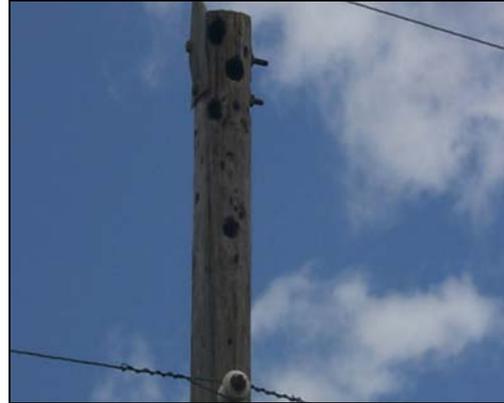
**Photo 3: Woodpecker holes (B83-001)**

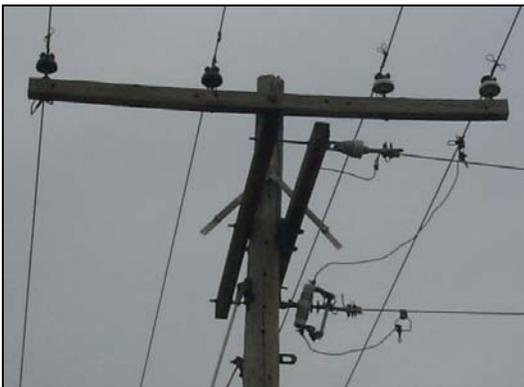
**Photo 4: Two braces detached (E37-001)**

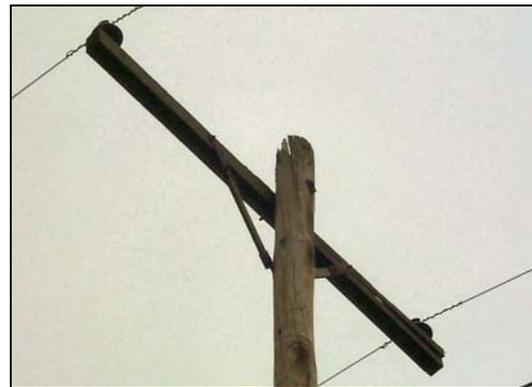
**Photo 5: Splitting cross arm (E37-001)**

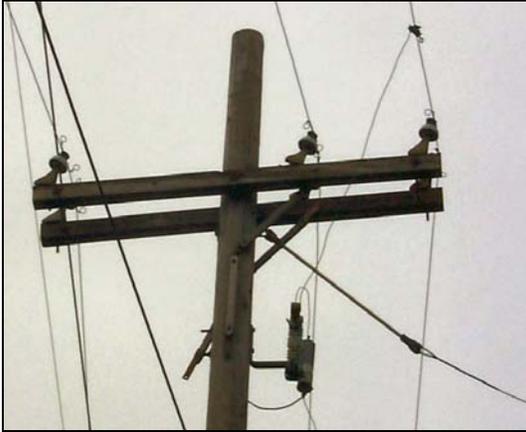
Photo 6: Two braces detached (E37-001)

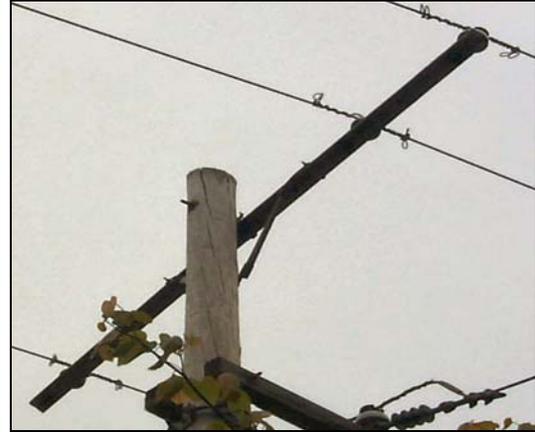
Photo 7: Strained cross arm (E37-001)

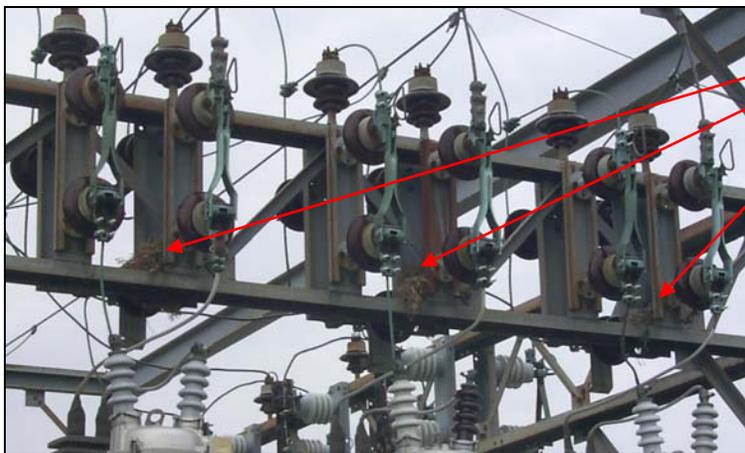
Staff noted significantly more threats to reliable service on Circuit E10-001 than on any of the other AmerenCILCO circuits inspected. The first threat to reliable service that Staff noted was located at the substation: birds had constructed nests behind the disconnect switches on all 3 phases (Photo 8). This is a reliability threat not only because of the birds themselves, but because other animals, such as raccoons and opossums sometimes go after birds and their eggs, and might be attracted to the nests. These larger animals might cause significant facility damage if they cause a fault when climbing on energized components or the energized bus in the substation. AmerenCILCO should strive to keep its substation equipment clear of nesting debris.

**Photo 8: Bird nests behind disconnects for all 3 phases (E10-001)**

- When inspecting AmerenCILCO's distribution circuits, Staff noted that birds had been nesting at disconnects that were mounted on the electrical bus within the substation that is the source for Circuit E10-001 (all three phases). Interruptions due to electrical faults at substations can affect a very large number of customers since multiple distribution circuits might be affected. In addition, replacement parts for damaged substation equipment might not be readily available, lengthening the outage duration. AmerenCILCO should strive to keep nesting material off of its substation equipment. In addition to its regularly scheduled substation inspections, Staff suggests that AmerenCILCO include at least a cursory inspection of the source substation bus and equipment when conducting its distribution circuit inspections, even if from outside the substation fence.

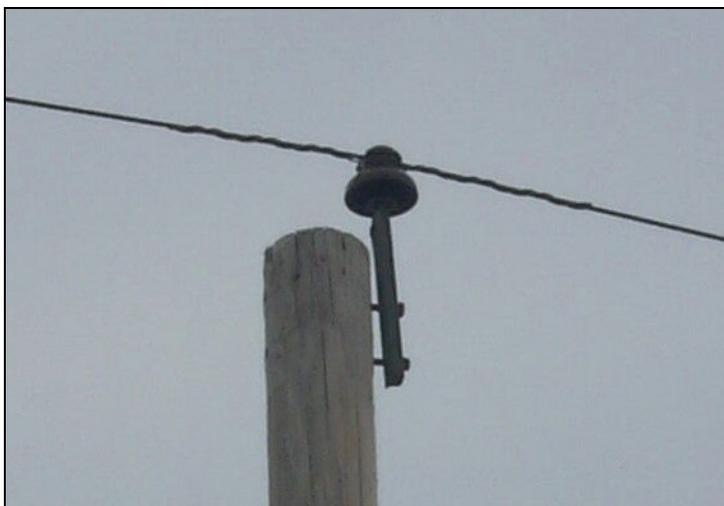
Out on the circuit loose hardware was a recurring problem. Staff observed at least 6 locations where the nuts holding pole top pins to the pole were either loose or missing (Photo 9). Staff noted many splitting or rotted wooden cross arms, braces, and insulator pins (some examples shown in Photo 10-12), and 5 blown lightning arresters. Staff also noted one lightning arrester detached from its mounting so that it was suspended in the air: attached only by the wire jumpers (Photo 13). Lightning arresters were installed regularly in some areas of the circuit, but there were no

**Photo 9: Nuts missing from bolts on pole top pin (E10-001)**

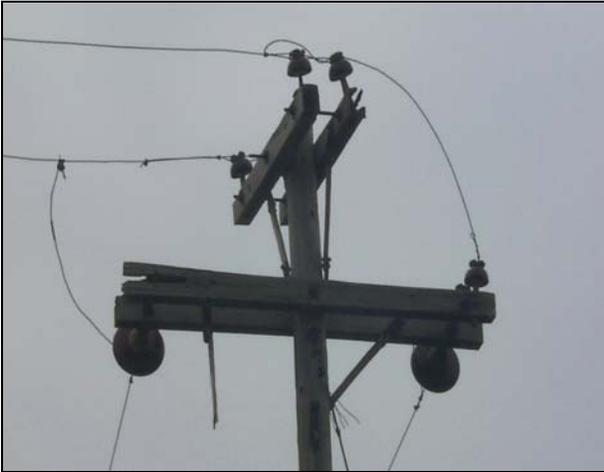
**Photo 10: Failing arms and braces (E10-001)**

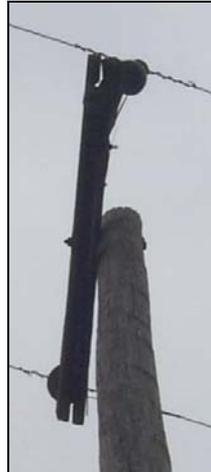
**Photo 11: Split cross arm (E10-001)**

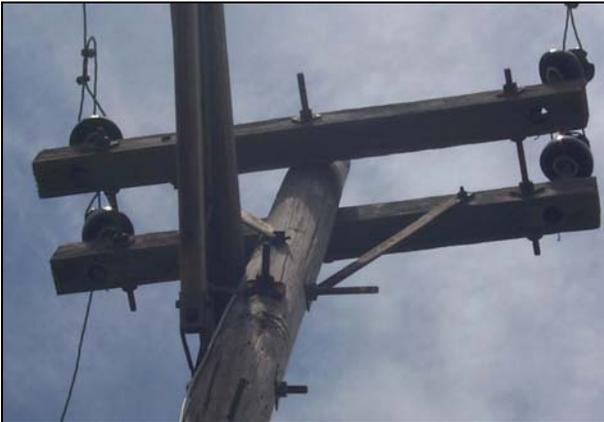
**Photo 12: Failed insulator pins (E10-001)**

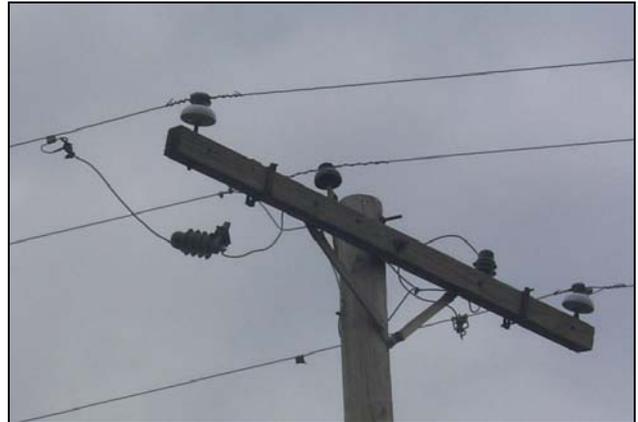
**Photo 13: Arrester off bracket (E10-001)**

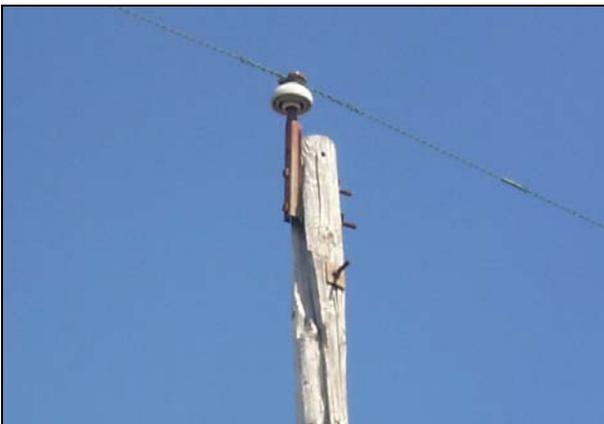
lightning arresters installed in other areas, even where significant lightning damage was evident (Photo 14). Staff observed trees contacting the primary conductor at 3 locations (example in Photo 15). On a positive note, it appeared that AmerenCILCO did a good job installing animal guards at distribution transformers. Staff noted AmerenCILCO had recently replaced several poles on the circuit, and many more poles had been marked to be replaced.

**Photo 14: Lighting damage (E10-001)**

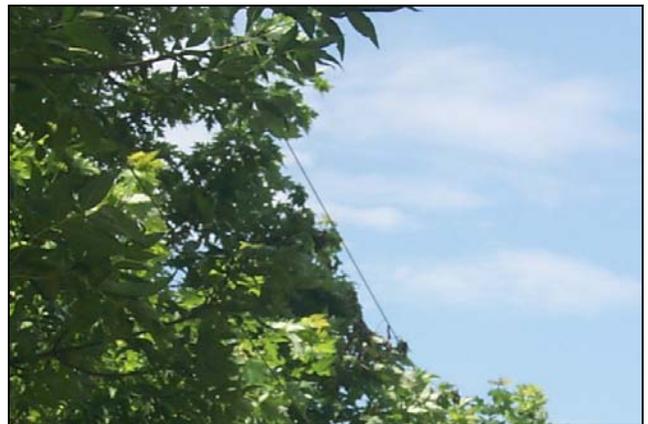
**Photo 15: Trees contacting primary (E10-001)**
