Illinois Commerce Commission
Assessment of
Interstate Power and Light Company's
Annual Reliability Report and
Electric Service Reliability
For Calendar Year 2004

Pursuant to 83 Ill. Adm. Code 411.140

2005

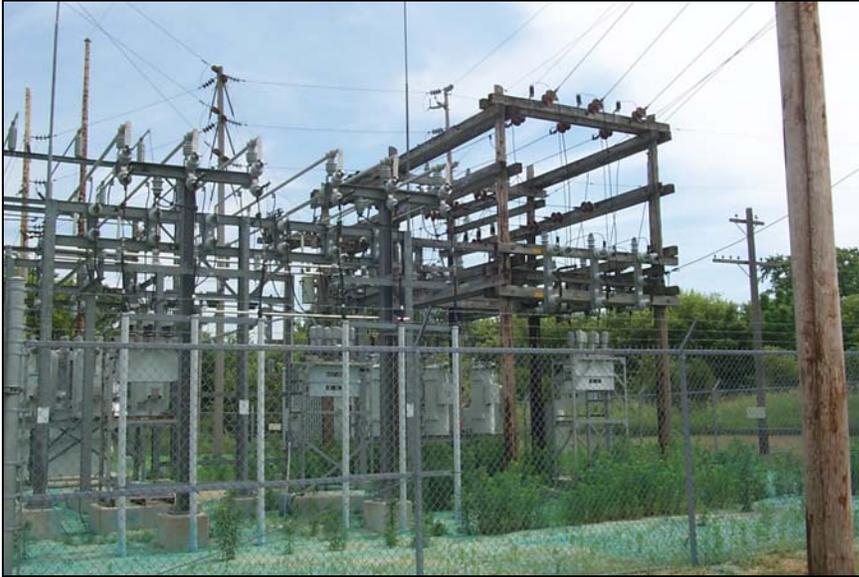
Staff observed trees close to the distribution lines in only a couple locations, and none contacting, but was concerned that the source substation for the circuit was overgrown with weeds (see Photo 1). Such a condition could be an impediment to IPL's employees trying to work inside the substation to restore service during an interruption. Along the distribution circuit, the very few visible threats to reliable service that Staff observed included a splitting cross arm, a lightning damaged pole top, and two damaged down guys. Generally the circuit appeared to be in good shape, and Staff saw no reason to expect it to be a worst performing circuit in 2005.

Photo 1: Weeds Growing within IPL's Mt. Carroll Substation (MTCL8114)

- High weeds in IPL's Mt. Carroll Substation, in addition to being unsightly, could slow down service restoration and potentially become a hazard (cause tripping, obstruct equipment or dropped tools, contribute to fire, etc.) to IPL's employees.

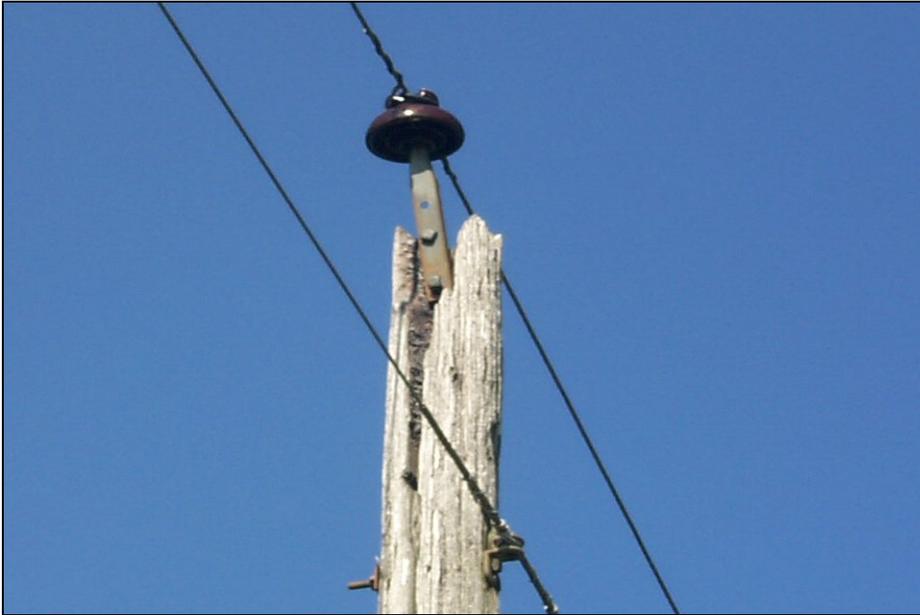
When inspecting GALW8314, Staff observed only one tree contact. Other facility problems Staff observed included 2 failing cross arms, 3 deteriorated pole-tops (see Photo 2), and several adjacent poles on a cross-country line section that were leaning fairly severely. Though some facilities on this circuit appeared to be quite old, the circuit appeared to be well maintained, with good use of animal guards. Staff noted hit and miss lightning arrester coverage, with signs of minor lightning damage on several poles. This circuit might benefit from more arresters. Staff also believes GALW8314 would be a good circuit on which to install overhead fault indicators since much of it was constructed away from roadways and would be hard to patrol when trying to locate an outage cause.

Photo 2: Deteriorated pole top (GALW8314)

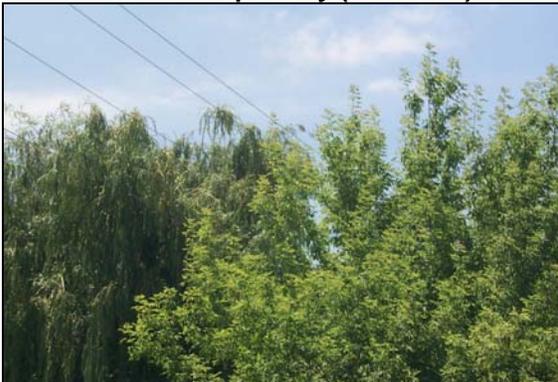
During its inspection Staff observed seven locations where trees were contacting the power lines (Photo 3): many more than on the other IPL circuits Staff inspected. Some of these locations were near the substation outlet. Staff also noted 4 deteriorated pole tops (Photo 4), and a span with inadequate ground clearance. Staff was pleased with IPL's promptness in reporting it had removed enough slack from the primary and neutral at this location so that National Electrical Safety Code requirements were met. Staff believes mid-cycle tree trimming and selectively installing overhead fault indicators would improve the reliability of this circuit.

Photo 3: Tree into primary (ELIZ8372)

- On Circuit ELIZ8372, which was a worst performing circuit in 2004, Staff is concerned that several trees were observed contacting the primary conductor near the substation outlet. This condition could cause additional momentary and/or sustained service interruptions for all customers on this distribution circuit.

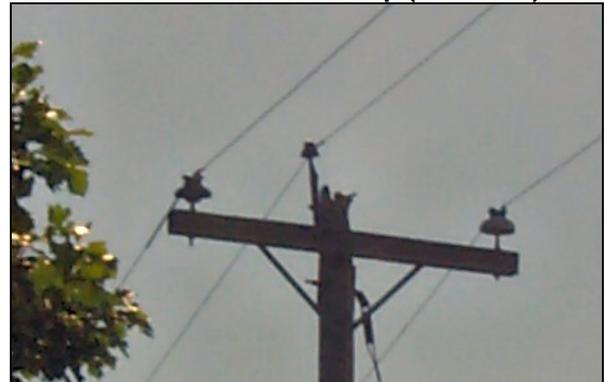
Photo 4: Deteriorated Pole Top (ELIZ8372)
