Illinois Commerce Commission
Assessment of AmerenIP's
Reliability Report and Reliability Performance
for Calendar Year 2007

Pursuant to 83 Illinois Administrative Code 411.140

July, 2008

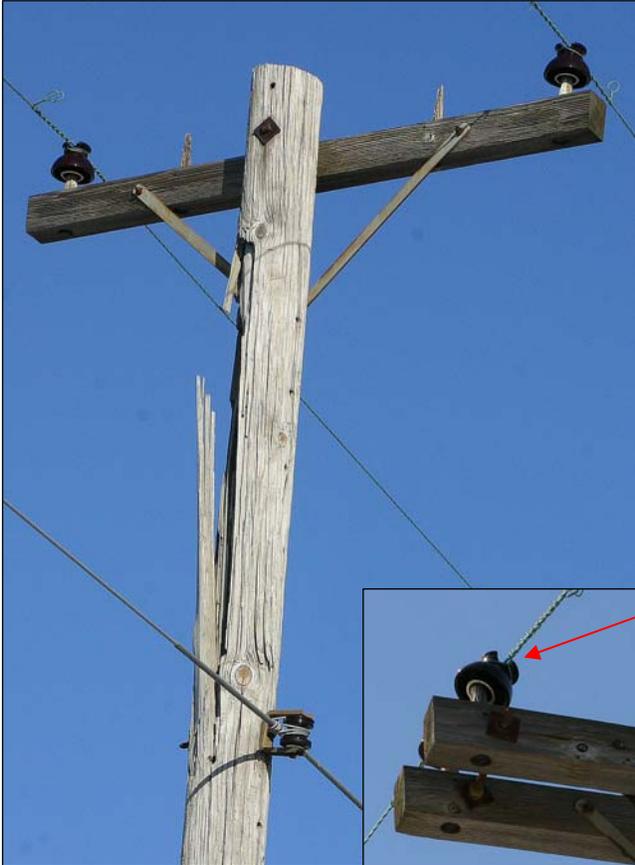
Figure 1 (Photo 08-IP1818)
Badly lightning damaged pole top
Circuit P47123, Rd. 1300N, west of
Larchland

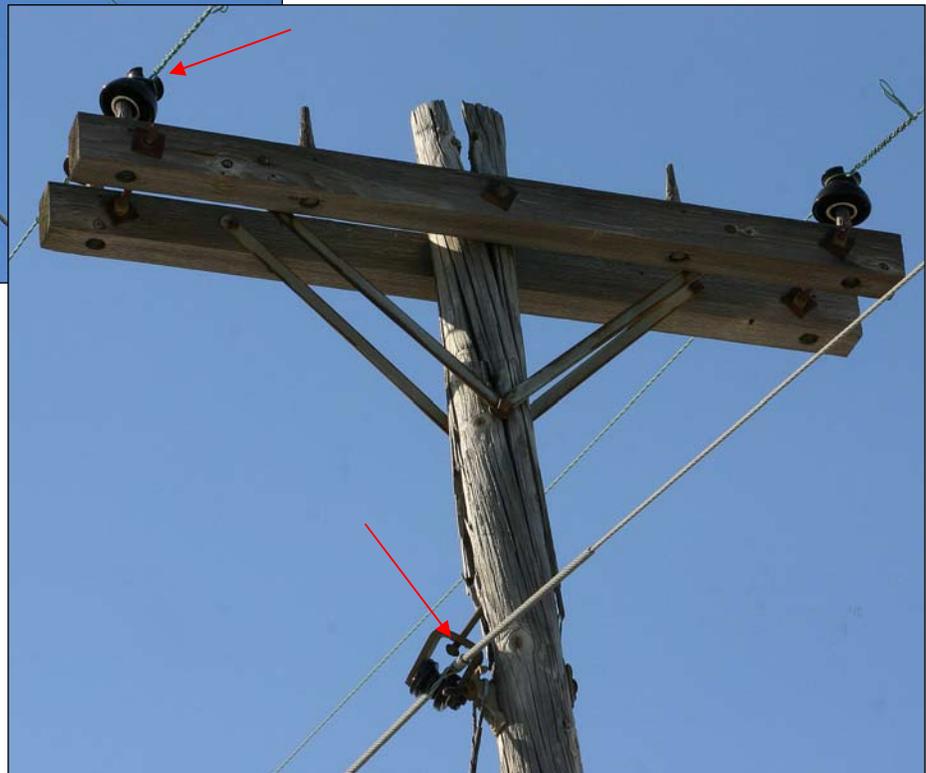
Figure 2 (Photo 08-IP1816)
Split pole top, insulator coming off pin, &
neutral falling off pole
Circuit P47123, Rd. 1300N,
west of Larchland

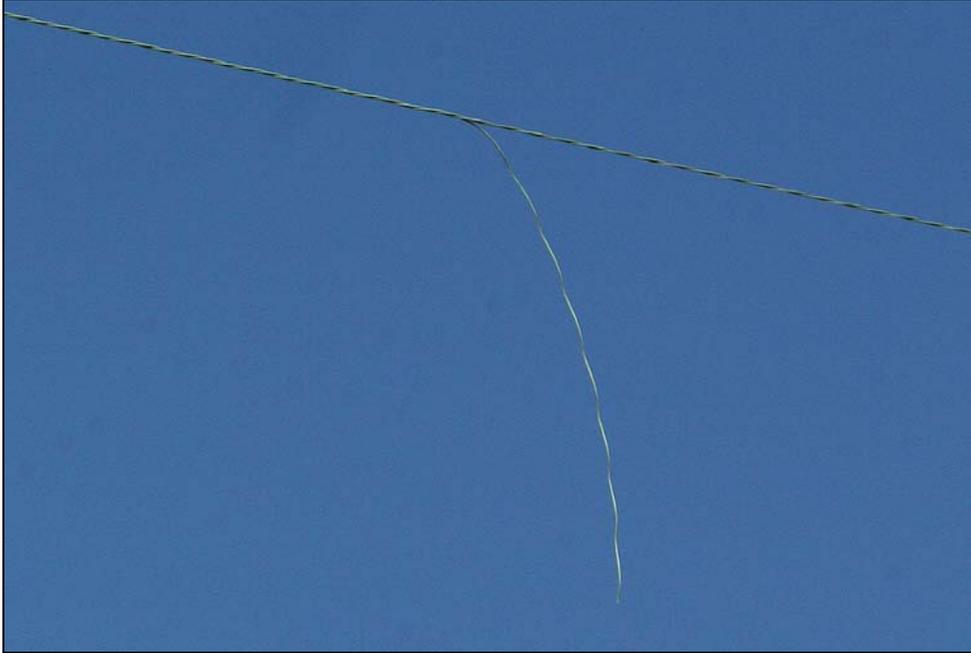
Figure 3 (Photo 08-IP1812)
Broken strand in single-phase 6A CWC primary
Circuit P47123, Rd. 1500N, west of Ormone

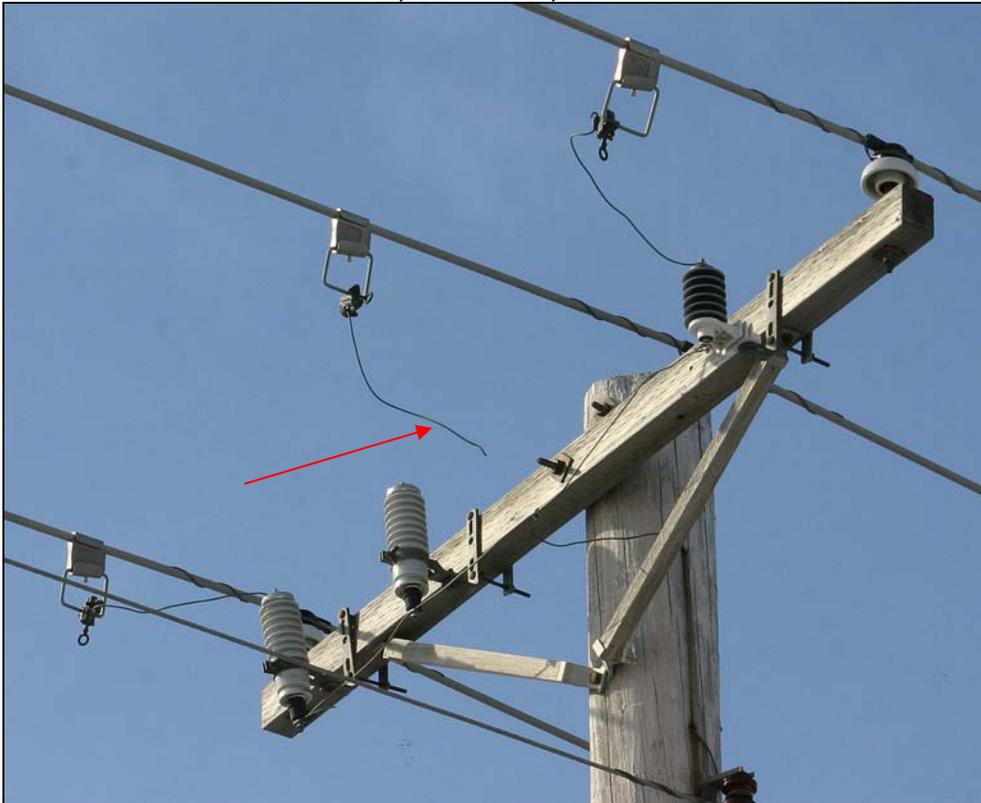
Figure 4 (Photo 08-IP1831)
Broken jumper to top of center lightning arrester
Circuit P47123, Rd. 1600N, north of Ormone

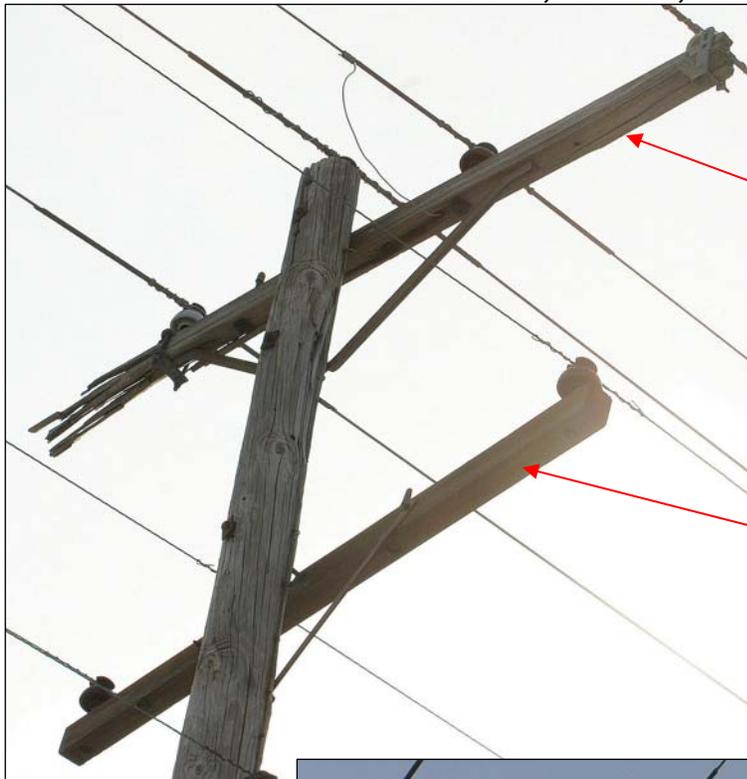
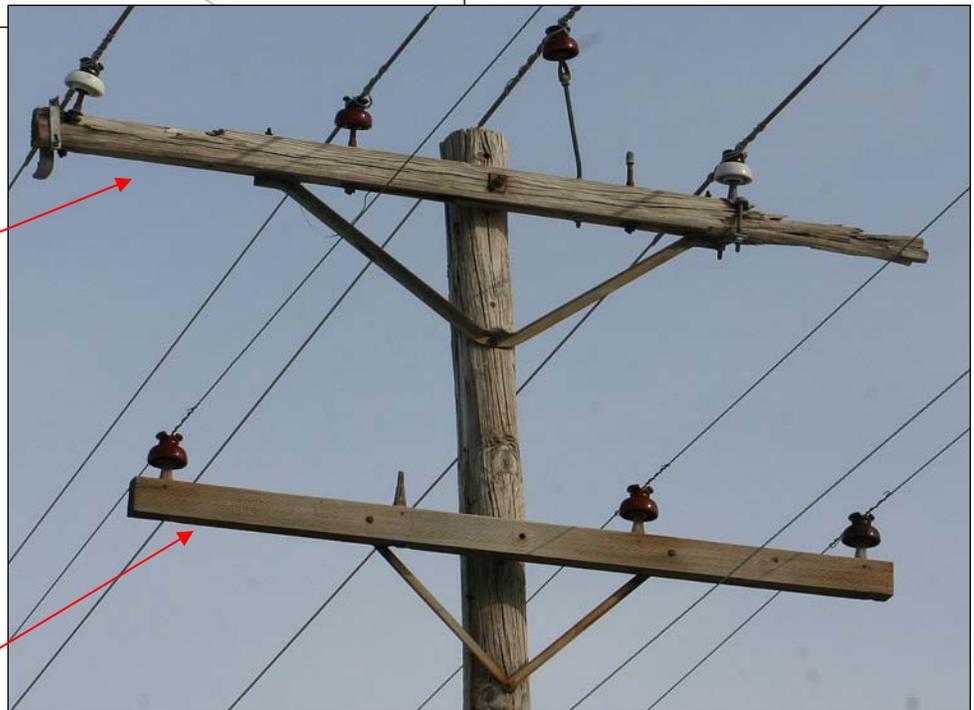
Figures 5 & 6 (Photos 08-IP1829 & 1830)
Badly deteriorated CO-OP crossarm above AmerenIP 3-phase circuit
Circuit P47123, Rd. 900E, north of Ormone

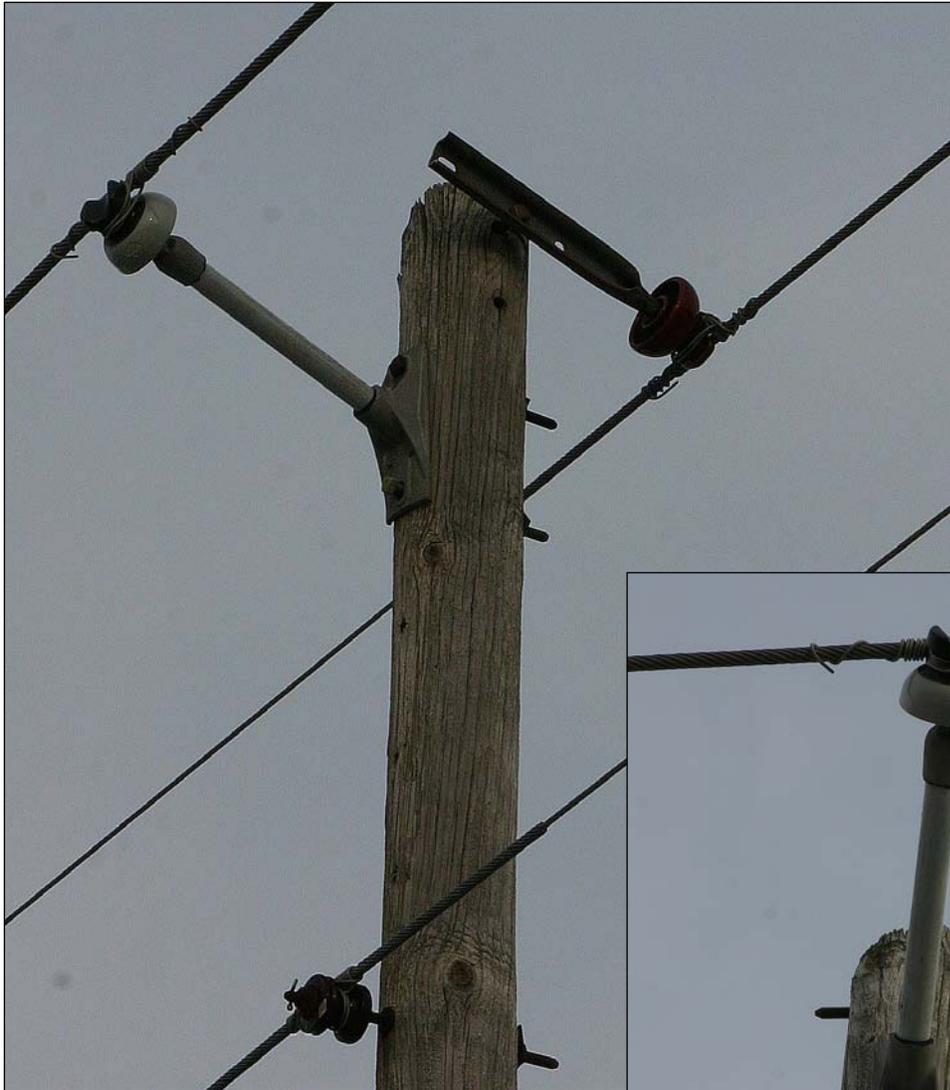
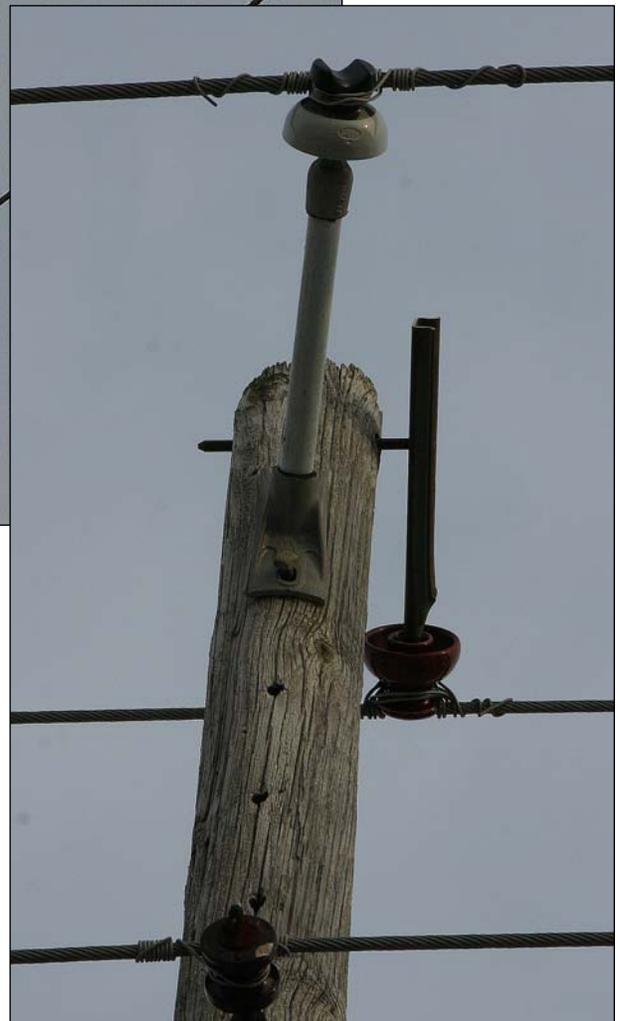
Figures 7 & 8 (Photos 08-IP1822 & 1823)
Poletop pin coming off pole & primary conductor about to fall
Circuit P47123, Rd. 1400N, northwest of Berwick
(AmerenIP notified 2/20/08 & made repairs that day)

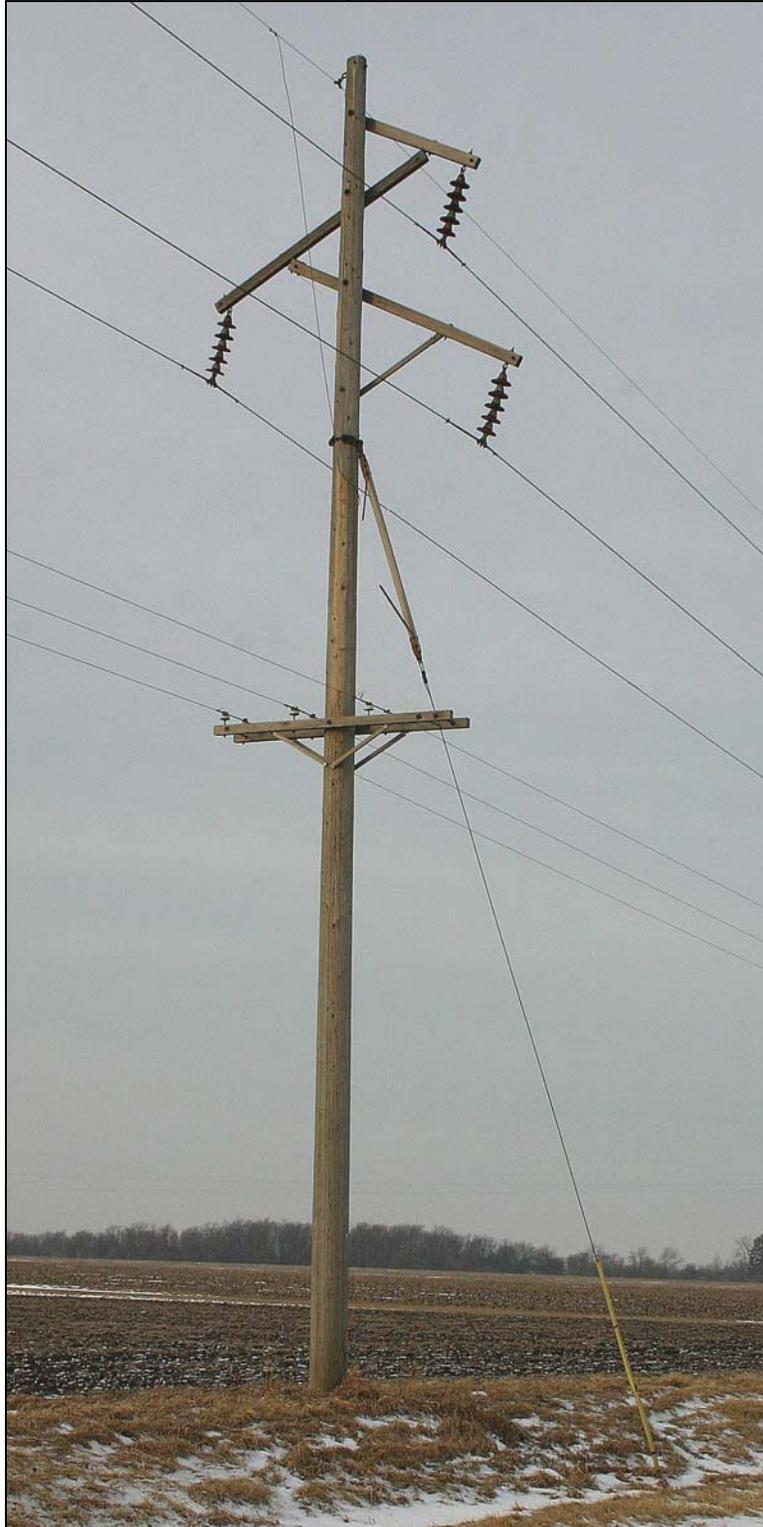
Figure 9 (Photo 08-IP1819)

**Ungrounded 69 kV downguy without strain insulator properly placed below 12 kV
conductors (NESC Guying Violation)**

Circuit P47123 (69 kV Str. 293), Rd. 1400N, southwest of Cameron

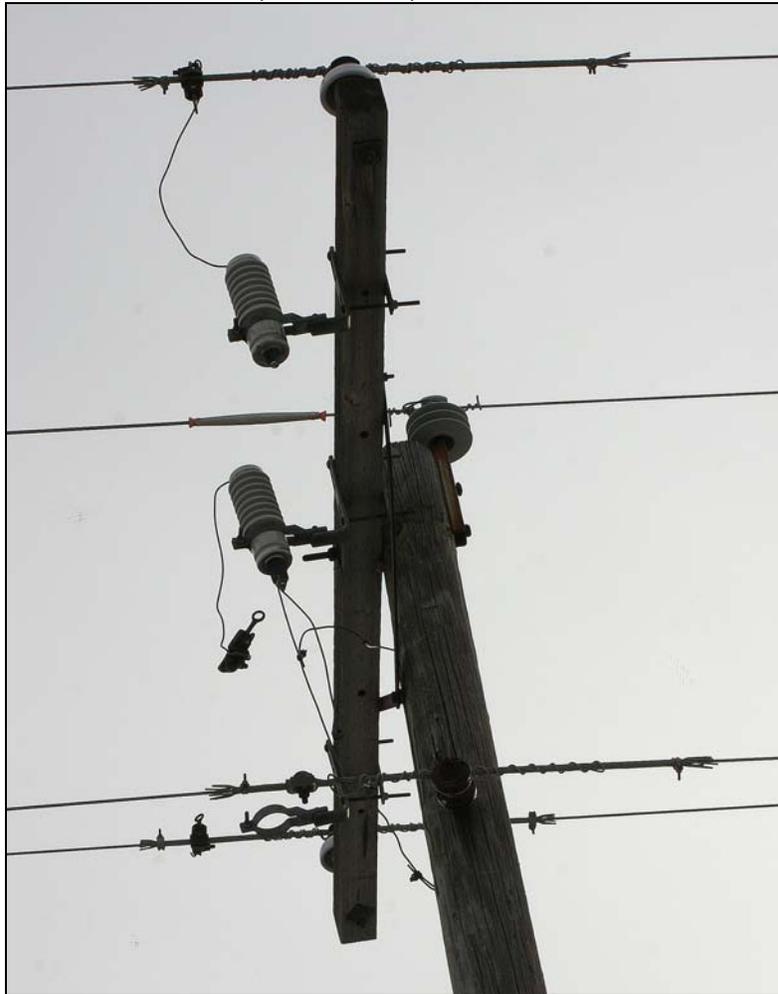
Figure 10 (Photo 08-IP1828)
Field side lightning arrester missing, center arrester disconnected,
& road side arrester blown
Circuit P47123, Rd. 1100E, southwest of Cameron

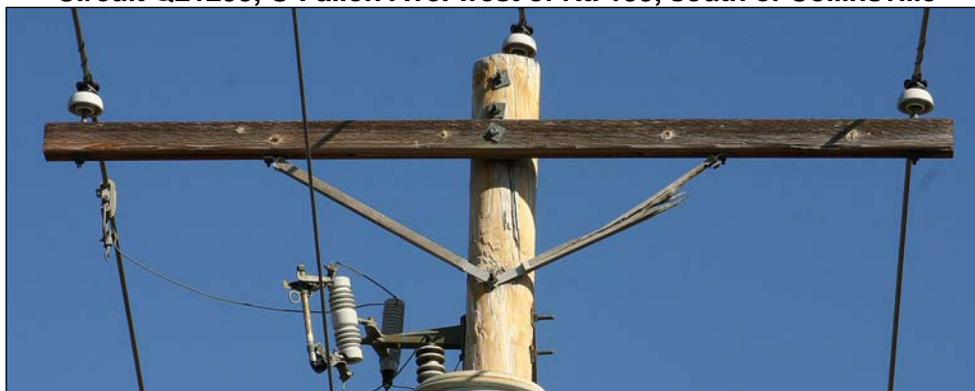
Figure 11 (Photo 08-IP1834)
Split (lightning damaged) wood brace
Circuit Q21293, O'Fallon Ave. west of Rt. 159, south of Collinsville

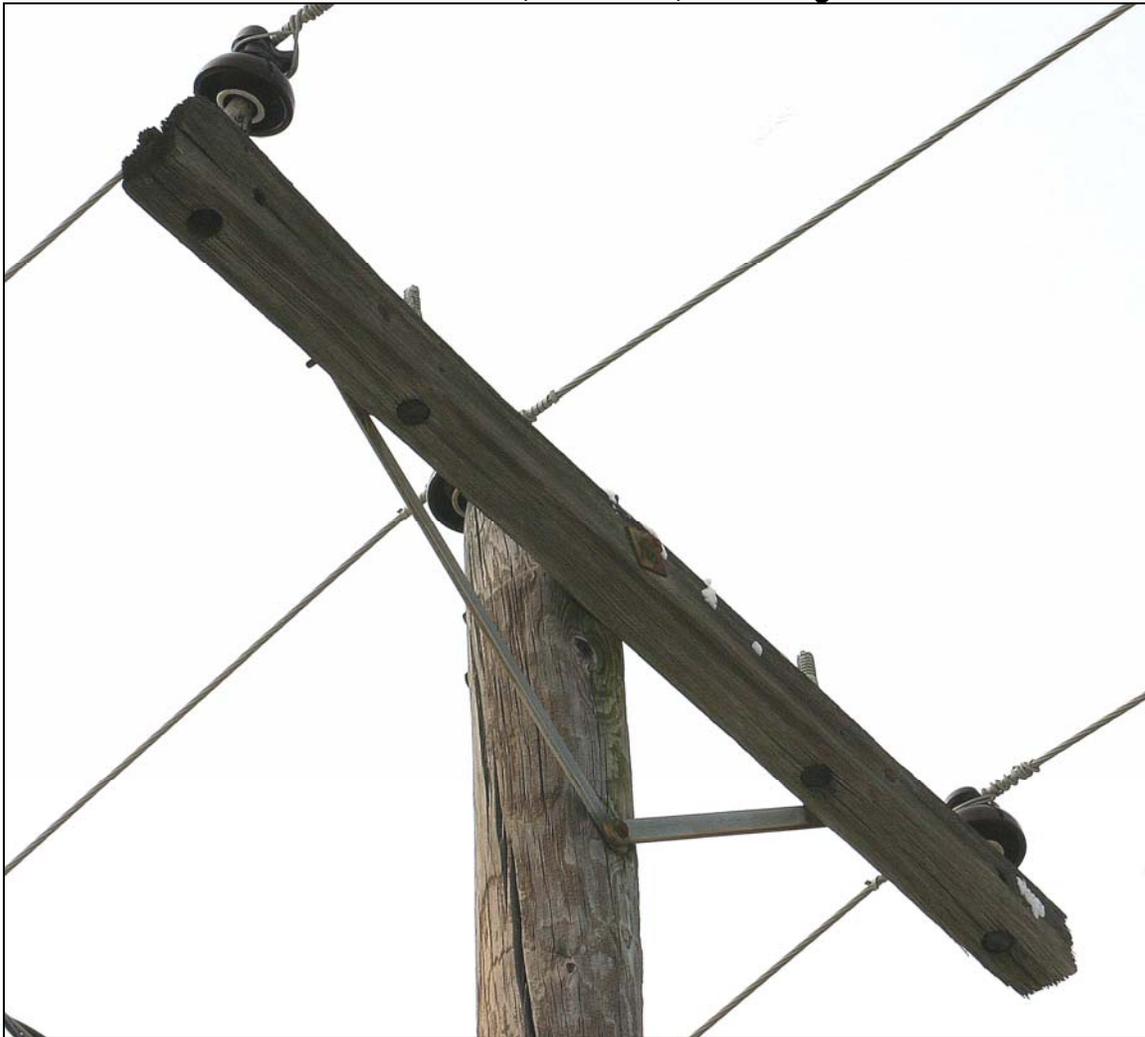
Figure 12 (Photo 08-IP1838)
Deteriorated & split wood pin crossarm
Circuit M37191, Willard St., Galesburg

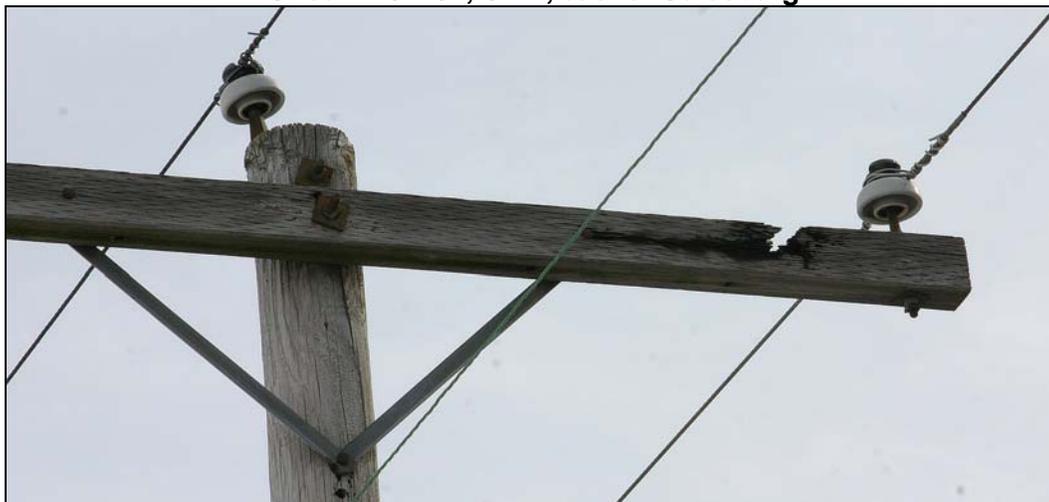
Figure 13 (Photo 08-IP1840)
Badly burned crossarm
Circuit M37191, CH 7, east of Galesburg

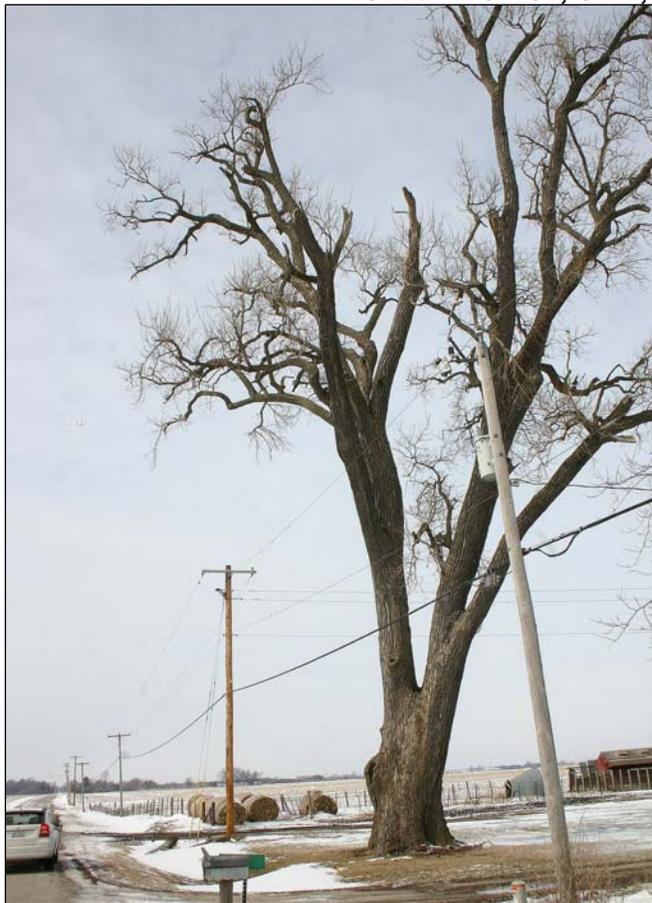
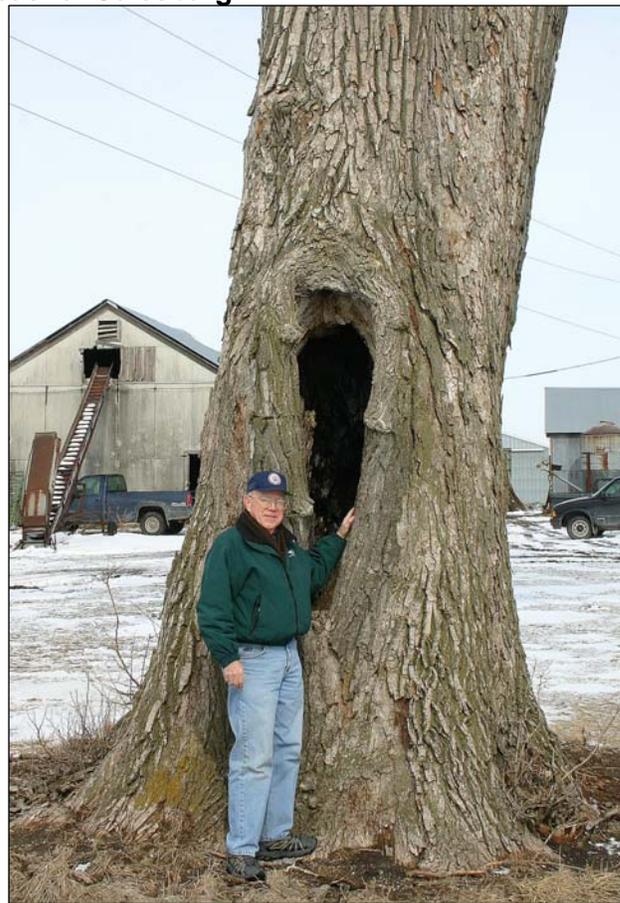
Figures 14 & 15 (Photos 08-IP1841 & 1845)
Very large hollow danger tree (approx. 5 ft.(+) dia. tree w/ approx. 4 ft.(+) dia. void)
Circuit M37191, CH 7, east of Galesburg

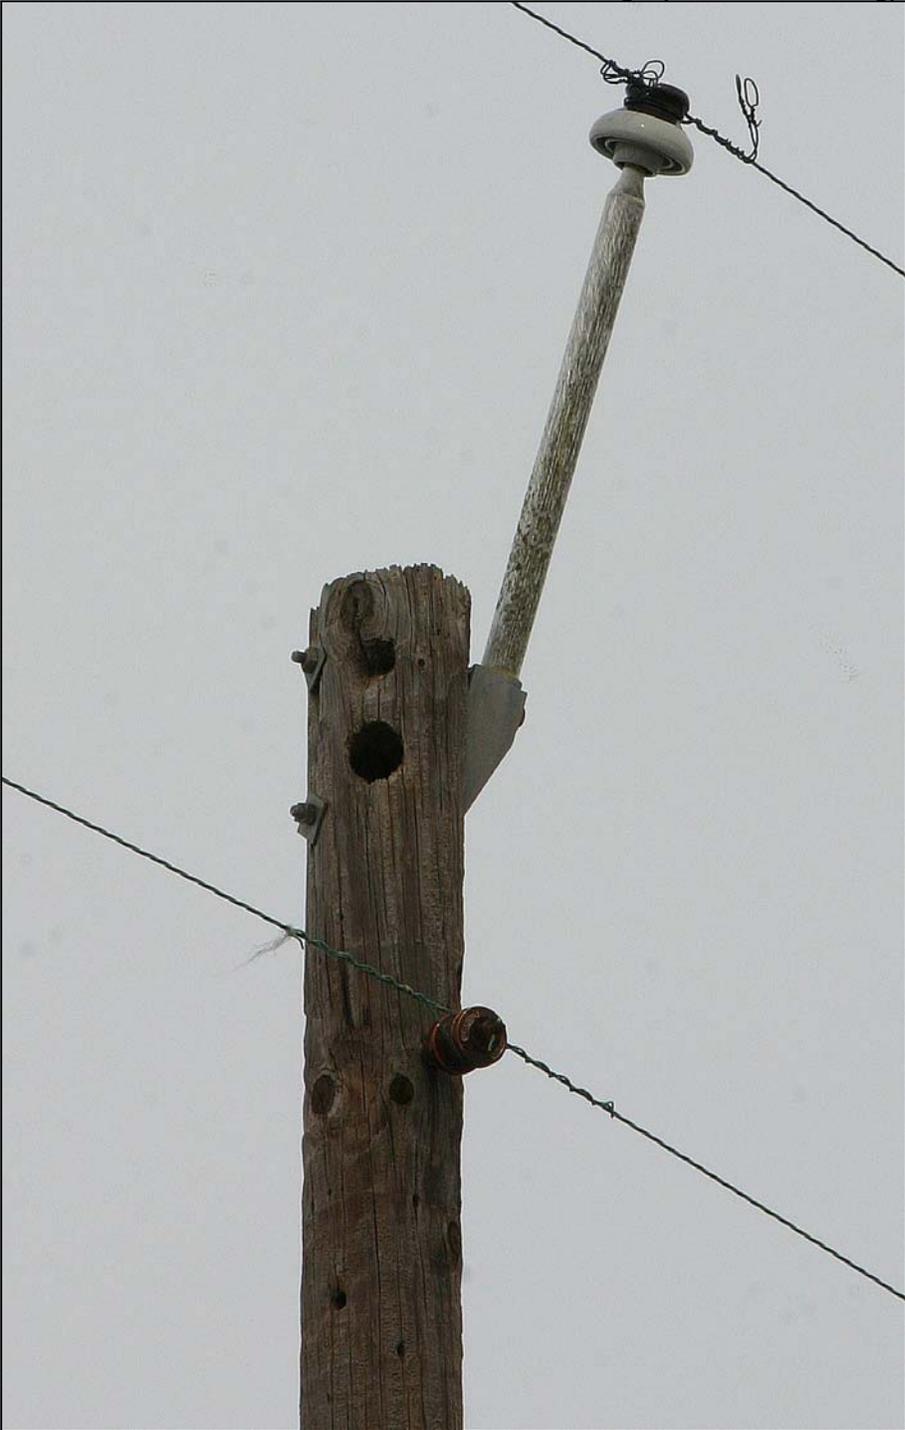
Figure 16 (Photo 08-IP1846)
Woodpecker holes in pole top & pole top extension leaning
Circuit M37191, Rd. 1950N, southeast of Wataga (NE of Galesburg)

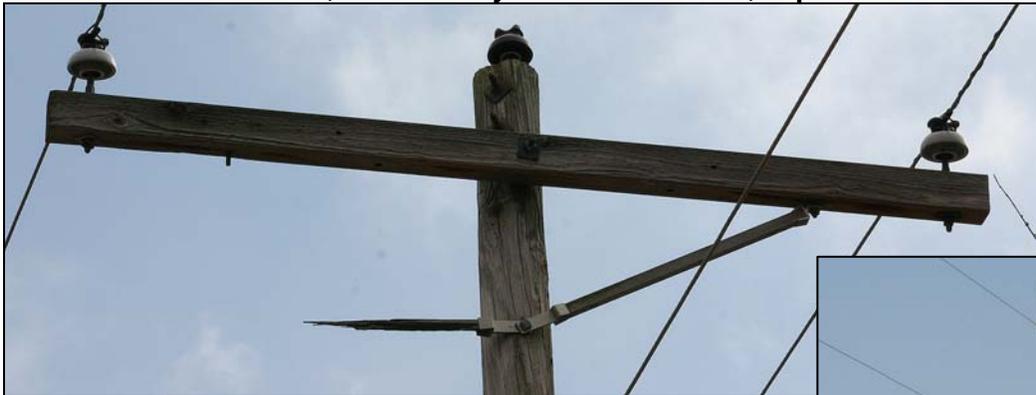
Broken wood brace

Circuit Q32170, Lincoln St. just west of 10th St., Oquawka

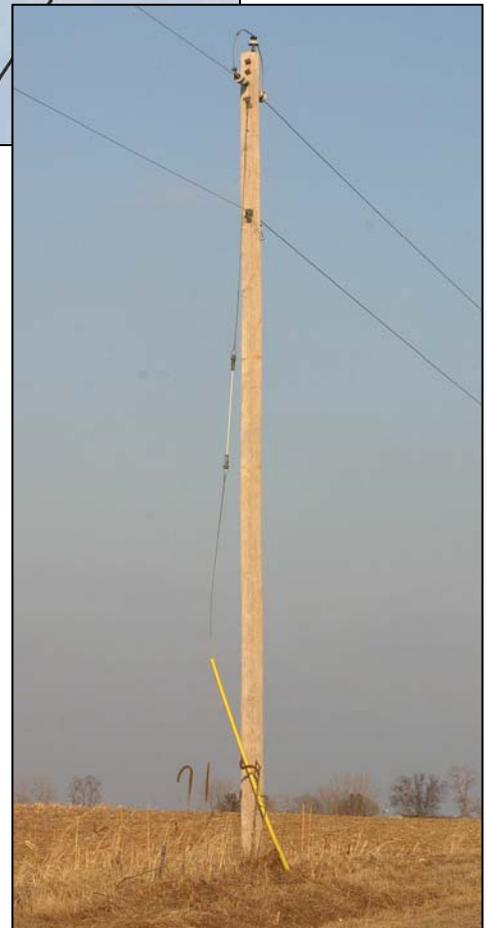
Figure 18 (Photo 08-IP1856)

Broken primary downguy

Circuit Q32170, Rd. 2200N, east of Oquawka

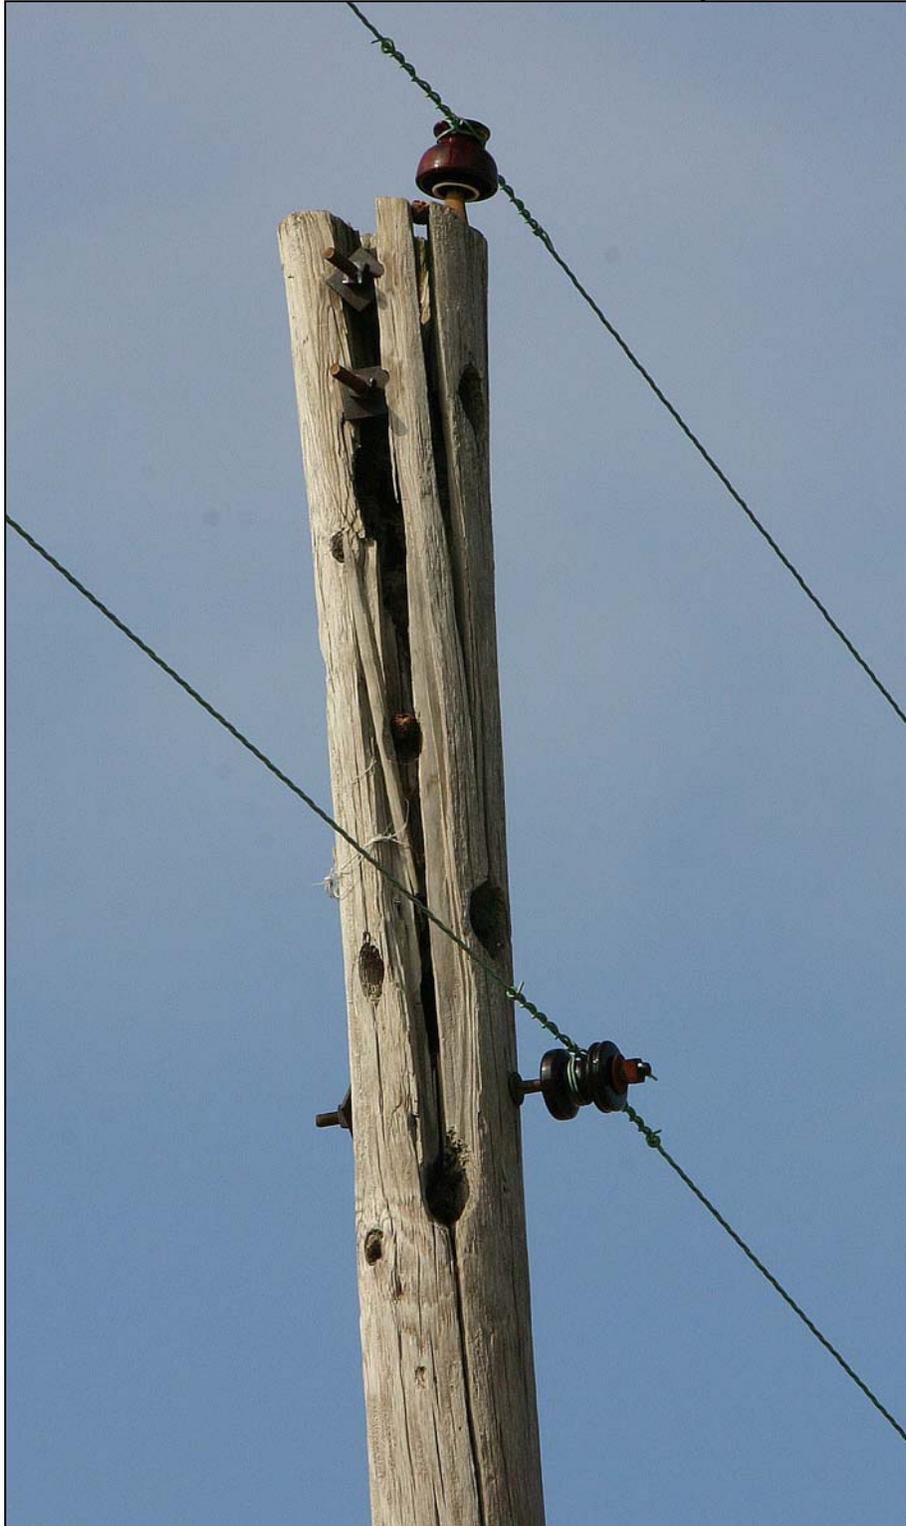
Figure 19 (Photo 08-IP1851)
Badly split pole top w/ large woodpecker holes
Circuit Q32170, Rd. 1900N, southeast of Oquawka

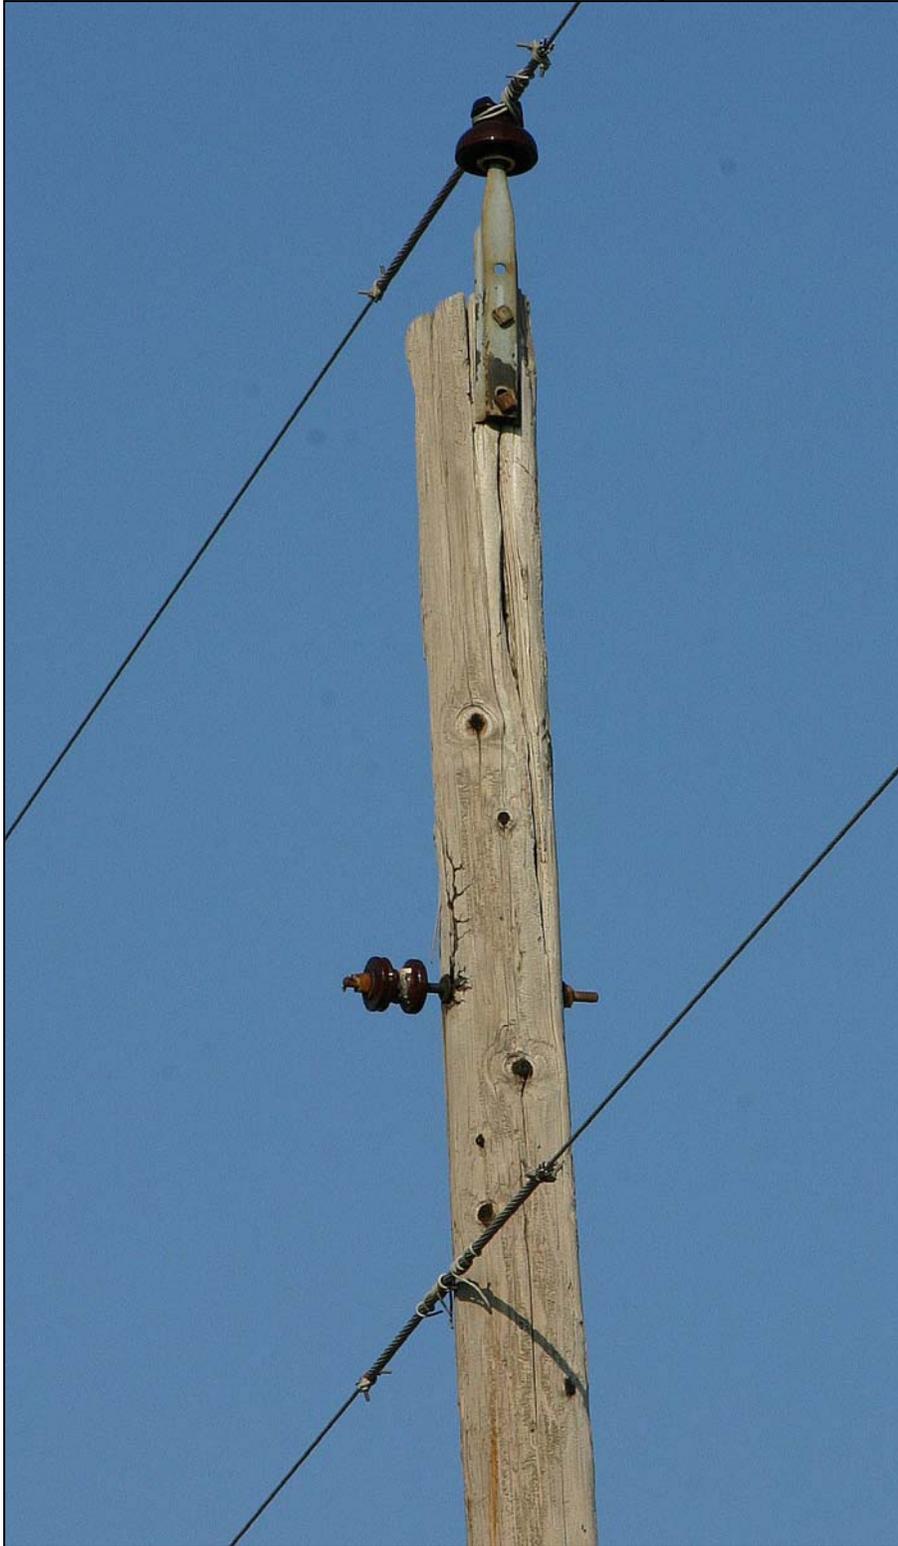
Figure 20 (Photo 08-IP1849)
Neutral conductor off the spool
Circuit Q32170, CH 1, southeast of Oquawka

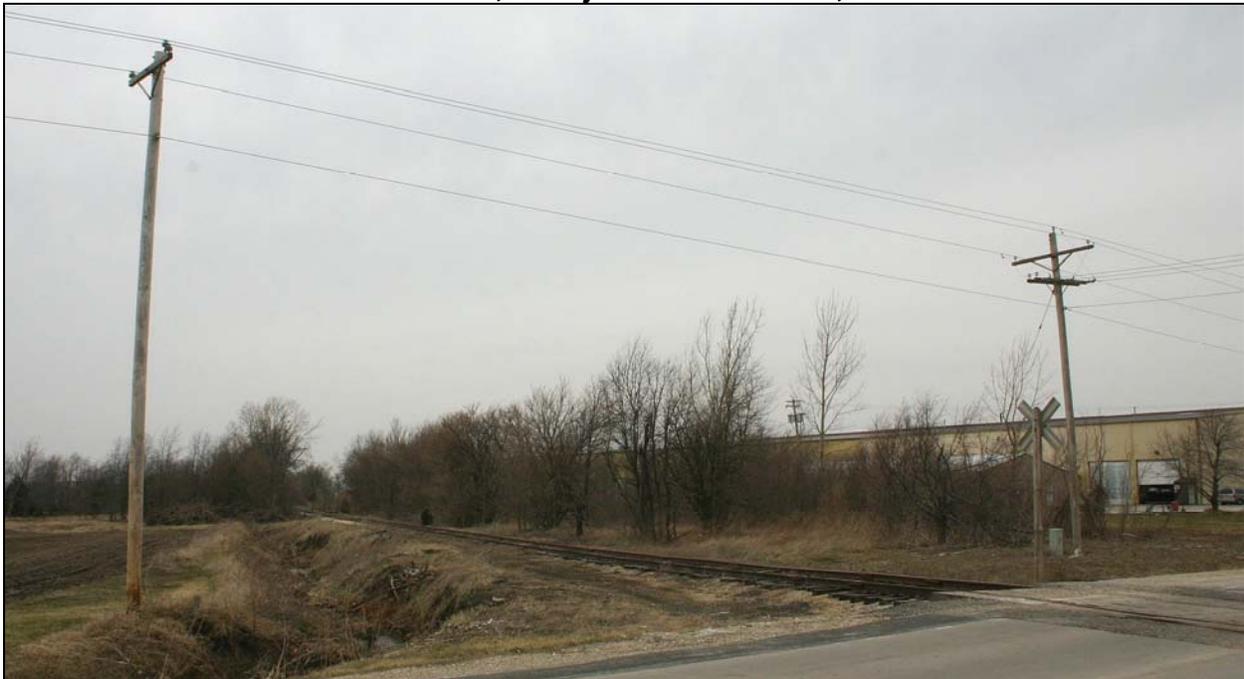
Figure 21 (Photo 08-IP1867)
Single wood crossarms on both sides of a railroad crossing
(NESC Railroad Crossing Violations)
Circuit K39153, CH 1 just south of Rt. 10, Clinton

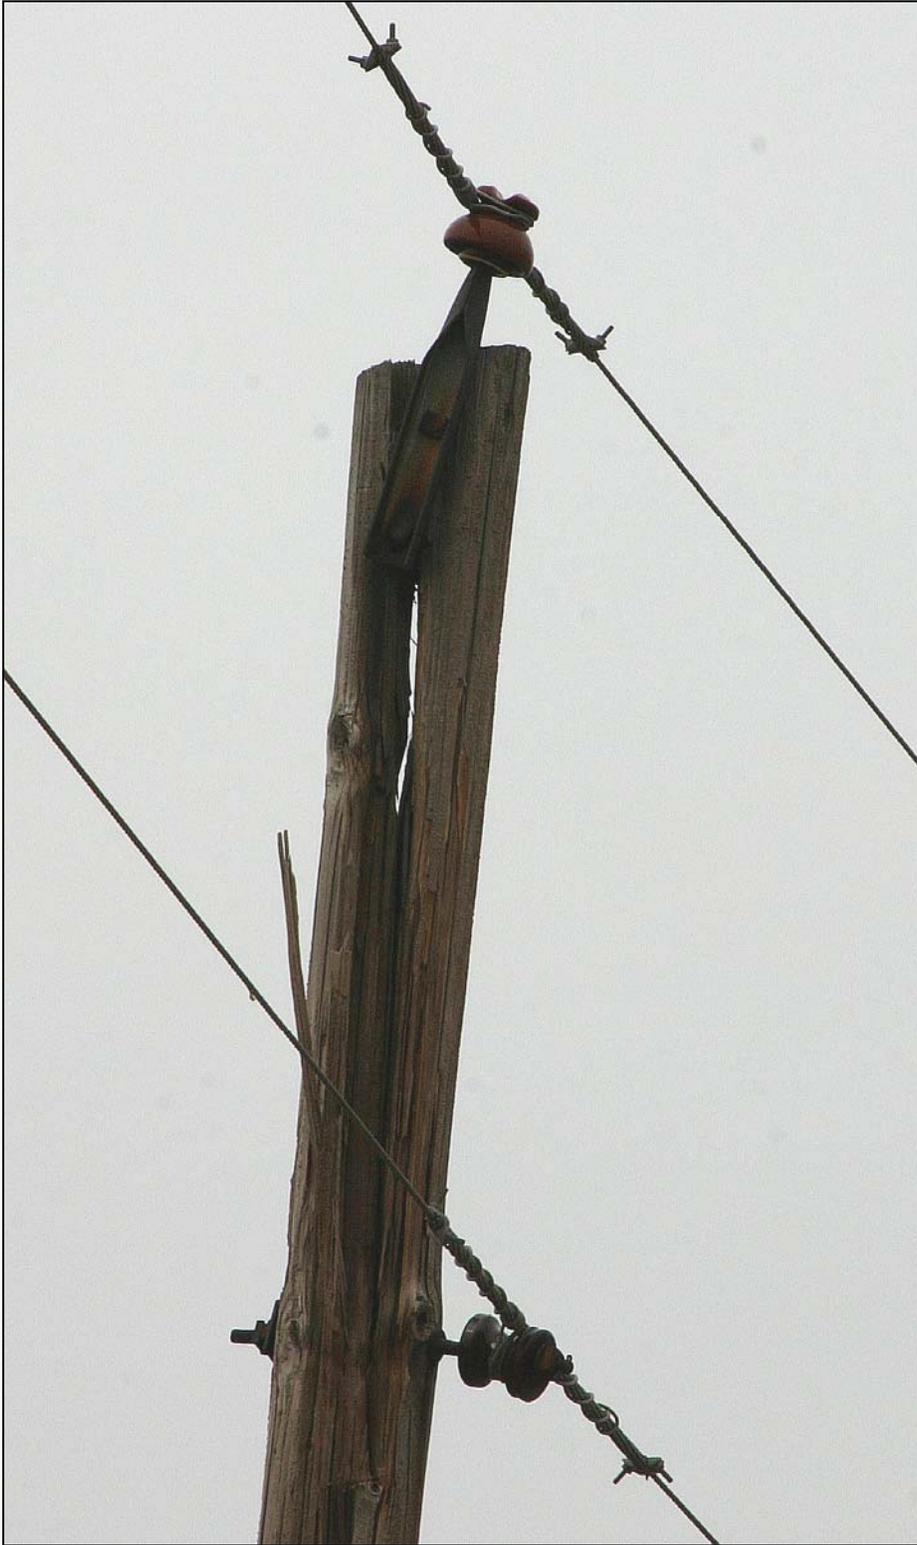
Figure 22 (Photo 08-IP1870)
Badly split pole top
Circuit K39153, CH 18, southeast of Clinton

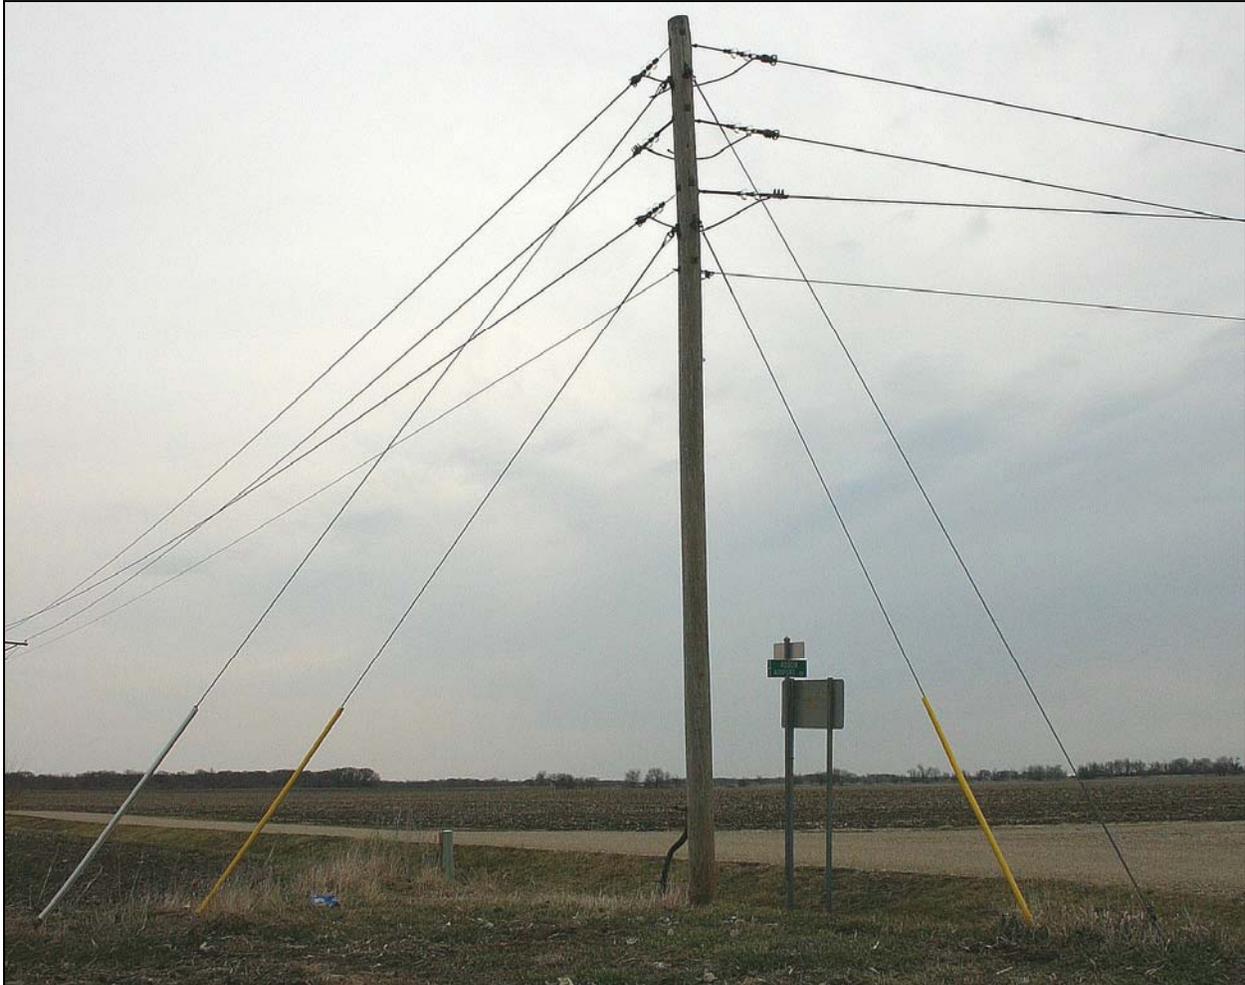
Figure 23 (Photo 08-IP1863)
Four ungrounded 12 kV downguys without strain insulators
(NESC Guying Violations)
Circuit K39153, Rd. 1600E, southeast of Lane

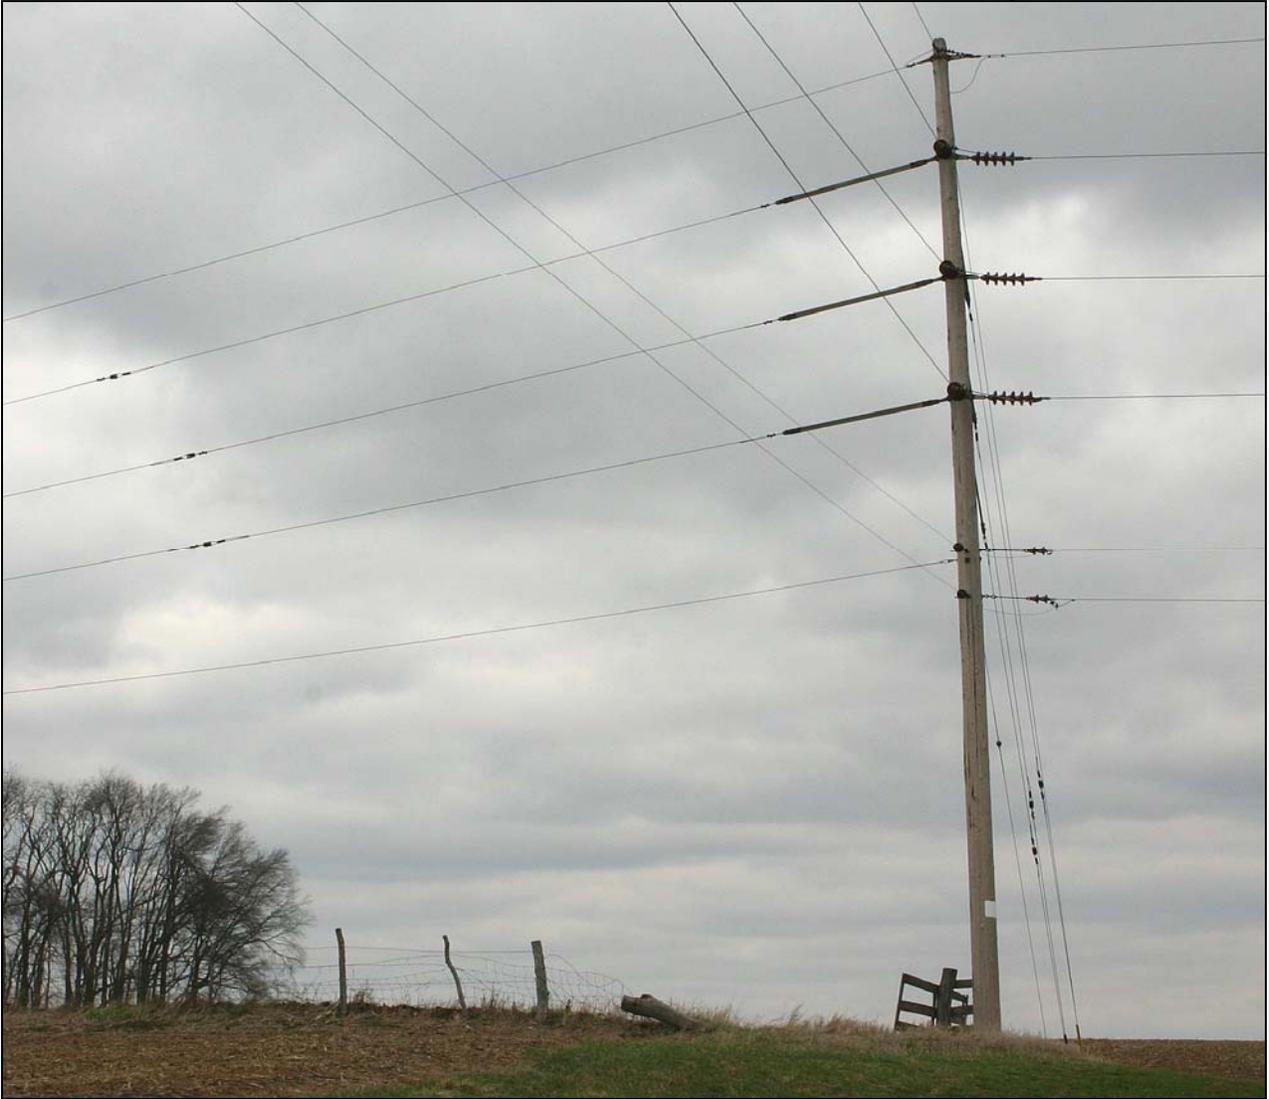
Four ungrounded 69 kV & one 12 kV overhead guys with strain insulators not properly positioned (NESC Guying Violations)

Circuit K62102, Bethel Ln. & Base Line Rd., northwest of Chapin

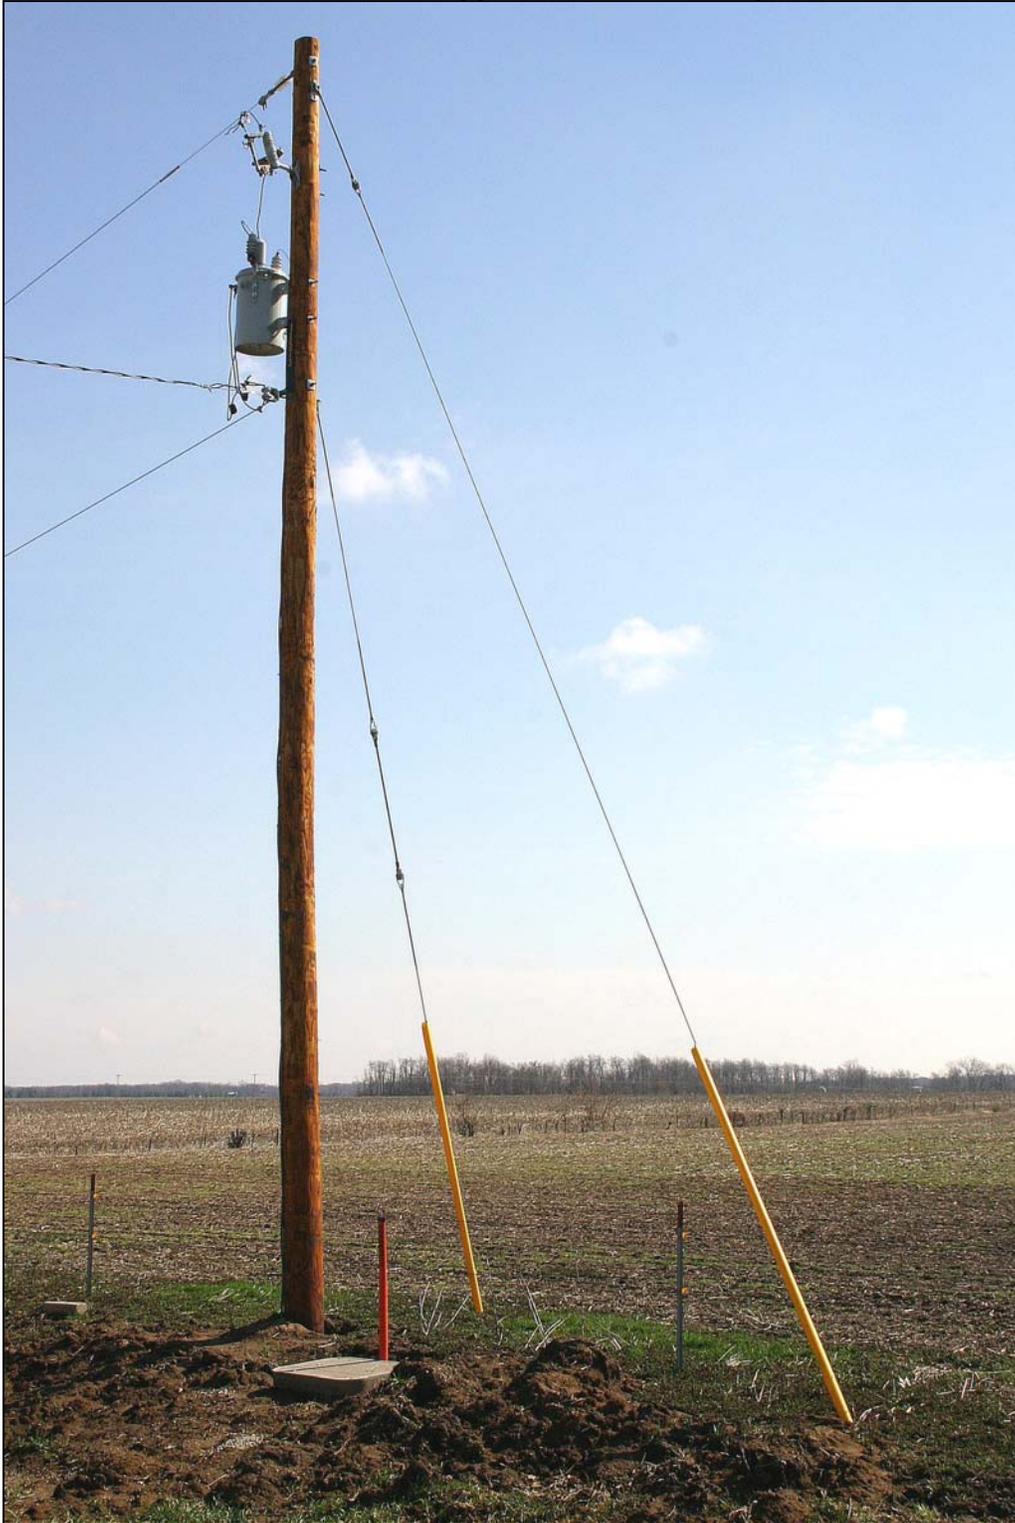
Figure 25 (Photo 08-IP1887)
Ungrounded 7.2 kV downguy with strain insulator not low enough (ON NEW POLE)
(NESC Guying Violation)
Circuit K62102, Apples Rd., east of Chapin
