Illinois Commerce Commission
Assessment of AmerenIP's
Reliability Report and Reliability Performance
for Calendar Year 2007

Pursuant to 83 Illinois Administrative Code 411.140

July, 2008

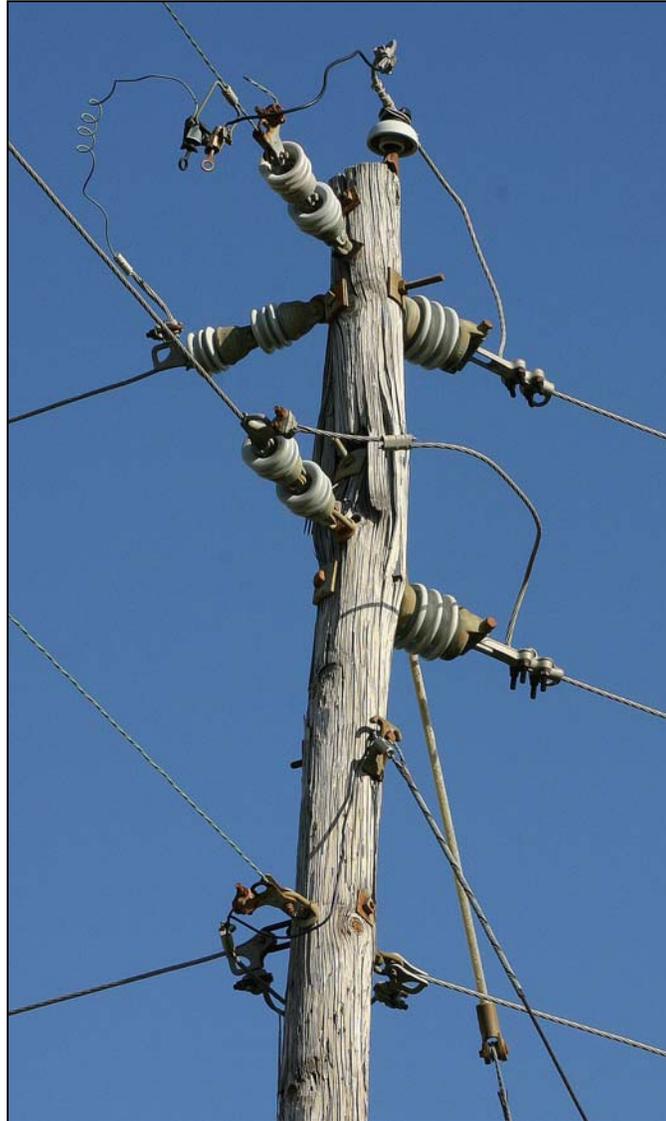
Figure 26 (Photo 08-IP1879)
Badly damaged pole top
Circuit K62102, Poor Farm Rd., east of Concord

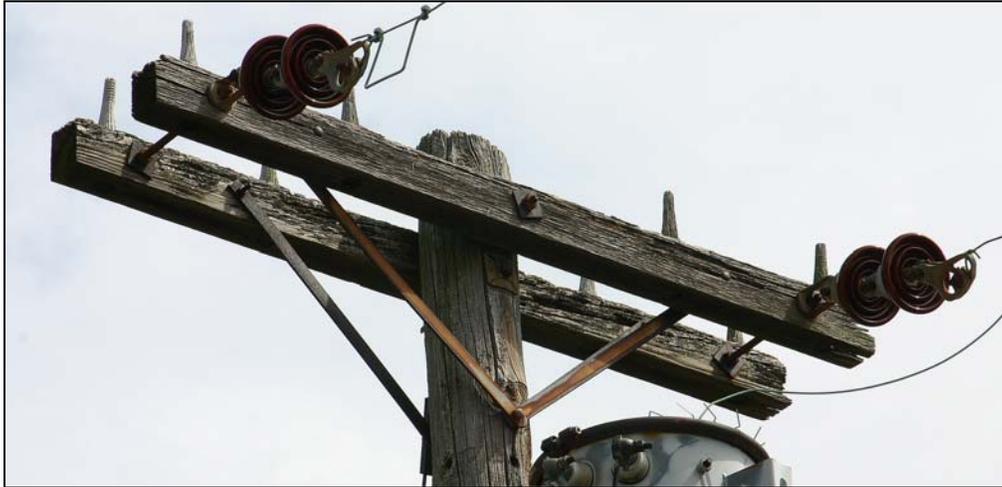
Figure 27 (Photo 08-IP1890)
Deteriorated crossarms
Circuit R06212, Laurel Dr., South Jacksonville

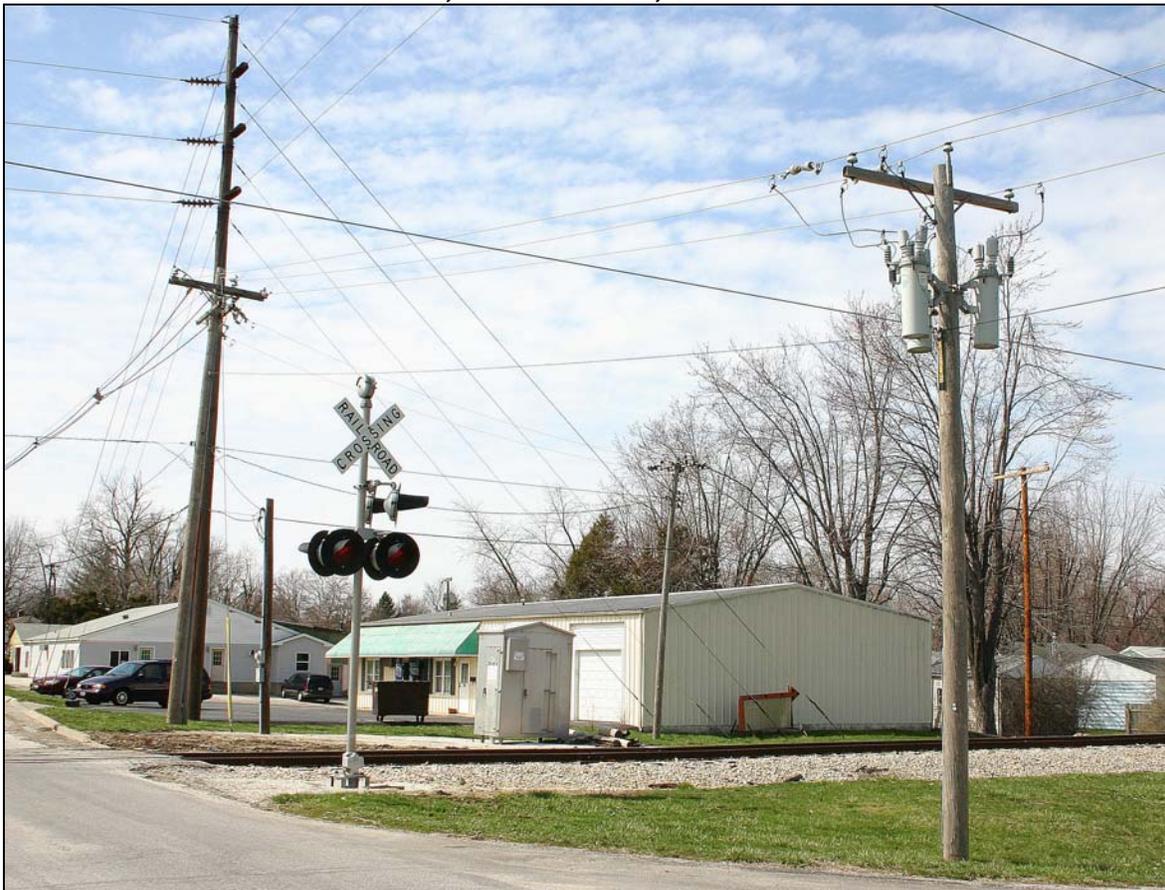
Figure 28 (Photo 08-IP1893)
Single wood crossarm on the east side of a railroad crossing
(NESC Railroad Crossing Violation)
Circuit R06212, E. Vandalia St., South Jacksonville

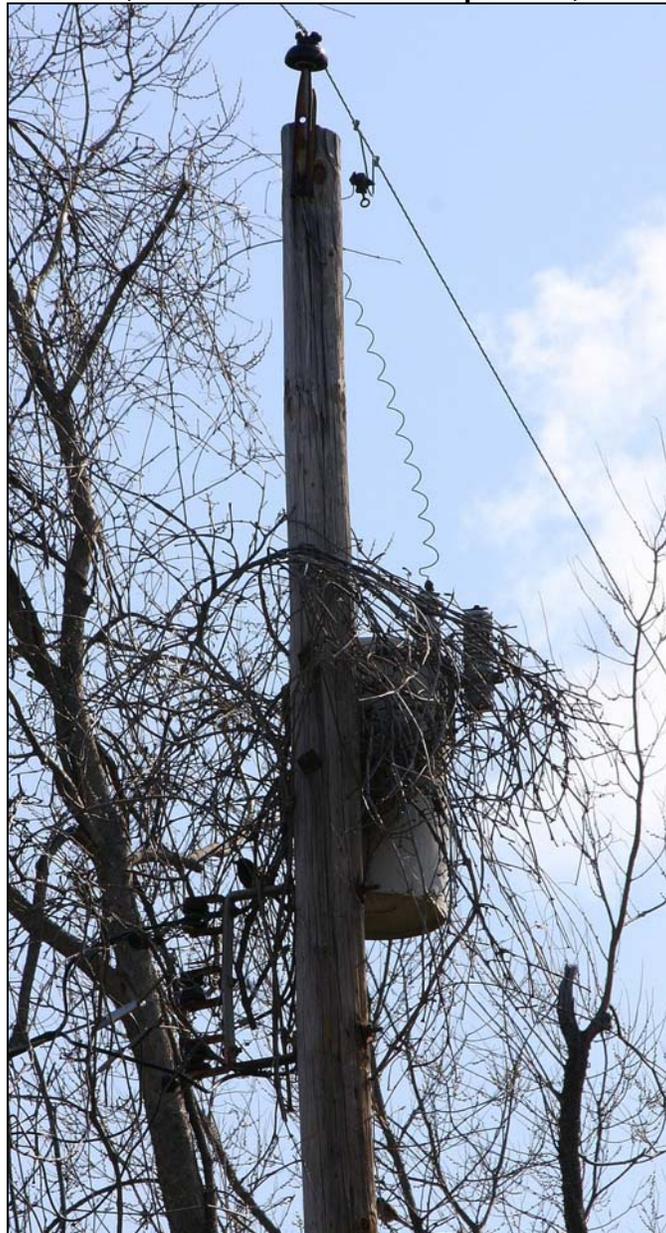
Figure 29 (Photo 08-IP1894)
Vines around transformer on pole
Circuit M49410, Easement south of Hampton Dr., Glen Carbon

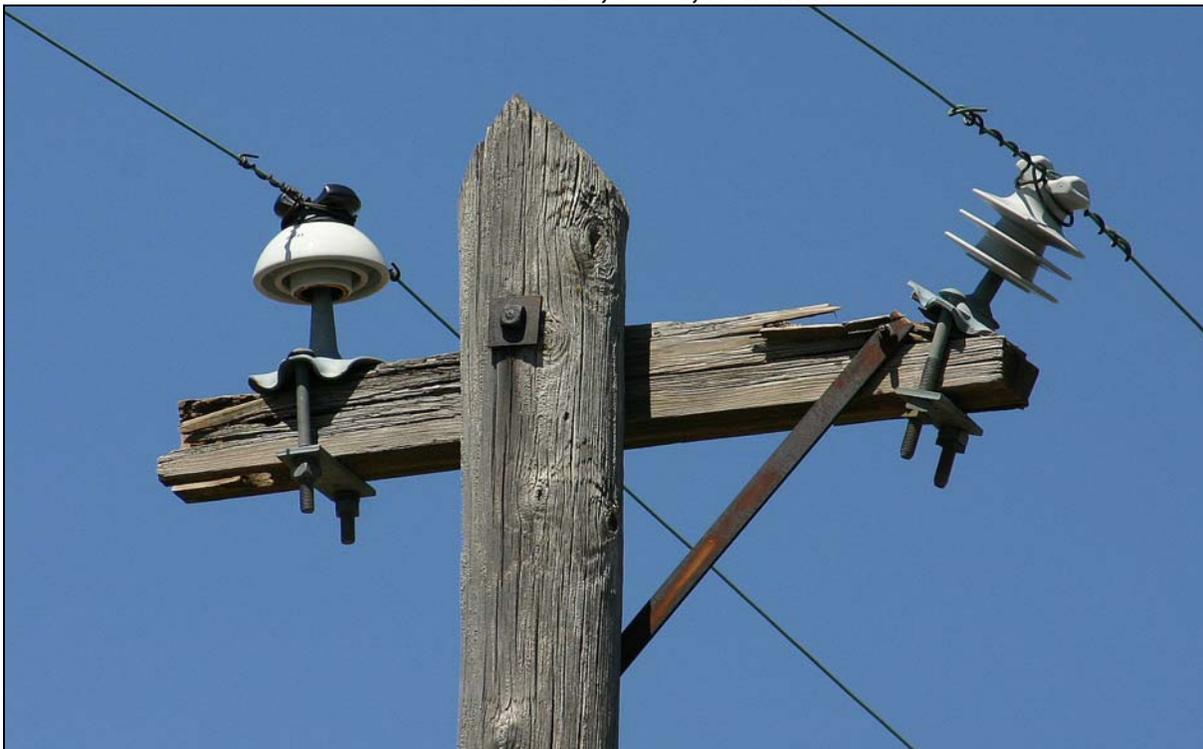
**Badly deteriorated crossarm with saddle pins & primary falling off end of arm
Circuit M31203, 7th St., Nekoma**

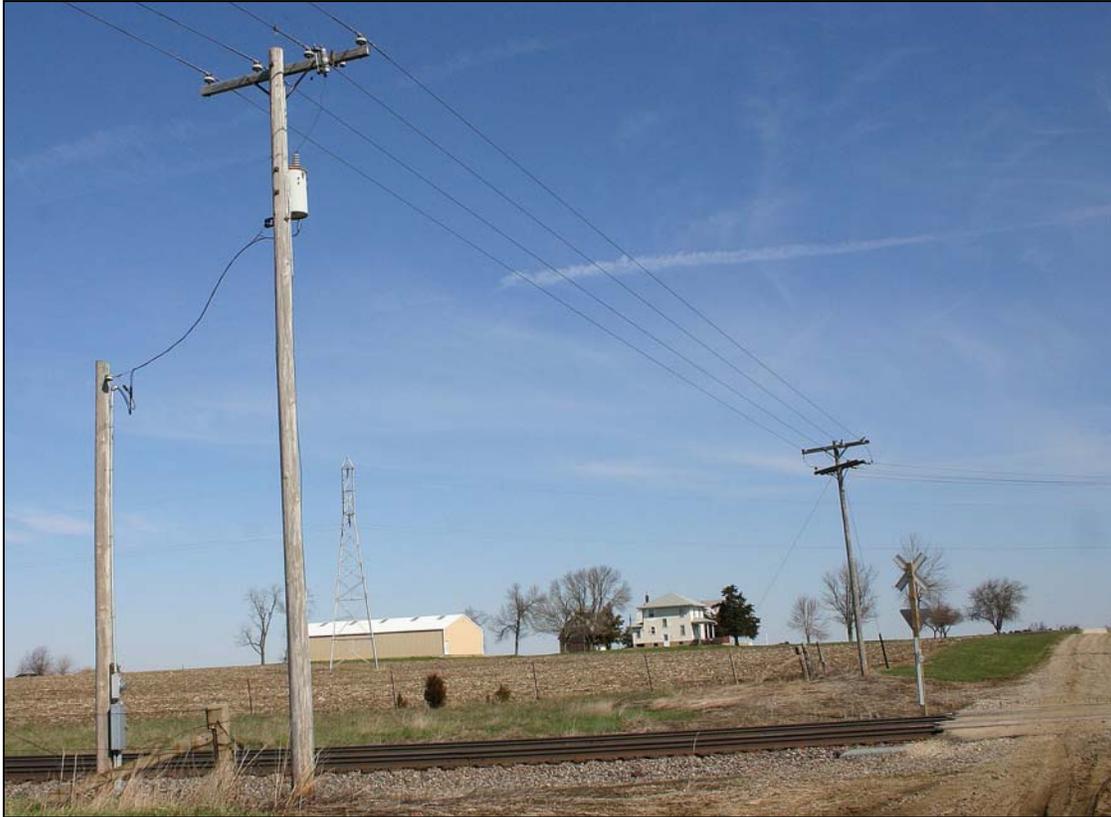
Figure 31 (Photo 08-IP1900)
Single wood crossarm on the south side of a railroad crossing
(NESC Railroad Crossing Violation)
Circuit M31203, Rd. 1800E, southwest of Galva

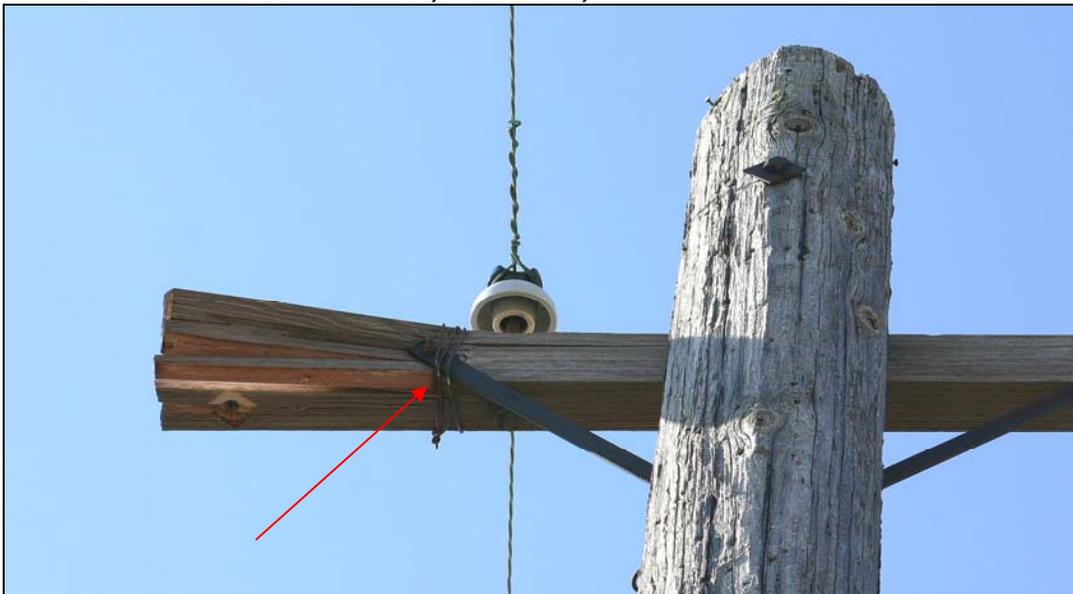
Figure 32 (Photo 08-IP1896)
Lightning damaged crossarm—wired together (see arrow)
Circuit M31203, Rd. 1850E, northwest of Galva

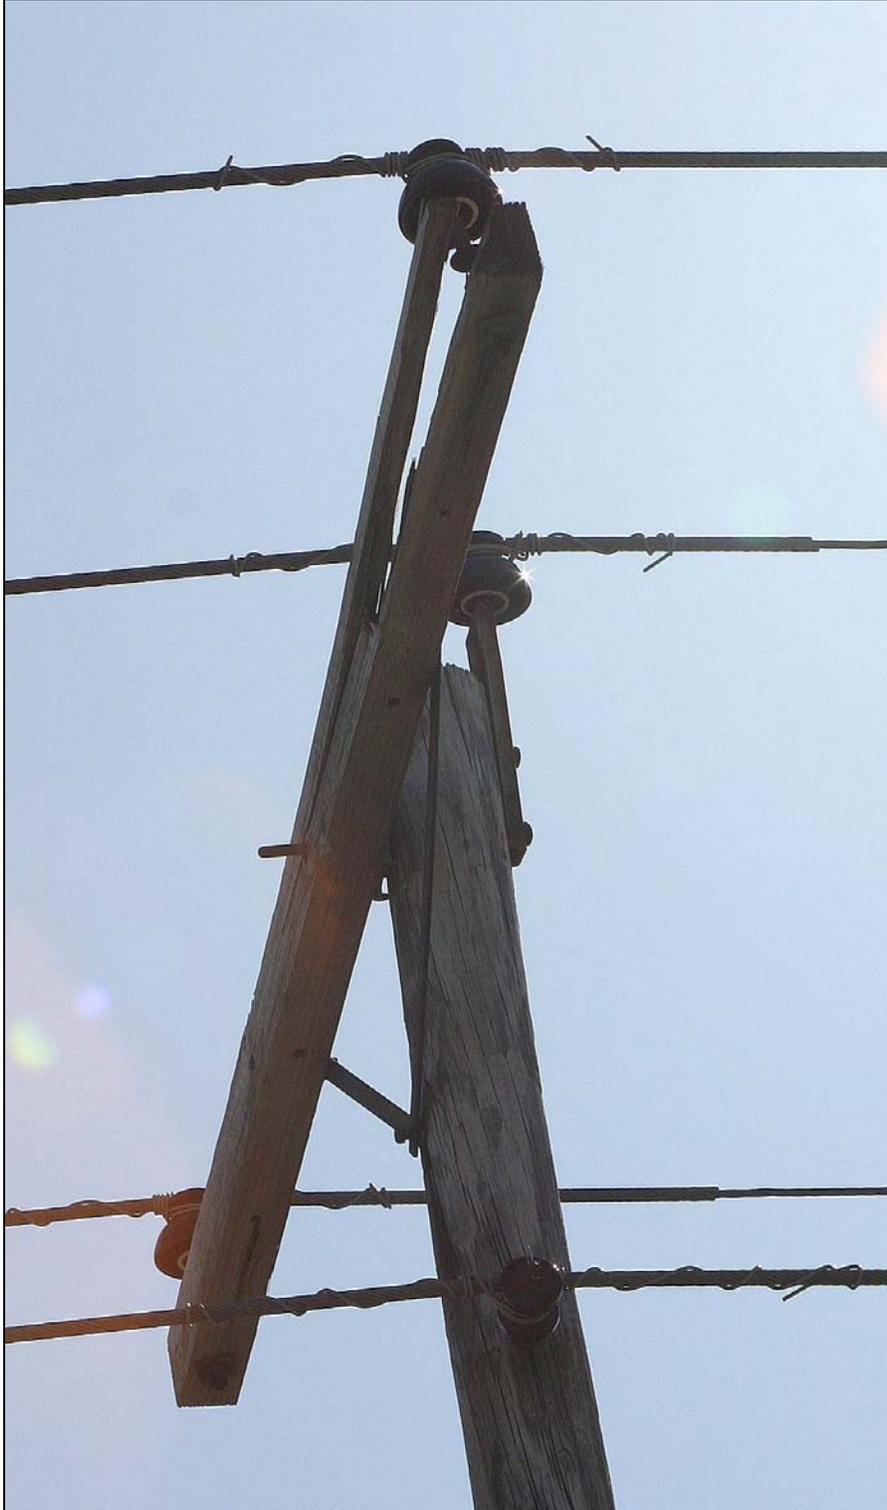
Figure 33 (Photo 08-IP1898)
Badly split (lightning damaged) crossarm
Circuit M31203, Rd. 1770E, west of Galva

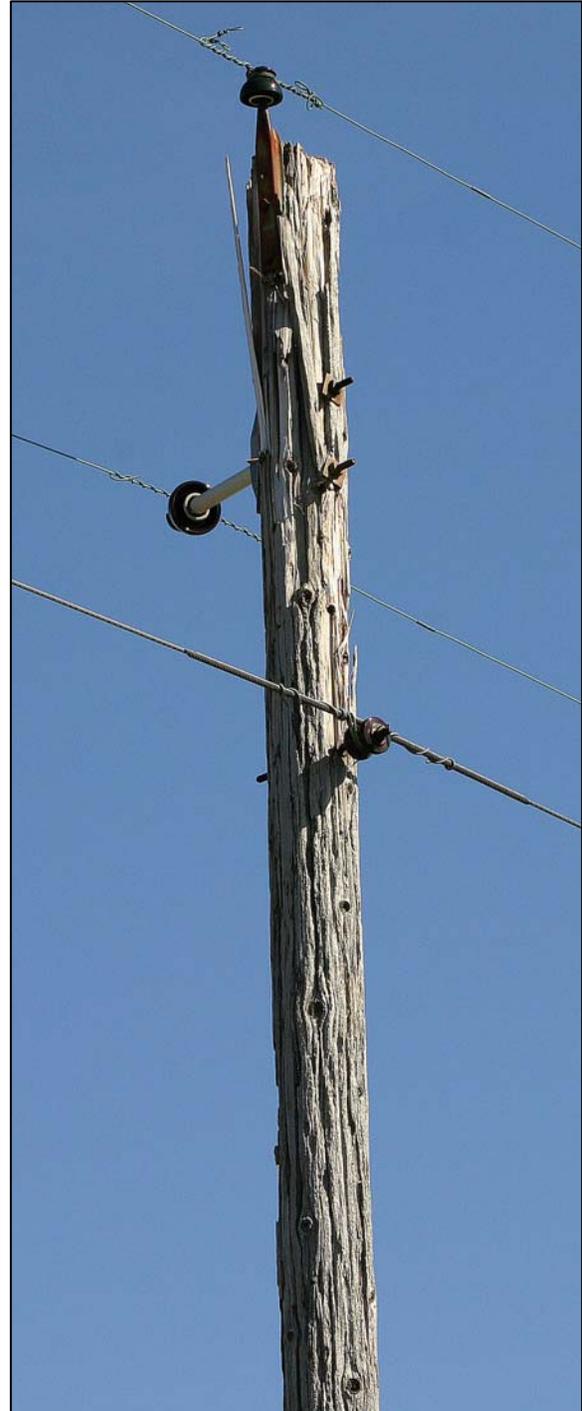
Figure 34 (Photo 08-IP1905)
**Badly shell rotted & lightning damaged pole
with bad top**
Circuit N70332, Rd. 2450E, south of Kewanee

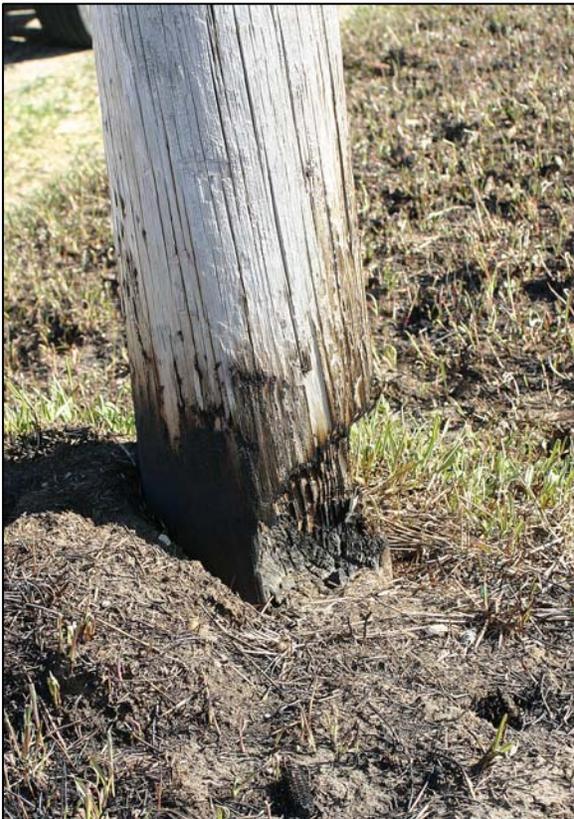
Figure 35 (Photo 08-IP1907)
**Pole badly burned at ground line
(marked for replacement)**
Circuit N70332, Rd. 2550E, south of Kewanee

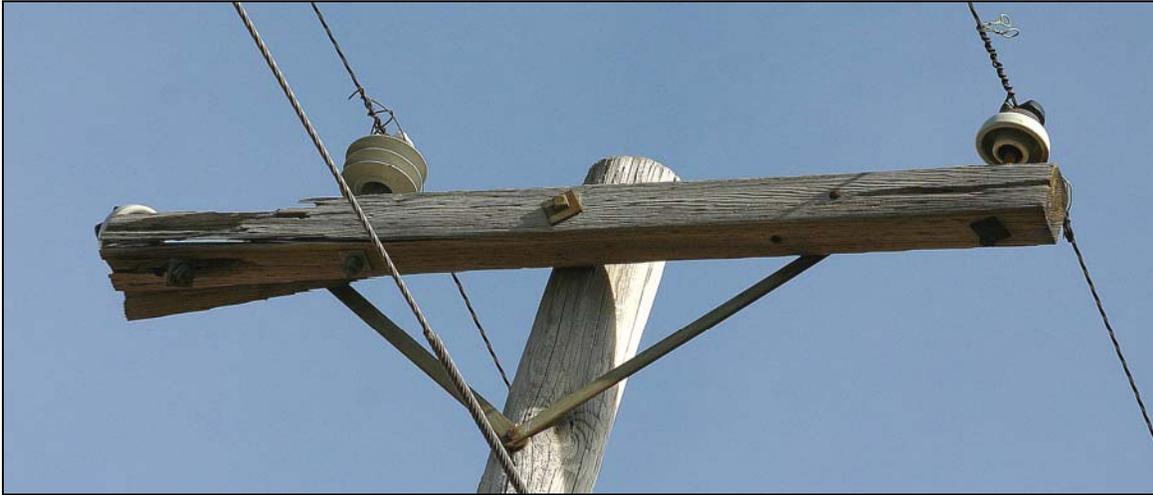
Figure 36 (Photo 08-IP1908)
Badly split (lightning damaged) crossarm
Circuit N70332, Rd. 2750E, south of Kewanee

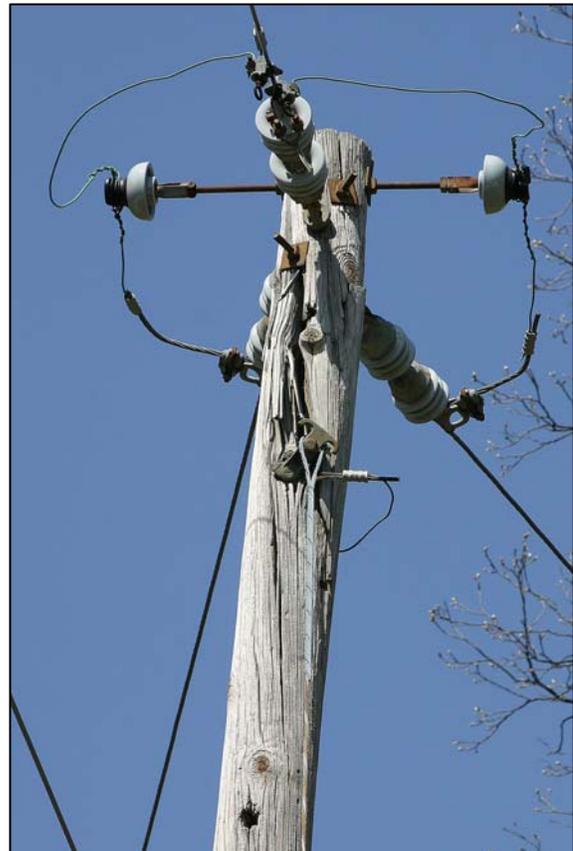
Figure 37 (Photo 08-IP1912)
Split pole top & woodpecker hole in pole
Circuit P26284, Troll Rd., south of Marseilles

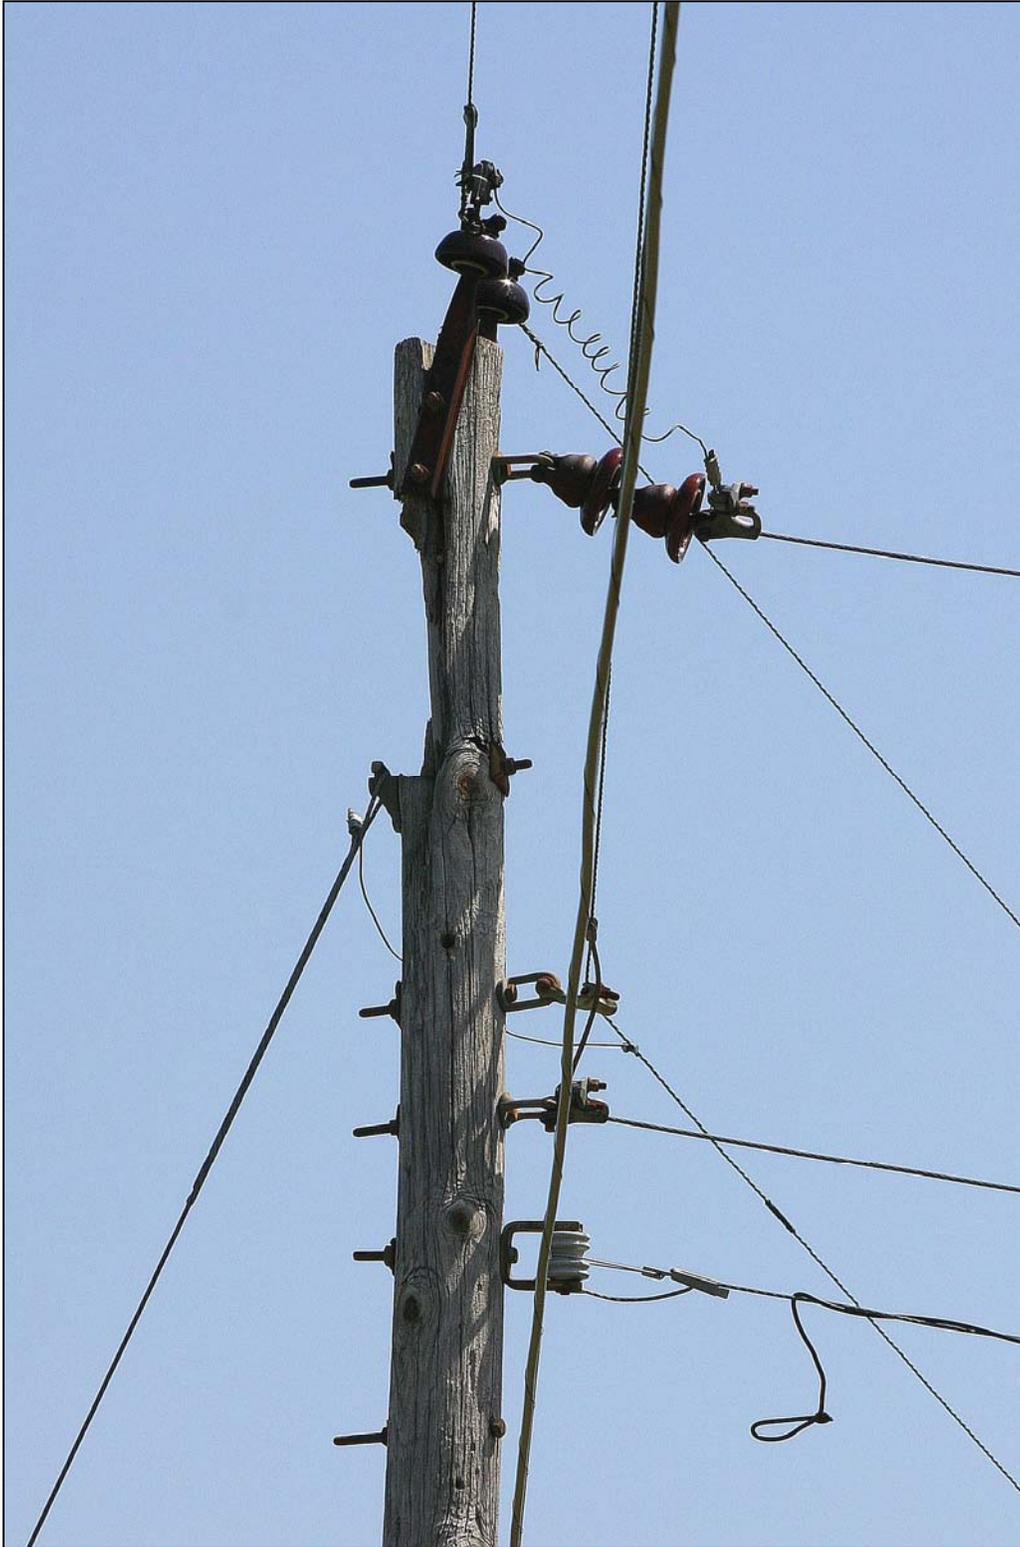
Figure 38 (Photo 08-IP1910)
Badly deteriorated & weakened pole top (at 3-way corner)
Circuit P26284, E. of 2350th Rd., south of Marseilles

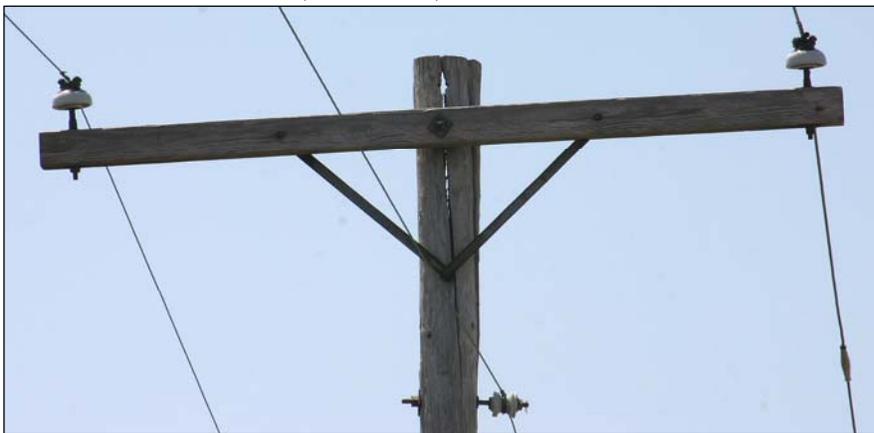
Circuit N50331, York Rd., northeast of Jacksonville

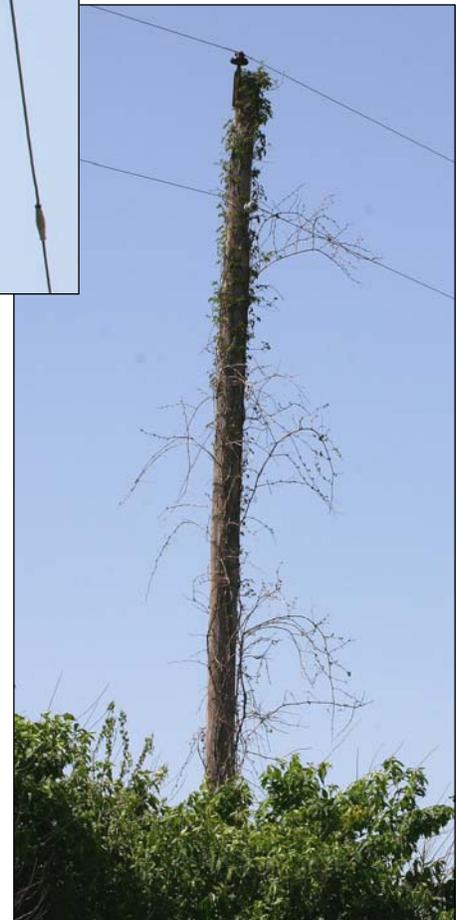
Figure 40 (Photo 08-IP1932)

**Vines up pole to single-phase primary conductor
Circuit N50331, Wohlers Rd., east of Jacksonville**

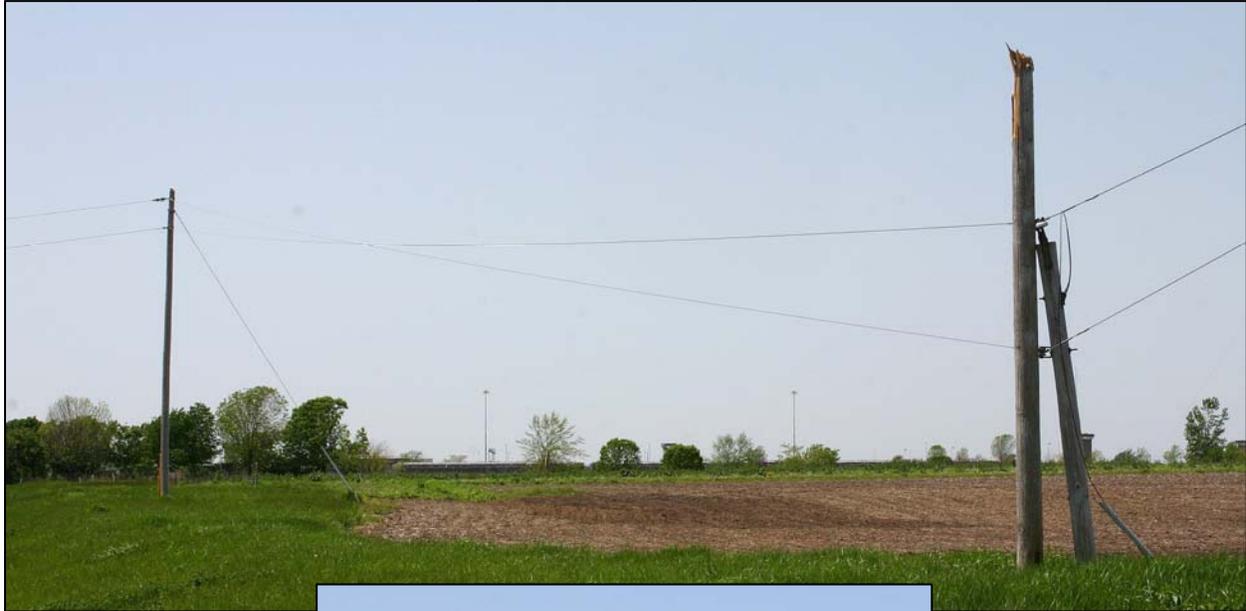
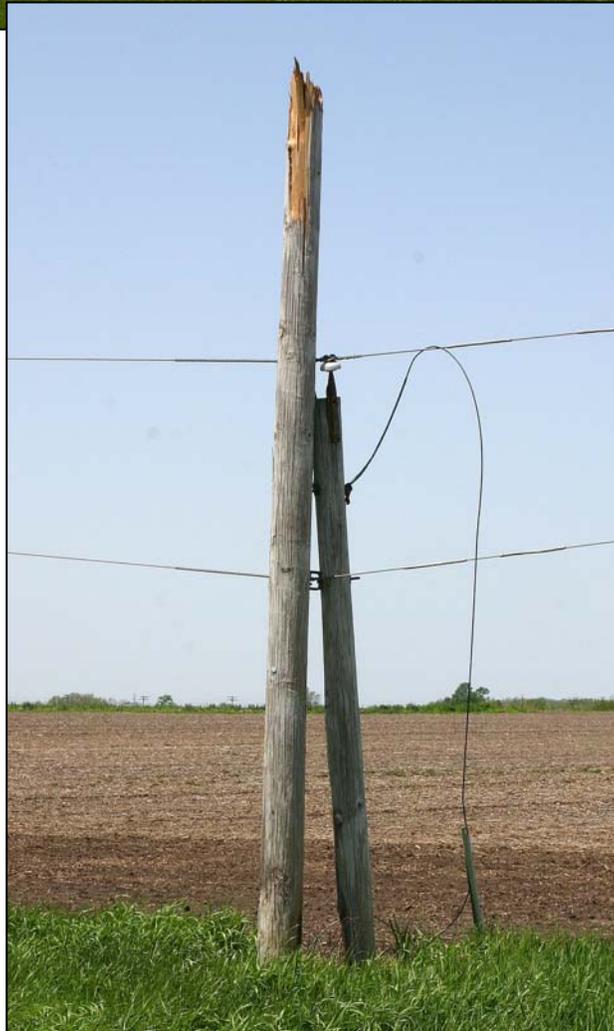
Figures 41 & 42 (Photos 08-IP1930 & 1931)
Broken pole and broken downguy in de-energized line, resulting in
NESC Ground Clearance Violation
Circuit N50331, Old Rt. 36 East, east of Jacksonville

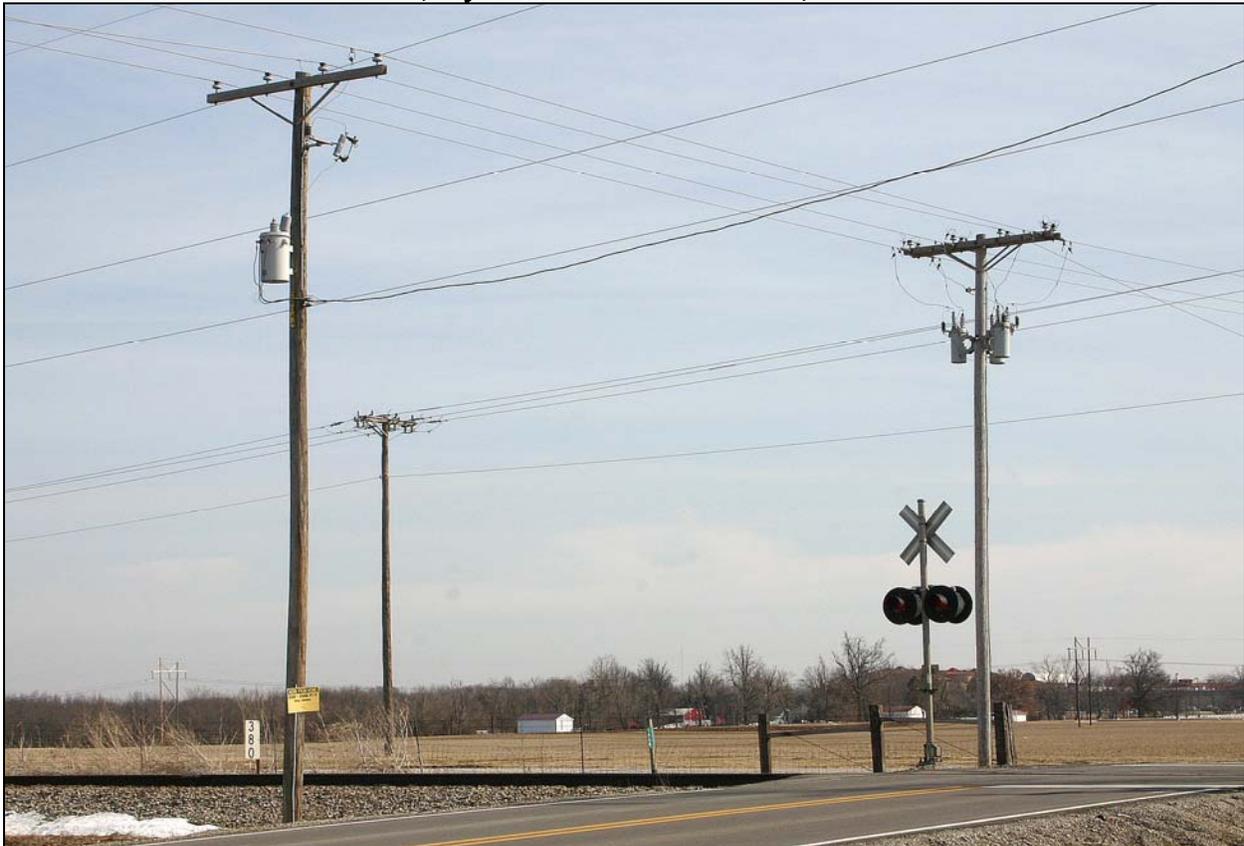
Figure 43 (Photo 08-IP1859)
Single wood crossarm supporting a 3-phase crossing of a railroad
(NESC Railroad Crossing Violation)
Circuit M18131, Wyckles Rd. north of Rt. 36, west of Decatur

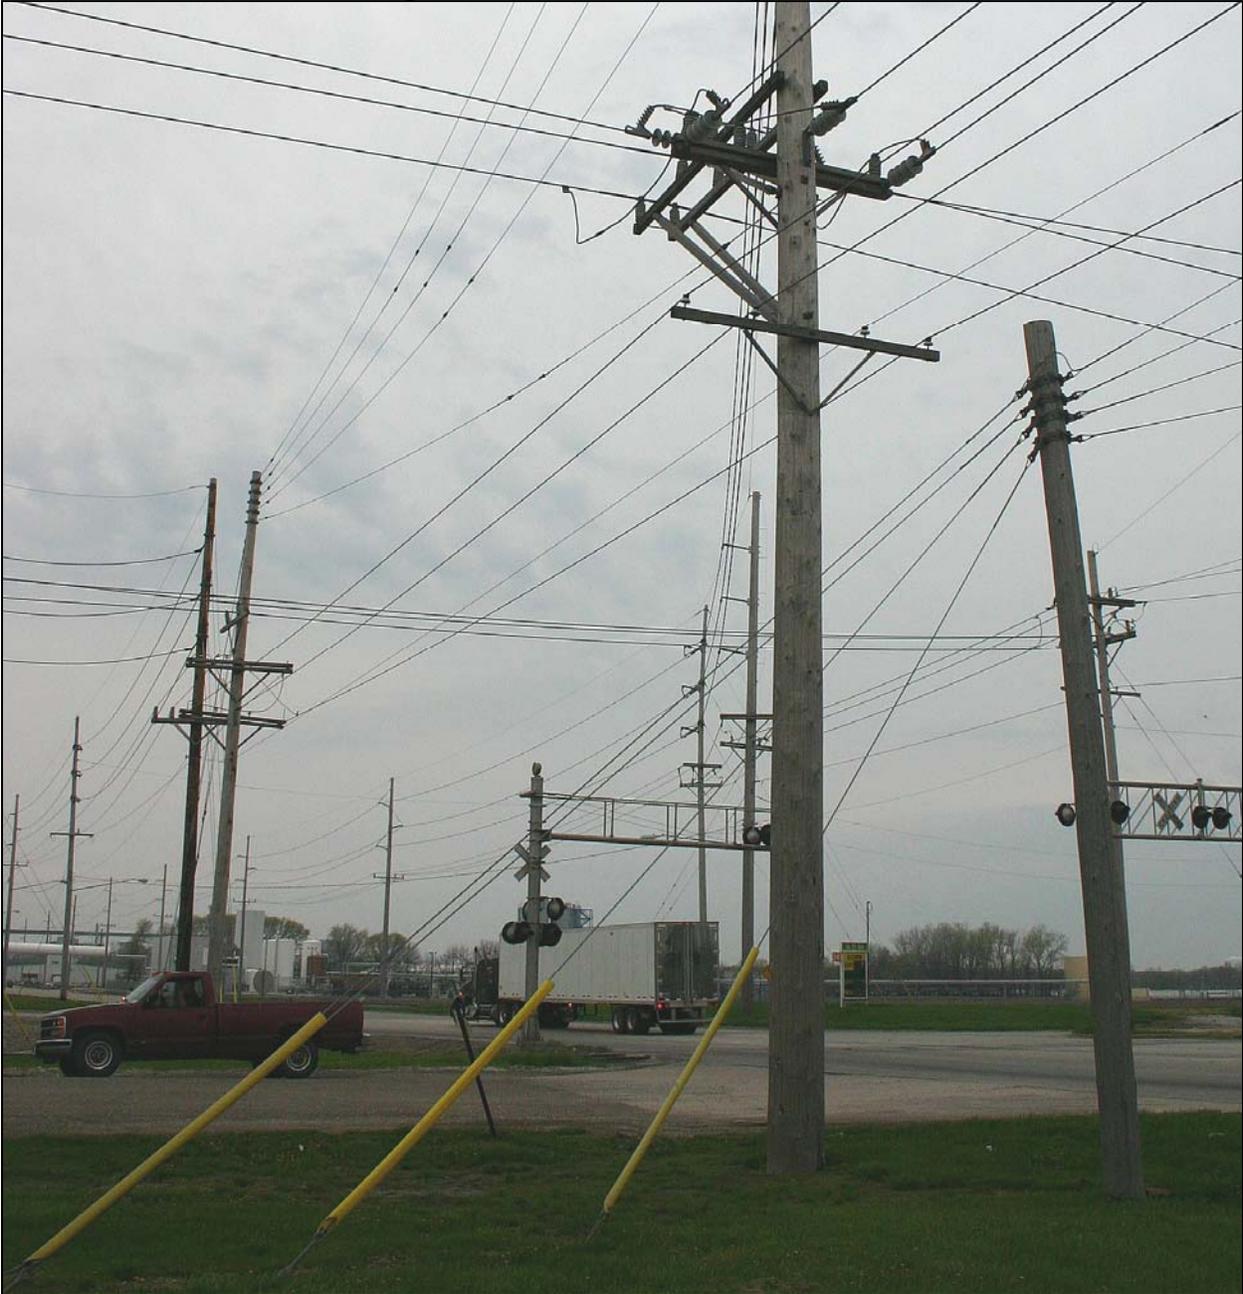
Figure 44 (Photo 08-IP1913)

**Single wood crossarm supporting a 3-phase crossing of a railroad
(NESC Railroad Crossing Violation)**

Circuit K91115, Brush College Rd. south of Reas Bridge Rd. at ADM Substation, Decatur

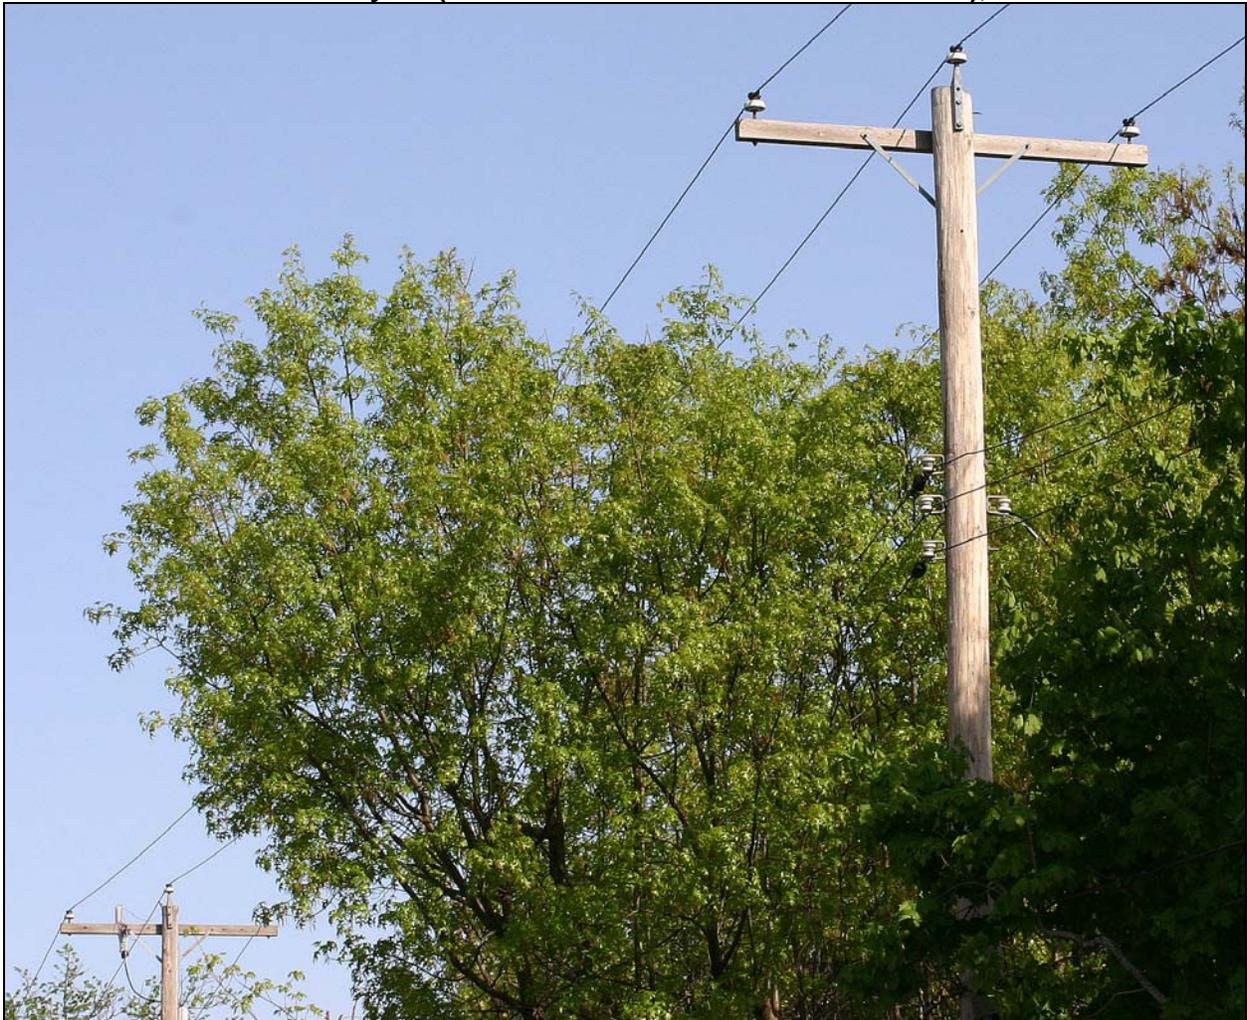
State St. east of Finley St. (across from Illinois School for the Deaf), Jacksonville

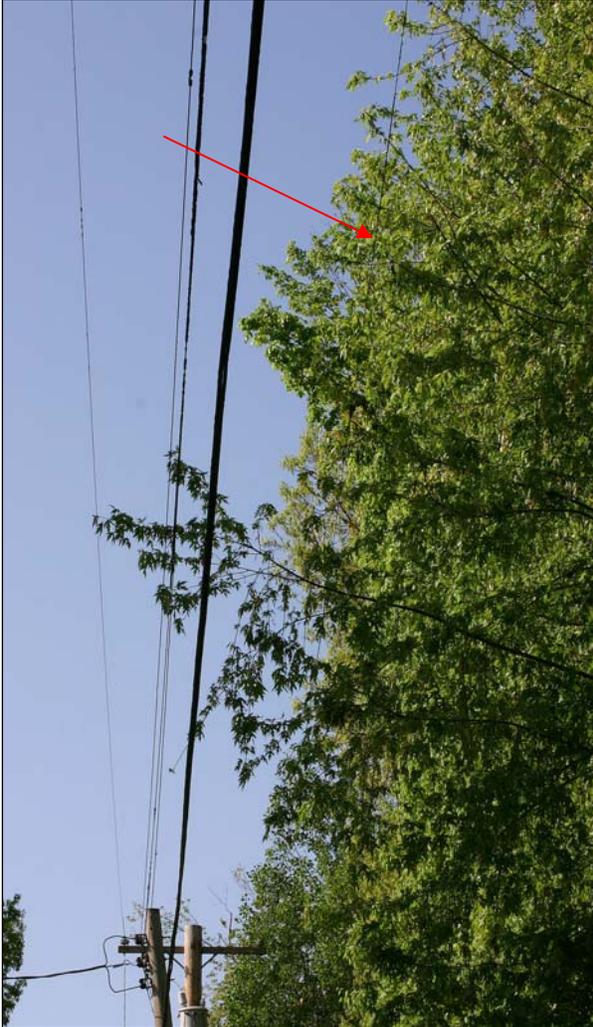
Figure 46 (Photo 08-IP1922)
Silver maple tree into primary
N. Sandusky north of Duncan Park, Jacksonville

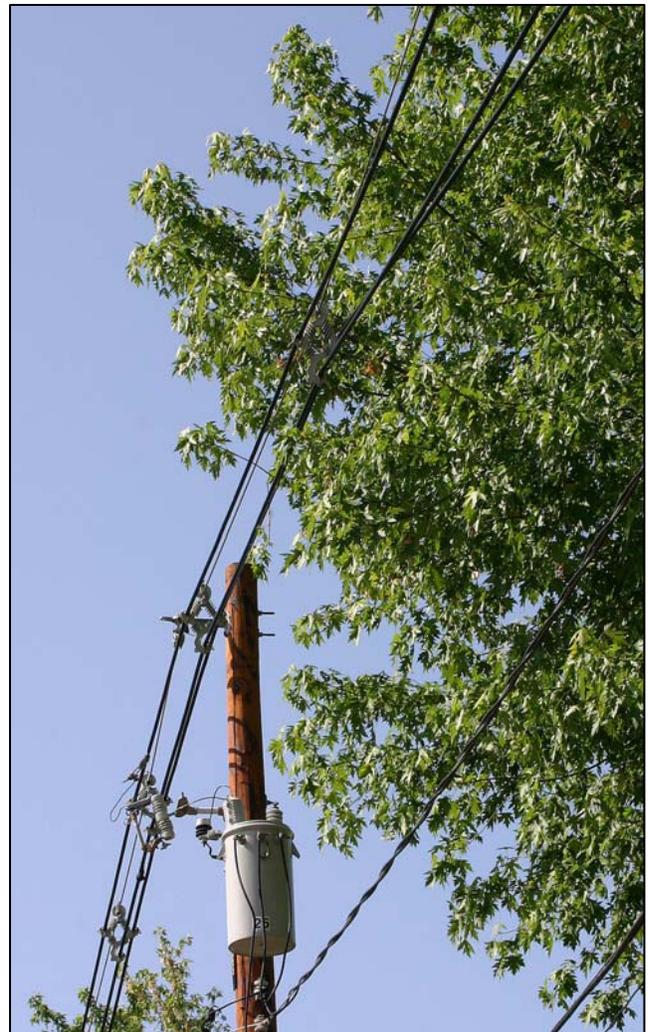
Figure 47 (Photo 08-IP1925)
Silver maple tree into 3-phase spacer cable
Diamond St. just south of Beecher Ave.,
Jacksonville

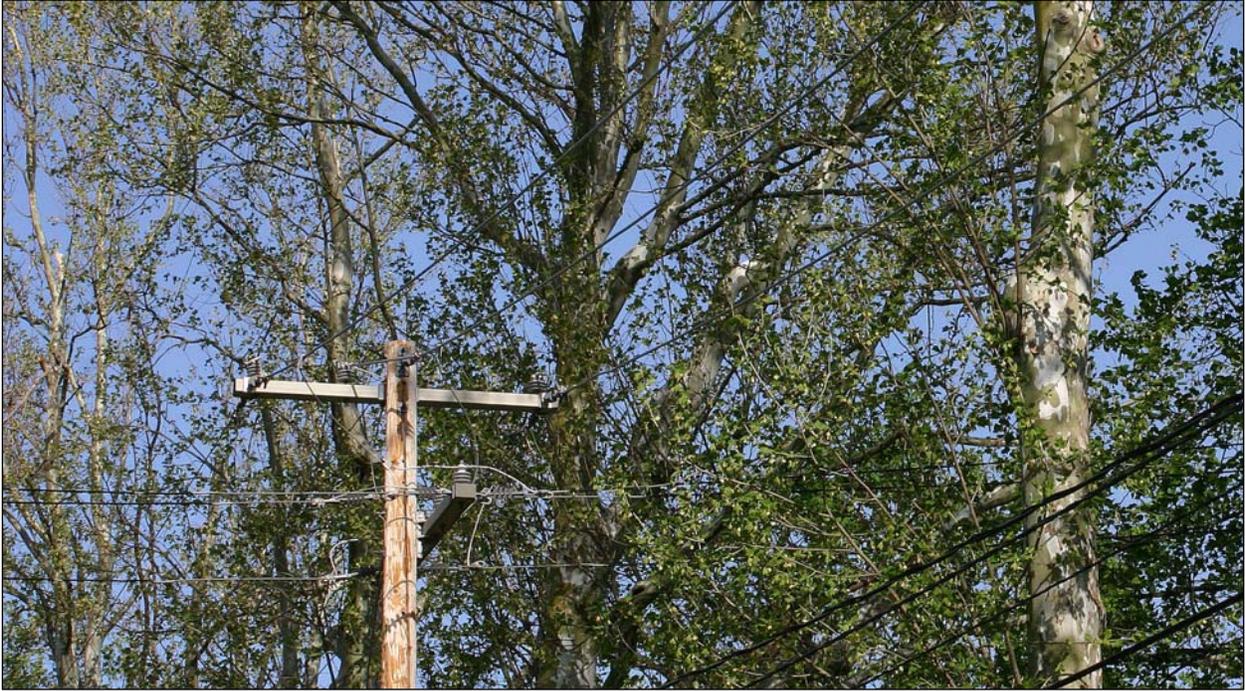
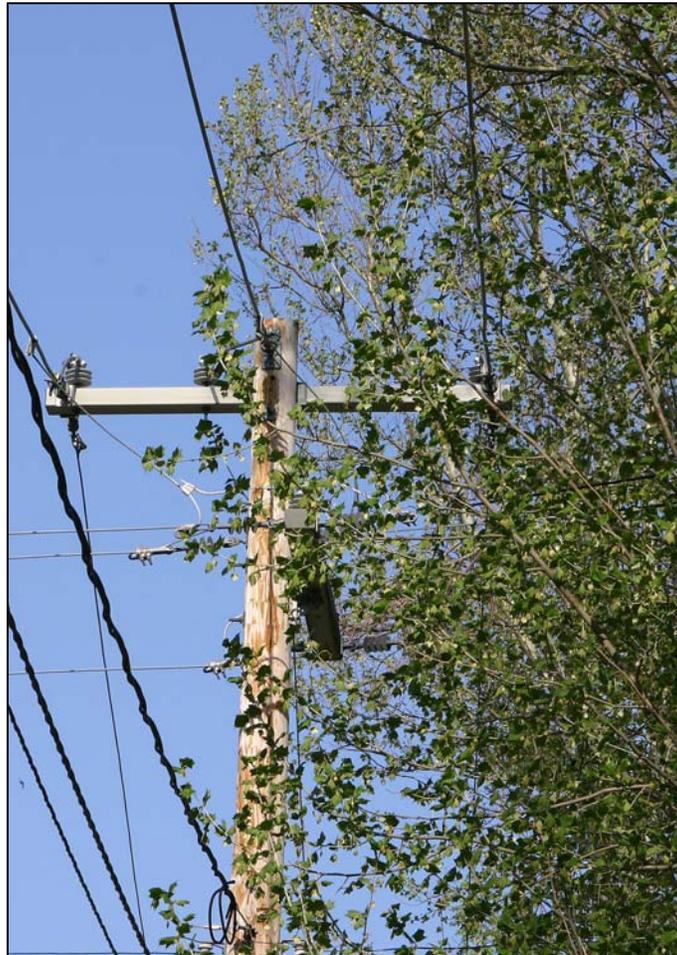
**Figures 48 & 49 (Photos 08-IP1918 & 1919)
Sycamore tree into & overhanging 3-phase primary
Mound Ave. west of Woodland Place, Jacksonville**
