Annual Report for the 2000 Reporting Period
Pursuant to 83 Illinois Administrative Code 411

June 1, 2001

Revised June 25, 2001

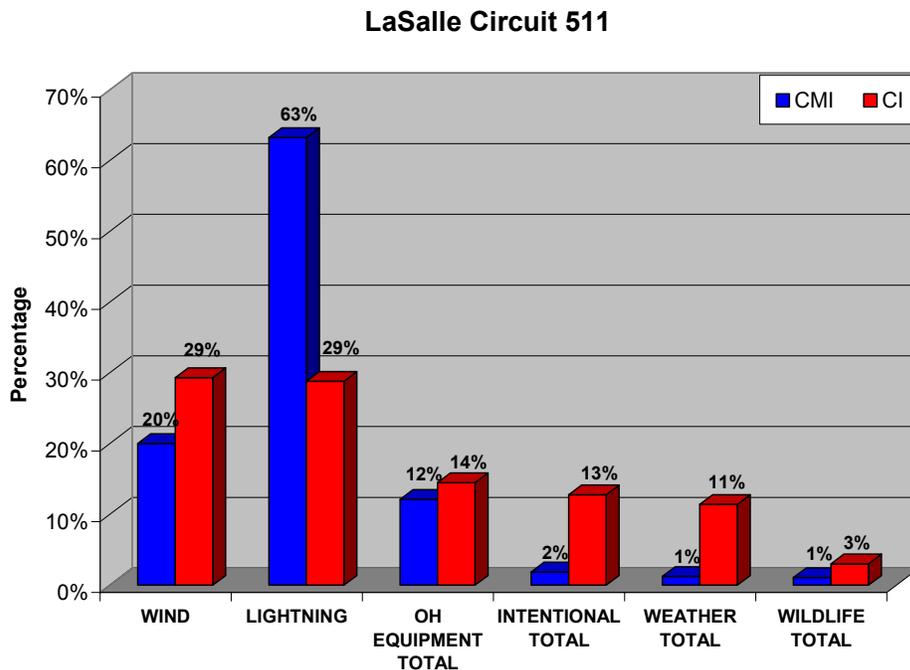
• Figure 23. LaSalle Circuit 511 Causes of 2000 Interruptions

This circuit was a worst performer from both a SAIFI and CAIFI perspective. It serves 1583 customers at 12.47 kV and is mostly overhead. Based on the customer density per circuit mile, the circuit is classified as urban. Figure 23 shows the percentage of customers interrupted and customer minutes interrupted by cause category for 2000. Wind and Lightning were the predominant cause of high CI and CMI.

This circuit was patrolled in both 1999 and in 2001. It was trimmed in 1998 at a cost of \$128,771 in constant 1998 dollars. There is no indication of tree related issues and this

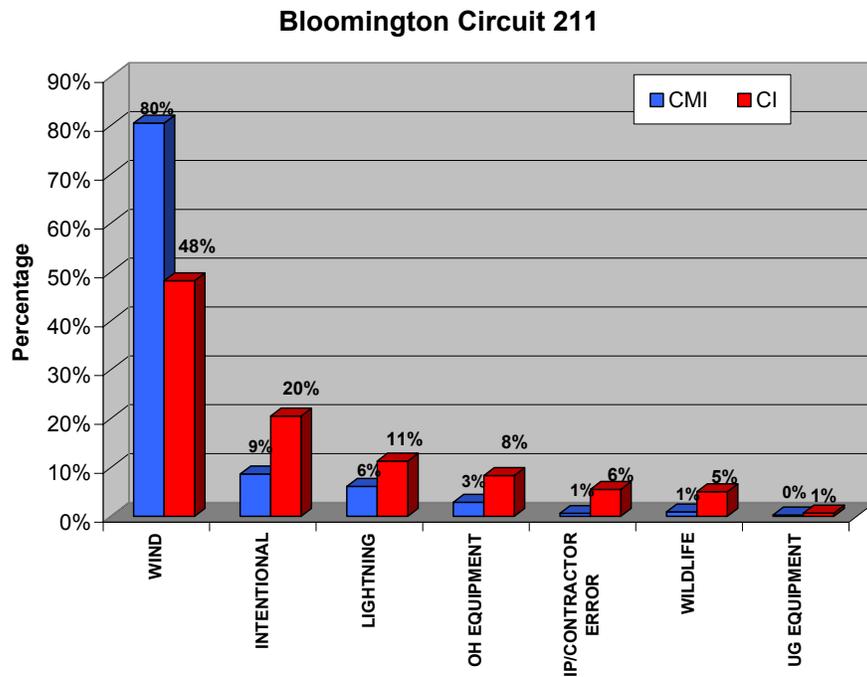
• Figure 24. Bloomington Circuit 211 - Causes of 2000 Interruptions

This circuit was a worst performer from both a SAIFI and CAIFI perspective. It serves 920 customers at 12.47 kV and is mostly overhead. Based on the customer density per circuit mile, the circuit is classified as rural. Figure 23 shows the percentage of customers interrupted and customer minutes interrupted by cause category for 2000. Wind was the predominant cause of high CI and CMI.

This circuit was patrolled in both 1998 and in 2001. It was trimmed in February 2001 at a cost of \$42,603 in *constant 1998 dollars*. This recent trim may reduce the number of wind related issues that this circuit experiences in 2001. Approximately fifteen to twenty fuses are being installed at a cost of \$23,679 in *constant 1998 dollars*. Approximately two hundred and four animal guards are being installed at a cost of \$15,166 in *constant 1998 dollars*. One hundred and seventy-seven items were identified on the maintenance patrol as possible repair opportunities. A planning and coordination study is being performed on this circuit and will be complete by December 2001. Findings from this study will be implemented by June 2002.

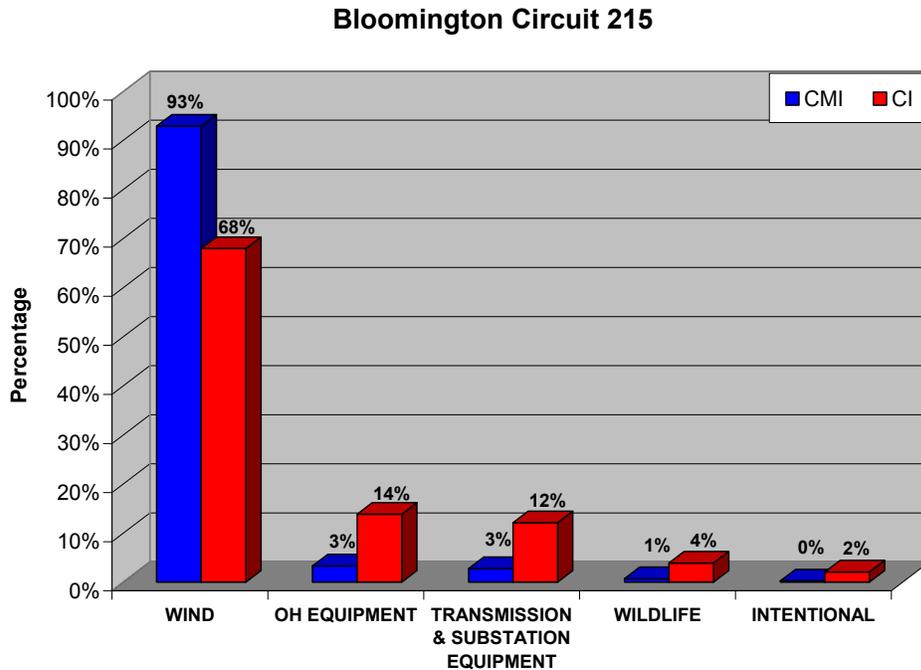
• Figure 25. Bloomington Circuit 215 - Causes of 2000 Interruptions

This circuit was a worst performer from both a SAIFI and CAIFI perspective. It serves 807 customers at 12.47 kV and is mostly overhead. Based on the customer density per circuit mile, the circuit is classified as rural. Figure 25 shows the percentage of customers interrupted and customer minutes interrupted by cause category for 2000. Wind was the predominant cause of high CI and CMI.

This circuit was patrolled in both 1998 and in 2001. It was trimmed in April 1998 at a cost of \$39,163 in *constant 1998 dollars*. One hundred and seventy three animal guards are being installed on this circuit at a cost of \$13,271 in *constant 1998 dollars*. Twenty-six additional items were identified during the maintenance patrol as potential repair opportunities.

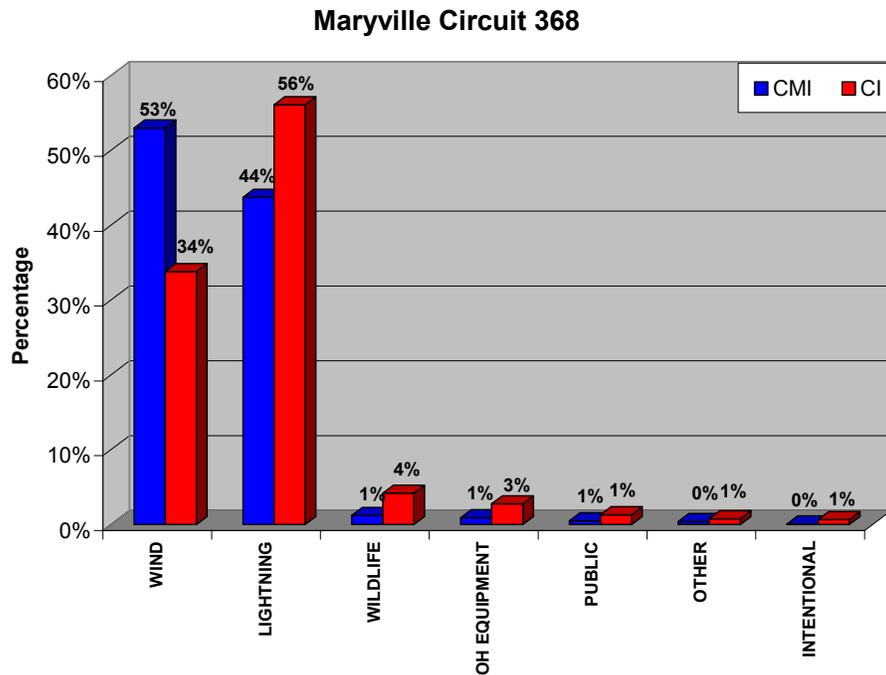
• Figure 35. Maryville Circuit 368 - Causes of 2000 Interruptions

This circuit was a worst performer from both a SAIFI and CAIFI perspective. It serves 783 customers at 12.47 kV and is 80% overhead. Based on the customer density per circuit mile, the circuit is classified as rural. Figure 35 shows the percentage of customers interrupted and customer minutes interrupted by cause category for 2000. Wind and lightning were the predominant cause of high CI and CMI.

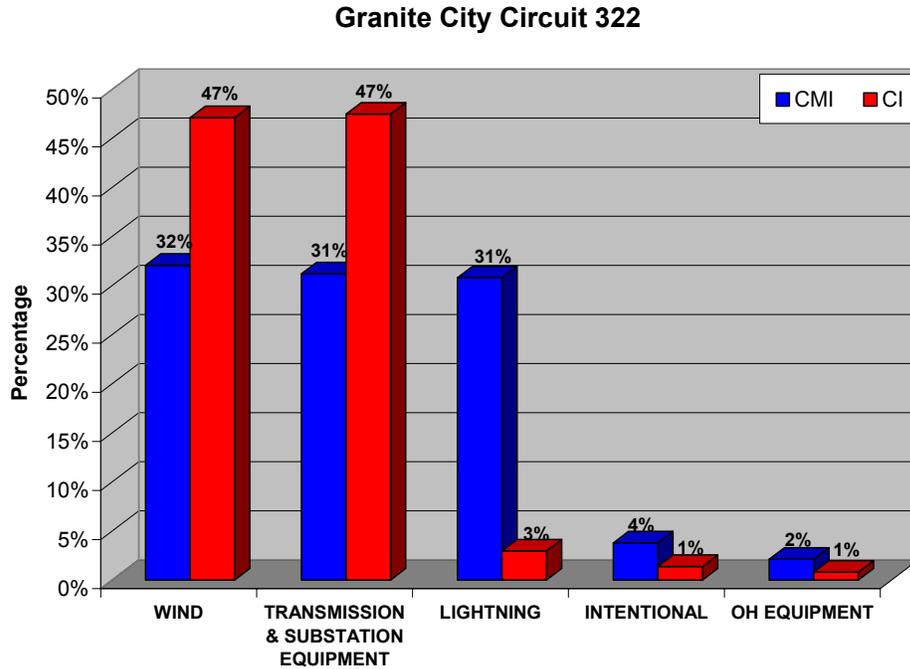
• Figure 38. Granite City Circuit 322 - Causes of 2000 Interruptions

This circuit was a worst performer from a CAIDI perspective. It serves 676 customers at 4.16 kV and is mostly overhead. Based on the customer density per circuit mile, the circuit is classified as urban. Figure 38 shows the percentage of customers interrupted and customer minutes interrupted by cause category for 2000. Wind, transmission and substation equipment, and lightning were the predominant cause of high CI and CMI.
