Illinois Commerce Commission
Assessment of AmerenIP's
Reliability Report and Reliability Performance
For Calendar Year 2009

Pursuant to 83 Illinois Administrative Code 411.140

July 12, 2011

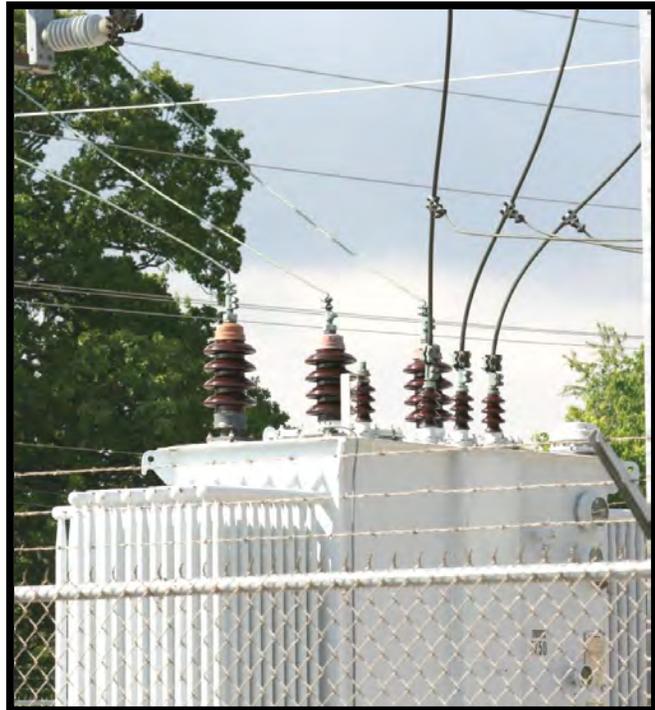
Circuit R71286 Located at Valmeyer
Rt 156 Substation, North of IL RT
156

Photo No. 1: Substation Transformer without Animal Guards

with red ribbons as a sign of rejection during a circuit inspection. Staff also noted some transformers without animal guards. AmerenIP corrected some of Staff's findings and provided a schedule to correct others.

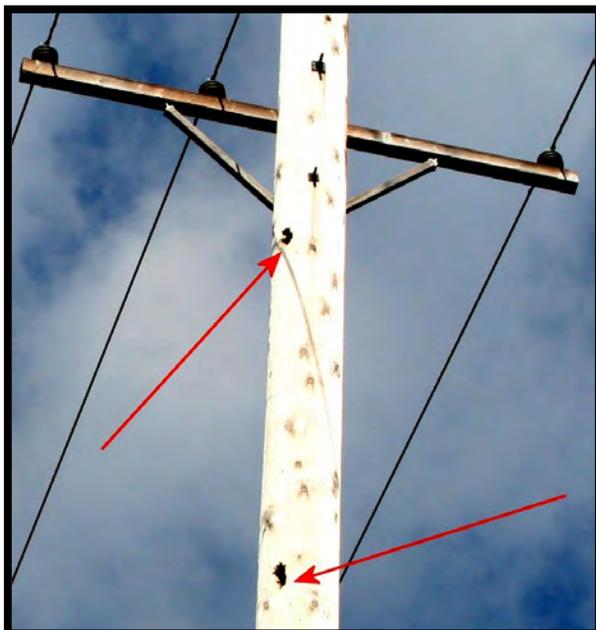
Circuit R71286 – Pole No. 2315406

Photo No. 2: Woodpecker Holes in a Pole

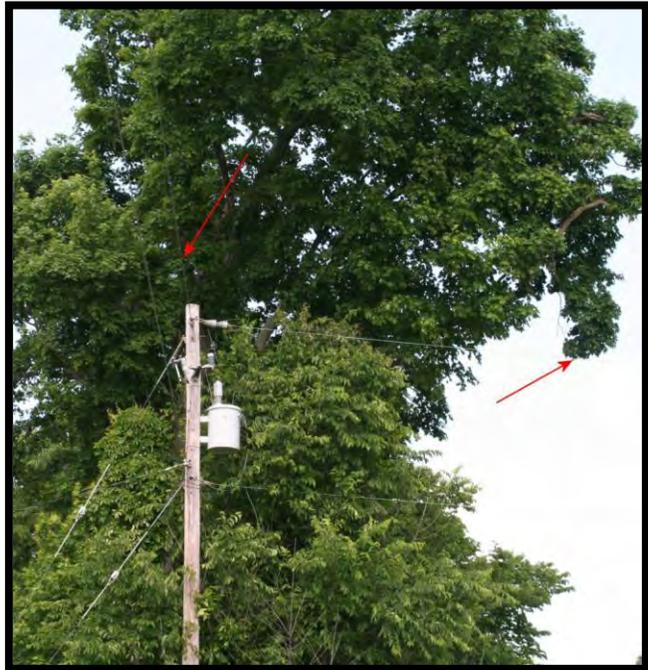
Circuit R71286 – Pole No. 2874634 on IL RT 156

Photo No. 3: Trees Close to the Primary

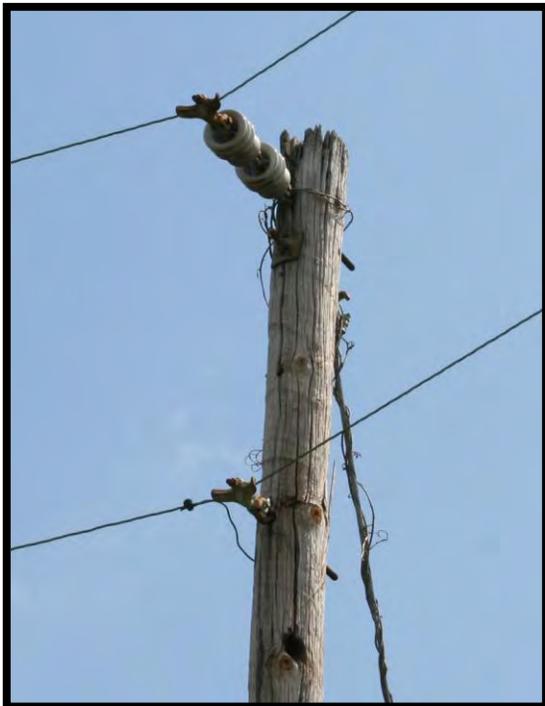
Circuit R71286 – Located at Deer Hill Rd - Pole No. 2875074

Photo No. 4: Deteriorated Pole Top

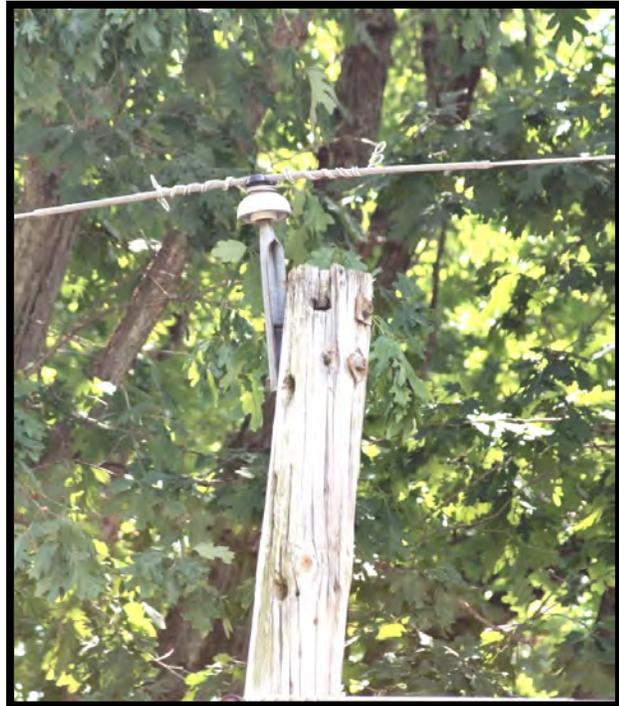
Circuit R71286 – Located in front of the intersection of Deer Hill Rd and Trout Camp Rd-Pole No. 2906220

Photo No. 5: Woodpecker Holes in a Pole and Loose Pole-Top Pin

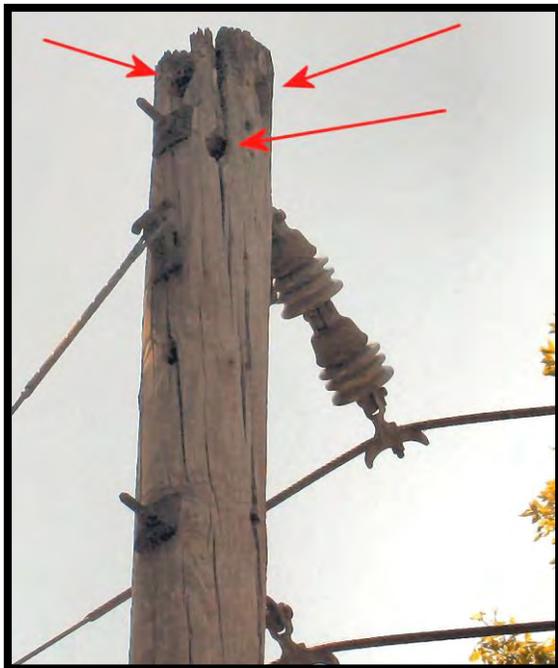
Circuit R71286 – Pole No. 2891985

Photo No. 6: Woodpecker Holes in a Pole

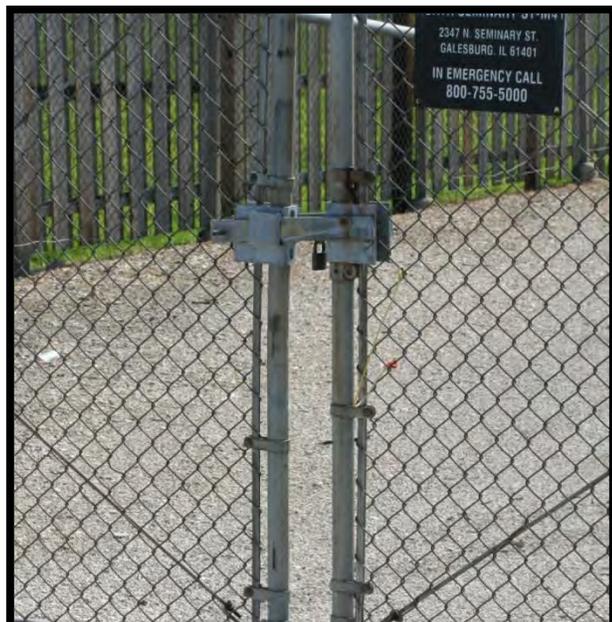
Circuit M41-112: Located at 2347 N Seminary St

Photo No. 7: Large gap in the substation gate

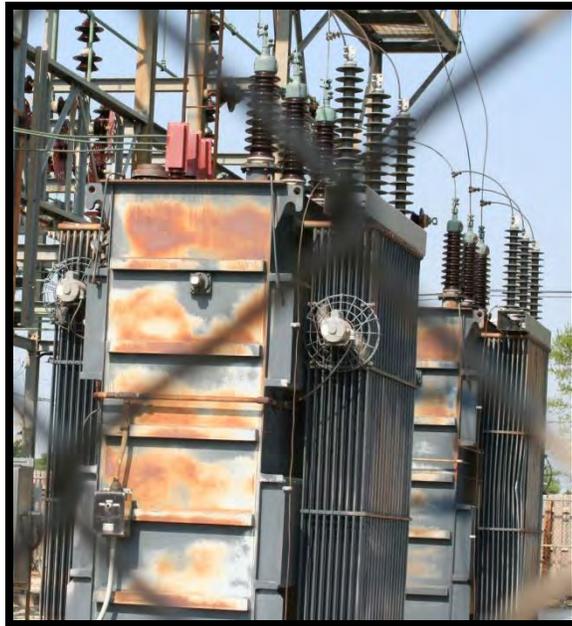
Circuit M41-112: Located at 2347 N Seminary St

Photo No. 8: Rusted substation transformers

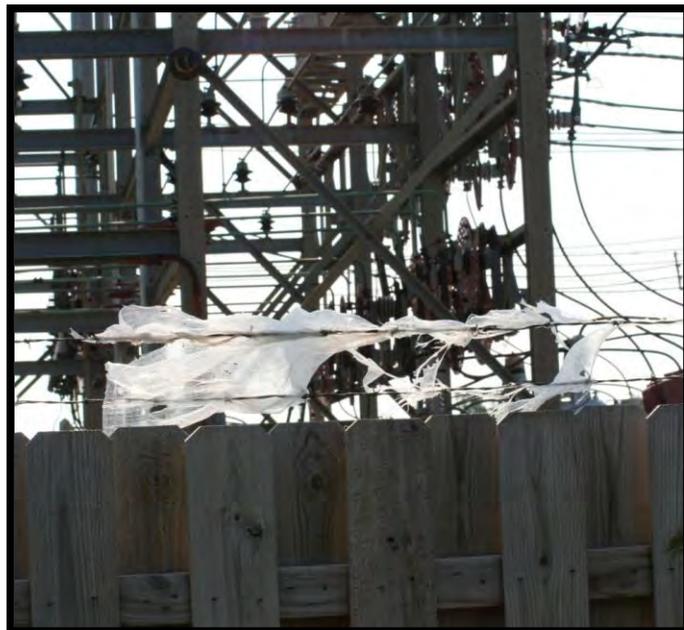
Circuit M41-112: Located at 2347 N Seminary St

Photo No. 9: Debris on the barbed wire above the substation fence

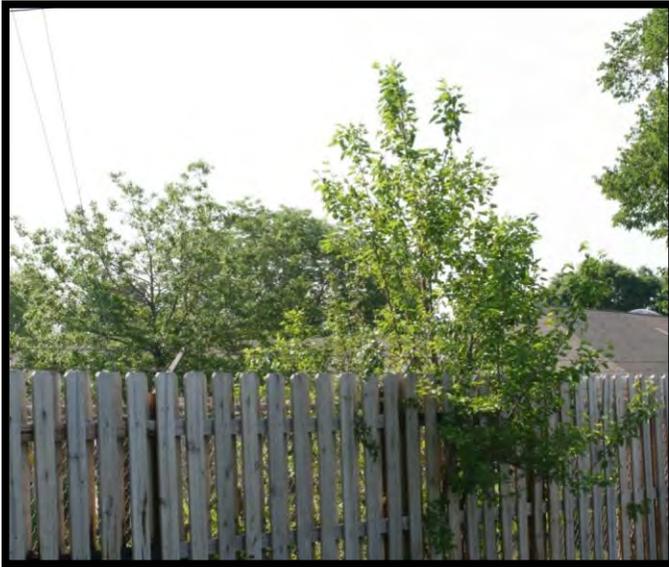
Circuit M41-112: Located at 2347 N Seminary St

Photo No. 10: A tree growing from inside the substation through the substation fence

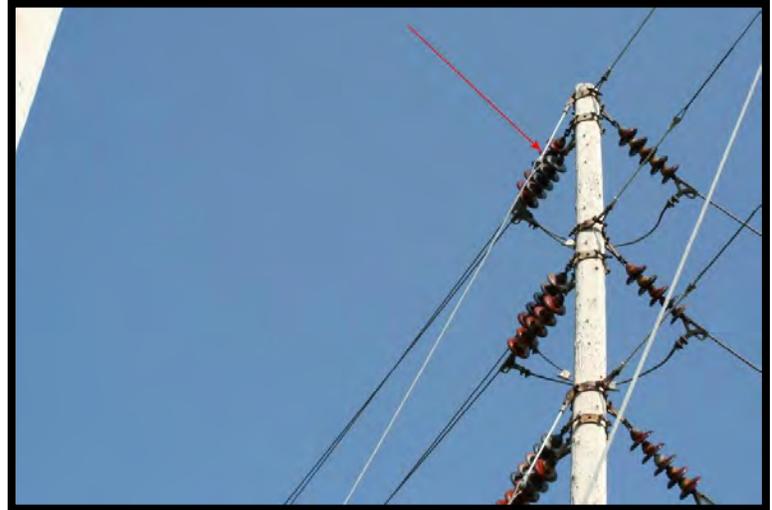
Circuit M41-112: Located at Carl Sandburg Dr. outside the Substation Fence

Photo No. 11: Bad insulator placement on a down guy (the insulator should be below the level of the lowest energized conductor when the guy is loose)

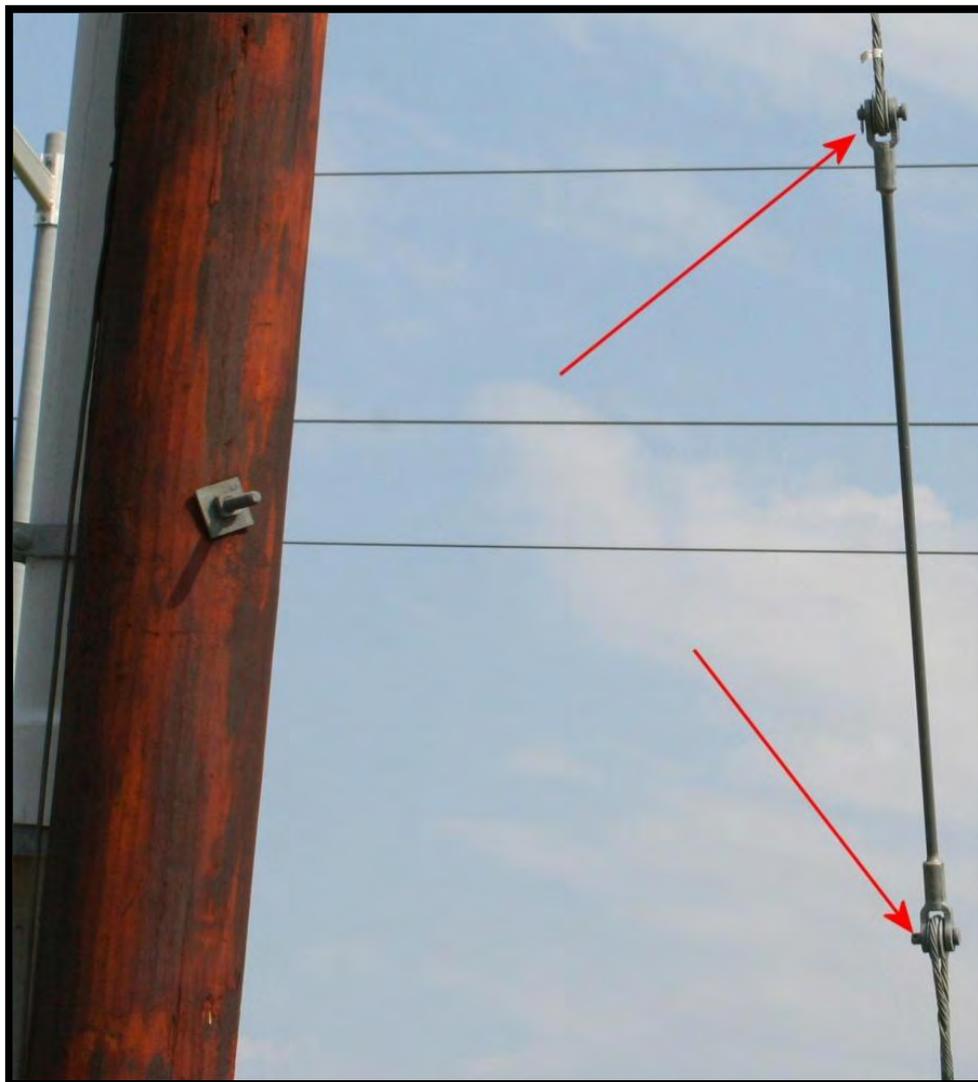
Circuit M41-112: Located on a The South Side in a Tap off Carl Sandburg Dr

Photo No. 12: Missing Cotter pin in the lower connection of guy insulator

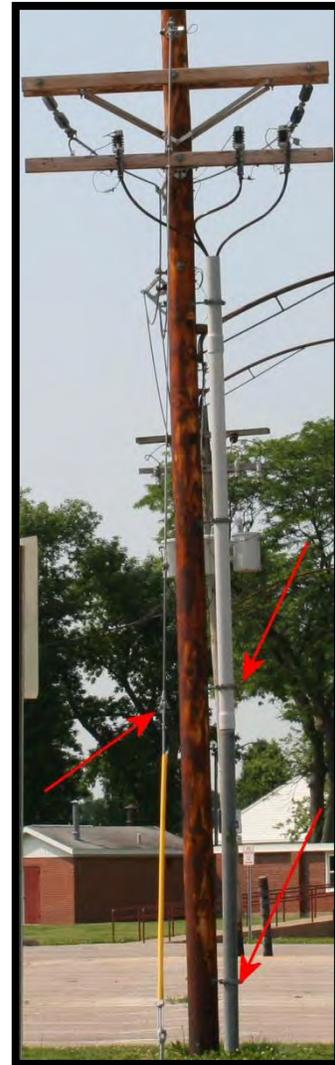
Circuit M41-112: Located on The South Side in a Tap off Carl Sandburg Dr

Photo No. 13: An ungrounded metal riser next to a school with Less than 8 feet between lowest two stand-off brackets and a down guy with improper insulator placement

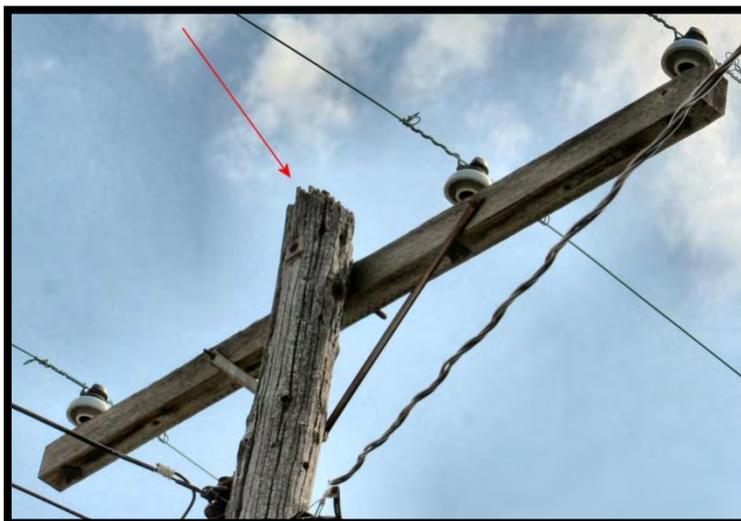
Circuit M41-112: Located in Front of 907 Lane Ave

Photo No. 14: A Deteriorated Pole Top

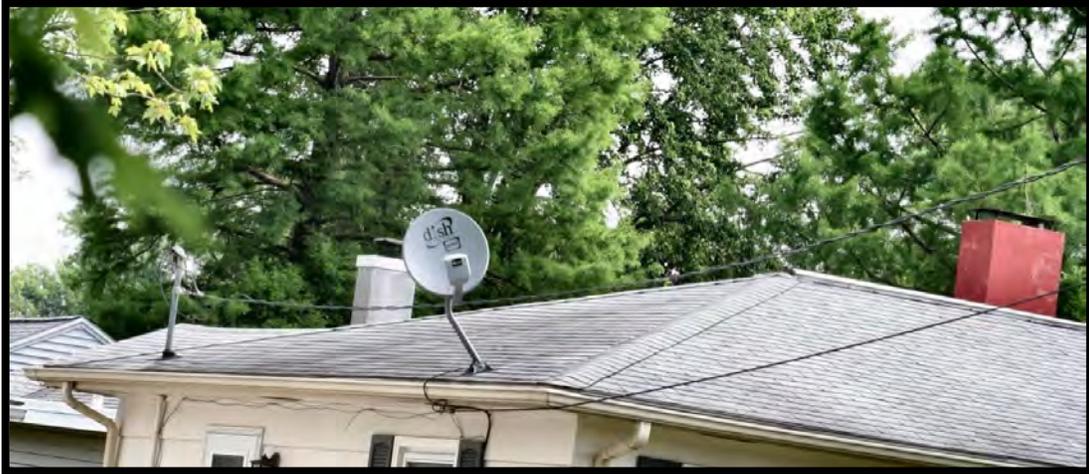
Circuit M41-112: Located on 907 Lane Ave

Photo No. 15: Service drop over a roof with inadequate clearance

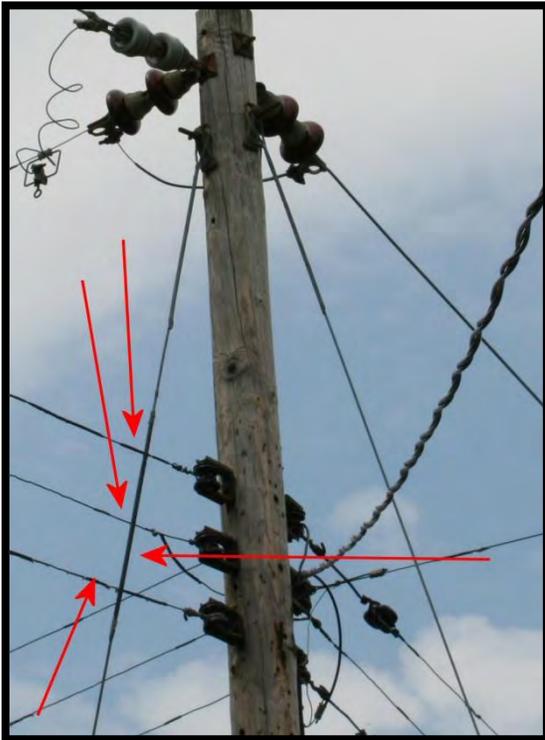
Circuit M41-112: Located in the Intersection of Dayton St and Willard St

Photo No. 16: A down guy W/O grounding or insulator, contacting the secondary line (three wires). There is a hose on the guy wire to keep the guy wire from being energized (inappropriate insulation)

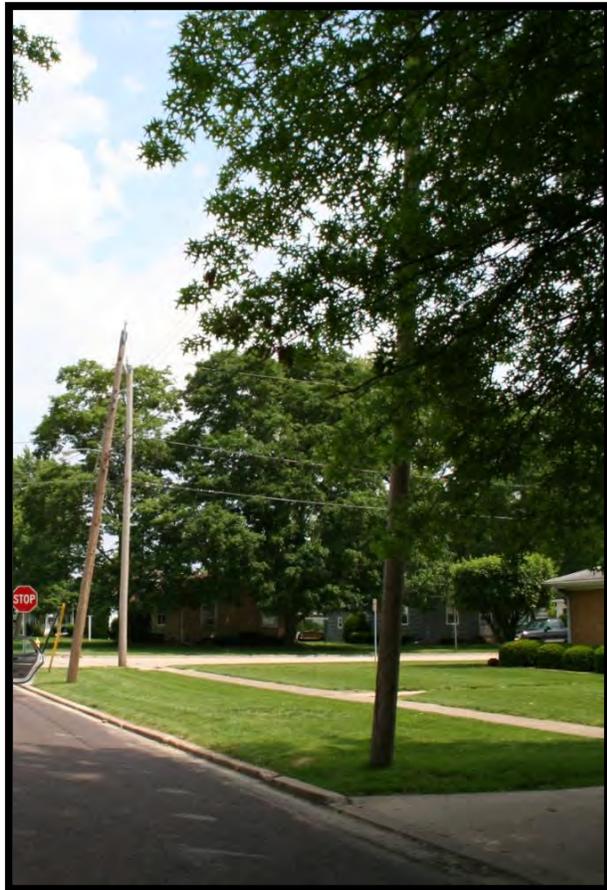
Circuit M41-112: Located in Front of 1187 Brown Ave. near the intersection of Brown Ave. and Fremont

Photo No. 17: Leaning Pole

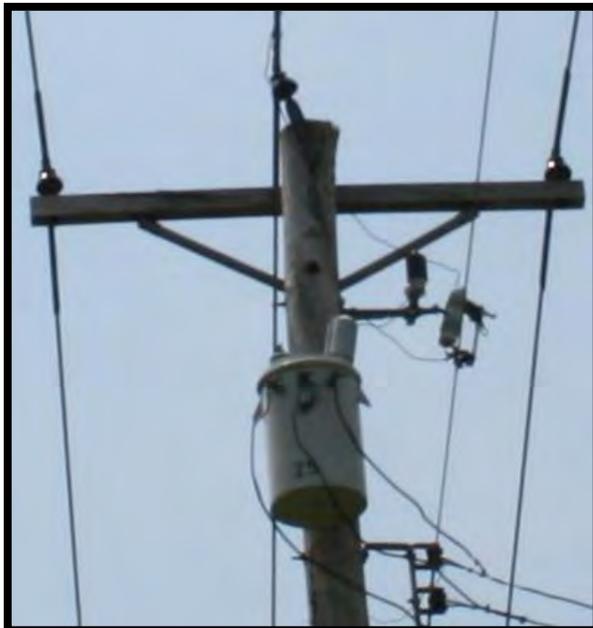
Circuit M41-112: Located near 1608 Morton Ave

Photo No. 18: Leaning Pole-Top Pin

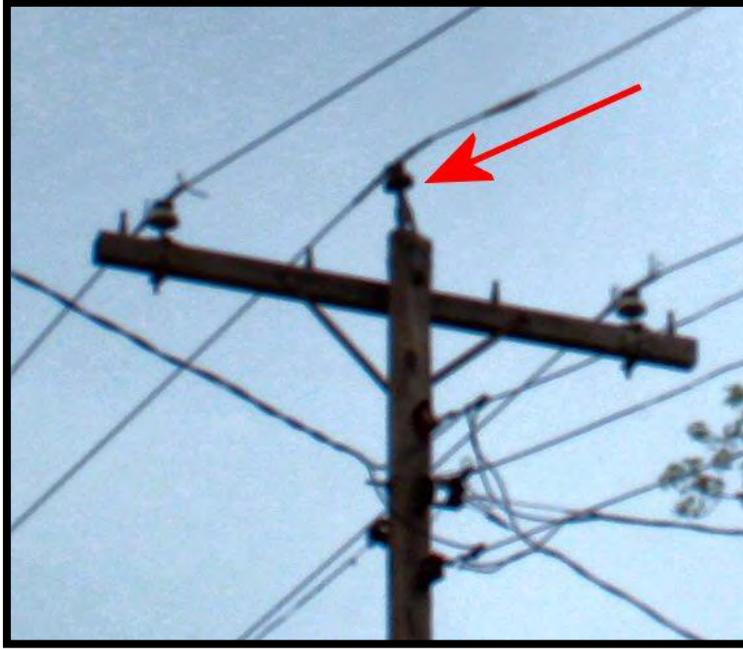
Circuit M41-112: Located near 1116 Harrison St

Photo No. 19: Leaning Pole-Top Pin

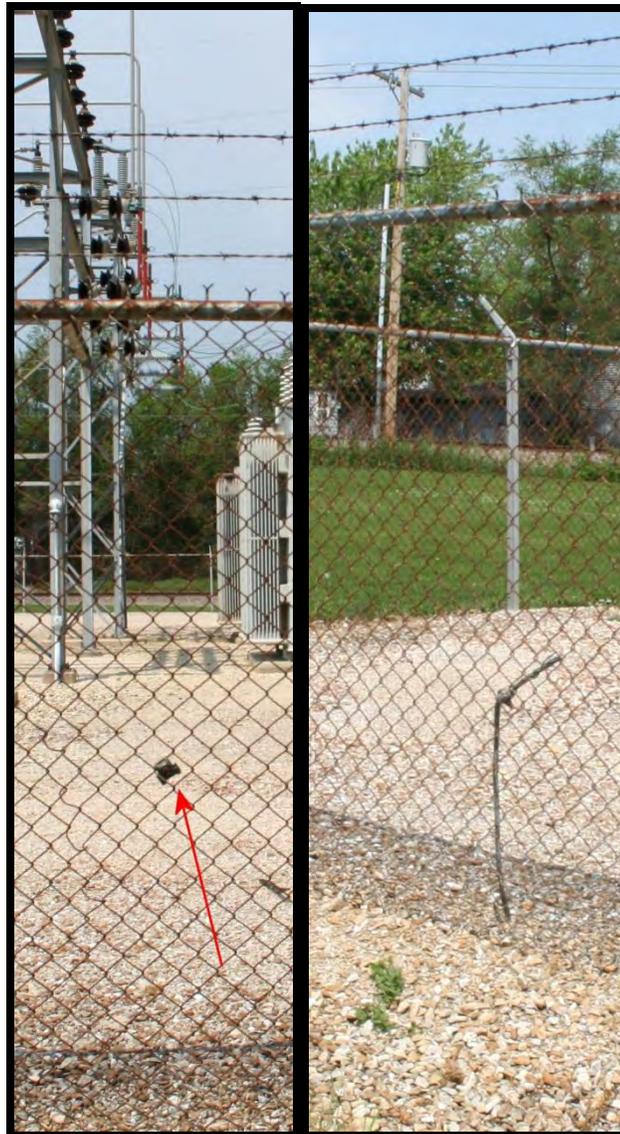
Circuit R05-115: Located at 1245 S Farnham St.

Photo No. 20: Missing ground wire from the substation fence in the left photo compared to the right photo

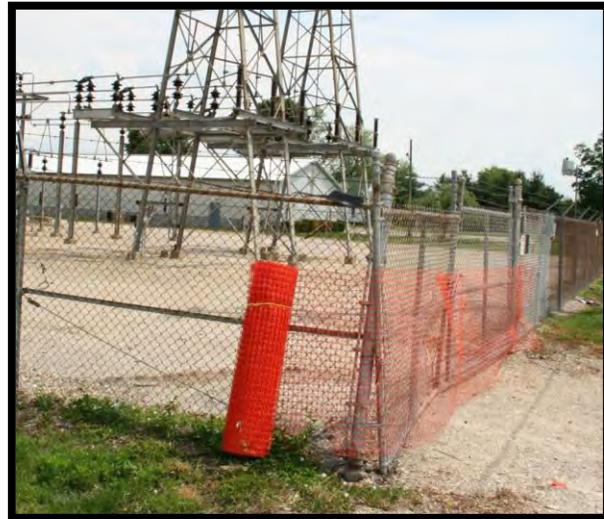
Circuit R05-115: Located at 1245 S Farnham St., S Farnham St Substation

Photo No. 21: Broken substation gate

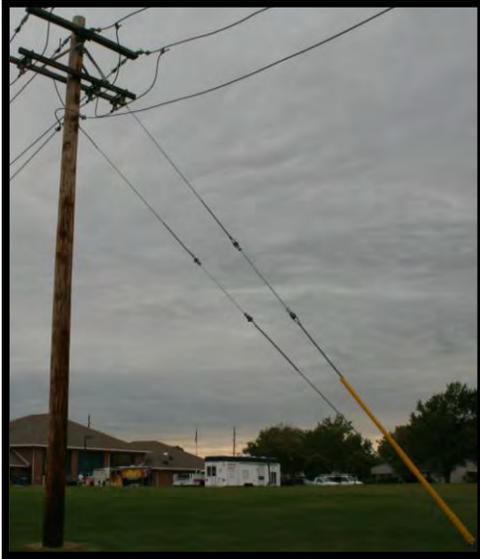
Circuit K74-166: Pole No. 2208302 – near Mattis Substation

Photo 22: Down guys with bad insulator placement

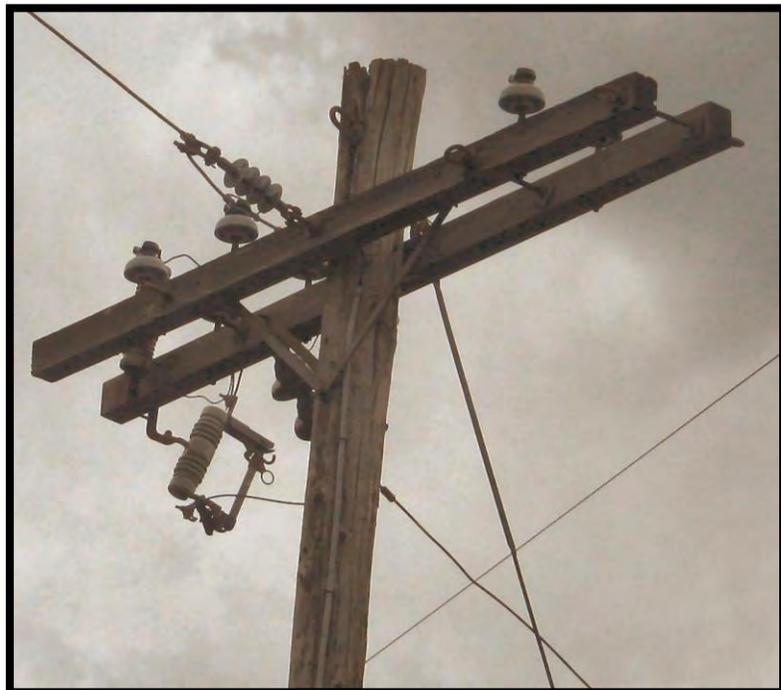
Circuit K74-166: Pole No. 2208301 – near Mattis Substation

Photo 23: Split Pole Top

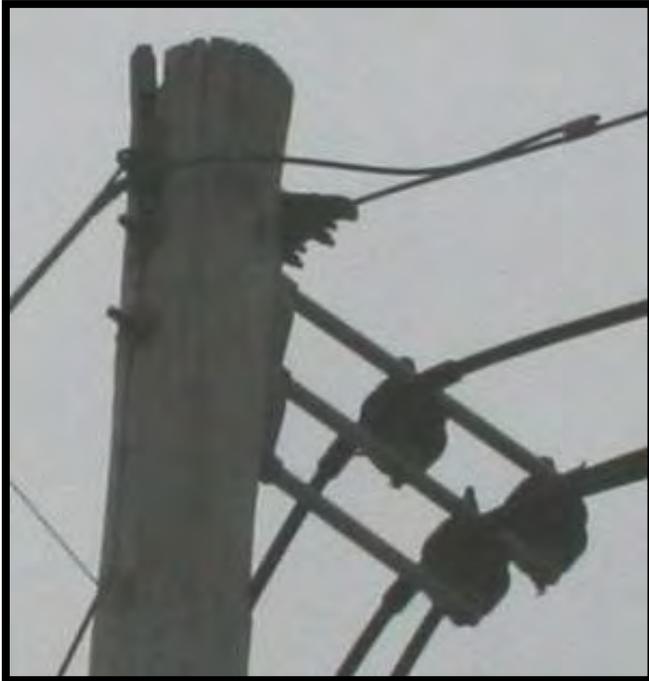
Circuit K74-166: Pole No.
2208305 – near Mattis Substation

Photo 24: Split/damaged pole top

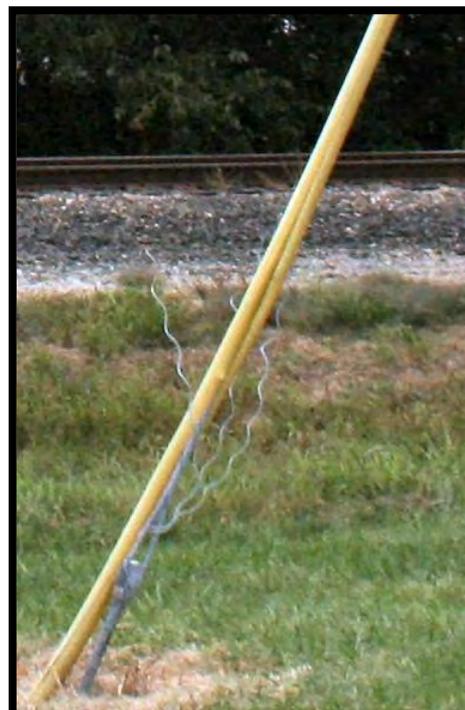
Circuit K74-166: Pole No. 2208305 – near
Mattis Substation

Photo 25: Unwrapped guy wire tie

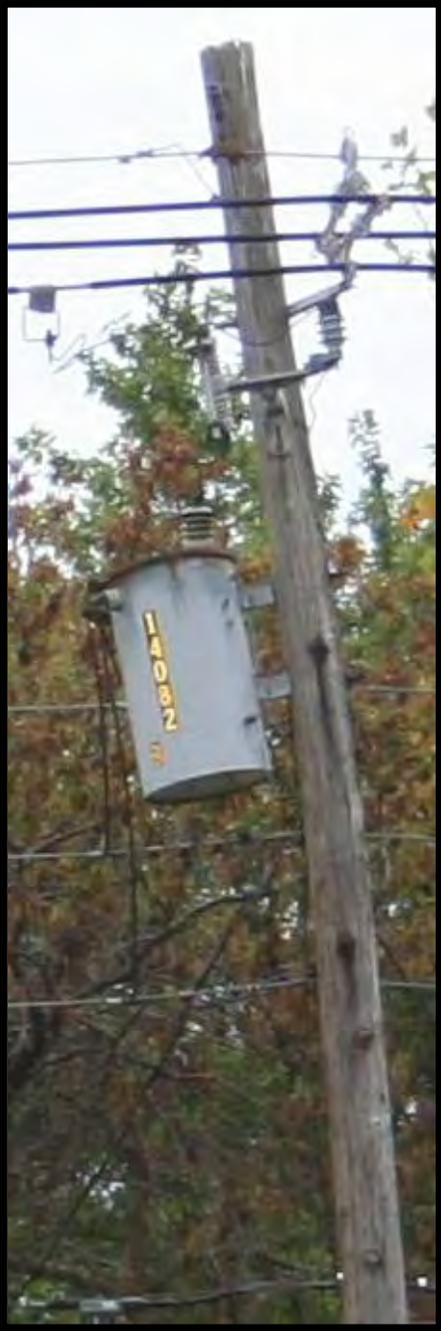
Circuit K74166: Across from the Mattis Substation and the Real Road

Photo 26: Leaning pole with equipment

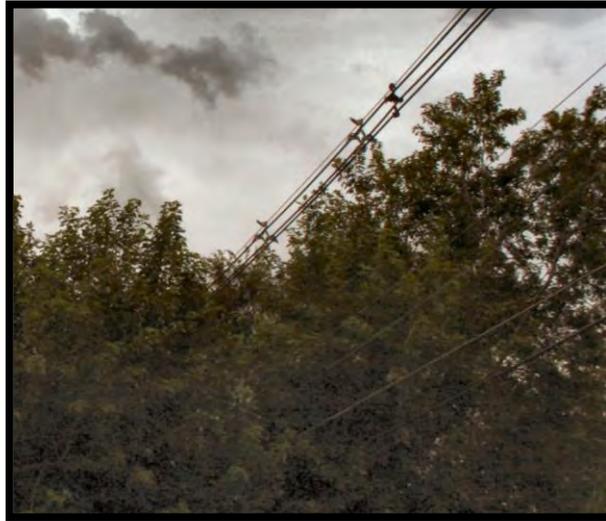
Circuit K74166: Next to pole No. 2208340

Photo 27: Trees close to the high voltage spacer cable

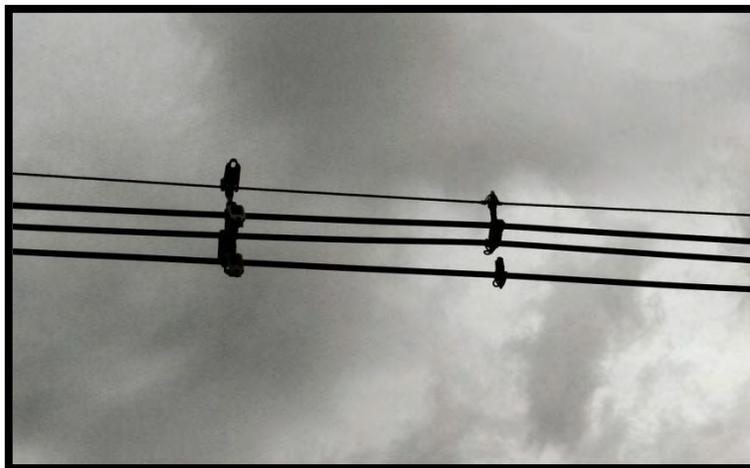
Circuit K74166: Next to pole No. 2208340

Photo 28: Broken spacer on a spacer cable (right)

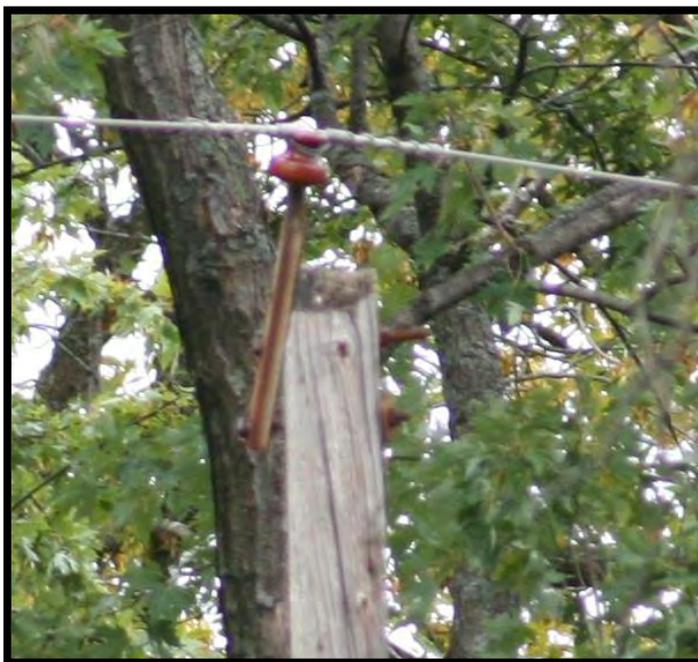
Circuit K74166: Behind 1318 Hedge Rd

Photo 29: Loose pole top pin

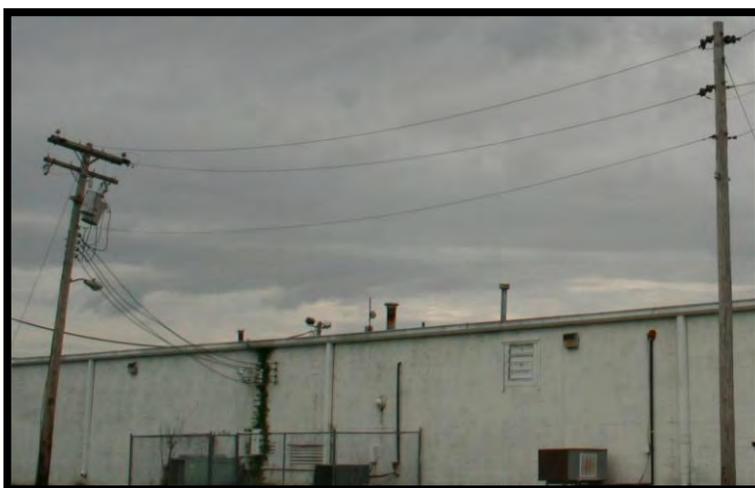
Circuit K74166: Pole Number 2225111

Photo 30: Leaning pole with equipment

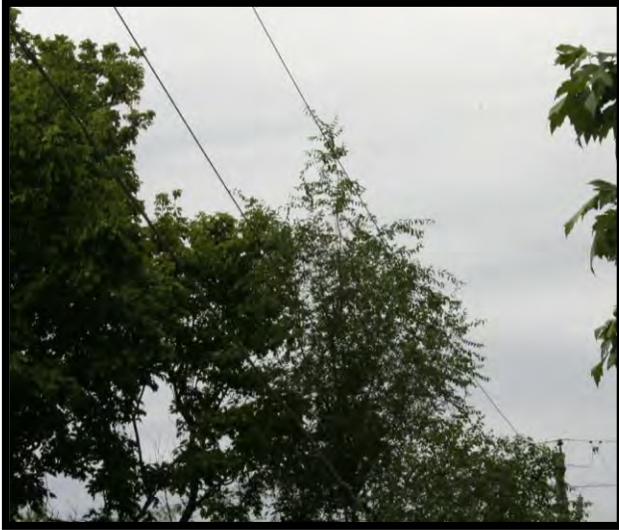
Circuit K74166: Between the back yards of 1507 and 1505 on Summit Ridge Dr

Photo 31: Trees close to the primary

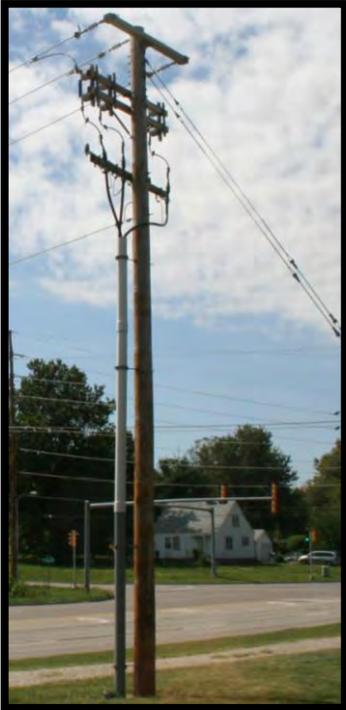
Circuit L00134: In front of Greenswitch Rd. Substation

Photo 32: Primary riser not grounded and low riser stand-off bracket (less than 8 feet between the lowest two brackets)

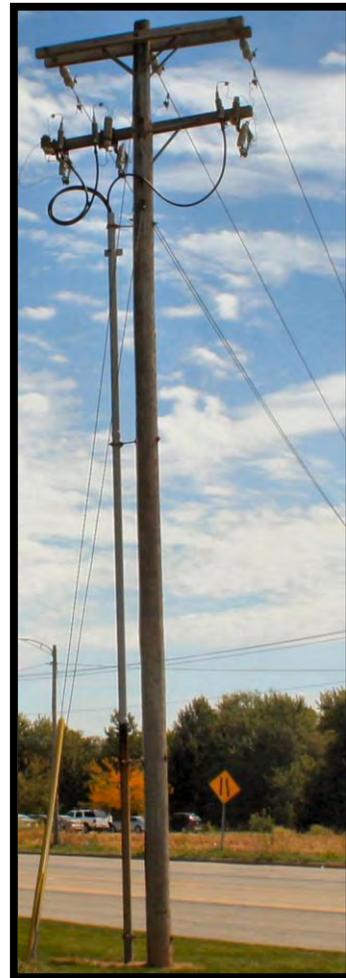
Circuit L00134: In front of Greenswitch Rd. Substation, next to Woods Apt

Photo 33: Low primary riser stand-off bracket

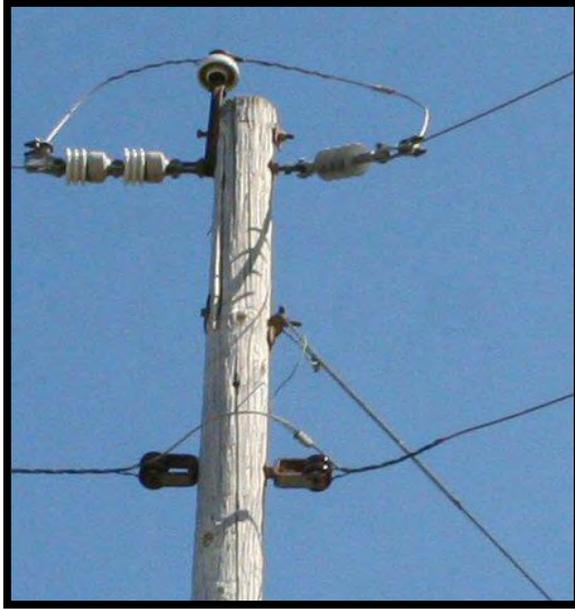
Circuit L00134: Pole Number 3347373

Photo 34: Loose pole top pin

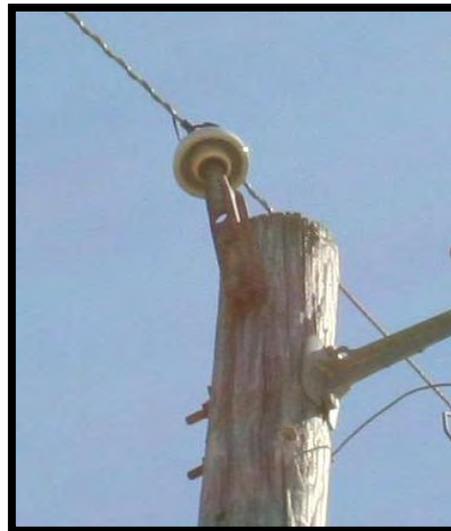
Circuit L00134: Pole Number 3360796 on Sawyer Rd

Photo 35: Loose pole top pin
