Route FAU 6406	Marked Route US 150	Railroad Norfolk Southern Railway	Section D5 RR IMP 2015-1	Authorization Date 08/29/16
RR File Number N/A	Project Number N/A	Completion Date 08/12/16	Location Bloomington, IL	Job Number C-95-020-15
Estimated Amount \$87,757.00	DOT/AAR Number 475 031 L	County McLean	Final Bill	Obligation Number RR515007

Crossing surface replacement - new ballast, HMA sub base, full depth rubber panels, and rail.

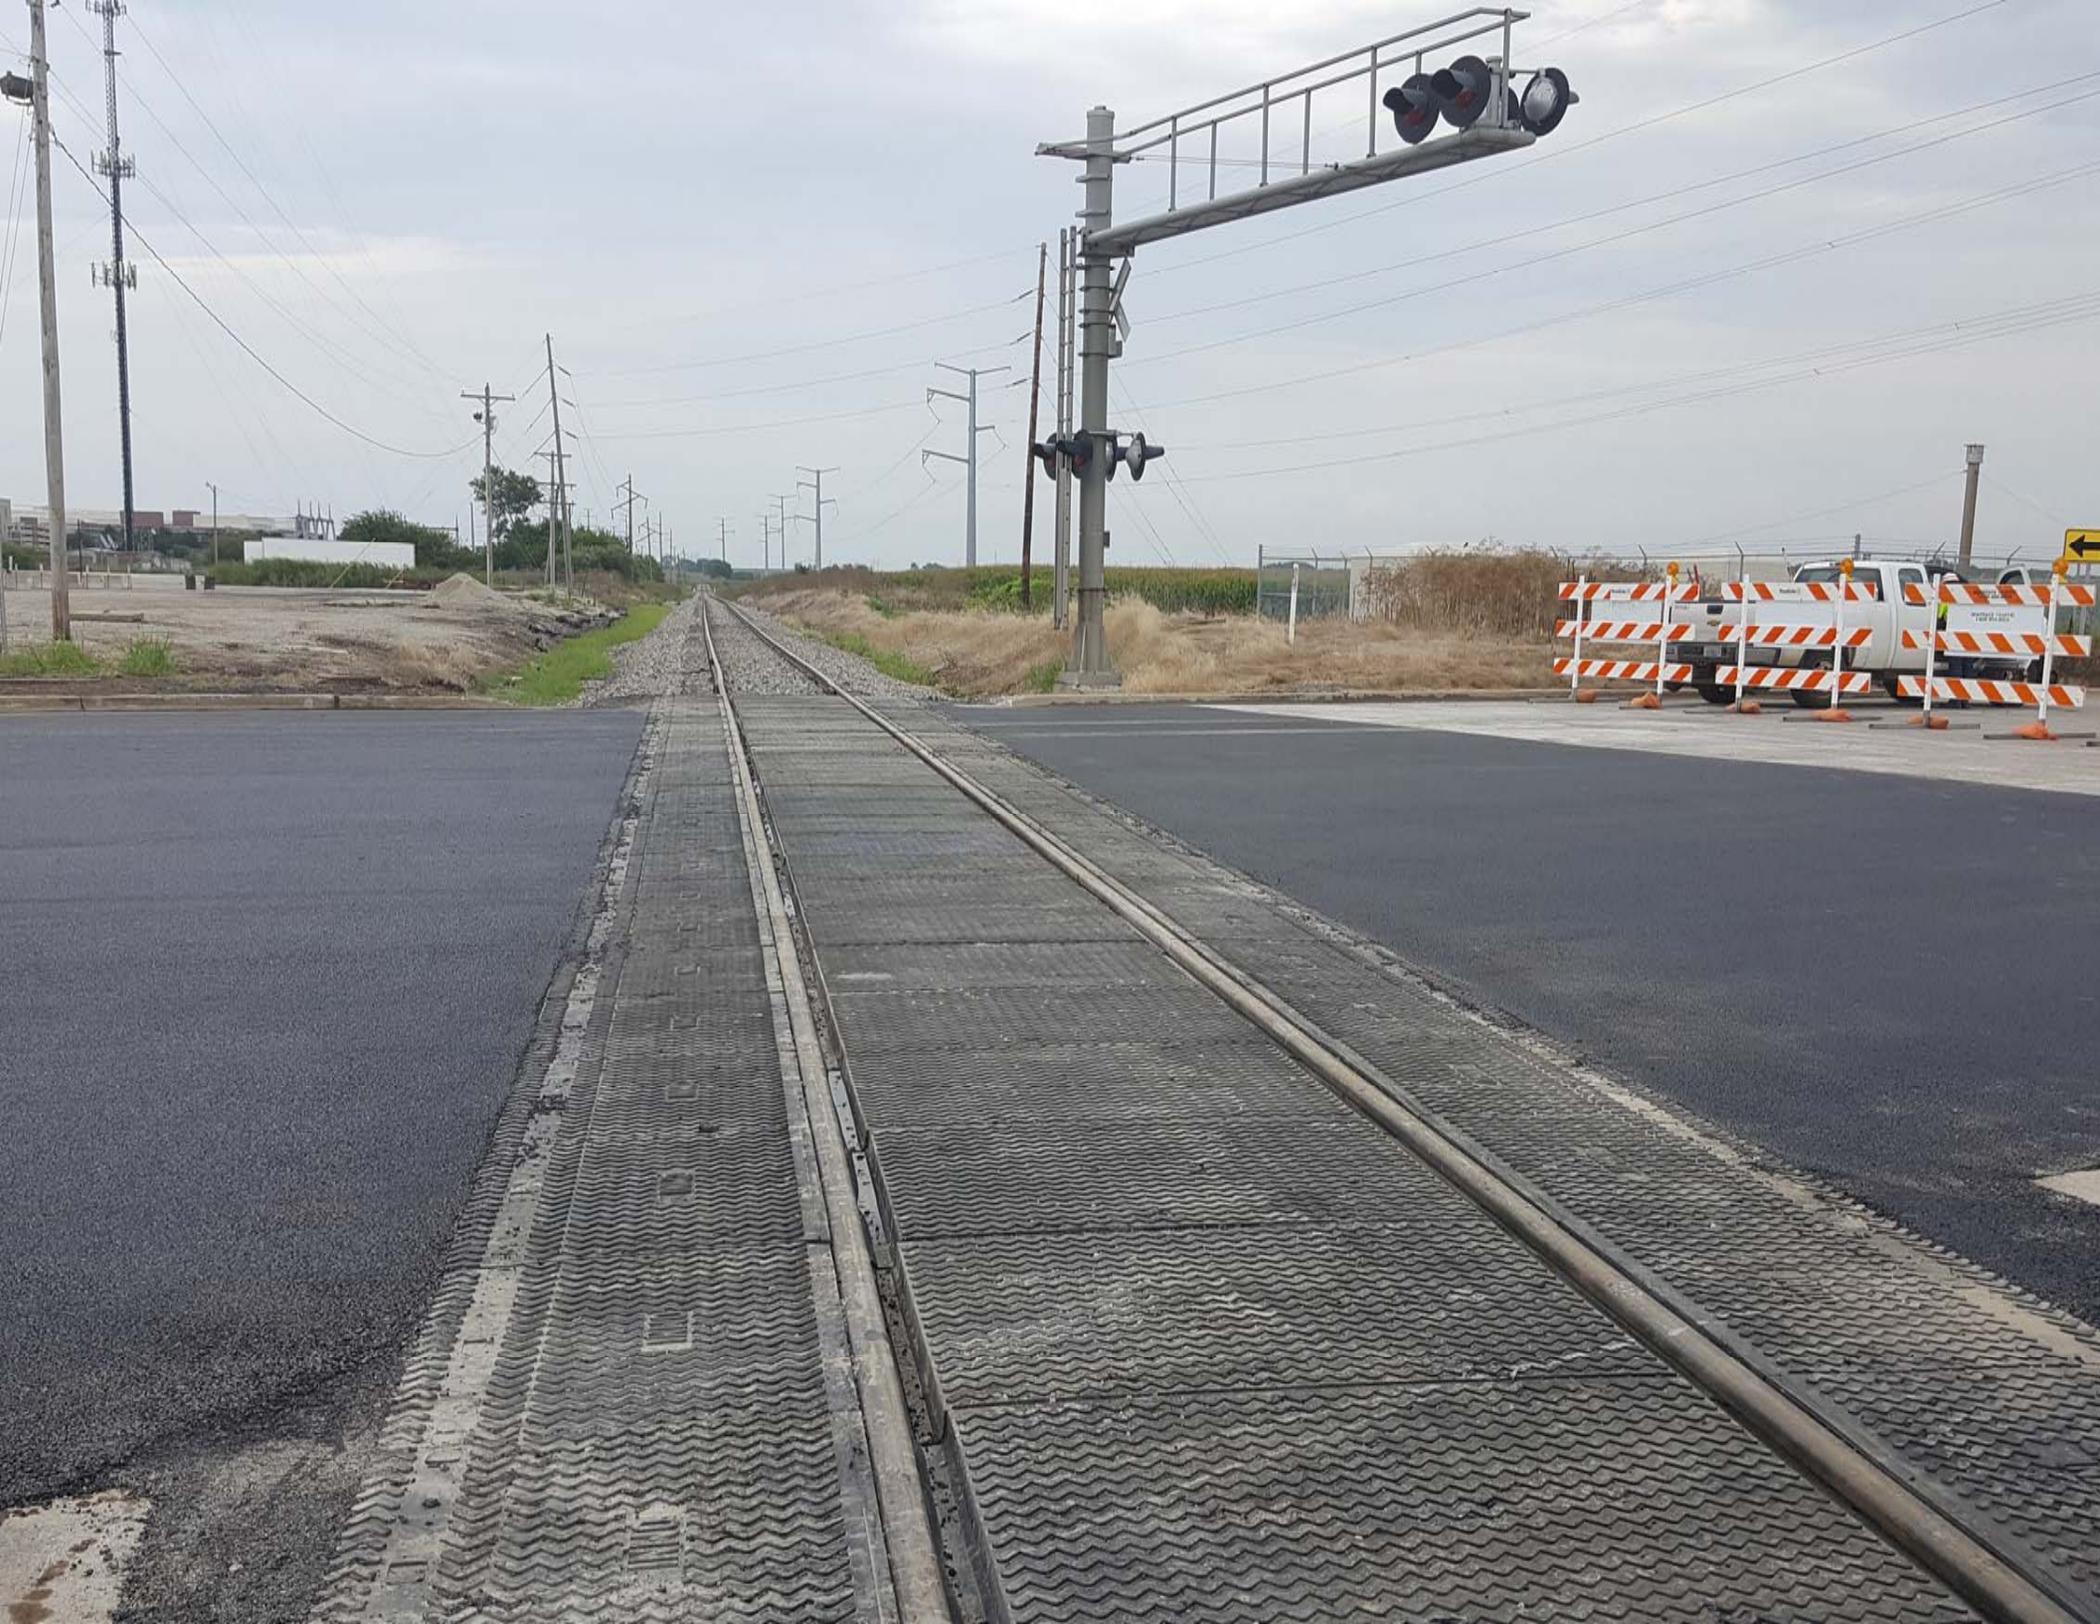
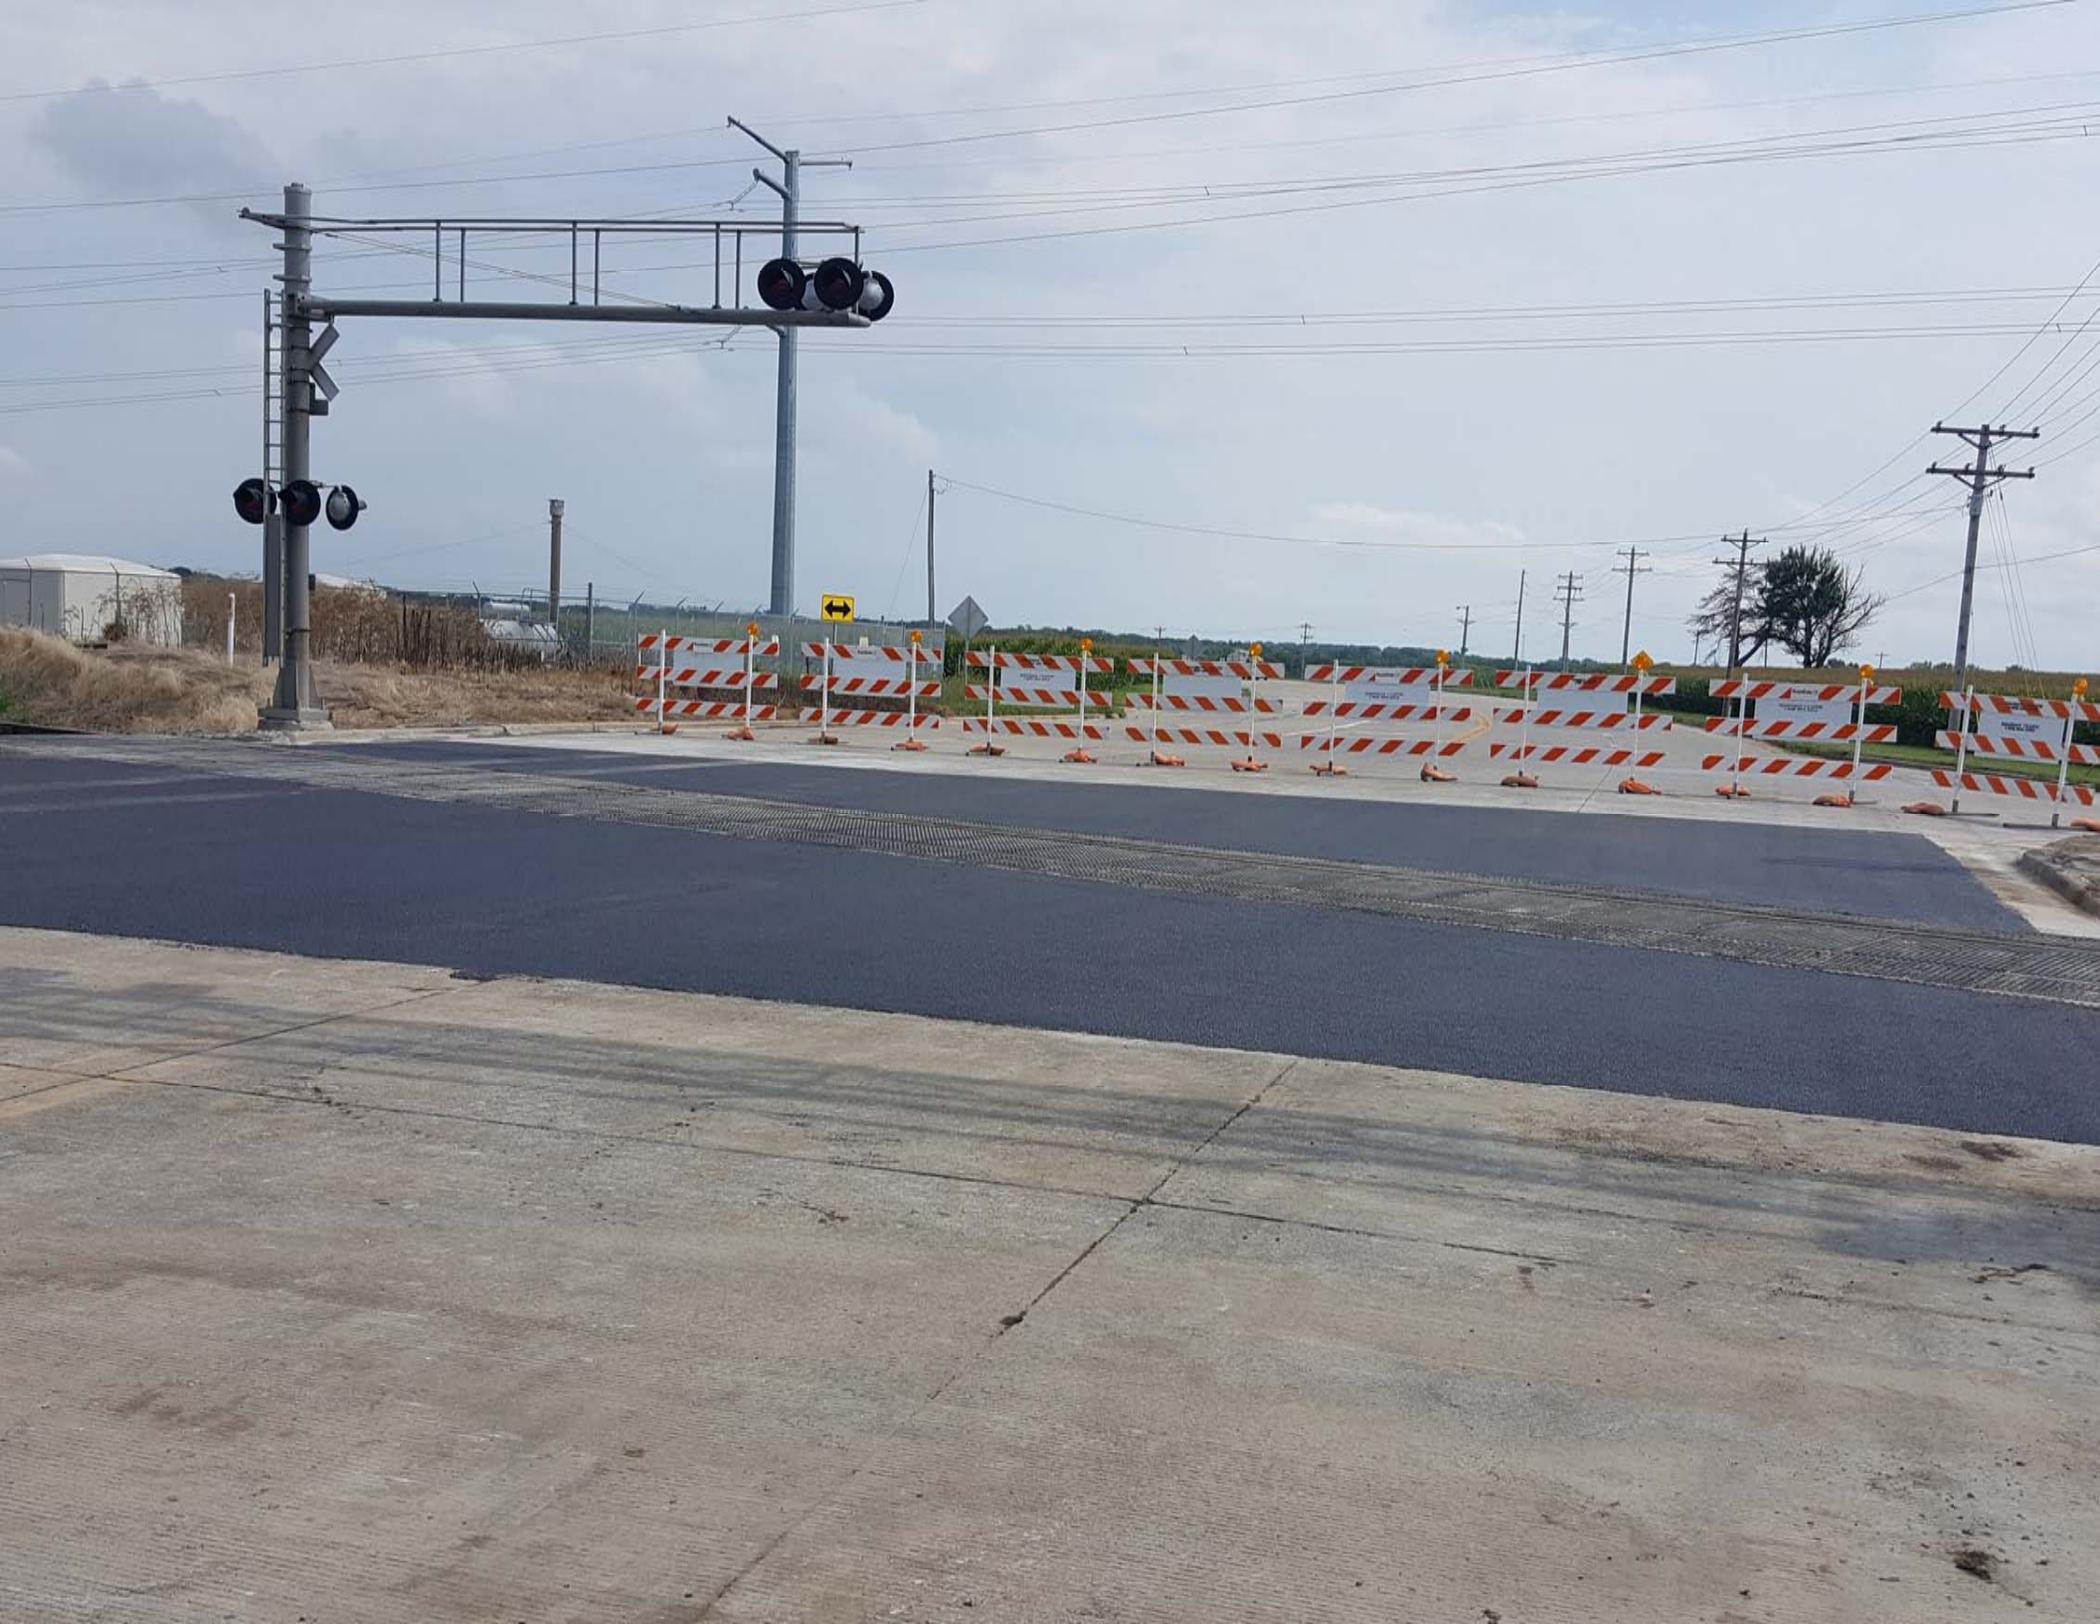
Comments: Ride is satisfactory, however the ride would be much better if the full depth patches were able to be compacted better. Since the rubber panels were wider, the saw cuts were too close to get a roller in the patches to compact them properly. There is already a couple of spots where the pavement has settled around the crossing surface making a small bump. This could be a maintenance issue down the line.
