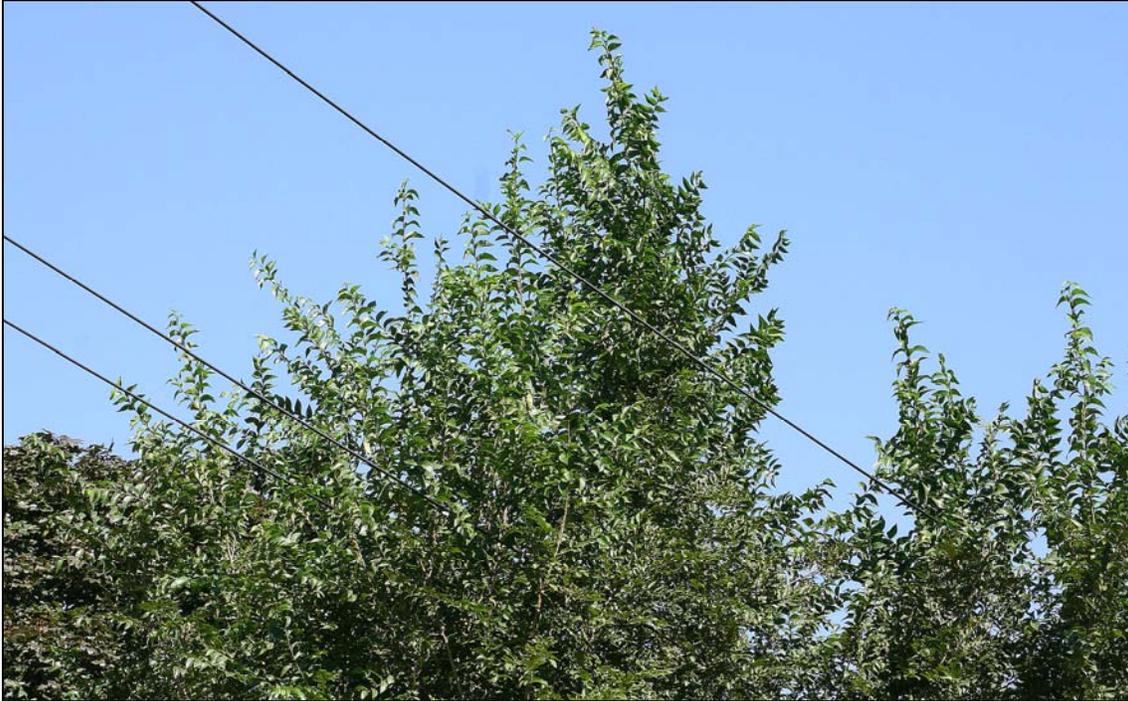
**Figure 9 (Photo 05-CE648a)**  
**3-phase primary through a Siberian elm tree,  
Union Street south of Columbia Street, Aurora**

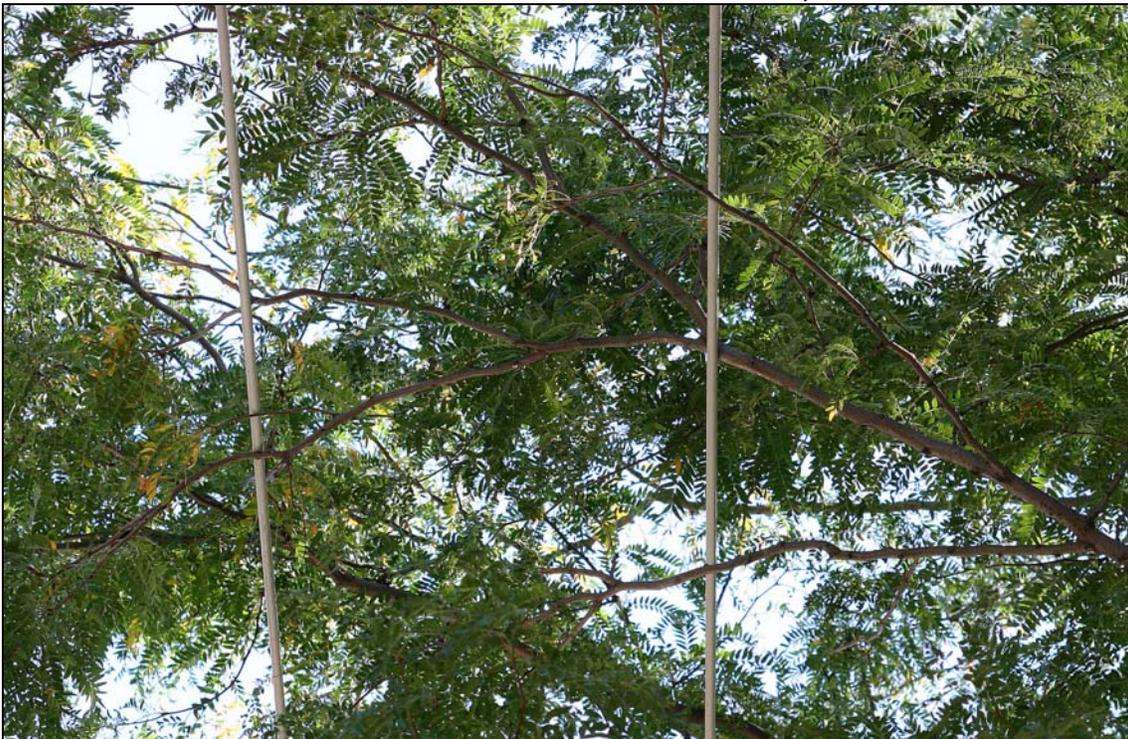
**Figure 10 (Photo 05-CE656a)**  
**Honey locust tree grown into (over & under) 3-phase primary,  
Prairie Street west of Elmwood Avenue, Aurora**

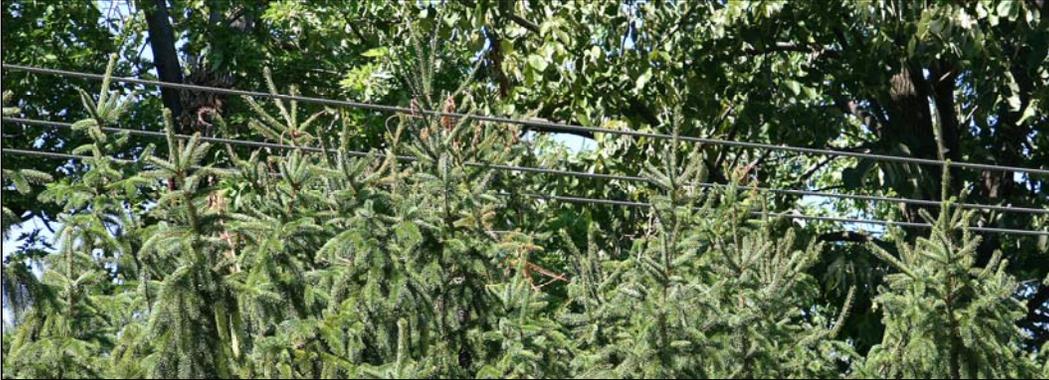
**Figure 11 (Photo 05-CE658a)**  
**Spruce trees growing into 3-phase primary (with burning),  
Clarendon Hills Road south of 68<sup>th</sup> Street, Darien**

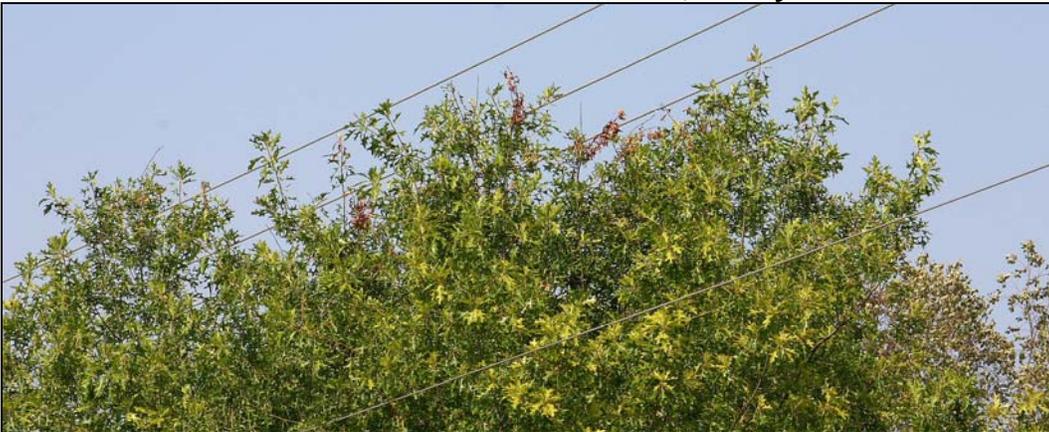
**Figure 12 (Photo 05-CE686a)**  
**Pin oak trees into 3-phase primary (with burning),  
84<sup>th</sup> Avenue south of 163<sup>rd</sup> Street, Tinley Park**

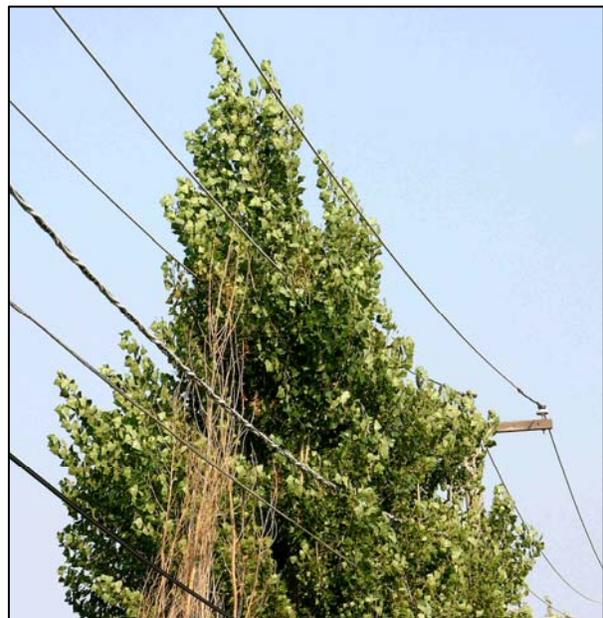
**Figure 13 (Photo 05-CE692a)**  
**Lombardy poplar trees through and  
engulfing 3-phase primary,  
175<sup>th</sup> St. west of Sandalwood Dr.,  
Tinley Park**

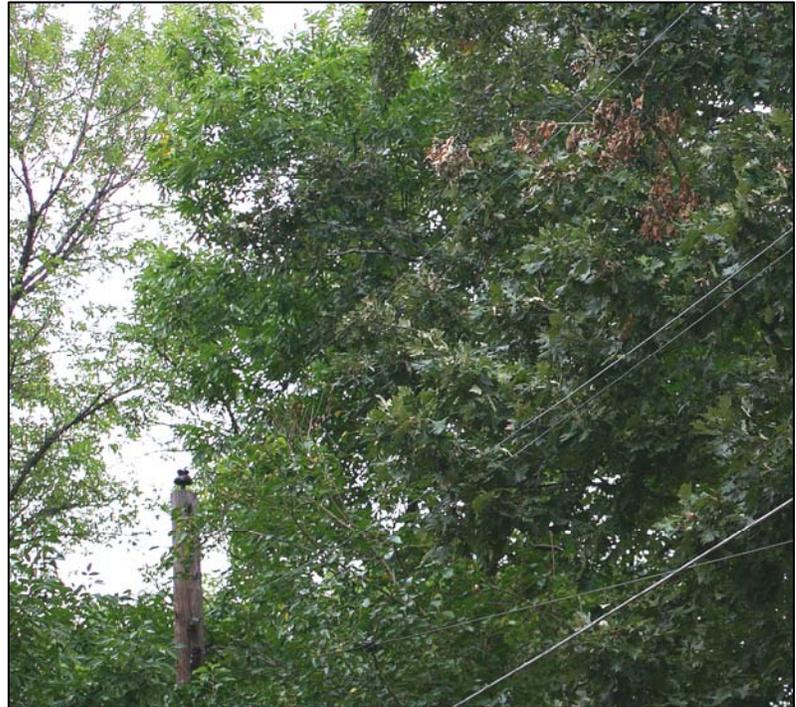
**Figure 14 (Photo 05-CE698a)**  
Primary through oak tree  
(with burning),  
Oakley N. of Lakeview Ave.,  
Joliet

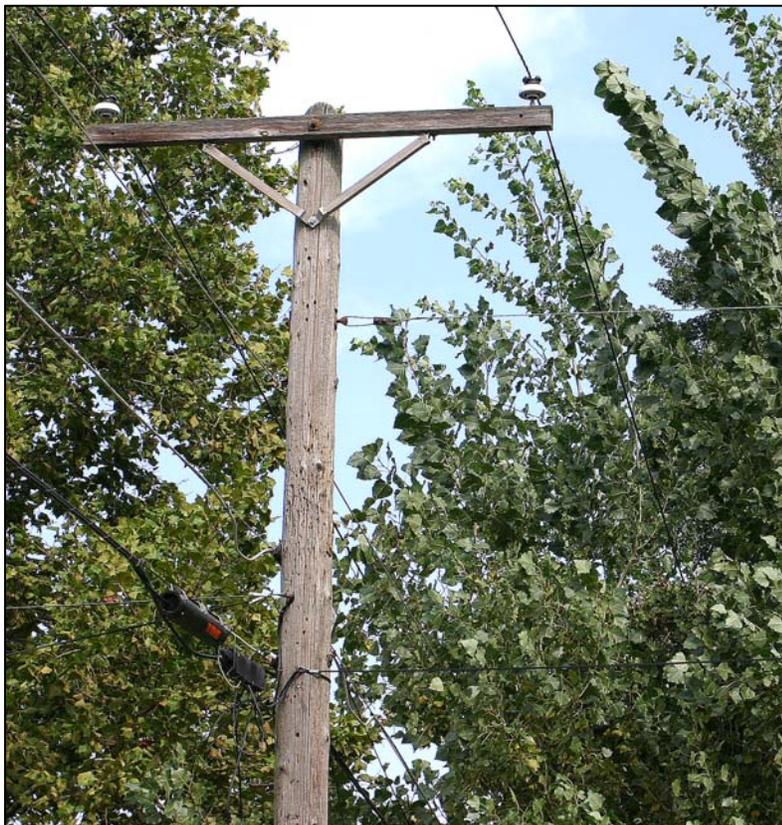
**Figure 15 (Photo 05-CE724)**  
Primary through poplar trees,  
East of Bradford St. in the  
alley north of Timber St.,  
Pontiac

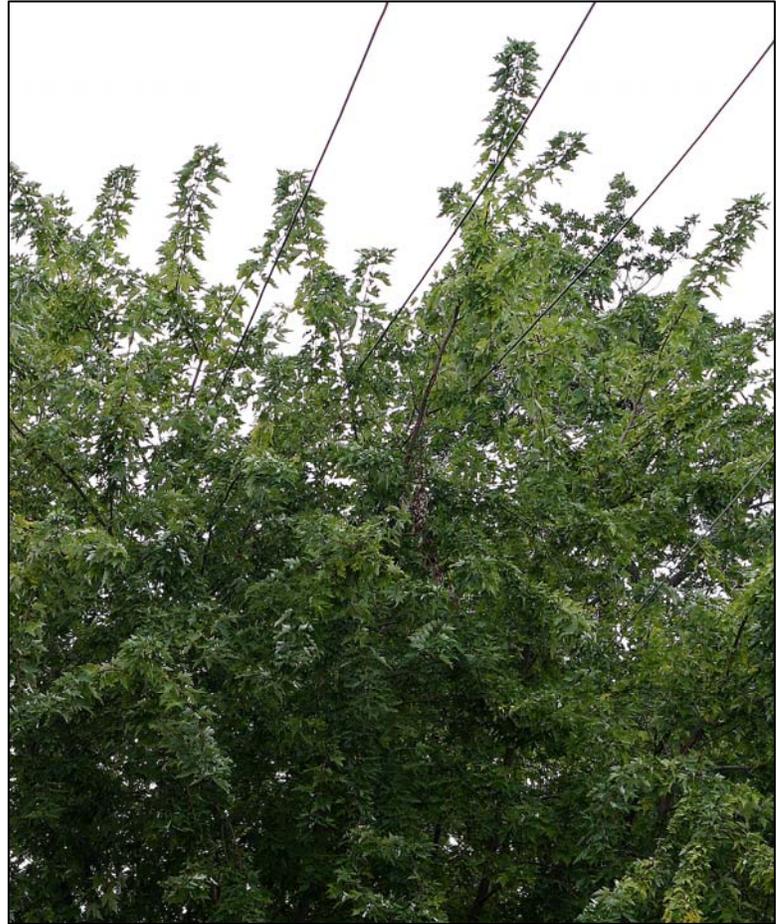
**Figure 16 (Photo 05-CE727a)**  
**3-phase primary through a  
silver maple tree,  
Mill St. south of North St.,  
Pontiac**

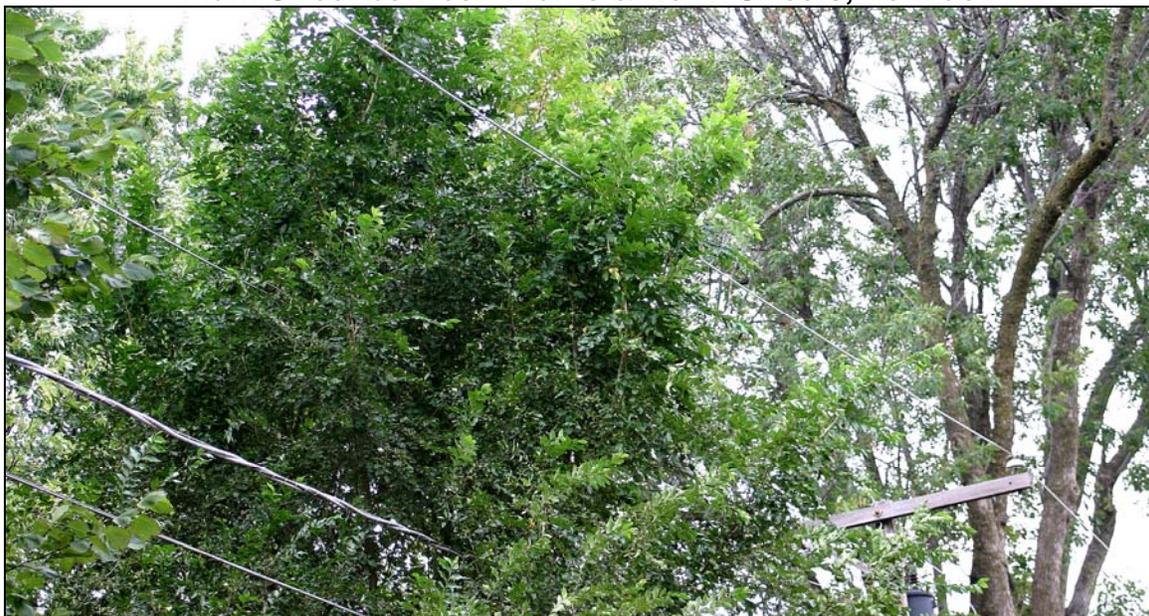
**Figure 17 (Photo 05-CE729a)**  
**Primary through elm trees,  
Plum Street between Prairie & North Streets, Pontiac**
