**MEMORANDUM**

RE: Tree Conditions in AmerenCIPS' Service Territory

**1. Introduction**

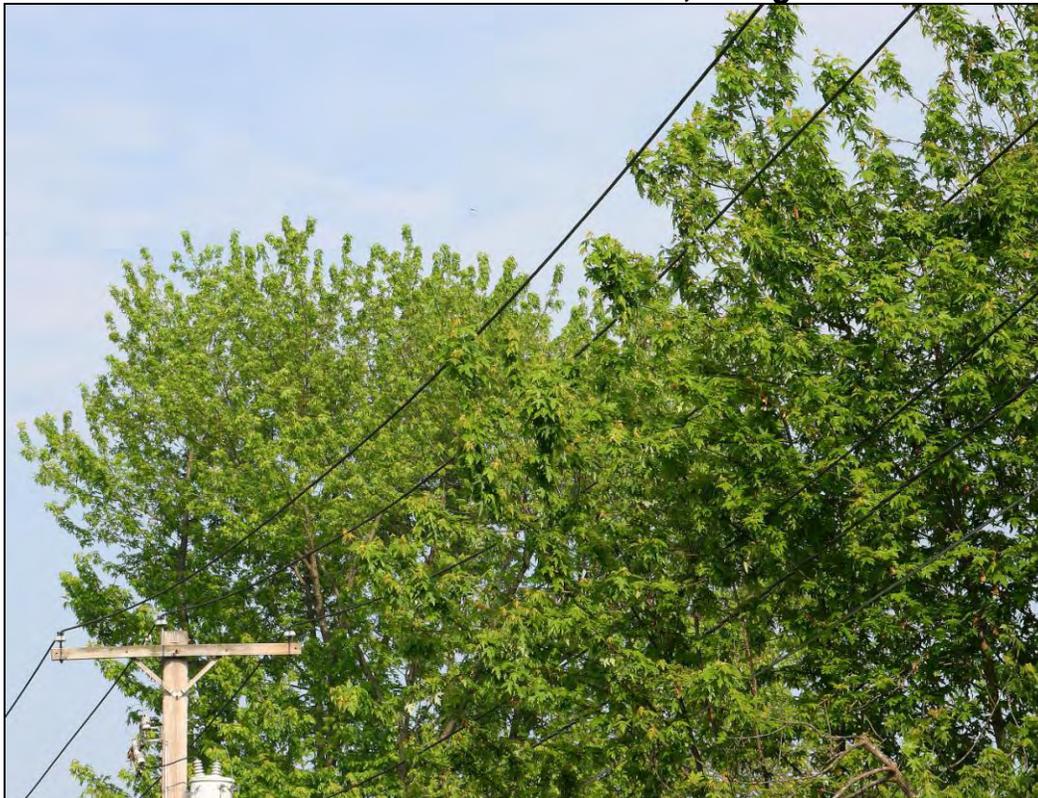
**Figure 1 (Photo 07-CIP1449)**  
**Soft maple tree into 3-phase primary,**  
**Franklin Ave. west of Lincoln St., Effingham**

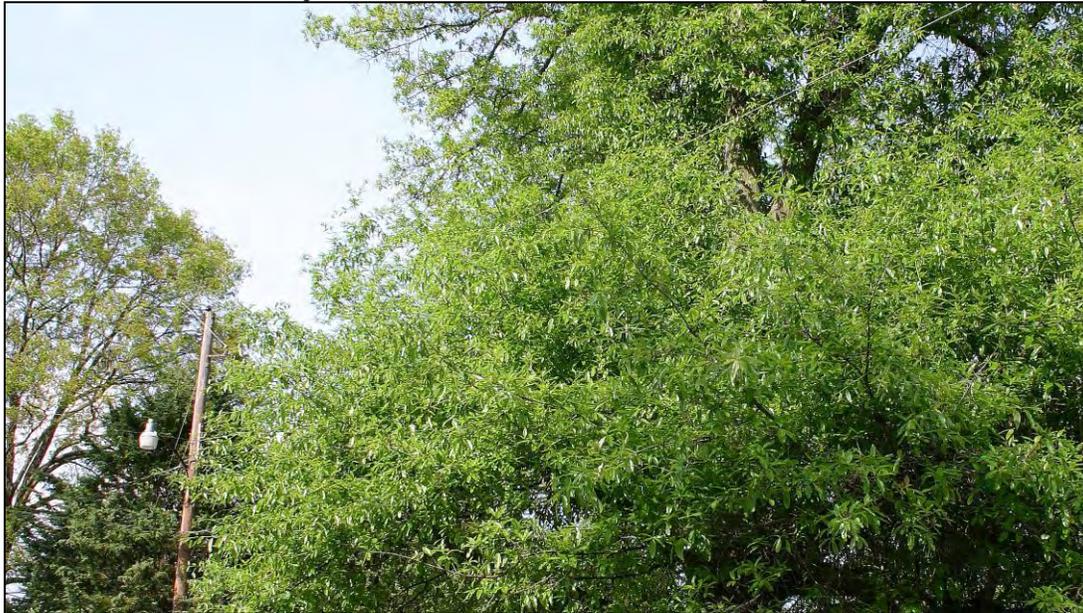
**Figure 2 (Photo 07-CIP1464)**  
**Tree into primary,**  
**21<sup>st</sup> St. just south of Roblee Ave., Murphysboro**

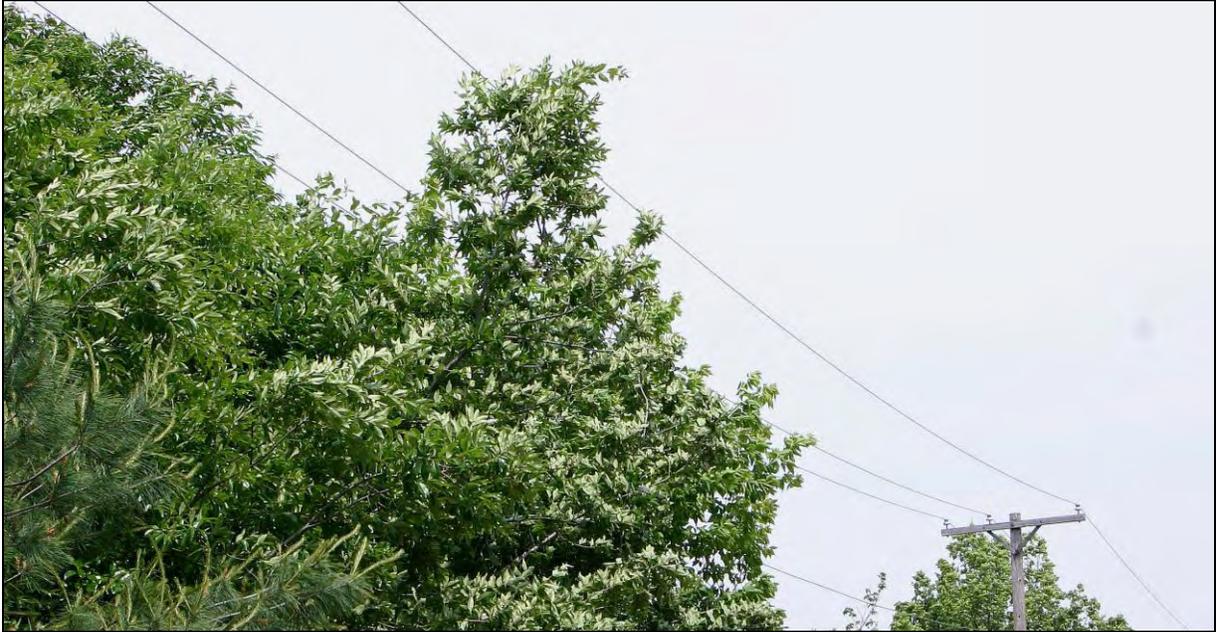
**Figure 3 (Photo 07-CIP1516)**  
**Laurel oak tree into 3-phase primary,  
Quailwalk Rd. south of Jamestown Rd., Macomb**

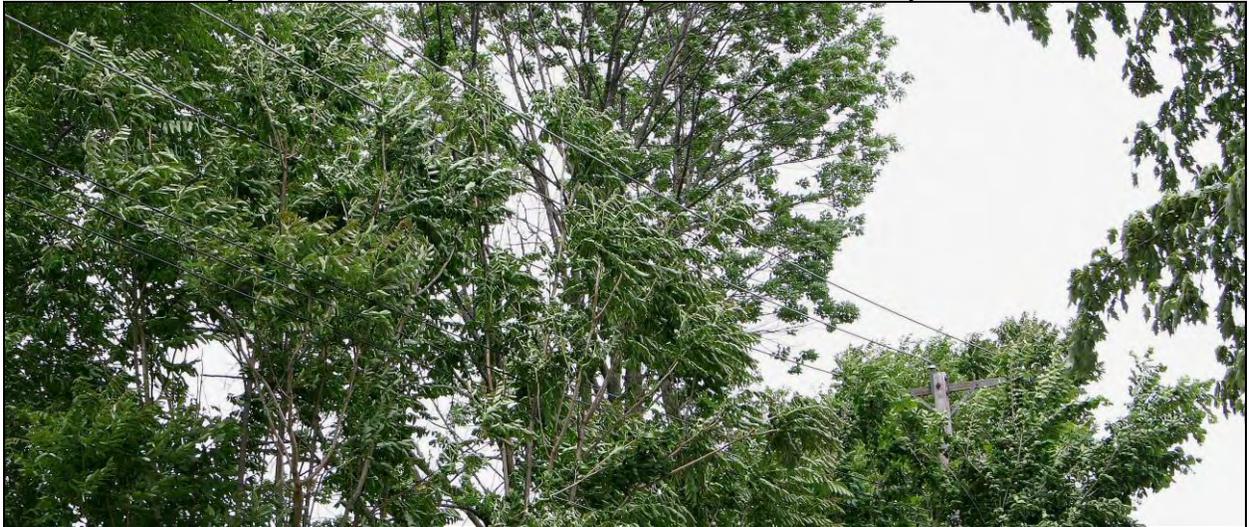
**Figure 4 (Photo 07-CIP1519)**  
**Alianthus tree into 3-phase primary,  
Maple Ave. south of Grant St. (near a substation), Macomb**

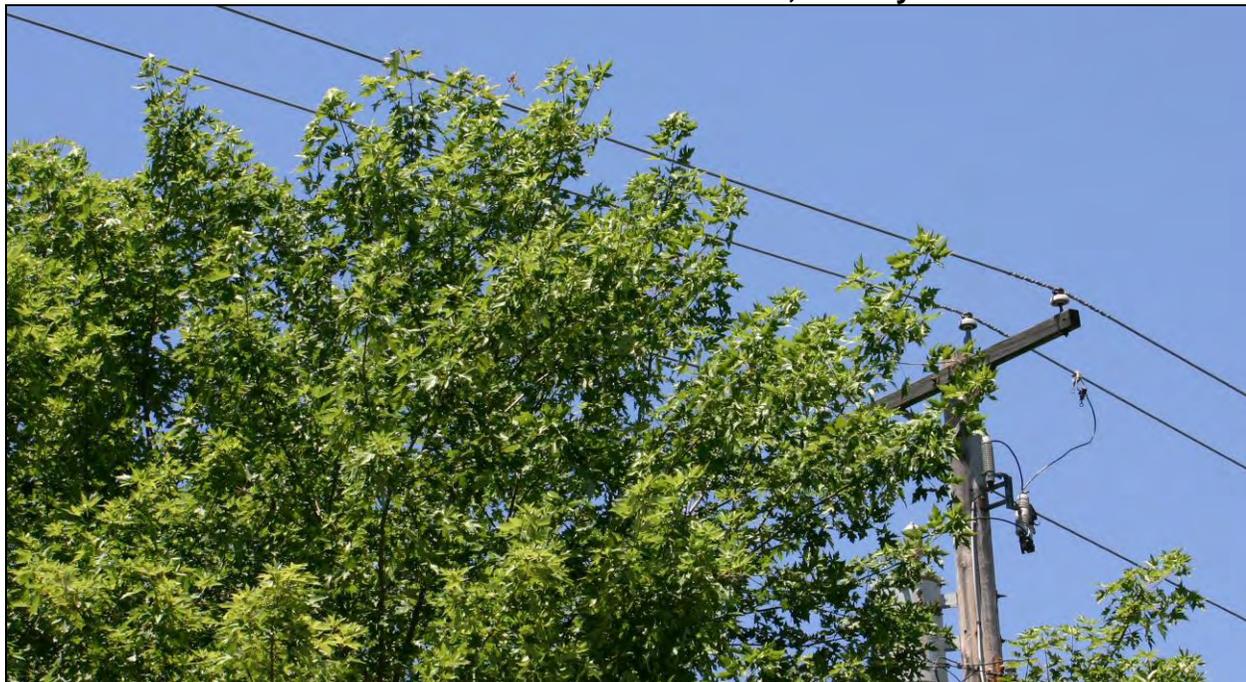
**Figure 5 (Photo 07-CIP1620)**  
**Soft maple trees into primary, with burning,**  
**24<sup>th</sup> St. south of VanBuren St., Quincy**

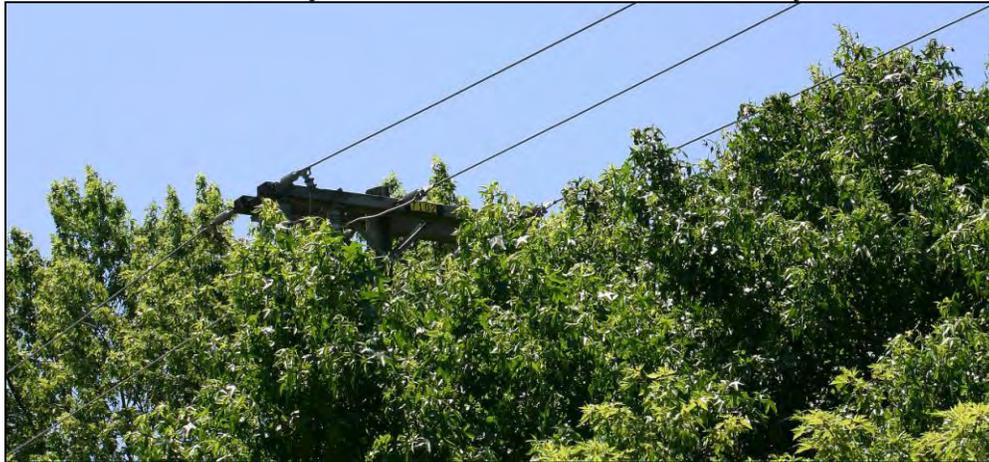
**Figure 6 (Photo 07-CIP1621)**  
**Sweet gum tree into primary, with burning,**  
**24<sup>th</sup> St. just north of Harrison St., Quincy**
