Illinois Commerce Commission  
Assessment of Commonwealth Edison Company  
Reliability Report and Reliability Performance  
for Calendar Year 2007

Pursuant to 83 Ill. Adm. Code 411.140

April 8, 2009

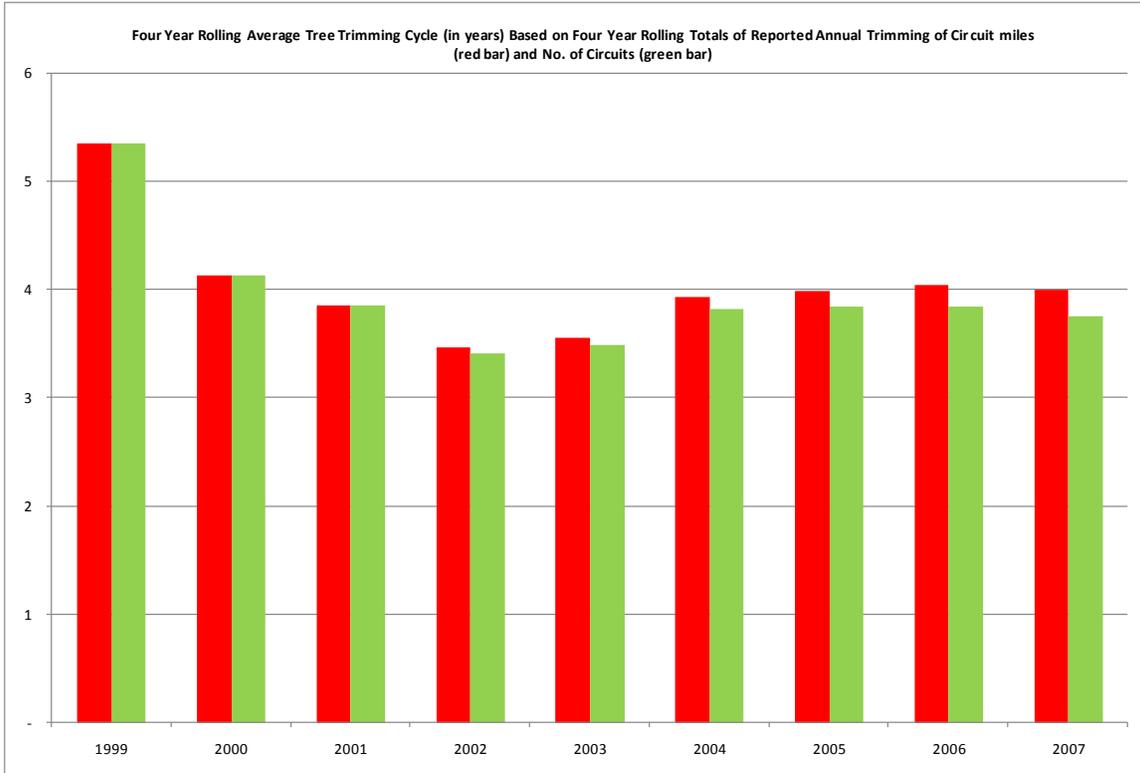
**Figure 25: Rolling Average Tree Trimming Cycle Based on Most Recent Four Year Totals**

Since May 18, 2000, ComEd has claimed to be on a four-year tree trimming cycle. Figure 25 indicates, based on most recent four year rolling totals of reported circuits trimmed<sup>29</sup>, that ComEd has been on a four-year cycle since the year 2000.

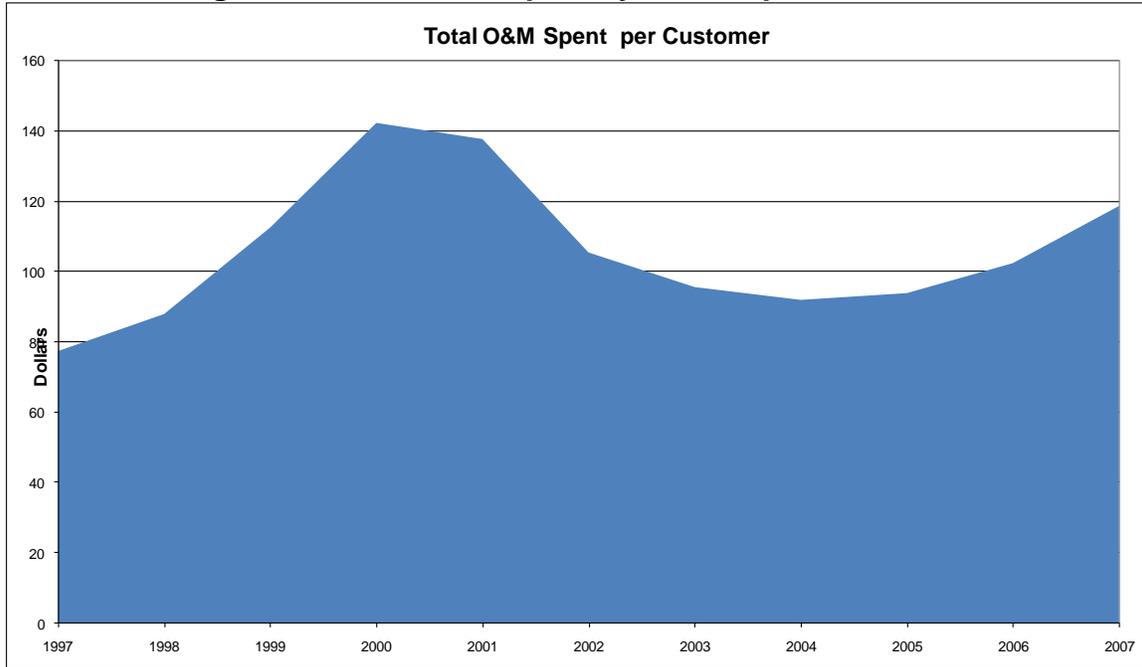
**Figure 26: Total O&M Spent by ComEd per Customer**

Figure 26 shows that total O&M dollars spent per ComEd customer had bottomed in 2004 and has significantly increased over the last year. Staff will continue to follow this closely.

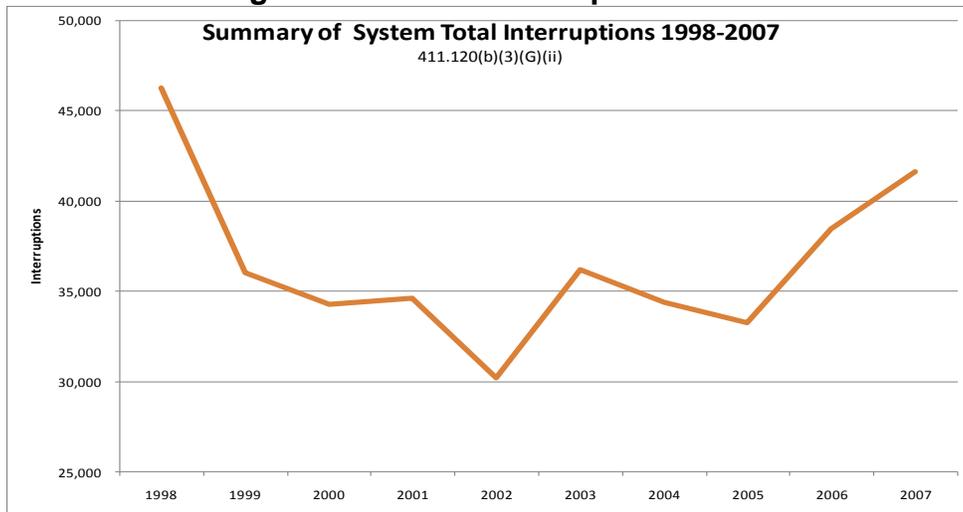
**Figure 27: Annual Interruption totals**

Figure 27 shows the trend in total annual system interruptions from 1998 through 2007 as defined in ComEd's responses to Section 411.120(b)(3)(G)(ii)<sup>31</sup>. The highest number of interruptions (46,286 interruptions) are seen in 1998 which corresponds to the time when ComEd's distribution system unavailability became so conspicuously apparent. For 2002, after ComEd spent a few years improving its system, ComEd reported only 30,548 interruptions in response to 411.120(b)(3)(G)(ii). Since 2002 the overall trend has been upward with total interruptions in 2006 and 2007 (38,488 and 41,645 interruptions respectively) at the highest number of annual interruptions since 1998. This recent upward trend is consistent with the trends that were discussed in relation to Table 4 in Section 7 Staff is concerned, should this multi-year trend continue, and will follow this issue closely.

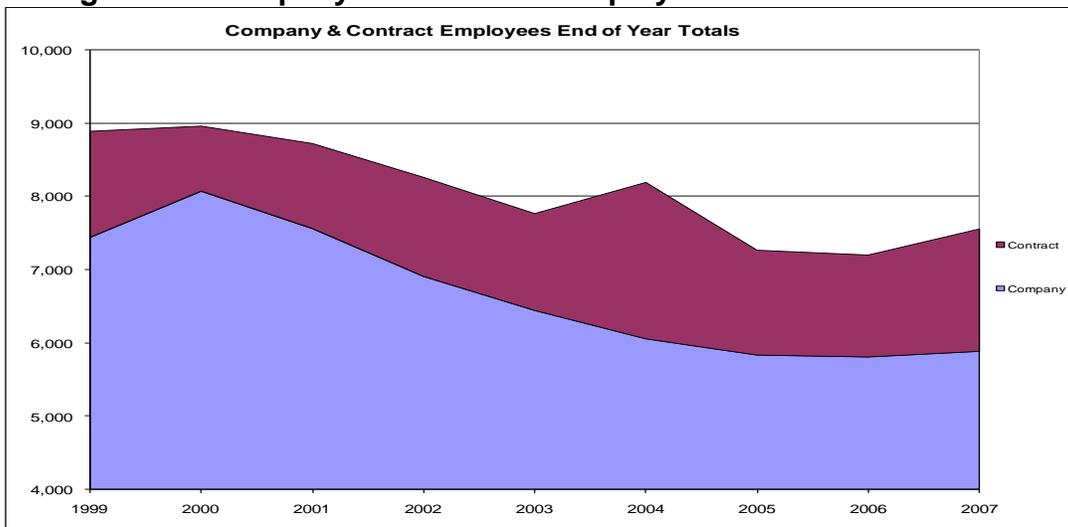
**Figure 28: Company and Contract Employees – End of Year Totals**

Figure 28 shows that the number of company employees declined by 21% from 1999 to 2007 while the number of contract employees increased by 15% for a total decrease over that period of 15%. The impact that this total employee decrease may have on reliability has yet to be determined, but Staff will continue to follow developments in this area for signs of direct or indirect impacts.

It is Staff's opinion that ComEd's transmission system vegetation management program has been weakened, in part, as a result of employee reductions. See Appendix E, Staff's Investigation Report into the July 2008 transmission line problems. Staff is concerned ComEd's 21% reduction of employees over the last 8 years may also suggest programmatic problems in distribution and substation operations yet to be discovered or reported to Staff. ComEd may not have enough personnel properly allocated to know with confidence that the work is

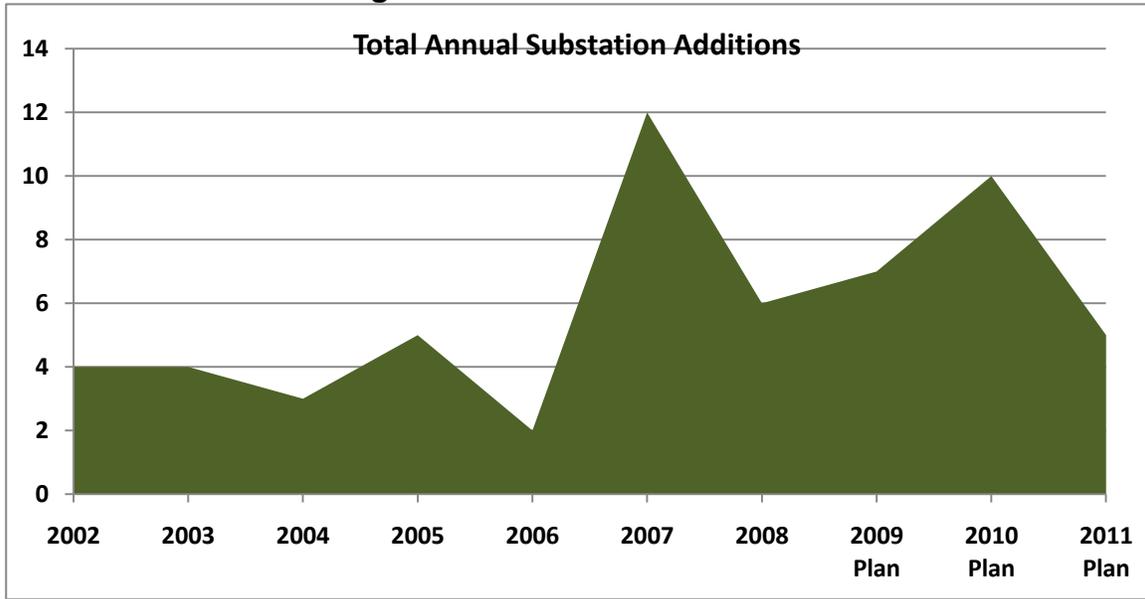
**Figure 29: Substation Additions**

Figure 29 illustrates actual substation additions through 2008 as well as planned additions through 2011. Staff believes that much of the improved performance illustrated in Figure 14 from 2006 to 2007 may be partly responsible to the increase in substation additions in 2007.

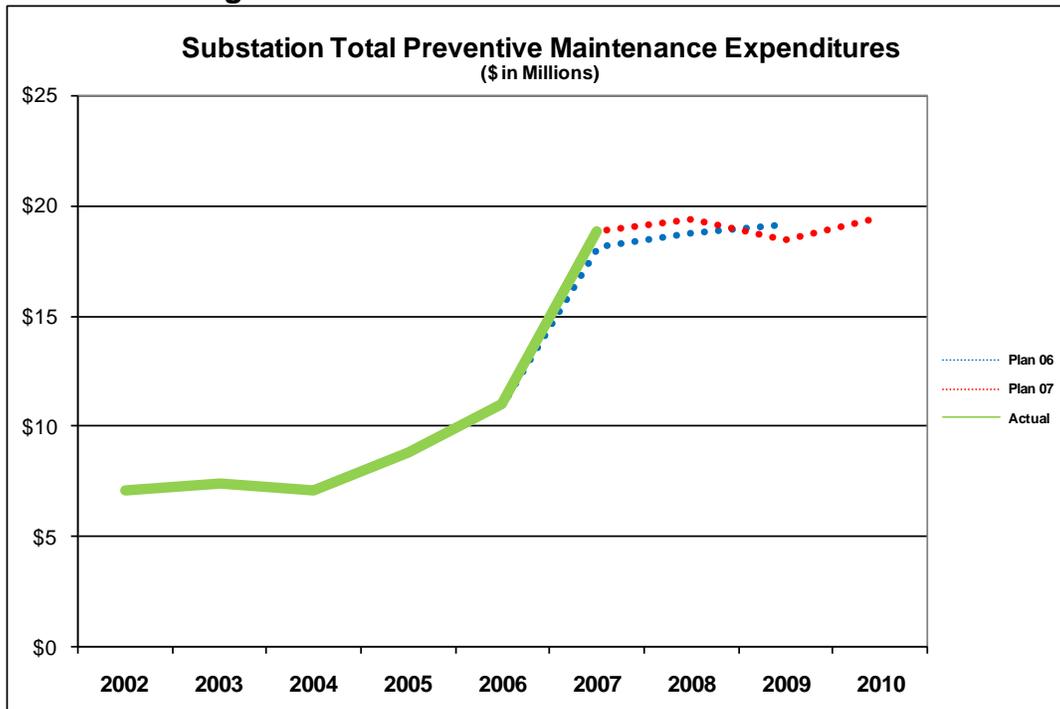
**Figure 30: Substation Preventive Maintenance**

Spending more on preventive maintenance, all other things being equal, should result in improved equipment reliability and availability. In Figure 30 the 2007 actual expenditure closely tracked the 2006 planned amount for that year. The planned preventive maintenance expenditures are projected to remain roughly level through 2010. In Figure 31 the actual expenditure in 2007 is markedly lower than the expenditures in 2006 but is higher than what was planned for 2007 in the 2006 plan. The 2007 plan projects increasing corrective maintenance expenditures through 2010. Staff will closely follow these trends.

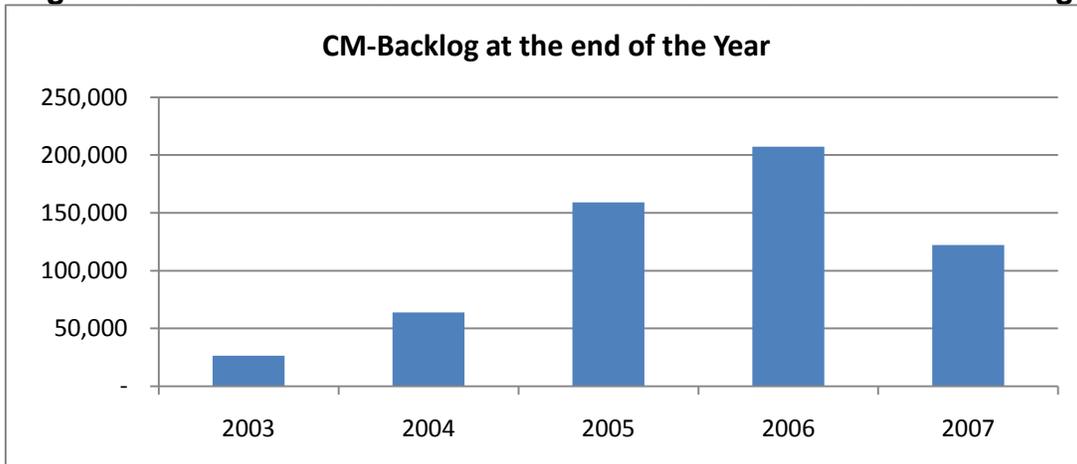
**Figure 32: Distribution Corrective Maintenance End of the Year Backlog**

Figure 32 is more telling when looked at in conjunction with the trends seen in Figure 23 where expenditures for inspection and maintenance climbed sharply after 2003. According to ComEd,<sup>32</sup> the Company expected distribution corrective maintenance backlogs to increase over their four-year distribution inspection cycle because they were looking harder and identifying more corrective maintenance items than would have been previously noted. Figure 32 shows for the first time in four years a decline in distribution corrective maintenance backlogs from 2006 to 2007. While Staff finds this change encouraging it is too soon to tell if it is a continuing real trend or if the quality of inspections and maintenance has been sustained over time.
