Illinois Commerce Commission  
Assessment of AmerenIP's  
Reliability Report and Reliability Performance  
For Calendar Year 2009

Pursuant to 83 Illinois Administrative Code 411.140

July 12, 2011

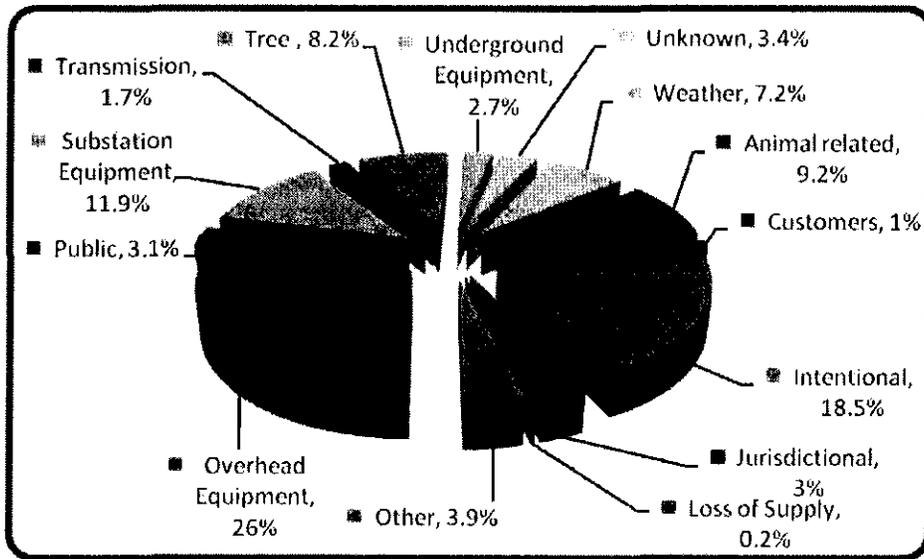
**Figure 1: 2009 - Percentage of CI By Cause Category**

Figures 1 and 2 provide a summary of 2009 interruptions by cause category in terms of customer interruptions ("CI") and customer minutes interruptions ("CMI").
