1.7 Examination of the Accident Pipe

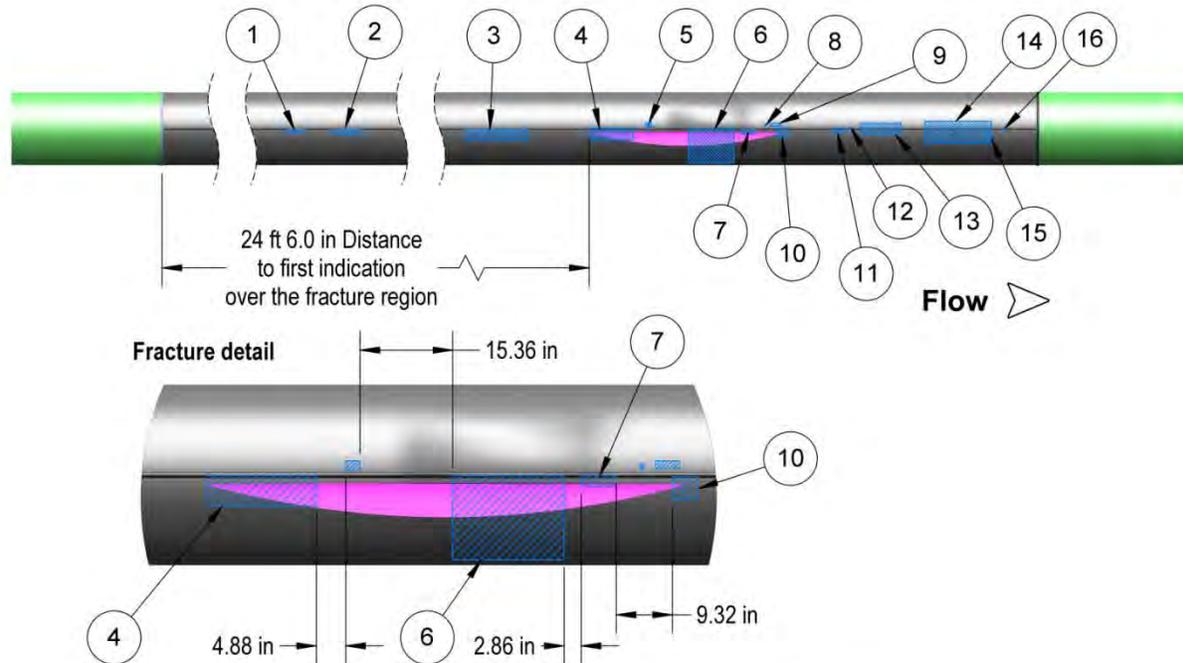
2004 USWM corrosion features on the ruptured segment

Figure 17. 2004 corrosion inspection of Line 6B and 16 regions of corrosion identified by the tool on the ruptured pipe segment. The detail view shows the areas of corrosion overlapped with the rupture location.

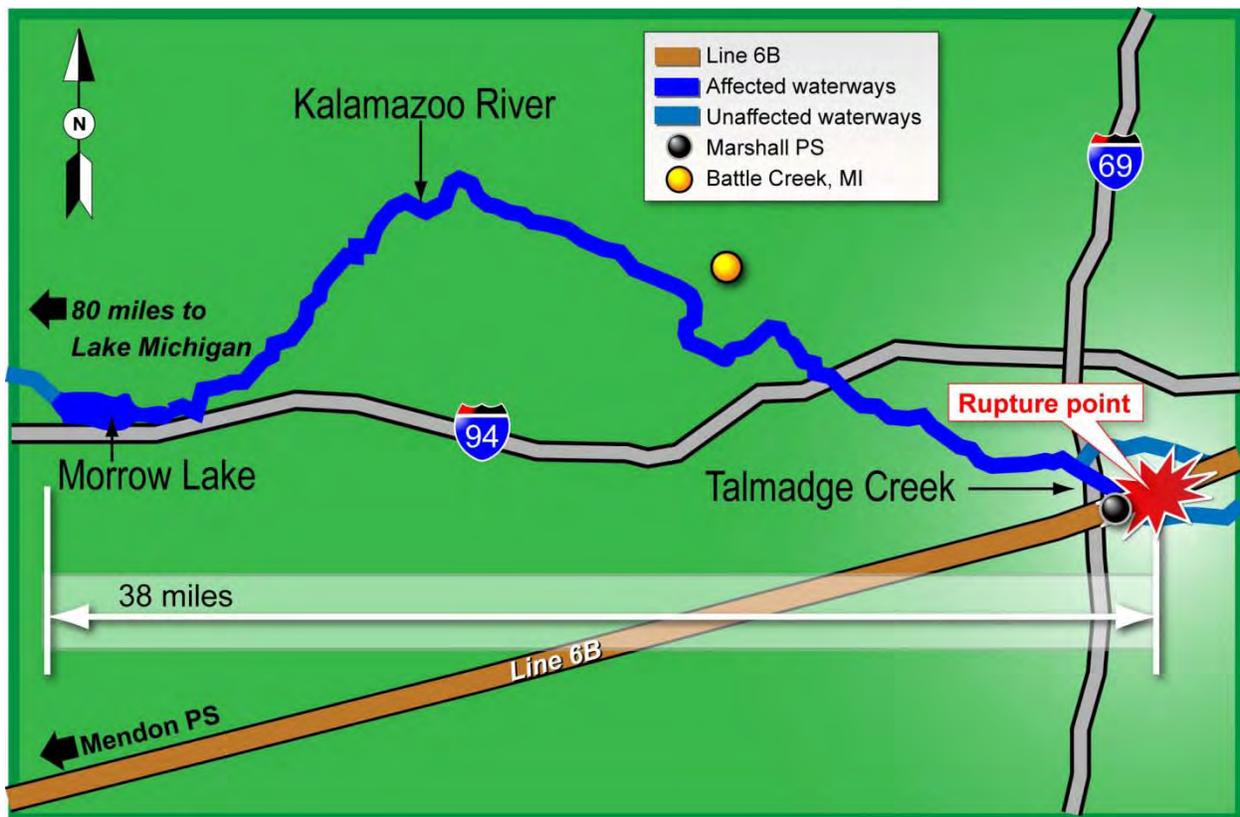
In the days following the accident, Enbridge and its contractors established about 33 oil spill containment-and-control points (from the release site to the west end of Morrow Lake in Kalamazoo County, covering about 38 miles of the river). (See figure 19.) The control points consisted of a variety of oil containment strategies, including underflow dams, oil booming, and sorbent booming. Vacuum trucks and oil skimmers were used to remove oil at these locations.

Figure 19. Map showing rupture location and affected waterways from Talmadge Creek to Morrow Lake.

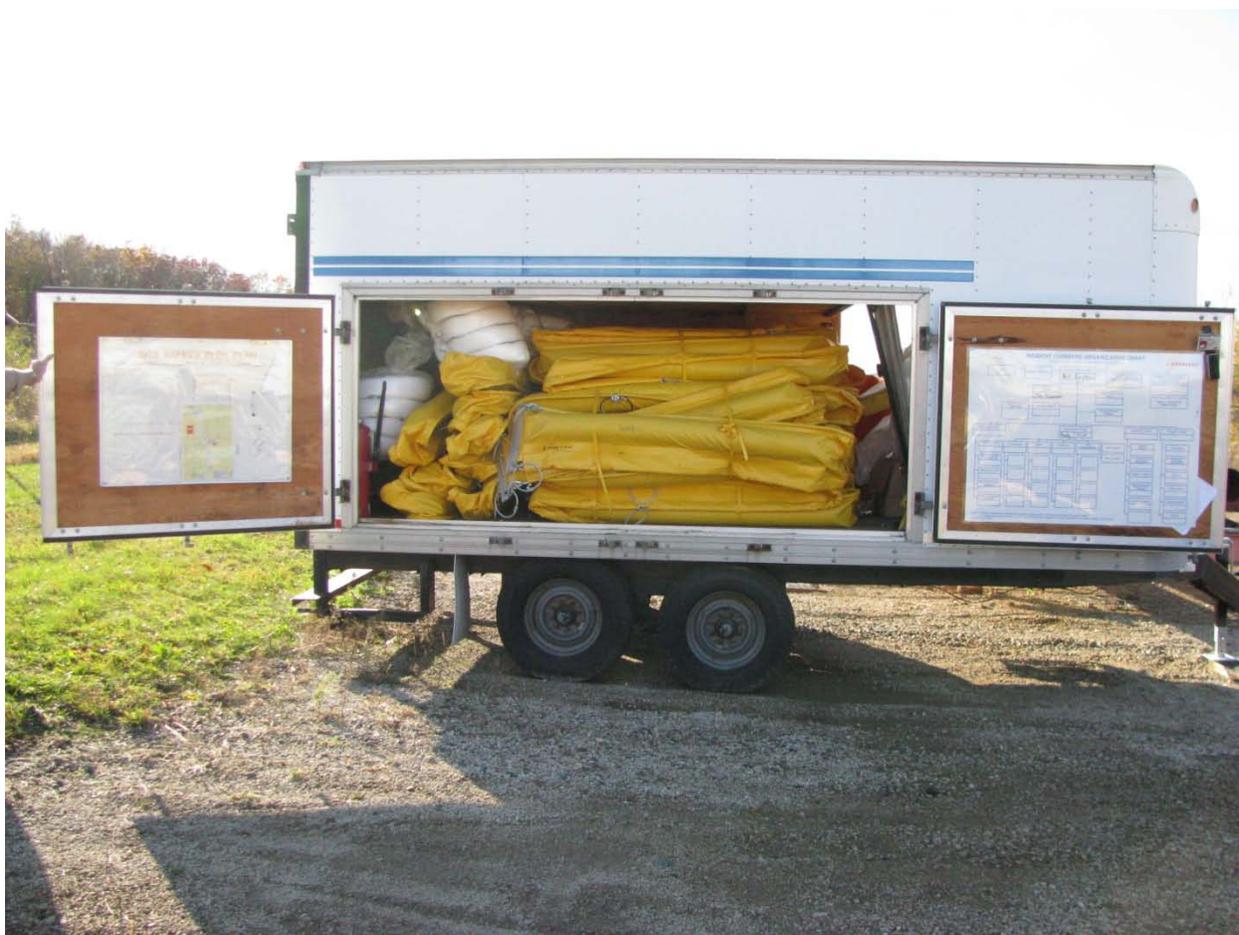
Enbridge's plan states that the company owns and maintains emergency response equipment throughout its Chicago region at 13 office locations and strategic locations, including the Marshall, Michigan, PLM shop. The plan lists the amounts and types of spill response equipment maintained at each PLM station for responding to a worse-case discharge, including the Marshall PLM. According to the plan, the single Marshall PLM inventory response trailer (see figure 20) was packed with 1,100 feet of river containment boom; 200 feet of small containment boom; 200 feet of sorbent boom; and 1,000 sorbent pads to respond to the stated worst-case discharge of 1,111,152 gallons. In addition to the trailer, the PLM shop equipment included 3 skimmers, 18 pumps, 1 storage tank, 3 boats, and a single 1,680- to 2,520-gallon-capacity vacuum truck. According to Enbridge's interpretation of response planning regulations, this equipment constitutes its Tier 1 response resources.

Figure 20. Enbridge PLM emergency response trailer containing the company's Tier 1 oil containment equipment, October 17, 2010.
