Illinois Commerce Commission
Assessment of AmerenIP's
Reliability Report and Reliability Performance
for Calendar Year 2005

Pursuant to 83 Illinois Administrative Code 411.140

December 18, 2006

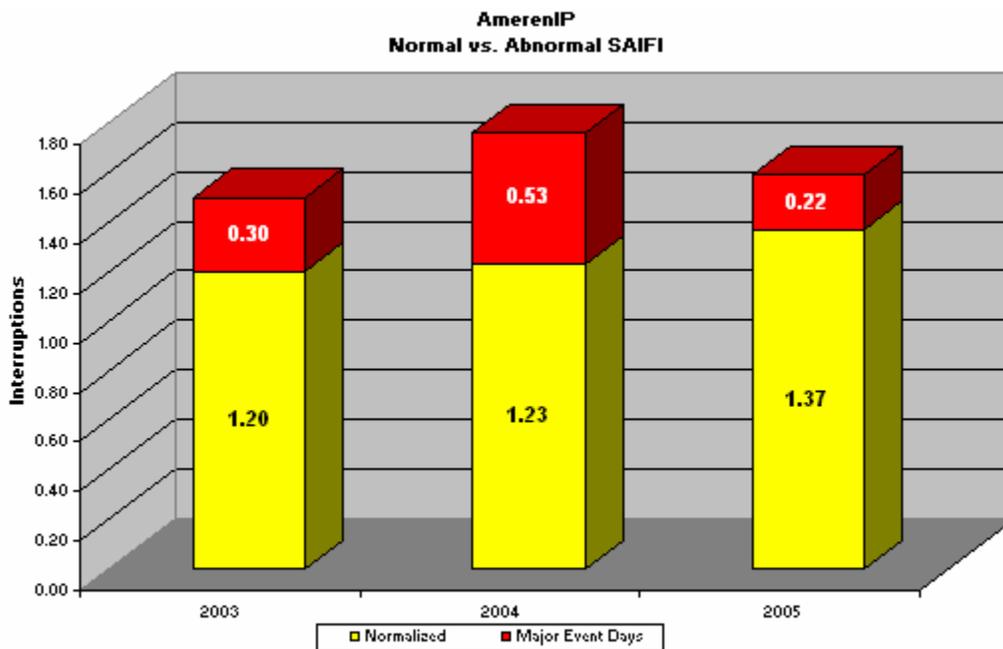
Figure 1 Normalized SAIFI Data

AmerenIP's System Average Interruption Frequency Index ("SAIFI") and Customer Average Interruption Duration Index ("CAIDI") demonstrate the significant impact of outages from the days in 2005 that were MED's, as seen in Figure 1 and Figure 2. The majority of these MED's were due to weather events.

The Commission should take note from Figures 1 and 2 in the above excerpt that Ameren's manipulation of the SAIFI and CAIDI indices by using Standard 1366 would seem to eliminate a significant number of electric service interruptions and cause their average duration to drop by nearly half in 2004. The Commission should also note Ameren's first hint in the last paragraph of the excerpt that it intends to place the blame for many electric service interruptions on "weather" and not on itself or its electricity delivery facilities. This theme runs throughout AmerenIP's report. Further, the Commission should note that Ameren has combined many separate causes together into one cause that it has chosen to call weather. Those many separate causes include tornados, floods, winds, excessive heat, excessive cold, and ice storms.
