Illinois Commerce Commission  
Assessment of  
Central Illinois Light Company's  
Annual Reliability Report and  
Electric Service Reliability  
For Calendar Year 2004

Pursuant to 83 Ill. Adm. Code 411.140

2005

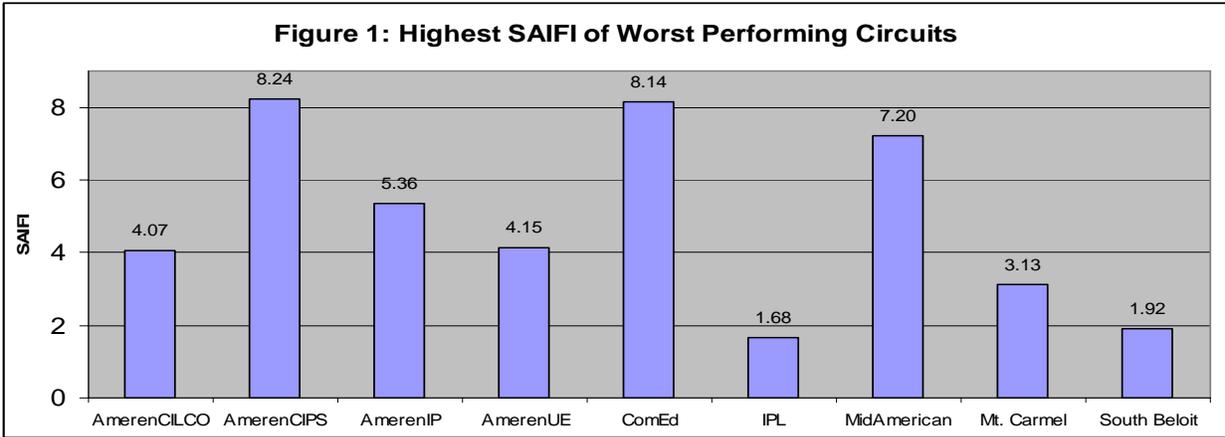
- The highest values of SAIFI reported for an individual distribution circuit during 2004 ranged from 1.68 (IPL) to 8.24 (AmerenCIPS), as illustrated by Figure 1. AmerenCILCO's highest SAIFI for an individual circuit in 2004 (4.07) was slightly less than the average of values reported.

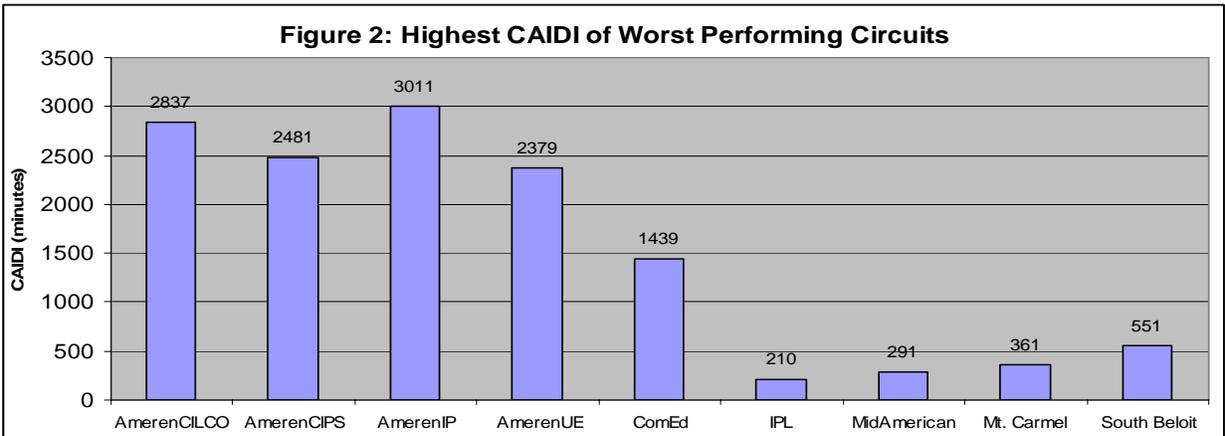
- The highest value of CAIDI reported for an individual distribution circuit during 2004 ranged from 210 (IPL) to 3011 (AmerenIP), as illustrated by Figure 2. AmerenCILCO's highest CAIDI for an individual circuit in 2004 (2837) was the 2<sup>nd</sup> highest (worst) value reported.

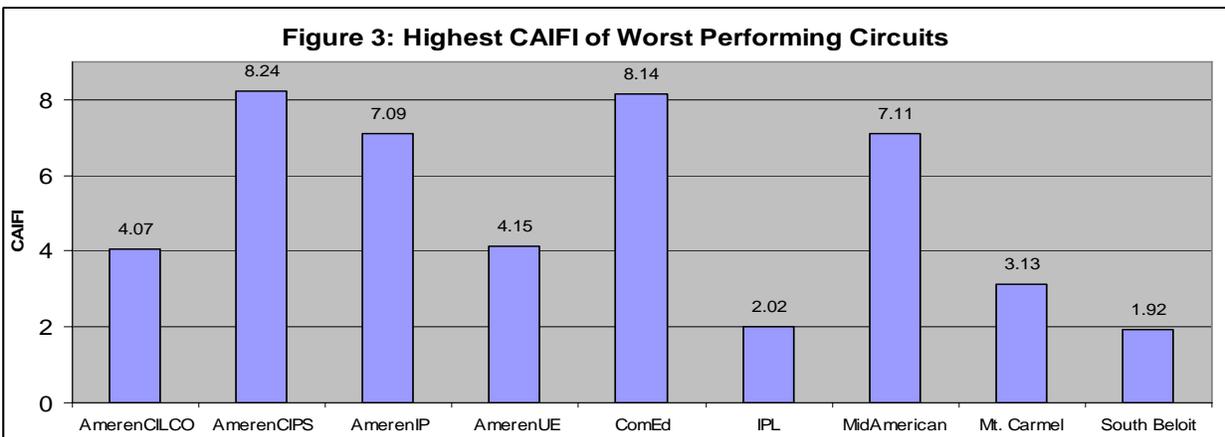
- The highest value of CAIFI reported for an individual distribution circuit during 2004 ranged from 1.92 (South Beloit) to 8.24 (AmerenCIPS), as illustrated by Figure 3. As with SAIFI, AmerenCILCO's highest CAIFI for an individual circuit in 2004 (4.07) was near the average of values reported.

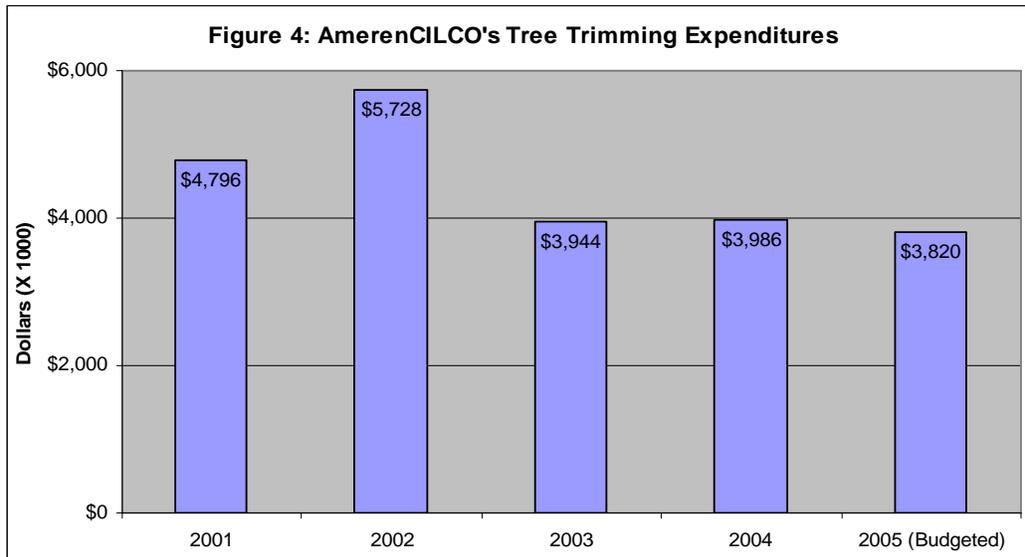
Figure 4 illustrates AmerenCILCO's actual expenditures for tree trimming for the years 2001-2004, and its budgeted tree trimming expenditure for 2005.

Staff has concern that AmerenCILCO is reducing its budget for tree trimming while stating it plans to implement mid-cycle trimming on certain fast growing trees. Staff plans to continue to periodically evaluate AmerenCILCO's effectiveness at keeping trees clear of its power lines.

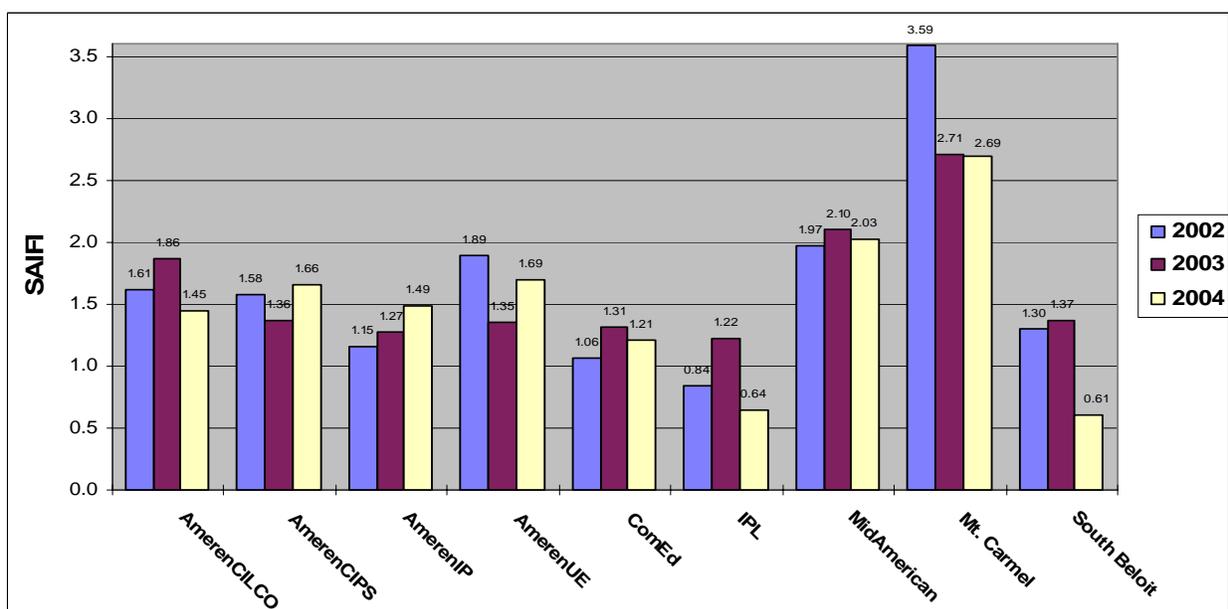
Figure 5: SAIFI by Utility (2002-2004)

- In 2002, AmerenCILCO's SAIFI was about 4% lower than the average of the SAIFI values reported by the eight other reporting utilities (AmerenCILCO's 2002 SAIFI=1.61).
- In 2003, AmerenCILCO's SAIFI increased (worsened) by approximately 16%, and was about 17% higher than the average of the SAIFI values reported by the eight other reporting utilities (AmerenCILCO's 2003 SAIFI=1.86).
- In 2004, AmerenCILCO's SAIFI decreased (improved) by approximately 22%, and was about 3% lower than the average of the SAIFI values reported by the eight other reporting utilities (AmerenCILCO's 2004 SAIFI=1.45).

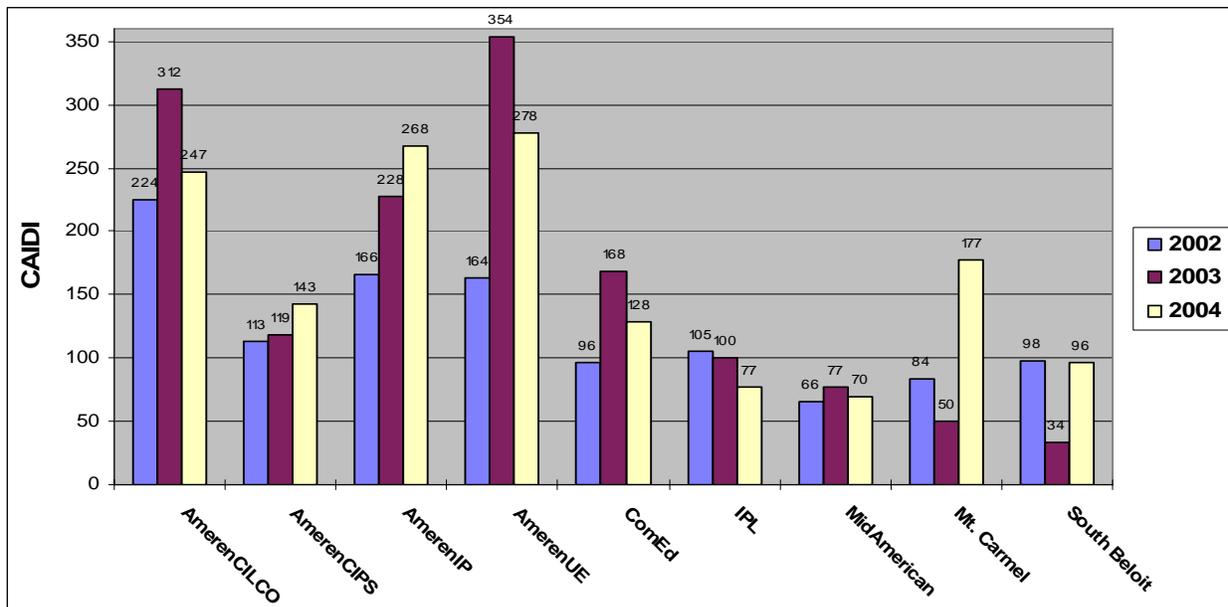
**Figure 6: CAIDI by Utility (2002-2004)**<sup>1</sup>

- In 2002, AmerenCILCO's had the highest (worst) CAIDI reported: approximately 101% higher than the average of the CAIDI values reported by the eight other reporting utilities (AmerenCILCO's 2002 CAIDI=224).
- In 2003, AmerenCILCO's CAIDI increased (worsened) by approximately 39%, and was about 121% higher than the average of the CAIDI values reported by the eight other reporting utilities (AmerenCILCO's 2003 CAIDI=312).
- In 2004, AmerenCILCO's CAIDI, decreased (improved) by approximately 21%, but was still about 60% higher (worse) than the average of the CAIDI values reported by the eight other reporting utilities (AmerenCILCO's 2004 CAIDI=247)

<sup>1</sup> Figure 6 illustrates that 3 Ameren electric utilities reported the worst CAIDI values each year during 2002-2004: significantly higher than the other reporting utilities. In addition, the 4<sup>th</sup> Illinois Ameren electric utility, AmerenCIPS, reported a higher (worsening) CAIDI each year.

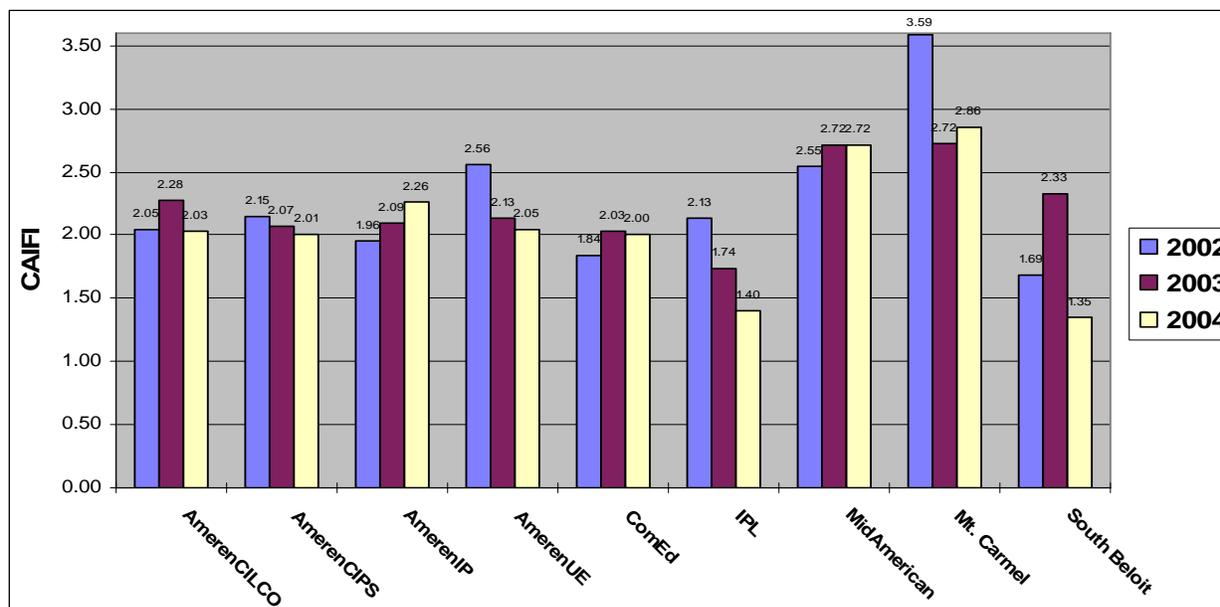
**Figure 7 CAIFI by Utility (2002-2004)**

- In 2002, AmerenCILCO's CAIFI was about 11% lower than the average of the CAIFI values reported by the other eight utilities (AmerenCILCO's 2002 CAIFI=2.05).
- In 2003, AmerenCILCO's CAIFI increased (worsened) by approximately 11%, and was about 2% higher than the average of the CAIFI values reported by the other eight utilities (AmerenCILCO's 2003 CAIFI=2.28).
- In 2004, AmerenCILCO's CAIFI decreased (improved) by approximately 11% and was about 2% lower than the average of the CAIFI values reported by the eight other reporting utilities (AmerenCILCO's 2004 CAIFI=2.03).

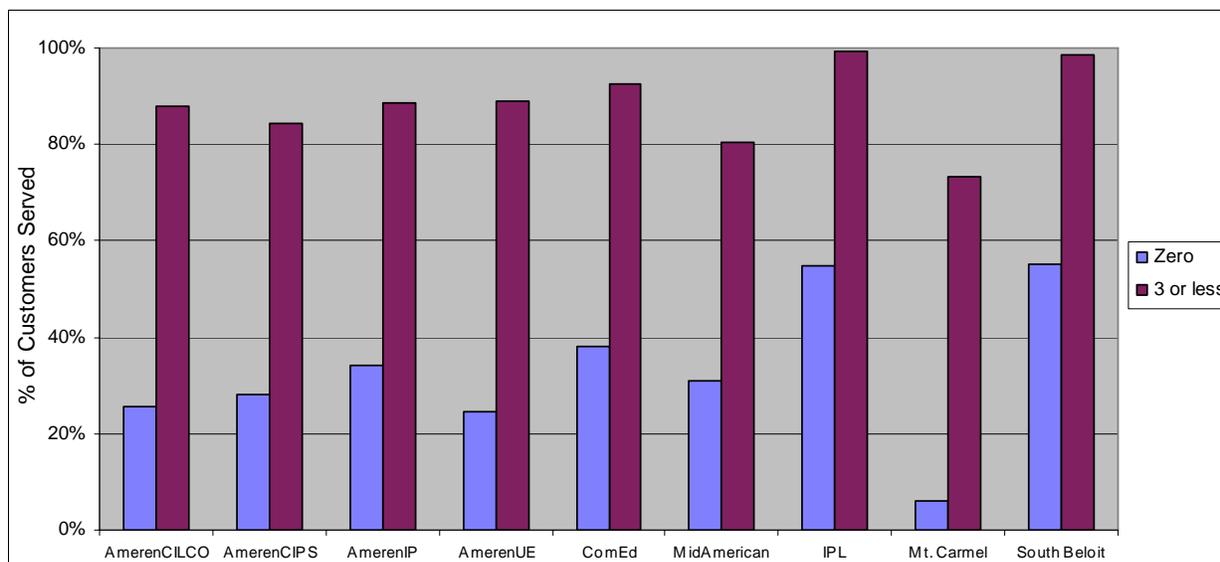
**Figure 8: Percentage of Customers with Zero and 3 or Fewer Interruptions in 2004**

- **Zero interruptions:** During 2004, 26% of AmerenCILCO's customers experienced zero interruptions. During 2003 and 2002 this value was 14% and 17%, respectively.
- **3 or Fewer Interruptions:** During 2004, 88% of AmerenCILCO's customers experienced 3 or fewer interruptions. During 2003 and 2002 this value was 81% and 83%, respectively.
- **More than six Interruptions:** During 2004, 0.8% of AmerenCILCO's customer experienced more than 6 interruptions. During 2003 and 2002 this value was 2.6% and 1.2%, respectively.

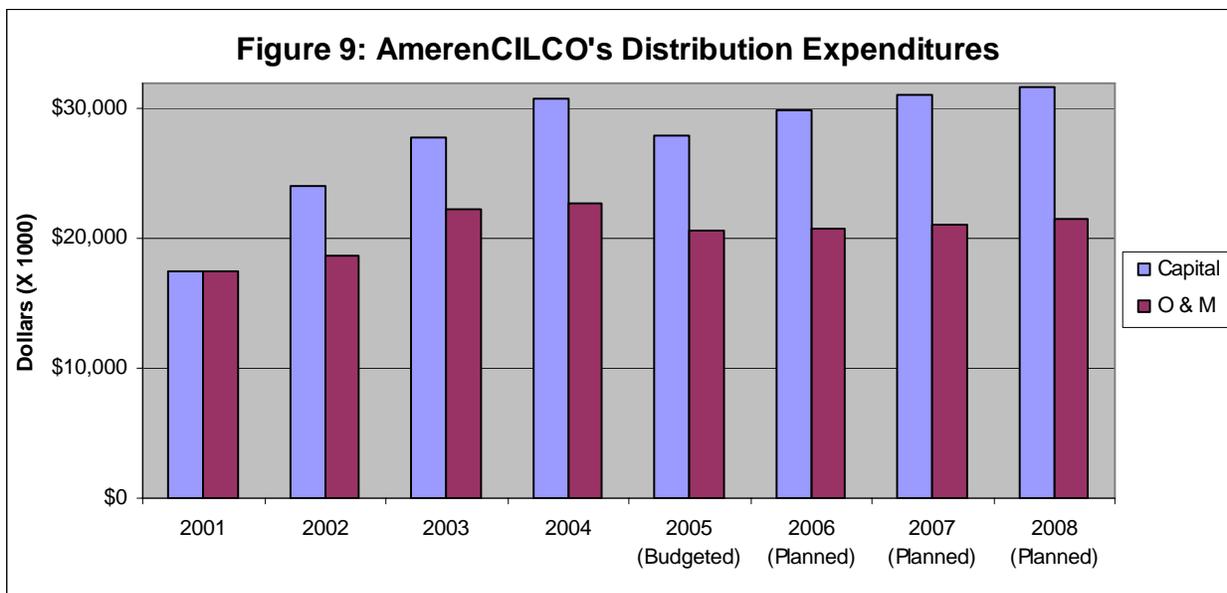
AmerenCILCO indicated it anticipates a decrease in both distribution capital and distribution O&M spending during 2005 when compared to 2004 and anticipates expenditures in 2006-2008 to be consistent with 2005 budgeted amounts, as illustrated by Figure 9. AmerenCILCO has reported average SAIFI and CAIFI indices for the past several years when compared to other reporting utilities and a CAIDI index that has been significantly worse than average. AmerenCILCO's planned flat distribution O&M spending levels for the next three years do not give Staff reason to expect any significant changes or improvements in AmerenCILCO's distribution maintenance activities.

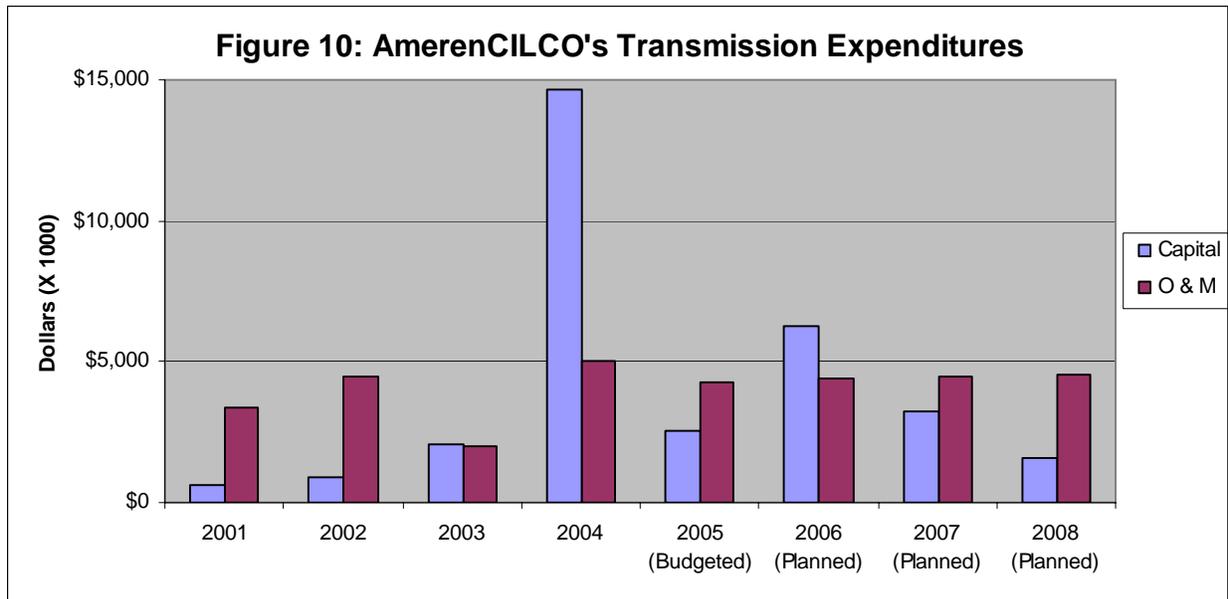
Figure 10 illustrates that AmerenCILCO budgeted a reduction in transmission capital and transmission O&M spending during 2005, and expects fluctuating transmission capital spending and fairly flat transmission O&M spending thereafter. Staff agrees with AmerenCILCO that it is reasonable for transmission capital spending to vary from year to year depending on the number of transmission construction projects scheduled.
