Annual Report for the 2000 Reporting Period
Pursuant to 83 Illinois Administrative Code 411

June 1, 2001

Revised June 25, 2001

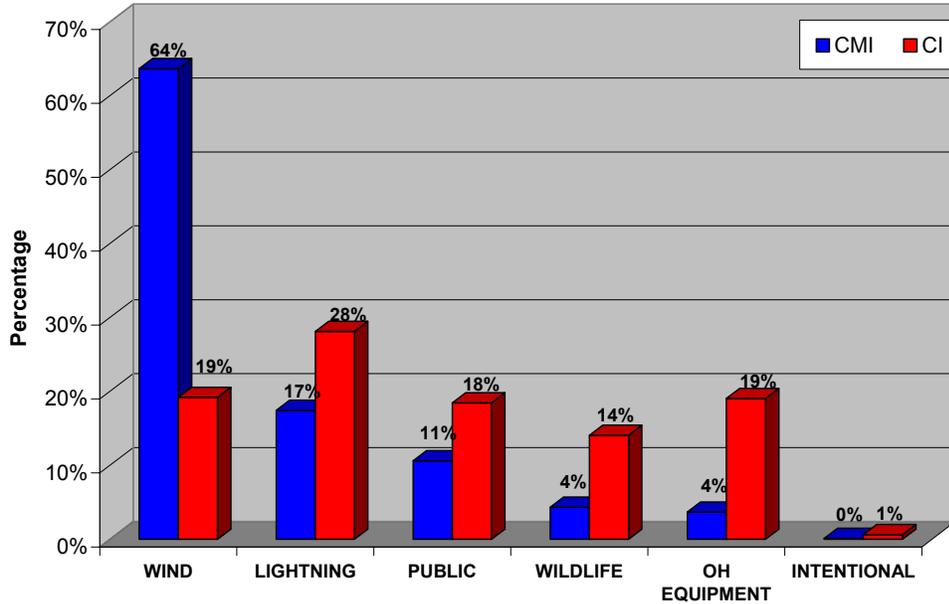
• Figure 33. Maryville Circuit 360 - Causes of 2000 Interruptions

This circuit was a worst performer from both a SAIFI and CAIFI perspective. It serves 1399 customers at 12.47 kV and is 92% overhead. Based on the customer density per circuit mile, the circuit is classified as rural. Figure 33 shows the percentage of customers interrupted and customer minutes interrupted by cause category for 2000. Wind and lightning were the top causes of high CI and CMI.

This circuit was patrolled in 2000 and 2001. This circuit was trimmed in June 2000 at a cost of \$190,515 in *constant 1998 dollars*. Fuses and animal guards will be installed at three hundred plus transformer locations at a cost of \$26,067 in *constant 1998 dollars*. One hundred and twenty seven potential repair items were identified during the 2001 patrol and work plans have been submitted to remediate the high priority items. The remediation plans will be completed by June 1, 2001. A planning and coordination study is currently on-going and will be complete by December 2001 with recommendations implemented by June 2002.

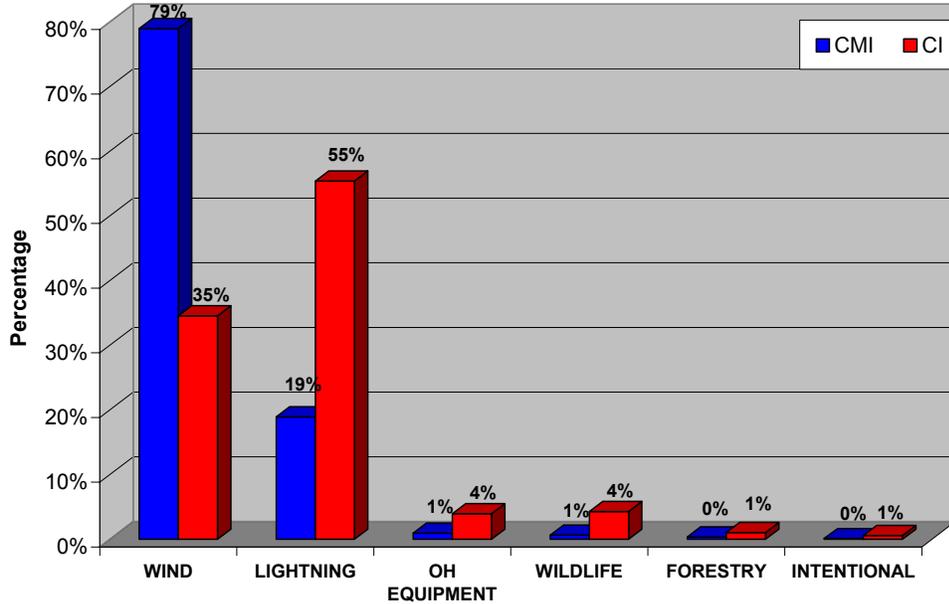
• Figure 34. Maryville Circuit 362 - Causes of 2000 Interruptions

This circuit was a worst performer from a CAIDI perspective. It serves 1261 customers at 12.47 kV and is 94% overhead. Based on the customer density per circuit mile, the circuit is classified as rural. Figure 34 shows the percentage of customers interrupted and customer minutes interrupted by cause category for 2000. Wind and lightning were the predominant cause of high CI and CMI.

This circuit will be patrolled by June 2001. This circuit will be trimmed in March 2001. Three additional fuses will be installed and one blown lightning arrester will be replaced at a cost of \$1,723 in *constant 1998 dollars*. The remediation plans will be completed by June 1, 2001. A planning and coordination study is currently on-going and will be complete by December 2001 and recommendations will be implemented by June 2002.

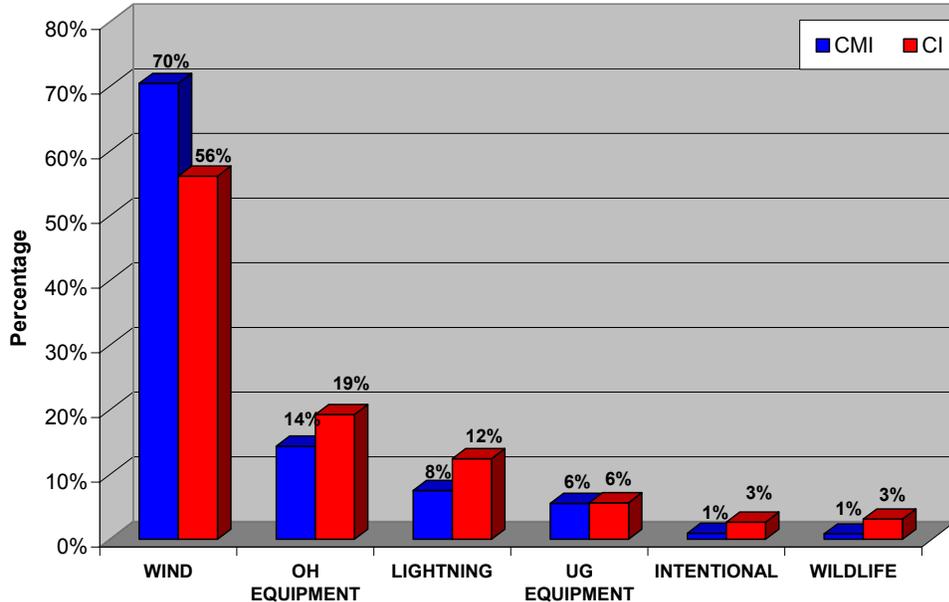
• Figure 36. Maryville Circuit 407 - Causes of 2000 Interruptions

This circuit was a worst performer from both a SAIFI and CAIFI perspective. It serves 1118 customers at 12.47 kV and is 84% overhead. Based on the customer density per circuit mile, the circuit is classified as urban. Figure 36 shows the percentage of customers interrupted and customer minutes interrupted by cause category for 2000. Wind was the predominant cause of high CI and CMI.

This circuit was trimmed in March 2001. During 2000, failed underground primary was replaced and a set of reclosers was upgraded at a cost of \$6,645 in *constant 1998 dollars*. The circuit was patrolled in 1997 and 2001. Seventy-seven potential repair items were identified during the 2001 patrol and work plans have been submitted to remediate the high priority items. During 2001, the following projects were completed:

- Replaced a pole,
- Replaced discs with 400 amp underslung blades, and
- Repaired twenty-five maintenance items

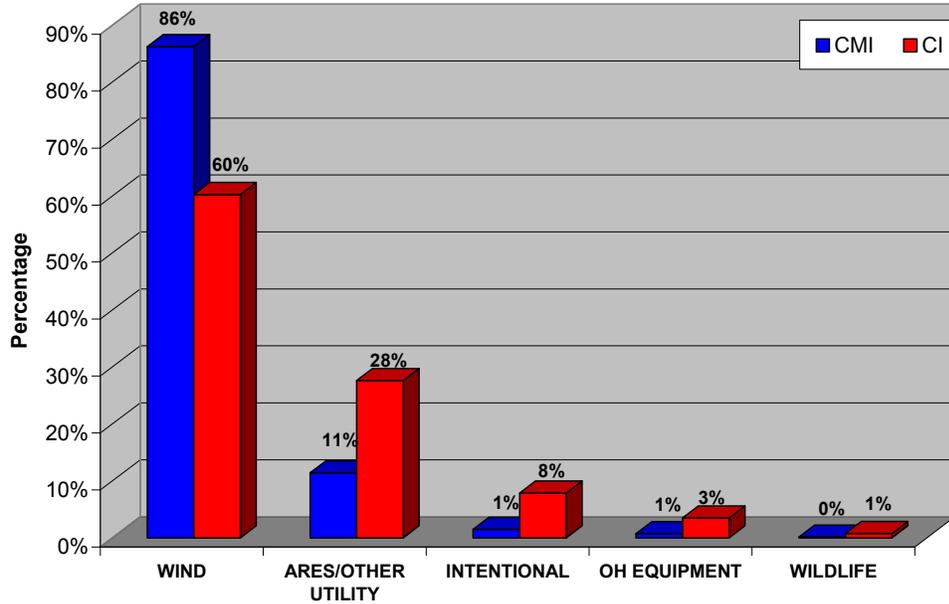
• Figure 37. Granite City Circuit 298 - Causes of 2000 Interruptions

This circuit was a worst performer from a CAIDI perspective. It serves 273 customers at 4.16 kV and is all overhead. Based on the customer density per circuit mile, the circuit is classified as urban. Figure 37 shows the percentage of customers interrupted and customer minutes interrupted by cause category for 2000. Wind was the predominant cause of high CI and CMI.

This circuit was patrolled in 2000 and four bad poles were replaced at a cost of \$6,170 in *constant 1998 dollars*. The circuit made the WPC list due to a storm. This circuit was trimmed in April 1999 at a cost of \$14,109 in *constant 1998 dollars*. Remediation plans will be completed by June 1, 2001.

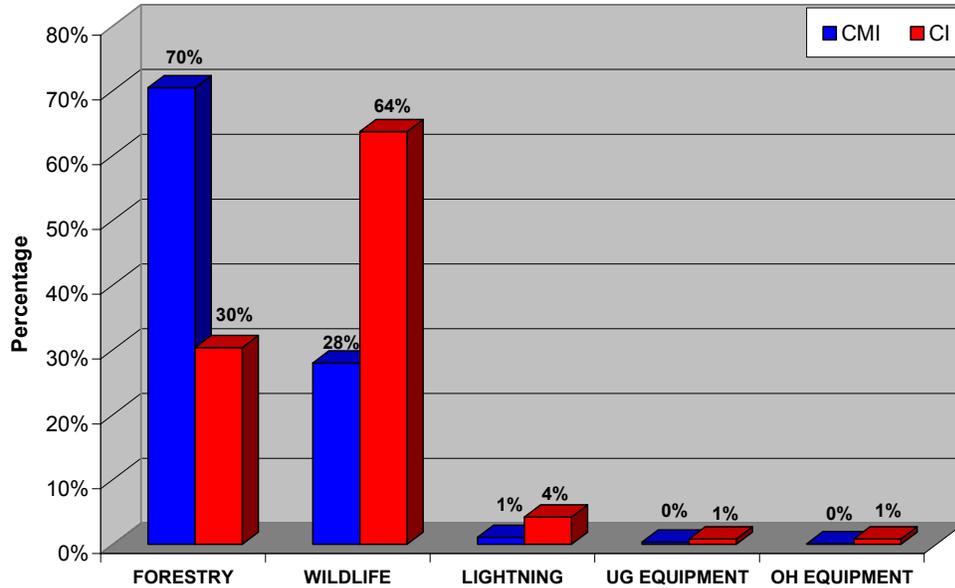
• Figure 39. Granite City Circuit 334 - Causes of 2000 Interruptions

This circuit was a worst performer from a CAIDI perspective. It serves 165 customers at 12.47 kV and is 93% overhead. Based on the customer density per circuit mile, the circuit is classified as rural. Figure 39 shows the percentage of customers interrupted and customer minutes interrupted by cause category for 2000. Forestry and wildlife were the predominant cause of high CI and CMI. This circuit was trimmed in October 1997 and is scheduled to be trimmed again in 2001.

This circuit was patrolled in 1999. It was trimmed in October 1997. Two new sets of fuses will be installed at an estimated cost of \$1,137 in *constant 1998 dollars*.

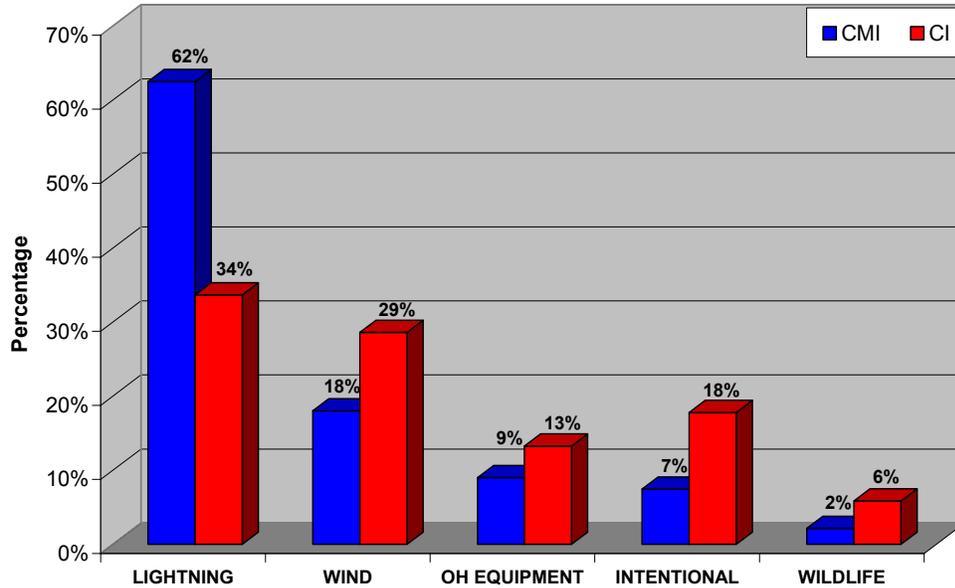
• Figure 40. Mt. Vernon Circuit 140 - Causes of 2000 Interruptions

This circuit was a worst performer from both a SAIFI and CAIFI perspective. It serves 891 customers at 12.47 kV and is mostly overhead. Based on the customer density per circuit mile, the circuit is classified as rural. Figure 40 shows the percentage of customers interrupted and customer minutes interrupted by cause category for 2000. Lightning and wind were the predominant cause of high CI and CMI.

This circuit was patrolled in 2000 and 2001. This circuit was trimmed in March 1998 at a cost of \$146,544. During 1999, thirty bad poles were replaced and a section of spacer cable was repaired at a cost of \$86,000. During 1999, several poles were replaced, two reclosers were upgraded, and one station was removed to reduce exposure at a cost of \$70,038 in *constant 1998 dollars*.
