Illinois Commerce Commission  
Assessment of Commonwealth Edison Company  
Reliability Report and Reliability Performance  
for Calendar Year 2009

Pursuant to 83 Ill. Adm. Code 411.140

December 31, 2010

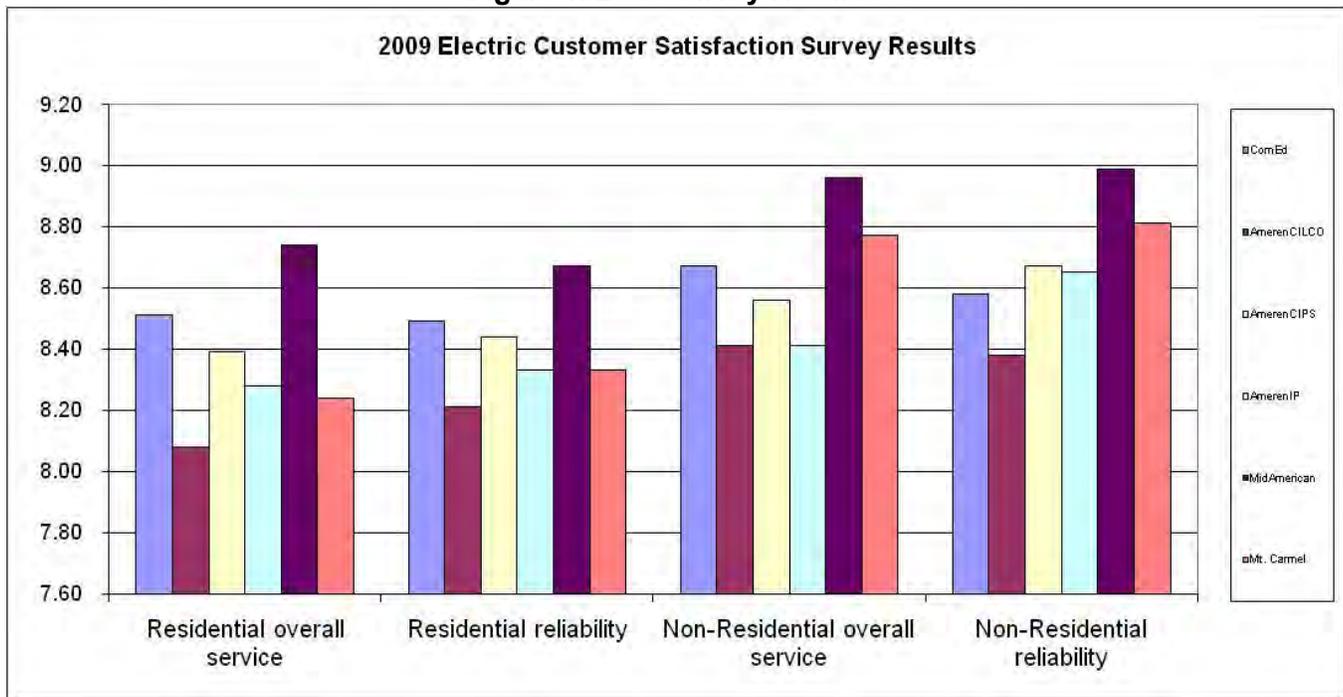
**Figure 1: 2009 Survey Results**

Figure 1 compares ComEd’s 2009 customer satisfaction ratings to those of the other reporting utilities. In 2009 ComEd’s survey results were consistently as good as or better than the Ameren utilities but worse than MidAmerican and, in the case of Non-Residential reliability, ComEd’s survey results were also worse than Mt Carmel. While Staff commends ComEd’s continued improvements in customer satisfaction, Staff recommends that ComEd remain focused on improving customer service overall while directing additional attention on better communicating the need for tree trimming to customers.

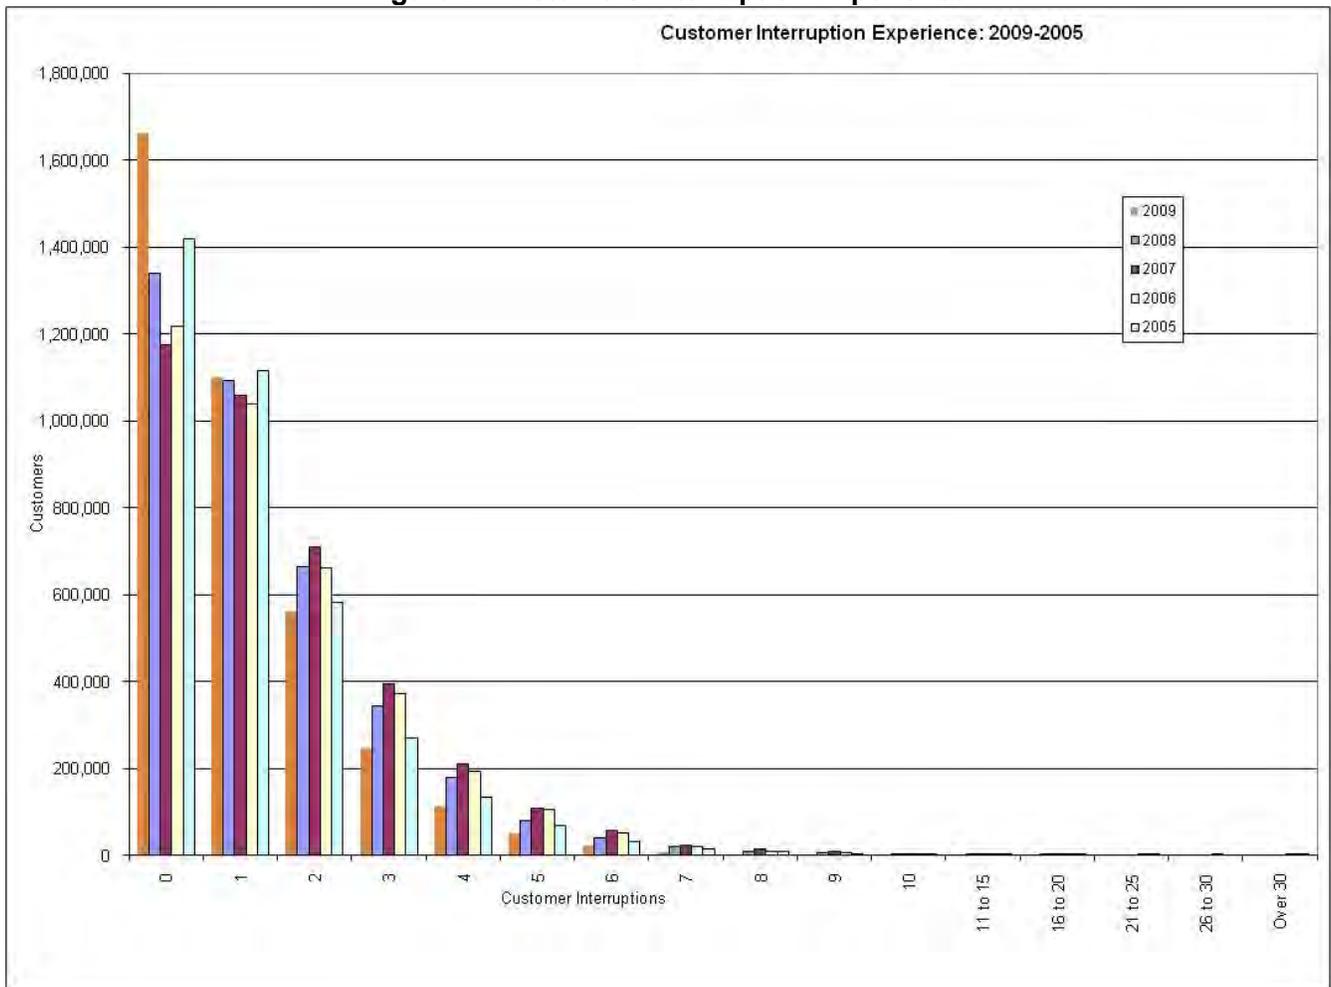
**Figure 2: Customers Interruption Experience**

Part 411.120(b)(3)(K) requires the utility to report the total number of customers that experienced a set number of interruptions during 2009. Figure 2 shows ComEd customer interruption experience for the last five years. In Figure 2, the height of the bars indicate the number of customers who experienced a given number of interruptions during the year. It is readily apparent in Figure 2 that the declining number of customers in 2006 & 2007 that had experienced no interruptions reversed in 2008. Additional improvement resulted in 2009 being the best year for customer interruption experience in the last five years. This clearly improving trend is apparent in Figure 3 where the number of customers

experiencing five or more interruptions has declined below 2004 and 2005 levels. It was ComEd's position that the poor experience in 2007 was due, in part, to unusually extreme weather conditions in 2007, in particular the August 23 & 24, 2007, storms. The 2008-2009 improvements apparent in Figures 2 & 3 tend to support that argument, at least in part, as well as Staff's position that insights from multi-year trends are more valuable than year-to-year variations. In 2009, only 273 customers experienced 11 or more interruptions -- which is substantially below the five year average of 1,631. Staff will closely monitor customers interruption experiences in the future.

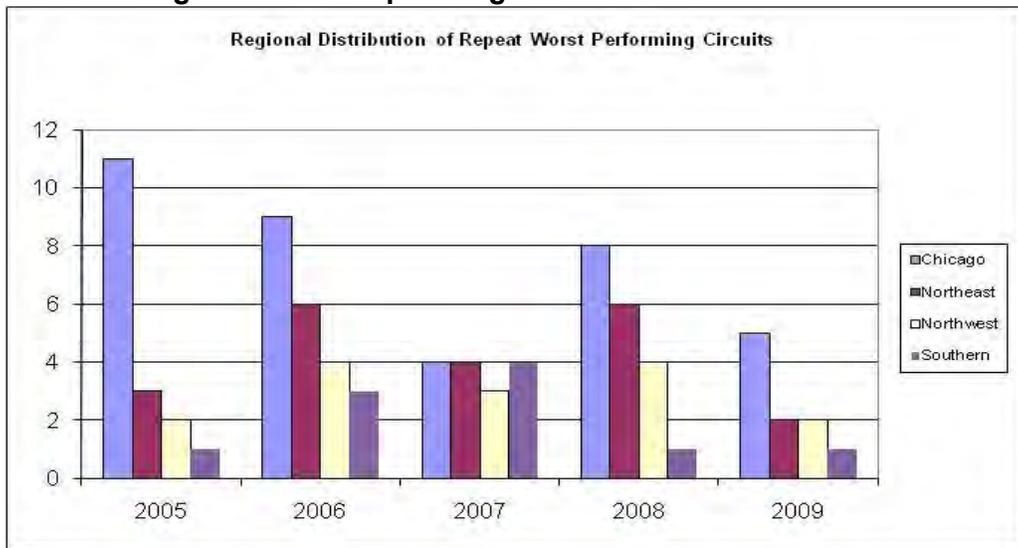
**Figure 4: WPC Repeat Regional Distribution 2005-2009**

Figure 4 illustrates the distribution of these WPC repeats in ComEd's regions. Figure 4 shows WPC repeats are down from the previous year in all of ComEd's regions.

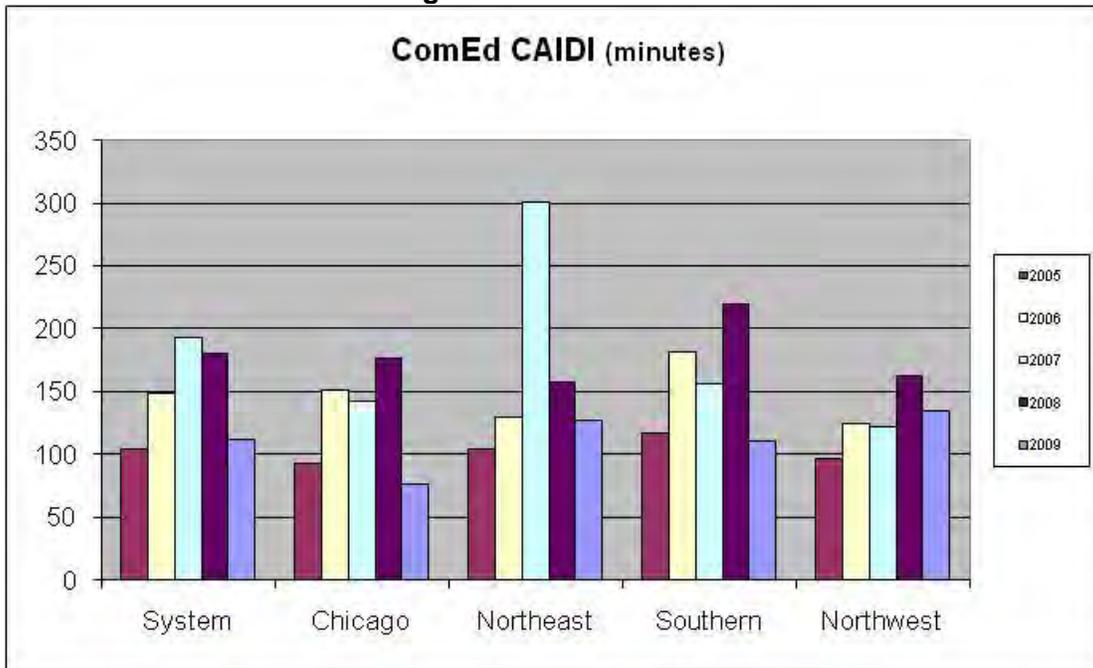
**Figure 5: ComEd CAIDI**

Figure 5 illustrates ComEd's CAIDI indices over the last five years in each region. Note that **lower** bar sizes in Figure 5 represent **better** performance.

In Figure 5 above, CAIDI performance has improved substantially in the Chicago and Southern regions while the other regions also show improved performance over 2008. For the Chicago and Southern regions, 2009 was the best performing year in the five-year period.

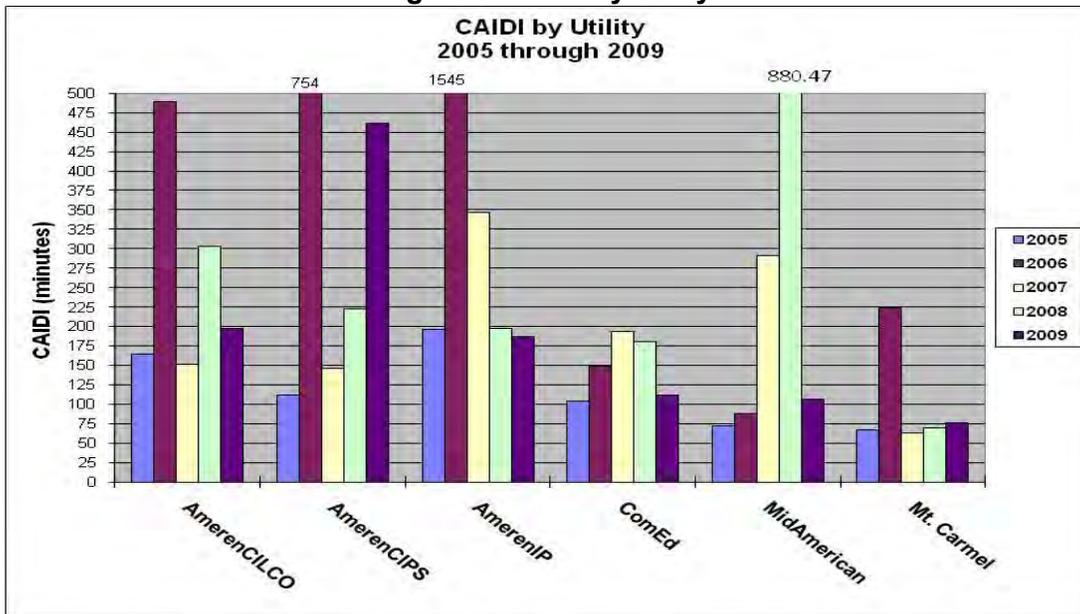
**Figure 6: CAIDI by Utility**

Figure 6 shows a comparison of CAIDI values reported for the years 2005 through 2009 by the utilities. In 2009, ComEd's performance ranked third behind Mt. Carmel and MidAmerican. Of the four largest utilities (AmerenCILCO, AmerenCIPS, AmerenIP, and ComEd) ComEd continues in first place for the second year in a row.

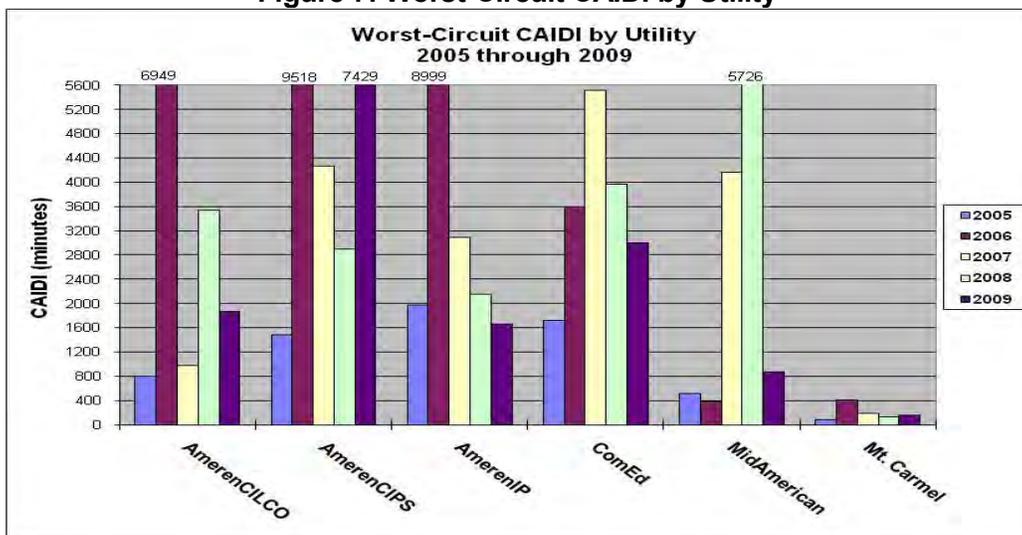
**Figure 7: Worst-Circuit CAIDI by Utility**

Figure 7 shows a comparison of CAIDI values for the worst circuit for each of the utilities from 2005 through 2009. In 2009, ComEd's worst-circuit<sup>29</sup> CAIDI performance is worse than all other utilities in Illinois except AmerenCIPS.

The performance of ComEd’s worst circuit in relation to the worst circuit of the other utilities for 2009 in Figures 7, 10, and 13 remains a matter of concern for Staff. While ComEd has improved over years past, Figures 7, 10, and 13 clearly show that potential exists for reliability improvement while demonstrating the existence of significant risk for future reliability problems. Staff will continue to closely follow developments in this area.

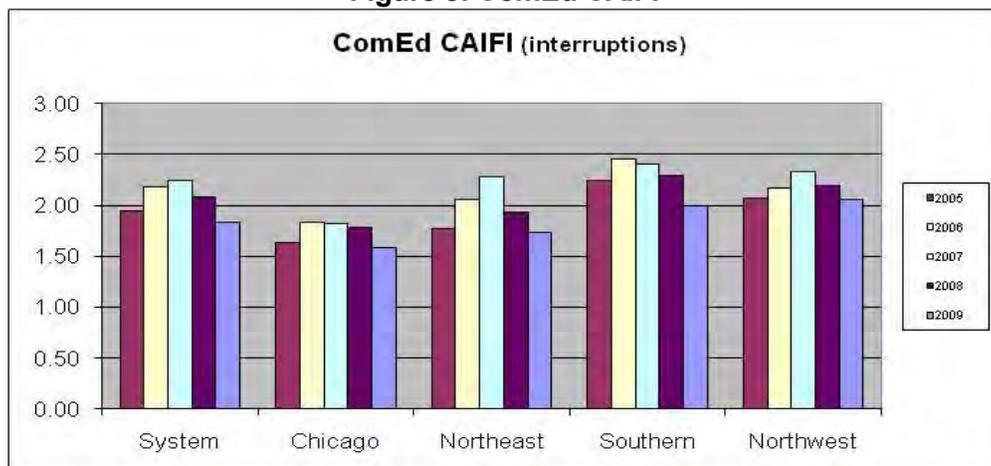
**Figure 8: ComEd CAIFI**

Figure 8 shows CAIFI improving for all ComEd Regions in 2009. In each of the five years 2005 through 2009 the Chicago Region demonstrated the best CAIFI performance while in 2005 through 2008 the Southern Region demonstrated the worst CAIFI performance and in 2009 the Northwest Region demonstrated the worst CAIFI performance. Note that the taller the CAIFI bar in Figure 8, the worse the CAIFI performance.

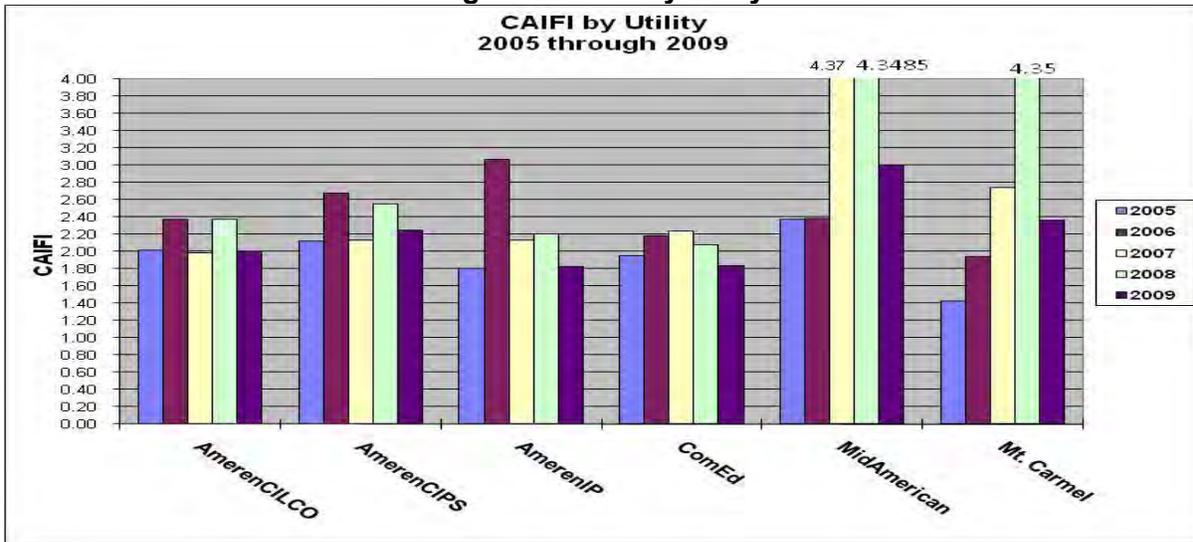
**Figure 9: CAIFI by Utility**

Figure 9 shows a comparison of CAIFI values reported for the years 2005 through 2009 by the utilities. In 2009, ComEd barely lost their first place CAIFI ranking to AmerenIP, 1.83 versus 1.84, amongst the utilities.

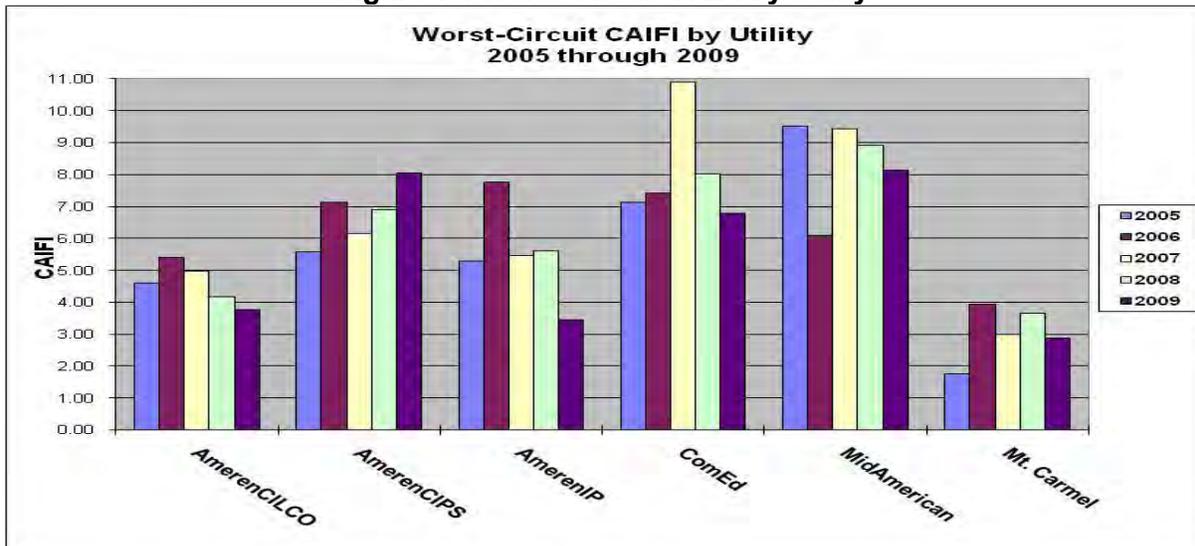
**Figure 10: Worst-Circuit CAIFI by Utility**

Figure 10 shows a comparison of CAIFI values for the worst-circuit<sup>30</sup> for each of the utilities in 2005 through 2009. ComEd moved from the second worst CAIFI performing circuit in 2008, of the six utilities, to the third worst CAIFI performing circuit in 2009.

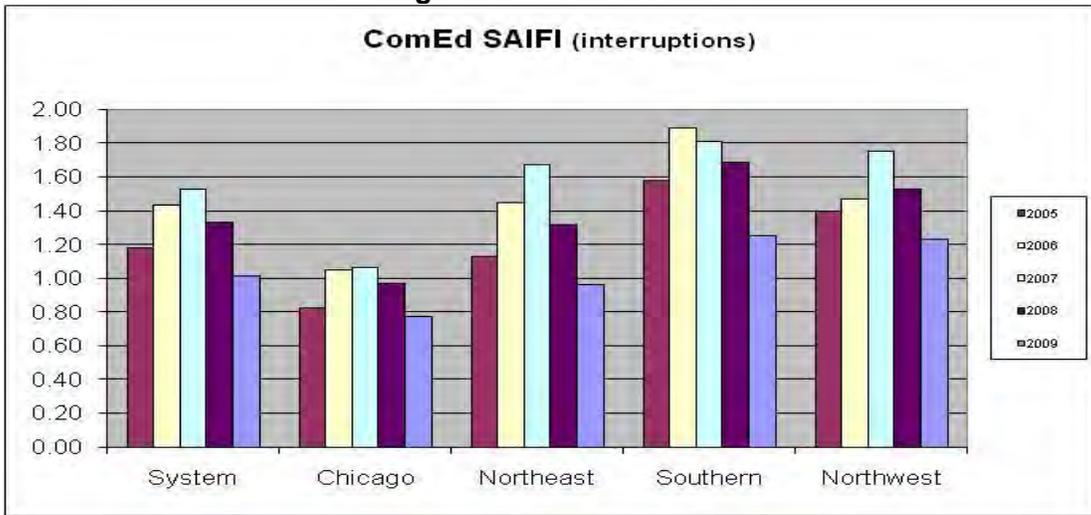
**Figure 11: ComEd SAIFI**

In Figure 11, all regions improved their SAIFI performance in 2009. ComEd's Southern Region's SAIFI performance improved for the third year in 2009 but it's overall 2009 performance is worse than that of the other Regions.

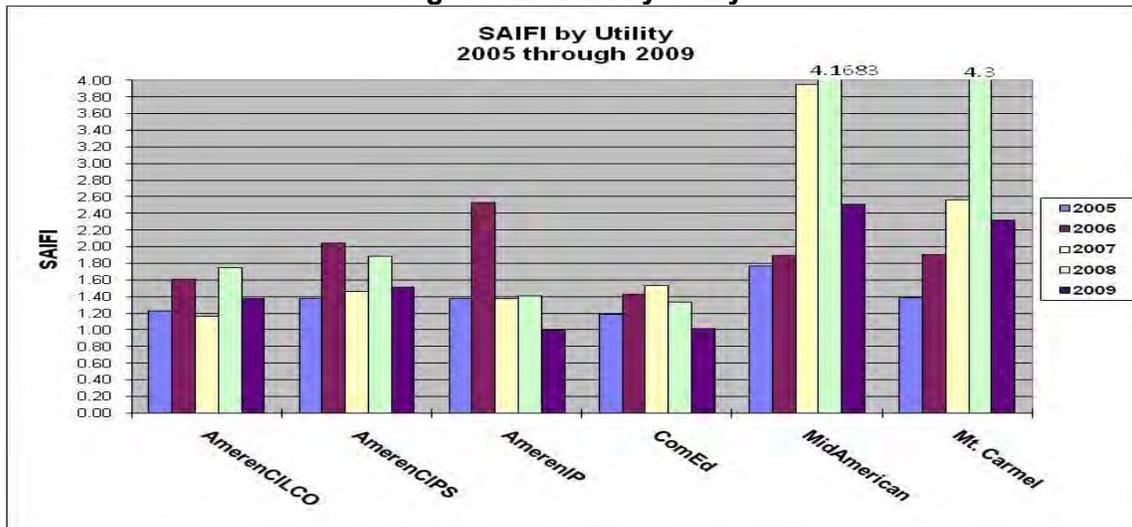
**Figure 12: SAIFI by Utility**

Figure 12 above shows a comparison of SAIFI values reported for the years 2005 through 2009 by the six utilities. In 2009, ComEd's SAIFI performance was second behind AmerenIP's, 1.01 versus 0.99. Two of ComEd's regions outperformed AmerenIP at 0.77<sup>31</sup> and 0.96<sup>32</sup> versus 0.99.

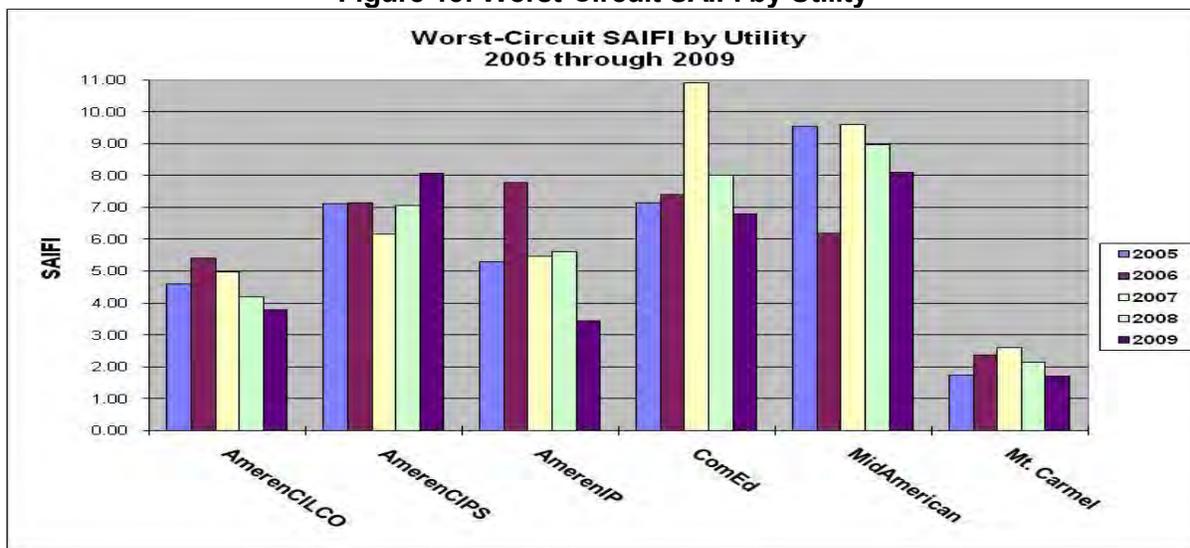
**Figure 13: Worst-Circuit SAIFI by Utility**

Figure 13 shows a comparison of SAIFI values for the worst circuit for each of the six utilities for 2005 through 2009. ComEd<sup>33</sup> moved from the second worst SAIFI performing circuit in 2008, of the six utilities, to the third worst SAIFI performing circuit in 2009.

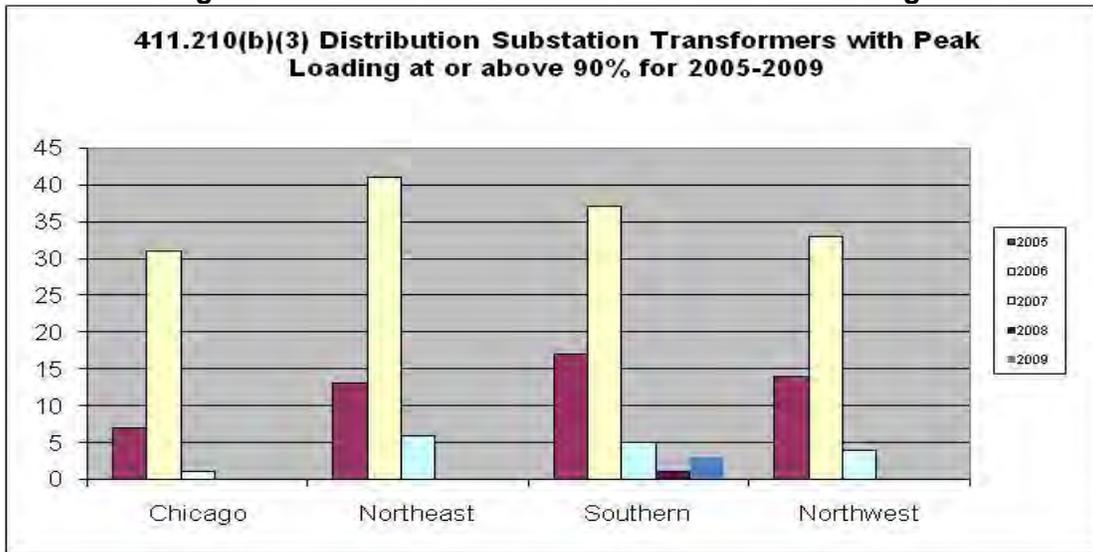
**Figure 14: Distribution Substation Transformer Loadings**

Figure 14 shows the historical distribution, by region, of substation transformers with a peak loading at or above 90% in the last 5 years, 2005-2009. To better understand this trend one needs to first study Figure 15.

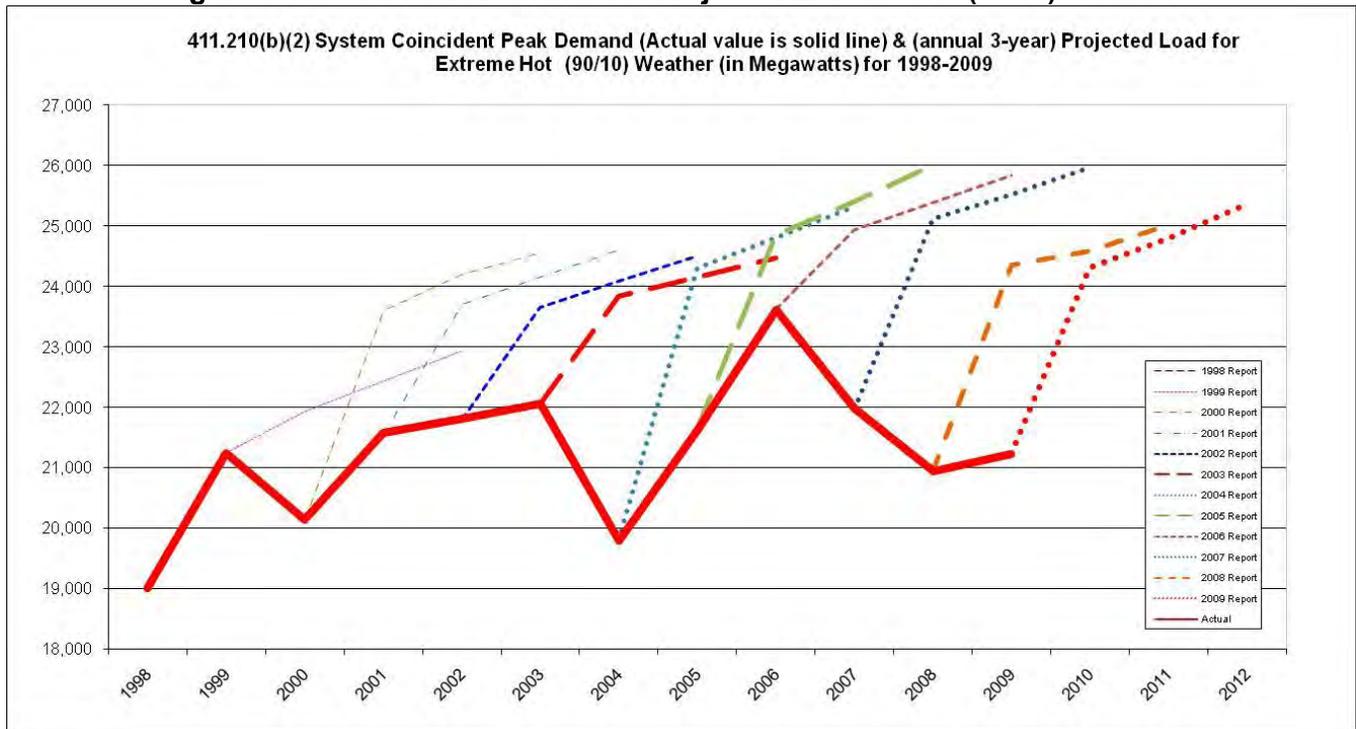
**Figure 15: Actual Peak Demand and Projected Extreme Hot (90/10) Weather**

The system peaks in 2004, 2007, 2008 and 2009, illustrated by the solid red line in Figure 15, are significantly below the overall trend for actual demand, illustrated by the dashed lines in Figure 15. The lighter dashed lines in Figure 15 represent the projected extreme hot weather load forecast (this is the projected load level where actual peak demand will be at or below nine out of ten years) that was adopted in 2000 as a more conservative policy regarding the weather condition ComEd will plan on for its

distribution system for. In 2009 the actual demand was 13% below the 2008 projected 90/10 load used to prepare the reliability infrastructure for the summer of 2009. Additionally, the 2009 actual demand was 18% below the 2006 projected 90/10 load used to prepare the reliability infrastructure for the summer of 2009. The trends of transformer loadings are an important indicator of how well capacity additions are keeping up with demand growth. When the system load realized in 2009 was much lower than that planned for capacity additions it should be no surprise that transformer loadings were as low as they were in 2009. The 90/10 load forecasts, used for planning substation capacity expansion, in the 2005-2007 reliability reports each terminate at about the 26,000 MW level in the third year of their forecast. Based on the 2009 lower forecasted 90/10 load levels it is likely that the number of distribution substation transformers with peak loading at or above 90% will remain at counts lower than were typical in the past except in areas where load growth rates are still high – such as parts of the Southern region.

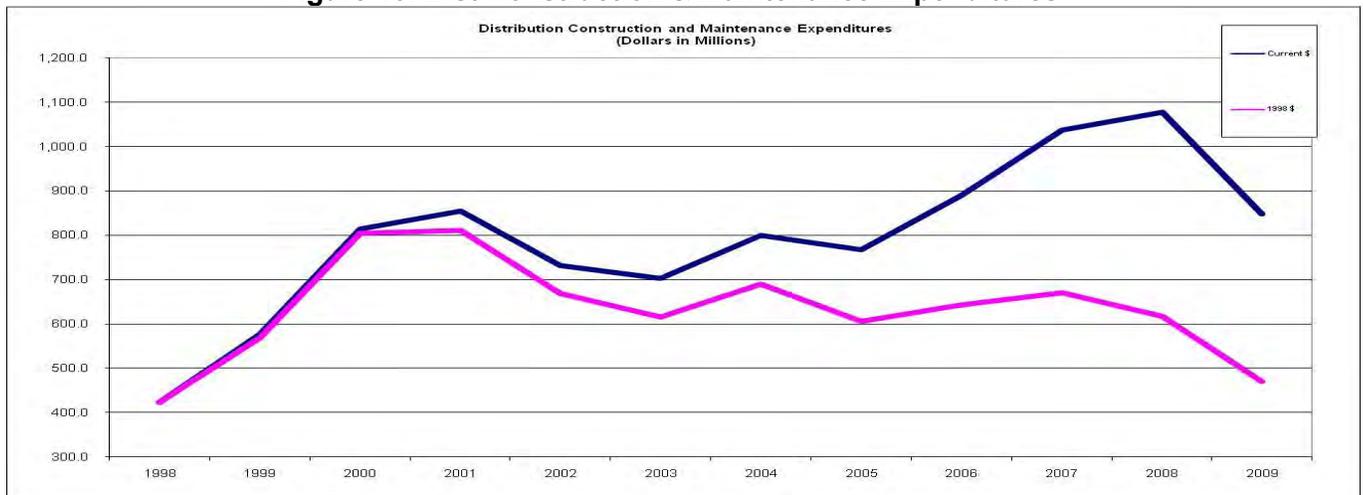
**Figure 16: Dist Construction & Maintenance Expenditures**

To understand the trend in real dollars for expenditures, Staff turned to the information from Part 411.120(b)(3)(G)(iii & iv). Figures 16 and 17 display "Construction and Maintenance Expenditures" in current and constant dollars for Distribution and Transmission, respectively.

When comparing ComEd’s annual expenditures for the years 1998 through 2009, in constant dollars only the 1998 expenditures are lower than the 2009 expenditures for distribution construction and maintenance, with 2009 expenditures 10.9% higher than 1998 levels. As a result, from 1998 to 2009, distribution construction and maintenance expenditures do show a positive real growth rate (an annual compound rate of 0.95%<sup>35</sup> based on constant 1998 dollars from 1998 to the 2009 level – Figure 16). When compared to constant dollar 2000 expenditure levels the 2009 expenditure levels are down by 41.5% ( or -5.8% compounded). The overall trend from the low 1998 levels is illustrated by the line in Figure 16 that represents annual expenditures in constant 1998 dollars, with the heavy ramp up of activity visible in 1999 through 2001 followed by a decline to the present level of expenditure.

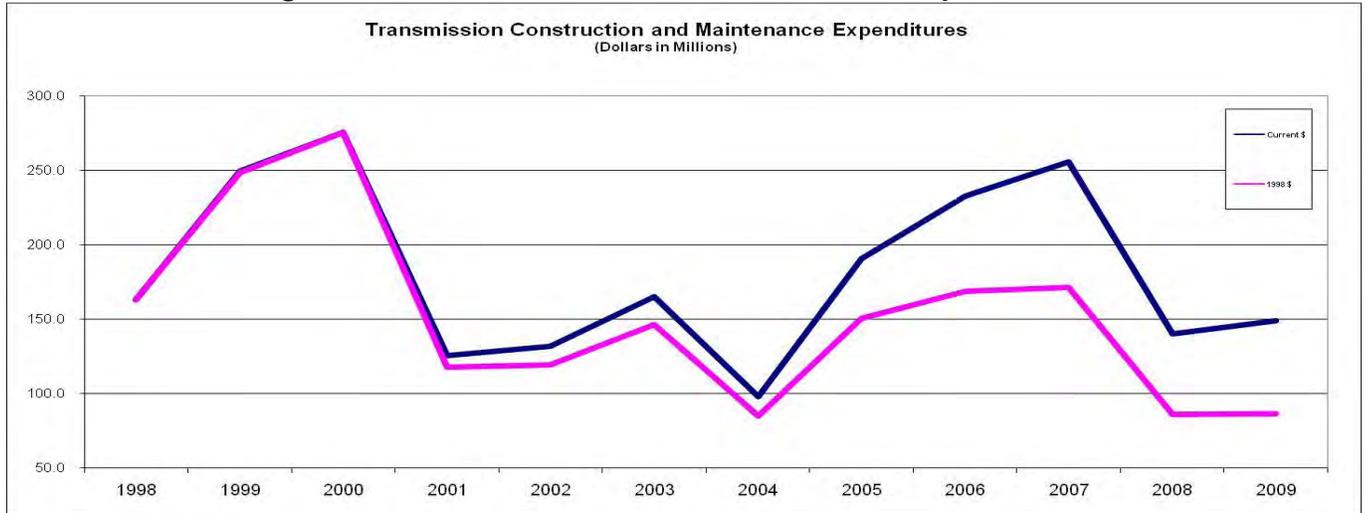
**Figure 17: Trans Construction and Maintenance Expenditures**

Transmission construction and maintenance expenditures (Figure 17) exhibit a negative overall growth rate (annual -5.6% compound growth rate) from 1998 to 2009 in constant 1998 dollars. In constant 1998 dollars the 2009 expenditures are 47% lower than the 1998 levels. From the peak spending levels in 2000, transmission construction and maintenance expenditures were 68.6% lower (-12.1% annual compound growth rate) in 2009. Figure 17 does illustrates the sizable buildup of expenditures in 1999 and 2000 before trailing off to below 1998 levels in constant 1998 dollars.

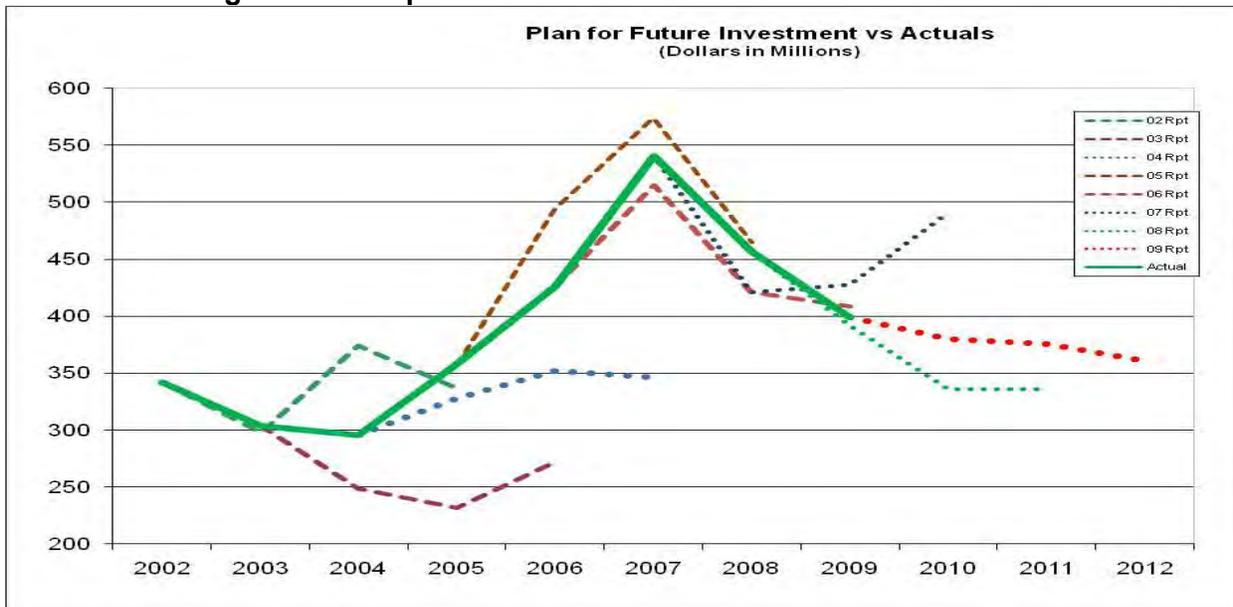
**Figure 18: Comparison of Actual vs Plan for Future Investment**

Figure 18 shows the actual 2009 investment level being lower than the plans in the 2006 and 2007 reports but slightly higher than the plan in the 2008 report. On pages A-1 through A-3 of the 2009 Reliability Report, ComEd describes its plan for future investment.

A detailed analysis of actual (using information from Part 411.120(b)(3)(B)) and projected investment plans (Part 411.120(b)(3)(A) information from the 2002 through 2009 Reliability Reports) is illustrated in Figures 18 through 23.

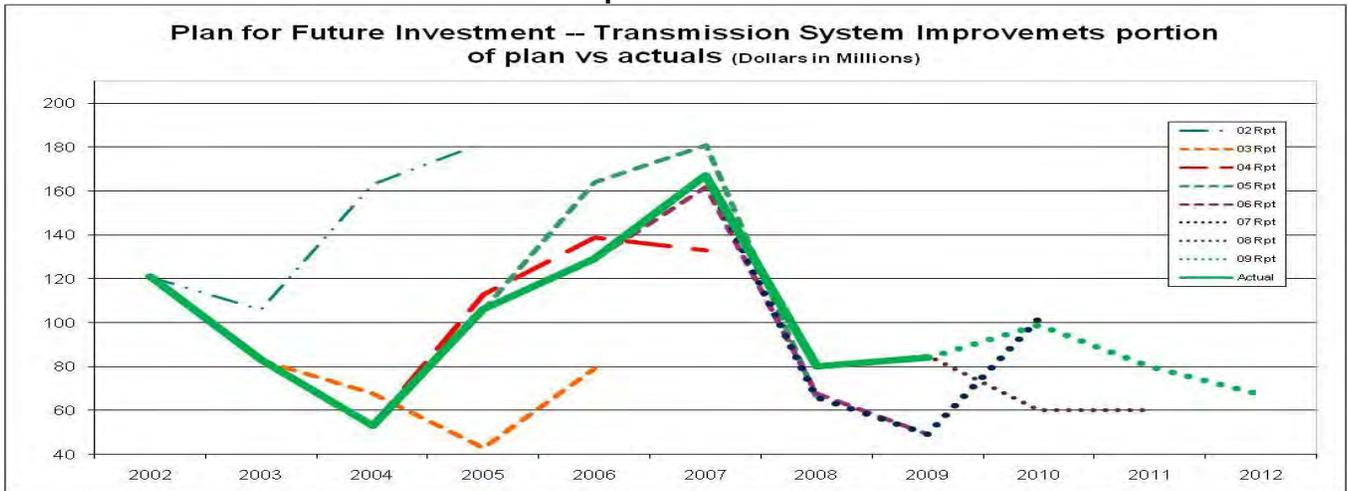
**Figure 19: Comparison of Actual vs Plan for Future Investment – Transmission System Improvements**

Transmission System Improvements spending levels are described by ComEd on page A-4 of the Report. ComEd reported that “[p]lanned expenditures for Transmission System Improvements in 2010 and 2011 are more than reported in the 2009 plan [the plan in the 2008 report filed in 2009] due to ComEd’s decision to commit additional resources to fiber optic communication system and various 138kV and 345kV line upgrades.”

Figure 19 summarizes a comparison of actual versus planned investment for “Transmission System Improvements” from the Reliability Reports from 2001 up to the present day. Page B-3 of the Reliability Report summarizes the work done in this function.

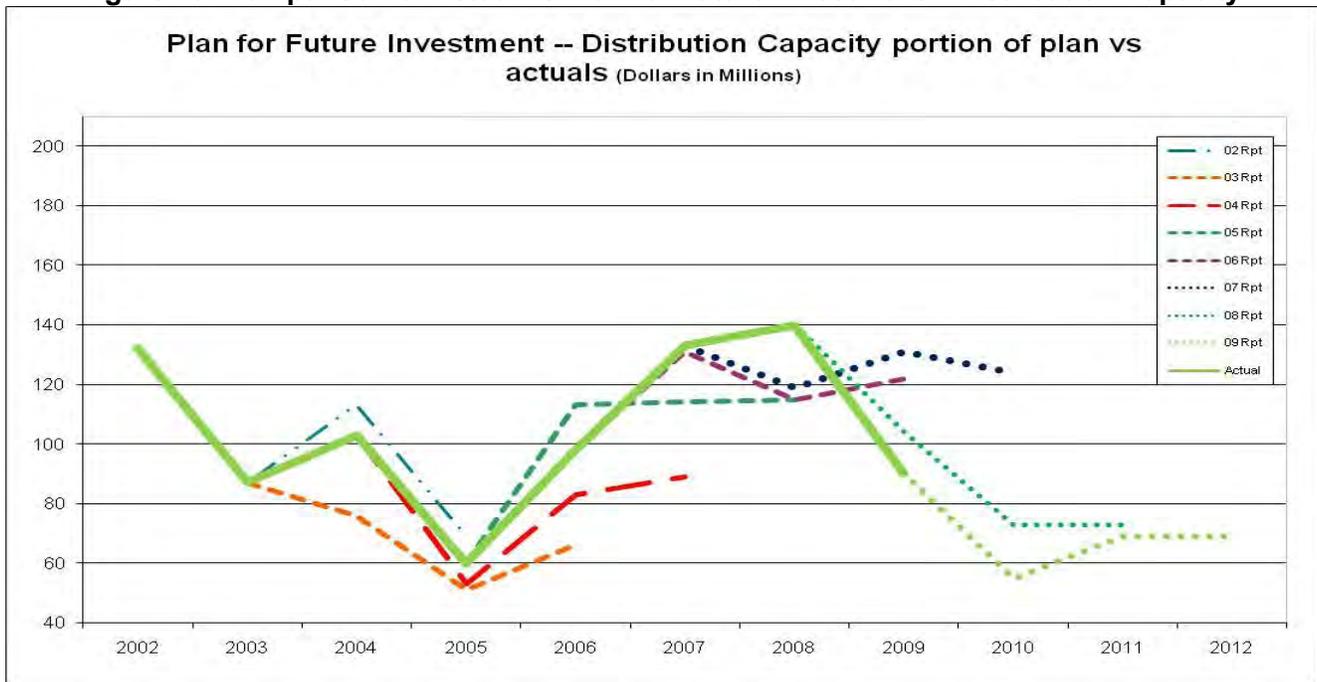
**Figure 20: Comparison of Actual vs Plan for Future Investment – Distribution Capacity**

Figure 20 shows that current planned investments in distribution capacity expansion are reduced from previous years due to current economic conditions requiring fewer capacity additions in the near future as described by ComEd on page A-5 of the Report.

Figure 20 summarizes a comparison of actual versus planned investment for “Distribution Capacity” from the Reliability Reports from 2001 up to the present day. Page B-4 of the Reliability Report summarizes the work done in this function.

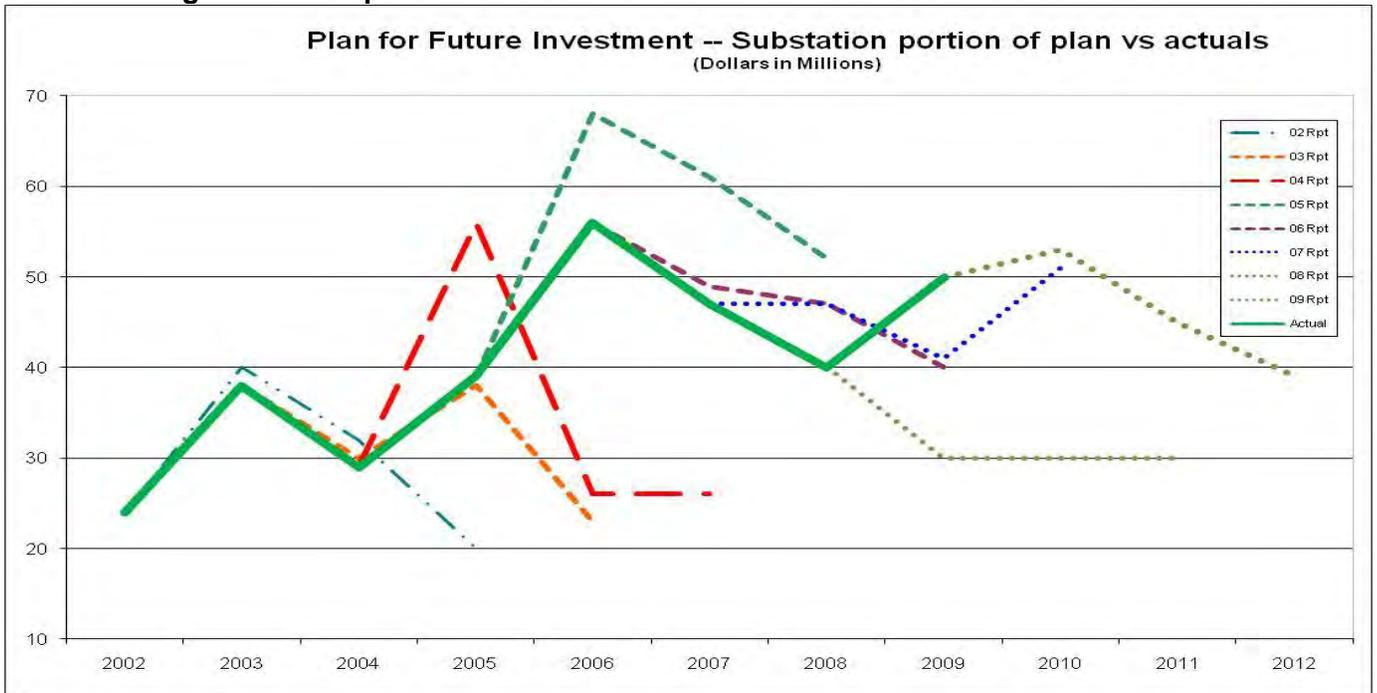
**Figure 21: Comparison of Actual vs Plan for Future Investment – Substation**

Figure 21 illustrates that current planned investment for maintenance and improvement of substations, discussed on page A-5 of the report, is more than last year due to ComEd’s decision to commit additional resources to various proactive breaker and transformer replacements.

Figure 21 summarizes a comparison of actual versus planned investment for “Substation” from the Reliability Reports from 2001 up to the present day. Page B-4 of the Reliability Report summarizes the work done in this function.

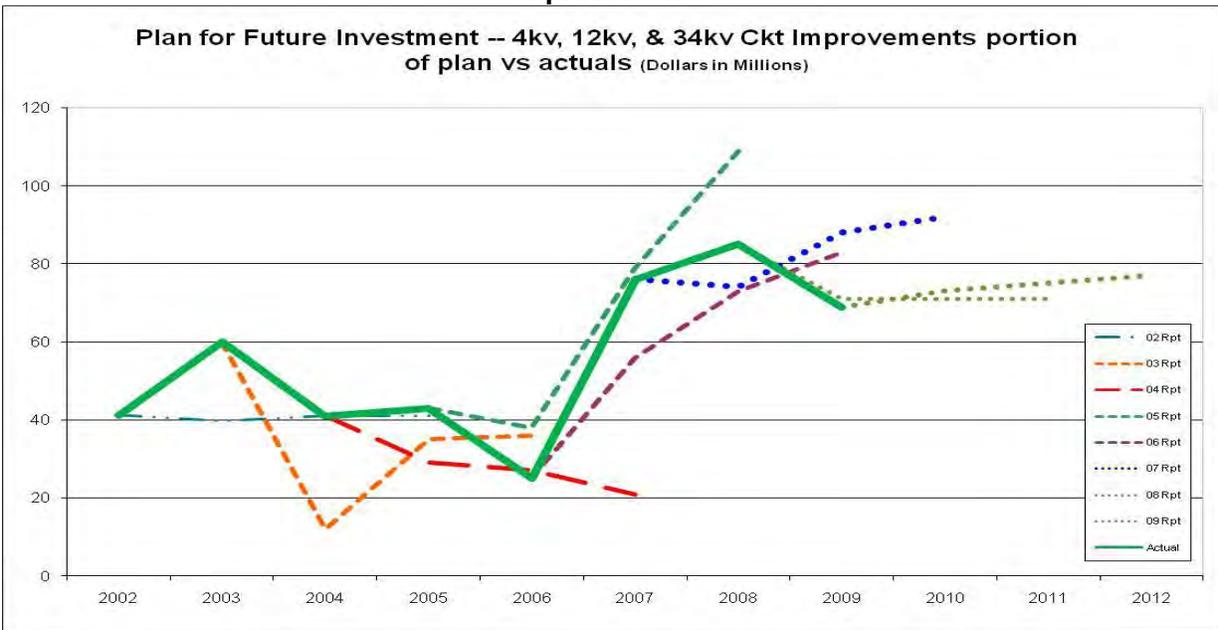
**Figure 22: Comparison of Actual vs Plan for Future Investment – 4kv, 12kv, & 34kv Circuit Improvements**

Figure 22 shows that, after a decrease in spending in 2006, actual spending increased substantially in 2007 and 2008 with a decline in 2009 followed by moderate increases over the next three years in

distribution circuit improvements to reduce interruption frequency and duration and to address line disturbances as discussed on page A-6 of ComEd's Report.

Figure 22 summarizes a comparison of actual versus planned investment for “4kV, 12kV, & 34kV Circuit Improvements” from the Reliability Reports from 2001 up to the present day. Page B-5 of the Reliability Report summarizes the work done in this function.

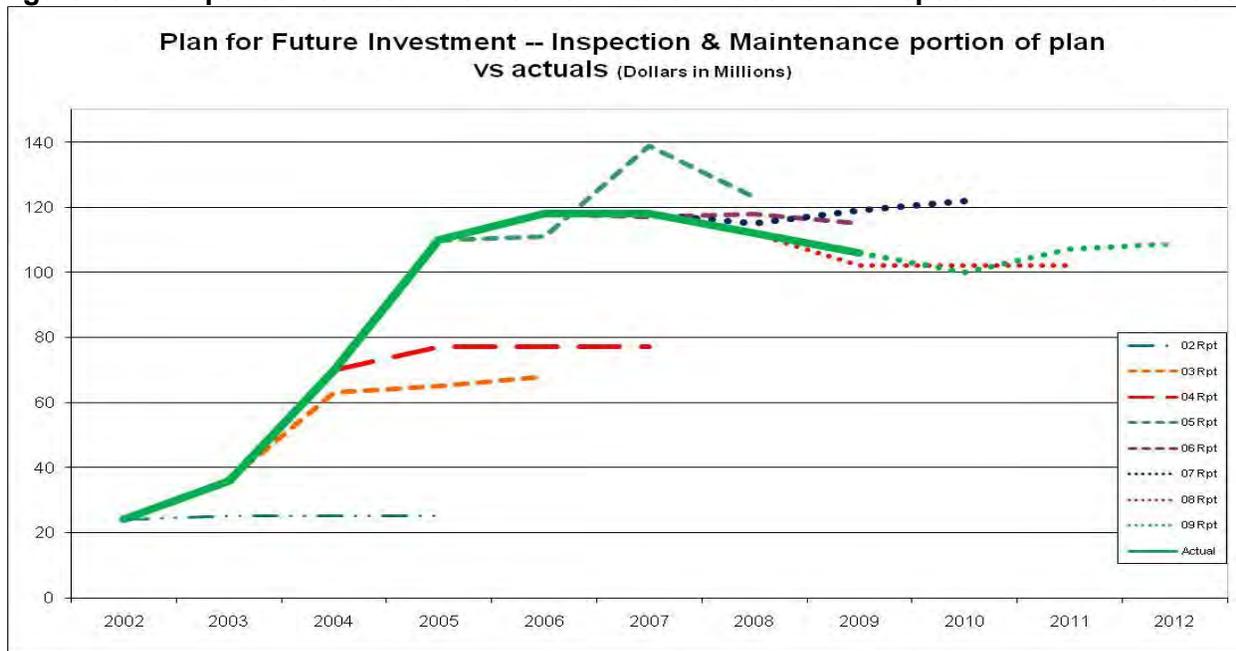
**Figure 23: Comparison of Actual vs Plan for Future Investment – Inspection and Maintenance**

Figure 23 shows that the current planned investment level will continue to decline slightly in 2010 before beginning moderate increases in 2011 and 2012 for inspection and maintenance.

<sup>38</sup> The data that makes up Figure 23 is collected from pages A-7 and B-6 of the current and previous ComEd Reliability Reports.

Figure 23 summarizes a comparison of actual versus planned investment for “Inspection and Maintenance” from the Reliability Reports from 2001 up to the present day. Page B-6 of the Reliability Report summarizes the work done in this function.

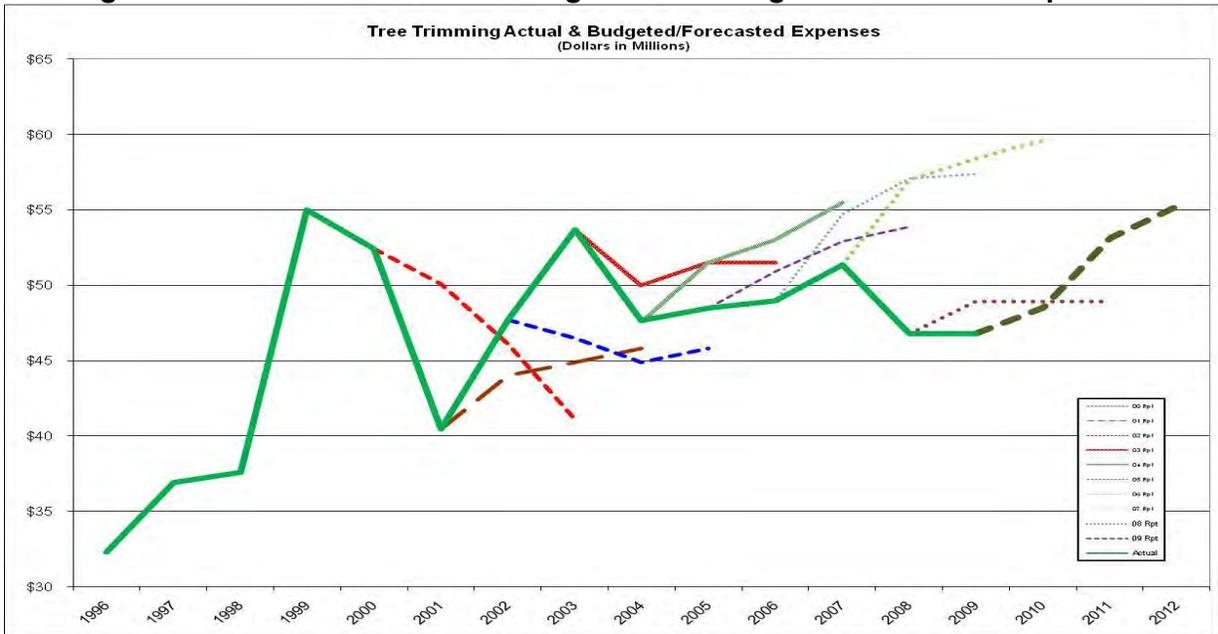
**Figure 24: Distribution Tree Trimming Actual & Budgeted/Forecasted Expenses**

Figure 24 illustrates the actual distribution tree trimming (vegetation management) expenditures from 1996 through 2009 as well as the three-year budget/forecasts<sup>36</sup> associated with the current and previous report analyses. The quality as well as quantity of vegetation management can significantly impact the number of customer-experienced interruptions during adverse weather conditions as well as more normal conditions. The overall distribution spending trend of Figure 24 has been upward with

four-year cyclical spending peaking in 1999, 2003, and 2007. The current distribution budgeted and forecasted spending levels are up 4% from the actual 2009 spending levels and substantially below what appeared to be the trend of past projections, but they do appear consistent with the actual amounts spent in 2003 through 2008 in that they are approximately the average of the amount spent in that time period.

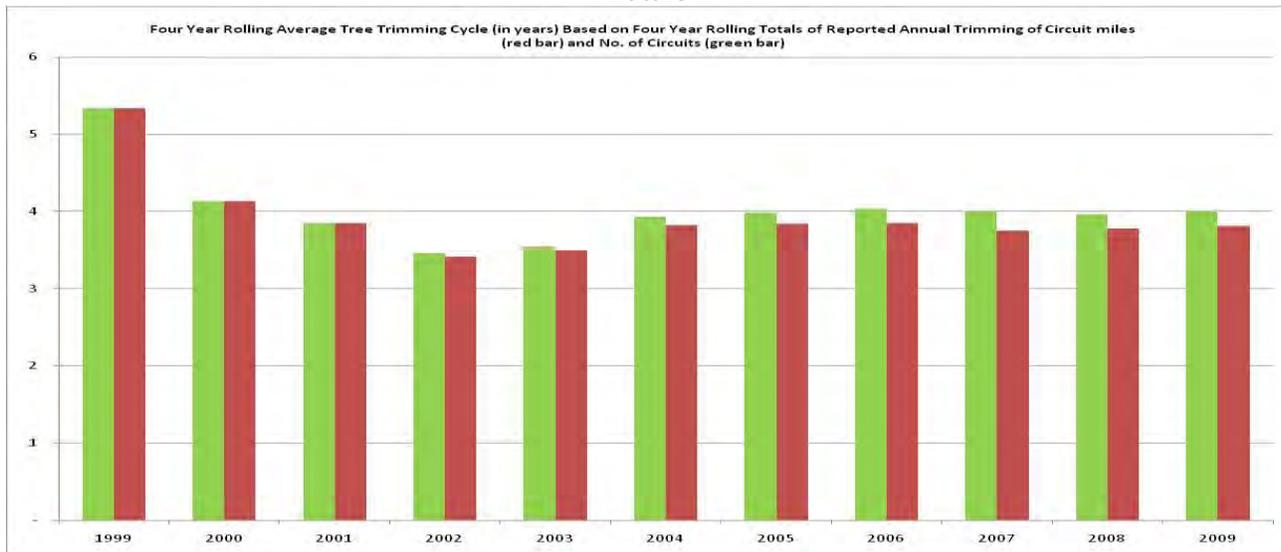
**Figure 25: Rolling Average Distribution Tree Trimming Cycle Based on Most Recent Four Year Totals**

Since May 18, 2000, ComEd has claimed to be on a four-year tree trimming cycle. Figure 25 indicates, based on most recent four year rolling totals of reported circuits trimmed, that ComEd has been on a four-year cycle since the year 2000. As noted in Section 7, problem areas still exist that ComEd needs to investigate and modify programs to advance *and maintain* a four-year (minimum) distribution tree trimming cycle throughout its service territory that is in compliance with NESC Rule 218.

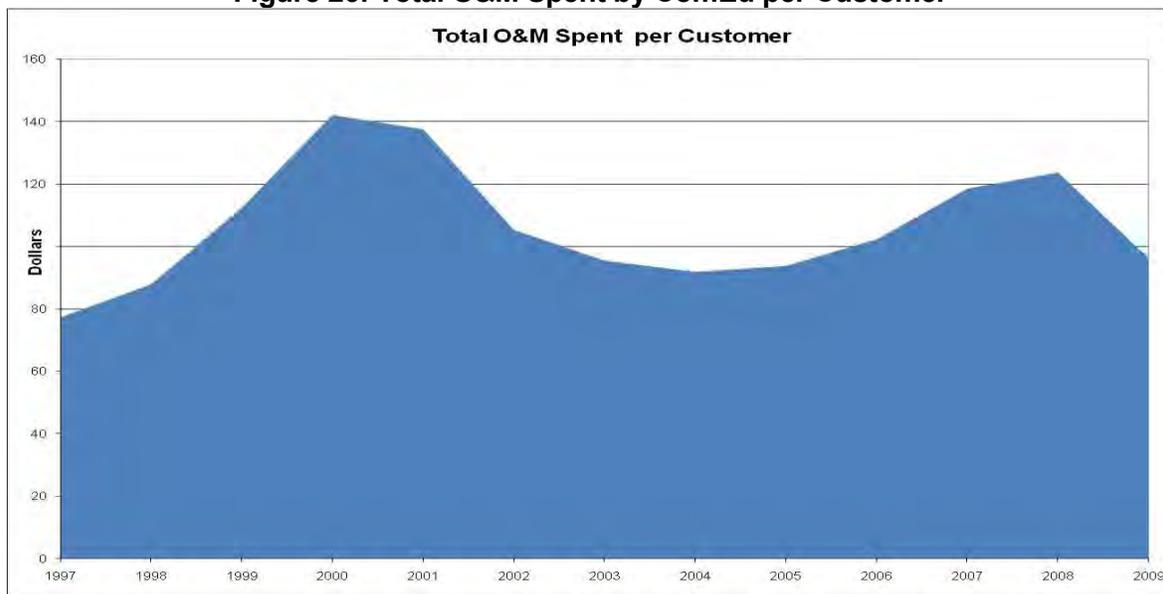
**Figure 26: Total O&M Spent by ComEd per Customer**

Figure 26 shows that total O&M dollars spent per ComEd customer had bottomed in 2004 after which it steadily increased to another peak in 2008 before a significant decline in 2009, though not down to 2003-2005 or 1997-1998 levels. Staff will continue to follow this closely.
