Illinois Commerce Commission  
Assessment of Commonwealth Edison Company  
Reliability Report and Reliability Performance  
for Calendar Year 2009

Pursuant to 83 Ill. Adm. Code 411.140

December 31, 2010

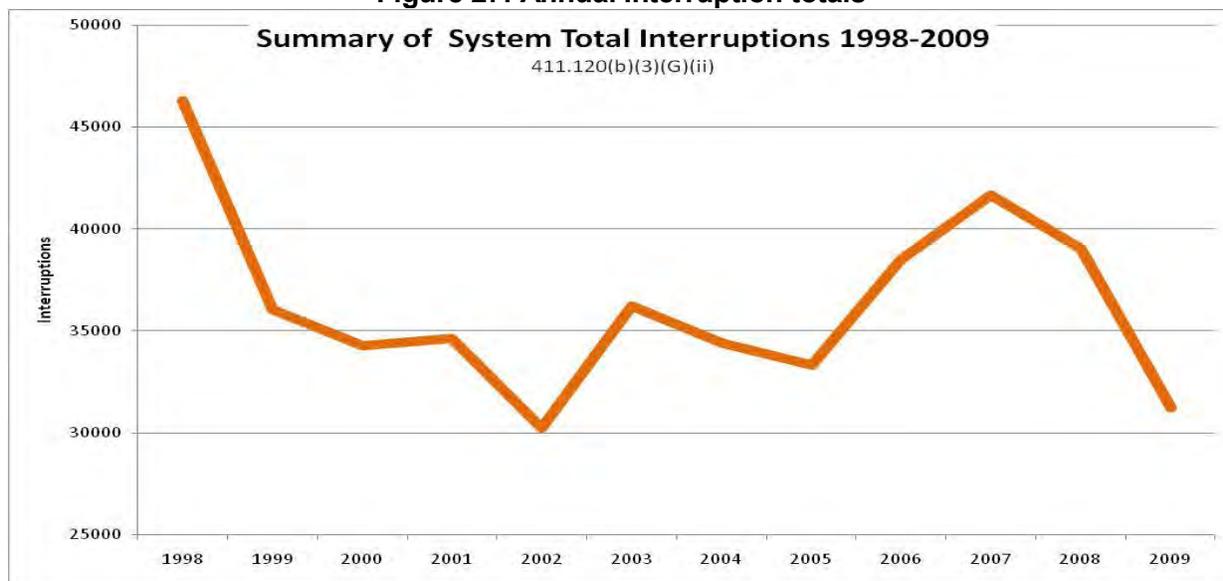
**Figure 27: Annual Interruption totals**

Figure 27 shows the trend in total annual system interruptions from 1998 through 2009 as identified in ComEd's responses to Section 411.120(b)(3)(G)(ii)<sup>39</sup>. The highest number of interruptions (46,286 interruptions) are seen in 1998 which corresponds to the time when ComEd's distribution system unavailability became so conspicuously apparent. For 2002, after ComEd spent a few years improving its system, ComEd reported only 30,548 interruptions in response to 411.120(b)(3)(G)(ii). Staff is encouraged that ComEd has returned to system total interruption levels more in line with the 2000-2005

<sup>39</sup> The 2009 System Total of 31,253 interruptions is from Table 12 on Page G-8 of ComEd's 2009 Report.

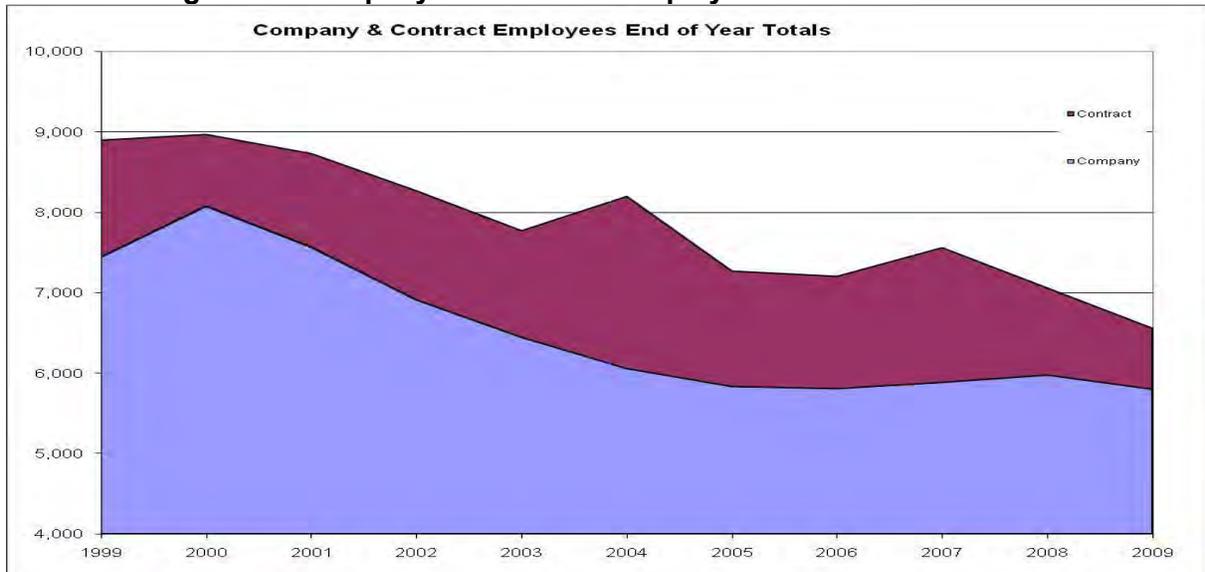
**Figure 28: Company and Contract Employees – End of Year Totals**

Figure 28 shows that the number of company employees declined by 22% from 1999 to 2009 while the number of contract employees decreased by 48% for a total decrease over that period of 26%. The impact that this total employee decrease may have on reliability has yet to be determined, but Staff will continue to follow developments in this area for signs of direct or indirect impacts.

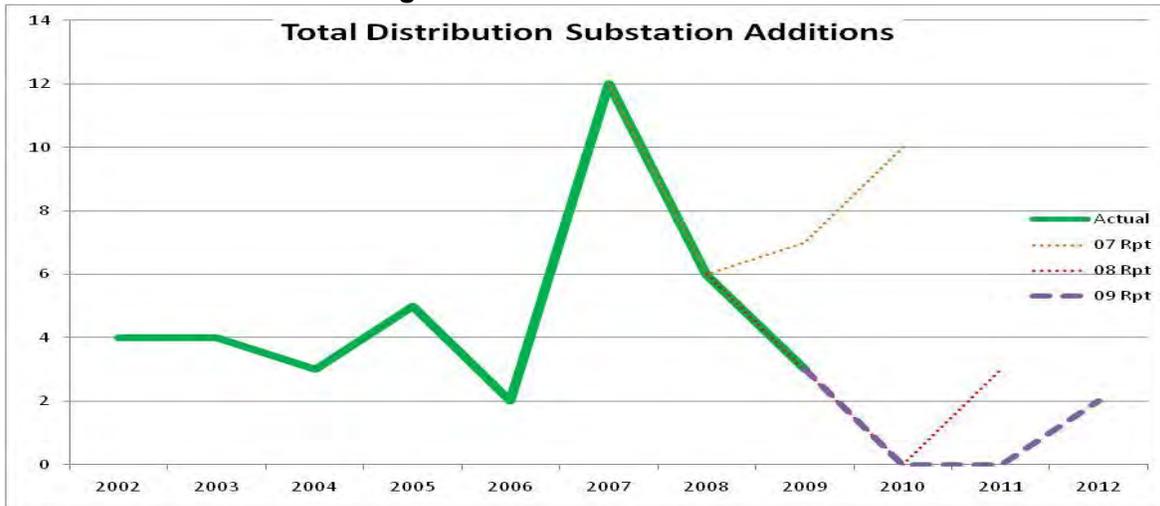
**Figure 29: Substation Additions**

Figure 29 illustrates actual substation additions through 2009 as well as planned additions through 2012. Staff believes that it is reasonable for substation additions planned in ComEd's 2007 and 2008 Reports to have been deferred in ComEd's 2008 and 2009 Reports because of the drop-off in economic activity and the resultant decreased load forecast.

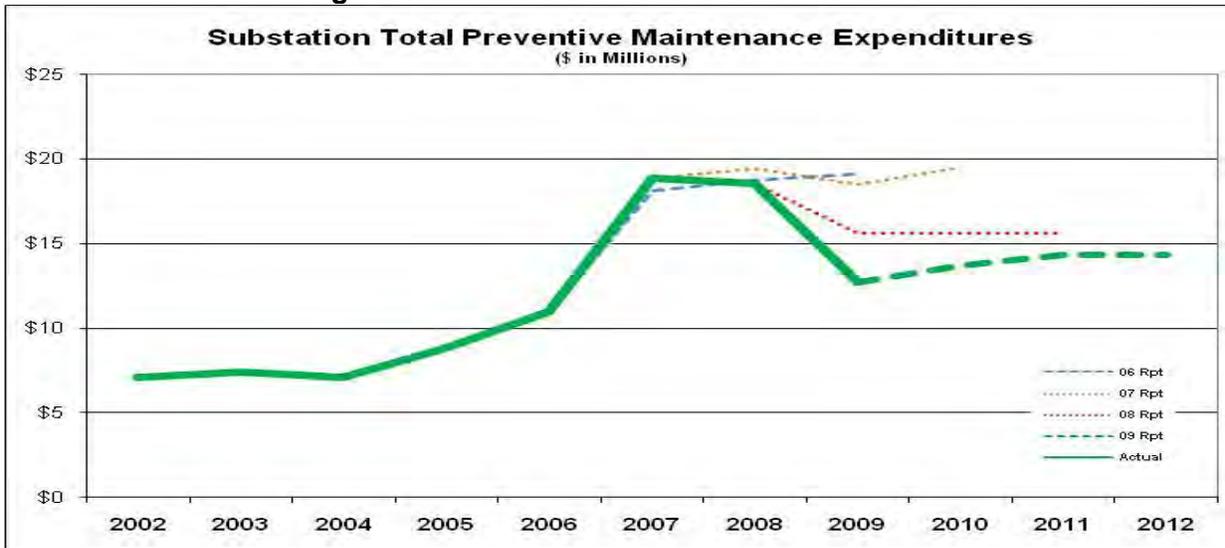
**Figure 30: Substation Preventive Maintenance**

Spending more on preventive maintenance, all other things being equal, should result in improved equipment reliability and availability. In Figure 30 the planned preventive maintenance expenditures dropped 31%<sup>41</sup> from 2008 to 2009 and the current plan is for increases of 8%, 4% and 0% for 2010, 2011, and 2012.. Corrective maintenance expenditures also dropped 9% from 2008 to 2009 but are projected to rise 5%, 5%, and 0% in 2010, 2011, and 2012 as shown in Figure 31.

In addition to building new substations to meet increased demand and to improve customer reliability, it is important that maintenance be scheduled and completed in substations to insure maximum capability, flexibility and reliability during periods of high demand. Figures 30 and 31 show the trends in spending on preventive and corrective maintenance expenditures.

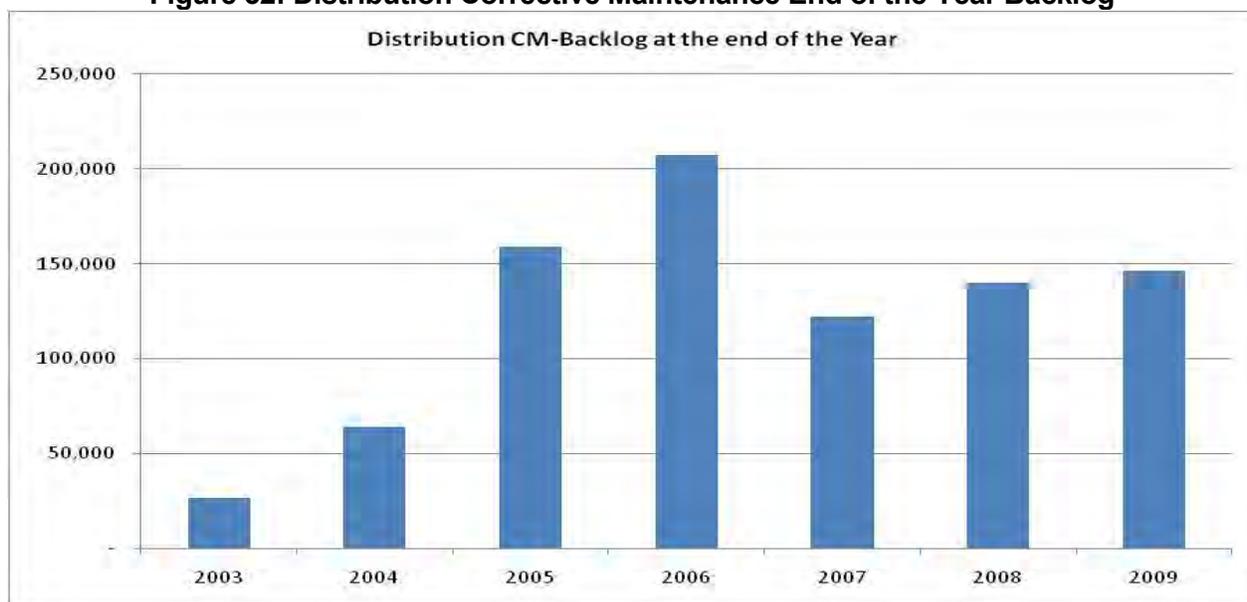
**Figure 32: Distribution Corrective Maintenance End of the Year Backlog**

Another way to gauge progress in energy delivery systems reliability and availability improvements is to analyze distribution corrective maintenance backlogs. Figure 32 tracks the end of the year backlogs for distribution corrective maintenance which increased 14% in 2008 and 4% in 2009.

As noted in previous assessments, beginning in 2003 expenditures for inspection and maintenance climbed sharply and, according to ComEd,<sup>42</sup> the Company expected distribution corrective maintenance backlogs to increase over their four-year distribution inspection cycle because inspectors were looking harder and identifying more corrective maintenance items than would have been previously noted. As Figure 32 shows, after the first-four year cycle distribution corrective maintenance backlogs declined 41% in 2007, but this has been followed by 14% increase in 2008 and a 4% increase in 2009. In 2008 ComEd attributed much of the distribution corrective maintenance backlog increase to a significant increase number of cable faults due to storms & flooding and a reduction of resources due to the mutual assistance provided in Louisiana & Kentucky. In 2009 ComEd attributed much of the distributed corrective maintenance backlog increase to focusing on getting the higher priority corrective maintenance work done and addressing the lower priority maintenance work “whenever they were part of a bundled task, or when it was opportunistic to do so”.<sup>43</sup> ComEd note that “[i]n 2009, C&M saw an increase in the number of Services and Streetlight cable faults, which contributed towards the overall rise in the number of Corrective Maintenance tasks.” Staff believes that if the backlog decline is not re-established soon, it would indicate that insufficient resources have been allocated to this maintenance function. Staff will be closely monitoring this trend.

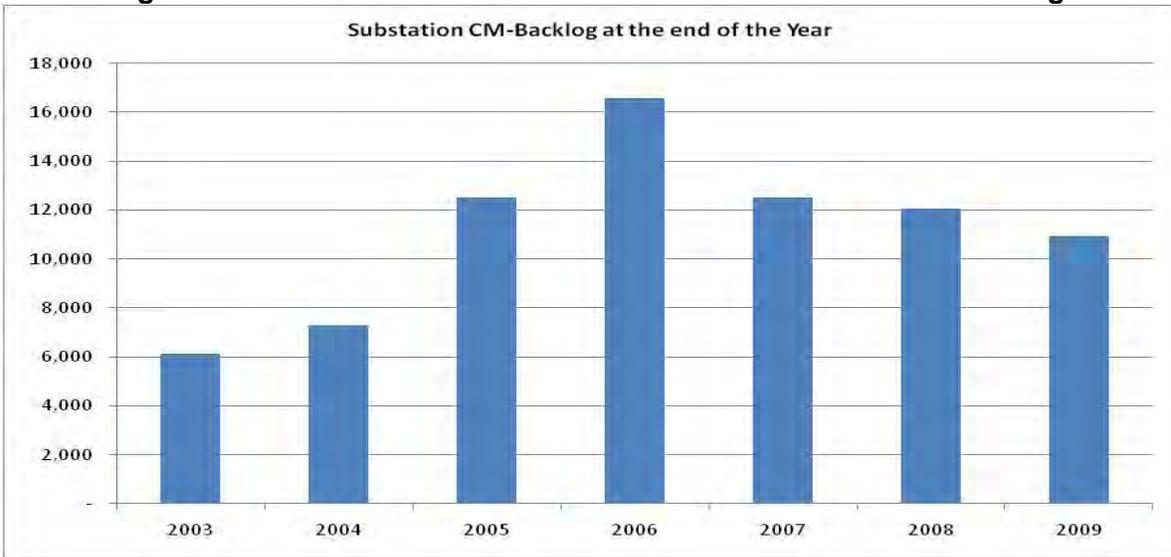
**Figure 33: Substation Corrective Maintenance End of the Year Backlog**

Figure 33 illustrates end of the year backlogs for Substation Corrective Maintenance. Since 2006 Substation Corrective Maintenance end of the year backlogs have been declining.
