U.S. DOT#: 079533G					Warning Device Description			
General Information					Type of Device: AFLS/Gates			
Type Of Crossing: AtGrade					Number Of Devices:			
Lat: 41° 47' 44" Long: 87° 59' 55"					CrossBucks:	2	Cantelever:	0
County: DU PAGE					Bells:	1	Gates:	2
City: DOWNERS GROVE In/Near: In					WigWags:	0	Pedestrian Gates:	2
Street Name: MAPLE AVE					Flashing Lights Pairs:	4	Masts:	4
RailRoad: BNSF					Mast Locations Edge of Road (Ft) Edge of Rail (Ft)			
RailRoad Station: FAIRVIEW AVE (E)					N	22.1	14.4	
RailRoad Milepost: 20.59					N	8	43.4	
Crossing Angle: 26.0°					W	9.4	16.5	
Data Collection Date: 7/24/2003					S	4.8	60.8	
Aerial Photography Date: Spring 2003					Track Description			
Nearest Intersecting Roads					Number of Tracks: 3			
Name	Distance (Ft)	Width (Ft)	Direction	Traffic Control	(Type of Tracks: Main)			
BURLINGTON	117.1	21.5	South West	Stop Sign	From	To	Distance (Ft)	
BLODGETT	252.2	27.3	South West	Stop Sign	Track 1	Track 2	14.4

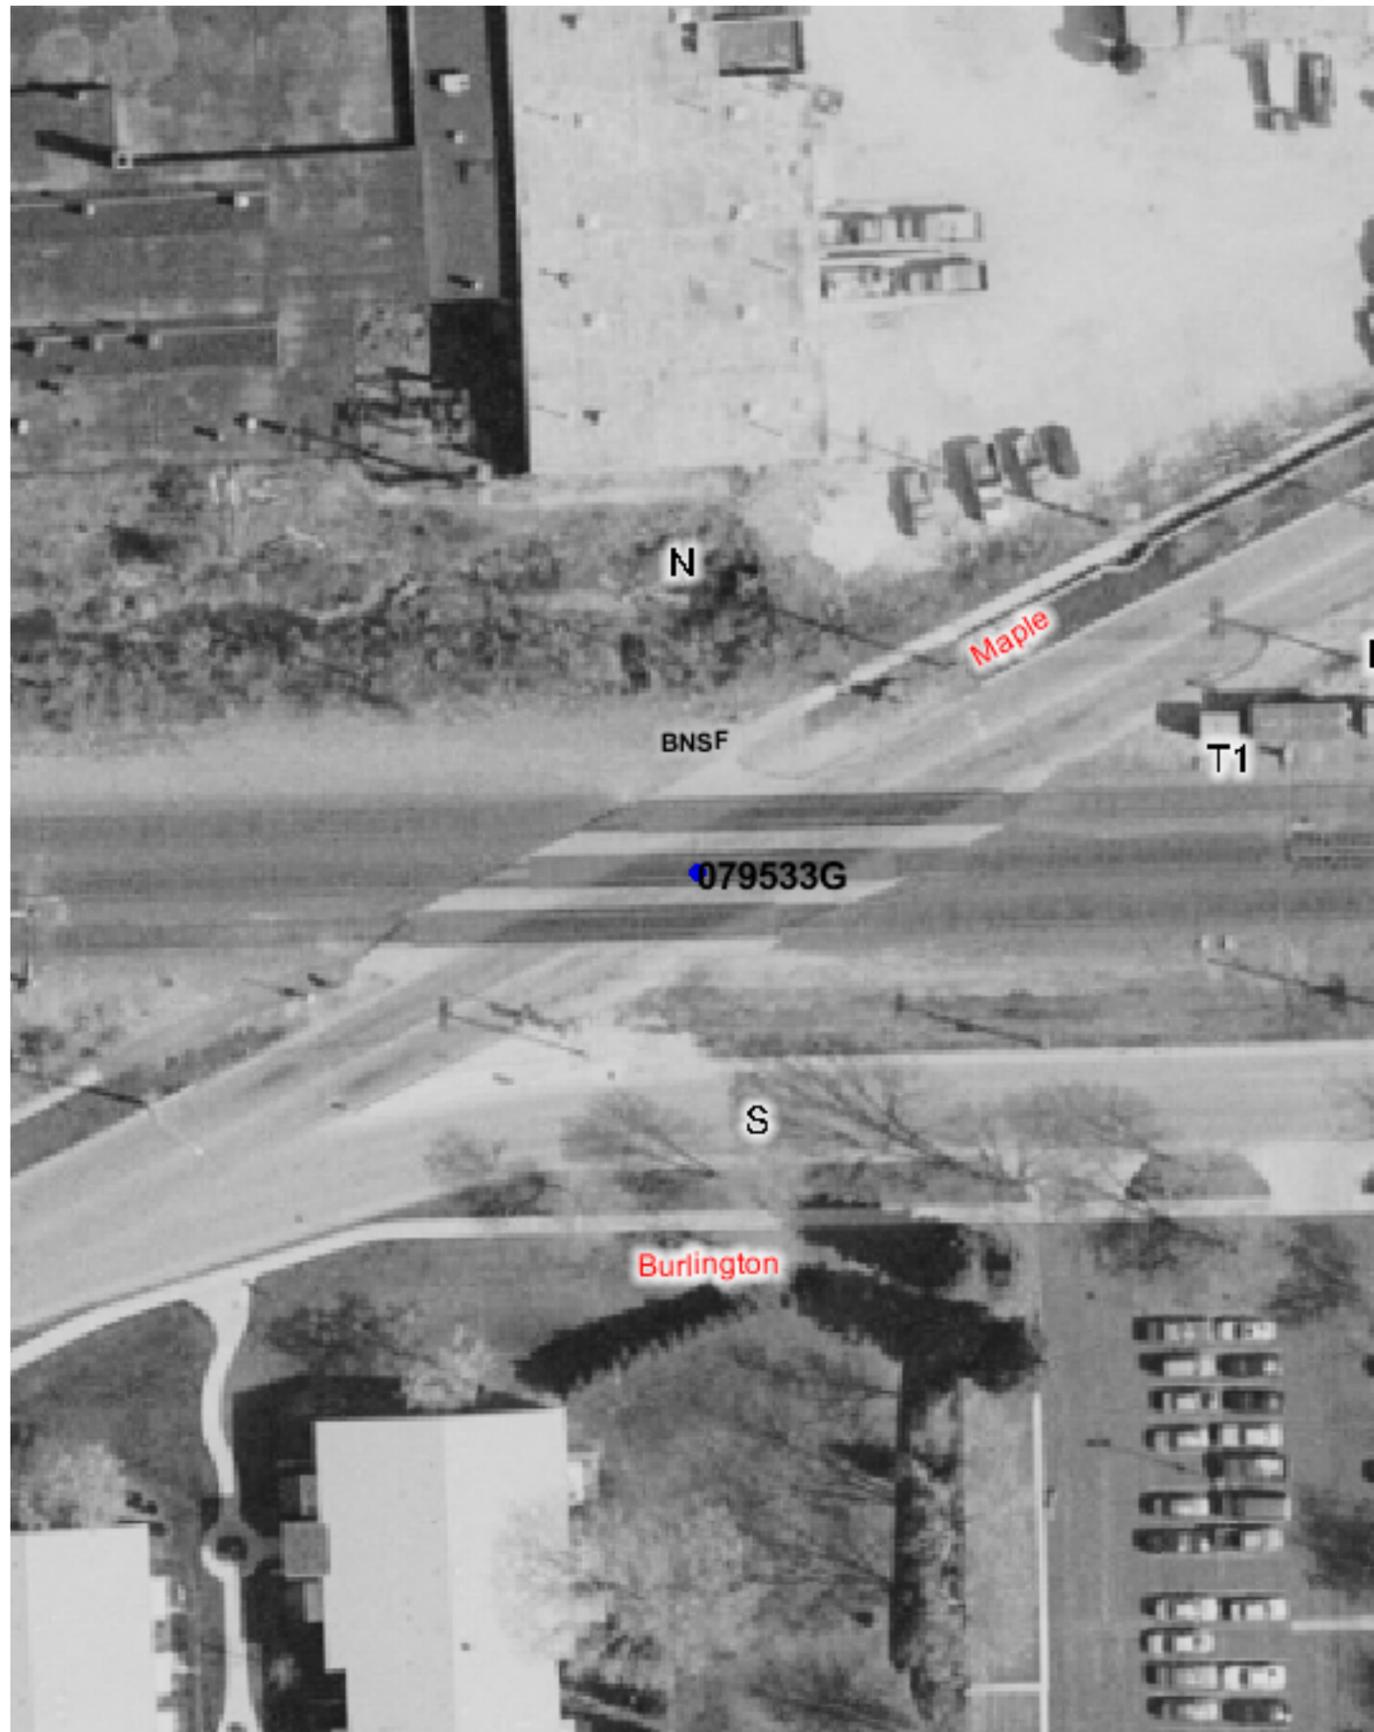
Number of Other Nearby Intersecting Roads: None					Track 2	Track 3	14.9	
North East Nearby Warning Signs					Adjacent Railroad Crossing			
Type	Distance (Ft)	ER	Type	Distance (Ft)	DOT#	Direction	Distance (Ft)	
W10-1	331.2		W10-1	214.1				
Number of Other Signs: 0					Number of Other Signs: 0			
North West Side		Roadway Material & Dimensions			South East Side			
		Roadway Material: Bituminous						
Dir	Dist NR	Sidewalk	Parkway	Road Width	Parkway	Sidewalk		
NE	32.0	5.0	14.5	25.0	0.0	0.0		
SW	32.0	5.8	7.8	25.6	0.0	0.0		
North West Side of Road:		Crossing Surface Material & Dimensions			South East Side of Road:			
		Distance			Distance			
Sidewalk Material	Sidewalk to Width (Ft)	Sidewalk	Roadway Material	Roadway to Width (Ft)	Sidewalk	Sidewalk	Total Crossing Width (Ft)	
Track1	Timber	9.4	0(*)	Rubber	103	0(*)	None 0 112.4	
Track2	Asphalt and Flange	10.1	0(*)	Rubber	108.3	0(*)	None 0 118.4	
Track3	Timber	4.8	0(*)	Rubber	112.8	0(*)	None 0 117.6

North East Side		Vertical Profile			South West Side			
A-50	A-32	Track1	Track2	Track3	B-32	B-50		
1.67%	0.94%	-0.71%	-0.67%	-3.12%	-10%			
Special Conditions? None					Missing Data? No
