U.S. DOT#: 175003E					Warning Device Description				
General Information Type Of Crossing: AtGrade Lat: 41° 53' 5" Long: 88° 23' 6" County: KANE City: GENEVA In/Near: Near Street Name: BRUNDIGE RD RailRoad: UP RailRoad Station: RANDALL (E) RailRoad Milepost: 39.4 Crossing Angle: 87.3° Data Collection Date: 7/14/2003 Aerial Photography Date: Spring 2003					Type of Device: Cant AFLS/Gates/Sidelights Number Of Devices: CrossBucks: 2 Cantelever: 1 Bells: 1 Gates: 2 WigWags: 0 Pedestrian Gates: 0 Flashing Lights Pairs: 4 Masts: 1				
					Mast Locations Edge of Road (Ft) Edge of Rail (Ft)				
					NW	8.5	13.6		
					SE	7.1	10		
Nearest Intersecting Roads					Track Description				
Name	Distance (Ft)	Width (Ft)	Direction	Traffic Control	Number of Tracks: 2 (Type of Tracks: Main)				
TEMP CONSTRUCTION ACCESS ROAD	31.1	25.5	South	Stop Sign	From	To	Distance (Ft)		
Number of Other Nearby Intersecting Roads: None					Track 1	Track 2	13.3

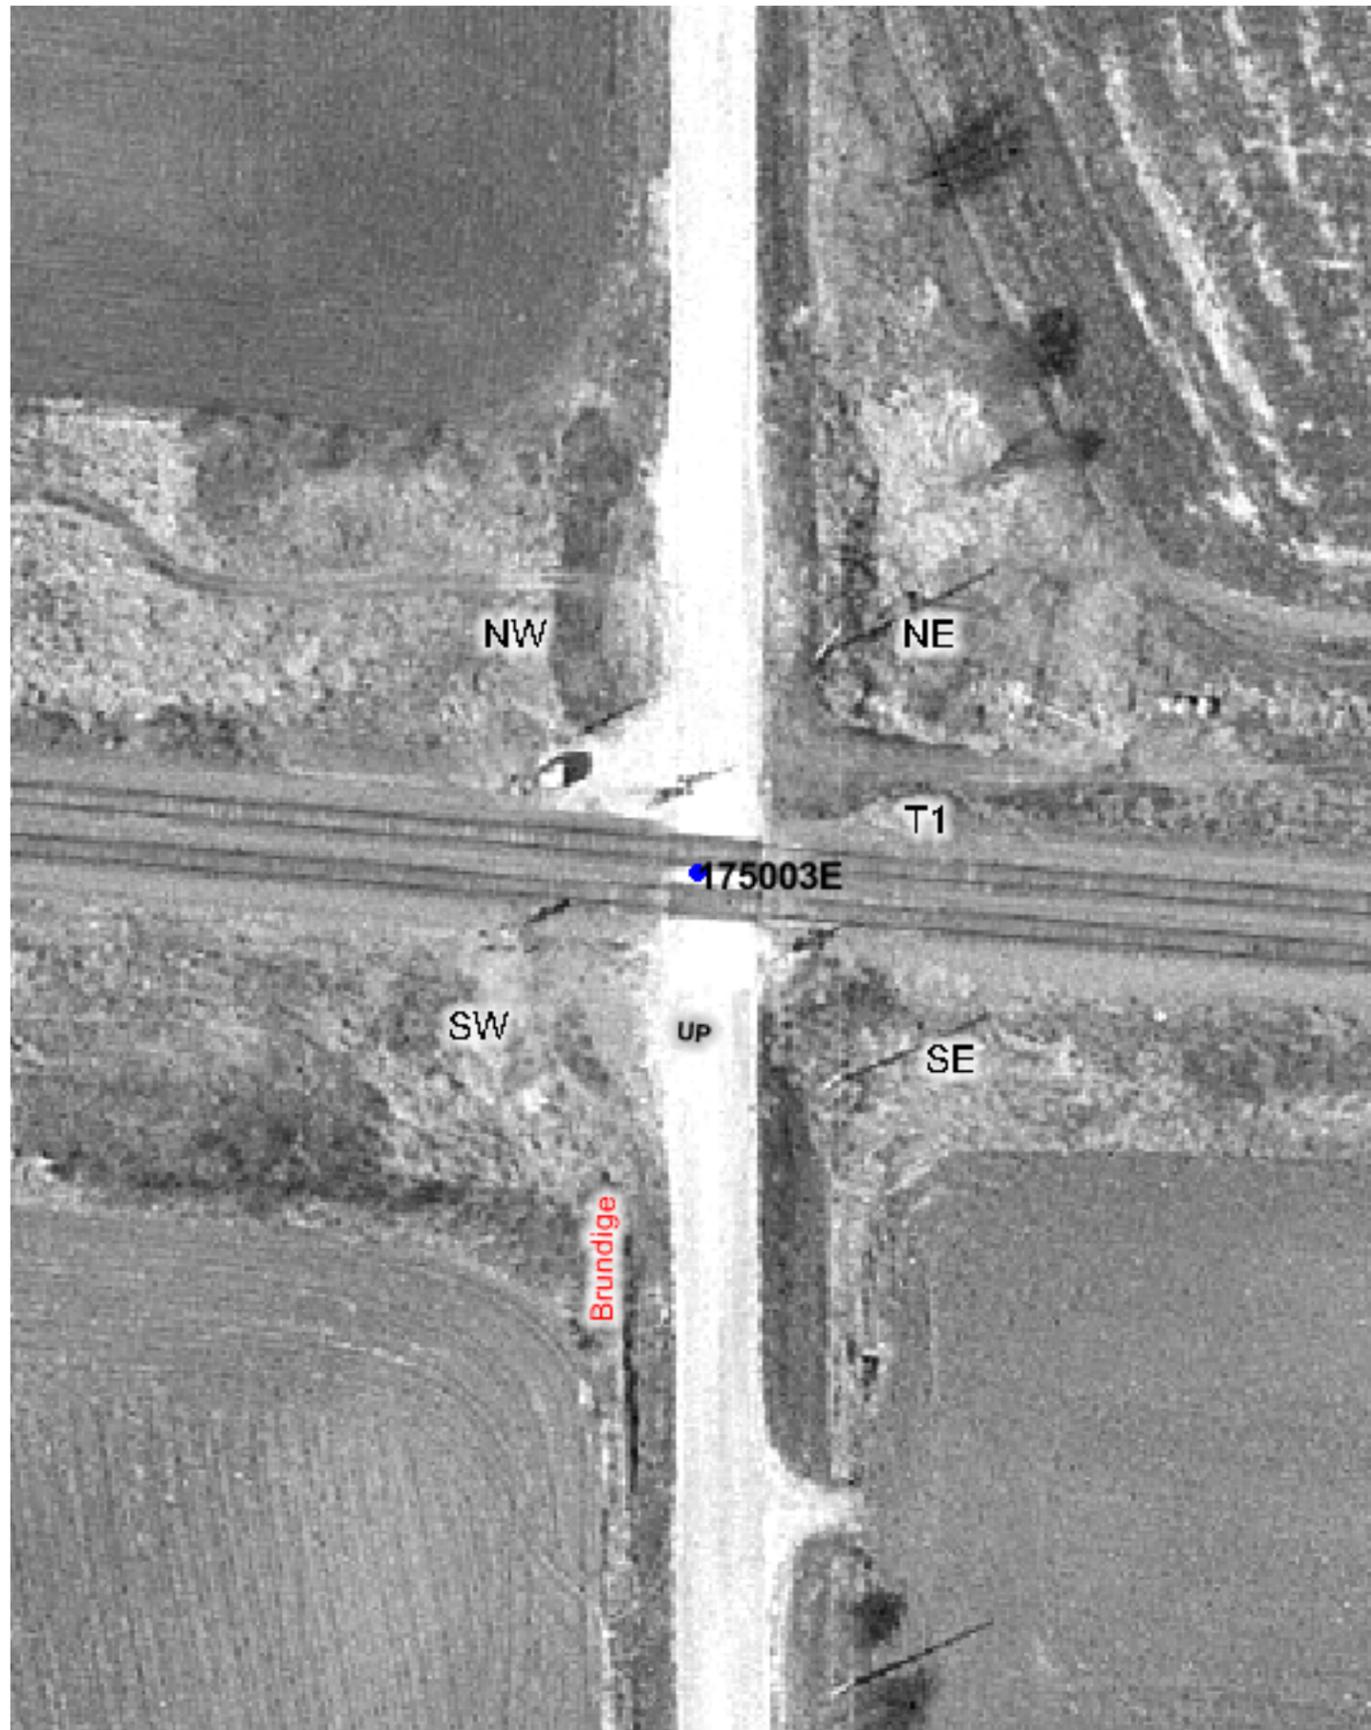
North Nearby Warning Signs South					Adjacent Railroad Crossing				
Type	Distance (Ft)	ER	Type	Distance (Ft)	ER	DOT#	Direction	Distance (Ft)	
R15-2	13.6		R15-2	10.0					
			W10-1	473.8					
Number of Other Signs: 0					Number of Other Signs: 0				
West Side		Roadway Material & Dimensions				East Side			
		Roadway Material: Gravel							
Dir	Dist NR	Sidewalk	Parkway	Road Width	Parkway	Sidewalk			
N	32.0	0.0	0.0	17.7	0.0	0.0			
S	32.0	0.0	0.0	15.9	0.0	0.0			
West Side of Road:		Crossing Surface Material & Dimensions				East Side of Road:			
	Sidewalk Material	Sidewalk Width (Ft)	Distance to Sidewalk	Roadway Material	Roadway Width (Ft)	Distance to Sidewalk	Sidewalk Material	Sidewalk Width (Ft)	Total Crossing Width (Ft)
Track1	none	0	1.7	Rubber	24	2	none	0	27.7
Track2	none	0	1.3	Rubber	30	1.6	none	0	32.9
North Side			Vertical Profile				South Side		
A-0	A-18	A-50	T-63	B-95	B-113

7.78%		4.06%	1.54%	-3.13%	-5%				
Special Conditions? None					Missing Data? No
