U.S. DOT#: 8000020					Warning Device Description				
General Information					Type of Device: X-Bucks				
Type Of Crossing: AtGrade					Number Of Devices:				
Lat: 41° 56' 38" Long: 87° 54' 38"					CrossBucks:	2	Cantelever:	0	
County: COOK					Bells:	0	Gates:	0	
City: FRANKLIN PARK In/Near:					WigWags:	0	Pedestrian Gates:	0	
Street Name: RUNGE AVE.					Flashing Lights Pairs:	0	Masts:	2	
RailRoad: SOO					Mast Locations				
RailRoad Station: BENSENVILLE YD (N)					Edge of Road (Ft)	Edge of Rail (Ft)			
RailRoad Milepost: 0					NW	8.2	5.5		
Crossing Angle: 89.9°					SE	6.6	6		
Data Collection Date: 8/13/2002									
Aerial Photography Date: Spring 2002									
Nearest Intersecting Roads					Track Description				
Name	Distance (Ft) ER	Width (Ft)	Direction	Traffic Control	Number of Tracks: 2 (Type of Tracks: Main)				
Number of Other Nearby Intersecting Roads: None					From	To	Distance (Ft)		
					Track 1	Track 2	17.0

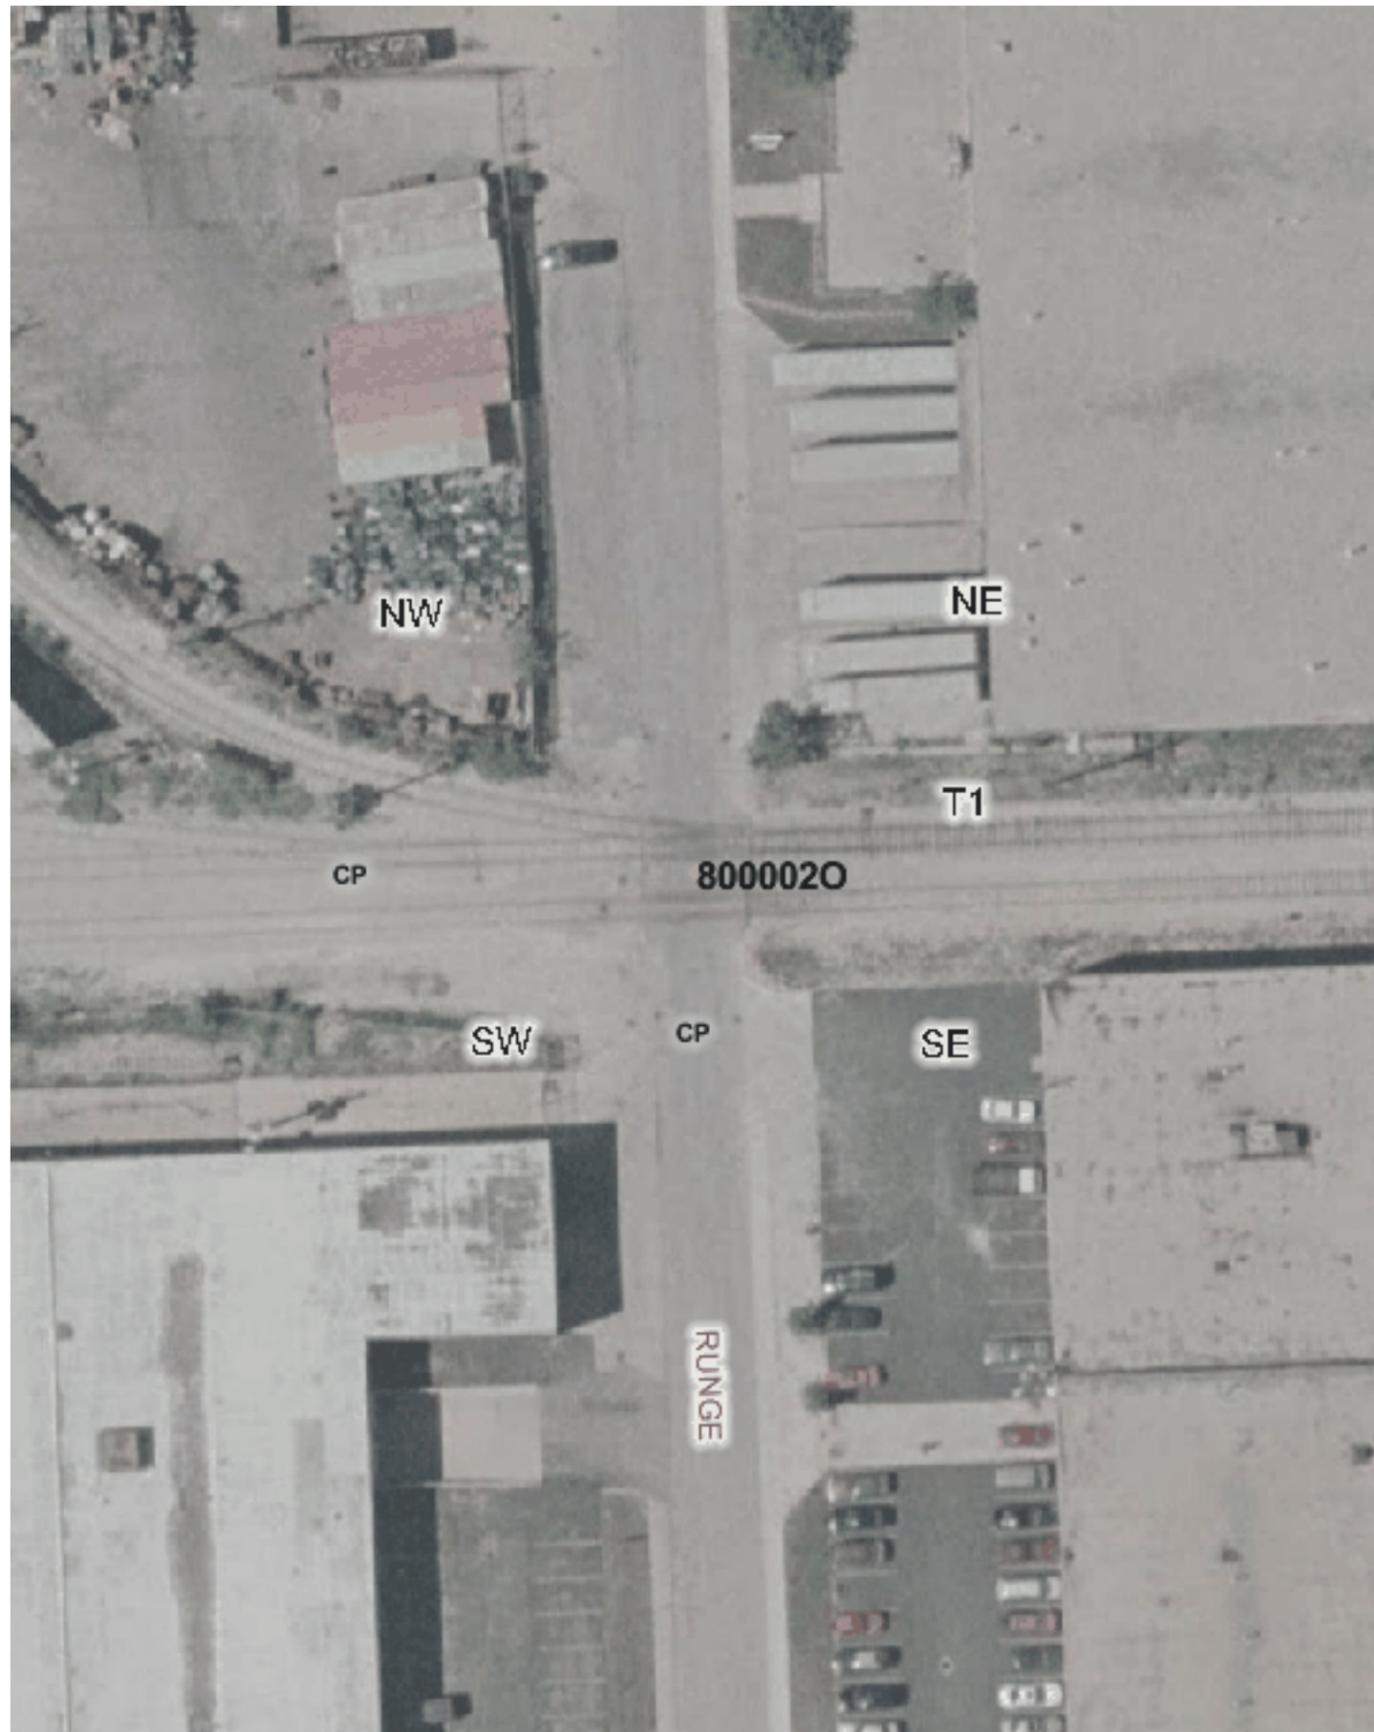
North		Nearby Warning Signs			South		Adjacent Railroad Crossing		
Type	Distance (Ft) ER	Type	Distance (Ft) ER	DOT#	Direction	Distance (Ft)			
Number of Other Signs: 0		Number of Other Signs: 0							
West Side		Roadway Material & Dimensions				East Side			
		Roadway Material: Bituminous							
Dir	Dist NR	Sidewalk	Parkway	Road Width	Parkway	Sidewalk			
N	32.0	0.0	0.0	24.0	0.0	0.0			
S	32.0	0.0	0.0	24.0	0.0	0.0			
West Side of Road:		Crossing Surface Material & Dimensions				East Side of Road:			
		Sidewalk		Roadway		Total			
	Sidewalk Width	Distance to Roadway	Width	Distance to Sidewalk	Sidewalk Width	Crossing Width			
	Material (Ft)	Sidewalk Material	(Ft)	Sidewalk Material	(Ft)	(Ft)			
Track1	None	0	0(*)	Asphalt and Flange	29	0(*)	None	0	29
Track2	None	0	0(*)	Asphalt and Flange	27.5	0(*)	None	0	27.5
North Side		Vertical Profile				South Side			
A-50		A-32	Track1	Track2	B-32	B-50			
0%		0%	0.59%	-0.31%	0.56%

Special Conditions? None				Missing Data? No
