U.S. DOT#: 372167M				Warning Device Description							
General Information Type Of Crossing: AtGrade Lat: 41° 58' 14" Long: 87° 57' 12" County: DU PAGE City: BENSENVILLE In/Near: In Street Name: COUNTRY CLUB DR RailRoad: SOO RailRoad Station: BENSENVILLE TV (S) RailRoad Milepost: 0.36 Crossing Angle: 88.6° Data Collection Date: 7/24/2003 Aerial Photography Date: Spring 2003				Type of Device: X-Bucks Number Of Devices: CrossBucks: 2 Cantelever: 0 Bells: 0 Gates: 0 WigWags: 0 Pedestrian Gates: 0 Flashing Lights Pairs: 0 Masts: 2							
				Mast Locations Edge of Road (Ft) Edge of Rail (Ft)							
				NW 7.6 9.1 SE 20 10.2							
Nearest Intersecting Roads				Track Description							
Name	Distance (Ft) ER	Width (Ft)	Direction	Traffic Control	Number of Tracks: 2 (Type of Tracks: Siding)						
Number of Other Nearby Intersecting Roads: None				From To Distance (Ft) Track 1 Track 2 8.3							
Nearby Warning Signs				Adjacent Railroad Crossing

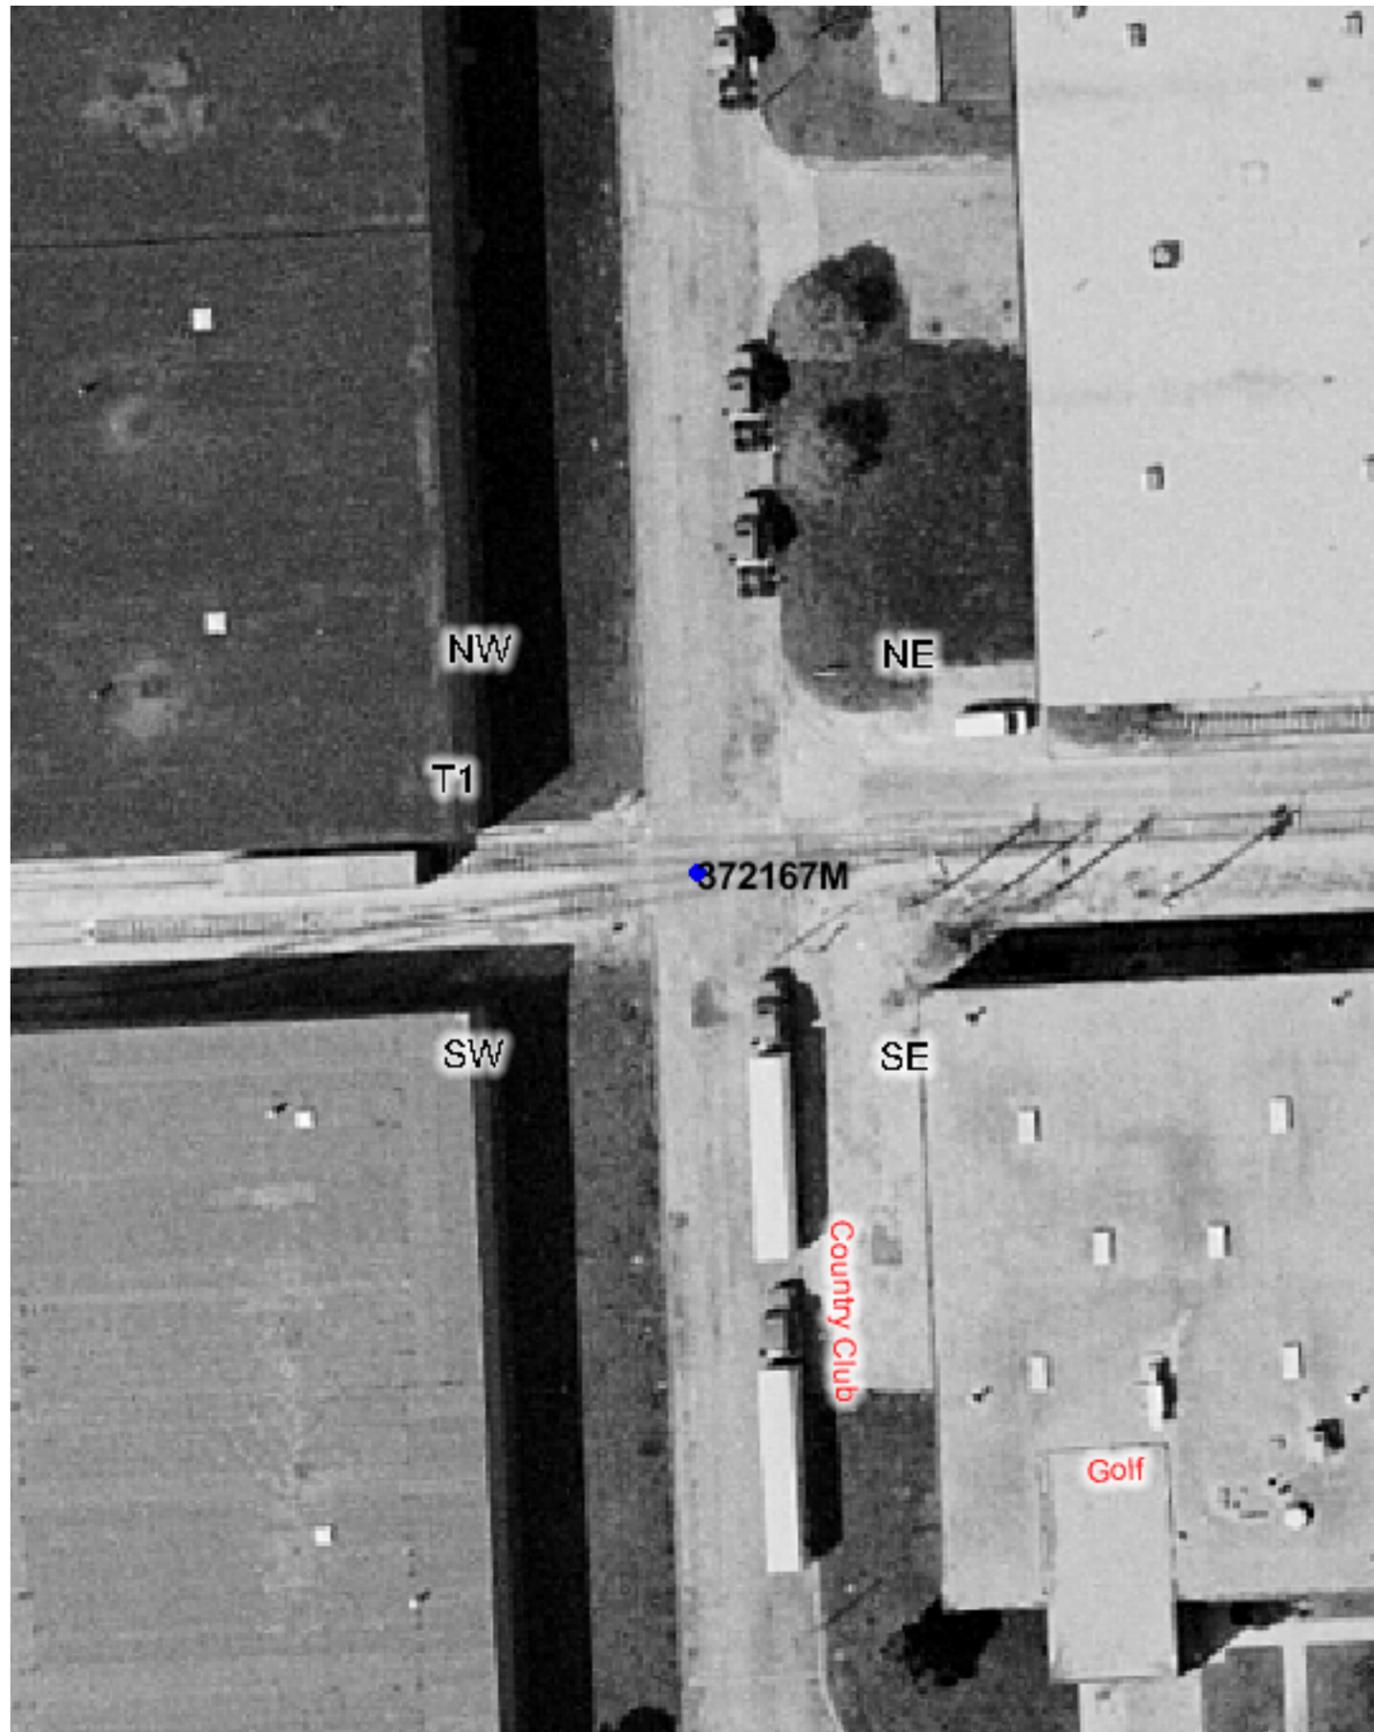
North	Type	Distance (Ft) ER	South	Type	Distance (Ft) ER	DOT#	Direction	Distance (Ft)			
	W10-1	301.5		W10-1	122.0						
Number of Other Signs: 0				Number of Other Signs: 0							
West Side		Roadway Material & Dimensions				East Side					
		Roadway Material: Bituminous									
Dir	Dist NR	Sidewalk	Parkway	Road Width	Parkway	Sidewalk					
N	32.0	0.0	0.0	34.7	0.0	0.0					
S	32.0	0.0	0.0	34.6	0.0	0.0					
West Side of Road:		Crossing Surface Material & Dimensions				East Side of Road:					
		Sidewalk		Roadway		Total					
	Sidewalk Width	Distance to Roadway	Width	Distance to Sidewalk	Sidewalk Width	Crossing					
	Material (Ft)	Sidewalk Material	(Ft)	Sidewalk Material	(Ft)	Width (Ft)					
Track1	None	0	0(*)	Asphalt and Flange	41.5	0(*)	None	0	41.5		
Track2	None	0	0(*)	Asphalt and Flange	41.3	0(*)	None	0	41.3		
North Side		Vertical Profile				South Side					
A-50		A-32		Track1		Track2		B-32		B-50	
0%		0%		1.25%		0.62%		1.11%

Special Conditions? None				Missing Data? No
