Substation Inspections for Monday & Tuesday, June 27-28, 2005:

Field Report – Monday, June 27, 2005

Appendix D: Substation Inspections

ICC Docket No. 05-0597
ICC Staff Exhibit 10.0
Attachment 10.1

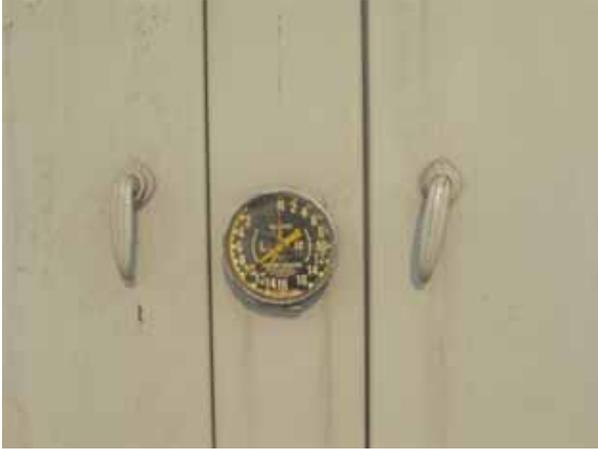
P6270004 – TR 76 Xfmr Tap at 10L w/range from nR to 12L. TR 77, 78, 79, 73 were similar.

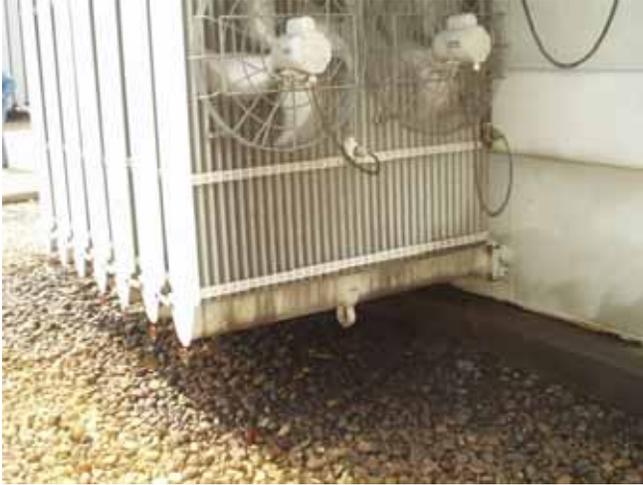
P6270032 – Oil on ground below cooling fins of XFMR71

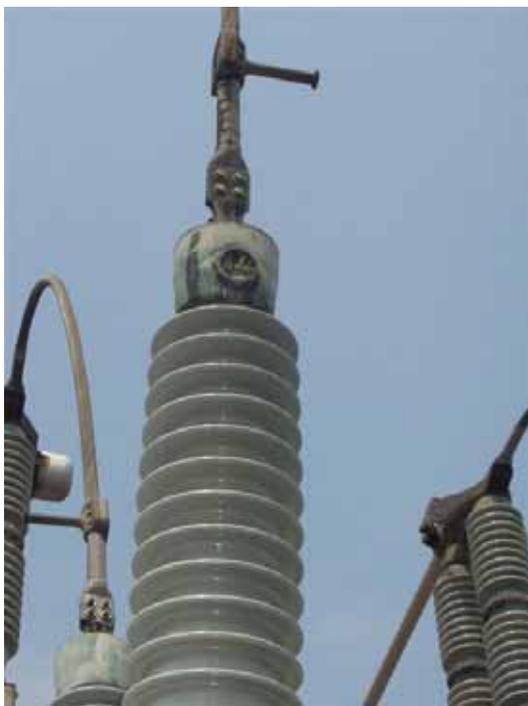
P6270049 – C phase bushing of Oil Circuit Breaker (“OCB”) L0708 oil level is high

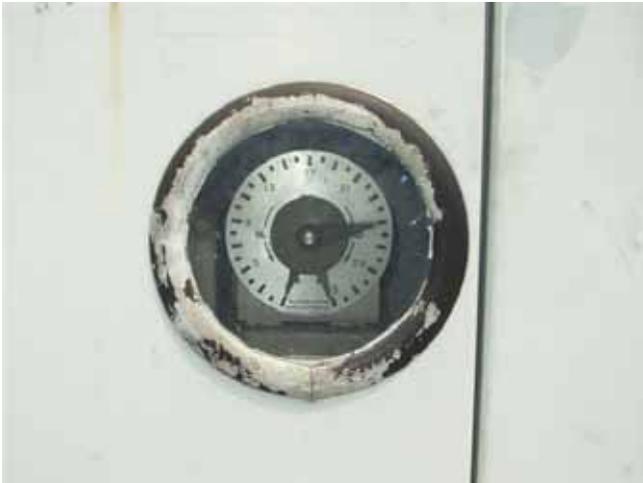
P6270067 – XFMR72Y LTC shows that it has operated in both extreme positions

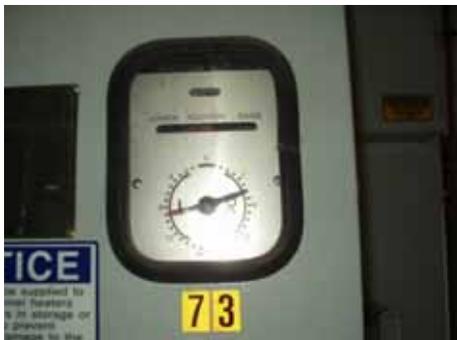
P6270078 – XFMR73 LTC -- Xfmr72 LTC & XFMR71 LTC looked similar

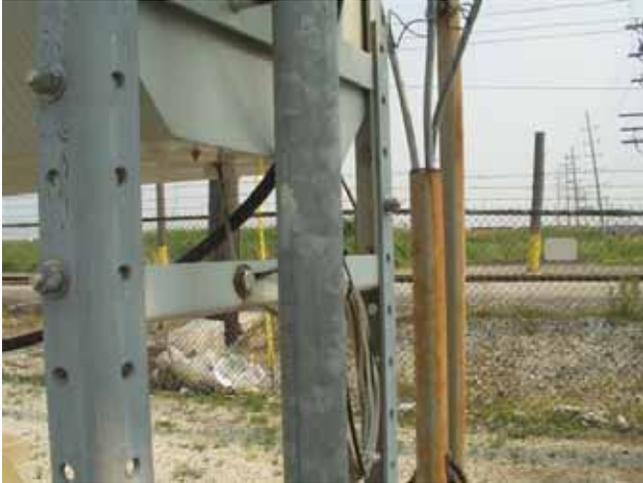
P6270098 – Ground wire coiled up outside to go inside D5004 switchgear

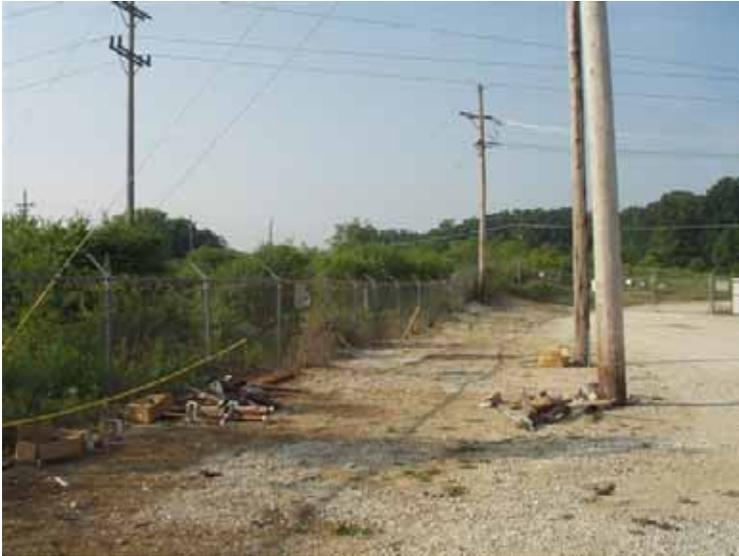
P6280103 – Equipment & debris in yard and along fence – as well as equipment stored for later use.

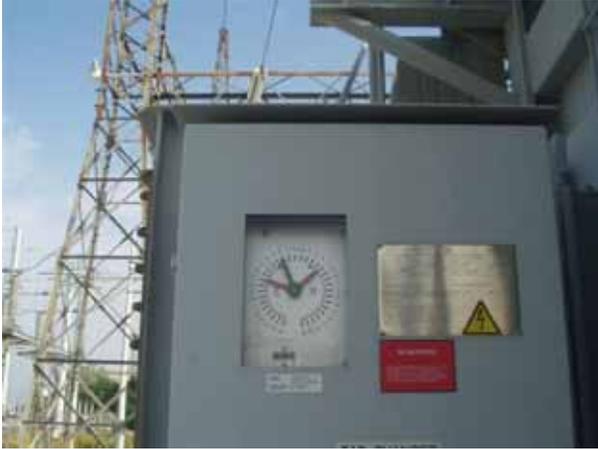
P6280106 – XFMR77 LTC – looks like operation is symmetrical about neutral.

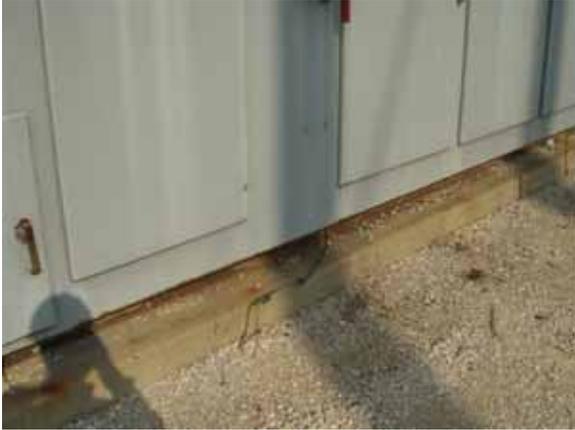
P6280111 – 12KV Cap bank #2 ground [center of picture]

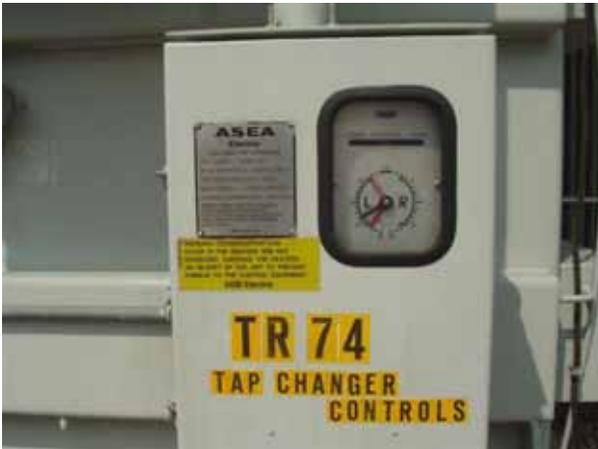
P6280125 – XFMR74 LTC – noted that XFMR had new radiators

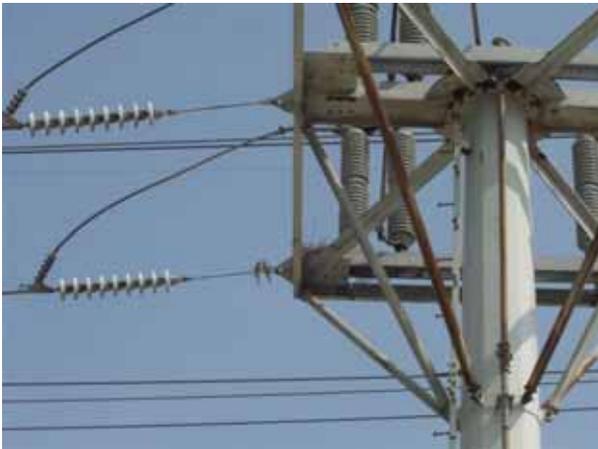
P6280126 – Two+ Monk Parakeet's and nest on transmission tower located in substation

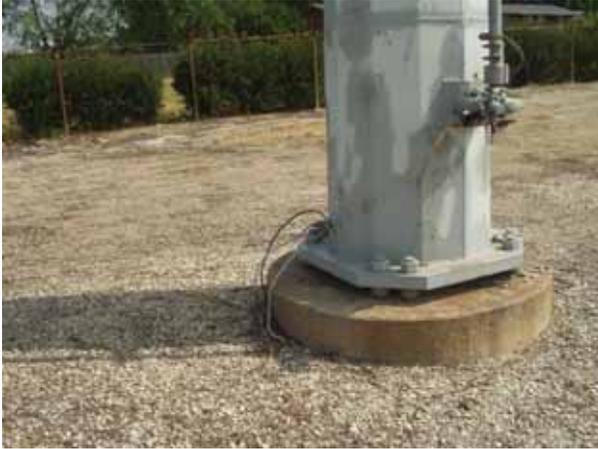
P6280128 – Tower grounds [lots of them] tied into station ground mat

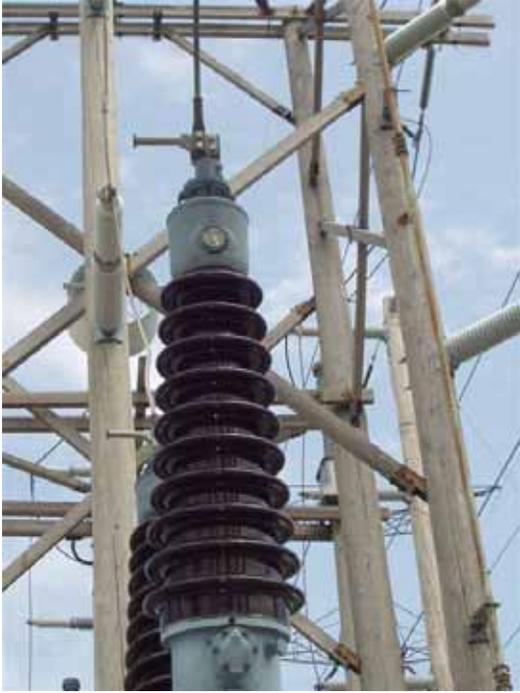
P6280140 – L14310 OCG 138KV BREAKER – B phase bushing oil low – ComEd personnel know about it and are waiting for the next planned outage to correct

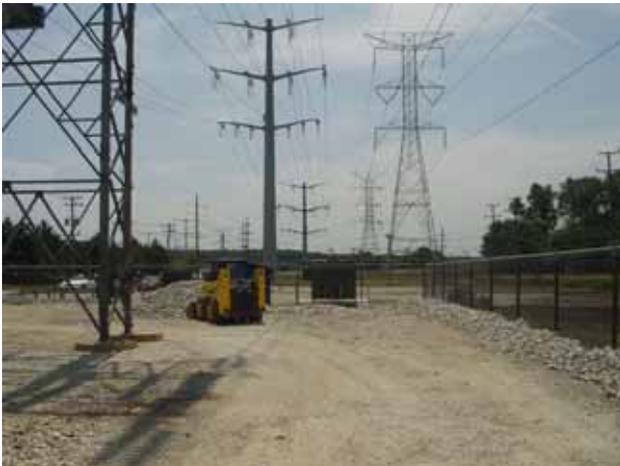
P6280147 – New gravel being put in place around fence – noted that ground in station has “smoothed out” in many places.

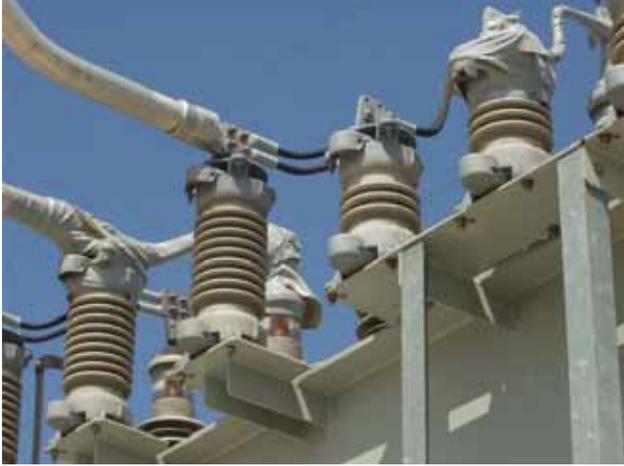
P6280173 – XFMR77 lose tape on insulator

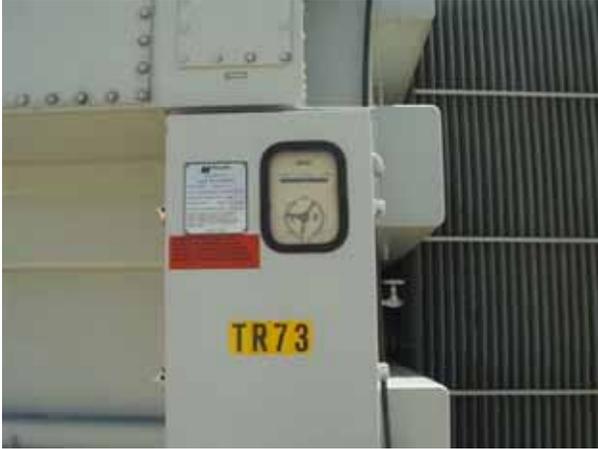
P6280176 – XFMR73 LTC – stop at 16 lower

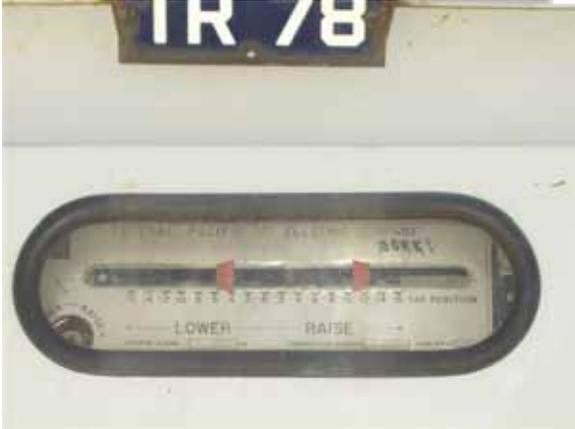
P6280179 – XFMR78 LTC -- XFMR 79 LTC similar
