Illinois Commerce Commission
Assessment of Commonwealth Edison Company
Reliability Report and Reliability Performance
for Calendar Year 2005

Pursuant to 83 Ill. Adm. Code 411.140

March 20, 2007

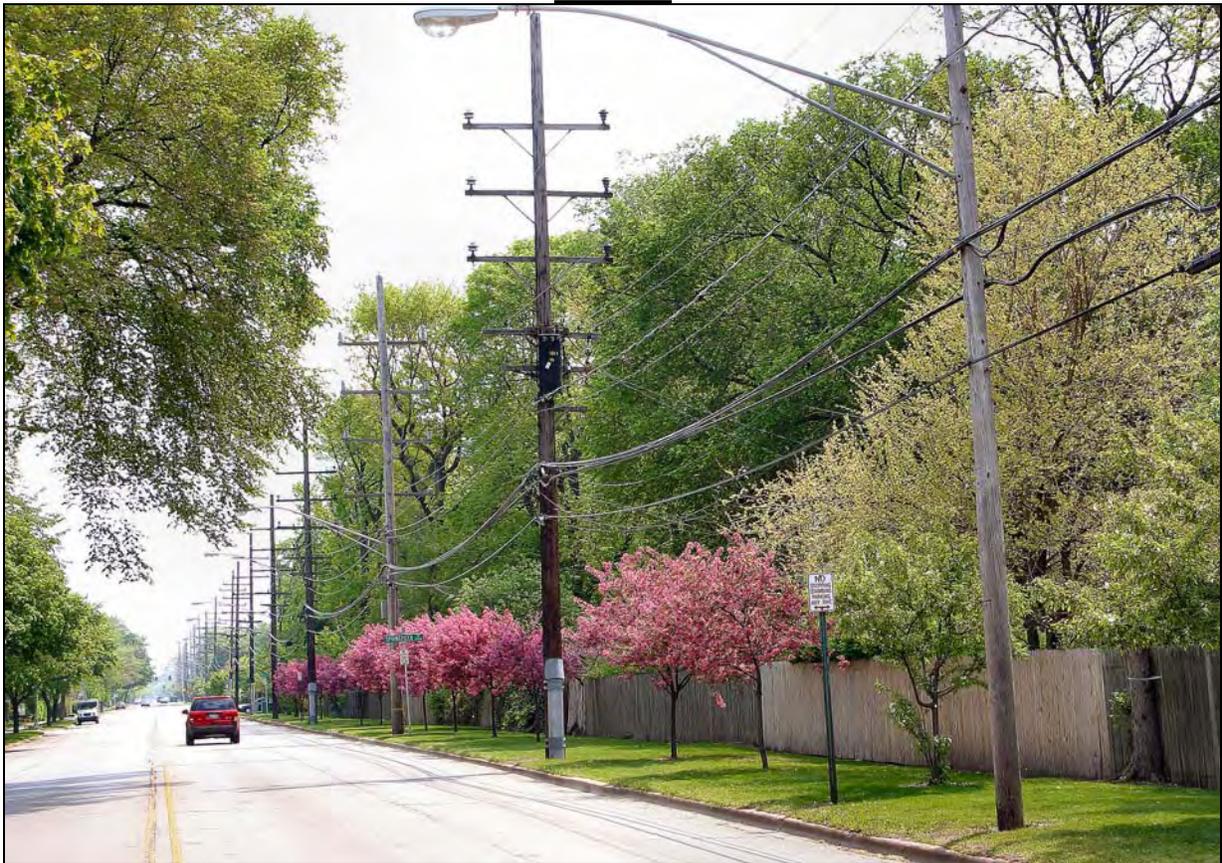
Photo 1

ComEd promotes planting “the right tree in the right place” near its power lines, and has reached a cooperative agreement with some of the communities it serves to share the cost of replacing troublesome tree species with more compatible low-growing species under its lines along city streets. Photo 1, below, shows the results of one such project on Church Street west of Springfield Avenue in Skokie. ComEd should be commended for its joint efforts with the involved communities in implementing this program.

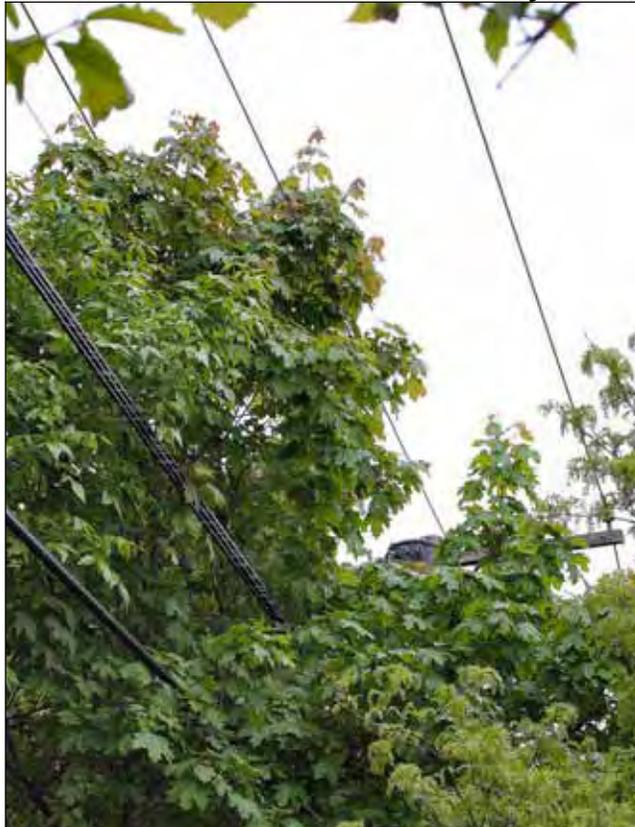
Figure 2 (Photo 06-CE961)
**Primary through Norway maple trees ,
Glenview Rd. between Chatham Dr. & Glenayre Dr., Glenview**

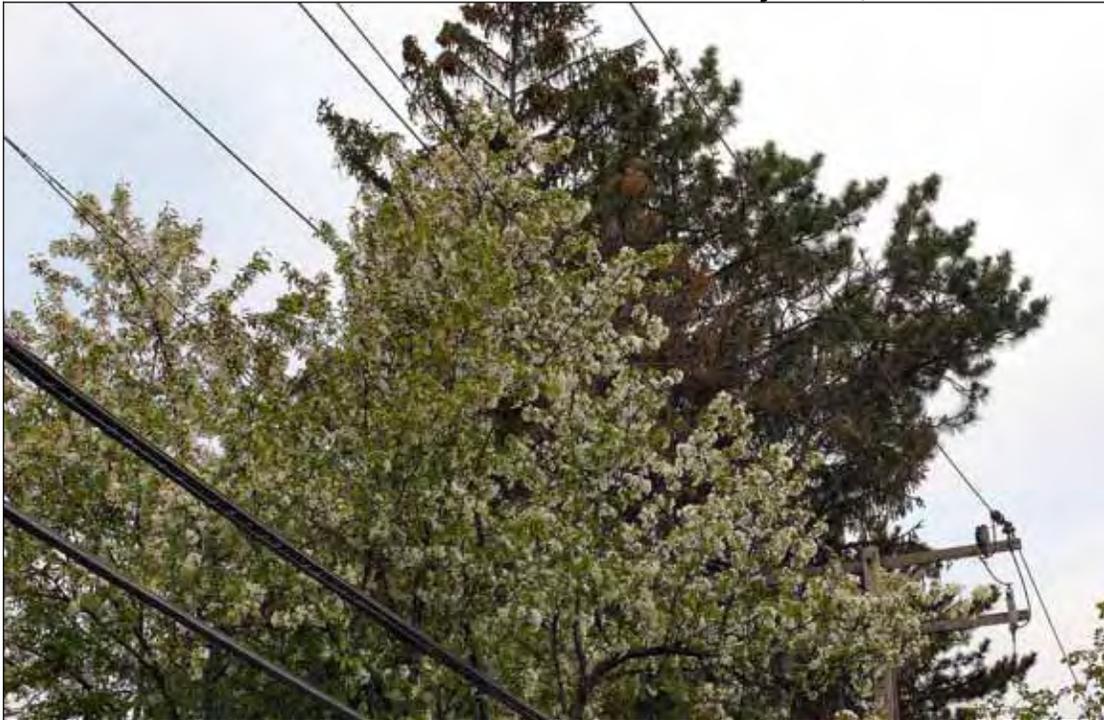
Figure 3 (Photo 06-CE962)
Crabapple tree into primary,
Glenview Rd. between Chatham Dr. & Glenayre Dr., Glenview

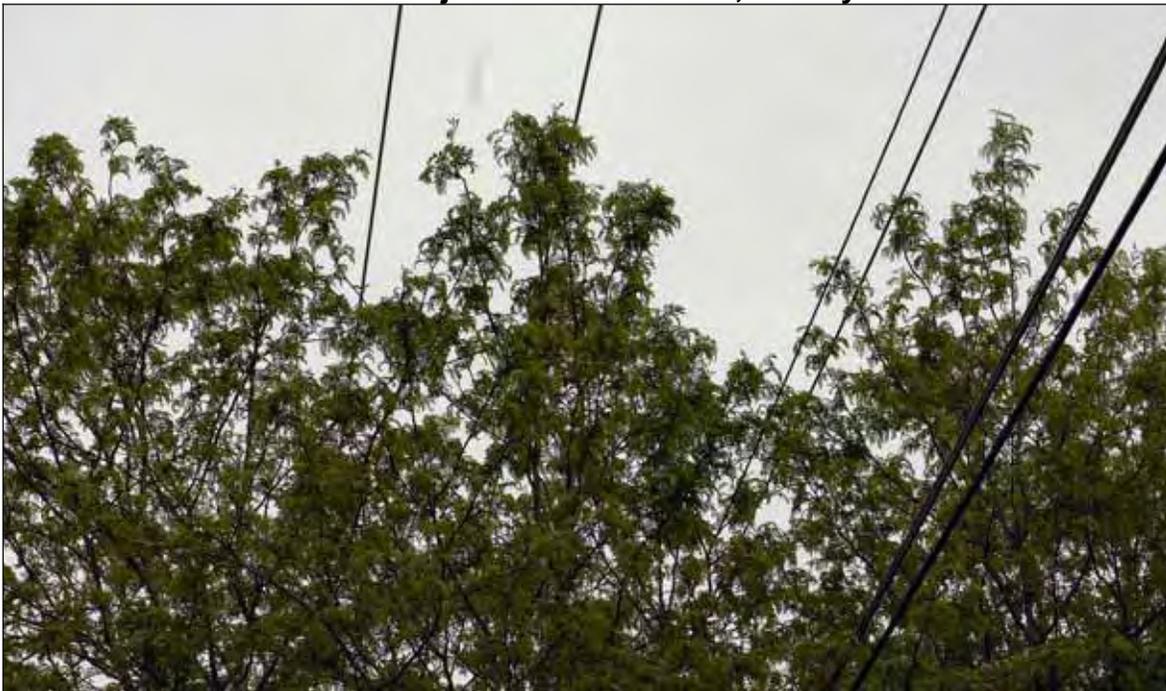
Figure 5 (Photo 06-CE973)
**Honey locust tree into primary,
Austin Ave. just west of Ash St., Libertyville**

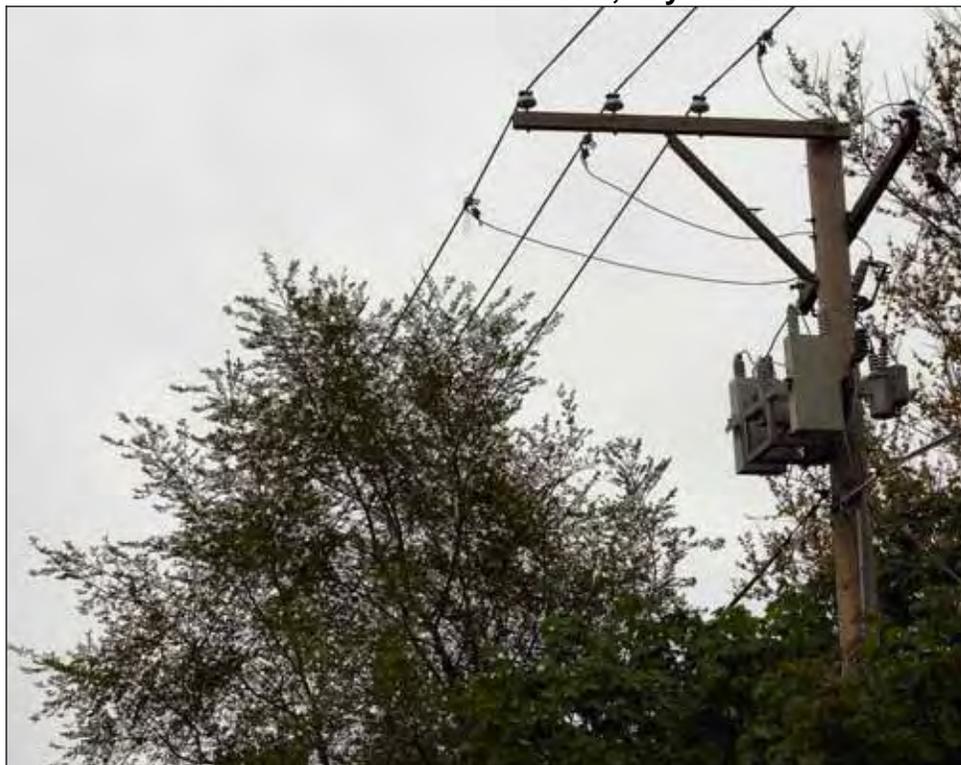
Figure 6 (Photo 06-CE987)
**Siberian elm tree into primary,
Oak St. north of Rockland Rd., Crystal Lake**

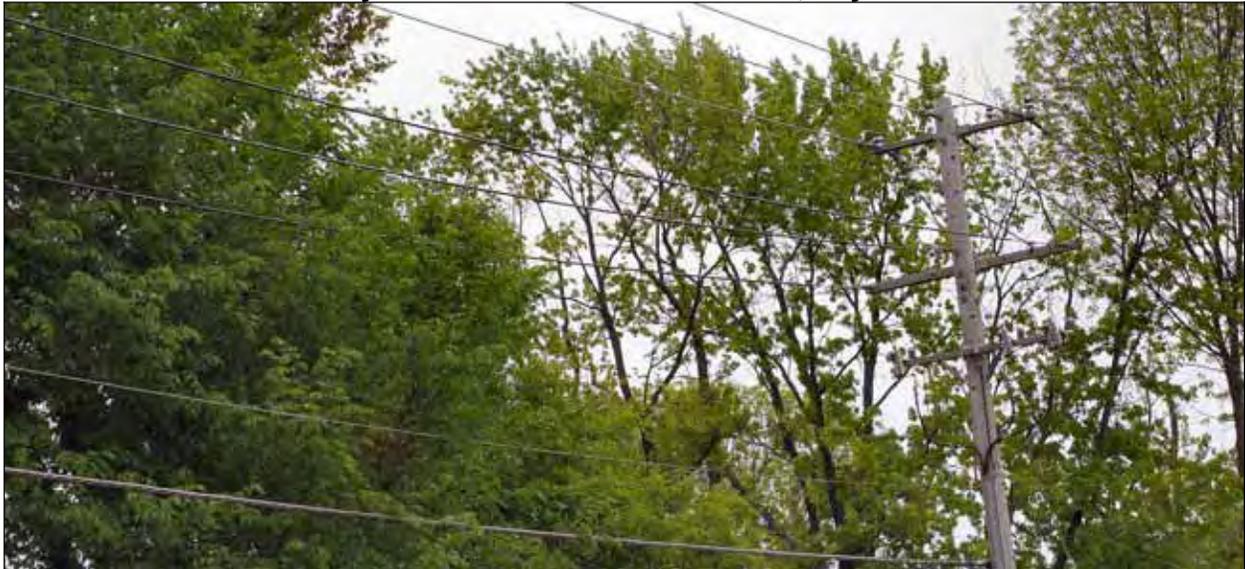
Figure 9 (Photo 06-CE981)
**Elm trees into 3-phase primary,
McHenry Ave. south of Berkshire Dr., Crystal Lake**

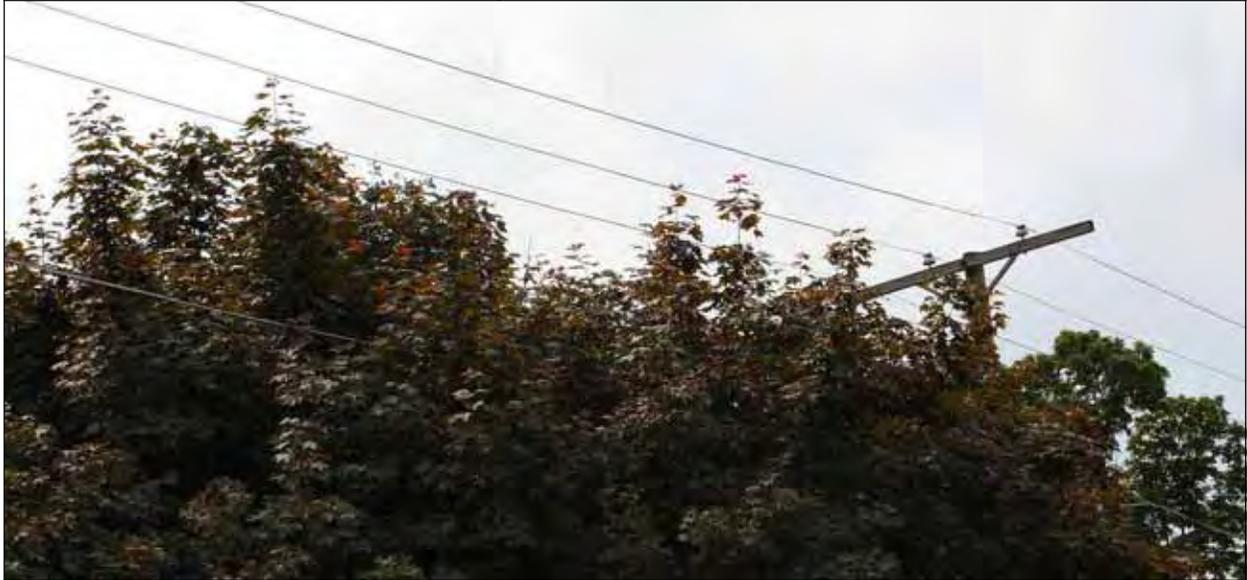
Figure 11 (Photo 06-CE1000)
**Hard (Norway) maple tree into primary, with contact,
Lincoln Ave. just south of 14th St., Mendota**

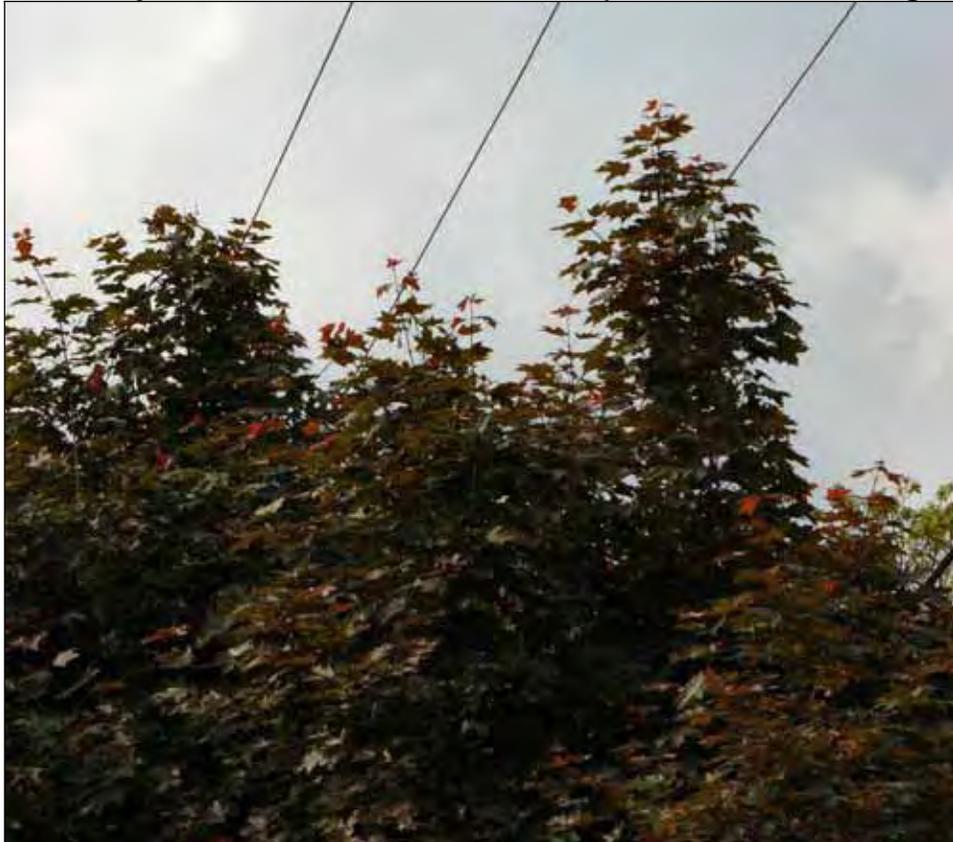
Figure 12 (Photo 06-CE999)
**Hard (Norway) maple tree into primary, with contact,
Lincoln Ave. just south of 14th St., Mendota (same location as Figure 11)**

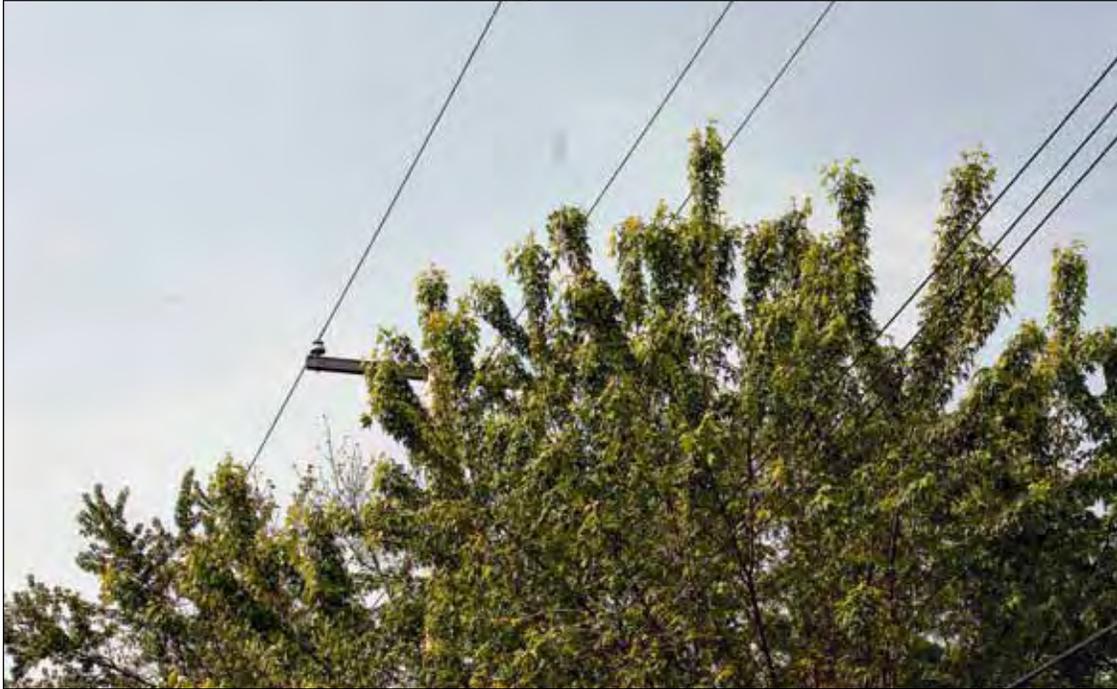
Figure 13 (Photo 06-CE994)
**Soft maple tree growing into 12 kV primary,
In alley east of 4th Ave., just north of 8th St., Mendota**

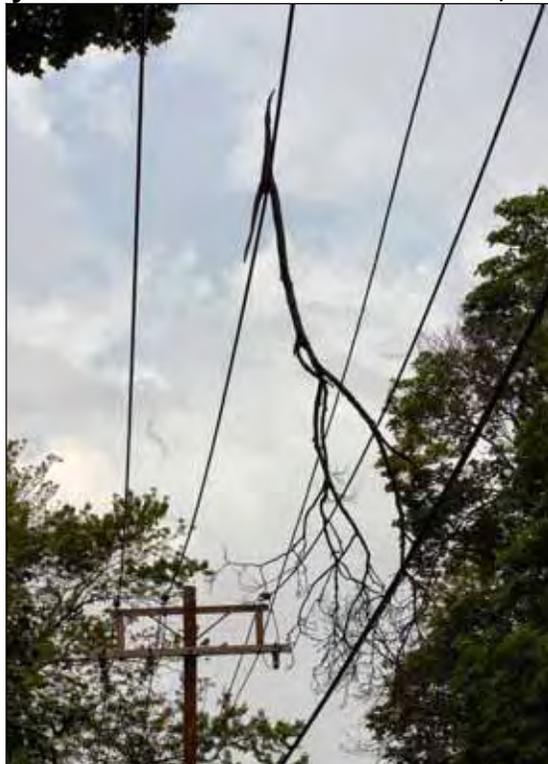
Figure 14 (Photo 06-CE1016)
**Large limb on center phase of primary,
Pennsylvania Ave. north of Monroe St., Mendota**

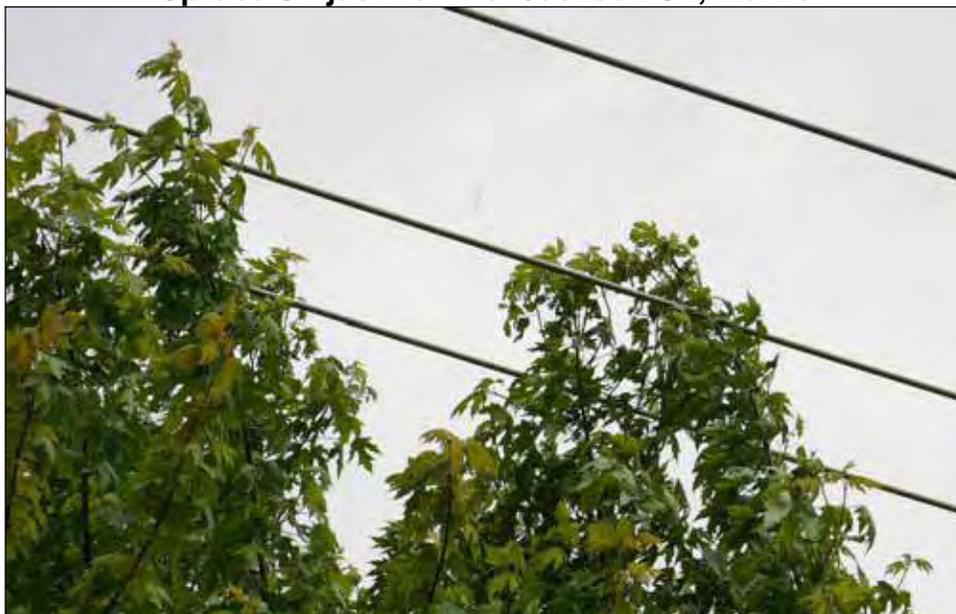
Figure 18 (Photo 06-CE1026)
**2 soft maple trees into primary, with contact & leaves curled,
Spruce St. just north of Jackson St., Morris**

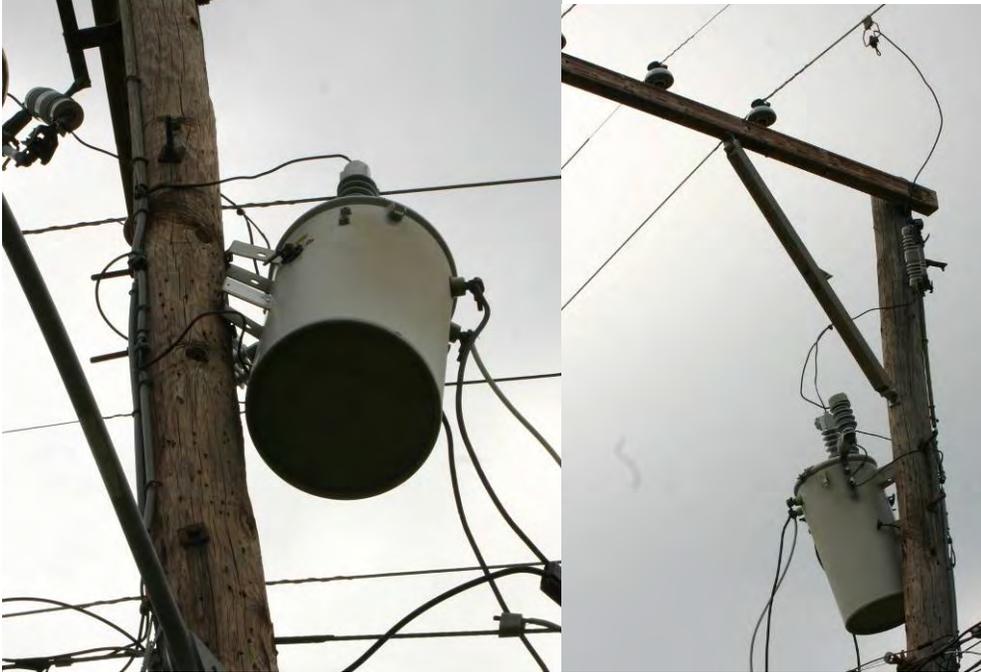
Img-1003 & 1004 – Transformer falling off pole (lower bracket off bolt through pole, upper bracket bent) – Pole #319-28-1A1

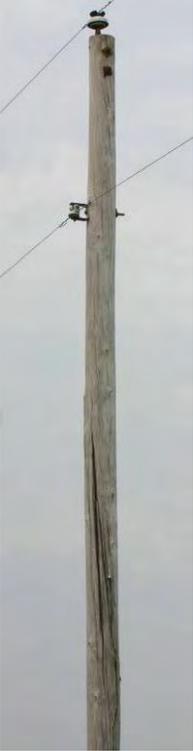
IMG-1008 – Old lightning damage to pole and broken spool in secondary clevis

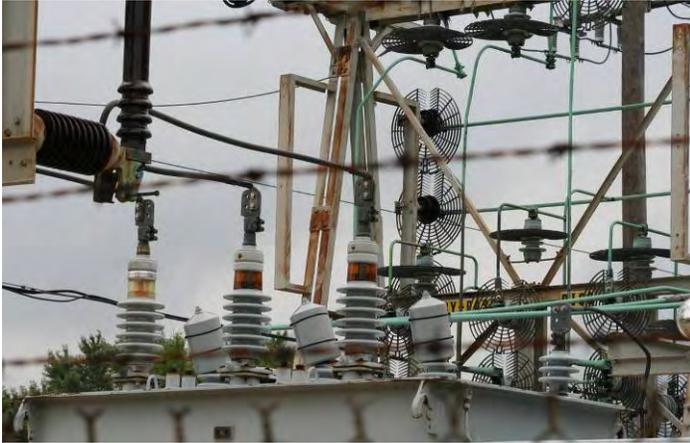
Pic_0060 – Insulating oil levels in equipment that was observed at DCW38 substation appeared normal from substation fence line. Animal protection devices are abundantly visible on top of the transformer and other equipment in the substation.

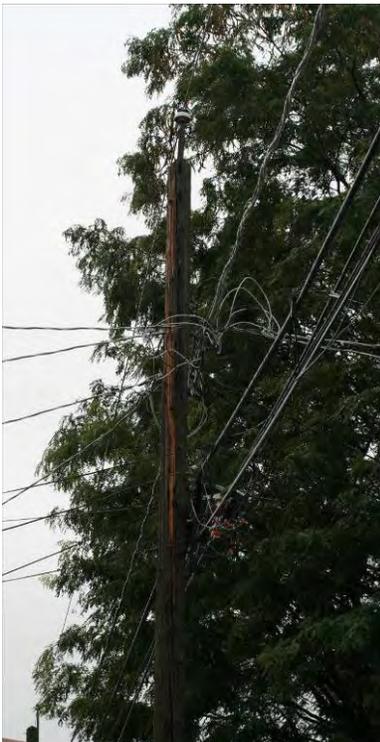
Pic_0072 – Primary into trees – Pole has Red tag. [Hegewich/South Chicago Area]

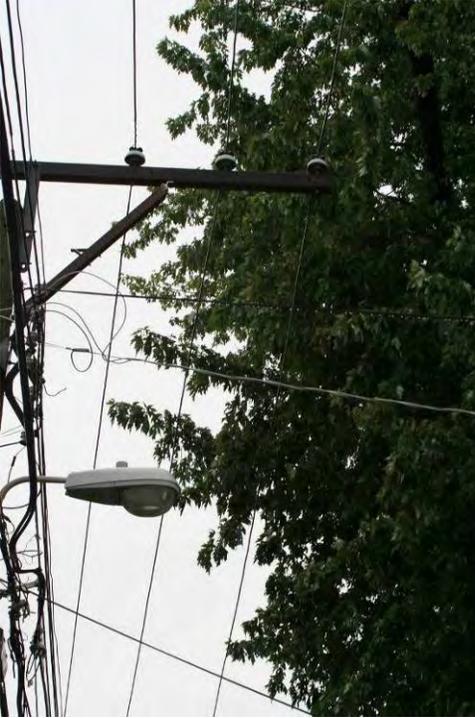
Pic_0074 – Primary into trees. [Hegewich/South Chicago Area]

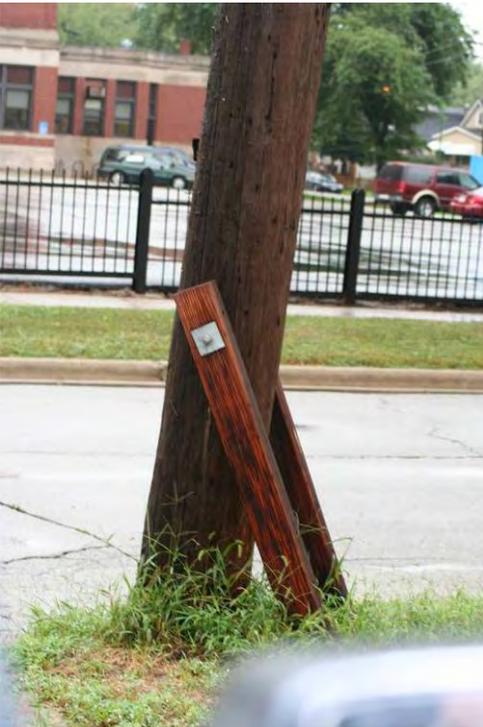
Pic_0077 – Cross arms used as braces on pole [Hegewich/South Chicago Area]

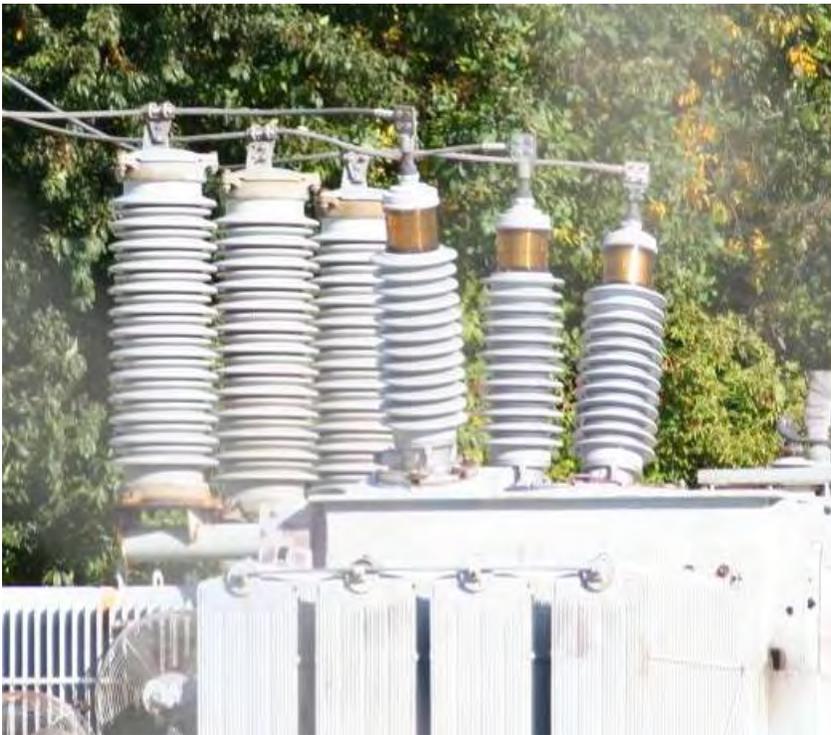
Pic_0129 – As the picture illustrates, Staff noted no problems with insulating oil levels in equipment visible from the fence line of TDC 380.

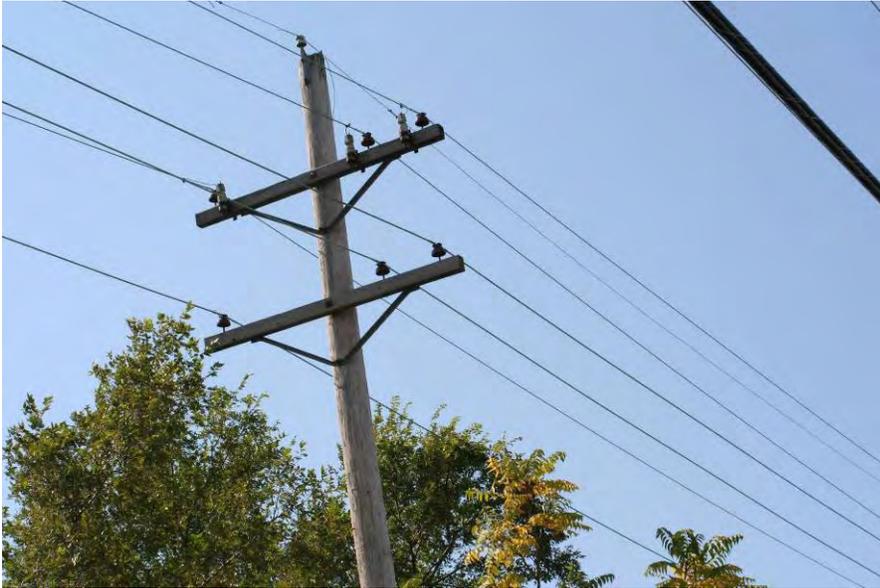
Pic_0166 – Thornton Area – field primary into tree.

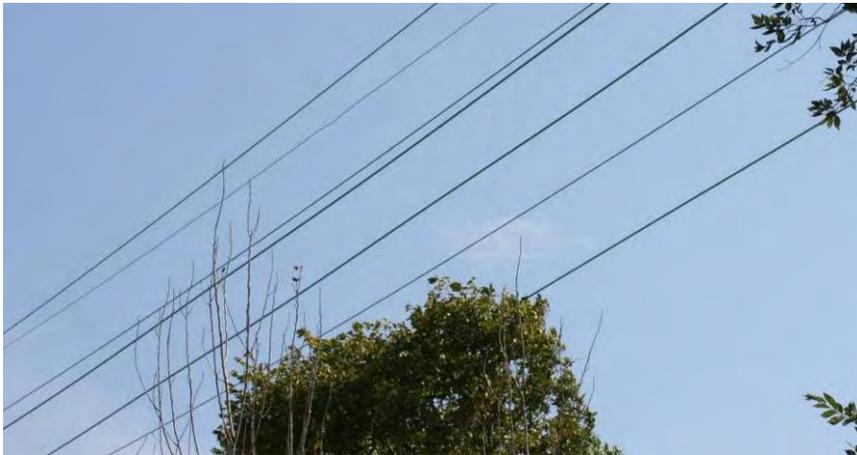
Pic_0167 – Thornton Area – Vegetation/Tree growing up into primary.

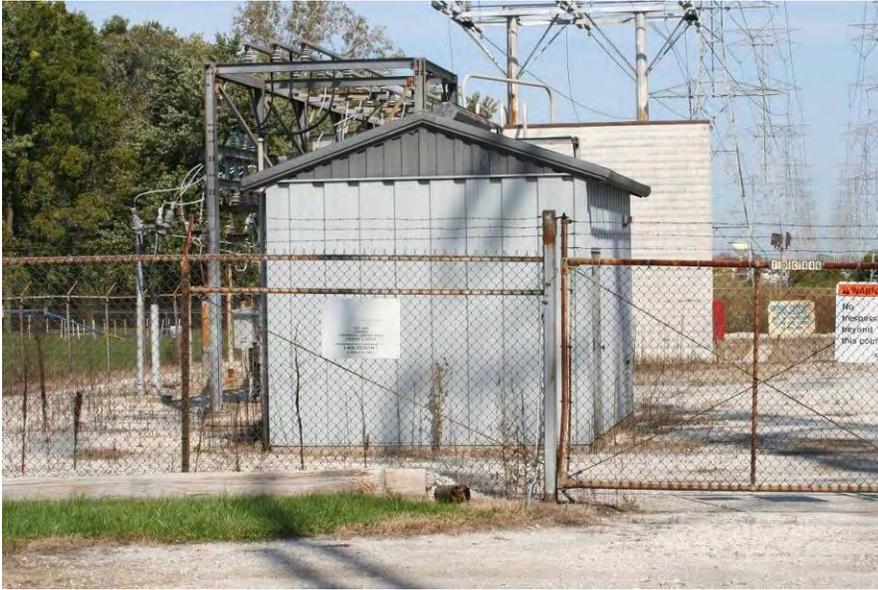
Pic_0171 – TDC 446 – While the vegetation in the substation yard appears dead it is apparent that there is a lot more vegetation than the previous year – see P6270024 below of TDC 446 taken in 2005.

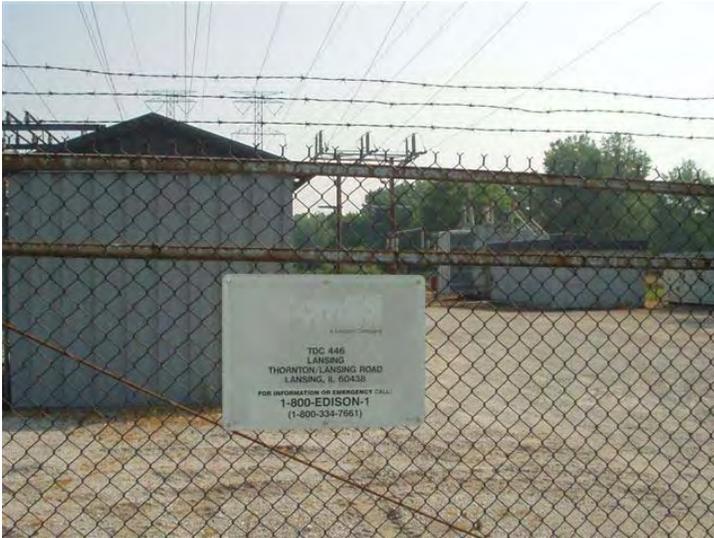
P6270024 – TDC 446 in June of 2005 – compare to Pic_0171 of TDC 446 taken in October of 2006.

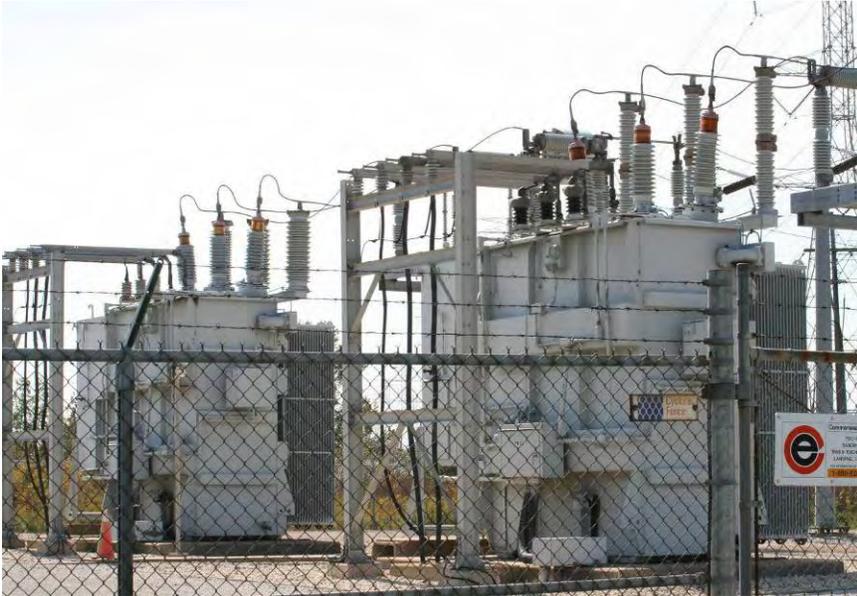
Pic_0179 – TDC 447 – yard is clear of vegetation.

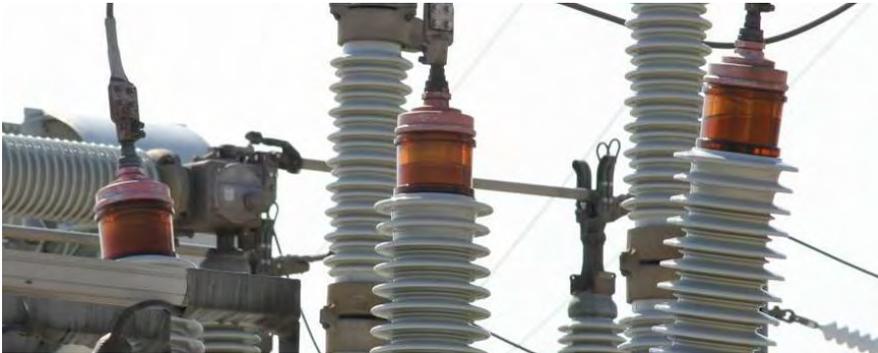
Pic_0180 – Bushing oil levels in north transformer. Bushing on the left – level is markedly higher than the other two.

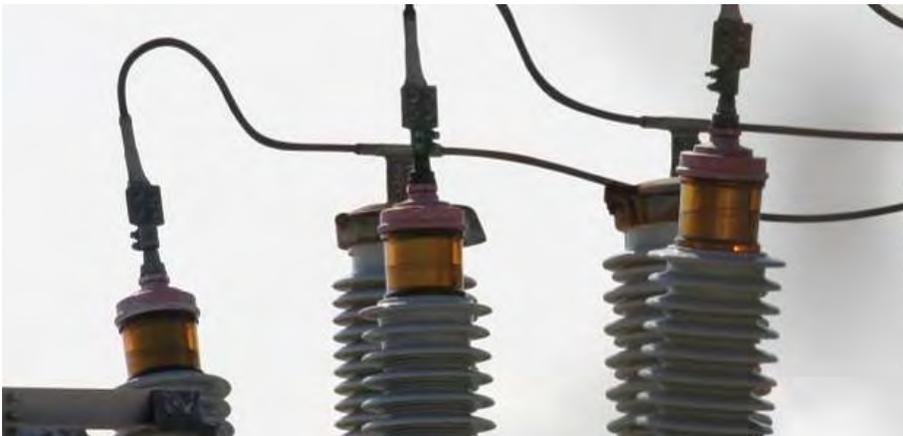
Pic_0182 – Bushing oil levels in South transformer.

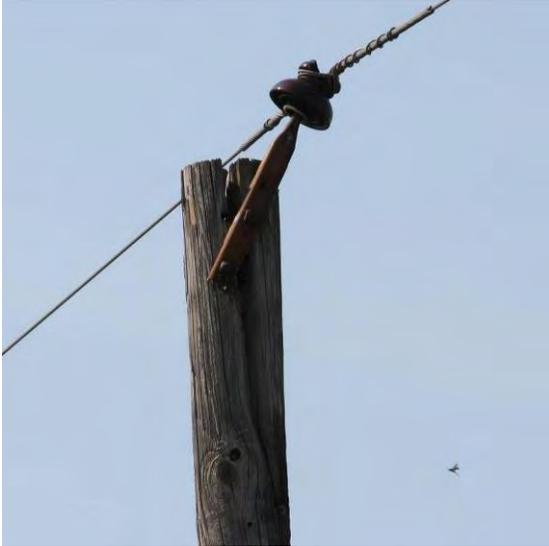
Pic_0188 – 3 poles south of transformer #533284A5 – this is visible from I-55 Southbound lanes along frontage road.

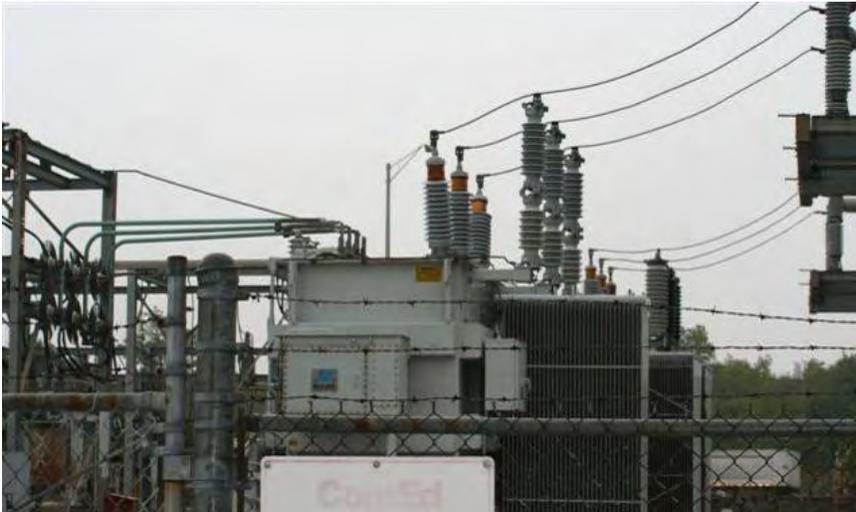
Pic_0036 – Insulating oil levels that could be determined outside of the originating substation fence line appeared normal – such as the bushing oil levels on the primary side of the above transformer.

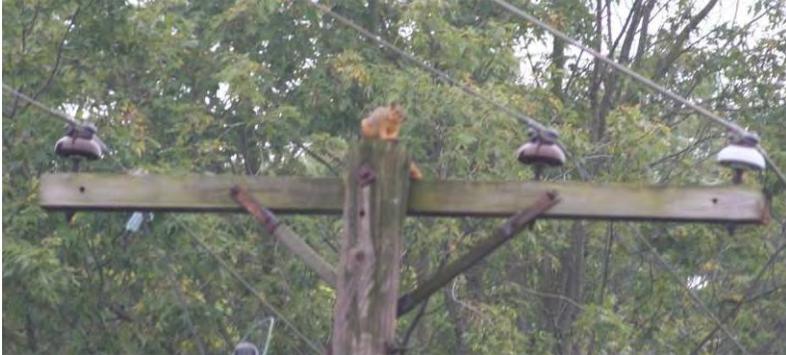
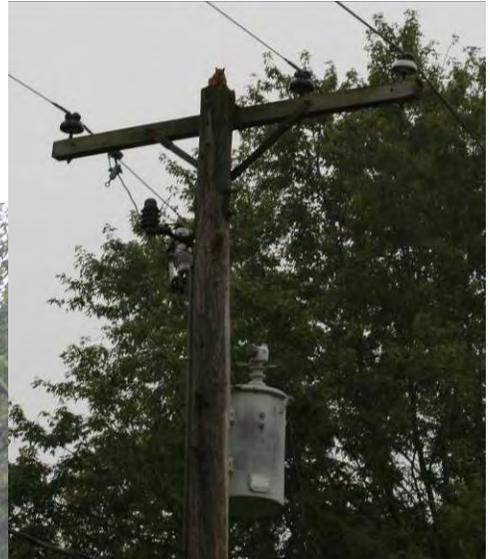
Pic_0043 & Pic_0044 – examples of the many squirrels seen on this circuit. Note the animal protection on the transformer. [ComEd Dwg W555 1 of 3]

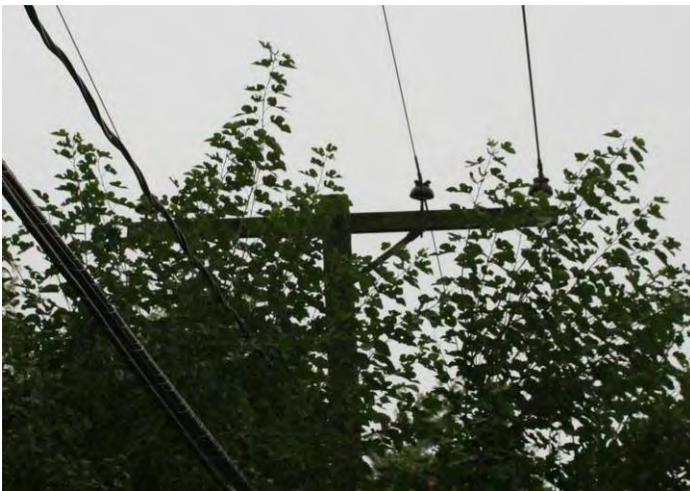
Pic_0045 – Mulberry tree into primary. [ComEd Dwg W555 1 of 3]

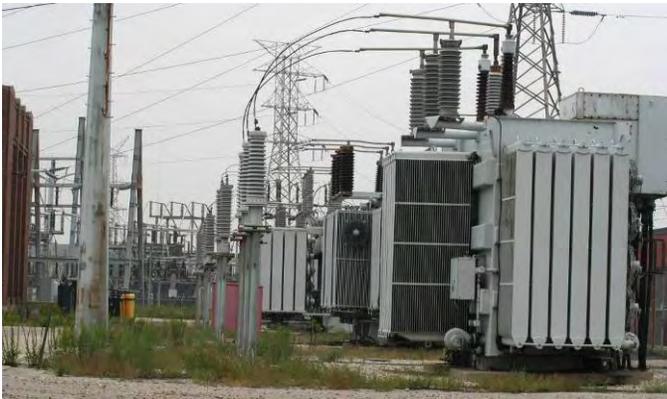
Pic_0047 – Insulating oil levels in equipment that was observed at the originating substation appeared normal.

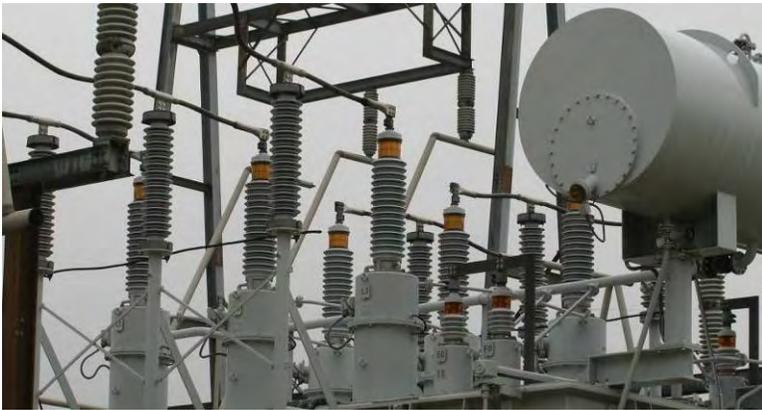
Pic_0055 – Insulating oil levels in equipment that was observed at the originating substation appeared normal.

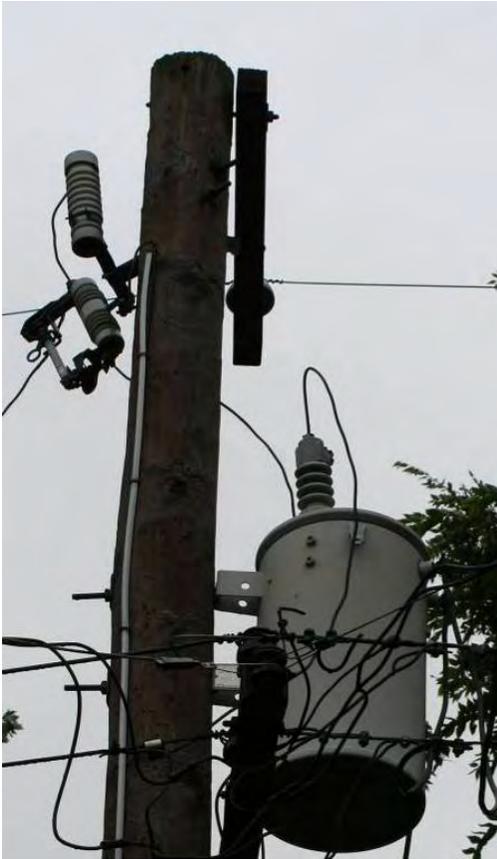
Pic_0068 – Gap between top crossarm & pole and gap between transformer top bracket and pole [Dwg G6083 – 2 of 4]

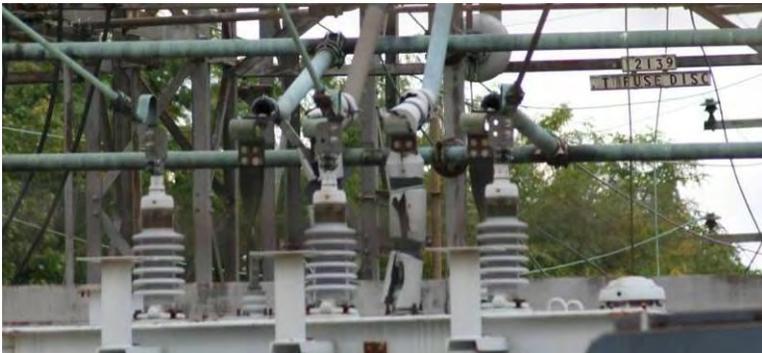
Pic_0095 – At TSS 121, where visible from the fence-line, insulating oil levels in devices appear normal.

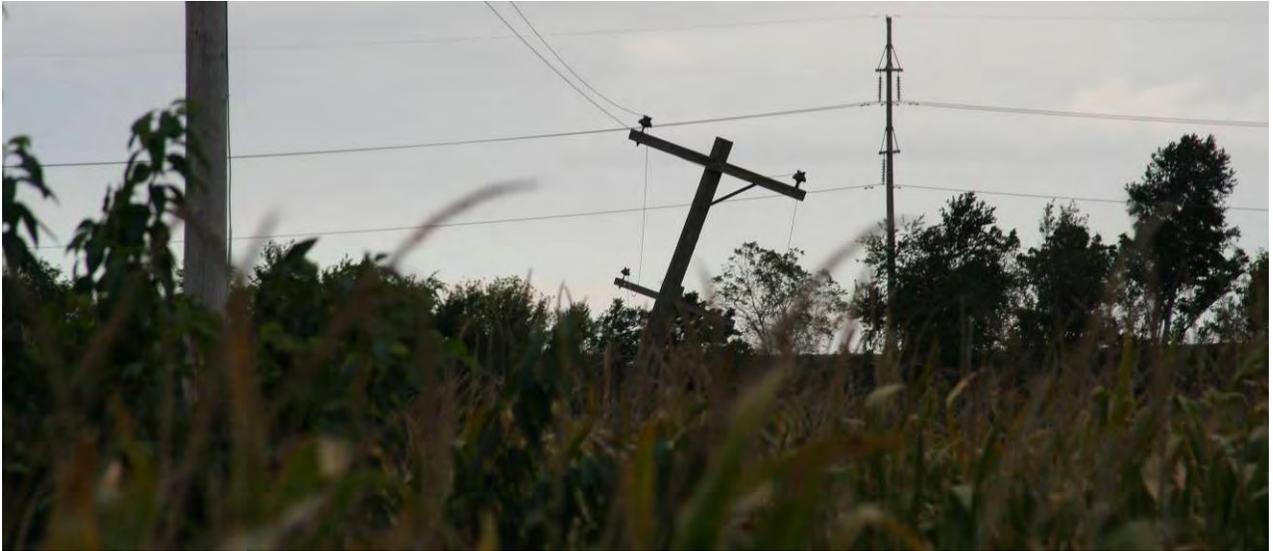
Pic_0113 – picture from road of tops of poles that are leaning in a field on this circuit. According to a local resident they had been leaning for three years. ComEd personnel indicated that the poles would be fixed this year (2006) after the crops had been taken in and the fields had dried out significantly. Dwg B210Y 6 of 17

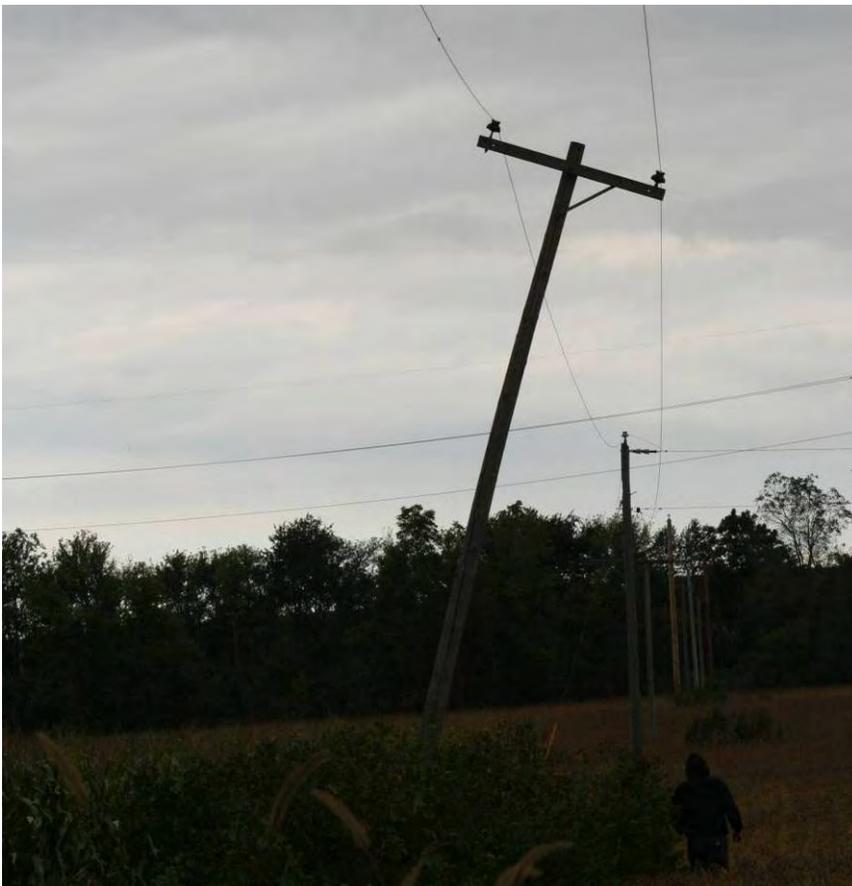
Pic_0114 – While the poles have a pretty good lean the primary doesn't appear to be excessively low. Picture taken from between leaning poles and away from road. Dwg B210Y – 6 of 17

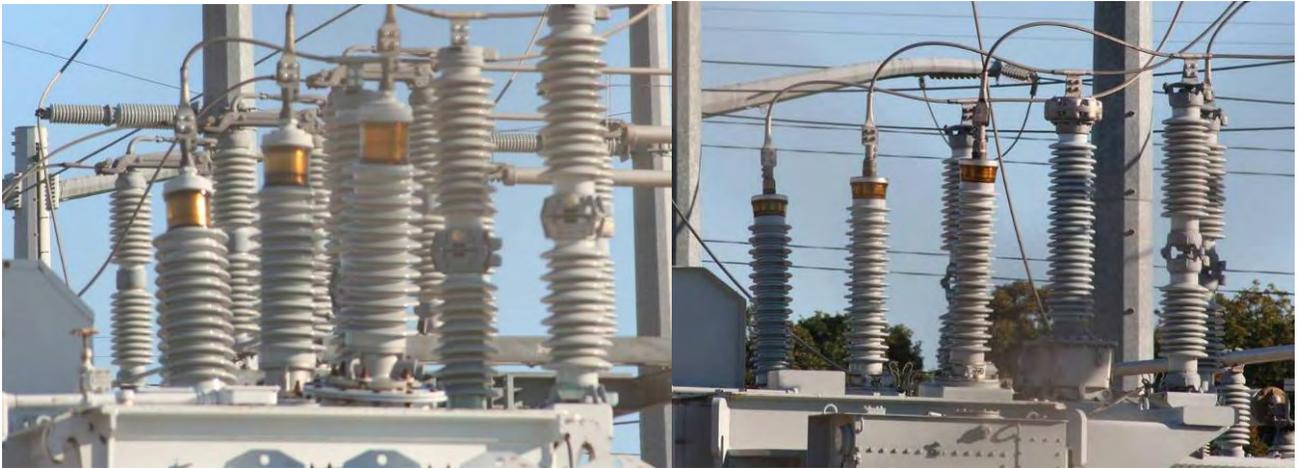
Pic_0131 & 132 – Station yard was clean while insulating oil levels in devices visible from fence line appeared appropriate.

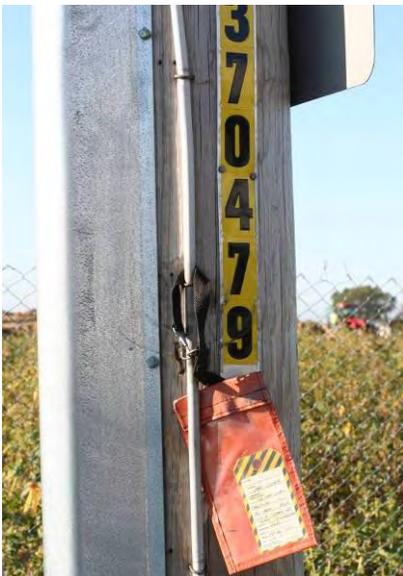
Pic_0134 – Red tag seen on riser/device near riser for W7217 – Red tag dated 3-18-2006 and say's “do not liven” but disconnects appear closed and fuses are in. Dwg W7217 1 of 7

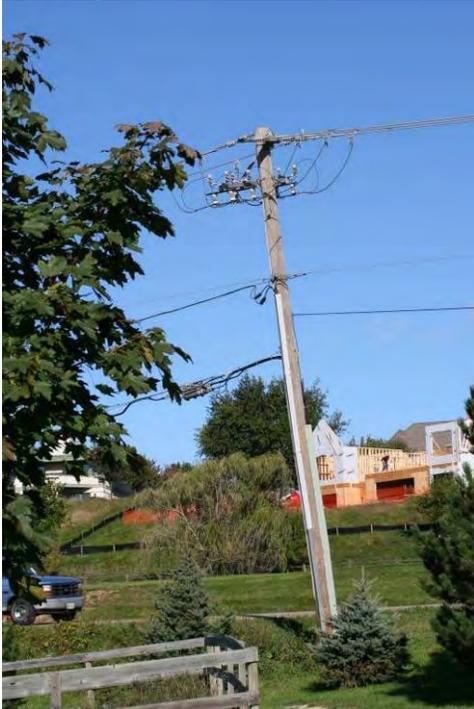
Pic_0141 – Pole has lean – Note that a large number of new evergreen trees are planted below primary between this pole above and next pole east along Boncosky Rd. and will be a source of recurring vegetation management costs in the future. Dwg W7217 3 of 7

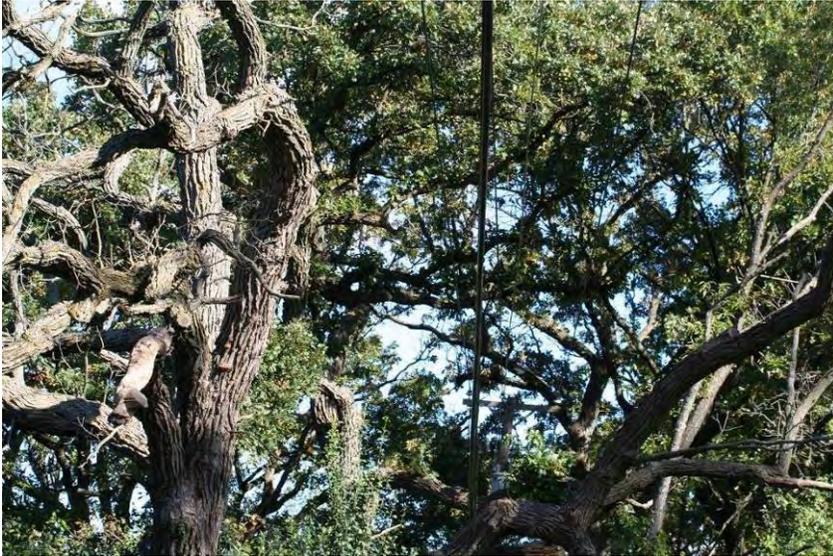
Pic_0145 – dead trees near primary and canopy of vegetation above primary. Dwg W7217 3 of 7

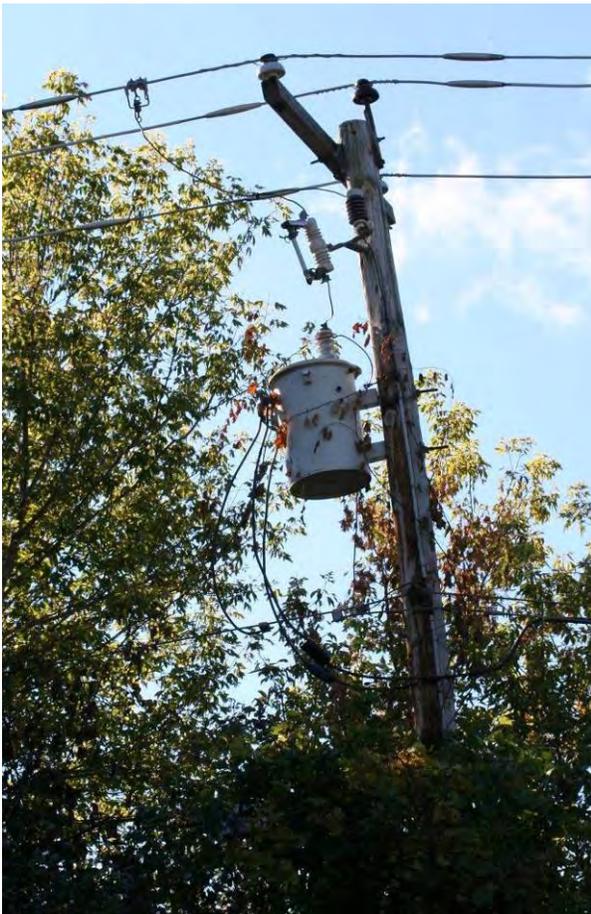
Pic_0147 – Vegetation growing up pole and transformer. Note six splices in primary in close proximity of pole. Dwg W7217 4 of 7

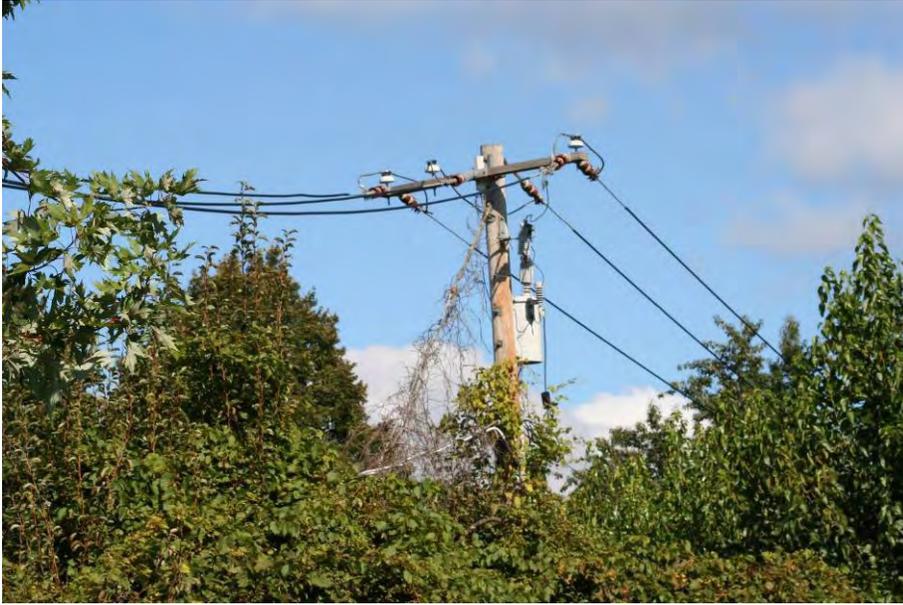
Pic_0153 – Dead vines on guy wire with newer vines growing up pole. Dwg W7217 4 of 7

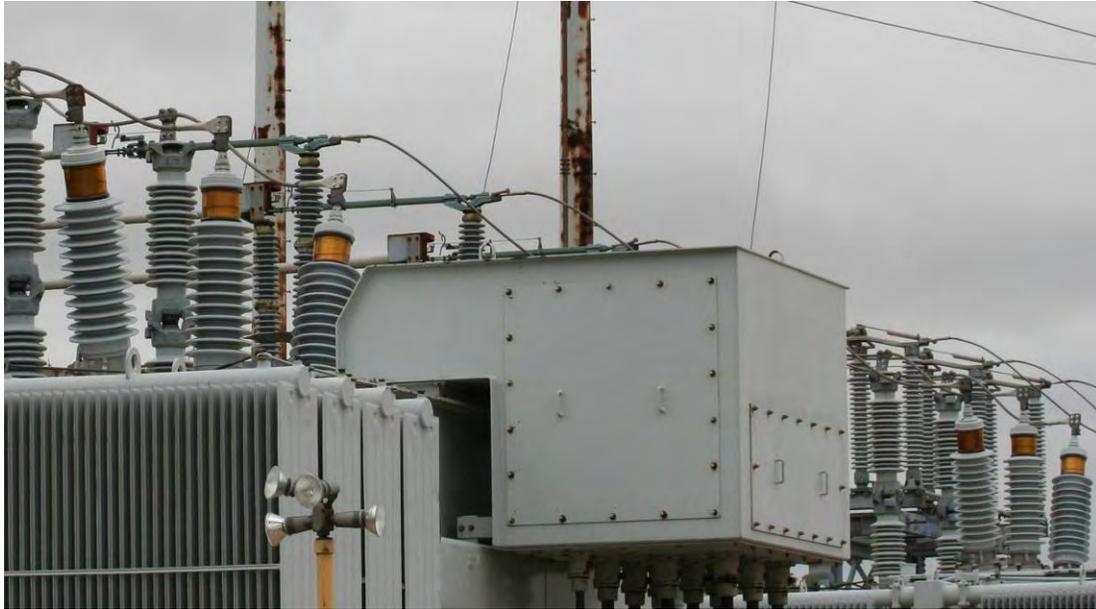
Pic_0212 – Insulating oil levels were observed in substation power equipment – such as the transformer bushings visible above.
