Illinois Commerce Commission
Assessment of Commonwealth Edison Company
Reliability Report and Reliability Performance
for Calendar Year 2005

Pursuant to 83 Ill. Adm. Code 411.140

March 20, 2007

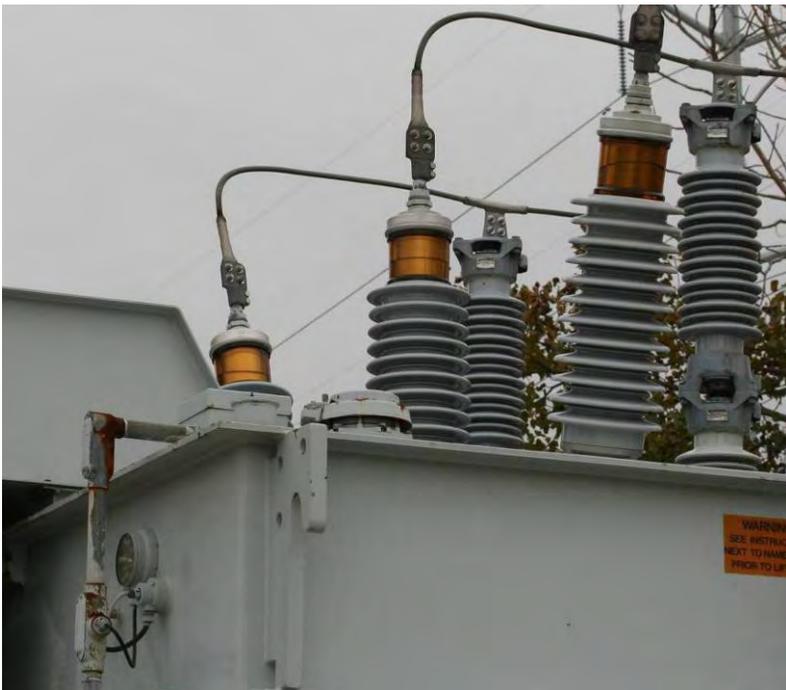
Pic_0292 – Insulating oil levels were observed in power equipment at the substation such as the transformer bushings above.

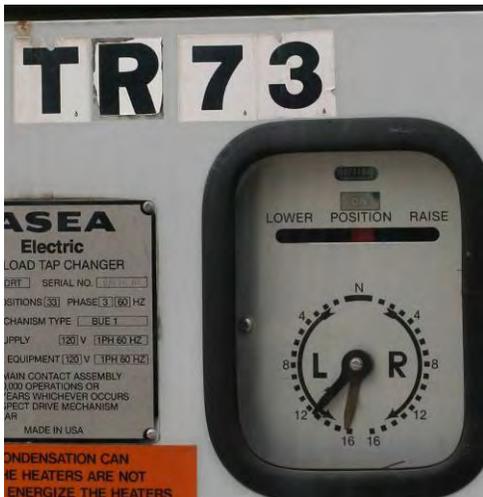
Pic_0302 – On transformer 73 the range of operation is at the very lower end of the load tap changer.
